# Home Inspection Report

3610 Ave Q, Galveston , TX 77550

**Inspection Date:**

Monday January 25, 2021

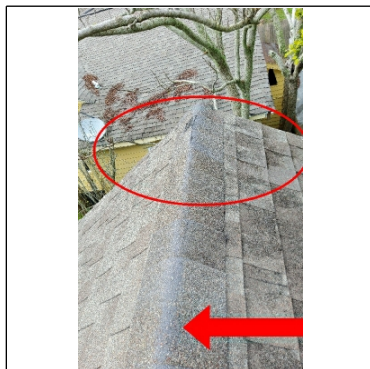
*Comments:* The Texas department of Insurance website states that the roof was re- roofed in 2002 and properly certified with a WPI8. There was wear of the roofing materials consistent with the age. There was granule loss occurring mainly at the ridges. There was also minor damage at the west side of the material from tree limbs overhanging the roof. The flat roof over the rear appears to be nearing the end of its expected lifespan and is recommended to be further evaluated by a qualified roofer for replacement. The pitched roof likely has approximately 5yrs of expected life remaining.

West side had minor damage or wear from the tree limbs, you can also see the granule wear

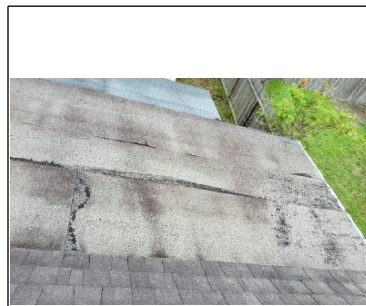
Flat roof has excessive granule loss

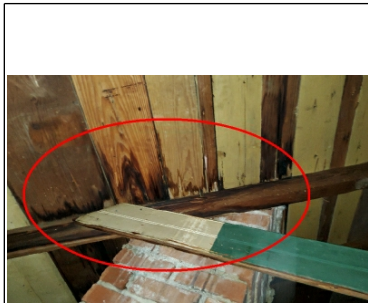
The chimney appeared to have minor leaks when viewed from the interior of the attic, recommend that the flashing be resealed at the penetration of the roof.

Moisture stains at the penetration of the roof from the chimney

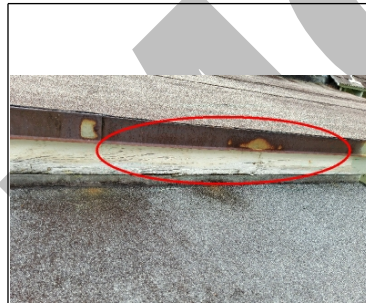
There was minor deterioration of the north side fascia board over the flat roof, recommend that the board be repaired.

Fascia board over the north side of the flat roof is deteriorating

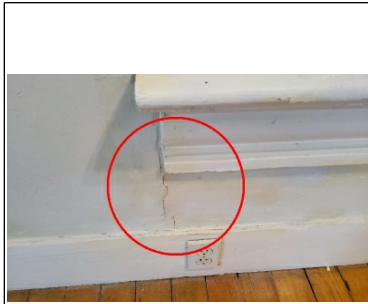
There are multiple cracks in the dry wall or interior walls around the headers of the doorways and window frames which indicates that there has been settlement of the structure. It is recommended that these areas be patched and monitored for further movement.

Example of cracks near windows.

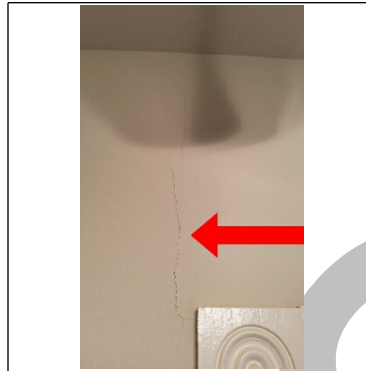
Example of crack above doorway header

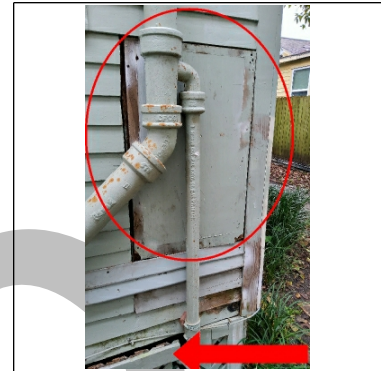
The wood siding exterior wall coverings were in pretty good shape, there was an area at the back northwest corner that had damage and was in need of proper repair. There was deterioration at the exterior window frame of the north wall east window, recommend that the window frame be repaired by a qualified contractor.

Exterior wall at the northwest corner of the home needs properly repaired

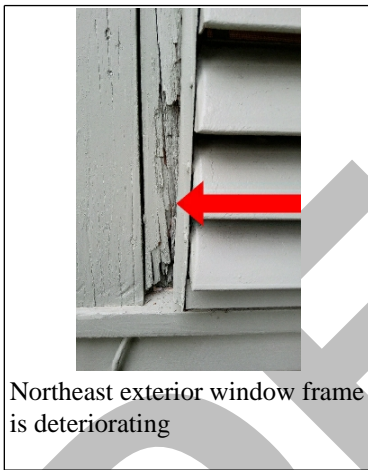
Northeast exterior window frame is deteriorating

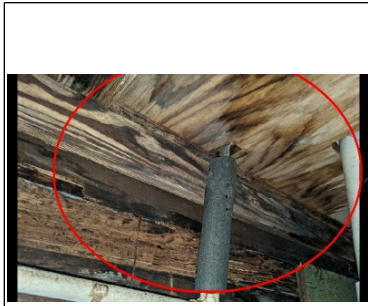
There was moisture damage under the bathroom floor that was viewed from the crawlspace, recommend that the areas be repaired.

Moisture damage under bathroom viewed from the crawlspace

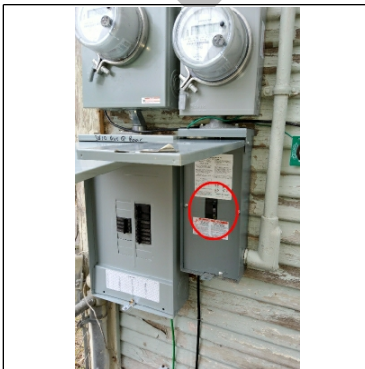
70amp main breaker for front home is located at the rear garage apt in the northwest corner

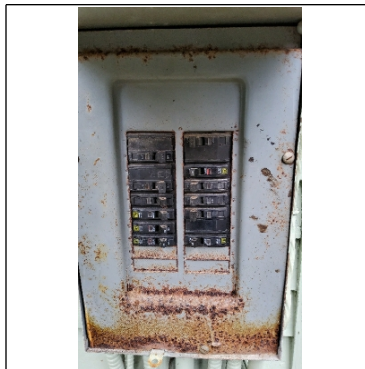
Breaker box is rusted

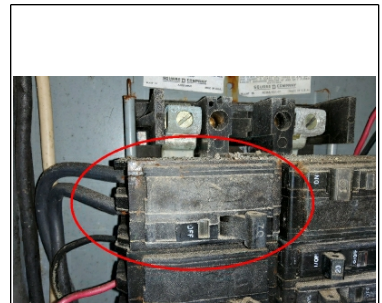
70amp main for the whole house

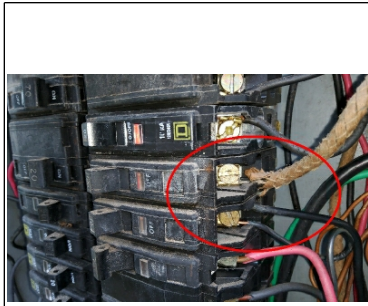
Old cloth wiring and a double tapped breaker

There is a double tapped breaker (two power wires on one breaker) at the right hand side of the box, recommend that each power line be own its own circuit breaker.

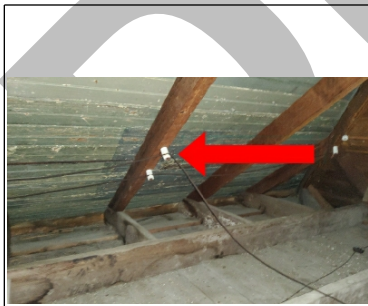
\*the majority of the wiring in the home was knob and tube or cloth wiring, it is highly recommended that the wiring be updated as this wiring is unsafe\*

Old knob and tube wiring in the attic was still in use

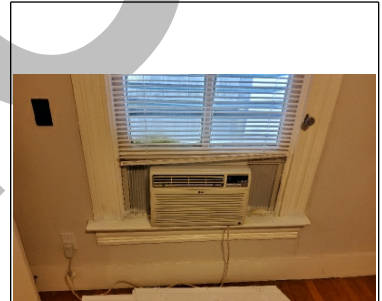
The dining room window unit was not functioning properly on the day of the inspection and only had a temperature reading from the supply of 59°. It is recommended that the dining room window unit be repaired/replaced.

Dining room window unit did not function properly

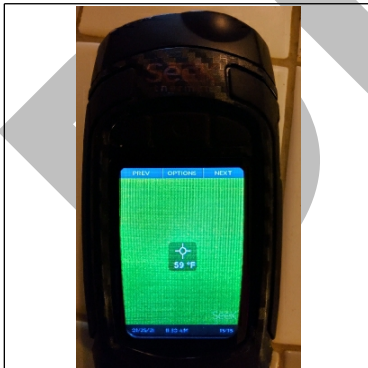
Dining room window unit only had a 59° temperature reading

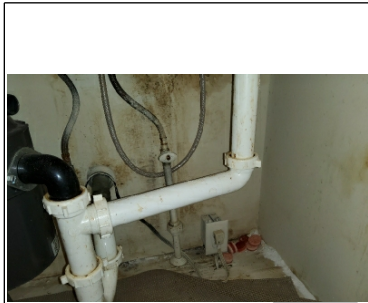
Moisture stains and mild fungal growth under kitchen sink

There is previous moisture damage and mild fungal growth under the kitchen sink, recommend that the area be repaired and cleared of the growth.

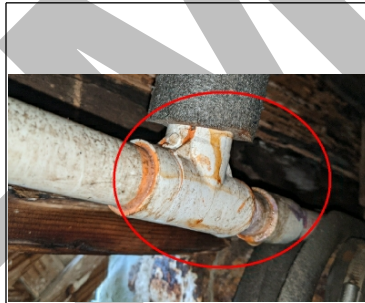
There was a leak in the distribution lines for the bathtub

The tile around the bathtub had multiple cracks, recommend that it be repaired. There was a leak observed while in the crawlspace at the water distribution line for the bathtub, recommend that the lines be repaired by a qualified professional.

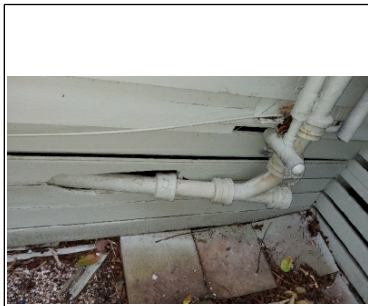
Older cast iron or steel drain waste lines

The majority of the drain lines are the older cast iron or steel lines. These lines have about a 50 year life expectancy and the smaller lines typically need replaced sooner.

It is recommended that a qualified plumber evaluate the drain waste lines for repair/replacement.

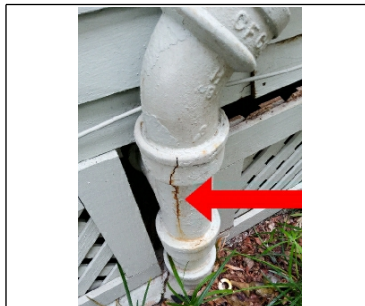
Crack in old cast iron or steel drain waste line

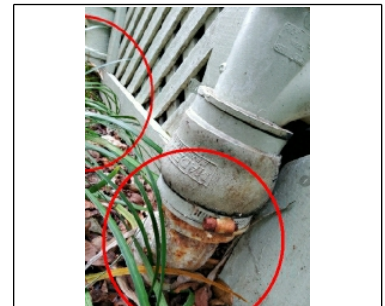
Old cast iron or steel drain line

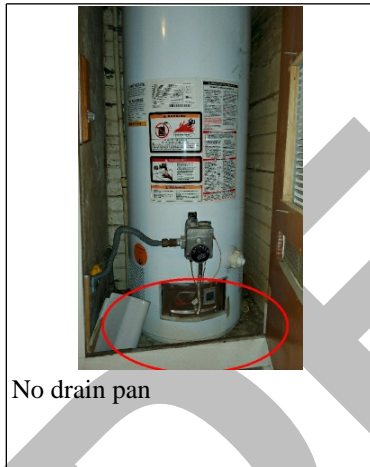
No drain pan

No safety pan and drain was found for the water heater. This should be repaired by the installation of a pan with a drain by a

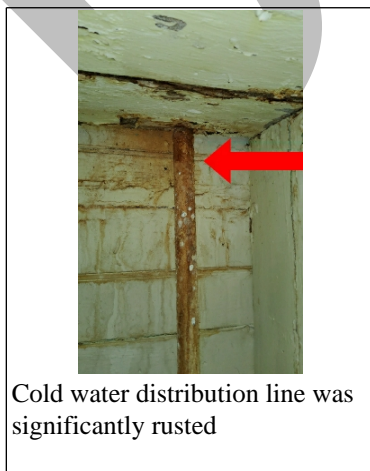
The cold water distribution line under the water heater was significantly rusted, it is recommended that the line be repaired by a qualified professional.

Cold water distribution line was significantly rusted

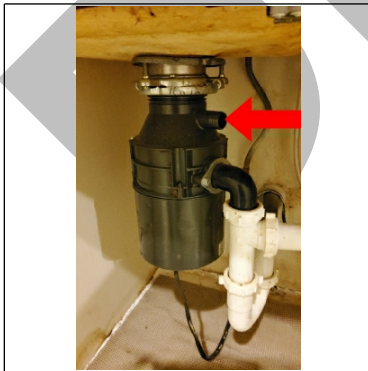
*Comments:* The Amana brand dishwasher was functioning properly on the day of the inspection when run on the "normal" wash setting. The plumbing for the dishwasher was tied into a drain waste line from under the home, it is recommended that the dishwasher drain line be run to the disposal or the drain waste line prior to the trap.

Dishwasher drain line is recommended to be tied in to the disposal
