# Home Inspection Report

3610 Ave Q Rear, Galveston , TX 77550

# PROPERTY INSPECTION REPORT

**Concerning:** 3610 Ave Q Rear, Galveston , TX 77550  
(Address or Other Identification of Inspected Property)

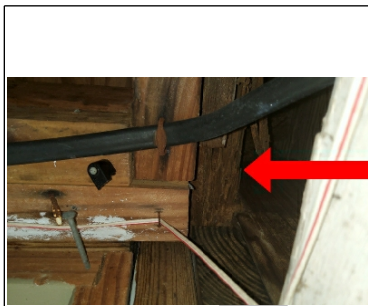
*Comments:* The entry door shows signs of settlement or a foundation issue at the south side. Upon entry in the west garage in the upper right corner there is evidence of either previous wood destroying insect damage or moisture damage. It appears that this damage is the reason for the entry door upstairs being out of square and not operating correctly. It is recommended that a qualified contractor further evaluate this area for repair.

Picture is looking up at the right side just inside the west garage entry, there appears to be previous wood destroying insect damage

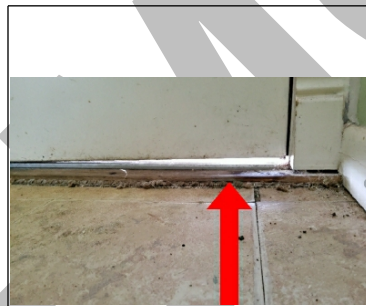
Door at the area above the damage from the wood destroying insects or moisture, you can see there has been a significant drop in the area

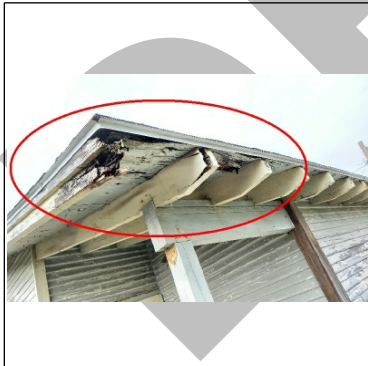
*Comments:* There were multiple roof rafters that extend through the attic and to the eaves that were deteriorating/rotting.

Southeast corner has deterioration of the roof structure

The roof decking was deteriorating/rotting in multiple places as well, recommend that a qualified contractor repair the decking and roof rafters that are damaged.

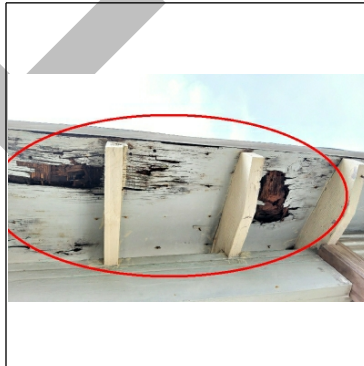
Roof decking at the southeast corner is deteriorating

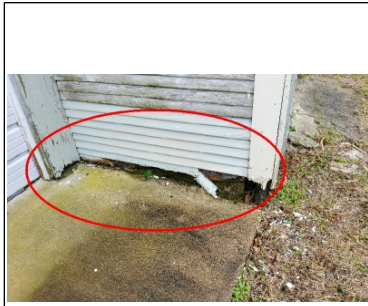
The exterior walls had a few areas that were in need of repair but overall it appeared that the structure was mainly in need of a good painting.

Damage to the exterior siding near garage

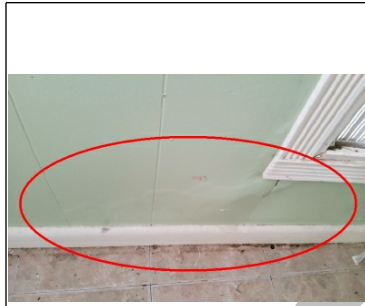
Damage under the south window

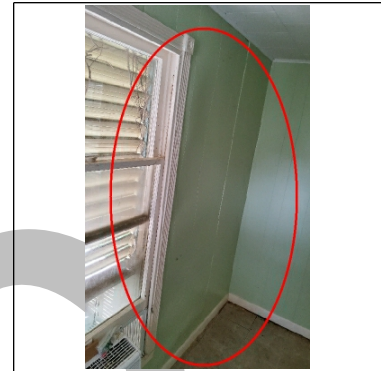
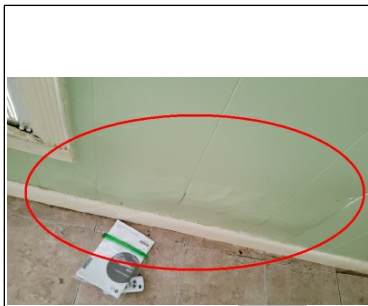
The interior walls at the south side and the north side of the upstairs living area had significant damage behind the wall paneling. It is undetermined whether the damage was caused from previous wood destroying insects or moisture however it is highly recommended that further investigation be done to determine the amount of damage that is behind the wall paneling. The paneling in these areas was ripped significantly.

Damage at the south wall

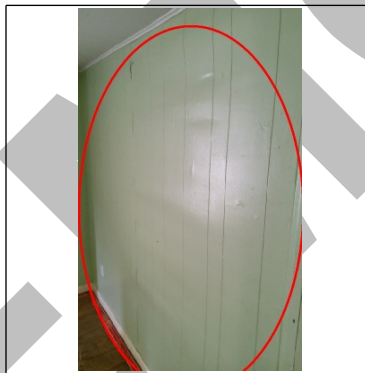
North wall has damage behind paneling

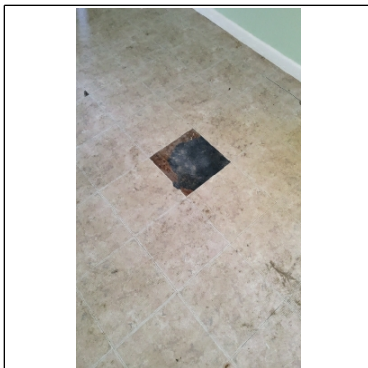
Glue down laminate flooring is in need of repair

The flooring throughout the home was unfinished or in need of repair, recommend that a qualified contractor repair/finish the flooring.

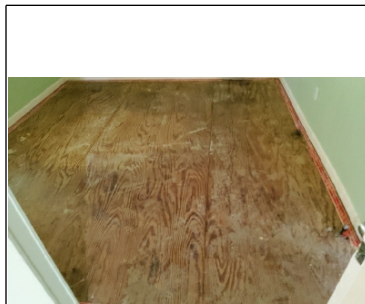
North bedroom carpet has been removed

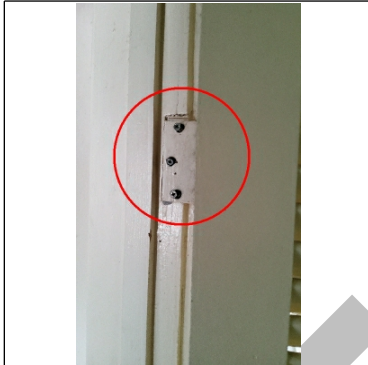
The door at the entryway from the bedroom to the kitchen/bathroom area has loose hinges that are in need of repair so the door will operate correctly.

Upper hinges at door from bedroom to bathroom needs repaired

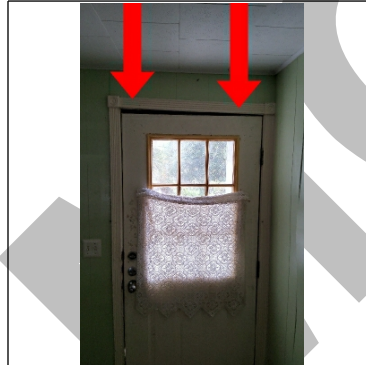
Comments: The front entry door is in need of significant adjustments as previously discussed there has been excessive settling or movement. The door is obviously not square and there is approximately a 2" gap at the bottom right corner of the door.

Front entry door is not square and catches the frame when opened

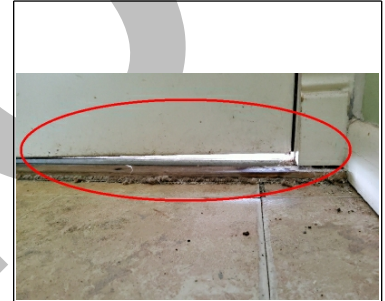
Gap at the front entry door

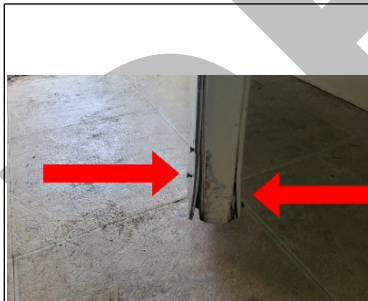
Front entry door paneling is coming loose from the door catching the frame

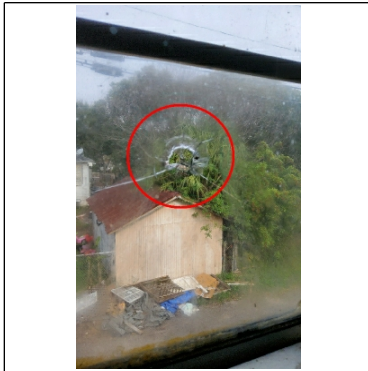
Kitchen window was damaged at the exterior of the upper pane

The kitchen window has a broken or damaged upper pane on the exterior, recommend that the window be replaced as moisture will start to gain entry inside of the glazing and cause damage.

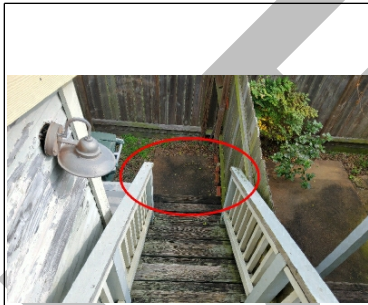
*Comments:* The stairway had the proper headroom, tread depth, riser height, handrail, spindle with and exterior lighting for safety. The only recommendation is that the handrail be continuous all the way to the bottom for safety reasons.

Handrail did not quite reach all the way to the bottom of the stairs

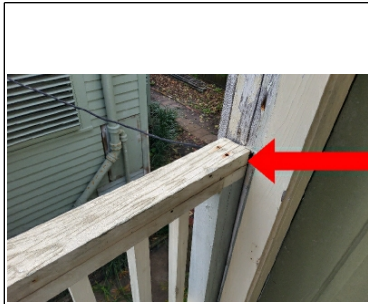
*Comments:* The railing at the front porch where it attaches to the structure was loose and needs to be resecured for stability.

Railing is loose where it attaches to the home

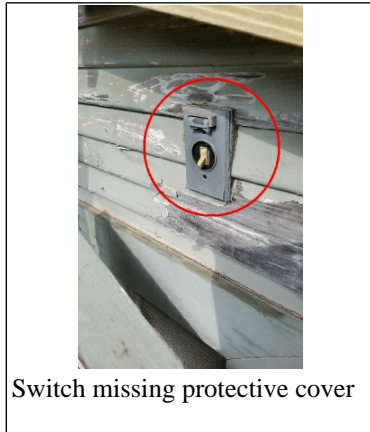
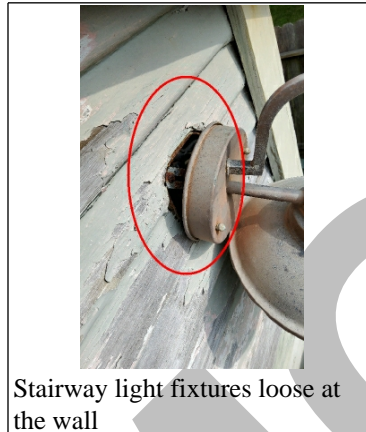
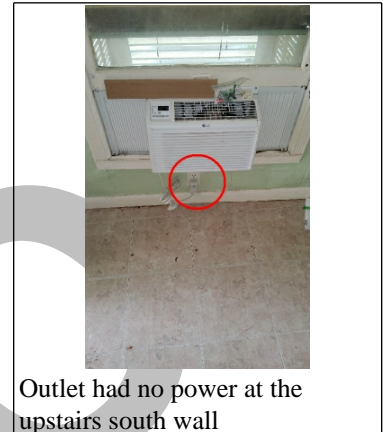
Comments: There was no power to the outlet located on the upstairs south wall where the window unit was plugged in, recommend that a qualified electrician evaluate the circuit for repair.

The exterior light switch at the top of the stairs was missing its weather protective cover, recommend that it be repaired to keep the switch out of the elements.

The light fixtures providing lighting for the exterior stairway did not function and was loose at the wall allowing moisture to enter behind the fixture, recommend that a qualified electrician repair the fixture.

There were multiple outlets in the west garage that were wired reverse polarity (hot/neutral backwards), recommend that the outlets be properly rewired by a qualified electrician.

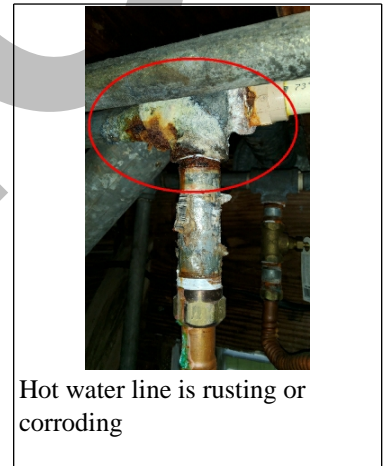
Hot water line is rusting or corroding

The hot water supply line is rusting or corroding, recommend that the line be replaced by a qualified professional

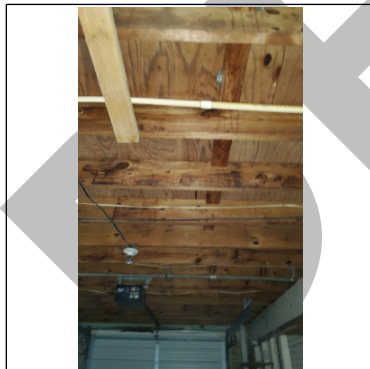
Although it was not a code at the time of the build it is recommended that the garage ceiling be made of a fire rated material such as drywall or fiber cement board to help prevent the spread of fire to the main living area in the event of a fire in the garage.

Recommend that garage ceiling be covered with a fire rated material
