This report was prepared at the request of Eric & Ashley Jenson and presents the results of inspecting the house at 506 Chip St., La Marque, TX 77568. The inspection was completed on 03/23/21 and was performed by Ed Fryday of Space City Inspections, LLC.

PROPERTY INSPECTION REPORT

Prepared For:	Eric & Ashley Jenson (Name of Client)		
Concerning:	506 Chip St., La Marque, TX 77568 (Address or Other Identification of Inspected Property)		
By:	Ed Fryday, Lic #6932 (Name and License Number of Inspector)	03/23/2021 (Date)	
	(Name, License Number of Sponsoring Inspector)

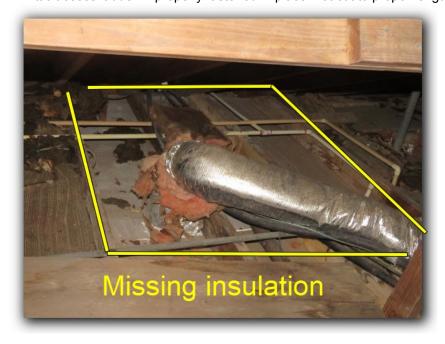
Comments: Abandoned attic fan in attic not inspected

- ☐ Evidence of moisture penetration
- ☐ Damaged and/or missing vent screens
- ☐ Damaged and/or missing roof sheathing
- ☐ Inadequate roof support and/or failed members
- ☐ Attic ventilation fan(s) not working / not accessible limited inspection
- **☑** Some attic floor insulation is missing
- ☐ Some vertical insulation in the attic is missing or has fallen down
- ☐ Less than 30" of clear workspace in front of heater/A-C air handler
- ☐ Inadequate and/or unsafe access to air handler(s) or water heater(s)
- ☐ Attic access ladder improperly fastened in place/ not cut to proper length/ needs hinge repair

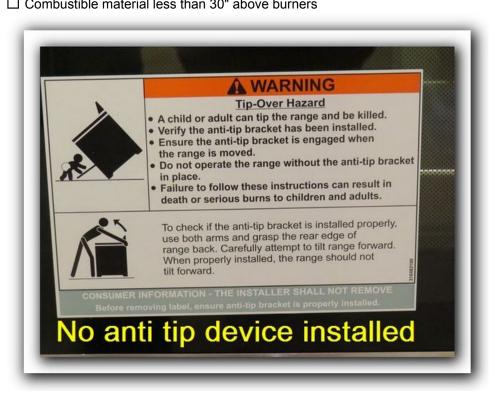
☐ Control knobs are loose and/or missing
☐ Gas leaks were detected around unit
☐ Burners do not operate at high and low settings
☐ Gas shut off valve not readily accessible
☐ Improper materials used for gas connections
☑ No anti-tip device on stove
☐ Deficiencies in the operation of the gas flame
Combuctible material loce than 20" above burners
