I. STRUCTURAL SYSTEMS

According to HAR, the house was built in 1968.

II. ELECTRICAL SYSTEMS

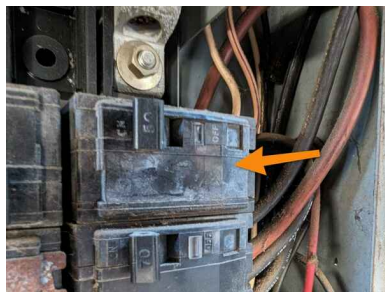
1: Breakers Oversized - A/C condensing unit

The circuit breakers for air conditioning condensing unit was rated higher than the maximum size allowed by the manufacturer of the condensing unit. The breakers should be replaced by the size listed on the manufacturer's nameplates located on the condensing unit.

Obtain Cost Estimate

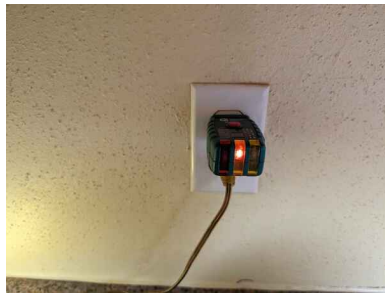
Hall Bath Kitchen

2: Outlet - Ungrounded

A three prong outlet that was not grounded properly was observed and the outlet needs to be repaired. It is recommended that an electrician be contacted to repair the outlet in an approved manner.

Obtain Cost Estimate

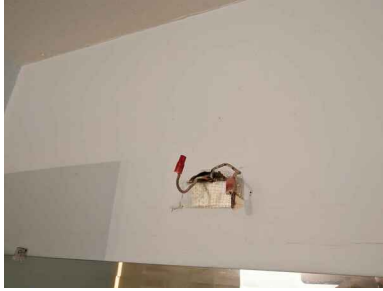
Master Bedroom

3: Light Fixture - Missing

A light fixture was missing.

Obtain Cost Estimate

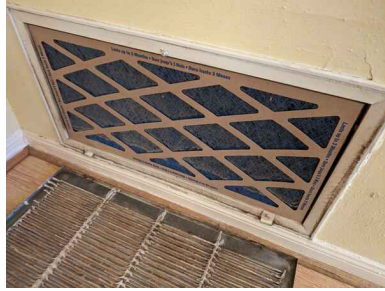
1: Air filters - Dirty

The filters were dirty and need to be replaced. Dirty filters can allow the evaporator coils to become dirty along with the ductwork systems, which can affect the performance of the systems.

Obtain Cost Estimate

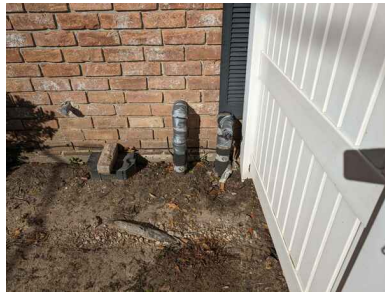
Unable to detect which one is for the house

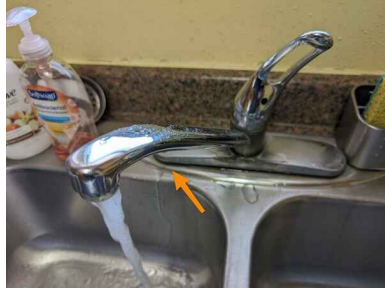
Kitchen

1: Faucet - Drip leaking

A drip leak that needs to be repaired was observed at a faucet.

Obtain Cost Estimate

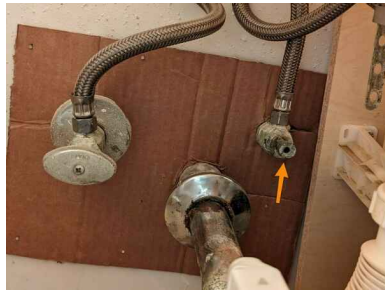
Master Bath

2: Shut Off Valve - Missing handle

The handle for a water shut-off valve was missing.

Obtain Cost Estimate

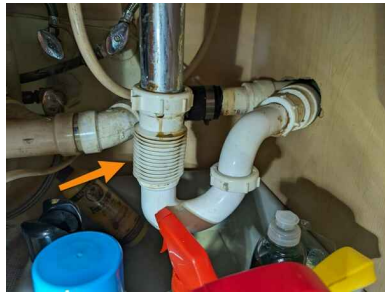
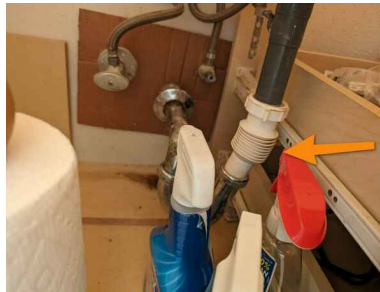
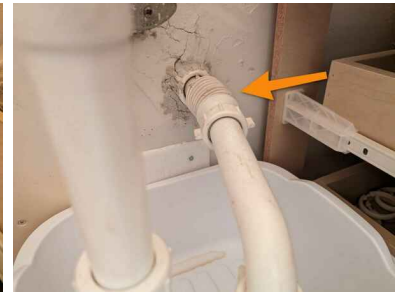
Kitchen Master Bath Bathroom

3: Bellows Drain Piping

Bellows piping was used on a portion of the drain piping. In the plumbing industry the use of bellows piping is considered amateur workmanship as bellows piping is prone to frequent clogs. Consideration should be given to replacing the Bellows piping.

Obtain Cost Estimate

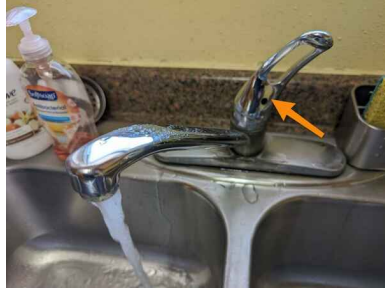
4: Valve Handle loose

The valve handle was loose and needs to be secured at the faucet.

Obtain Cost Estimate

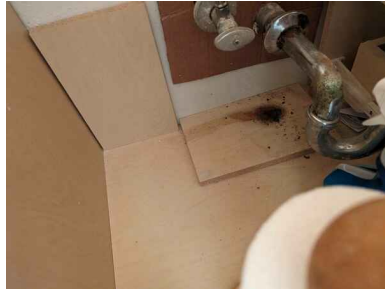
Bathroom

5: Water Stains/Damage Under Sink

Evidence of a previous leak was visible under a sink, where water stains/damage were visible at the bottom of the cabinet. No leaks were visible at the time of the inspection.

Further investigation is recommended.

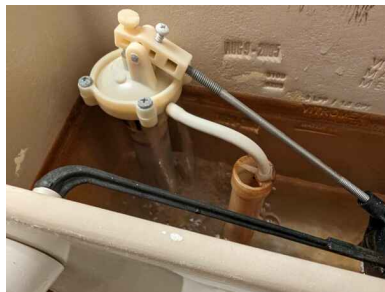
6: Toilet - Fill valve leaking

The toilet fill valve was leaking inside the toilet tank and is in need of replacement. A leaking fill valve will allow cross contamination in the freshwater supply.

Obtain Cost Estimate

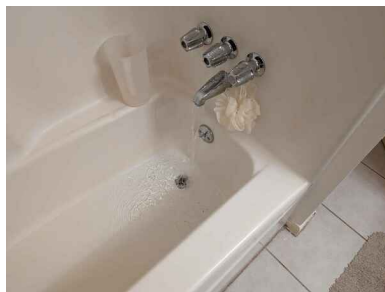
Bathroom

7: Tub/Shower - Water leaks past diverter

The diverter valve was leaking water past the valve when the valve was turned to the shower.

Obtain Cost Estimate

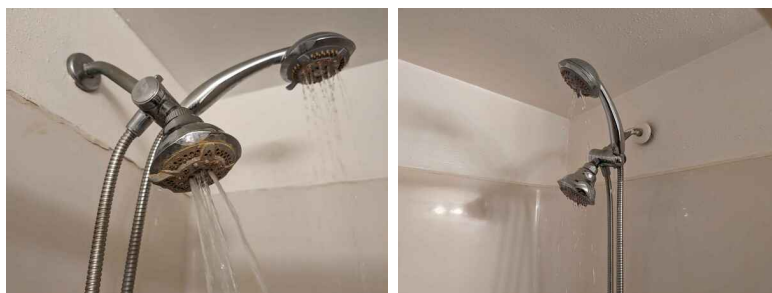
Bathroom Master Bath

8: Shower/Tub - Shower head clogged

The shower head was significantly clogged and needs to be cleaned/replaced.

Obtain Cost Estimate

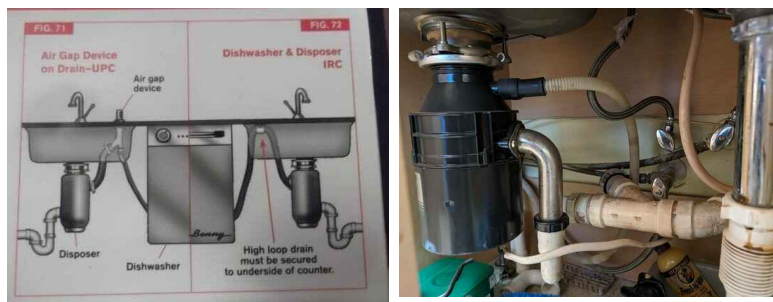
1: No Anti-Siphon

The drain line under the sink was not equipped with an anti-siphon device, nor was it looped up so that the top of the loop is at least six inches above the entrance of the drain line into the disposal. It is recommended at least that the drain line be looped to prevent the water from the garbage disposal from siphoning back into the dishwasher, or an anti-siphon device installed.

Obtain Cost Estimate

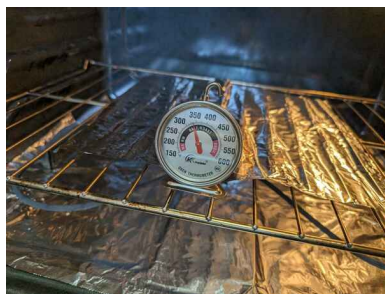
1: Range - No anti-tip

The range was not equipped with an anti-tip device.

Obtain Cost Estimate

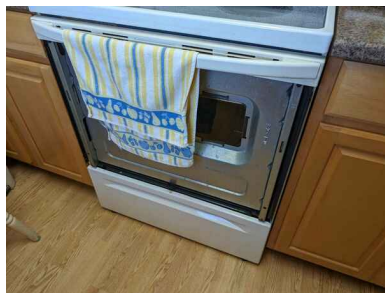
2: Door - front missing

The oven door cover was missing and needs to be replaced.

Obtain Cost Estimate
