**Elevation Readings  
14333 Memorial Drive #75**

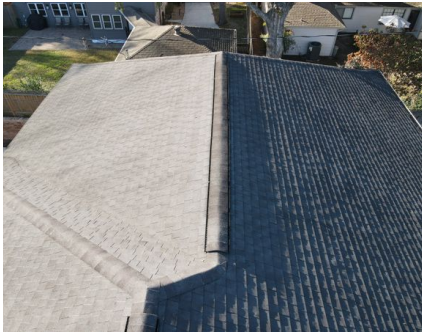
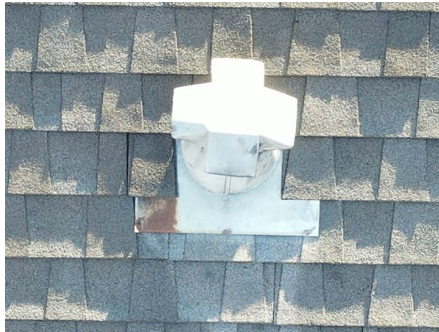
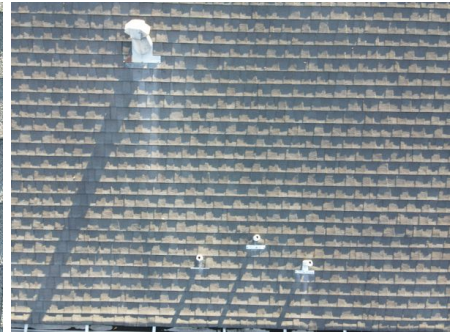
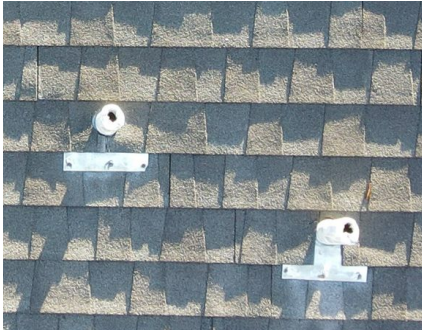
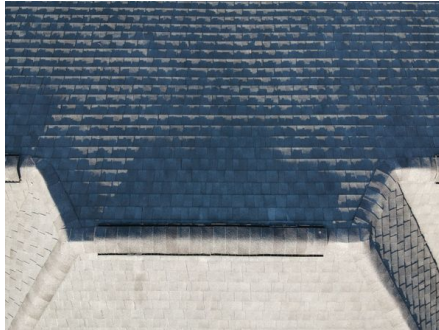
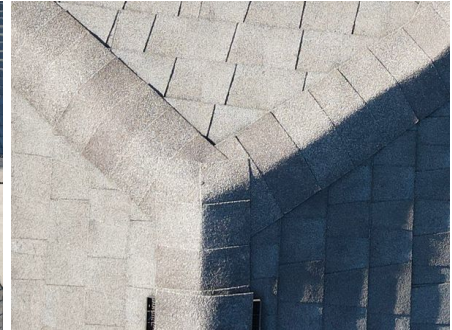
**Wear and Deterioration: Composition - Some**

Nail Heads not Sealed, Discolored

The composition roof surface was showing evidences of some deterioration of the roof surface as described above and shown below.

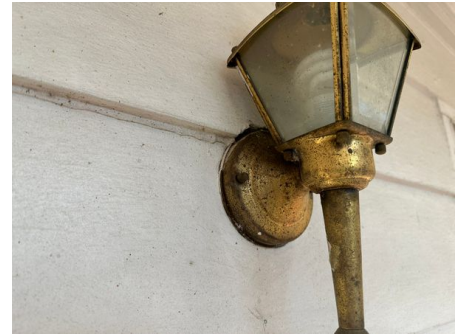
### 7.1.1 Water Penetration

#### VULNERABILITY TO WATER PENETRATION

Sealants deteriorated/missing

A substantial vulnerability to water penetration was observed at penetrations/openings through the exterior building envelope, and it is recommended that all penetrations/openings be sealed against water penetration. Typical examples on a structure may include light fixtures, air conditioning refrigerant lines, water piping, gas piping, vent caps, windows, doors, expansion joints, etc. Below is a representative sample of locations and/or photographs showing some, but not necessarily all, locations where there is a vulnerability to water penetration. Have a contractor provide a cost estimate to seal all vulnerable areas on the exterior building envelope against water penetration and/or open up any clogged weepholes in the veneer.

**Obtain Cost Estimate**

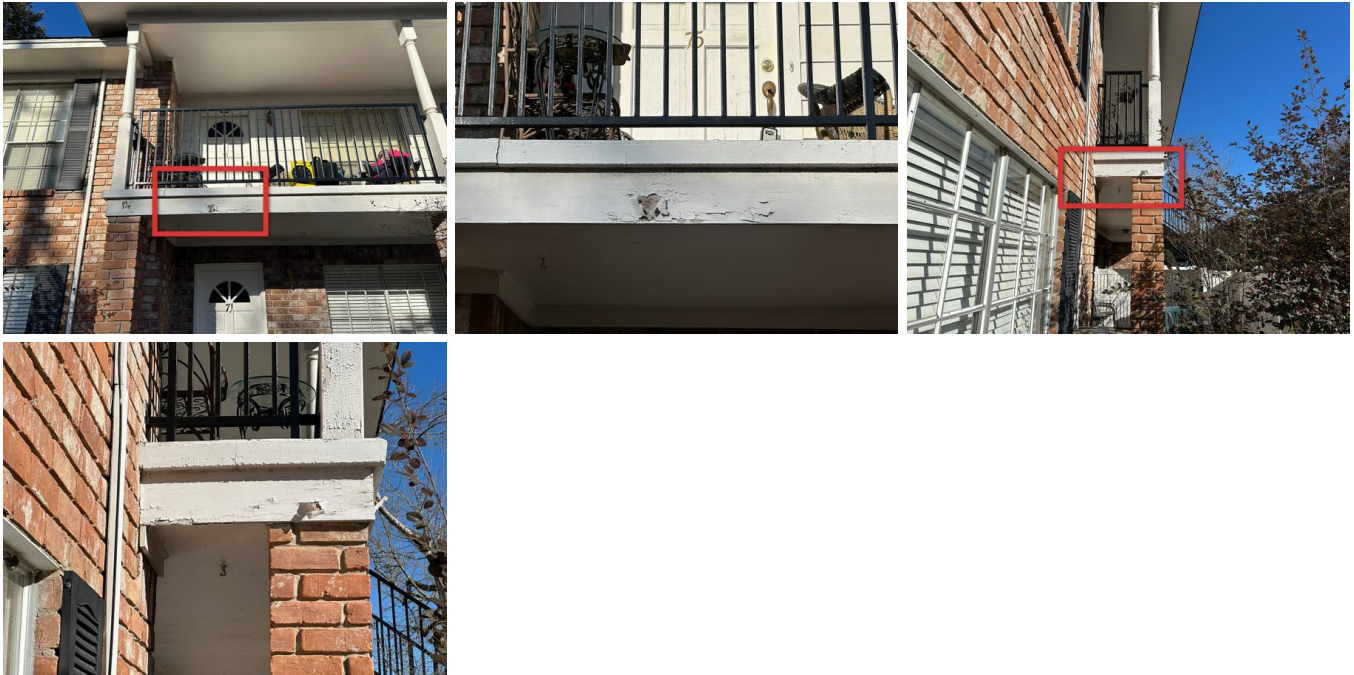
### 10.4.1 Wood Rot

#### **WEATHERED**

We observed weathered wood at the exterior of the house. The wood does not appear to be rotted at this time, but if the wood is not sealed and painted, it can be anticipated that deterioration will occur quickly, with replacement of the wood becoming necessary. Further investigation with a contractor is recommended to obtain a cost estimate to seal and paint the exterior wood.

**Obtain Cost Estimate**

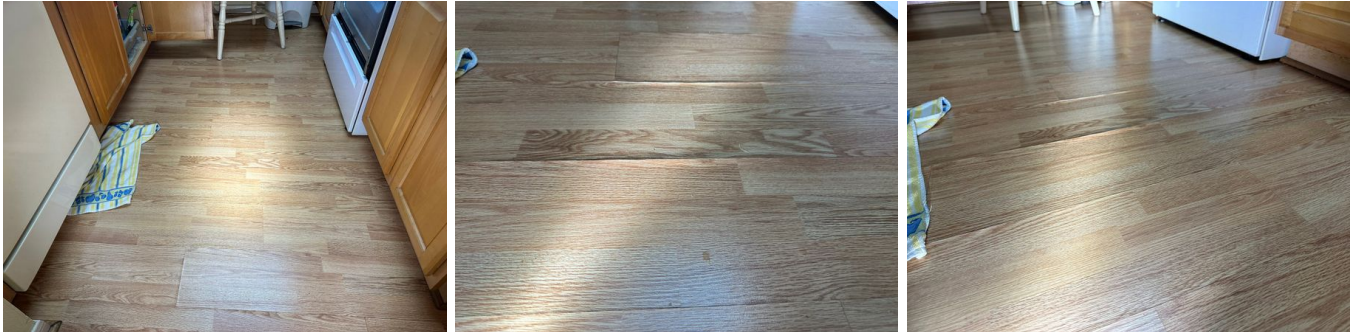
11.4.1 Floor coverings

**VINYL FLOOR CUPPING**

KITCHEN

The floor was observed to be cupped, with the edges of the boards curling downwards into a “cupping” effect. This condition is typically caused when the floors have excessive moisture in them. Potential sources of moisture could be coming from the dishwasher or the kitchen sink. Further investigation with a floor specialist and/or a service company is recommended to determine the source of the condition, and to provide a cost estimate for any needed repairs.

**Obtain Cost Estimate**

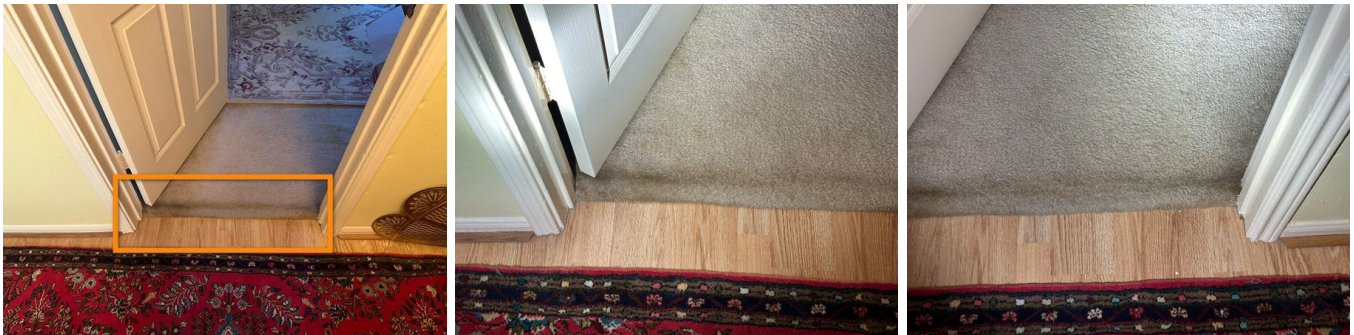
11.4.2 Floor coverings

**CARPET STAINED**

NORTH BEDROOM

The carpet was observed to be stained, and it is recommended that it be cleaned or replaced.

**Obtain Cost Estimate**
