North Star Inspections, Inc.

**13606 Crystal Palace
Pearland, TX 77584**

**Prepared Exclusively For:
John & Diana Derbas**

PROPERTY INSPECTION REPORT FORM

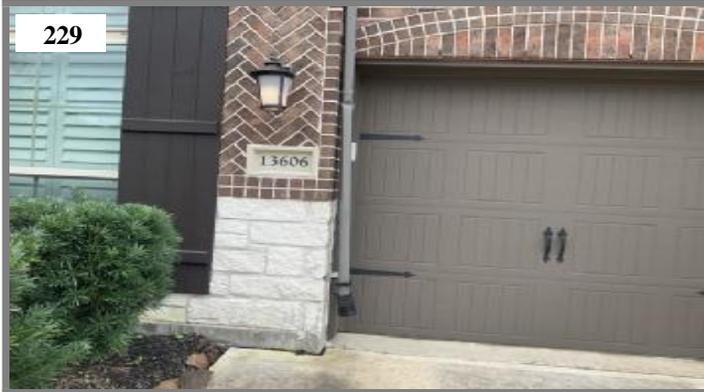
Damaged gutter downspout left side of garage

There is a damaged gutter on the left side of the garage.

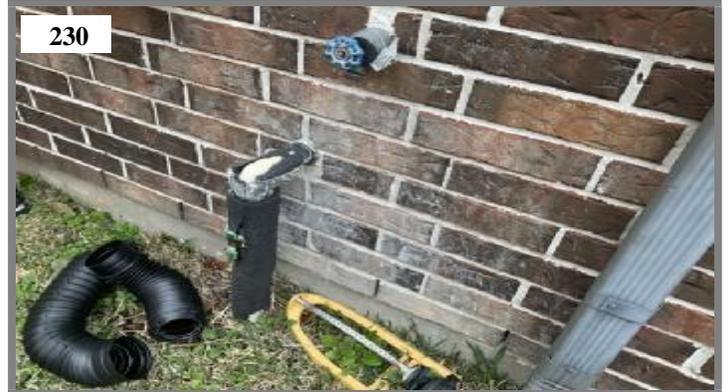
On the left side of the home there is paint on the brick under the hose bib from the painters cleaning their paint brushes .
 The exterior walls are in good overall condition .

Paint on the brick from the painters cleaning the paint brushes

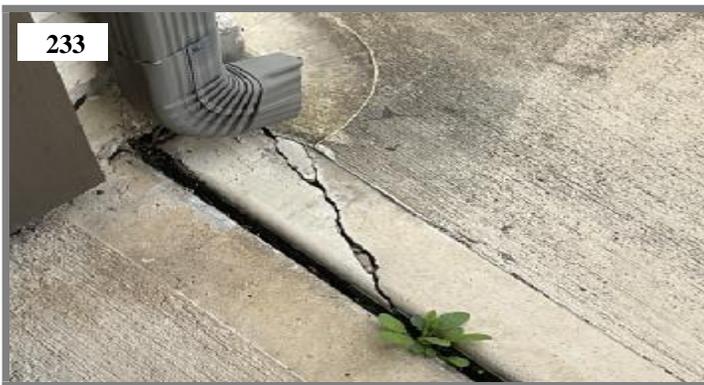
Crack in the driveway at the top by the garage door

At the top of the driveway left side there is a corner crack in the driveway .

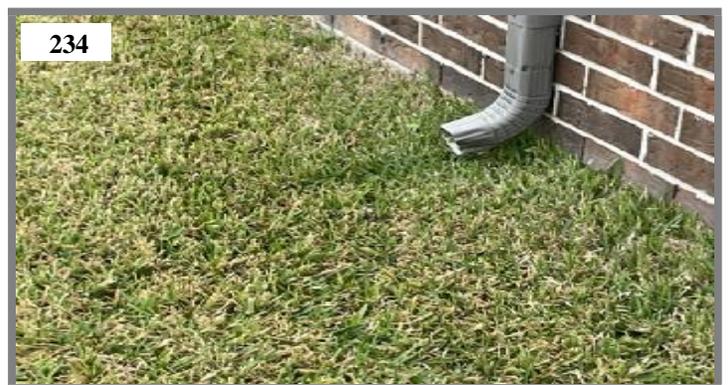
Splash block needed

D - Splash pads or other devices need to be added where missing to direct flow from the gutters away from the foundation. Moisture at the foundation can cause foundation movement in expansive soils.

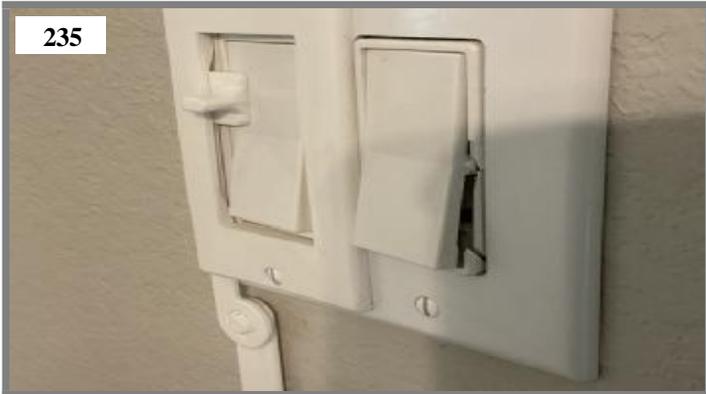
235

Broken plastic light switch in the art studio area

There is a damaged light switch (cracked plastic) in the Art Room .

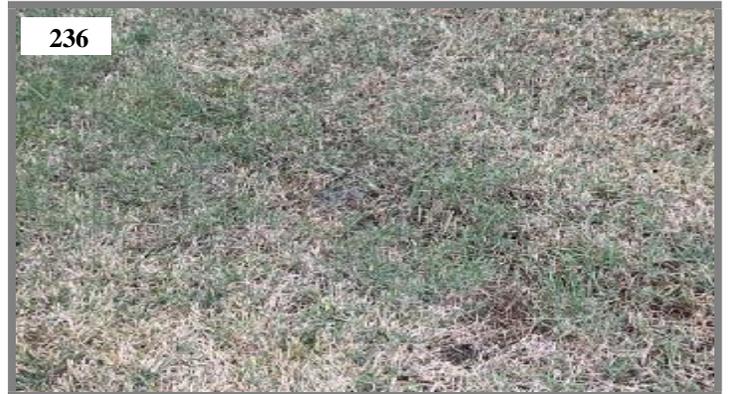
236

Drainage swale in the backyard holding water slightly and needs a slight correction

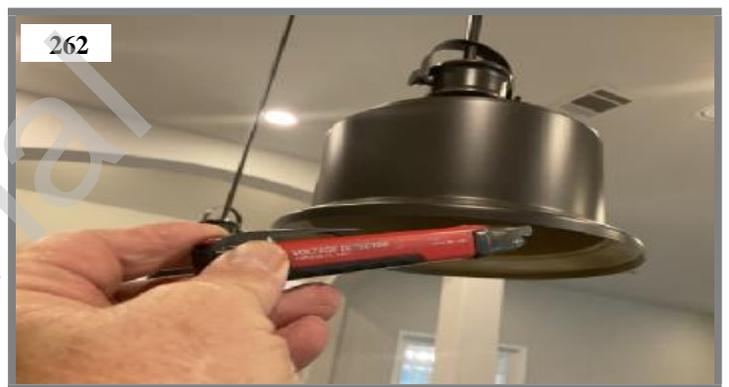
Kitchen island light missing bulb only

The light over the kitchen island is missing a bulb only.

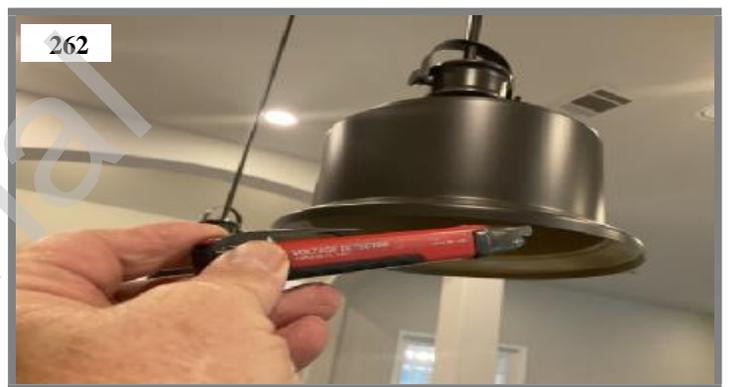
Kitchen island light missing bulb only
