## **PROPERTY INSPECTION REPORT**

**Report#:** 005329

**Concerning:** 1650 Rancho Grande, Houston TX 77049  
(Address or Other Identification Inspected Property)

**By:** John Bennett License# 7171 10/31/23  
(Name and License Number of Inspector) (Date)

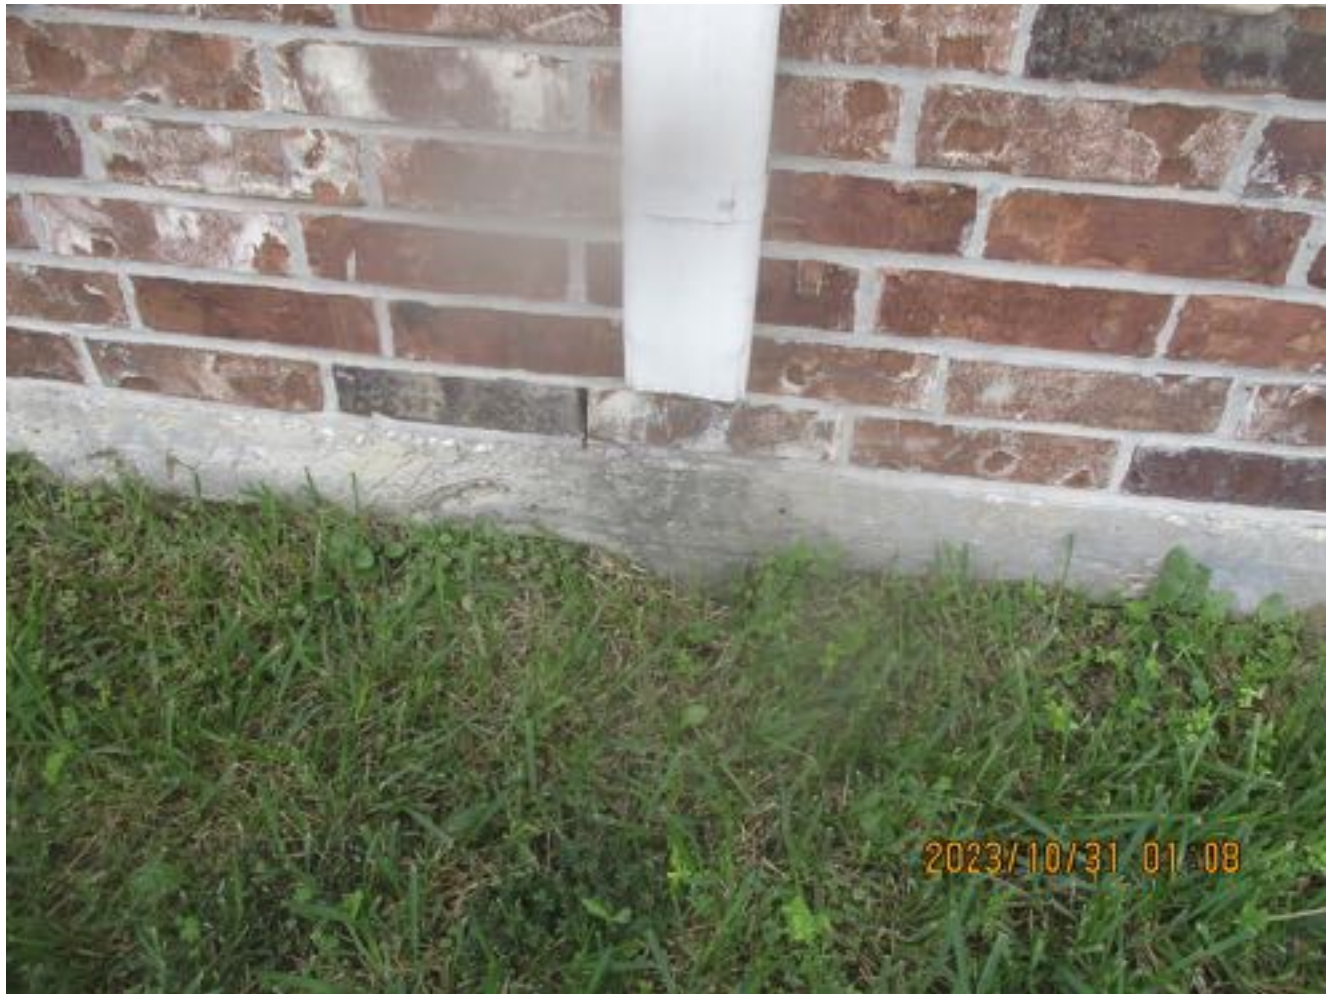
Picture 1

*Gutter downspout on the left exterior was missing the kick-out elbow (Picture 1) and downspouts were missing the splash blocks or extensions that reduce soil erosion next to the foundation (Picture 2).*

1. Grading & Drainage: Gutter downspout on the left exterior was missing the kick-out elbow (Picture 1) and downspouts were missing the splash blocks or extensions that reduce soil erosion next to the foundation (Picture 2).

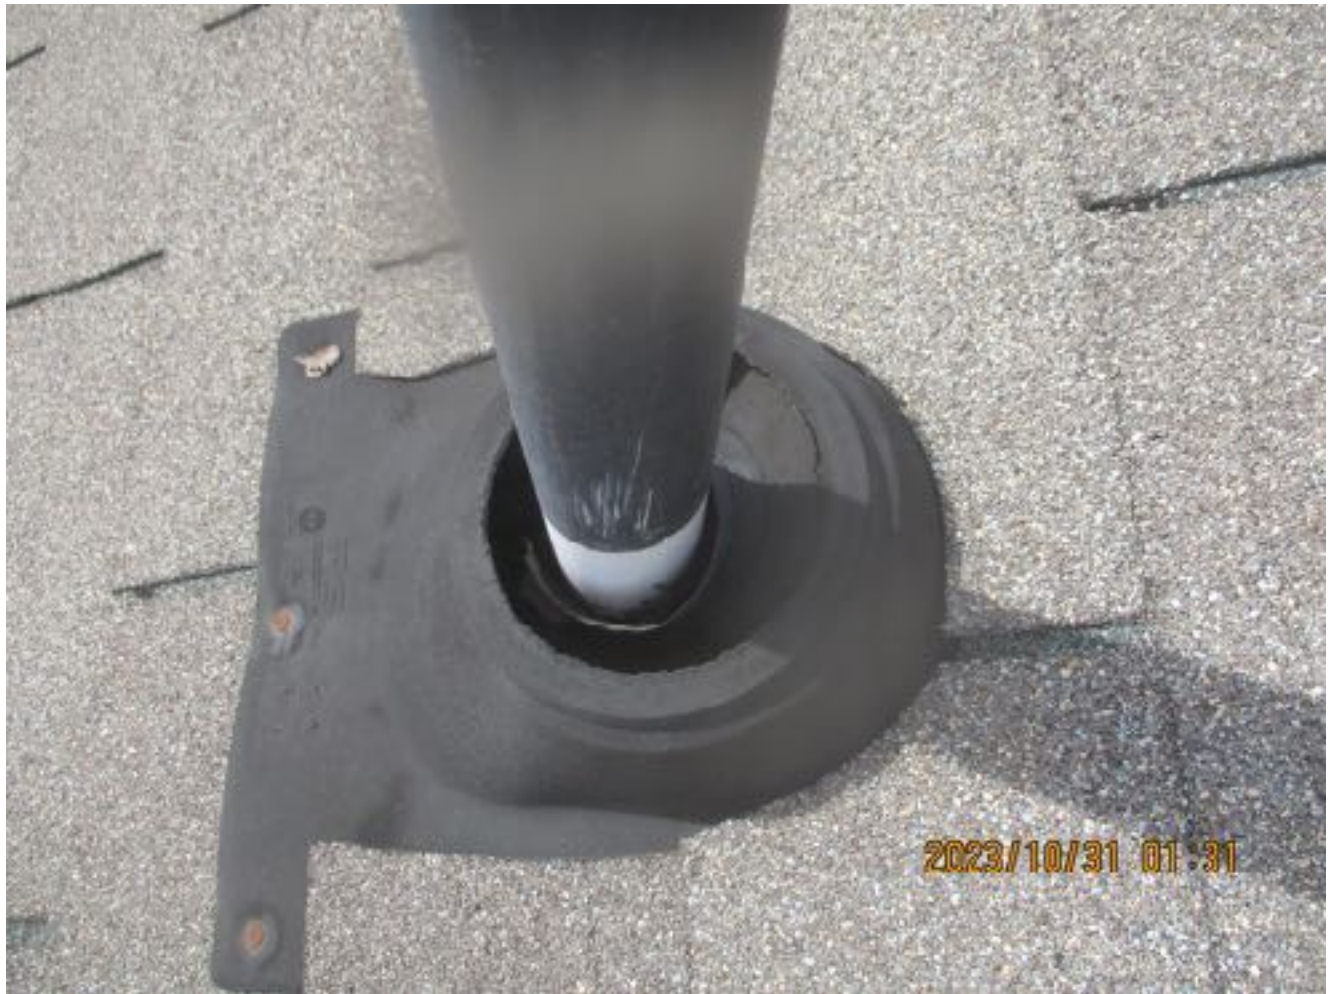
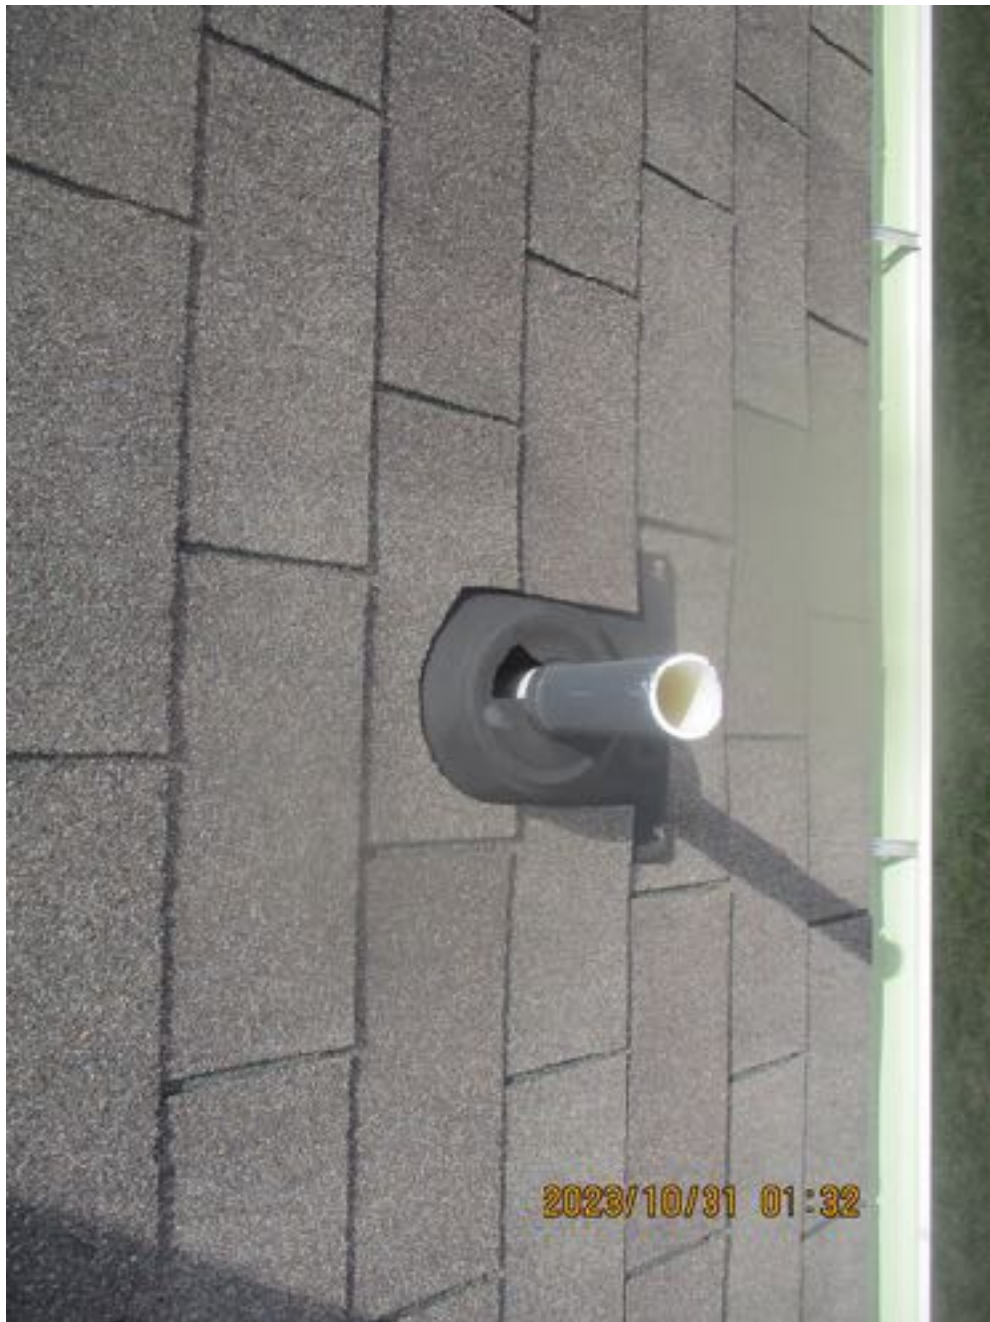
Picture 3

2. Roof Covering: Roof covering had damaged rubber boots on the vent stacks (Picture 3&4). Left roof plane had lifted shingles indicated by loose tabs in a zipper fashion from the roof edge to the ridge and fasteners backing out lifting the tabs of the shingle (Picture 5). All exposed nail-heads will need to be sealed with roofing compound (Picture 6). Satellite dish on the left roof-lane will need to be removed when no longer in use and shingles re-sealed (Picture 7). A roofing professional will need to be consulted to further evaluate the roof covering.

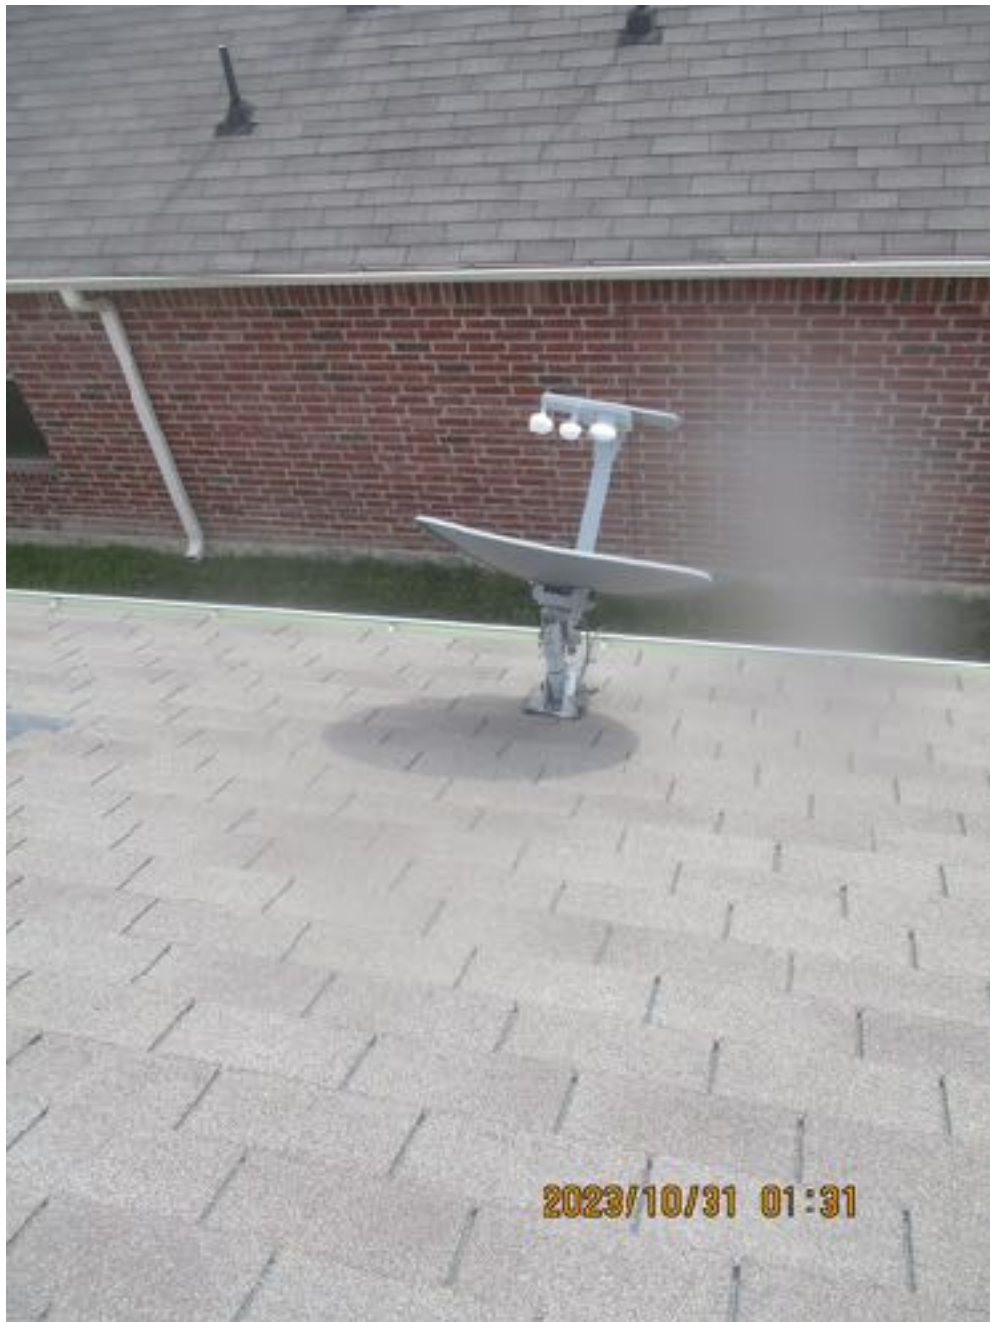
Picture 7

I=Inspected		NI=Not Inspected		NP=Not Present		D=Deficiency		Inspection Item
I	NI	NP	D					
<input checked="" type="checkbox"/>	<input type="checkbox"/>	<input type="checkbox"/>	<input checked="" type="checkbox"/>	<b>C. Roof Covering</b> (If the attic is inaccessible, report the method used to inspect.)				
Type of Roof Covering: Three Tab Shingles								
Roof Inspected By: Walked on Roof								
Type of Fasteners: Nails								
Viewed From:								
<i>Comments:</i>								
<i>Roof covering had damaged rubber boots on the vent stacks (Picture 3&amp;4). Left roof plane had lifted shingles indicated by loose tabs in a zipper fashion from the roof edge to the ridge and fasteners backing out lifting the tabs of the shingle (Picture 5). All exposed nail-heads will need to be sealed with roofing compound (Picture 6). Satellite dish on the left roof-lane will need to be removed when no longer in use and shingles re-sealed (Picture 7). A roofing professional will need to be consulted to further evaluate the roof covering.</i>

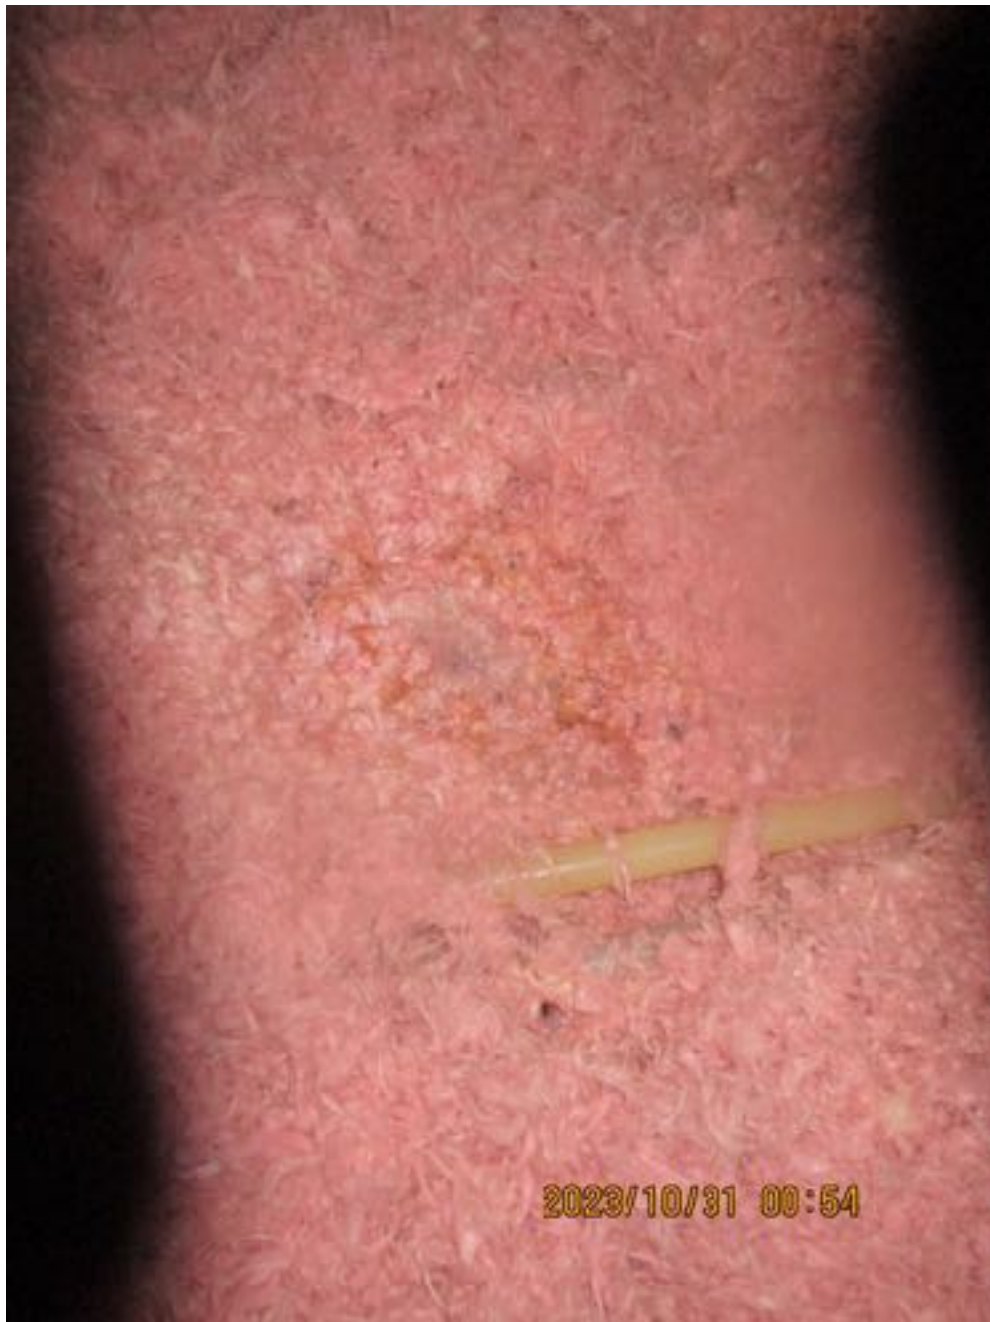
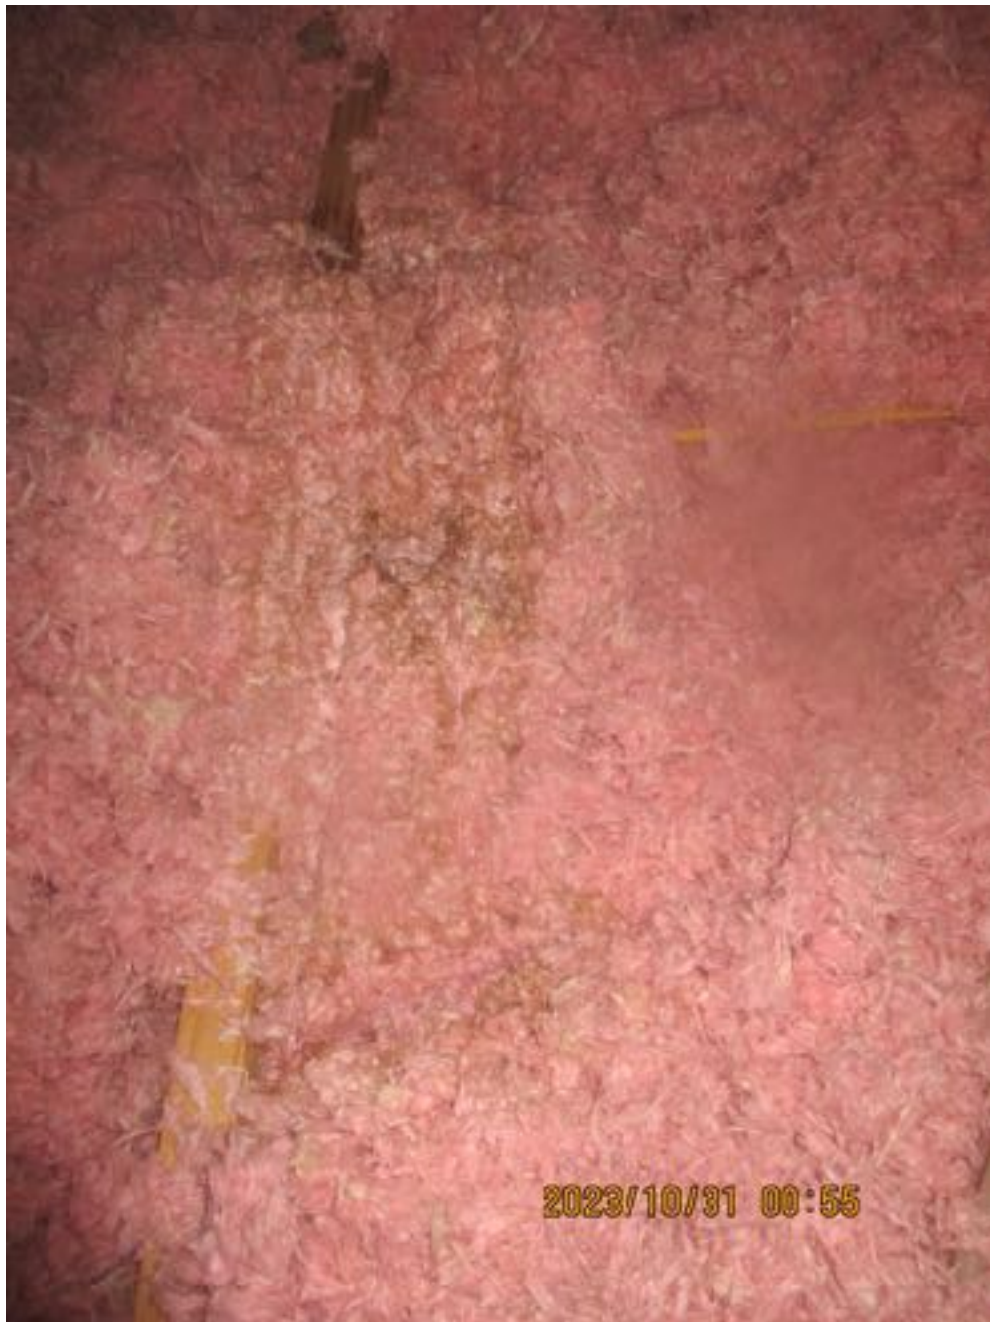
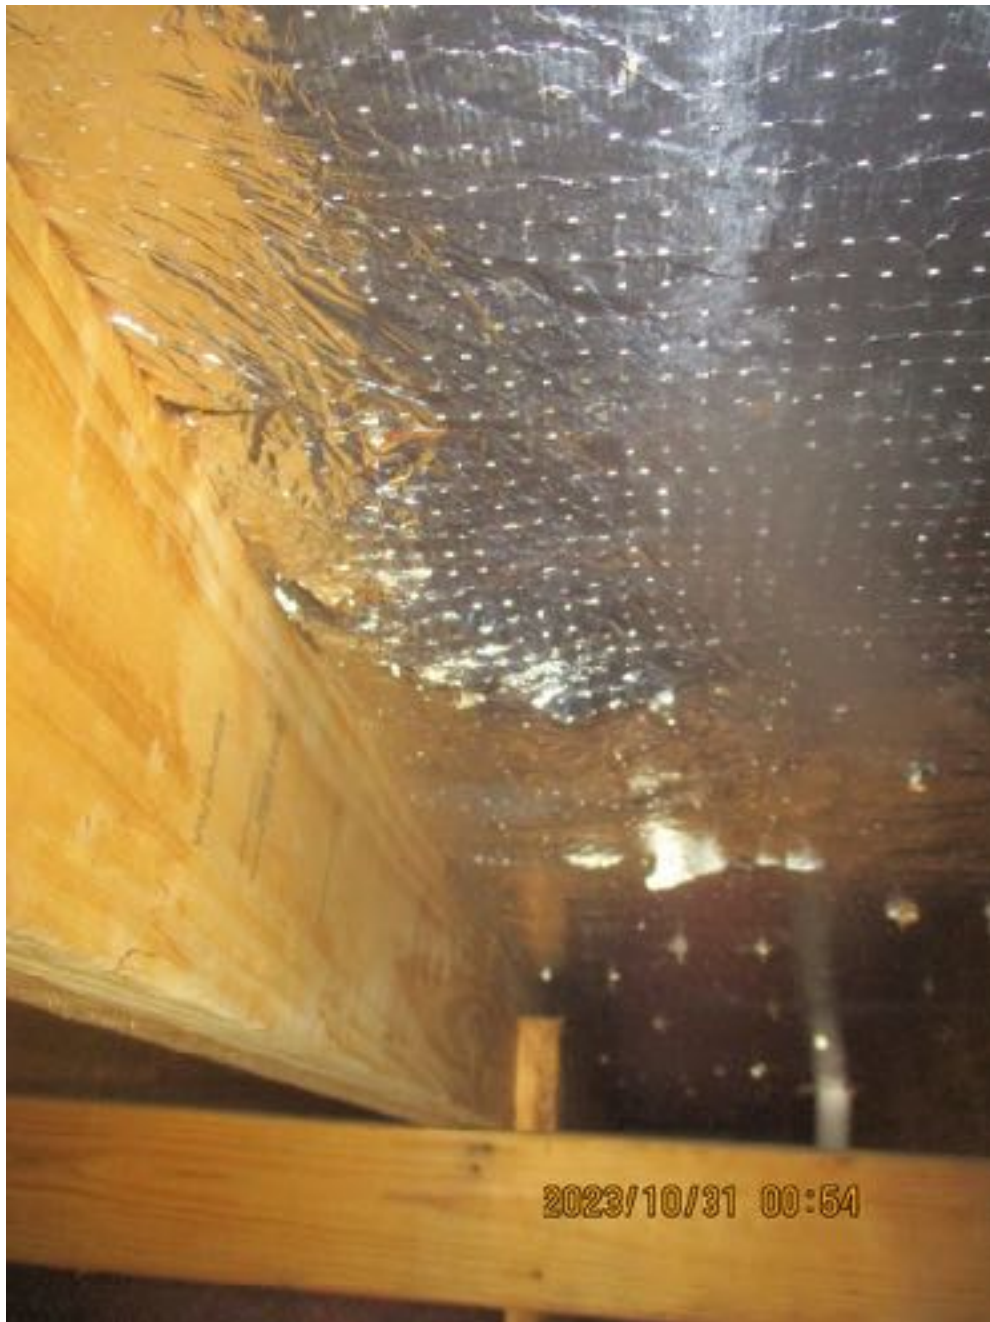
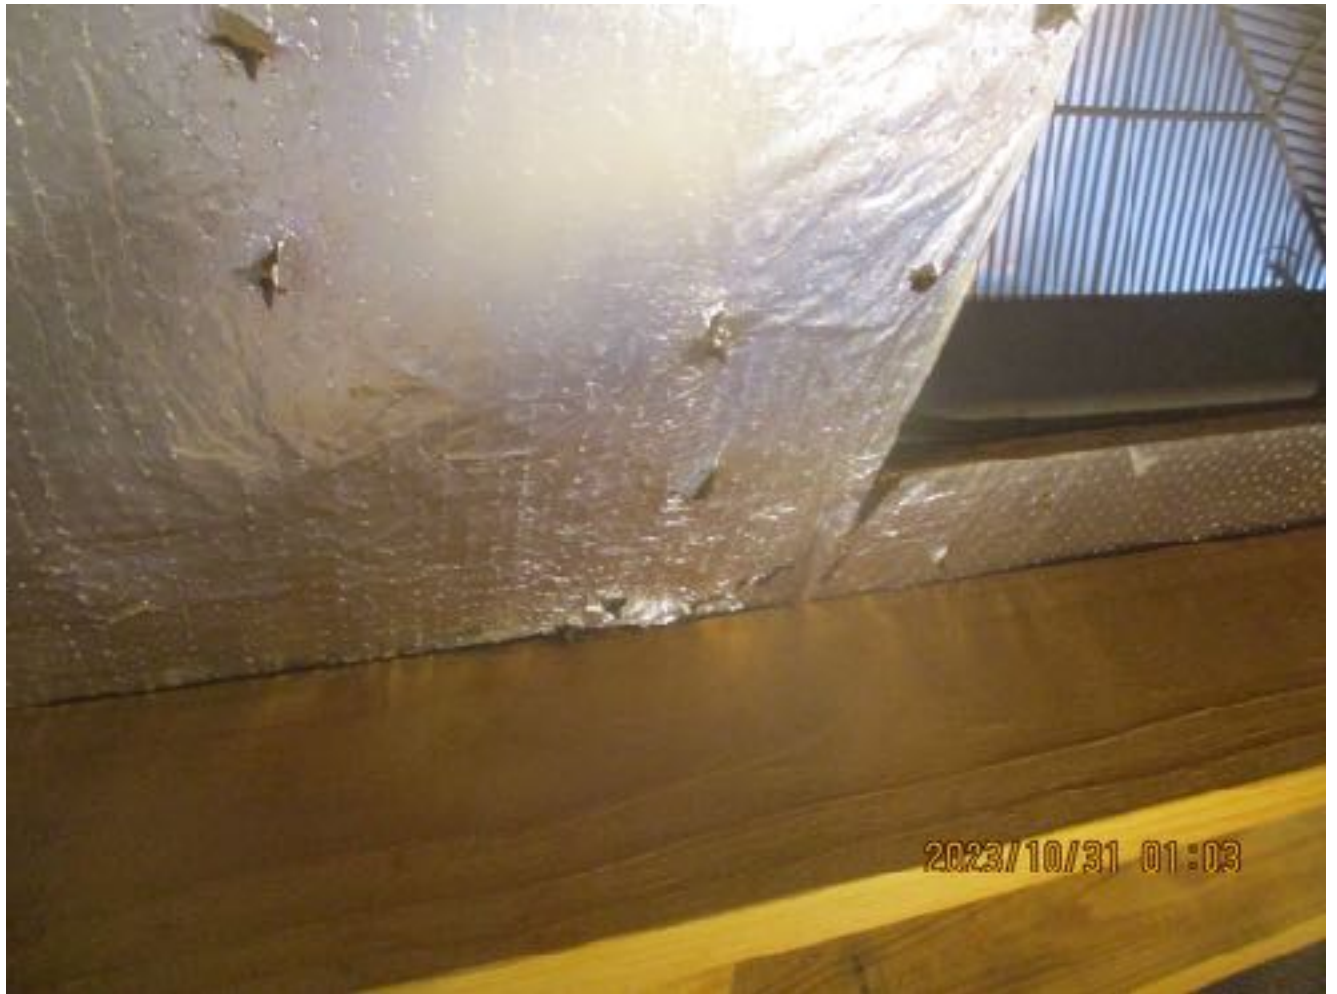
Picture 8

3. Roof Structure & Attic: Roof leaks were evident from the roof structure with soiled insulation and water damage to the roof decking (Picture 8,9,10,11).

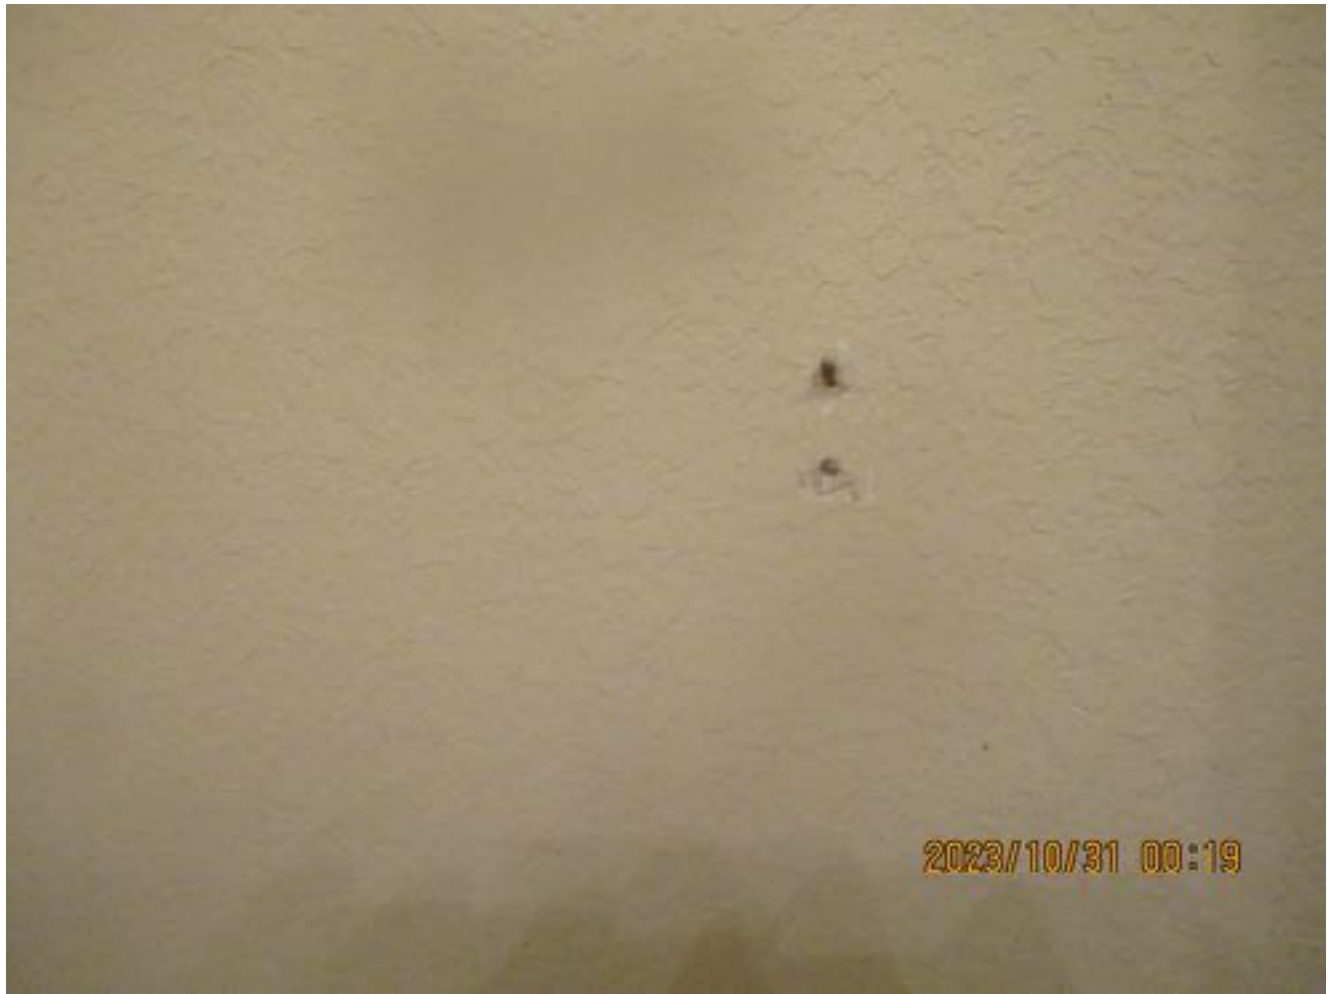
Picture 12

<input checked="" type="checkbox"/>	<input type="checkbox"/>	<input type="checkbox"/>	<input checked="" type="checkbox"/>	<b>D. Roof Structure and Attic</b> (If the attic is inaccessible, report the method used to inspect.)				
Approximate Average Depth of Insulation: Fiberglass - 10" - R30								
Attic Inspection: Entered Attic								
<i>Comments:</i>								
<i>Roof leaks were evident from the roof structure with soiled insulation and water damage to the roof decking (Picture 8,9,10,11).</i>								
<input checked="" type="checkbox"/>	<input type="checkbox"/>	<input type="checkbox"/>	<input checked="" type="checkbox"/>	<b>E. Walls (Interior and Exterior)</b>				
<i>Comments:</i>								
Interior Walls: Drywall								
Exterior Walls: Brick Veneer & Fiber-Cement Siding								
Exterior Wall Structure: Wood Frame								
<i>Holes in the sheetrock was detected in the main bath (Picture 12).</i>

4. Walls: Holes in the sheetrock was detected in the main bath (Picture 12).
5. Ceiling & Floors: Water stains was viewed on the ceiling in several areas of the interior including main bath, master bath, and middle bedroom (Picture 13&14).

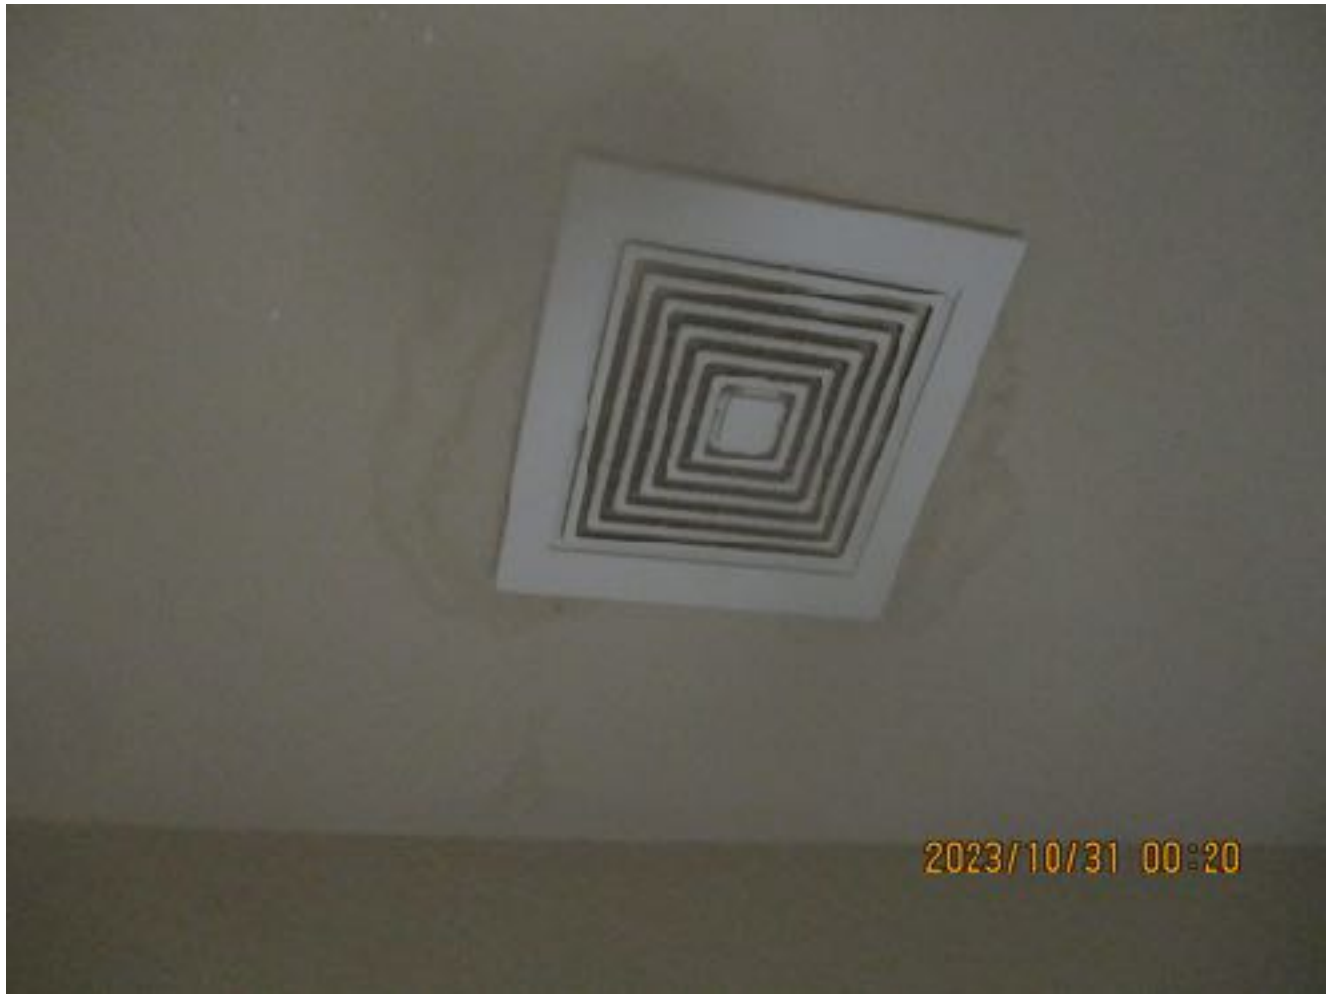
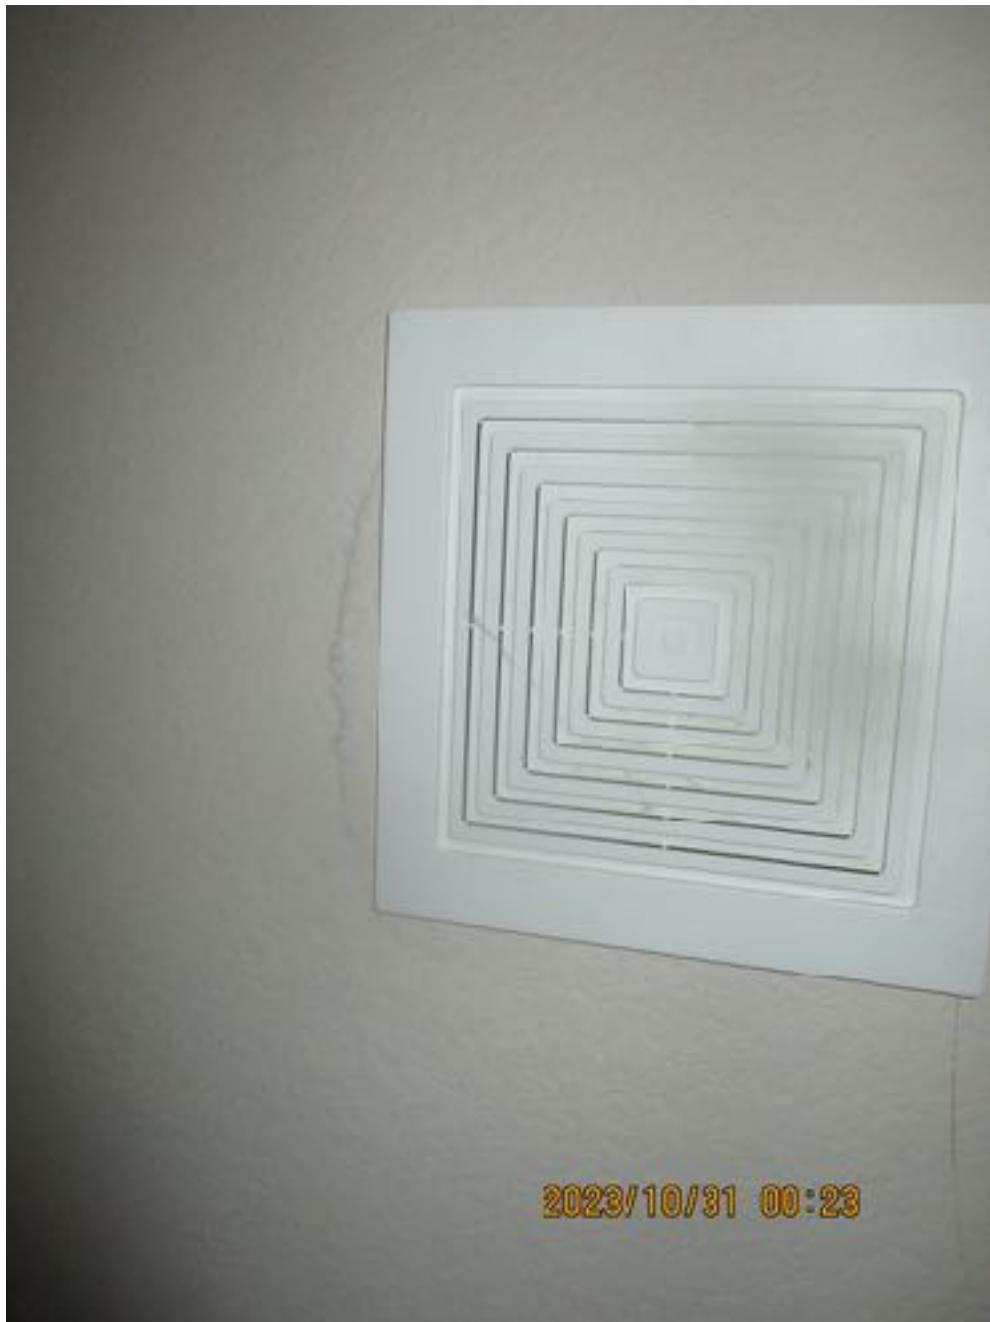
Picture 13

<input checked="" type="checkbox"/>	<input type="checkbox"/>	<input type="checkbox"/>	<input checked="" type="checkbox"/>	<b>F. Ceilings and Floors</b>				
Floor Surfaces: Carpet & Vinyl								
<i>Water stains was viewed on the ceiling in several areas of the interior including main bath, master bath, and middle bedroom (Picture 13&amp;14).</i>

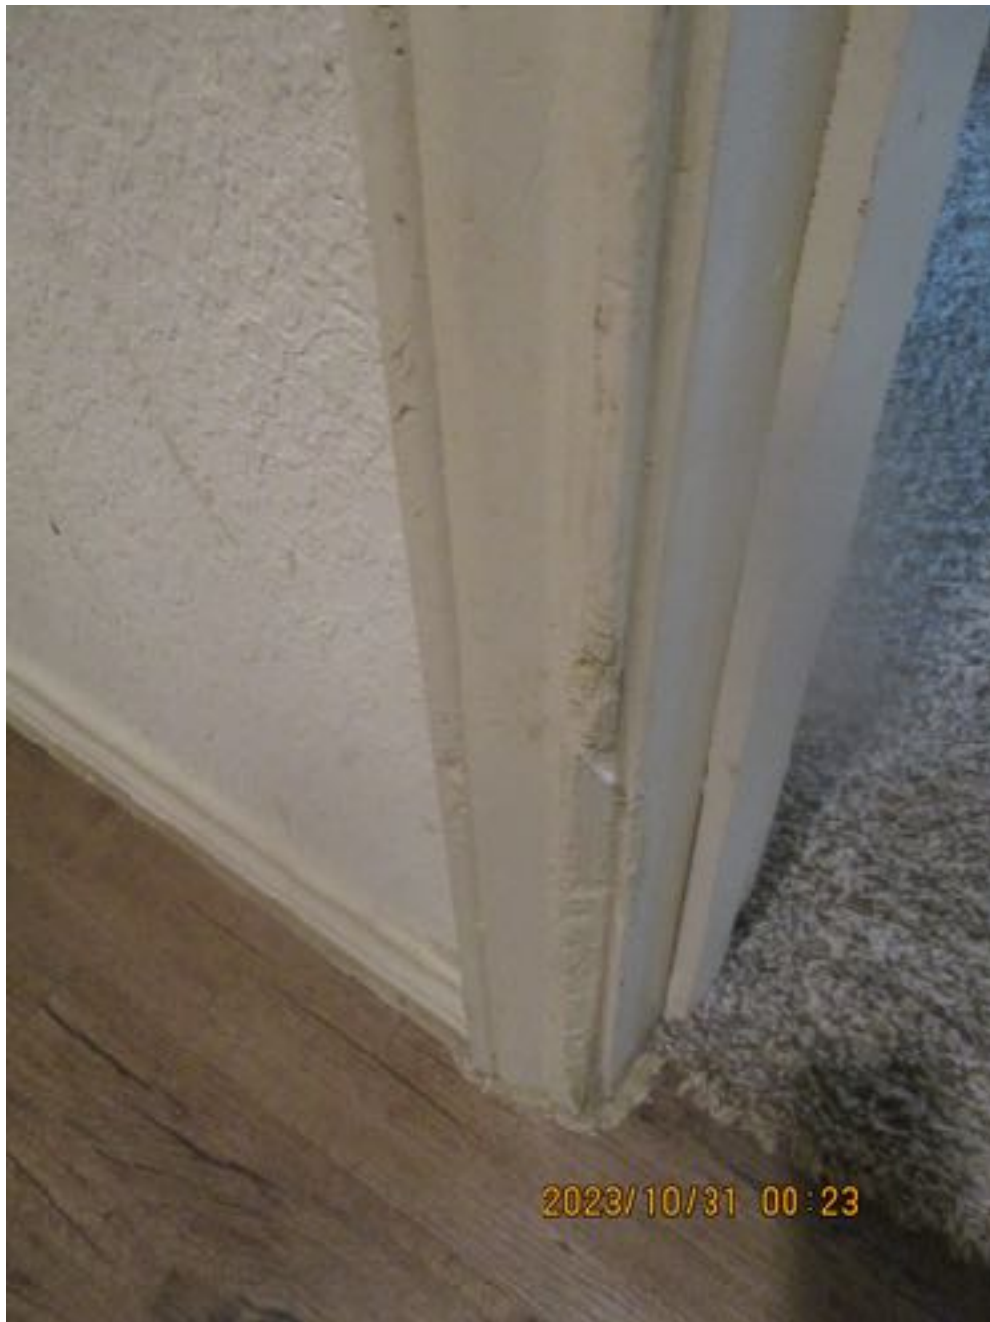
Picture 15

6. Doors: Door from the interior to the garage was not latching to the striker plate. Damaged door casing was detected on the interior door frame in the utility room (Picture 15).

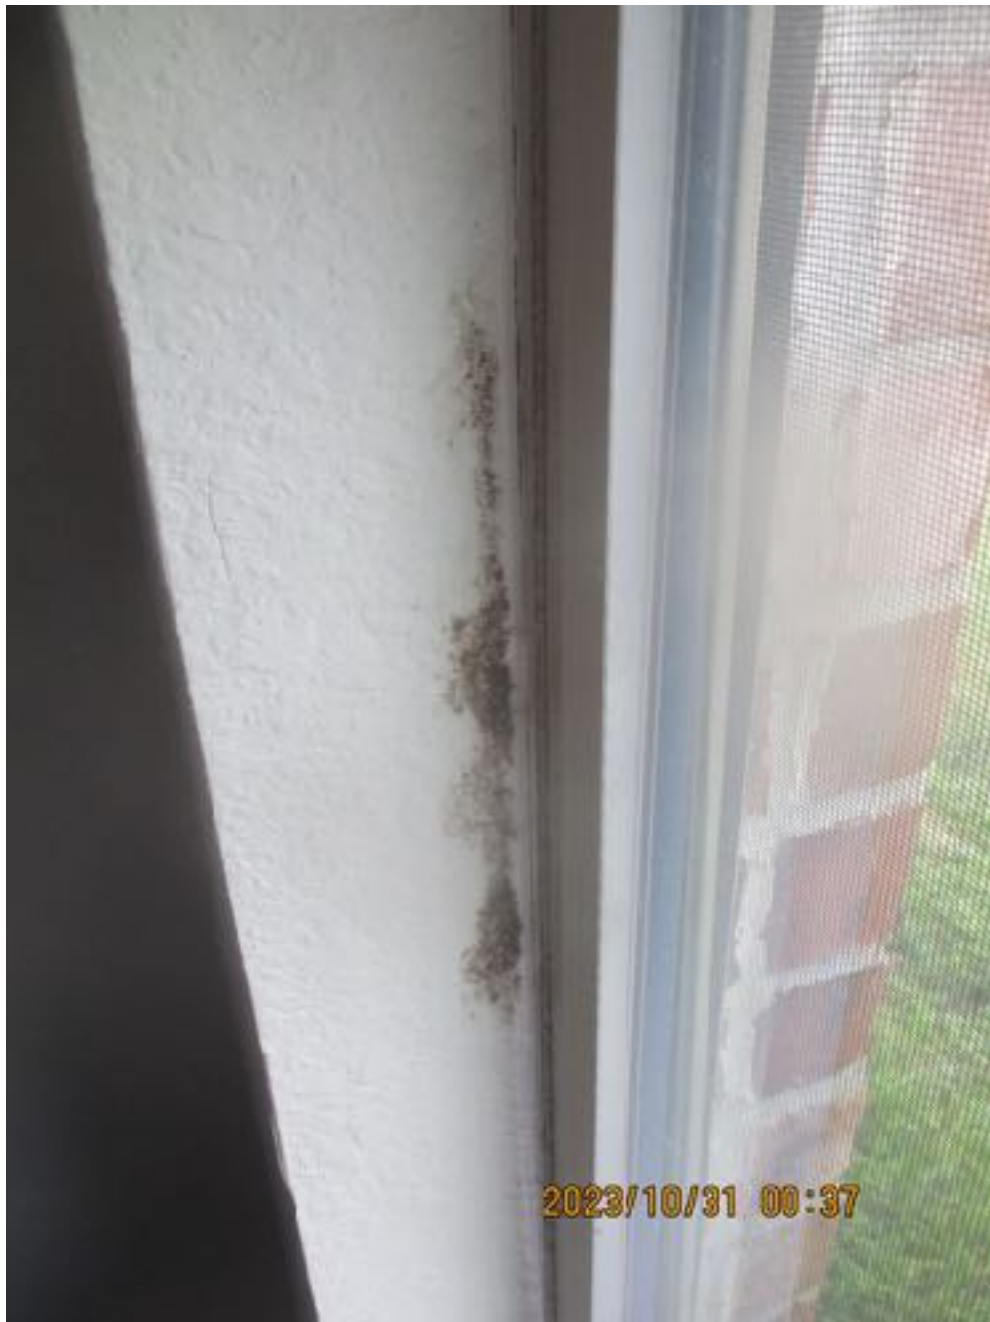
Picture 16

7. Windows: Microbial growth was detected on the sheetrock on the window framing in the left bedroom (Picture 16).
8. Other: Smoke detector in the meter bedroom was not working when tested and will need to be replaced.

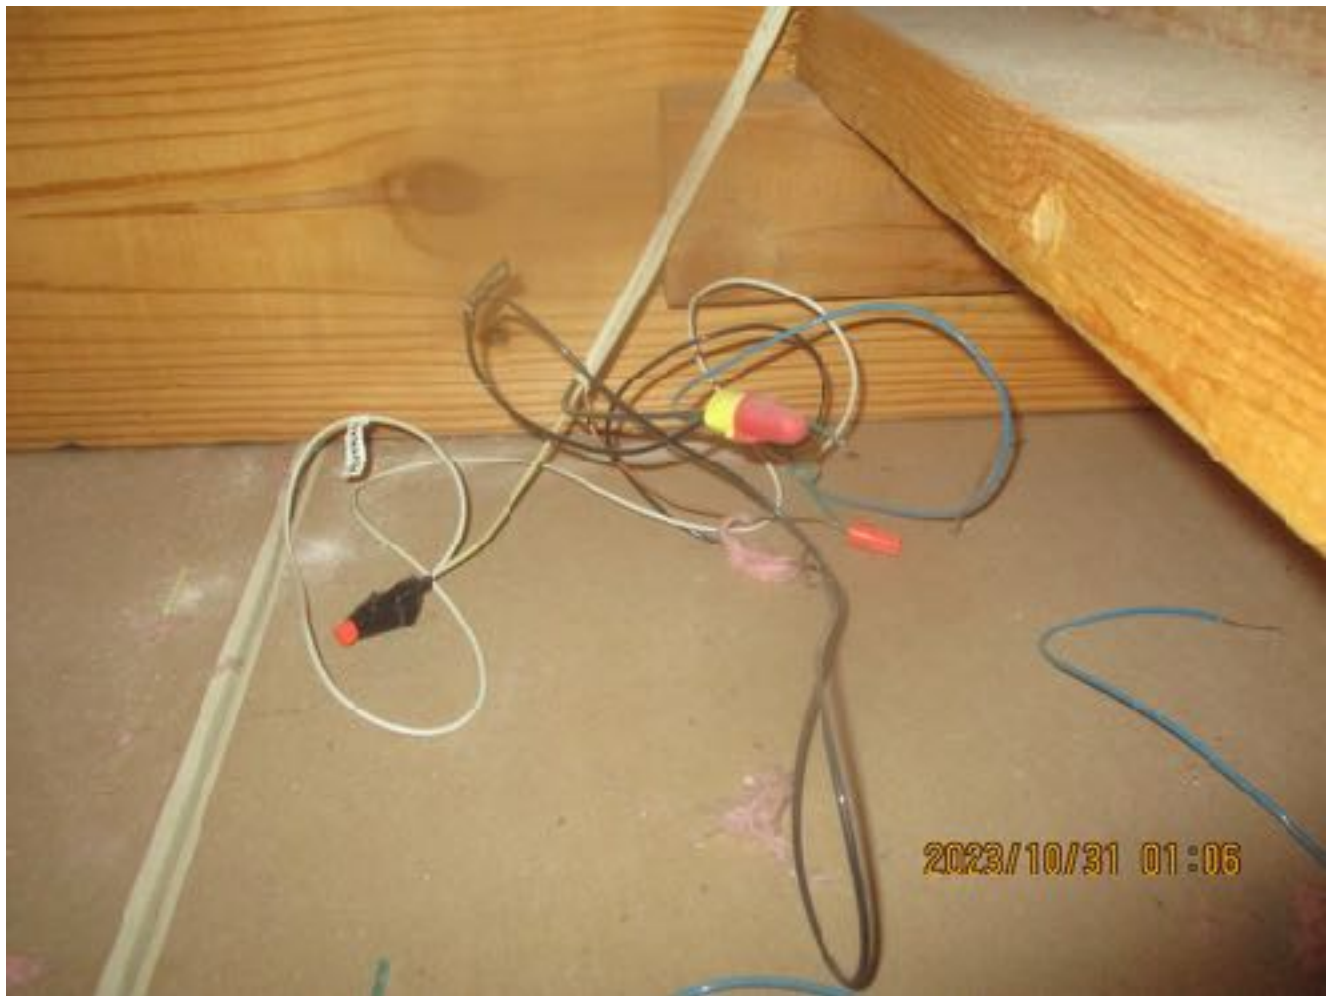
Picture 17

*Open electrical splices in the attic above the garage will need to be installed in a junction box and have cover-plate installed (Picture 17). Damaged cover-plate was viewed in the front left bedroom (Picture 18).*

9. Branch Circuits: Open electrical splices in the attic above the garage will need to be installed in a junction box and have cover-plate installed (Picture 17). Damaged cover-plate was viewed in the front left bedroom (Picture 18).

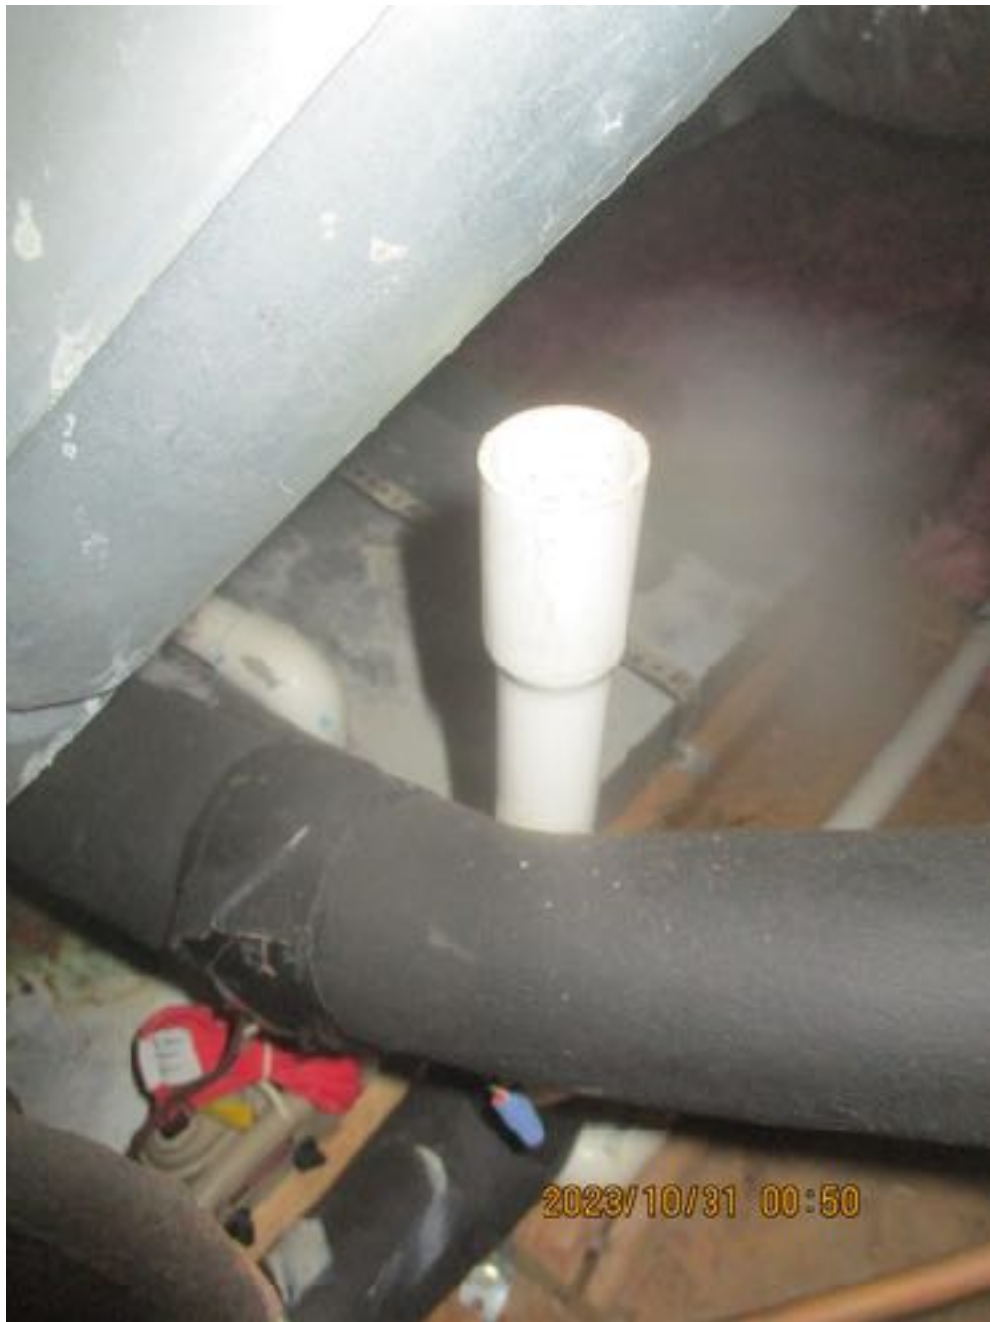
Picture 19

<input checked="" type="checkbox"/> <input type="checkbox"/> <input type="checkbox"/> <input type="checkbox"/>	<p><b>B. Cooling Equipment</b>  <i>Type of System: Central Forced Air System</i>  <i>Make &amp; Model: Carrier Model# CA16NA036-A 3-ton condenser</i>  <i>(Dated 2016)</i>  <i>Energy Source: Electric</i>  <b>Comments:</b>  <i>Testing the differential temperature of the supply (ambient) air and the return (vent) air is best for diagnosing the present condition of the air-conditioning equipment. The normal range is between 15.0 F and 20.0 F.</i>  <i>TEST RESULTS: 18.0 F (Return = 73; Supply = 55)</i>  <i>Cooling equipment was working properly according to the temperature differential recorded.</i>  <i>Note: Client will need to pour approximately 12 ounces of bleach in the stub pipe on the primary drain line every year (Picture 19).</i></p>
--	--

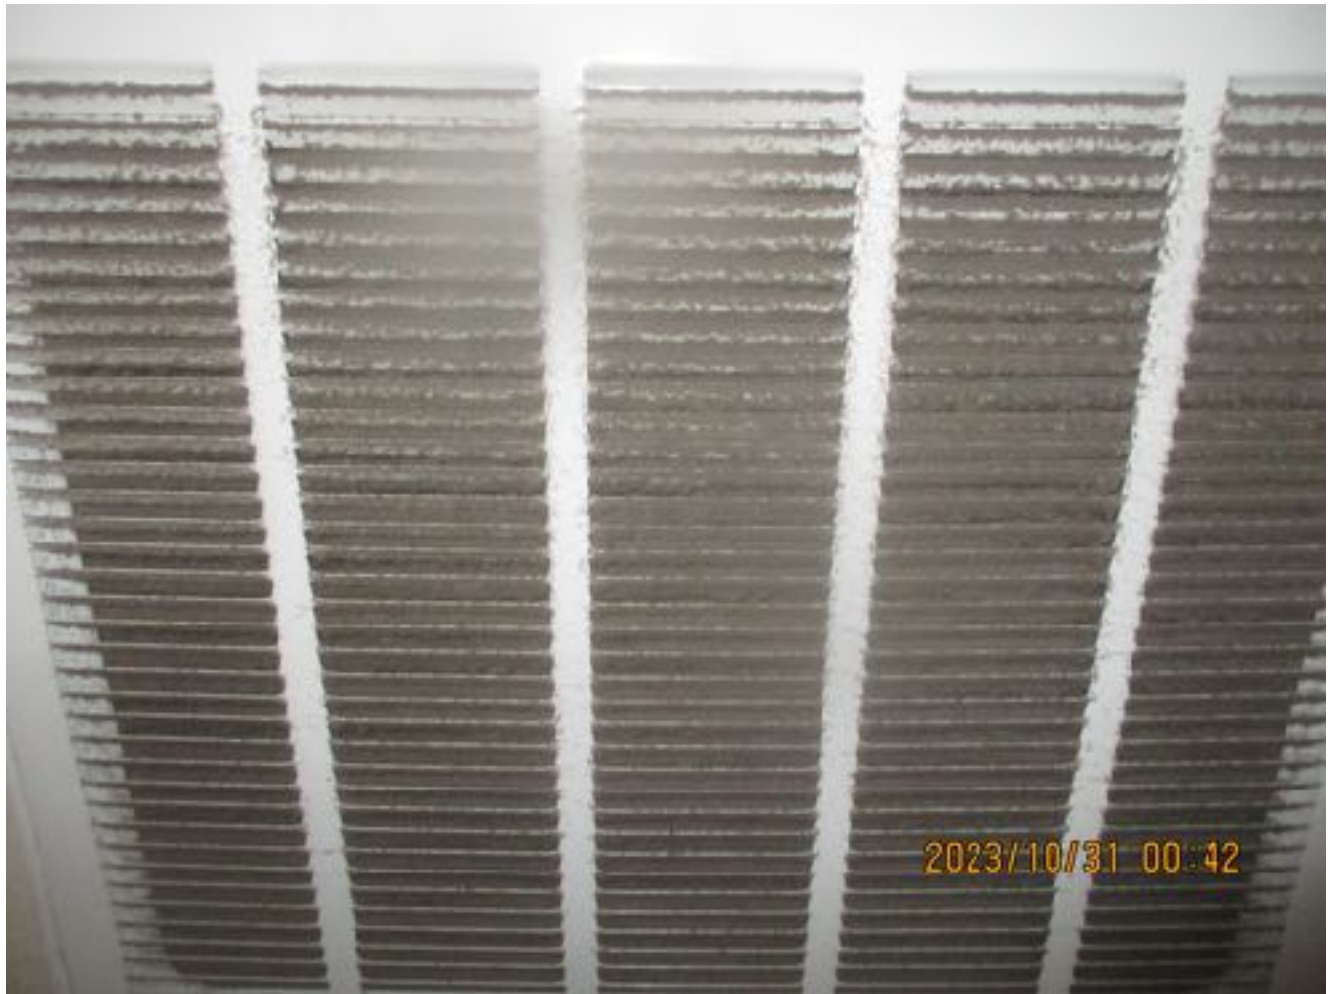
Picture 20

<input checked="" type="checkbox"/> <input type="checkbox"/> <input type="checkbox"/> <input checked="" type="checkbox"/>	<p><b>C. Duct System, Chases, and Vents</b>  <b>Comments:</b>  <i>Return air intake and filter were extremely dirty and will need to be cleaned and filter replaced (Picture 20). Recommend having a licensed HVAC professional cleaned the cooling equipment.</i></p>
---	--

10. Duct System, Chases, Vents: Return air intake and filter were extremely dirty and will need to be cleaned and filter replaced (Picture 20). Recommend having a licensed HVAC professional cleaned the cooling equipment.
