## **PROPERTY INSPECTION REPORT**

**Report#:** 005329

**Concerning:** 1650 Rancho Grande, Houston TX 77049  
(Address or Other Identification Inspected Property)

**By:** John Bennett License# 7171 10/31/23  
(Name and License Number of Inspector) (Date)

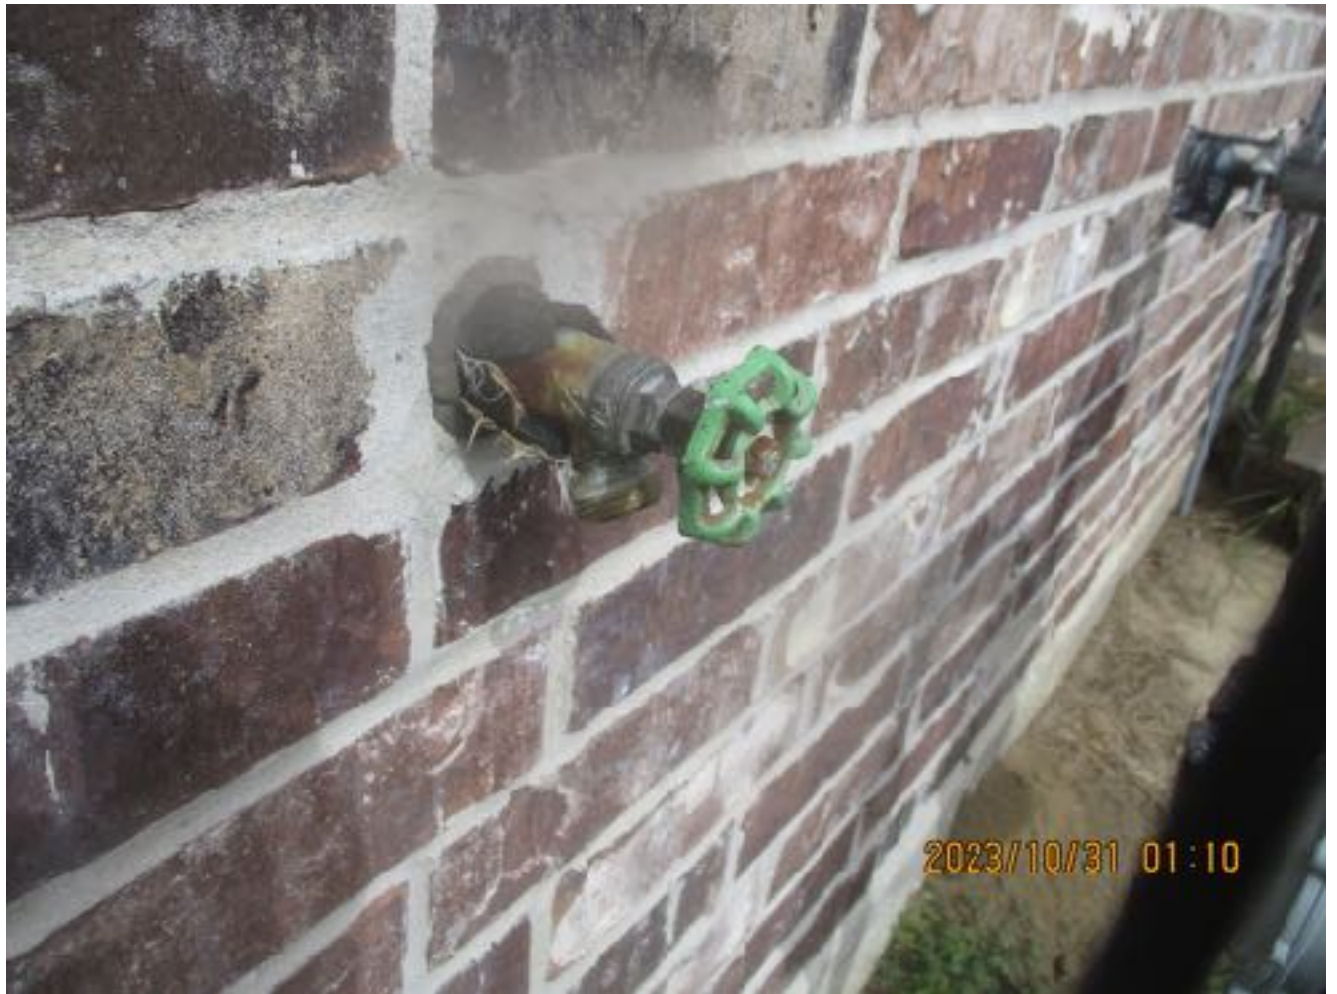
Picture 22

<input checked="" type="checkbox"/> <input type="checkbox"/> <input type="checkbox"/> <input checked="" type="checkbox"/>	<p><b>A. Plumbing Supply, Distribution System, and Fixtures</b>  <i>Location of Water Meter: Front Street</i>  <i>Location of Main Water Supply Valve: Left Exterior</i>  <i>Static Water Pressure Reading: 53 lbs</i>  <i>Type of Supply Piping Material: Plastic - Picture 21</i>  <b>Comments:</b>  <i>Exterior hose bibs were missing the anti-siphon or air gap valves that prevent cross contamination of the potable water system (Picture 22).</i></p>
---	--

11. Plumbing Supply, Distribution System, and Fixtures: Exterior hose bibs were missing the anti-siphon or air gap valves that prevent cross contamination of the potable water system (Picture 22).

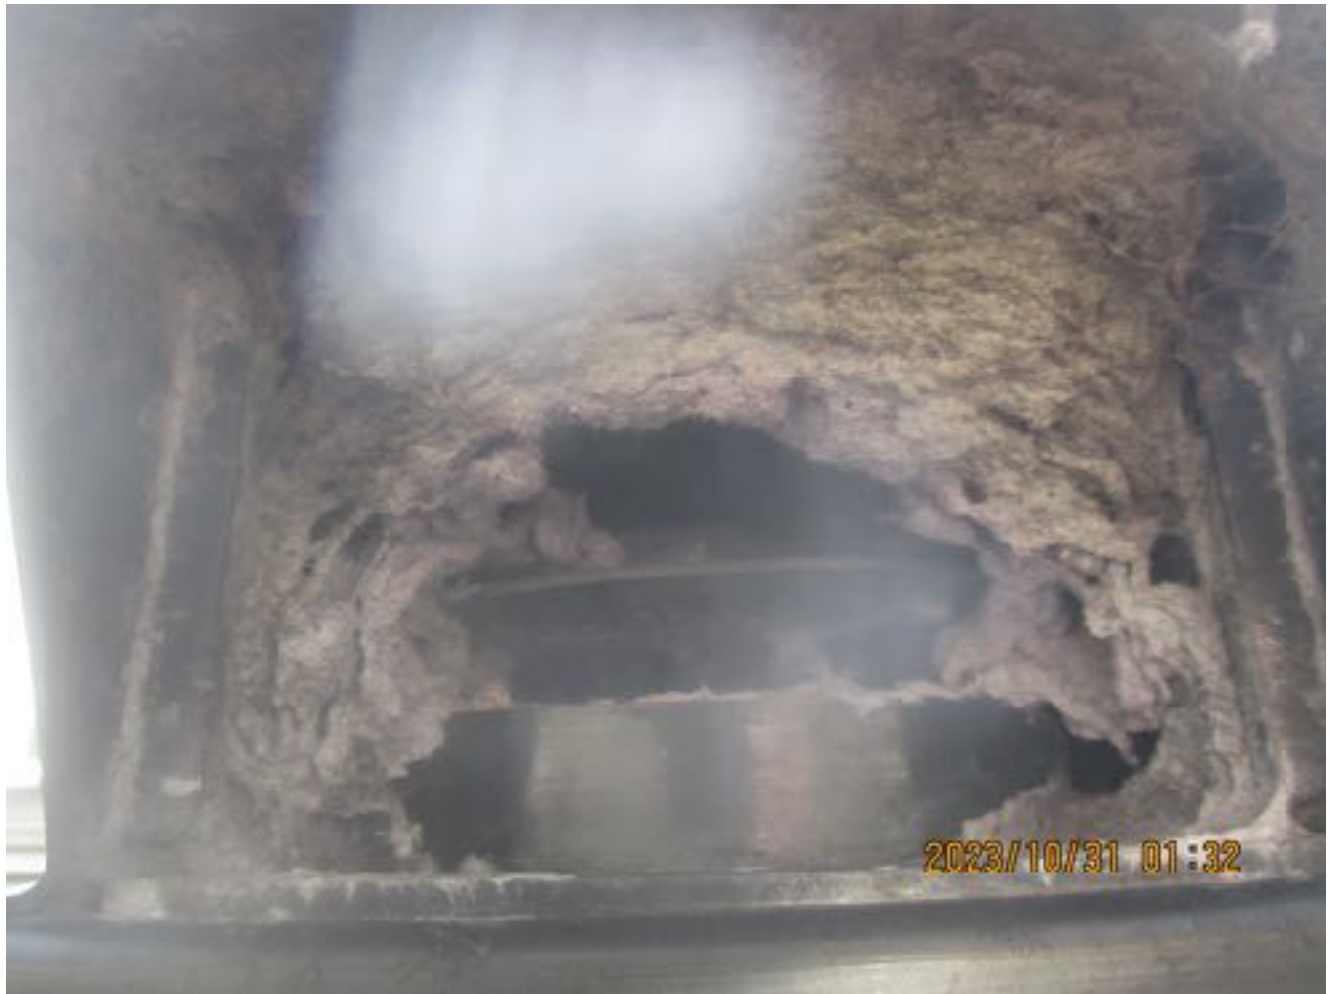
Picture 23

<input checked="" type="checkbox"/>	<input type="checkbox"/>	<input type="checkbox"/>	<input checked="" type="checkbox"/>					<b>H. Dryer Exhaust Systems</b> <i>Comments:</i> Dryer exhaust system had excessive lint build-up at the exterior termination (Picture 23). Dryer exhaust system will need the vent pipe cleared of lint by a professional.
<input type="checkbox"/>	<input type="checkbox"/>	<input checked="" type="checkbox"/>	<input type="checkbox"/>					<b>I. Other</b> <i>Comments:</i>
<b>VI. OPTIONAL SYSTEMS</b>								
<input type="checkbox"/>	<input type="checkbox"/>	<input checked="" type="checkbox"/>	<input type="checkbox"/>					<b>A. Landscape Irrigation (Sprinkler) Systems</b> <i>Comments:</i>
<input type="checkbox"/>	<input type="checkbox"/>	<input checked="" type="checkbox"/>	<input type="checkbox"/>					<b>B. Swimming Pools, Spas, Hot Tubs, and Equipment</b> <i>Comments:</i>
<input type="checkbox"/>	<input type="checkbox"/>	<input checked="" type="checkbox"/>	<input type="checkbox"/>					<b>C. Outbuildings</b> <i>Comments:</i>

14. Dryer Exhaust System: Dryer exhaust system had excessive lint build-up at the exterior termination (Picture 23). Dryer exhaust system will need the vent pipe cleared of lint by a professional.
