SELLER'S DISCLOSURE NOTICE

CONCERNING THE PROPERTY AT: 2808 Marble Brook Lane, Pearland, Texas 77584

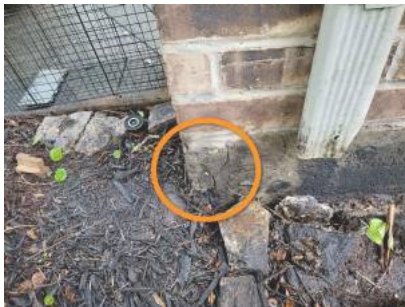
Front Right

3: Wedge Chip

Wedge chip or “corner cracks” were observed at the slab perimeter. Informational: Wedge chip cracks should be repaired when more than one third of any masonry is not supported or cracks develop. This can be conducive to wood destroying insects. Wedge chip cracks and the repair should not be confused with underpinning of the foundation. Repair should be performed by a qualified foundation repair company.

Recommendation: Contact a foundation contractor.

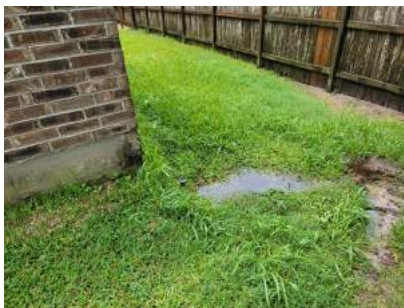
Rear Left

3: Ponding

Area of ponding was observed within 10' of the slab perimeter. Informational: A drainage swale (if effect, a wide and shallow ditch) may be evened out or other means of controlling drainage should be established.

Recommendation: Contact a qualified grading contractor.

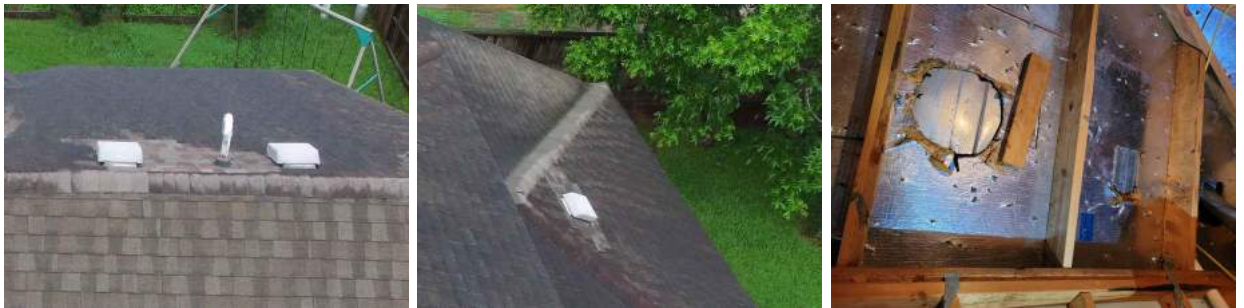
Previous repairs were observed at several areas as indicated by different coloration of the shingles.

Informational: When repairs are undertaken the Client should inquire when the work was performed, the reason for any work and or warranty that may be provided. The inspector is not required to determine the efficacy of any repair.

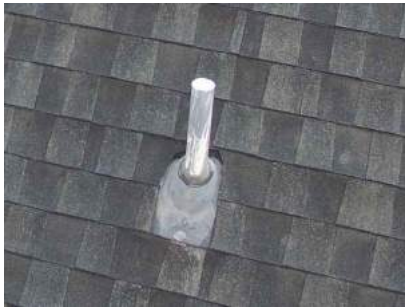
2: DWV Not Painted

The DWV piping isn't painted above the roofline. Informational: Painting of the pipe and plastic boots is required to prevent damage from UV exposure.

Recommendation: Contact a qualified roofing professional.

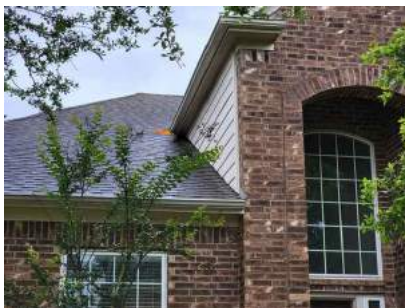
3: Gutters 2 Roof

Upper gutter(s) drain onto the lower roof covering(s). Informational: Gutters that drain onto roof coverings can cause aggregate loss due to waterflow and leaks may occur due to the volume of water. One or more manufacturers don't warranty shingles at these locations. Technical bulletin: [GAF Tech Bulletin](#)

Recommendation: Contact a qualified roofing professional.

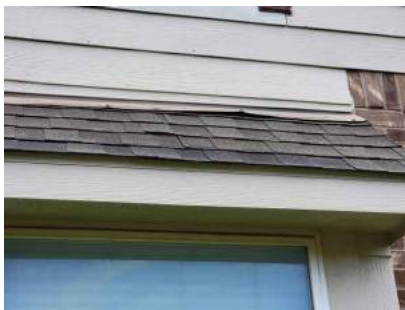
Left Side

5: Raised Flash

Raised flashing was observed. Informational: Raised flashing should be properly secured.

Recommendation: Contact a qualified roofing professional.

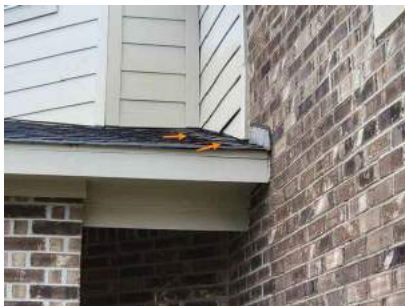
6: Raised SH/J flash

Raised areas of shingles were observed at the roof/sidewall flashings under the edge(s) of the J flashings. Informational: The edge at the J flashing under the shingles may damage the shingles over a period of time. Some shingle manufacturers and / or siding manufacturers may require step flashing. The IRC required step flashing until the release of the IRC 2012 which no longer requires step flashing.

Recommendation: Contact a qualified roofing professional.

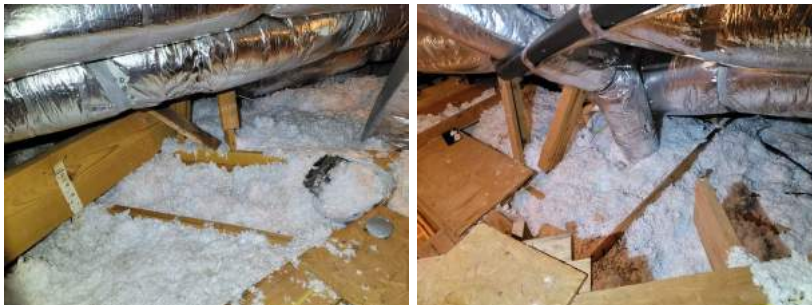
Insulation levels less than 10" were observed. Informational: Recommend additional insulation for increased energy efficiency (R30 is the current minimum at the floor of the attic). [Attic Insulation](#)

Recommendation: Contact a qualified insulation contractor.

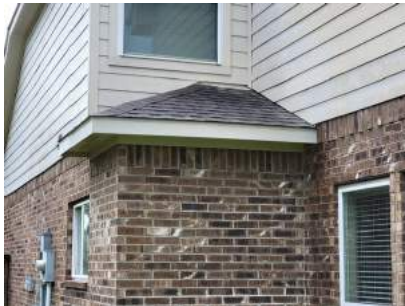
Right Side

4: Vent Miss

Ventilation isn't provided. Informational: Ventilation is required by the shingle manufacturer. Without venting the shingle warranty is usually void and the attic can easily heat to 140-150 degrees which will be radiated into the house. The total net free ventilation area shall not be less than 1/150 of the space ventilation (roughly divided between upper and lower vent areas) to 1/300. Proper ventilation will help to keep the house cooler during warm weather and extend the life of roofing materials. IRC R806.2

Recommendation: Contact a qualified roofing professional.

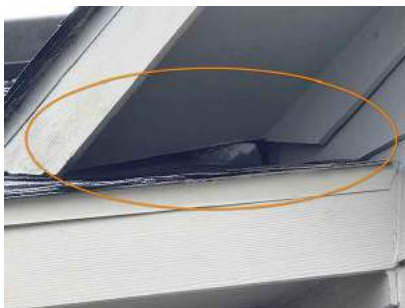
Voids were observed at the soffit / roof junction (corner under eaves). Protection isn't provided against rodent entry. Informational: All attic areas should be properly flashed / sealed to provide a barrier against rodents. IRC G2404.9

Recommendation: Contact a qualified professional.

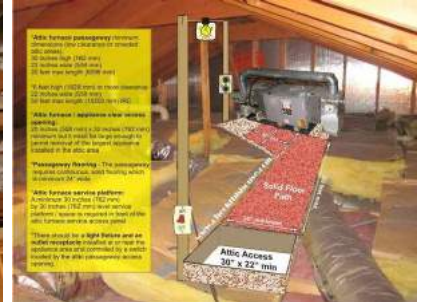
6: Walkway

Informational: A walkway (24" wide and solid flooring) and a service space (30" deep and wide) are required to and in front of the appliances in the attic. IRC M1305.1.3

Recommendation: Contact a qualified professional.

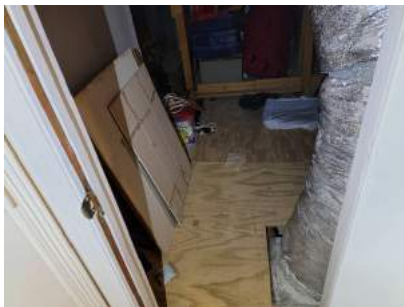
Lower Attic

7: Walkway Give

Give was noted at the walkway(s) and or platform(s) and is likely not sufficiently thick enough in this application (i.e. 7/8-1 1/8"). Informational: All area must be properly supported.

Recommendation: Contact a qualified professional.

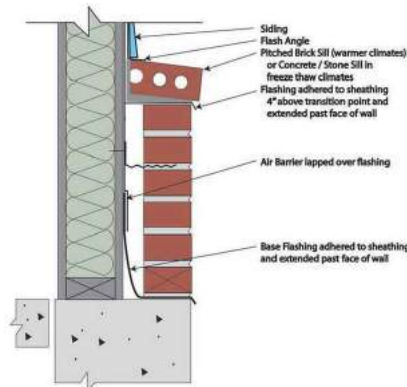
Flashing detail wasn't observed below the windows. Informational: IRC Figure R703.8 This is not a typical detail in the Gulf Coast area even though it is a code requirement. Correction of this detail is not possible without removal of the brick ledges.

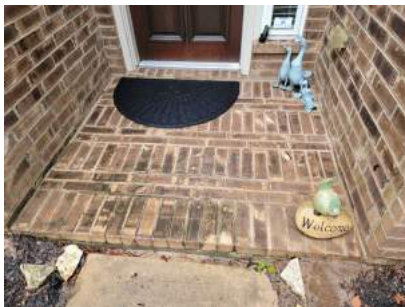
Weep holes are not provided at the front porch. Informational: Weep holes are required every 33" at the brick veneer. IRC R703.8.6

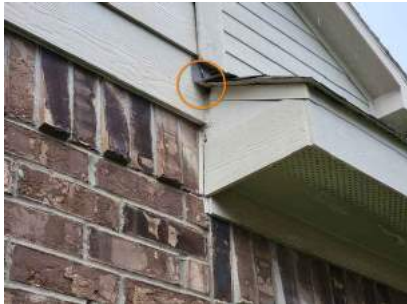
Right Side

Voids were noted at one or more locations. Informational: All exterior veneers should be properly sealed to provide a barrier against weather, insects, rodents and provide environmental control of the interior.

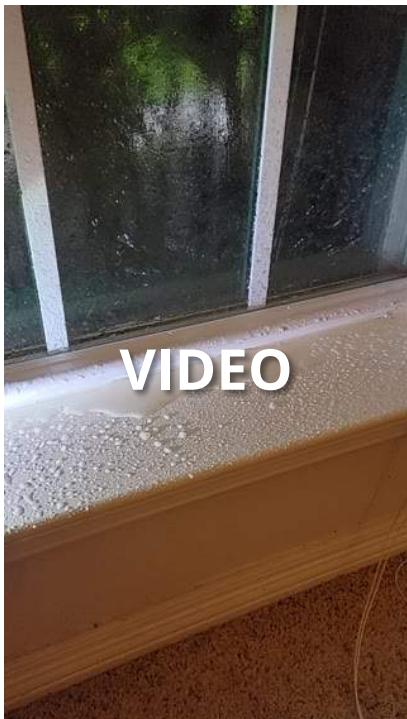
Dining room

9: Water Penetration

Water came into an area above a window during a heavy rain.

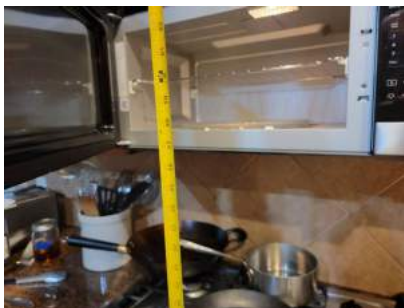
Microwave oven is installed more than the recommended height (National Kitchen and Bath Association). Informational: Safe for access and removal of hot food items. The National Kitchen and Bath Association says that "the bottom of the microwave to be no higher than 54 inches off the floor. If anyone likely to use the microwave is shorter than, say 5'4", even the recommended standard might be uncomfortably high."

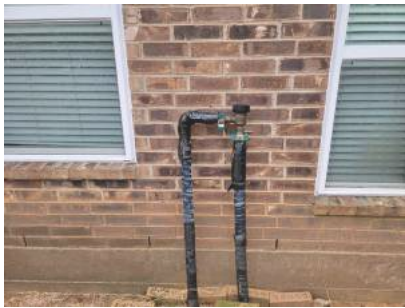
Water is turned to the off position at the backflow prevention device.
