PROPERTY INSPECTION REPORT FORM

Salvador Garc	03/19/2024
<i>Name of client</i>	<i>Date of Inspection</i>
16918 Hall Sheperd Rd, Houston, TX 77049	
<i>Address of Inspected Property</i>	
Felix D. Angel	20185
<i>Name of Inspector</i>	<i>TREC License #:</i>
N/A	N/A
<i>Name of Sponsor (If applicable)</i>	<i>TREC License #:</i>

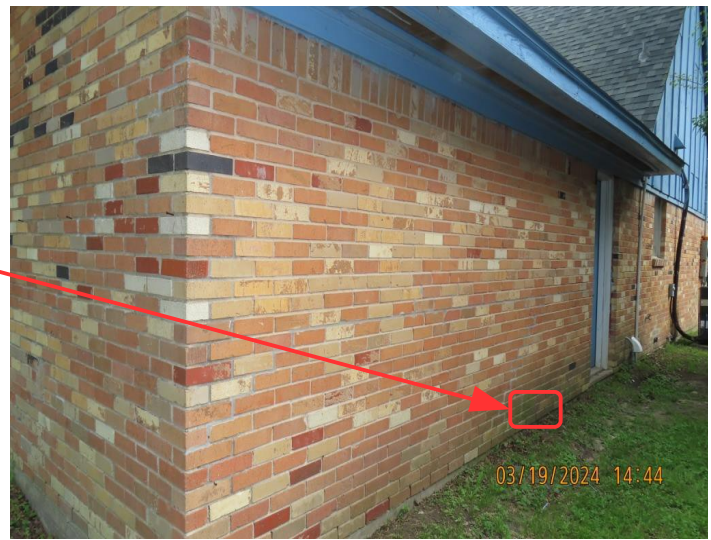
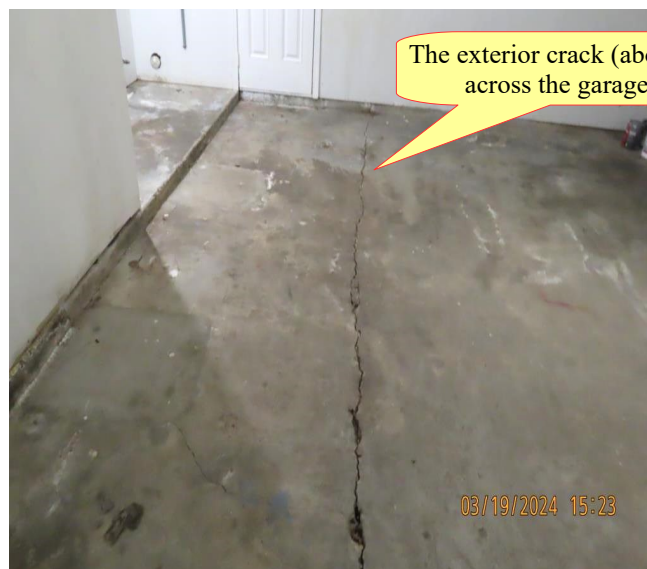
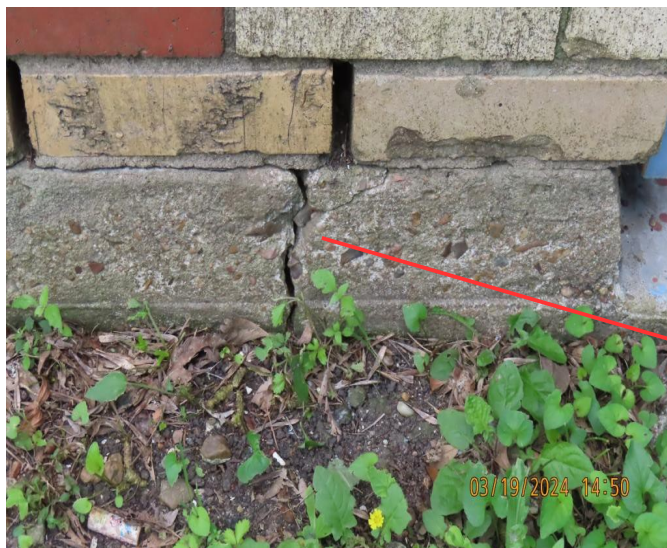
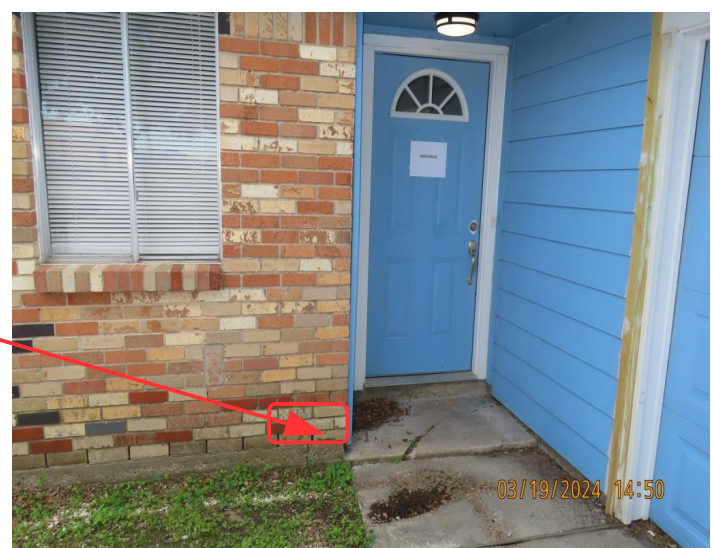
- There were cracks on multiple sides of the foundation slab and multiple settlement repairs on the exterior walls . These may be the reason for foundation repair. Recommend further investigation. Note: you have the option to consult with a structural engineer for further evaluation of the foundation slab and determine on corrective actions to be taken at this time (if any). samples

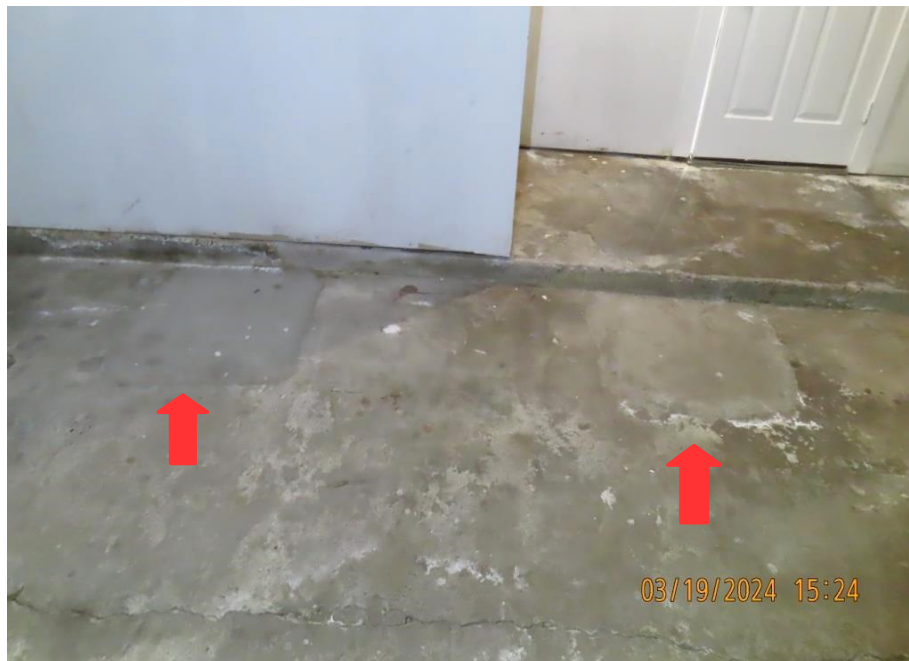
- **Note:** There was probable evidence of previous foundation repair ex: garage area etc. Note: A diagram indicating the measured elevations before repair, should be made available to the Buyer in addition to a diagram of where the foundation repair took place. We recommend that our client verifies that any warranty in effect is transferable and that service provider is stable (likely to be in business to honor future warranty claims). Note that there are often time limitations on transferring the warranty)
Information: The process of leveling and or stabilizing a foundation may cause wall and ceiling movement (cracks). Over the life of the structure, many cracks may have been repaired, and or doors/windows adjusted, etc. to compensate for the gradual movement and settlement of the foundation. Foundation repairs often causes additional signs of movement as the structure returns to its original position. We are not able to determine whether these signs of settlement and or movement occurred before, during or after repairs

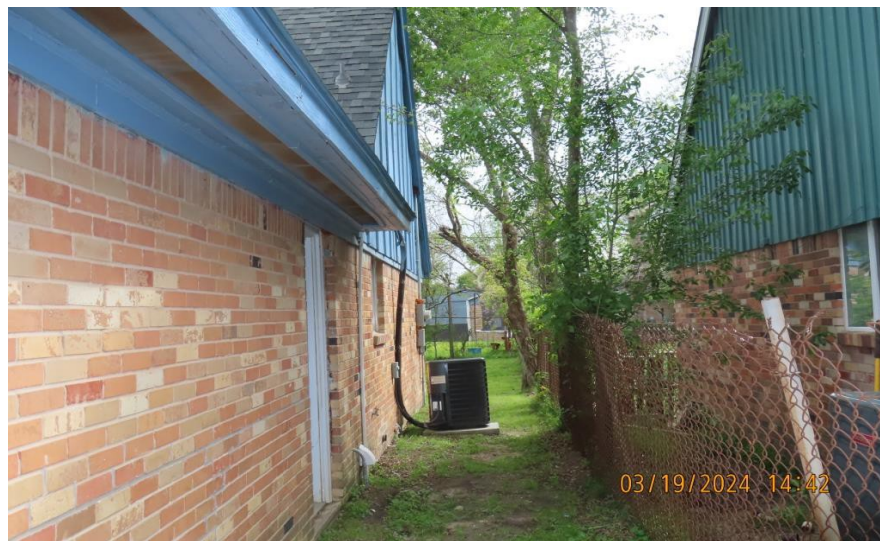
- Recommend the removal of tree and roots in close proximity to the structure or install root barriers to prevent possible damage to foundation. Note: Some types of mature trees can cause damage when these are too close to the structure.

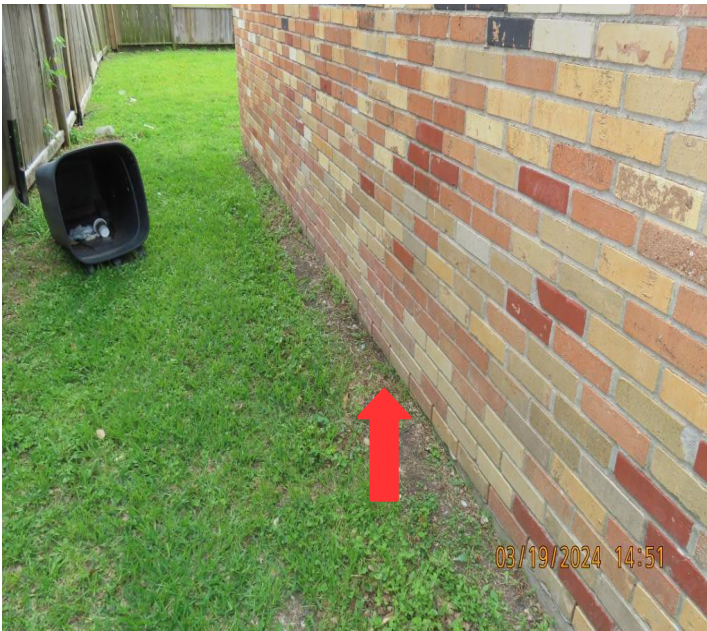
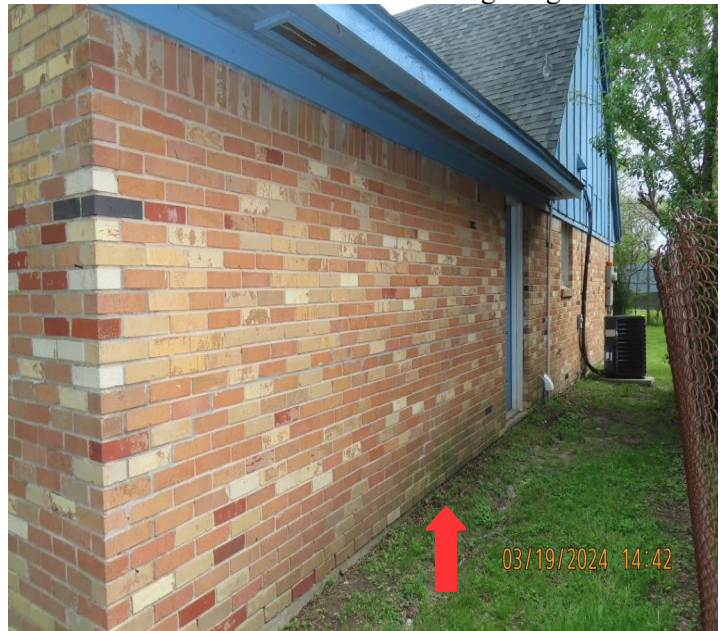
- The soil level was high on at least two locations. When soil levels and vegetation are high against the face of the foundation it promotes water penetration, siding rot and insect infestation. Brick veneer wall cladding should have about 4” of clearance between the soil and the first of bricks, and other materials should have 6” of clearance between other materials and the soil. We recommend lowering the grade.

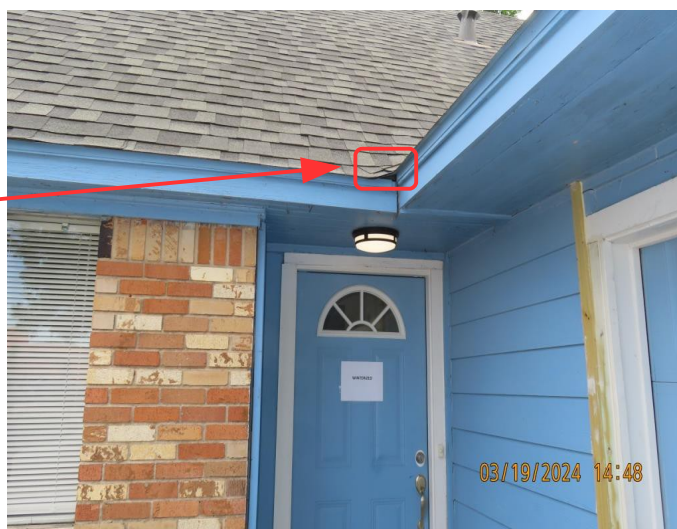
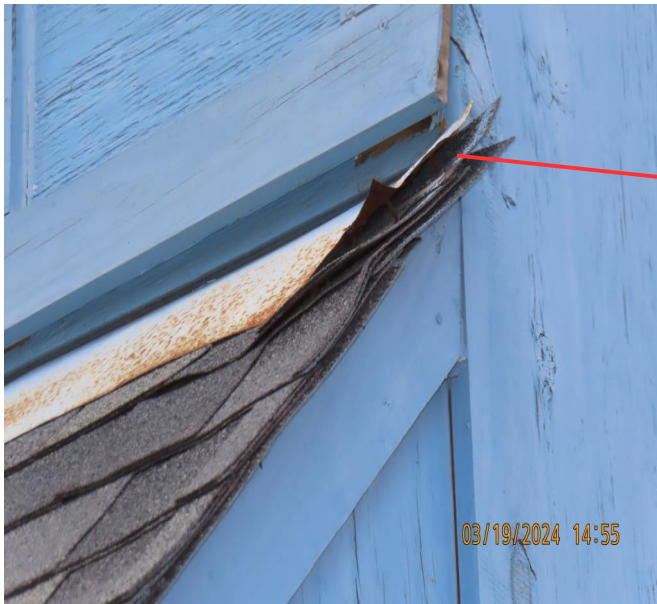
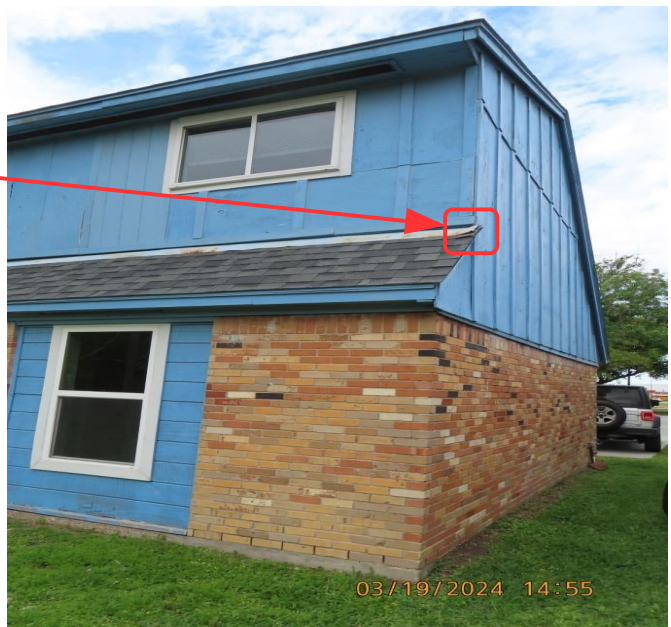
- Properly repair lifting shingles on the front valley and lifted flashing on the rear left overhang to prevent further deterioration and possible water intrusion

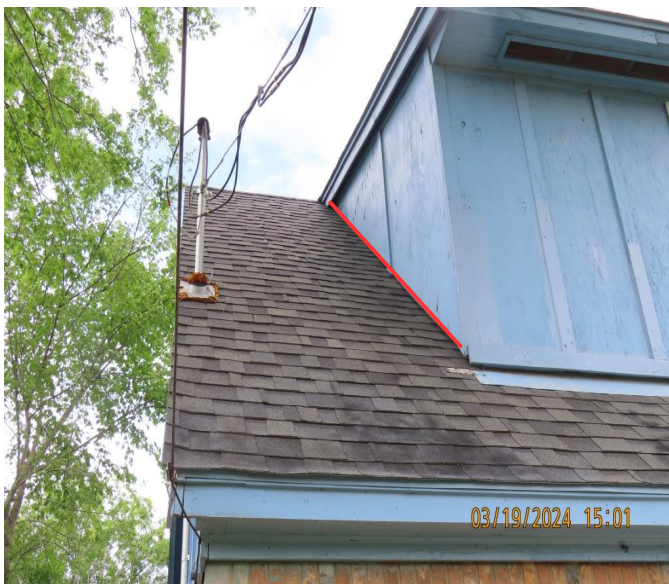
- Siding board is in contact with roof surface. There should be a 1.0” clearance. In need of repair
- Recommend replacement of foam sealant (absorbent material) on the mast for an approved and more effective type of sealant to prevent water infiltration

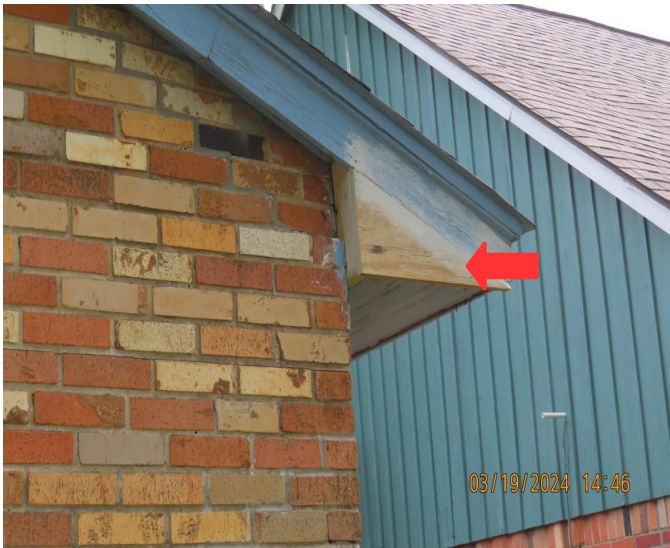
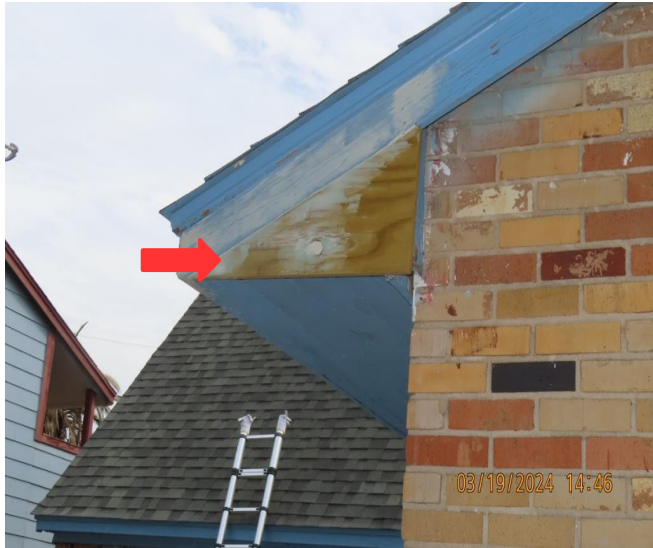
- Evidence of repair. Further investigate and confirm that installed materials is appropriate for outdoor use to avoid rot.

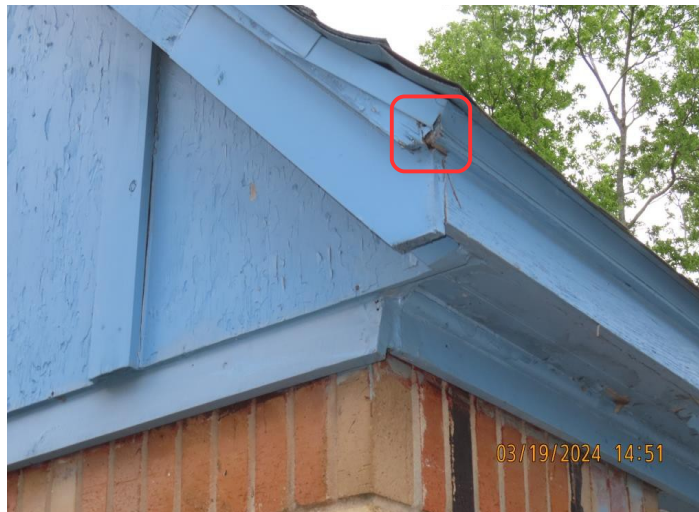
- Repair rotting trim and gaps where needed to prevent further deterioration

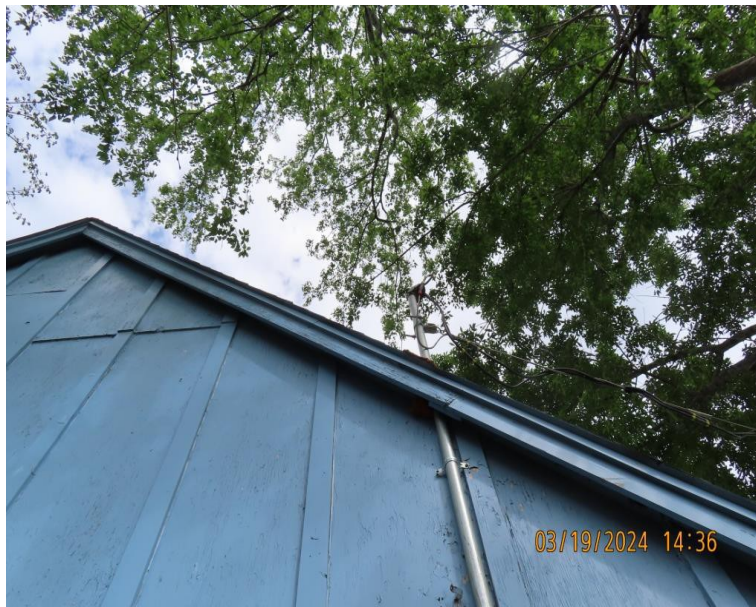
- Recommend trimming of tree limbs overhanging the roof to prevent inadvertent incidents

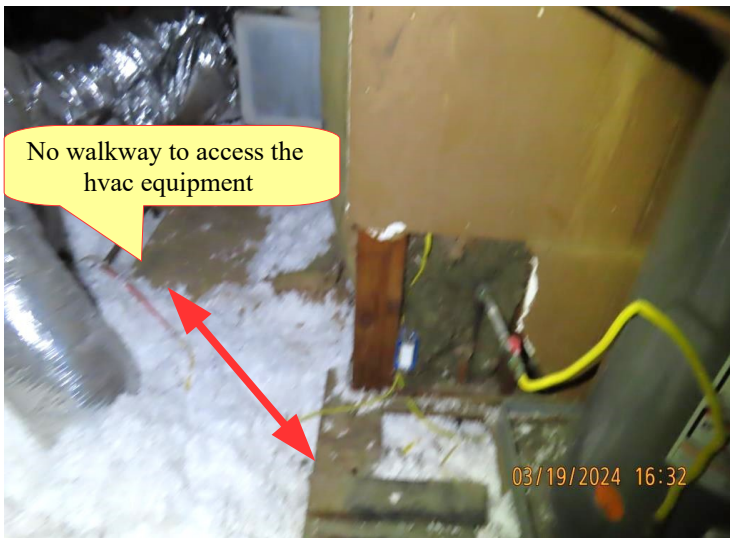
- Inadequate/missing attic walkway/platform to mechanical equipment and or attic space (unsafe condition). Standards require 30" head clearance and a minimum of 24" wide solid, (No gaps or obstructions) . In need of proper repair for personal safety

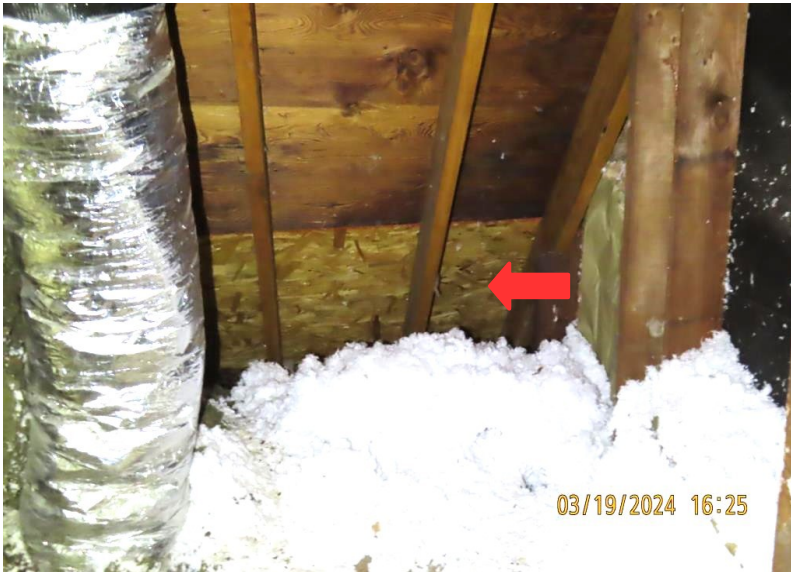
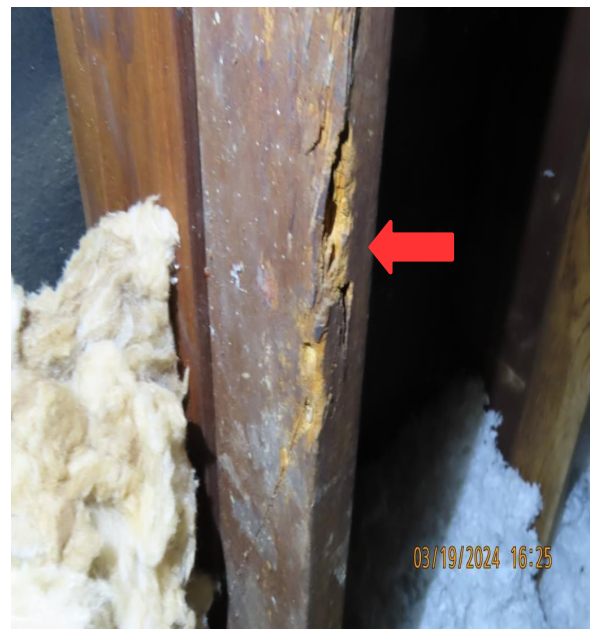
- Evidence of repair on the rear roof deck. Investigate further as needed
- Noticed what appeared to be rotting brace near the attic access. Investigate further and conduct proper repair

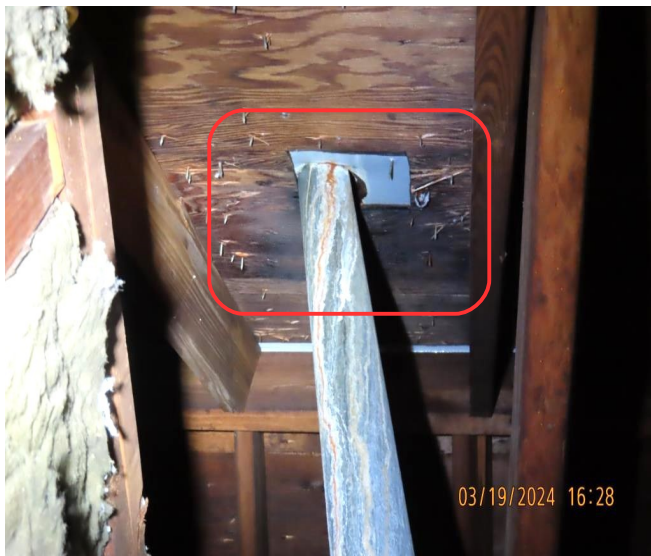
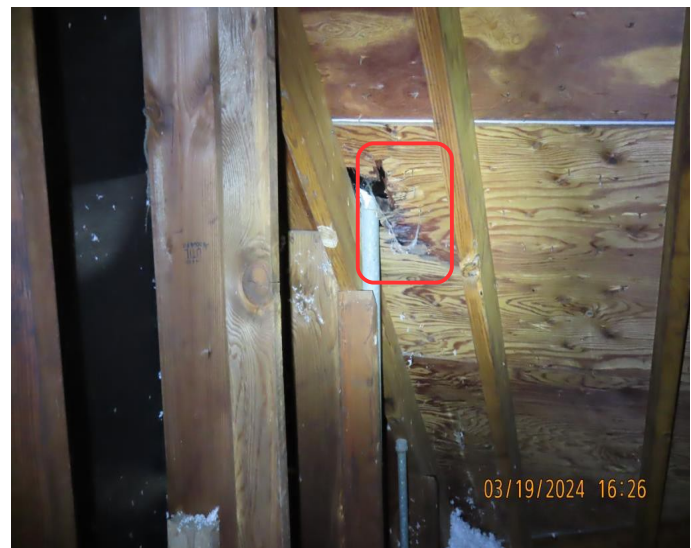
- There is evidence of what appeared to be water intrusion at the water heater flue pipe penetration and at one of the plumbing vents. Inspector was not able to determine if water marks were recent or prior to installation of existing shingles. Further investigate existing condition and as needed, perform proper repairs

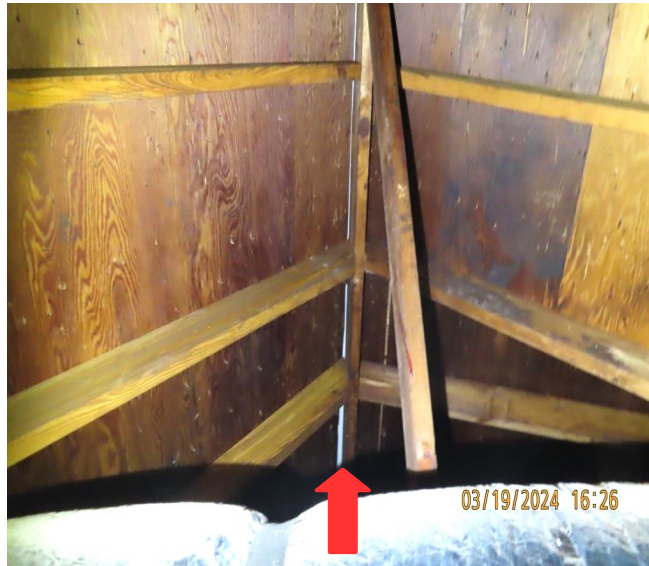
- Observed what appeared to be a separation on the roof hip. Investigate root cause and repair as needed

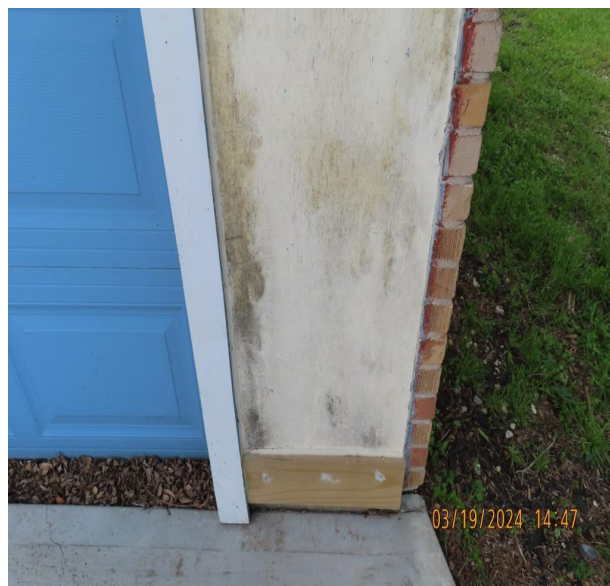
- Evidence of frame repair on left side of the garage door
- Noted what appeared to be microbial growth on the right side of the garage. Thoroughly investigate root cause and conduct proper repair to avoid further siding/frame deterioration

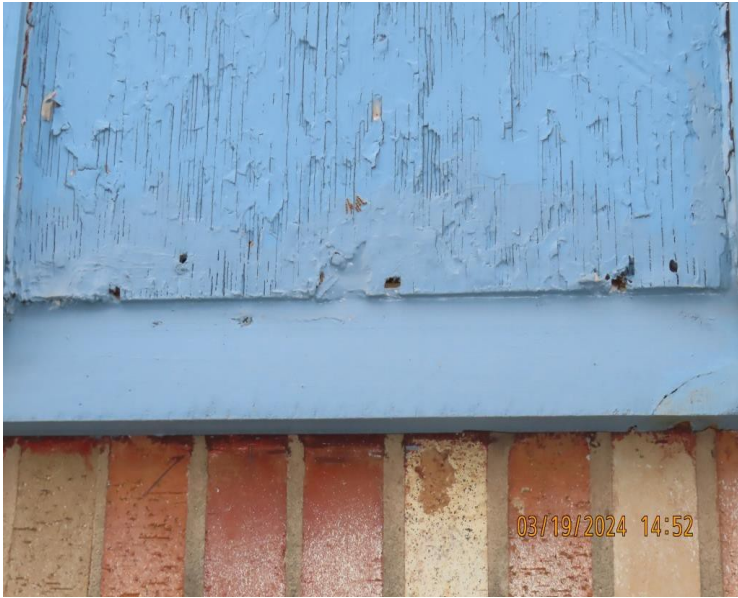
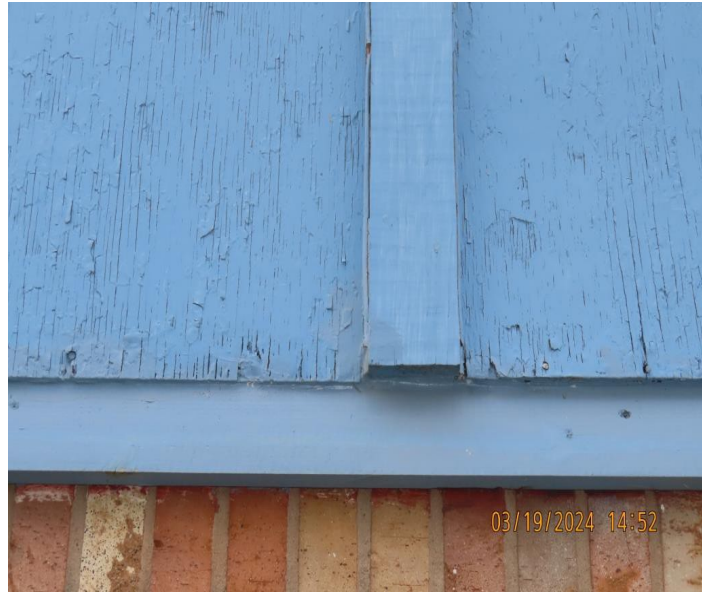
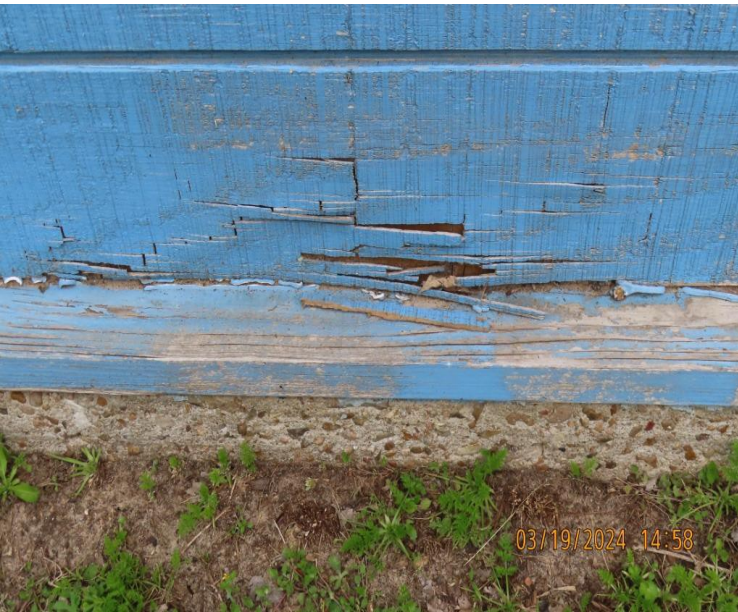
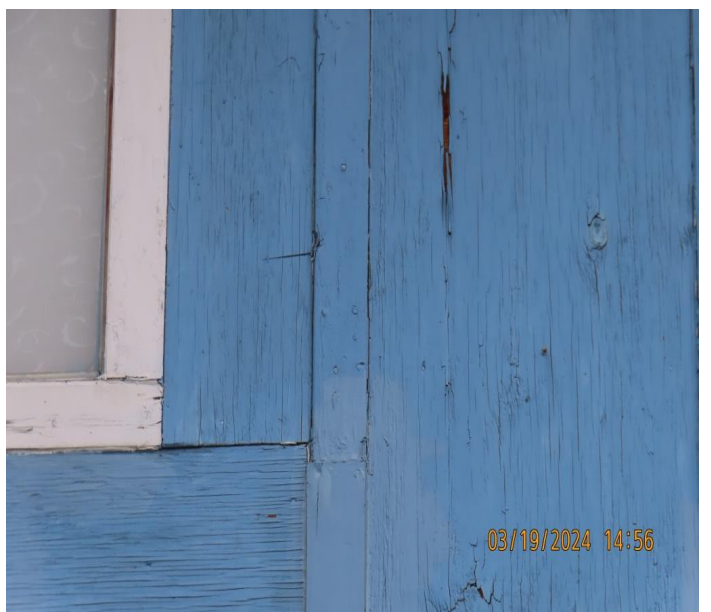
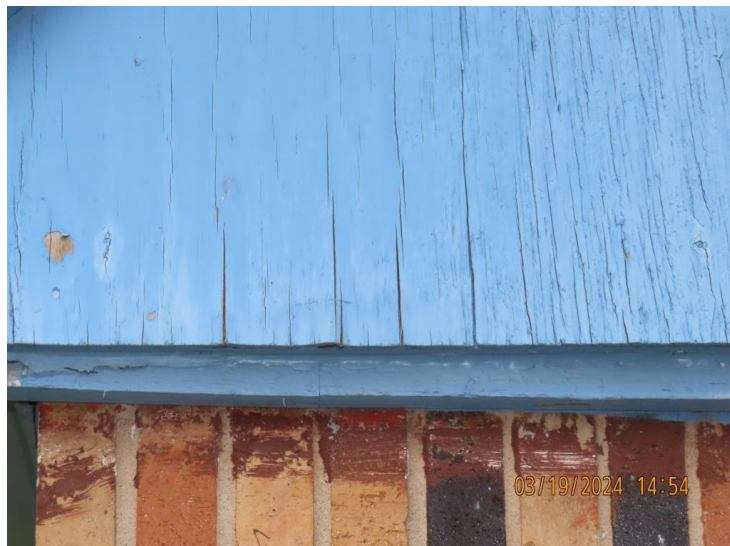
- Observed cracking/rotting siding throughout. Properly repair/replace to prevent further damage and possible water intrusion. samples

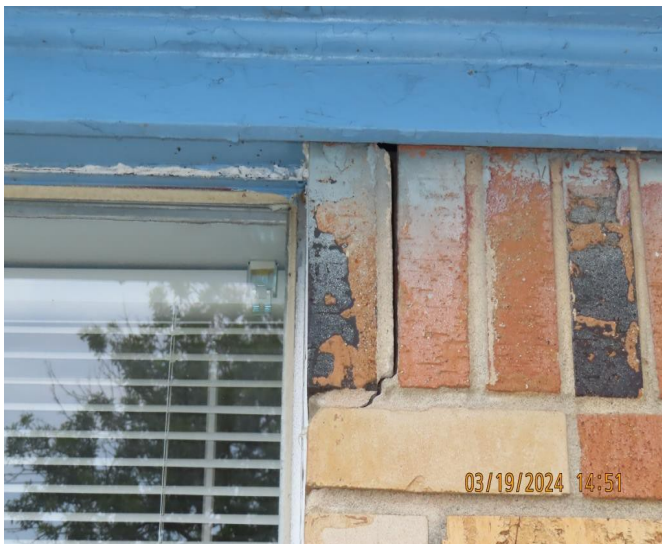
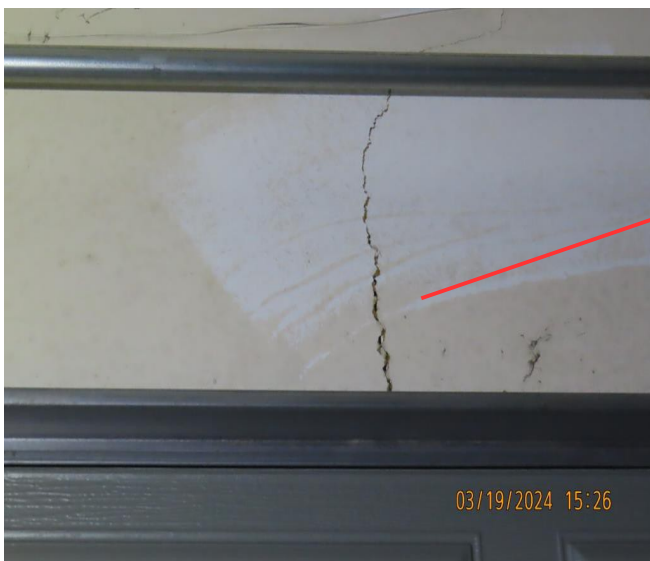
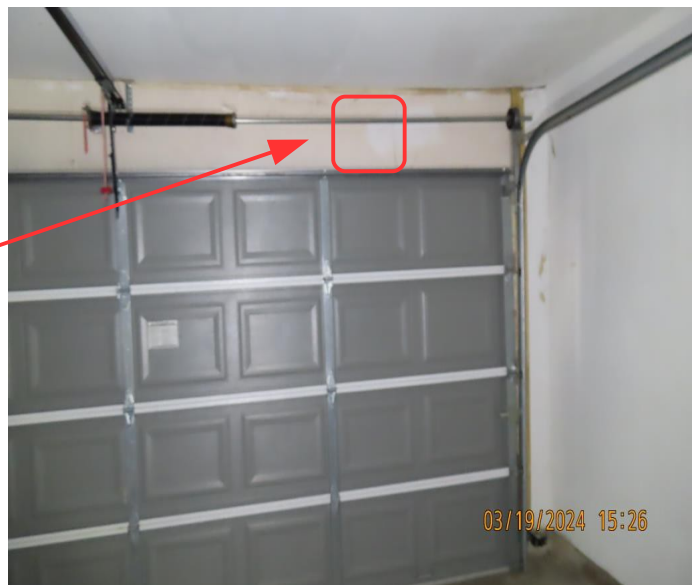
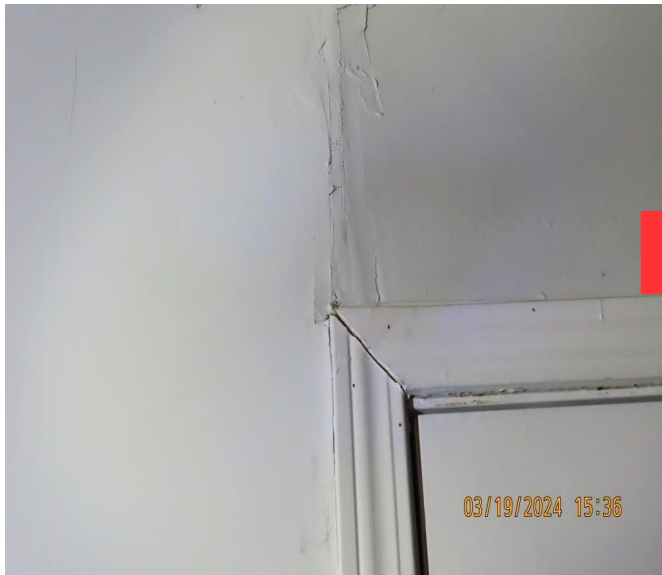
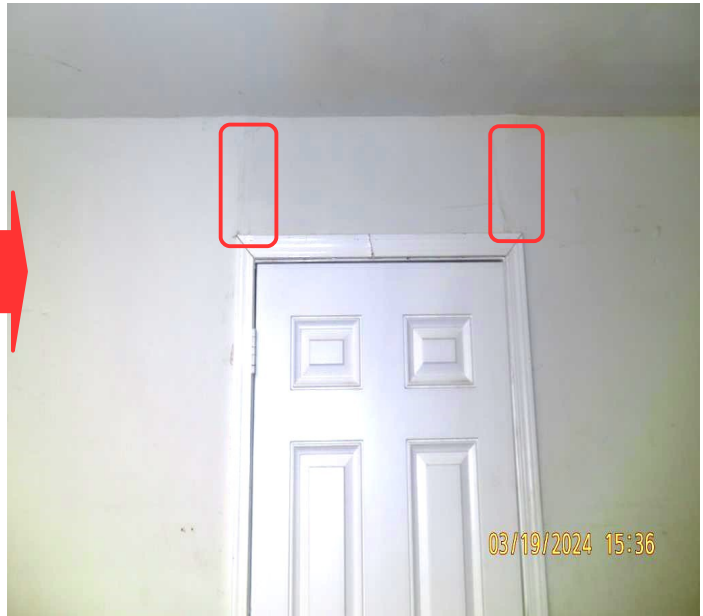
- Additional settlement cracks . Refer to “Section A” (Foundation) for corrective action details

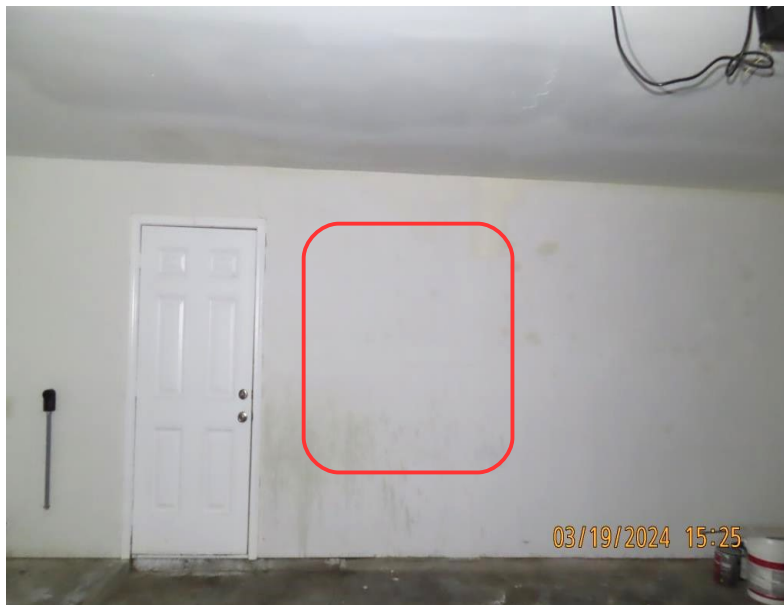
- Evidence of repair in a garage wall . Investigate further as needed

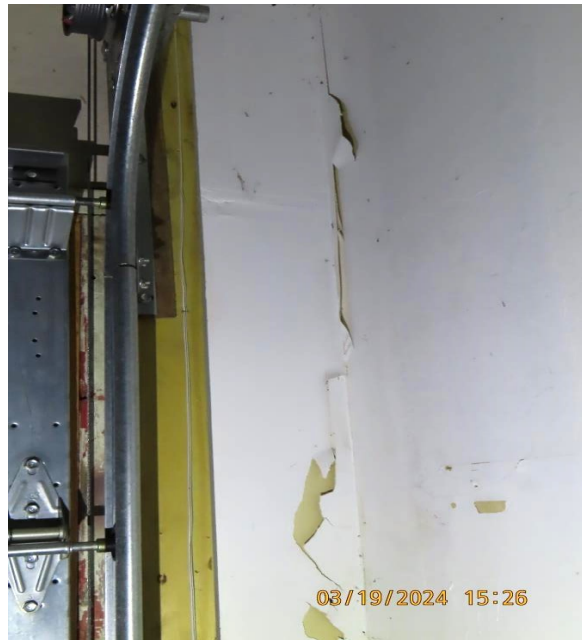
- Flaking paint in the garage walls and ceiling. Possible causes: aged paint, moisture, etc. In need of repair

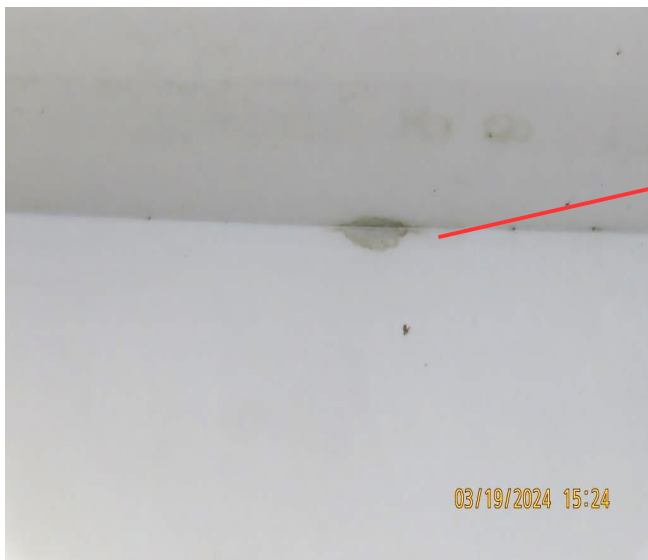
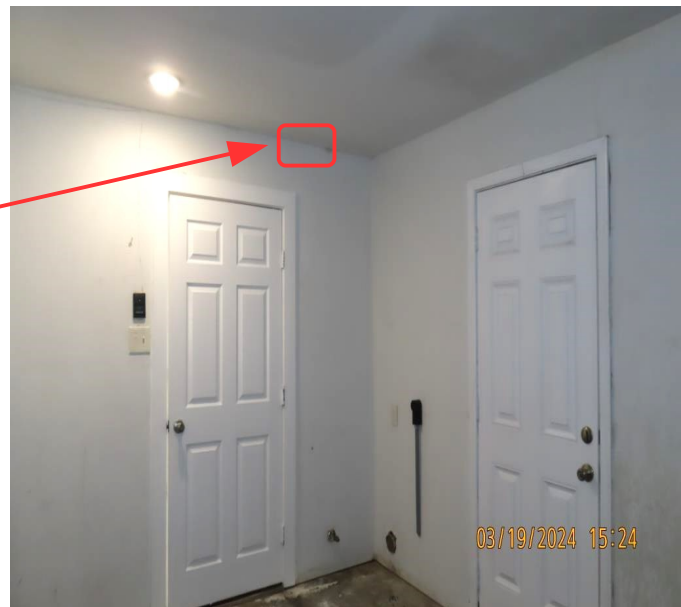
- Noticed discoloration in the garage area. Investigate further for possible water damage and conduct proper repair

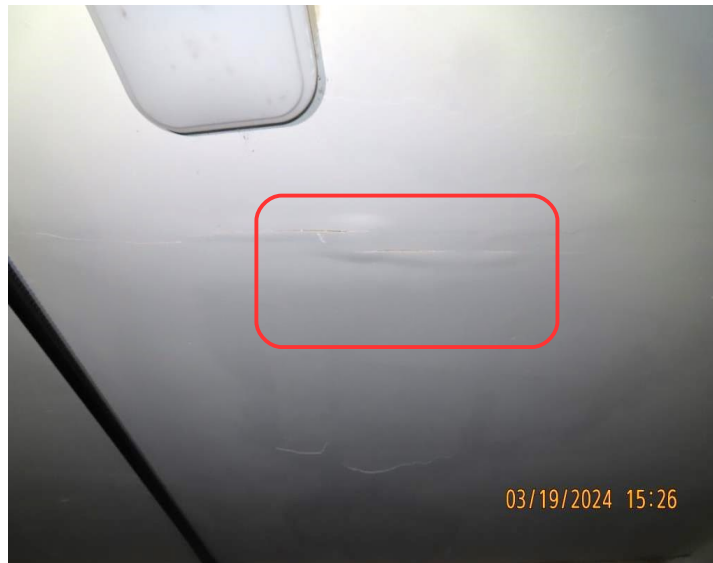
- Evidence of ceiling repair in the garage. Investigate further as needed

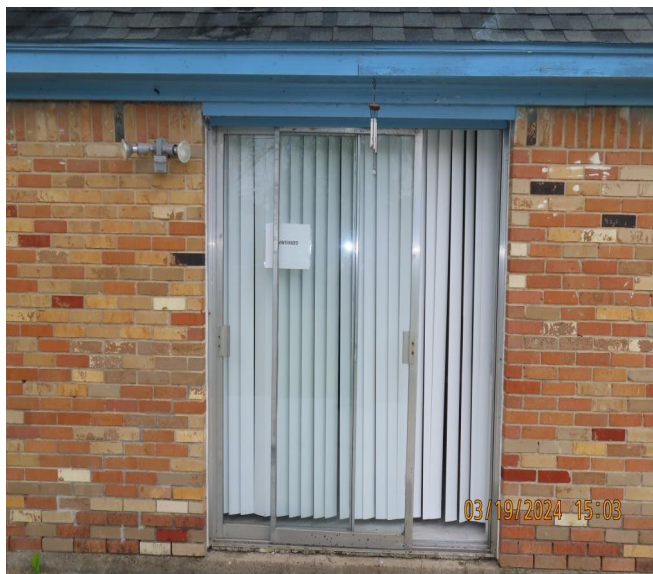
- Glass on sliding door (outer panel) does not appear to be safety/tempered glass. Repair as needed
Note: Proper use of safety glass is critical in areas that are subject to human impact.

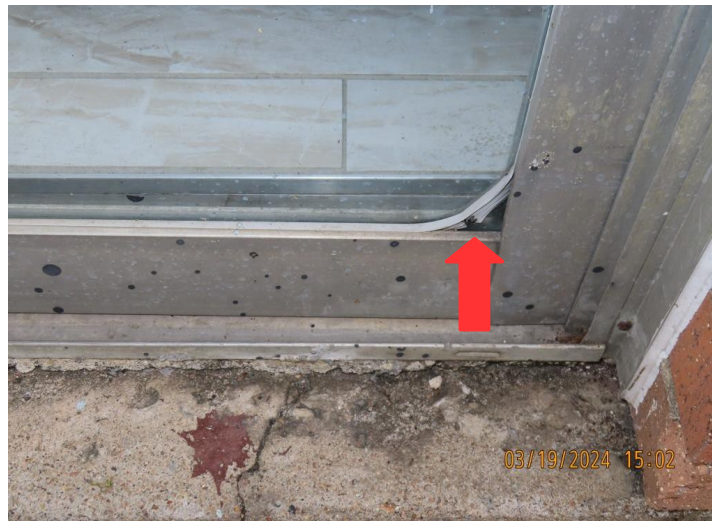
- Replace aged and deteriorating seals on the sliding rear door

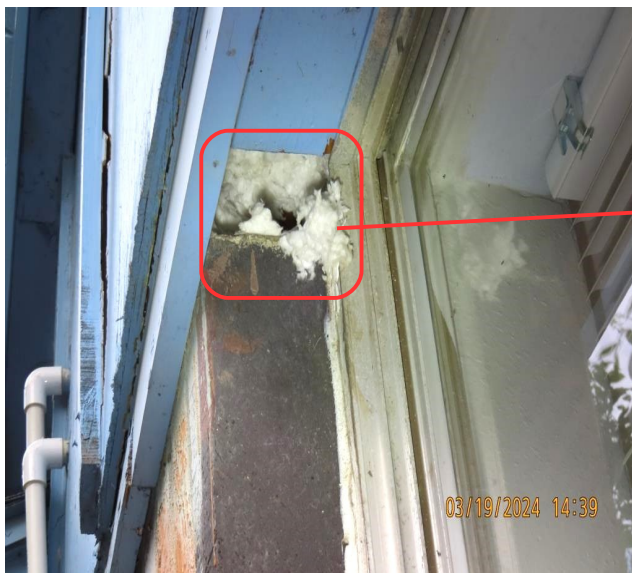
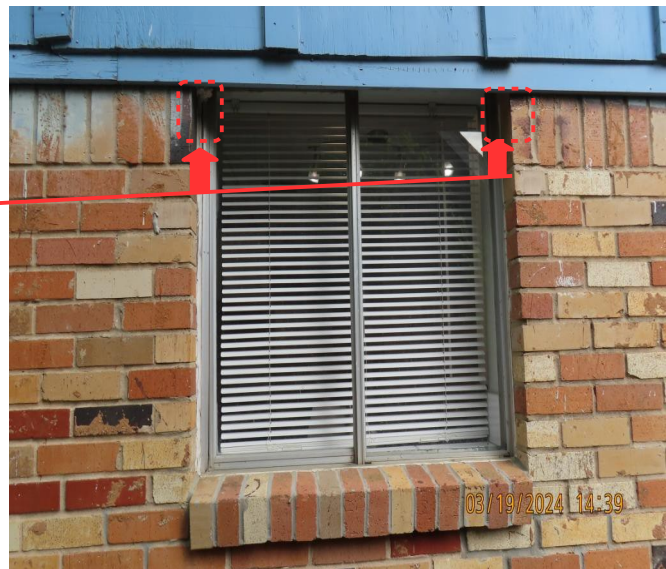
- Noticed large openings above the exterior kitchen window. Properly seal using approved materials to stop/prevent moisture intrusion.

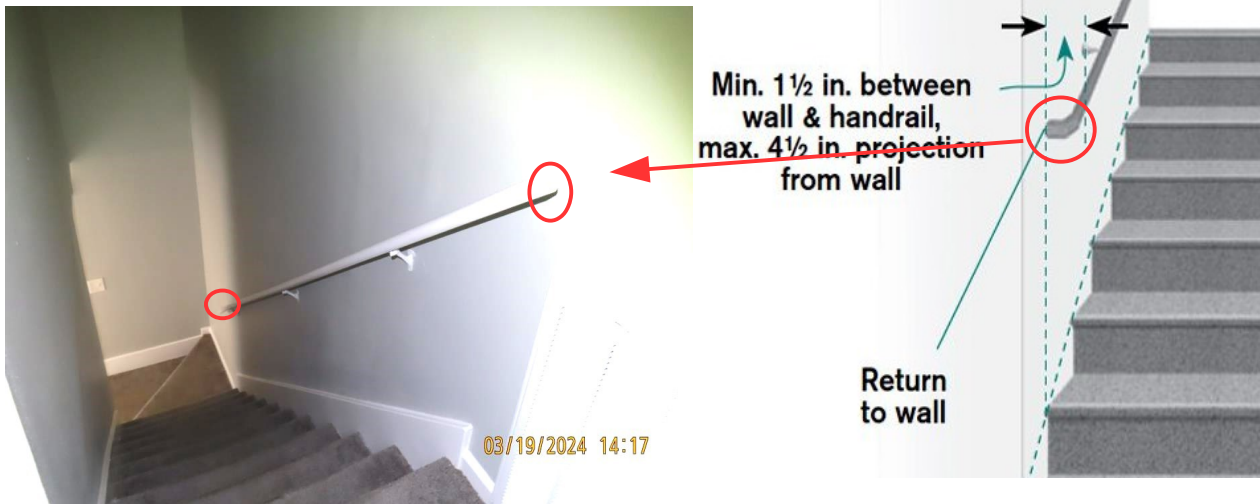
- The handrail ends were not properly terminated. Ends of handrails shall be returned to the wall or end in a newel post. In need of repair for safety.

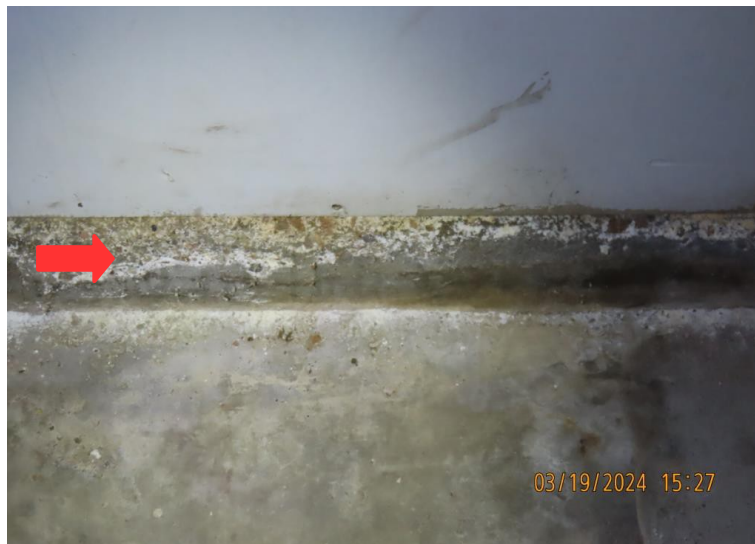
- Noticed efflorescence on the garage slab. Usually white in color, efflorescence is a discoloration caused by crystalline deposits of salts on concrete surfaces. These substances typically originate as soluble compounds within the concrete that are transported and deposited on the surface by upward moisture migration and evaporation. Sometimes, they originate in the underlying soil where they are carried by moisture upward through the concrete and deposited on the surface. Repair as needed

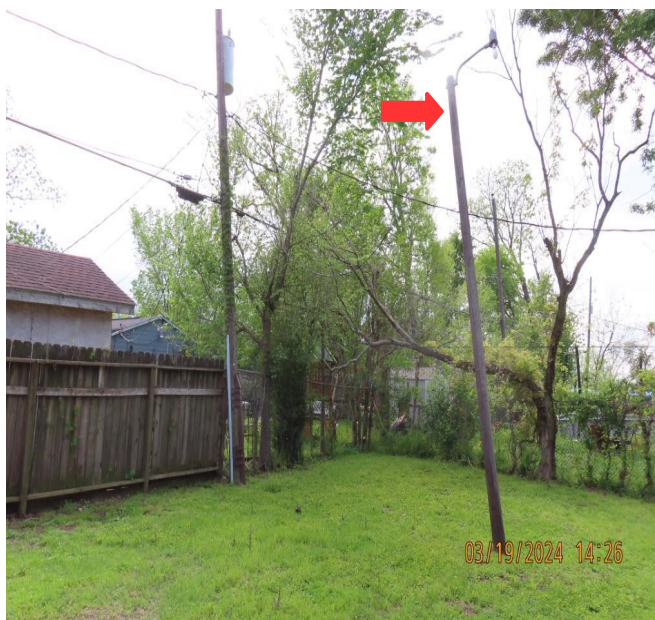
- Noticed a leaning light pole in the back yard. Consult with the utility company for a thorough assessment of existing condition and determine proper corrective actions

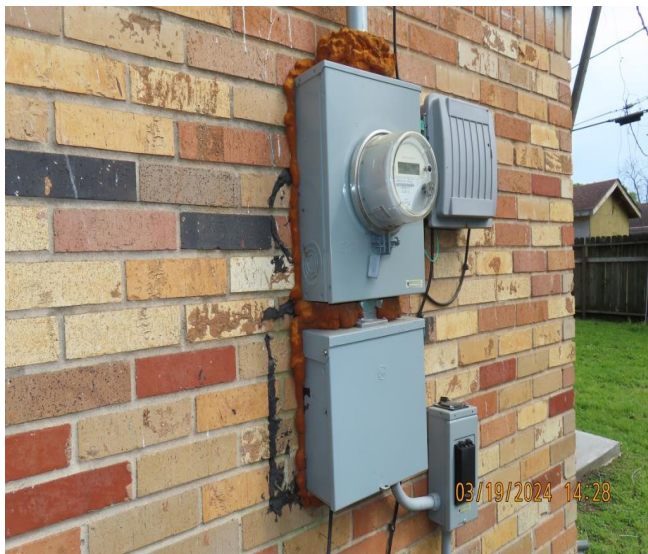
- Seal both sides and top of the enclosure to prevent water/moisture intrusion into the enclosure
- The dead front cover was found loose. The screw or hole thread appeared to be damaged or hole on the latch is misaligned with the screw . In need of repair

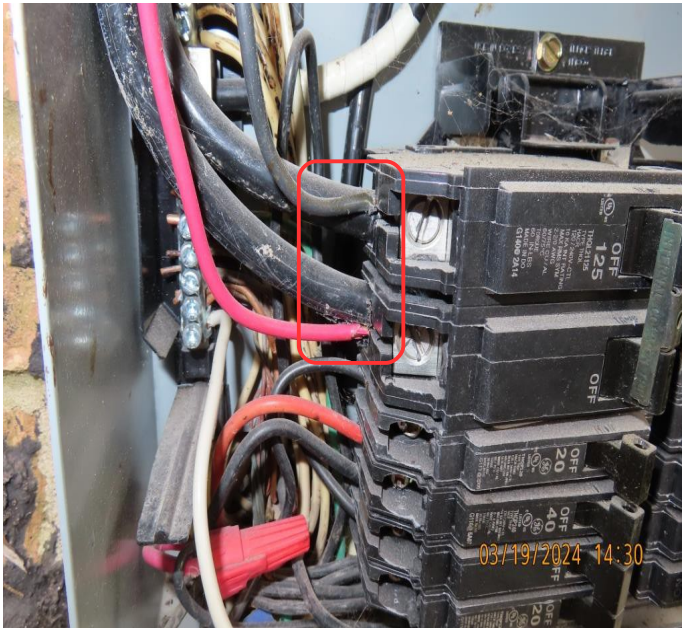
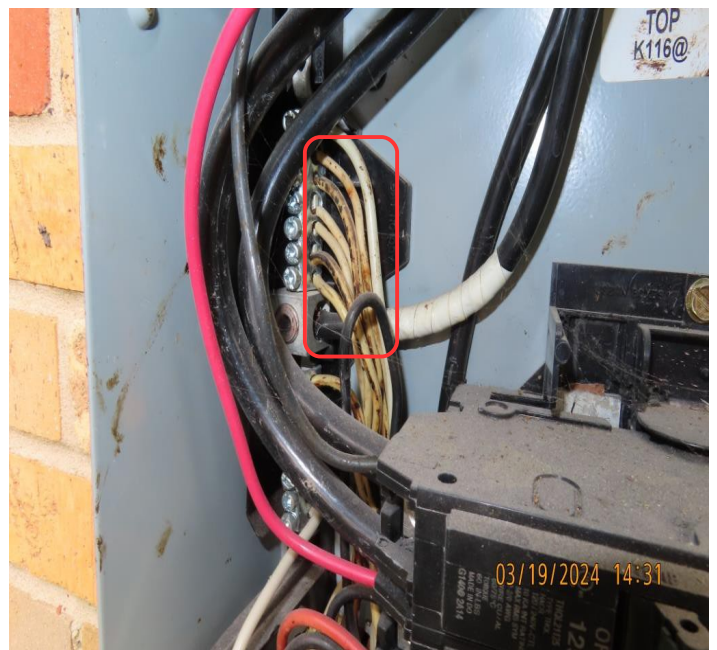
- Observed double lugging of Service cables with a 12 gauge hot wire in the main switch. This condition may be hazardous and can cause “Overheating” of same. Consult a licensed electrician for proper repair
- Noticed discoloration on the neutral wires. Investigate further for possible overheating of same and repair as needed

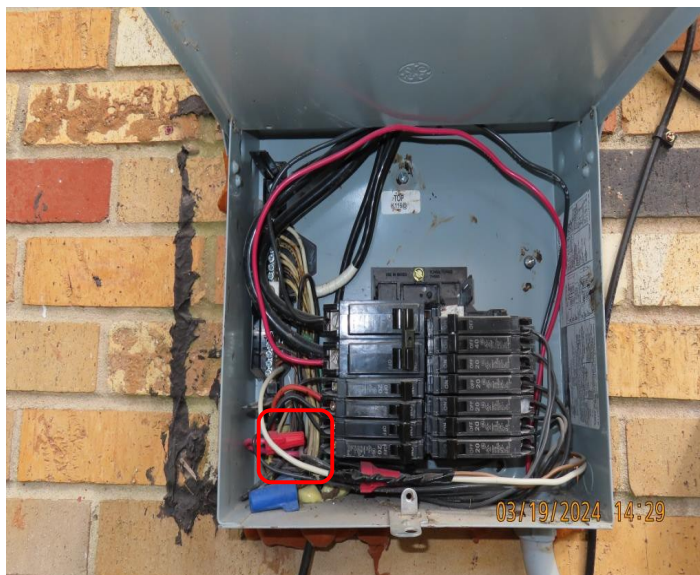
- Branch conductors were bundled and pass through a single penetration in the panel cabinet. Such constriction of conductors may generate excessive heat and de-rate the amperage of the cables. **Recommend 1~3 wires per knockout.**

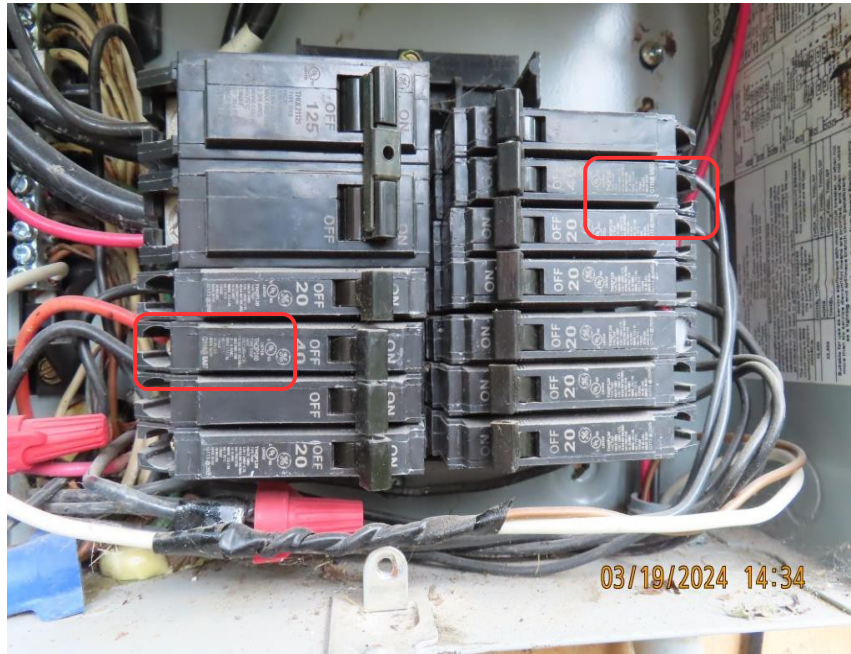
- Wire gauge mismatching on two 40 amp c. breakers: 40 amp on left block is connected to #10 wire gauge instead of #8, and the 40 amp on the right block is connected to #12 gauge instead of #8. In need of proper repair

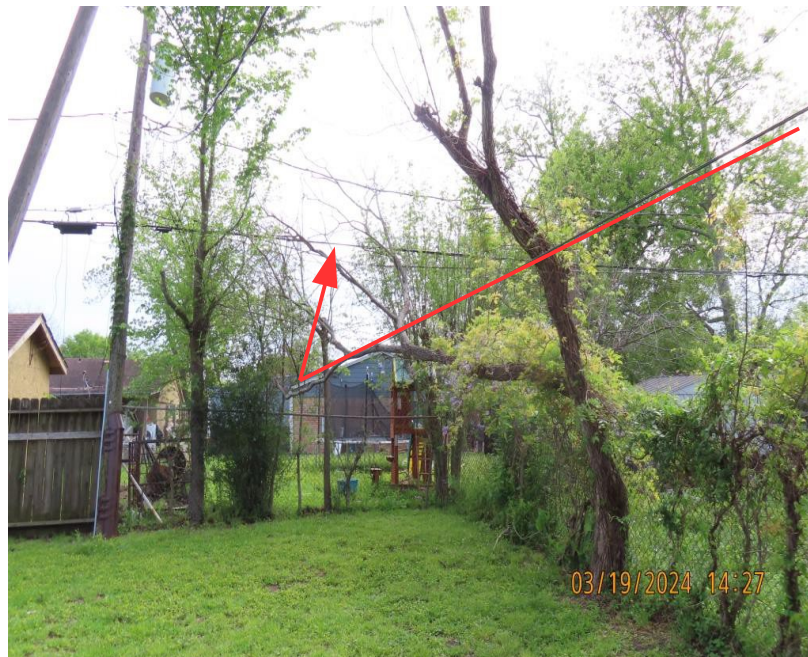
- Noticed what appeared to be telephone or cable wire going from the right wall near the meter box to the a rear pole and routed under a tree limb. Repair as needed
