PROPERTY INSPECTION REPORT FORM

Salvador Garc	03/19/2024
<i>Name of client</i>	<i>Date of Inspection</i>
16918 Hall Sheperd Rd, Houston, TX 77049	
<i>Address of Inspected Property</i>	
Felix D. Angel	20185
<i>Name of Inspector</i>	<i>TREC License #:</i>
N/A	N/A
<i>Name of Sponsor (If applicable)</i>	<i>TREC License #:</i>

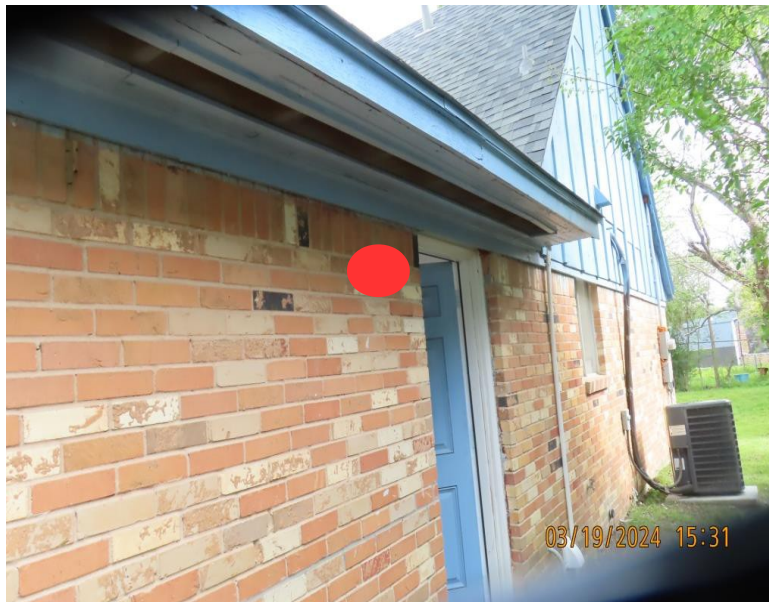
- Install the required light on each exterior door landing.

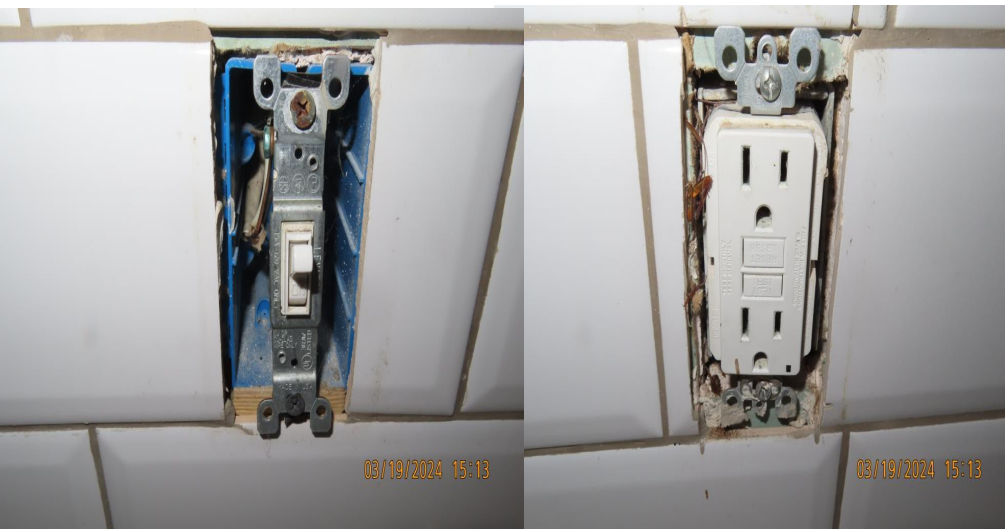
- Space between face plate and edge of the electrical junction box exceeds 1/4". Missing required spacer boxes (spark rings) on multiple kitchen /bath counter top outlets and switches with the tile/stone/granite back splash (reference NEC370-20 & current IRC E3906-6). Install to meet requirements

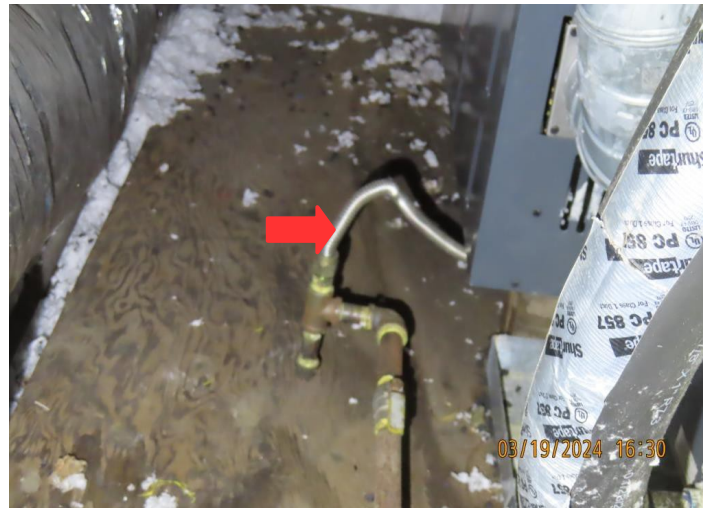
- Observed lack of electrical bonding on gas piping. Recommend installation by a licensed electrician for personal safety
The flexible gas connection between the iron gas pipe and the appliance (Any Gas Appliance) must have a #6 copper "Bonding Jumper" installed from the end connected to the black gas pipe, to the other end connected to the appliance. Consult a licensed electrician for proper repair

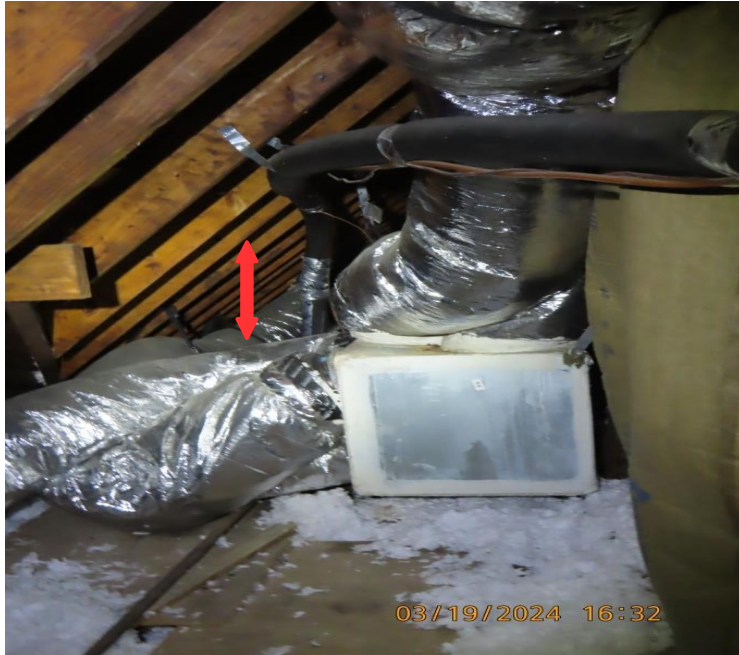
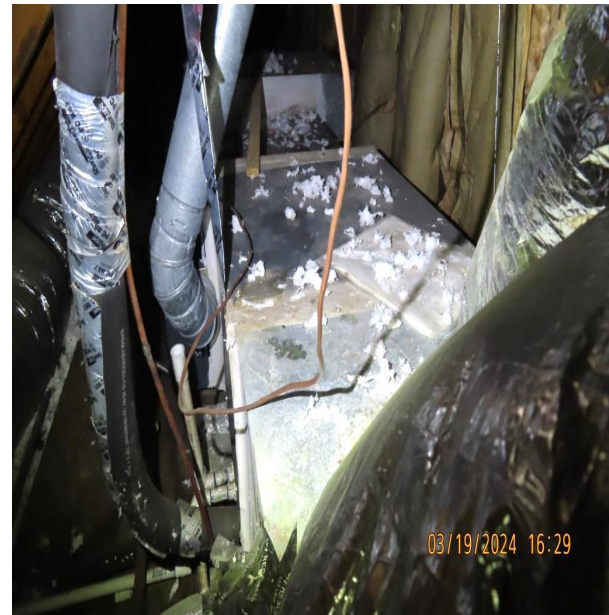
- Note: The hvac system was not fully accessible (limited visibility): obstructed with ductwork.
- Remove flammable debris from top of the furnace (hot surface)

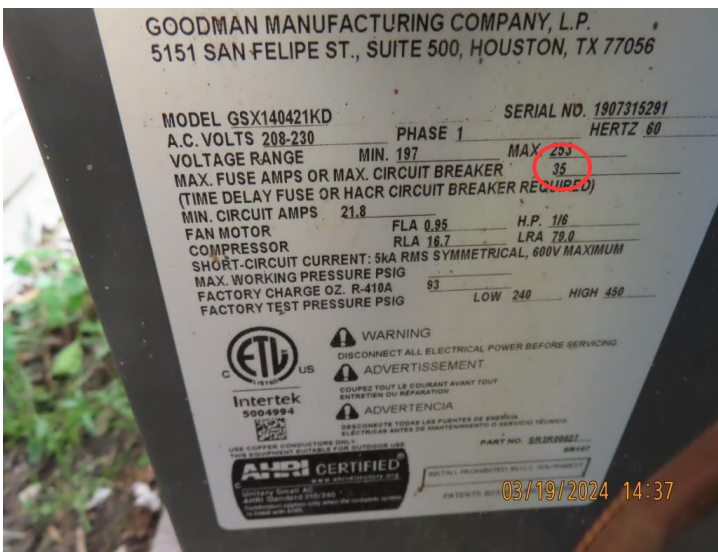
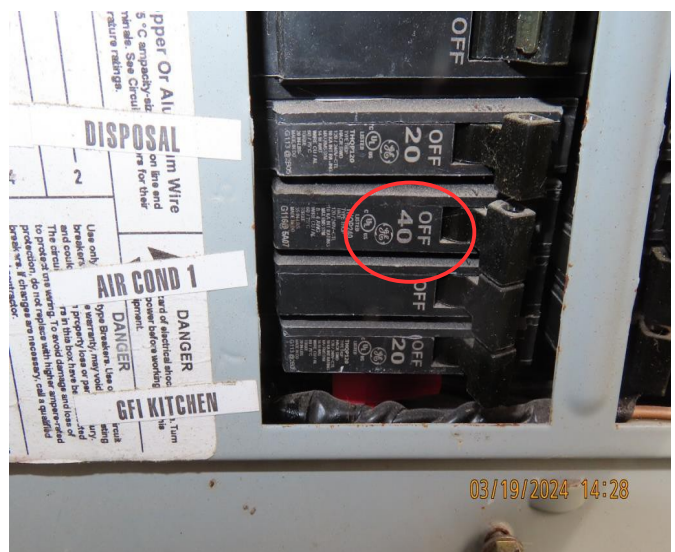
- The max c. breaker capacity per the manufacturer should be 35 amp. Actual capacity is 40 amp. Repair

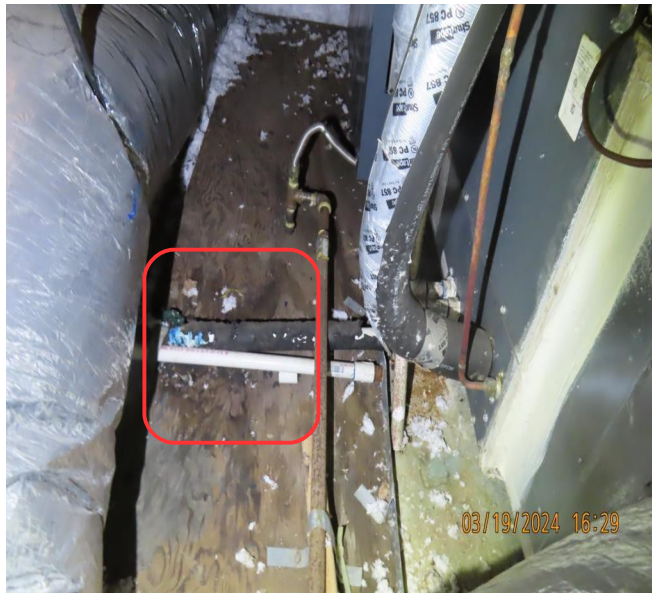
- Noticed water marks under the primary drain. Investigate further for possible condensate leak. Repair as needed

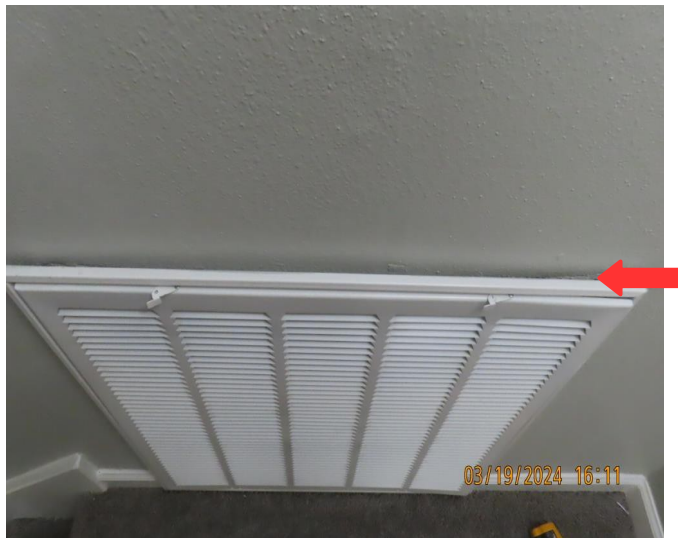
- Other: Unusual large gap between the wall and the grille. Repair as needed

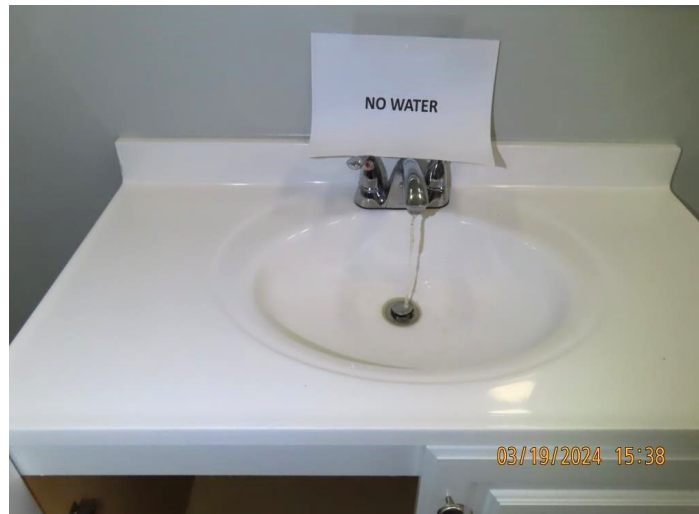
- **The Hot water pressure became** very weak in both bathroom sinks. Water pressure started normal then, it lost pressure significantly within seconds. Investigate root cause and repair appropriately by a licensed plumber

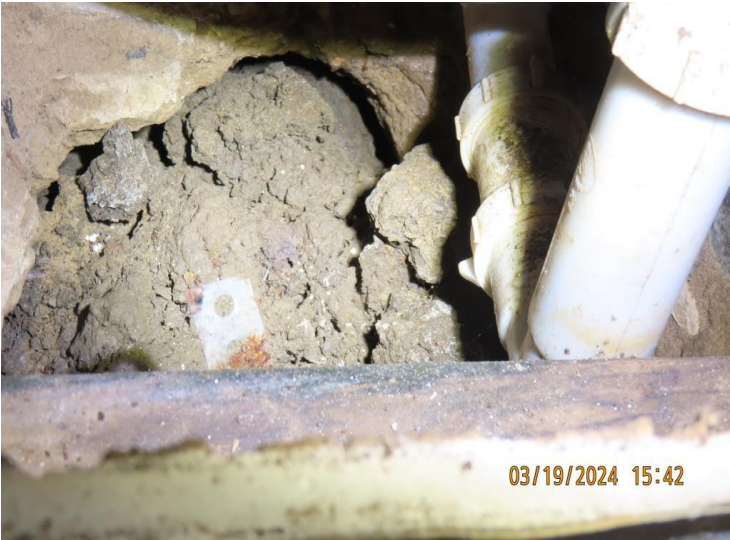
- The soil appeared to be soaked in the downstairs bathtub. No water leaks visible at this time. Investigate further and conduct proper repair as needed

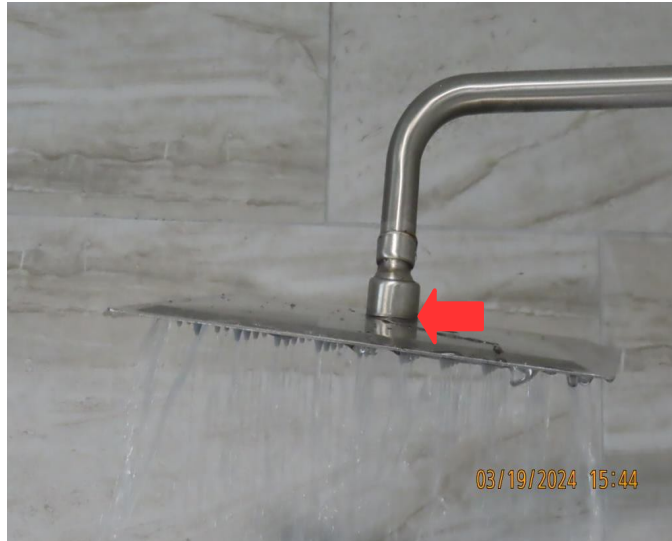
- In the downstairs bathroom, the shower head was leaking at the connection. In need of repair

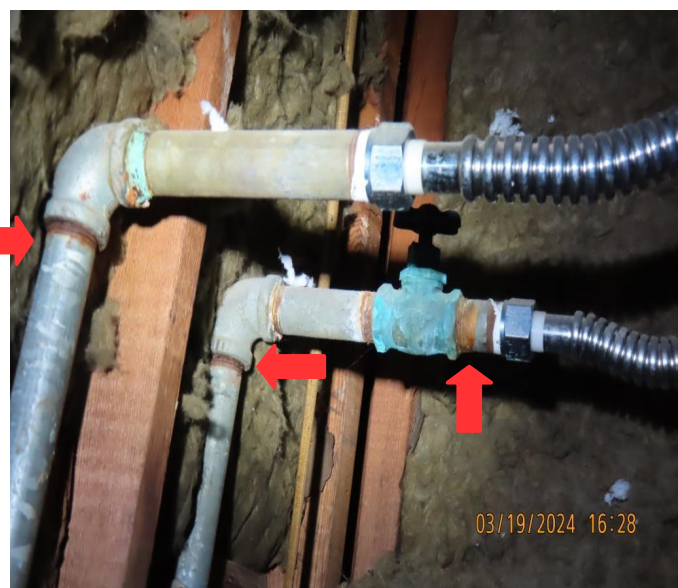
- Evidence of water leak through the flue pipe. Investigate root cause and repair appropriately
- Observed rusting connections. In need of proper repair to prevent leaks and damage to the property

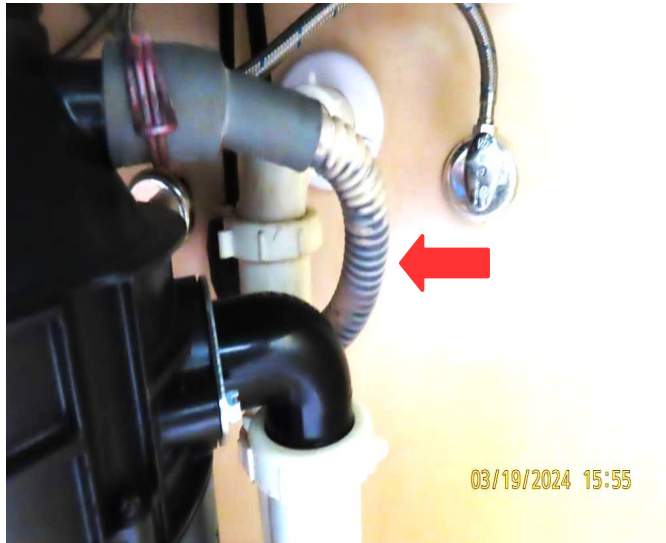
- Note: Drain line should loop to the highest point of under the sink, then down to the drain line at the disposal to prevent back siphoning of dirty dishwater back into the dishwasher.
- Replace dirty drain line to prevent clogging.
