**2328 Jackson St.
Houston 77004**

PROPERTY INSPECTION REPORT FORM

Paul Homeyer <i>Name of Client</i>	03/11/2024 <i>Date of Inspection</i>
2328 Jackson St., Houston 77004 <i>Address of Inspected Property</i>	
Ruben Santillan <i>Name of Inspector</i>	5570 <i>TREC License #</i>
<i>Name of Sponsor (if applicable)</i>	<i>TREC License #</i>

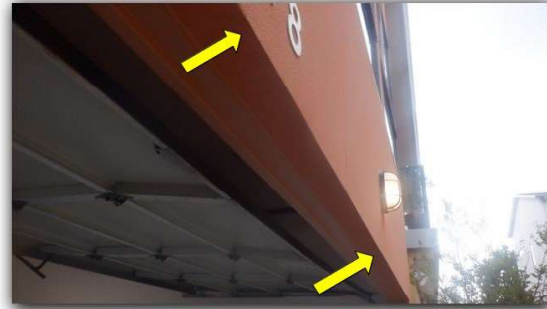
Did not observe weep screed at bottom of the stucco wall, where it intersects with the soffit. The following diagram depicts a “best practice” procedure as defined in the Texas Lathing and Plastering Contractor's Association (TLPCA) Stucco Resource Guide. This detail provide a means for moisture to exit from behind the stucco if the wall assembly leaks (we seldom see a weep screed at these locations on most stucco homes / buildings). If this exhibits a problem with moisture collecting in this area, a weep screed should be installed.

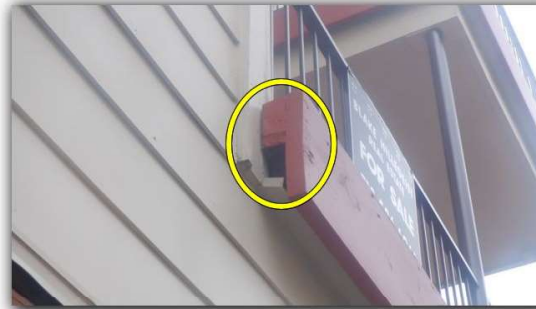
A section of small trim at the 2nd floor patio observed to be missing.

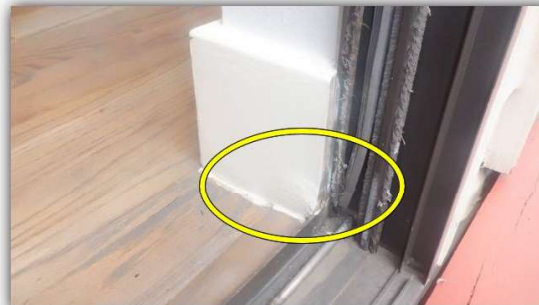
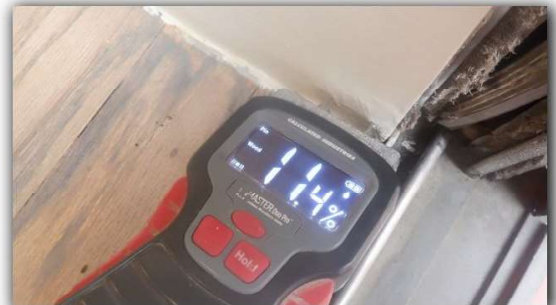
Water penetration observed at the following location(s):evidence of water penetration observed adjacent to the sliding door in the living room. Low moisture meter readings were taken at the time of this inspection.

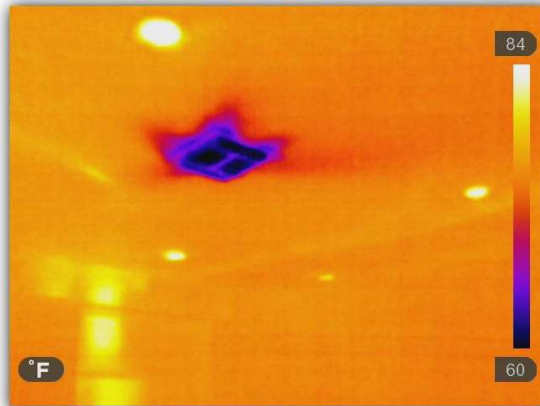
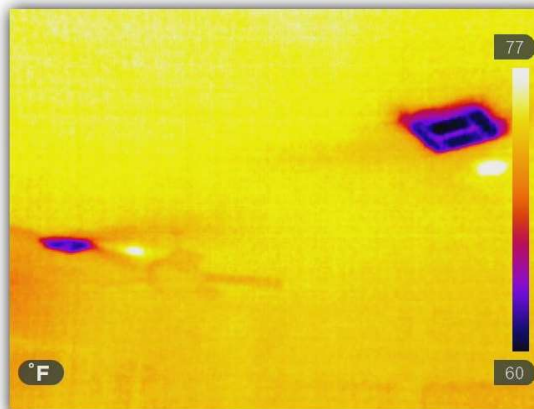
Evidence of painting and patching observed at one or more locations.

Thermal imaging of the interior was taken and no anomalies were observed.

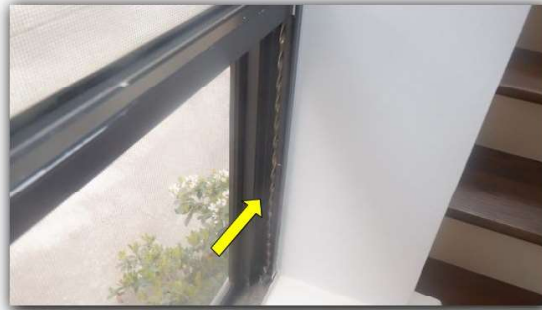
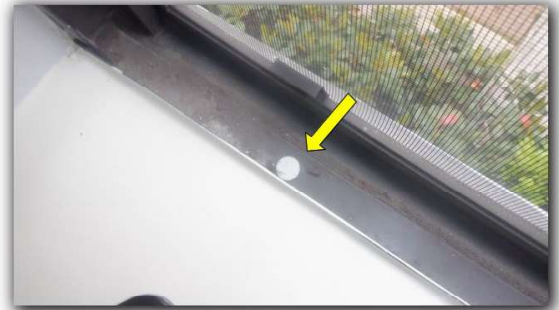
One or more window spring(s) were observed to be sprung/broken/detached. **(1st floor landing)**

Window jamb alarm sensors need to be sealed with silicone seal to prevent water entry.(1st floor landing)

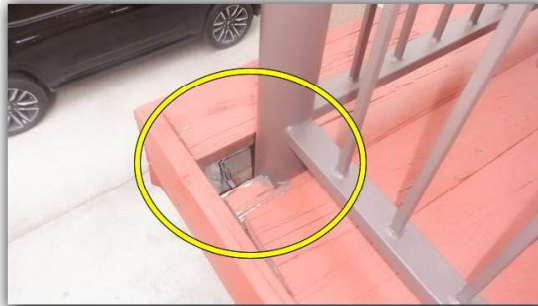
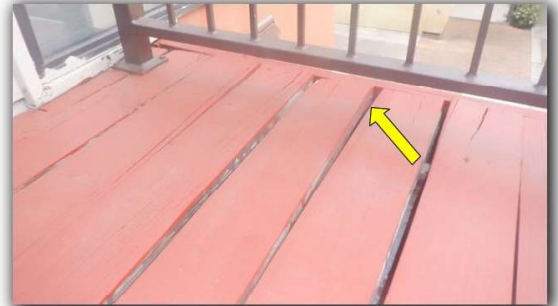
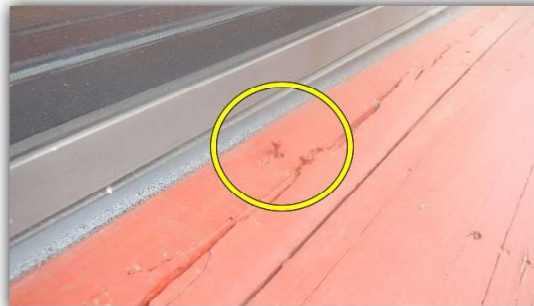
Balcony floor boards observed to be pulling loose, poor condition, and deteriorated. One or fasteners also observed to be pulling loose.

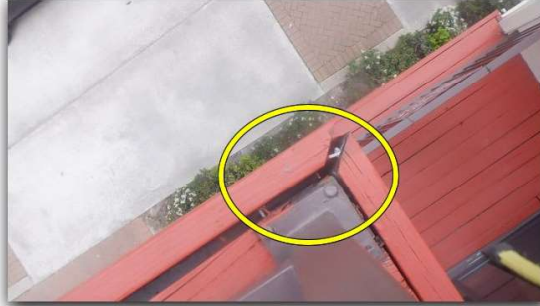
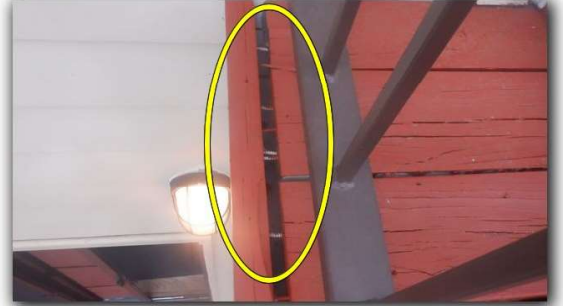
Perimeter fascia at both of the balconies observed to be in poor condition, loose and improperly fastened.

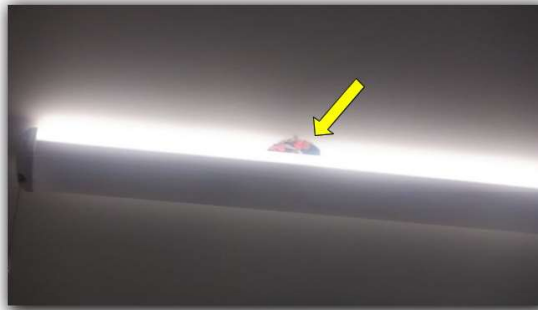
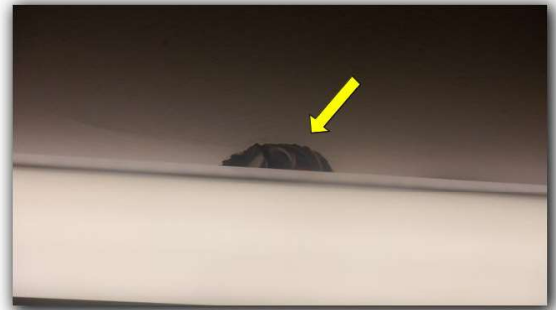
Open junctions observed on the ceiling fixtures in the garage and master closet area.

Recommend installing proper covers to prevent possible arcing or sparks from falling onto one self/ground.

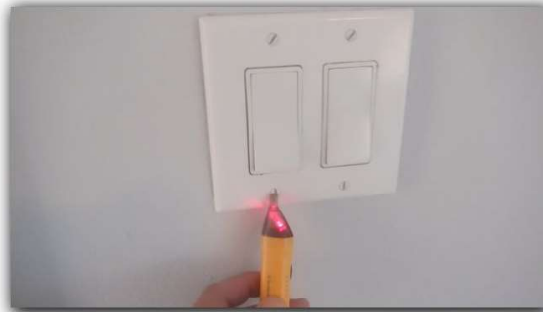
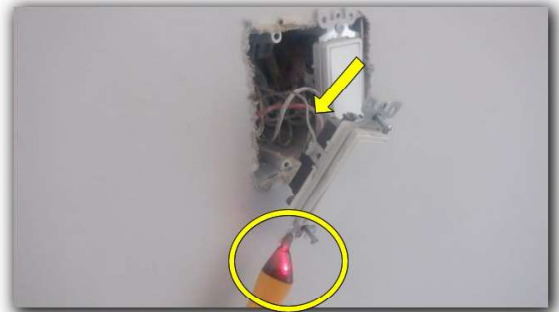
Random sampling showed switch(s) are not grounded as required by current industry standards / code; 1999 NEC 380-9(b) “Provisions for snap switch faceplates; Snap switches, including dimmer switches, shall be effectively grounded and provide a means to ground metal face-plates, whether or not a metal face-plate is installed.” Recommend grounding of all switches with ground lug.(master bedroom and 3rd floor landing only) Ground wires are connected to the switches, however a ground fault still exist. The cause and remedy should be investigated and corrected as necessary.

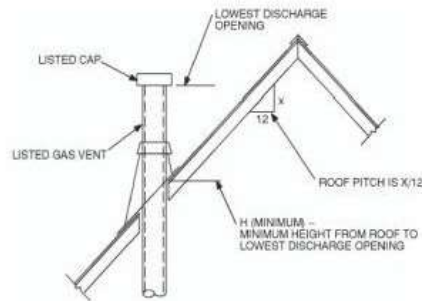
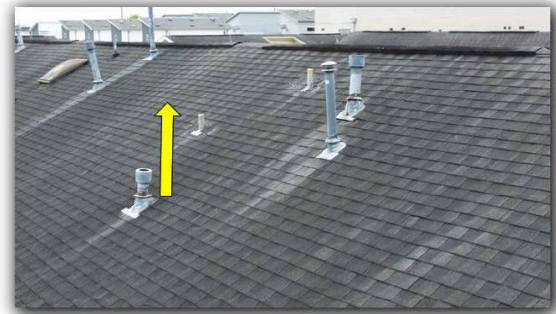
Improperly vented, does not extend high enough above roof. Vent pipe is required to extend and terminate at least 24 inches above roof line to the lowest discharge opening of the vent cap. (Ref: IRC 2004 Section 2427.6.5 Gas Vent Termination) (1st and 2nd floor unit)

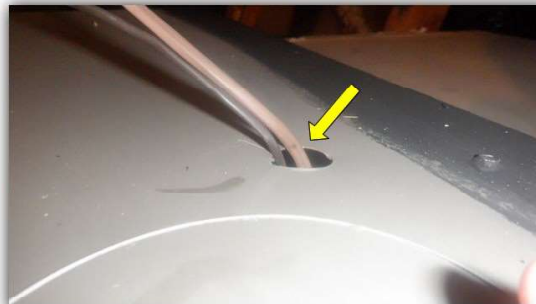
Thermostat wiring not secured to attic unit(s), missing small fitting that secures wiring to cabinet to prevent pulling loose by service personnel or homeowner.

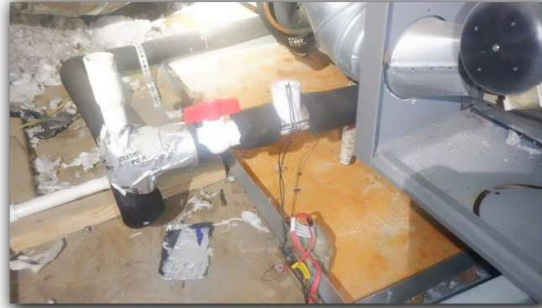
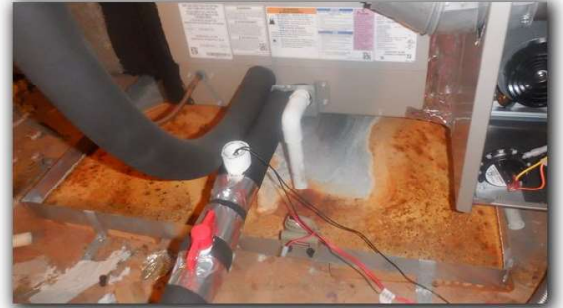
Secondary drain pan is very rusted, recommend replacement.(both units)

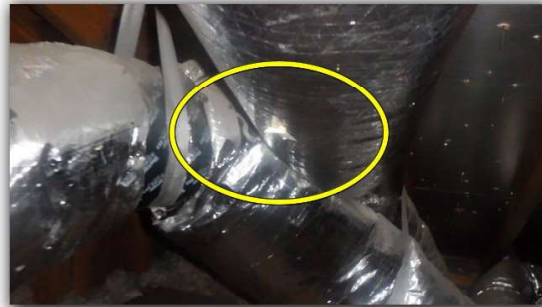
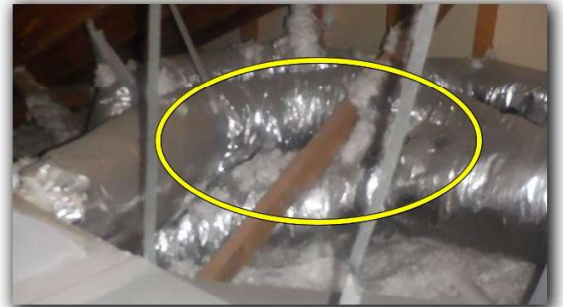
Observed several / multiple areas in attic where flex duct touch and are missing required 1" clearance from other ducts to prevent condensation between ducts that touch. Recommend general maintenance to flex ducts in attic, Re-support where needed, seal/tape minor air leaks, repair torn/damaged vapor seal, etc.

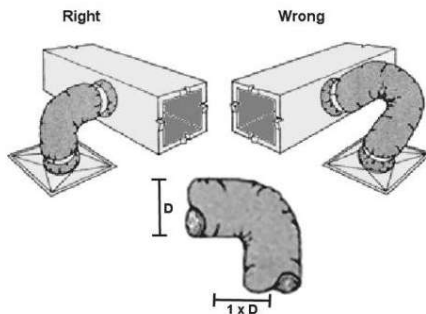
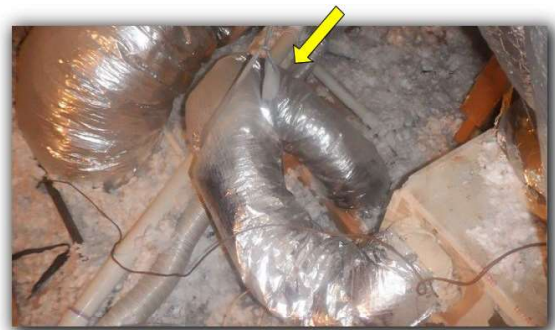
Some flex duct observed to be improperly routed with sharp bends and / or excess material in bends. Improper routing increases frictional loss in the duct and reduces heating and cooling efficiency. Radius at centerline of the bend should be no less than the diameter of the duct.

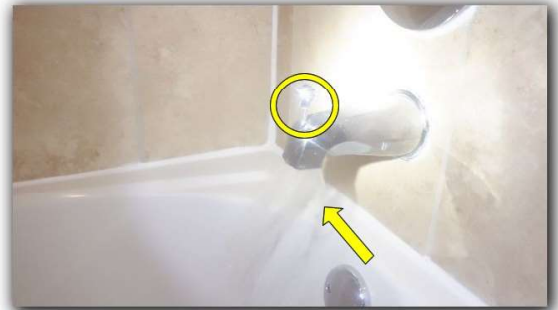
One or more shower head(s) leak water. **(1st floor bath)**

Shower diverter valve is not fully functional, does not direct all water to shower head during operation, 3rd floor back bathroom.

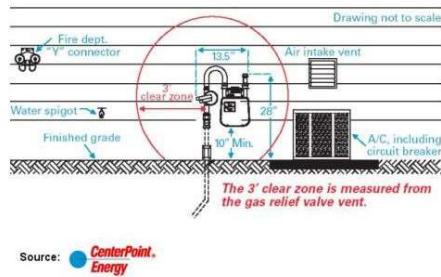
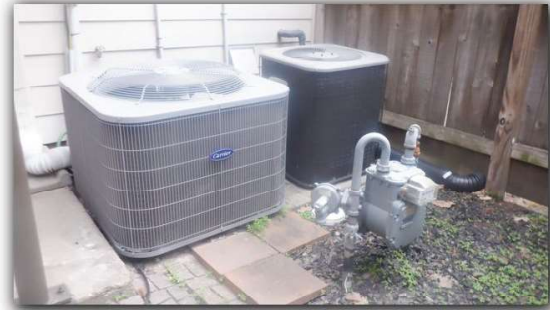
Proper flex

Close proximity to gas meter is potential hazard and NEC code violation.

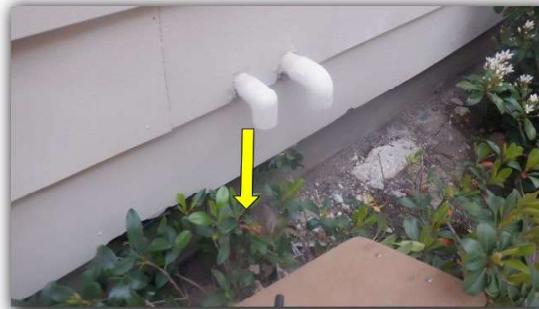
Drain line terminates improperly, current industry standards (Code) require drain line terminate within 6 inches from grade. Recognized safety hazard, repair IRC 2803.6.1.

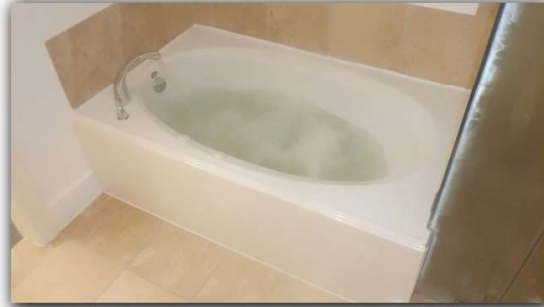
Was not able to access motor for visual inspection. Does not fully comply with National Electric Code (Reference NEC 680-72. Accessibility. "hydromassage bathtub electrical equipment shall be accessible for repair / replacement without damaging the building structure or building finish".) Should have access panel installed for servicing / access to pump motor IRC 4109.3.

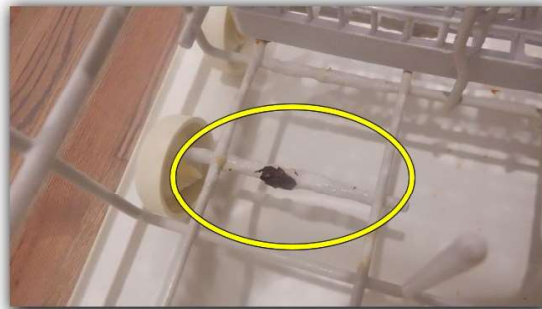
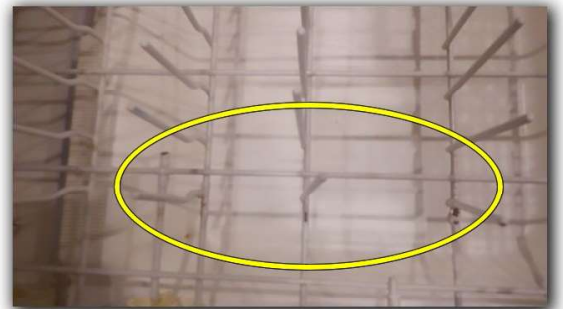
Rust observed on interior of cabinet and/or dish racks.

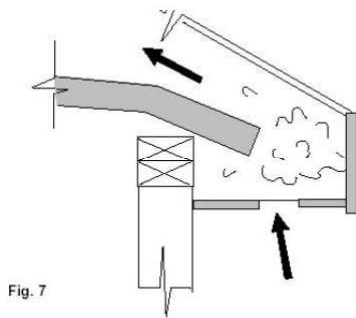
Improperly vents to soffit. Should vent to exterior.

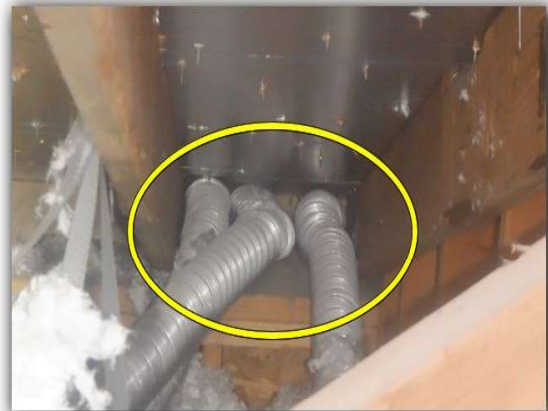
Fig. 7

Terminating exhaust fans to soffits/eaves builds up condensation moisture within the soffit that can deteriorate the fascia board, soffit and/or plywood roof decking and cause paint peeling. A soffit/eave is part of attic air space where exterior air is drafted in to the attic space with the exhaust duct fumes and moisture.
