**Savannah Taylor  
111 Anise Tree Pl  
Spring, TX 77382**

**September 14, 2021**

## PROPERTY INSPECTION REPORT

Concerning: 111 Anise Tree Pl, Spring, TX 77382  
(Address or Other Identification of Inspected Property)

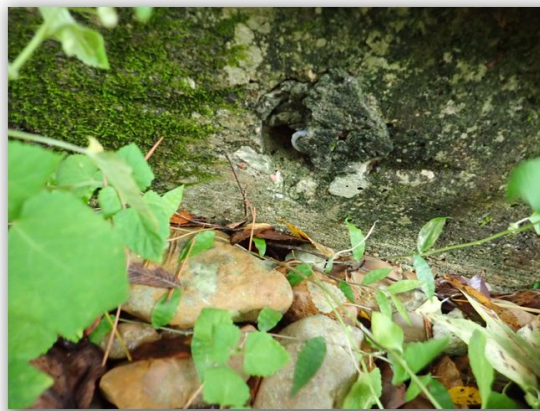
- One or more of the post tension cable ends are exposed and need to be properly sealed on the east side of the structure.

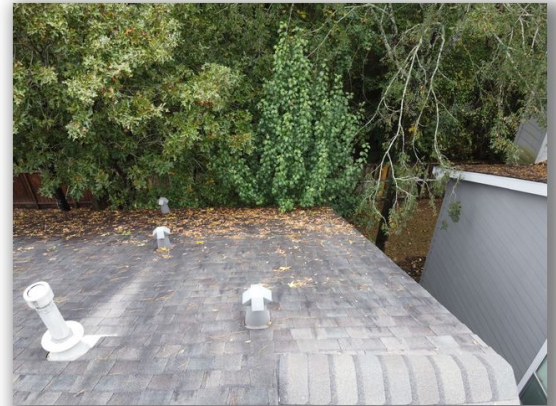
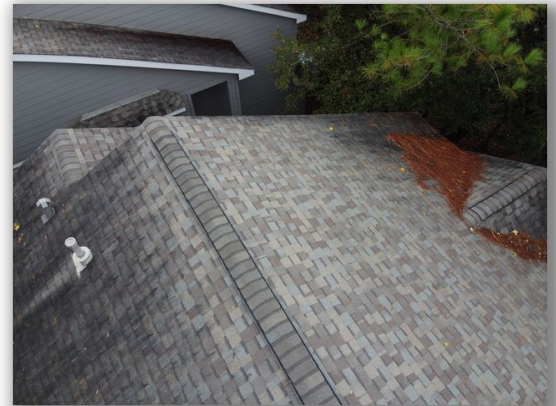
### Flashing Details

- The flashing is lifting and/or pulling loose and should be re-secured on the west side of the roof structure.
- There was no kickout flashing details observed at the lower bottom edge of the roof line interface and the sidewall that continues past the edge of the roof. The lack of this kickout flashing will allow water to penetrate at these points.
- The flashing needs to be painted to prevent rust and/or UV damage.
- The storm collar(s) at the roof level gas equipment vent pipe(s) need to be properly sealed to help prevent water intrusion into the structure.

The flashing details needs to be checked, reset or repaired as necessary. The observations made to support the rendering of this opinion are listed but may not be limited to:

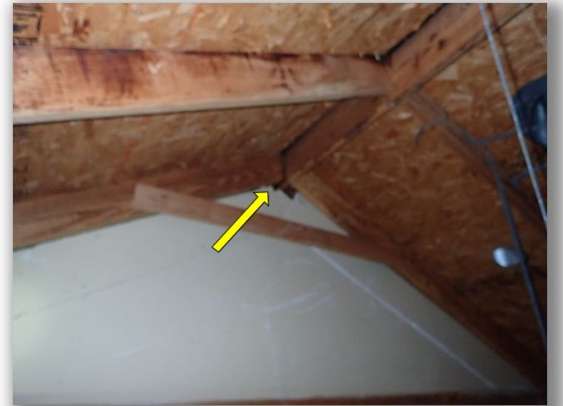
- The roof structure attic space ventilation appears to be marginal at the time of this inspection. It is recommended to increase the amount of lower and upper ventilation to help prevent heat buildup in the attic space area.

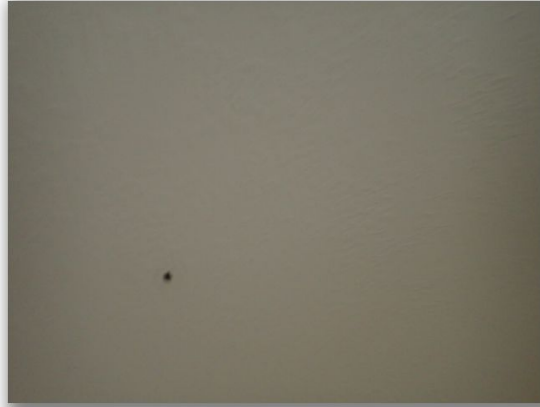
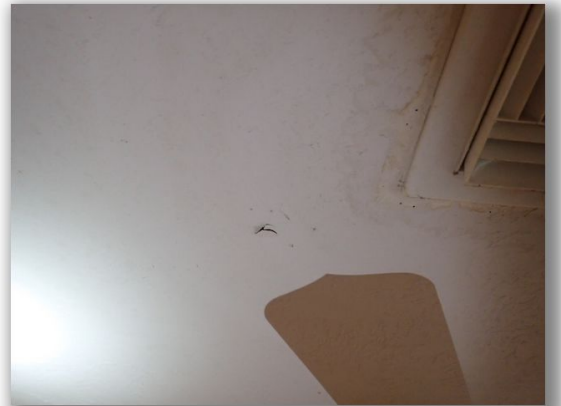
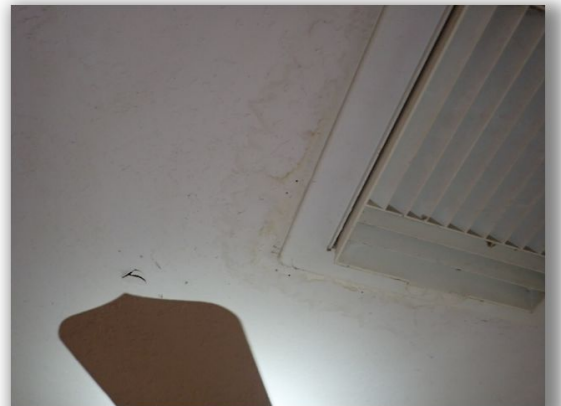
**Note:** There is evidence of painting and patching to the interior finish and prior interior finish repairs. This condition could limit the Inspectors visual observations and ability to render accurate opinions as to the performance of the structure.

**Note:** Nail heads were observed to be pushing through the interior finish in one or more locations.

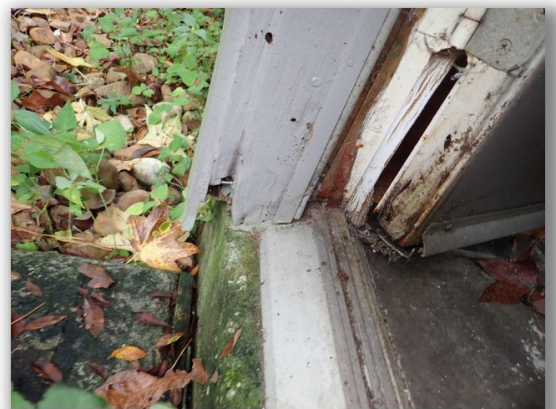
- Weather-stripping improvements are recommended for the backyard entry, front entry exterior door(s).
- Visible evidence of previous water intrusion was observed at and/or around the exterior backyard entry door(s). The cause and remedy should be investigated and corrected as necessary.
- The door frame has some damage to the backyard entry door.

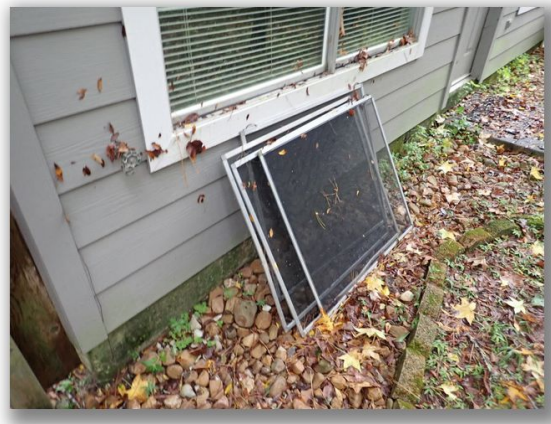
- One or more of the window screens were observed to be damaged.
- One or more of the window screens were observed to be missing.

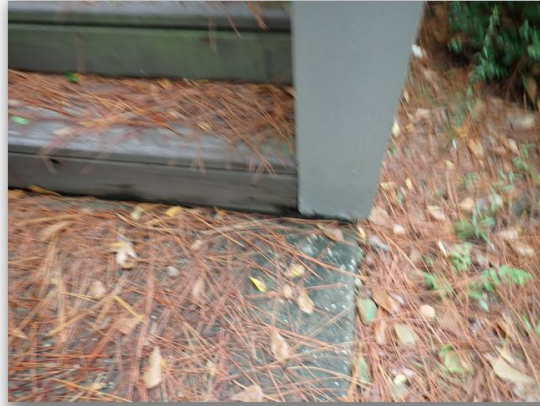
- Minor deficiencies were observed in the patio.

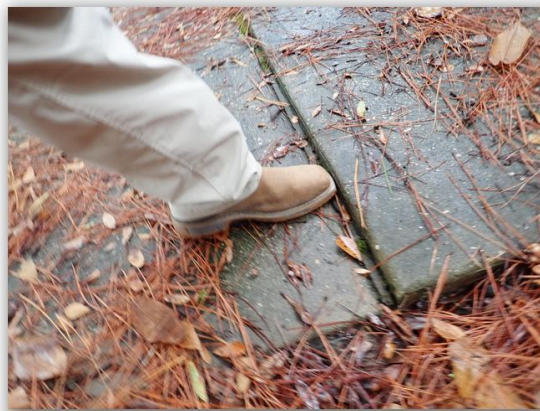
- Larger than typical cracks and/or deficiencies were observed in the driveway.

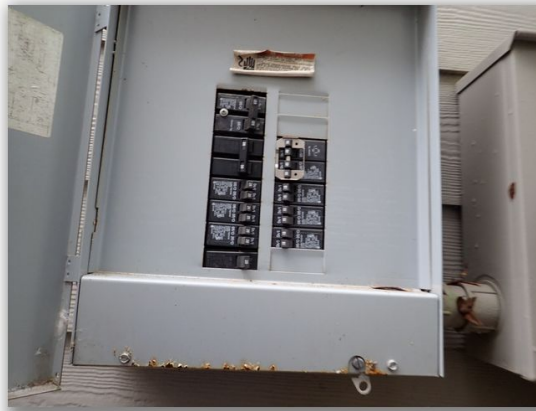
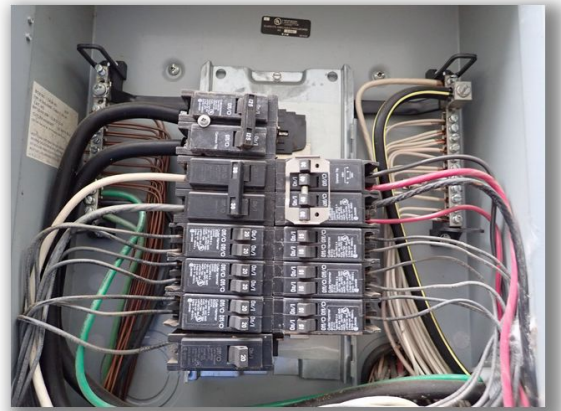
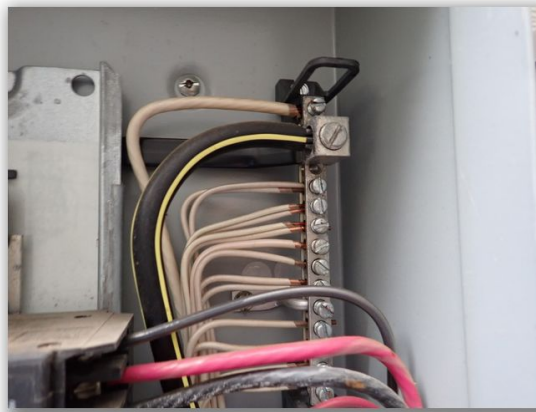
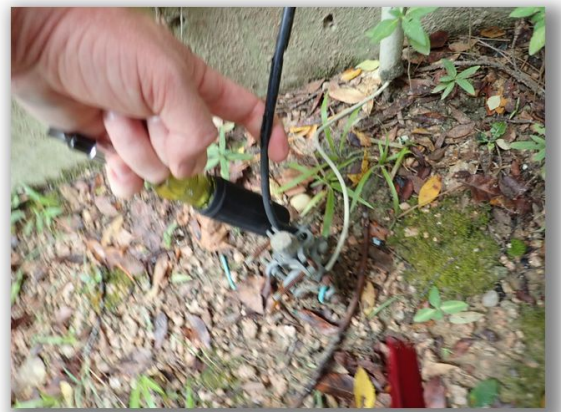
- The breakers (overcurrent devices) in the electrical panel are not properly labeled.
- The outside electrical cabinet was observed to be weathered and/or rusting.
- One or more of the neutral wires in the electrical cabinet were observed to be double lugged (i.e. two wires under one screw). The neutral wires need to be separated to prevent damage to the panel box and electrical system.

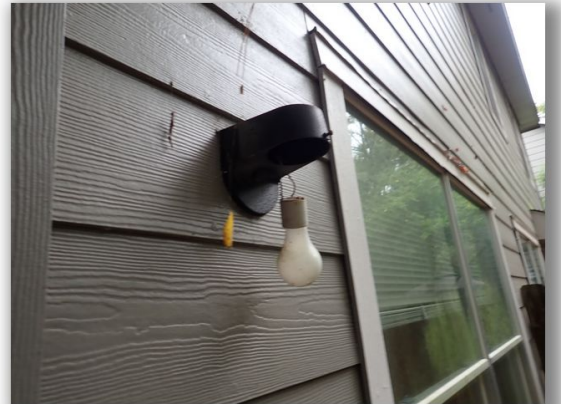
- The ceiling fan is not balanced properly and wobbles when operated in the family room.
- One or more of the light fixtures appear to be inoperative in the various locations throughout the house. This may be due to a bad bulb or some other unknown condition. This condition should be further evaluated and corrected as necessary.
- One or more of the exterior light fixtures were observed to be damaged on the west exterior wall, east exterior wall.
- One or more of the light fixtures do not appear to be functioning properly in the kitchen.
- The ceiling fan appears to be inoperative in the primary bedroom.

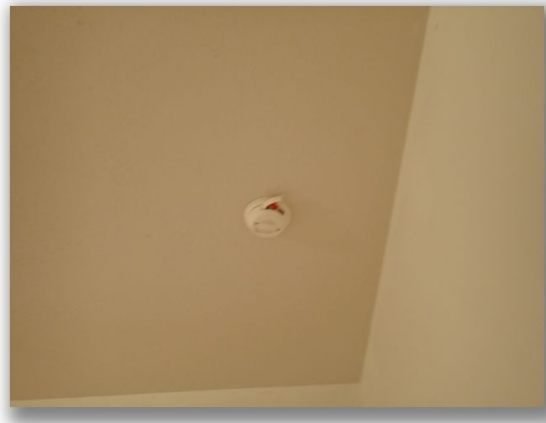
- Batteries were observed to be missing from one or more of the smoke detectors, indicating that the batteries need to be changed. It is recommended to replace the batteries in all of the smoke detectors once a year for reasons of safety.

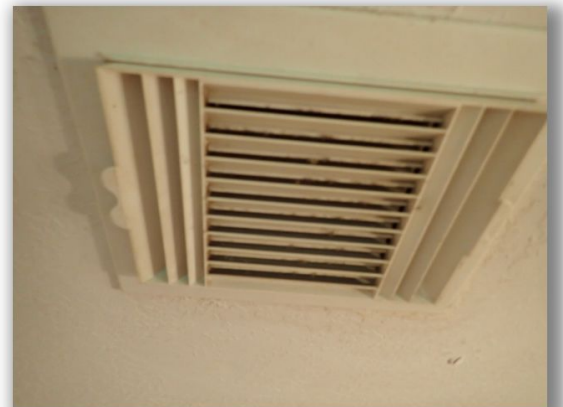
- The duct work in the attic area does not appear to be properly suspended and separated to help prevent condensation from developing. It is recommended to separate and suspend the duct work with supports in minimum intervals of 4-feet that have a minimum width of 1.5-inches.
- The air-return chase for the HVAC system is dirty and should be cleaned to help maintain good air quality.
- There is visible debris/dust and/or mildew on some of the air registers. The cause and remedy should be further evaluated. It is recommended to have the air registers and duct system cleaned for air quality purposes.

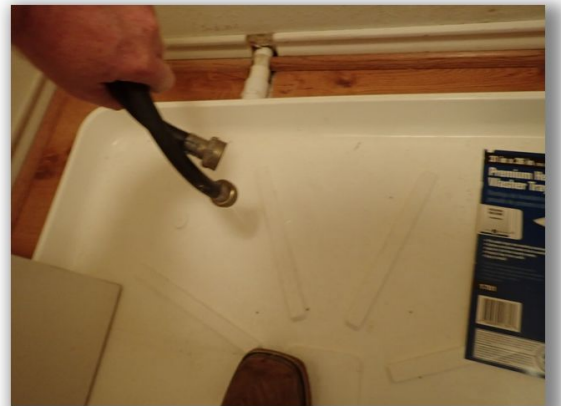
- One of the laundry connection hose bibbs has a slow leak when in the off position.

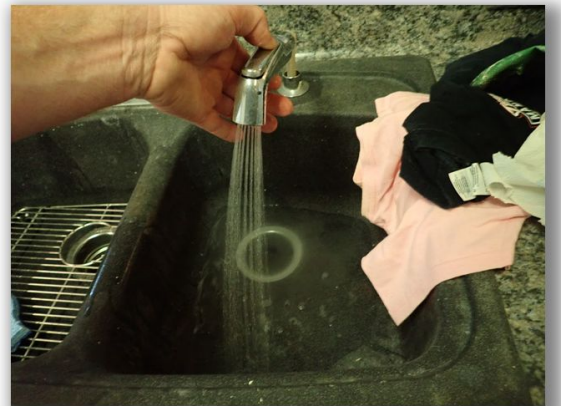
- The sprayer appears to have low water pressure. The cause and remedy should be further evaluated and corrected as necessary.

**Note:** Previous water leaks were observed at and/or around the drain connections under the sink. This would indicate previous problems and should be closely monitored and corrected when necessary.

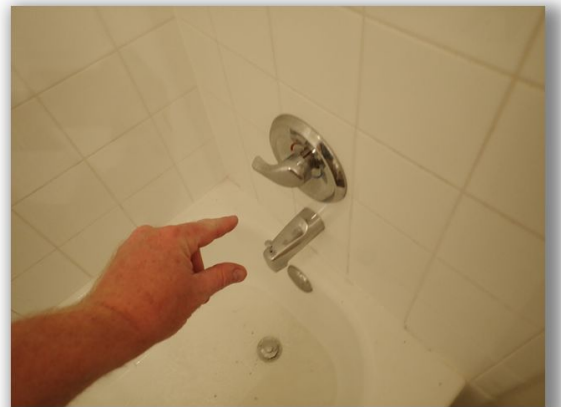
- Cracked, deteriorated and/or missing bathtub enclosure grout and/or caulking should be repaired or replaced as necessary.
- The faucet assembly is not sealed at the wall. This condition has the potential to allow water to leak back into the wall cavity.
- The faucet is unusually noisy (humming) at the time of inspection. This condition should be further evaluated and corrected if necessary.

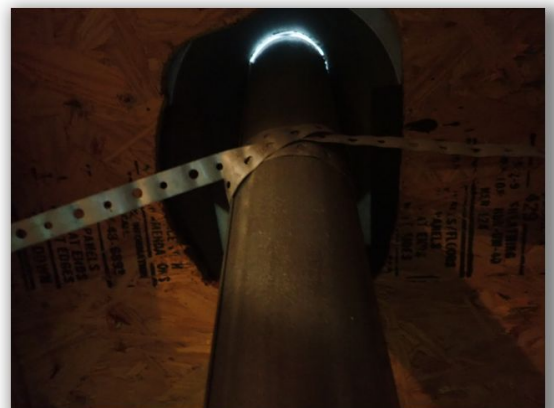
**Note:** There is evidence of prior leakage on or around the water heater housing. This should be closely monitored.

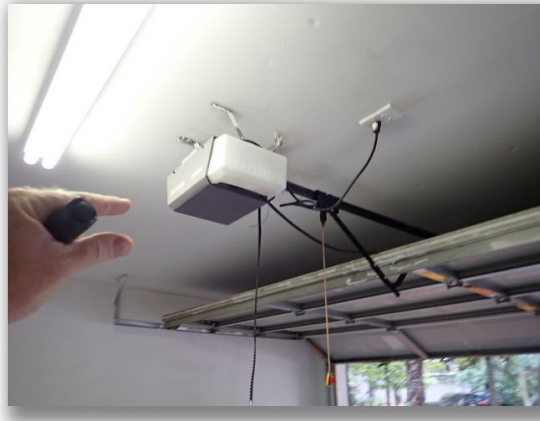
- When an automatic garage door opener is in use, the manual lock should be disabled or removed.
- The garage door opener chain is damaged and needs to be better secured and/or adjusted.

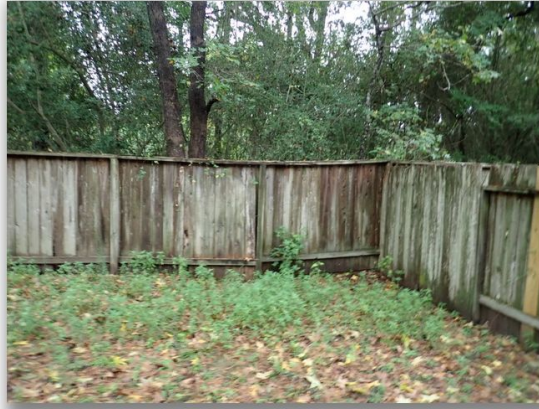
- The overall condition of the fence material, railing and posts are in poor condition and repair or replacement is necessary.

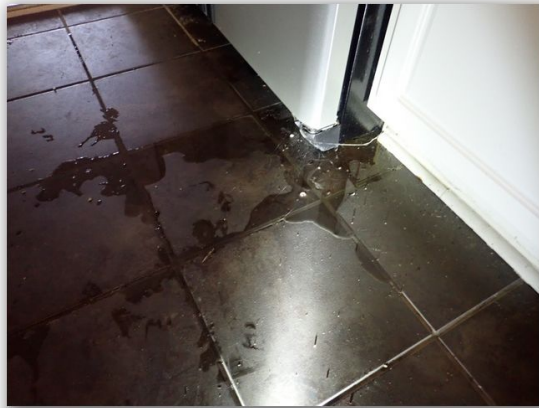
- The refrigerator was observed to be leaking at the time of this inspection.

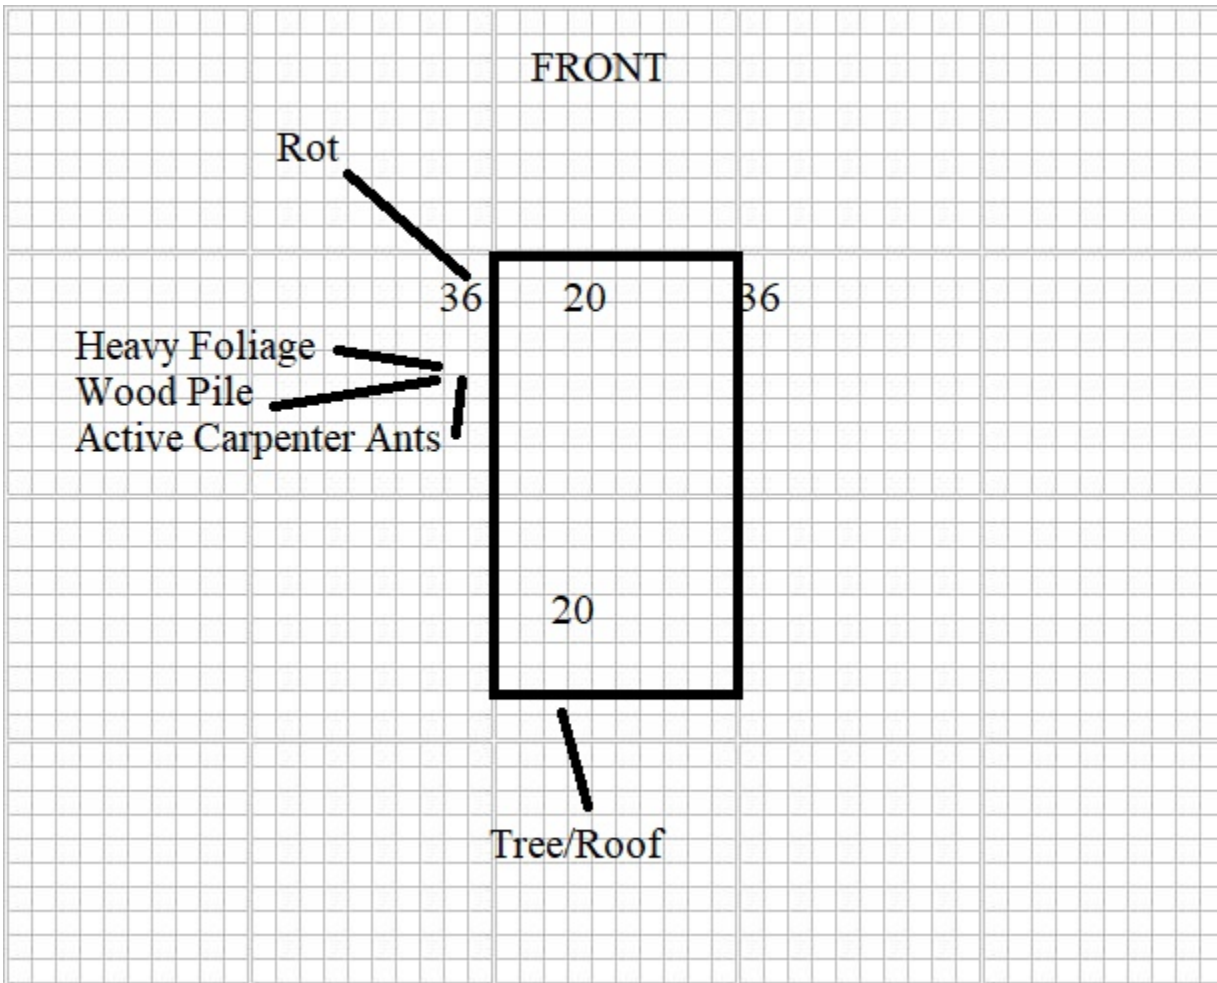
**Additional Comments** An ACTIVE Infestation of carpenter ants/bees was discovered at the time of this inspection. See diagram for location(s). Treatment Recommended.
