PROPERTY INSPECTION REPORT

Concerning: 2038 Wembley Way, Rosenberg, TX 77471
(Address or Other Identification of Inspected Property)

By: William Yeakley #9541 August 25, 2020
(Name and License Number of Inspector) (Date)

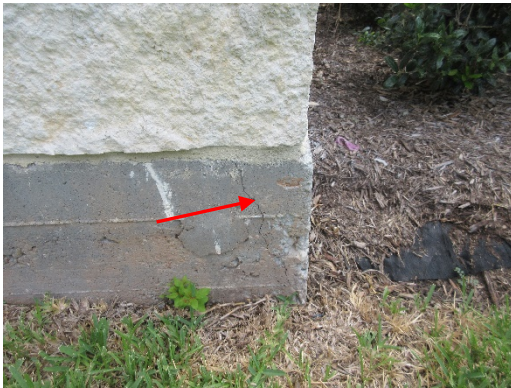
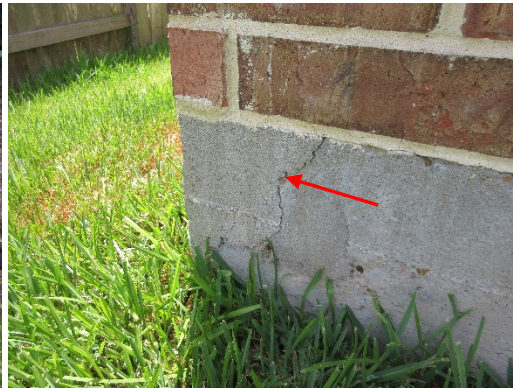
- The foundation is performing as intended. No significant problems were observed.
- Foundation has a corner pop. This is not a structural defect but a result of the original concrete pour.

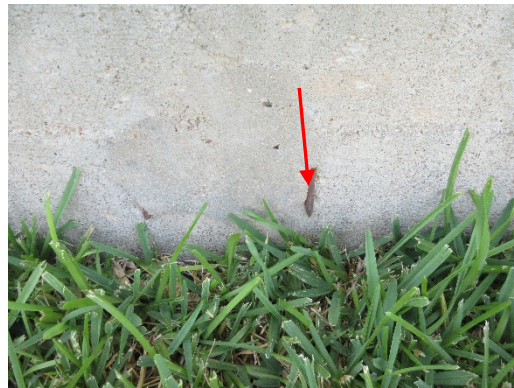
- Dead-end pocket former nails are exposed. These are a safety hazard and shall be clipped flush.

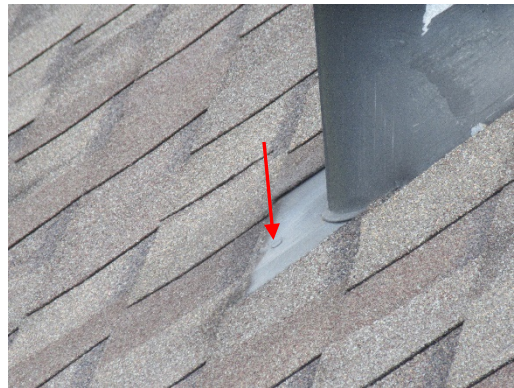
- Nail heads are exposed at the flashing. They shall be sealed to reduce risk of leaks.

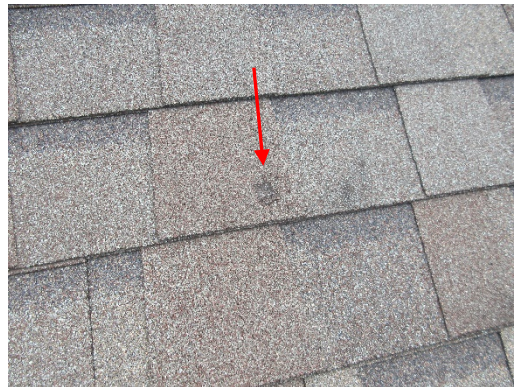
- *Some shingles are damaged*

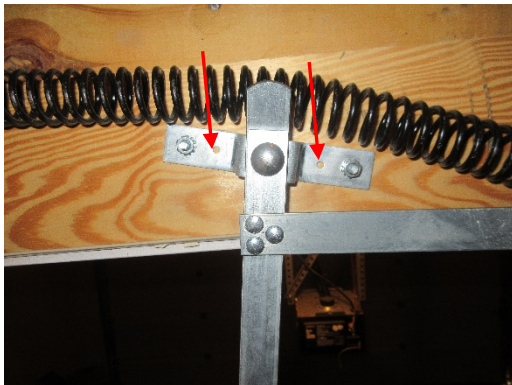
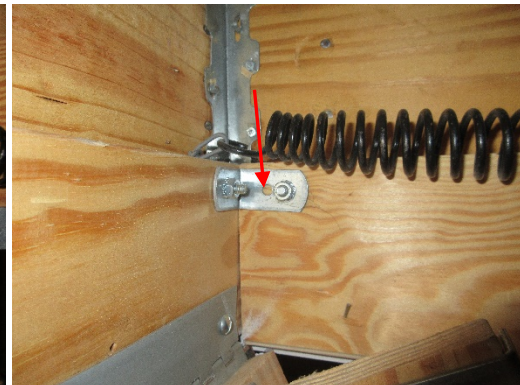
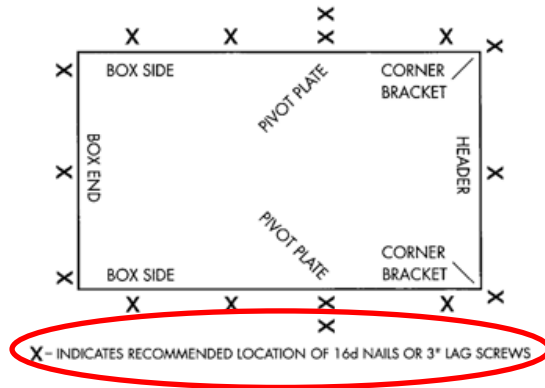
- Fiberglass blown-in
- Depth markers were in place
- *Attic access ladder is improperly fastened. The corner brackets and pivot plates are missing fasteners. This is a safety hazard and shall be corrected.*

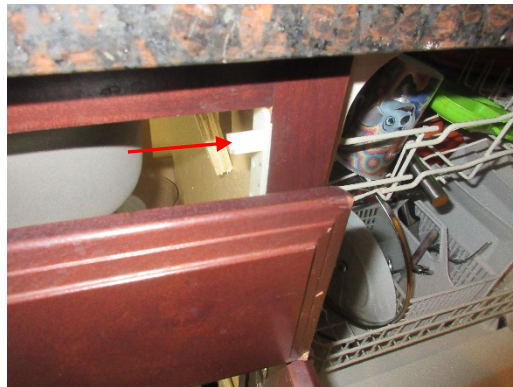
- False cabinet drawer front is not secured

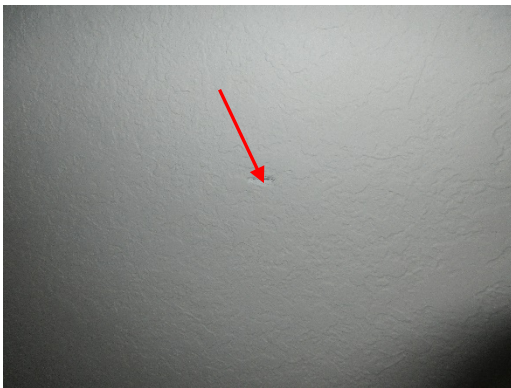
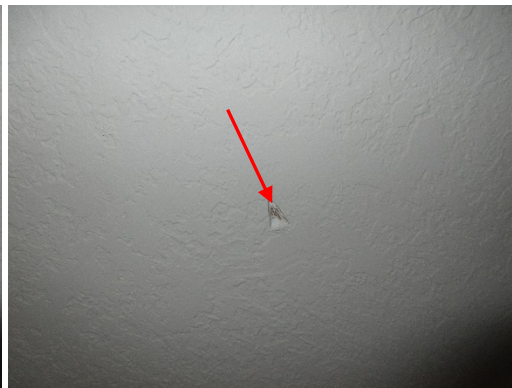
- Several rooms have damaged drywall

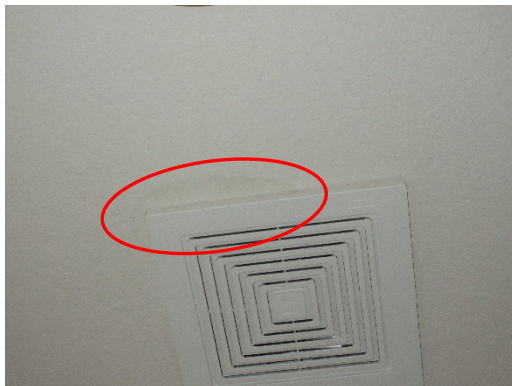
- *Master water closet ceiling has visible stains*

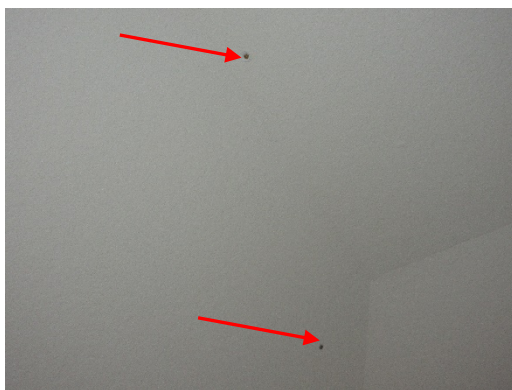
- *Several ceilings have nail pops*

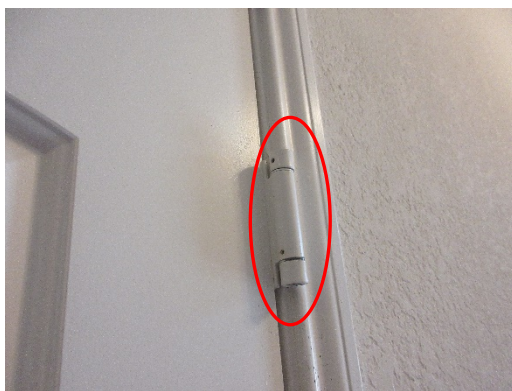
- *Self-closing hinges on access door from the garage in to the home shall be tensioned*

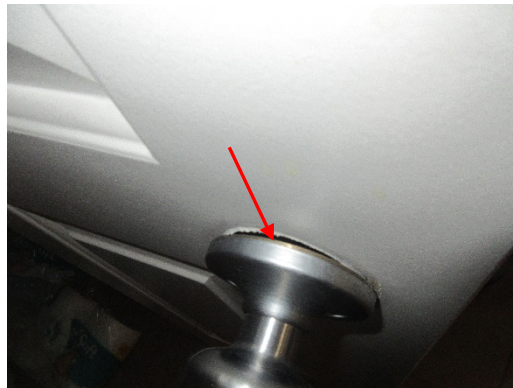
- *Master linen closet doorknob is loose*

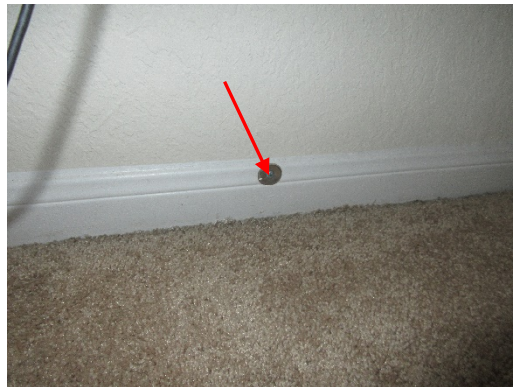
- *Doorstops are not installed*

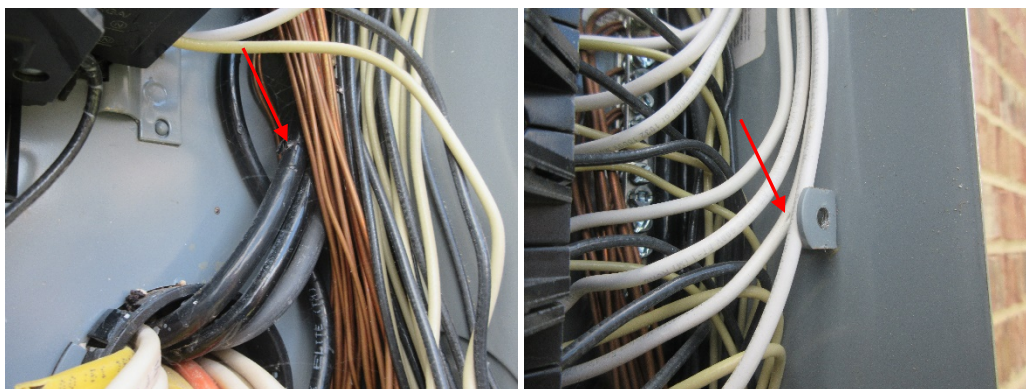
- Panel is properly rated
- Panel is labeled
- 2 20-amp kitchen small appliance circuits are present
- Aluminum service conductors
- *Cable insulation is damaged*

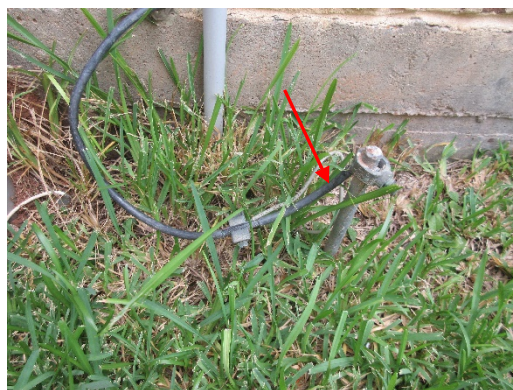
- *Grounding conductors are black. Grounding conductors shall be identified by stripping the insulation from its entire length, color the exposed insulation in green, or marking the insulation in green tape at the termination.*

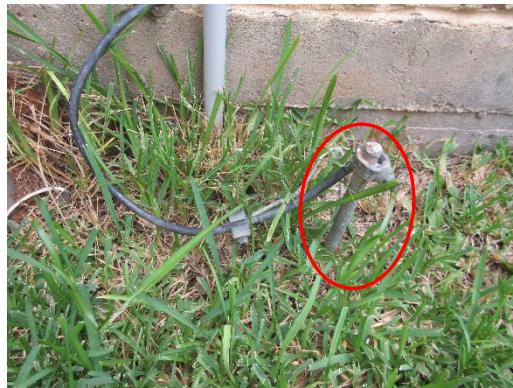
- *Upper end of rod-type grounding electrodes shall be flush with or below ground level except where the attachments are protected against physical damage*

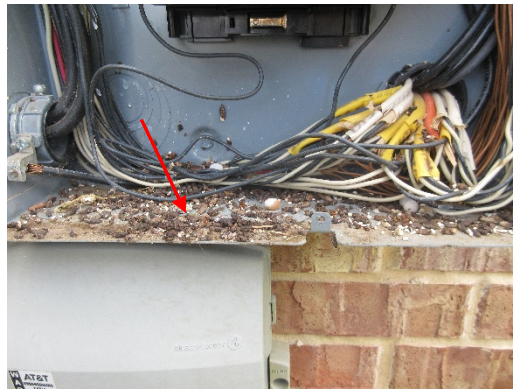
- *Debris shall be removed from service panel*

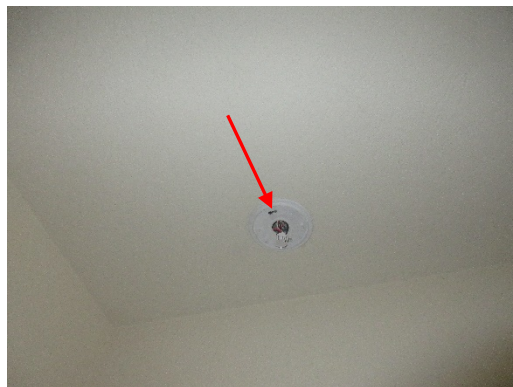
- *Smoke detector was removed from right middle bedroom. Smoke detectors are required in each sleeping area and in the immediate vicinity of each sleeping area. This is a life-saving issue and should be corrected before occupancy.*

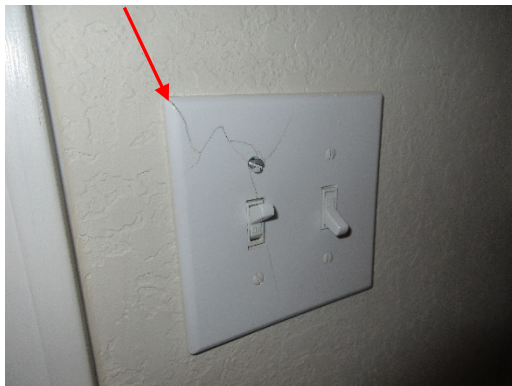
- *Switch faceplate is cracked*

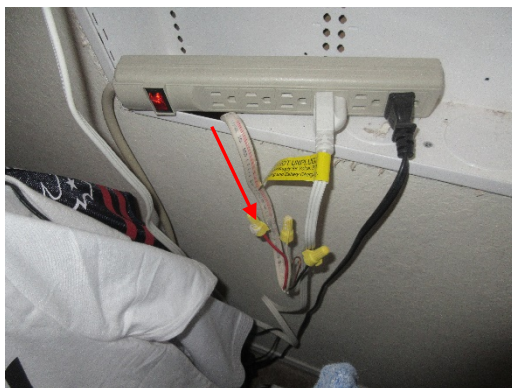
- *Electrical cable shall be installed in an outlet box with a cover or receptacle installed with a faceplate*

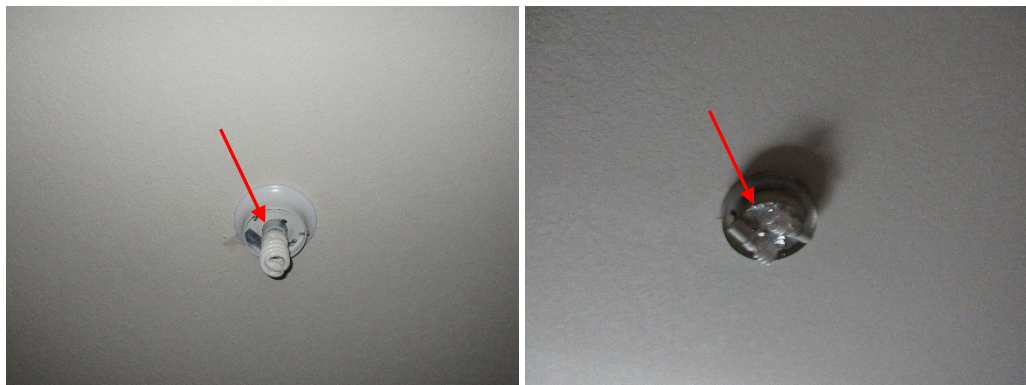
- *Several globes are not installed*

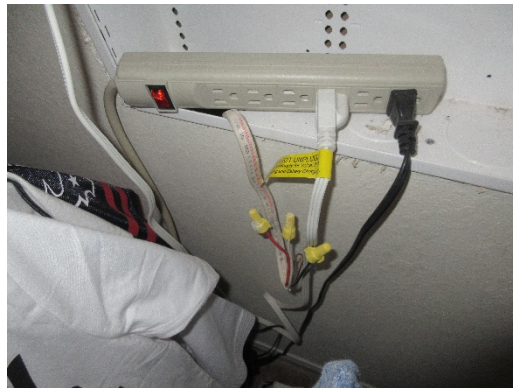
- *Extension cord is being used as permanent wiring*

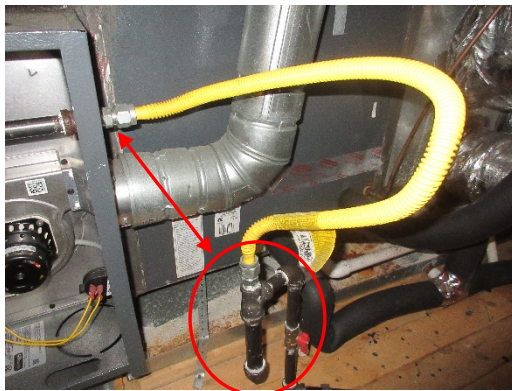
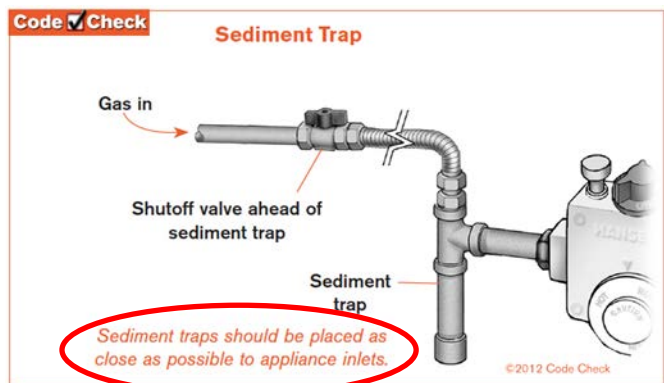
- Goodman 80,000 BTU Model #GMS80805CNBB Serial #1408001384
- Burners and combustion observed by removing access panel
- Unit working properly
- Gas supply line sediment trap shall be installed as close to appliance as possible

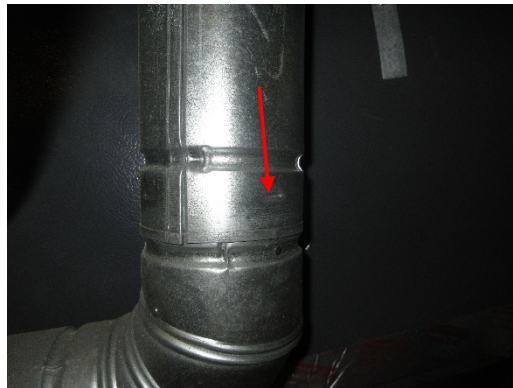
- Vent connectors shall have sheet metal screws or rivets at all joints

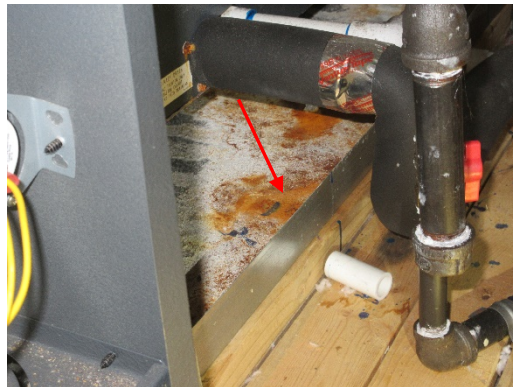
- Goodman 16+SEER R-410A 4-ton Model #GSX160481FC Serial #1502616839
- Honeywell Media Air filter
- Required exterior disconnect is present
- The temperature measured at the return was 70°, the temperature measured at the supply was 56° resulting in a temperature differential of 14°. This is within the acceptable range of 14°-22°.
- Auxiliary condensate disposal pan has rust. This shall be cleaned to minimize oxidation and potential leaks.

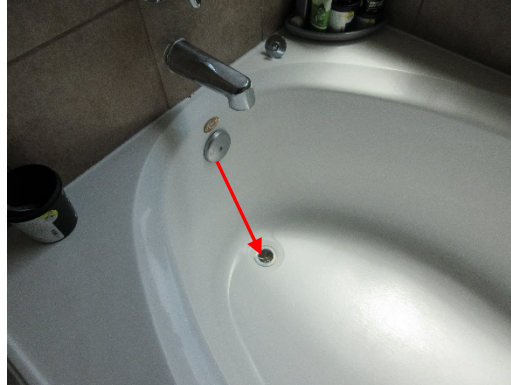
- *Bathtub stopper is not installed*

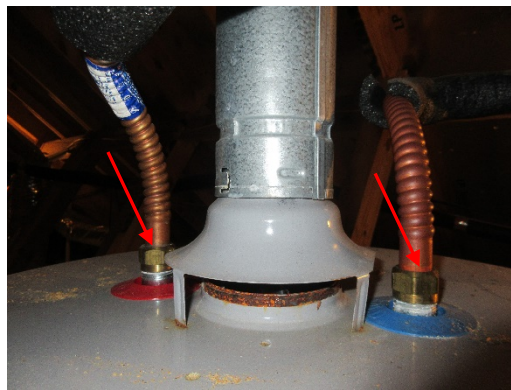
- American 40,000 BTU Model #FVG6250T403NOV Serial #1504J011073
- *Joints between copper or copper-alloy tubing and galvanized steel pipe shall be made with dielectric fittings. Install flex lines with dielectric fitting at dissimilar metal connection locations.*

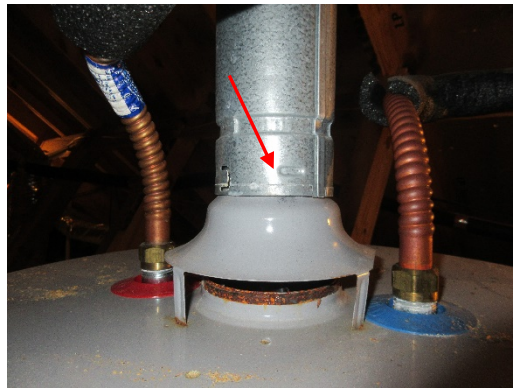
- *Vent connectors shall have sheet metal screws or rivets at all joints*

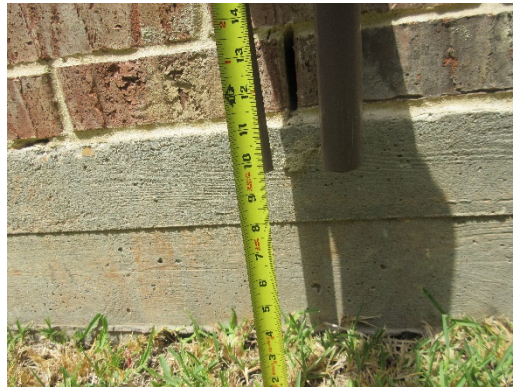
- TPRV discharge pipe shall not terminate more than 6 inches above the waste receptor (ground)

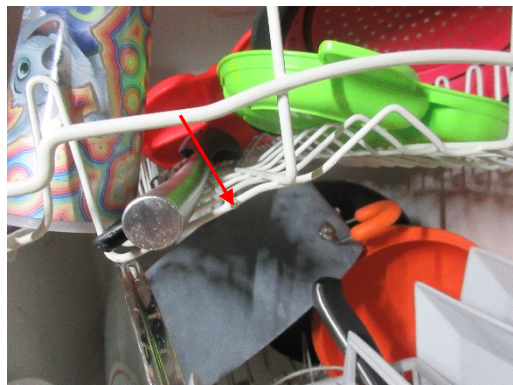
- Anti-tip device is installed
- Racks have visible rust

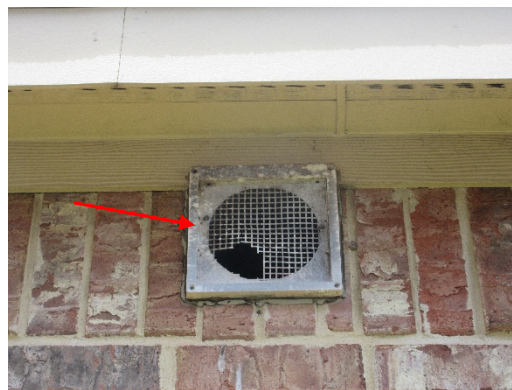
- Ducts were properly terminated to the exterior
- *Backdraft damper is missing*
