## PROPERTY INSPECTION REPORT

**Prepared For:** Brittene Wilson  
(Name of Client)

**Concerning:** 4529 Rosemont St, Houston, TX 77051  
(Address or Other Identification of Inspected Property)

**By:** Marc Gessner, Lic #6033 05/08/2020  
(Name and License Number of Inspector) (Date)

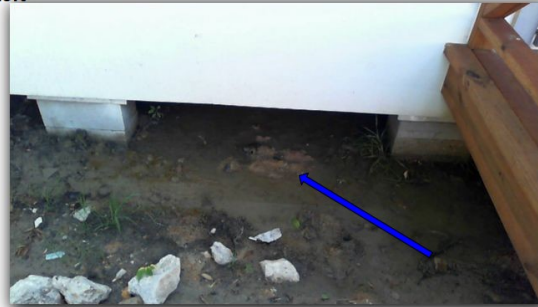
Left

Ponding occurs near the foundation- Left, Rear, Right.

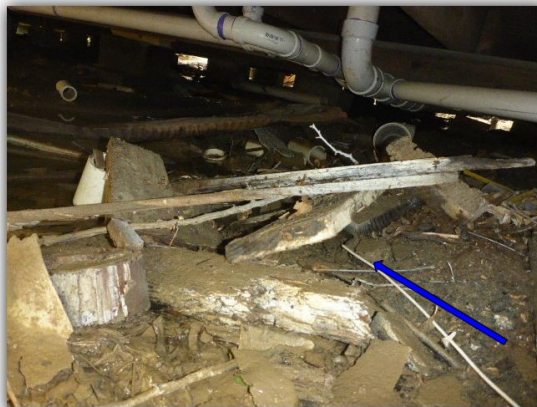
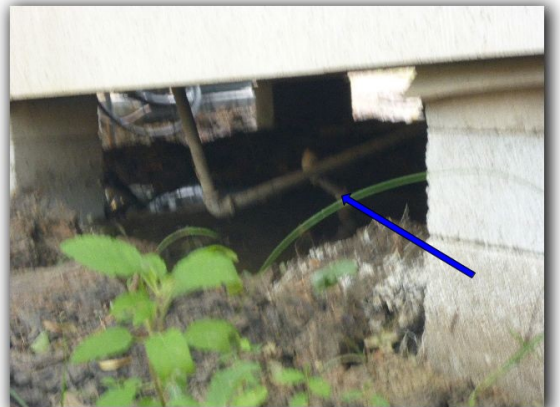
Debris in crawlspace - cast iron pipes, galvanized pipes and wood.

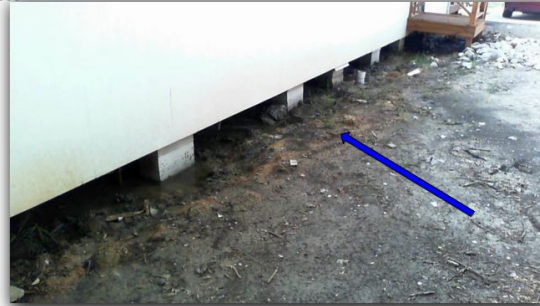
left

Improper drainage noted from foundation due to inadequate grading -Left, Rear, Right.

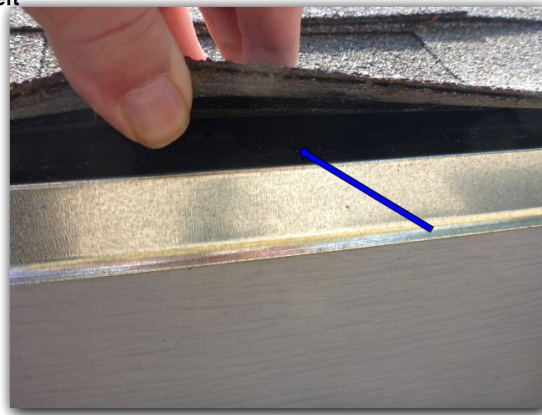
The roofing felt is installed incorrectly under the drip edge on a downward slope. left

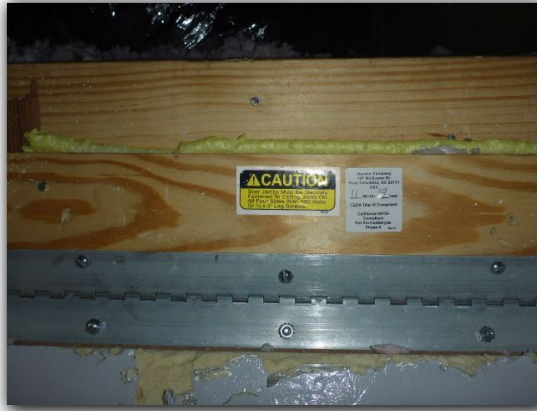
The attic access stairs framing is installed improperly with drywall screws. Add 16D nails

as per manufacturer.

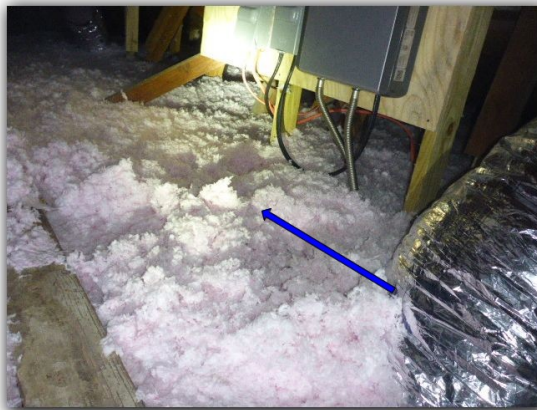
Areas of walk boards/ work platforms are missing to service water heater.

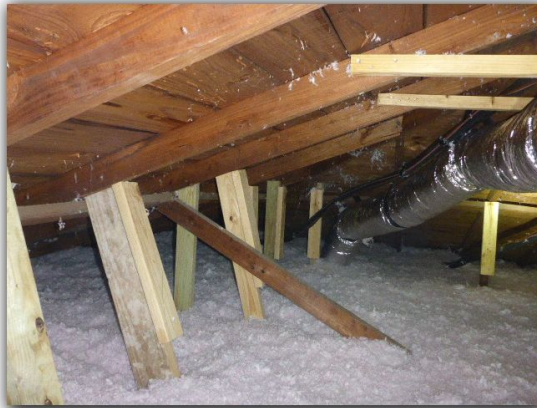
Ridge beam and rafters are too shallow/undersized. This was common in older construction. Additional support has been added. Structure appears to be performing adequately.

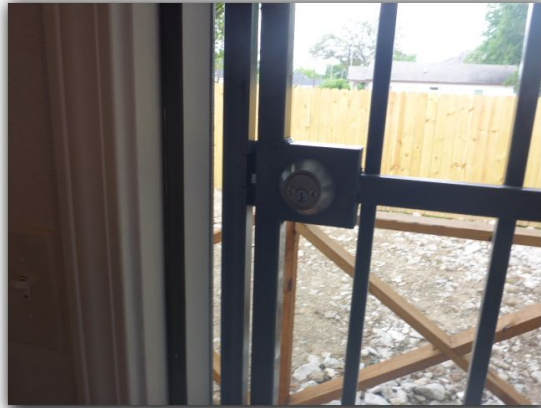
Security door - missing key to check operation.

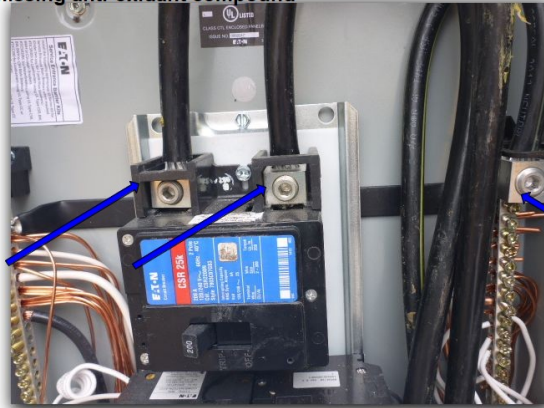
Aluminum termination points not treated with anti-oxidation paste.

missing anti-oxidant compound

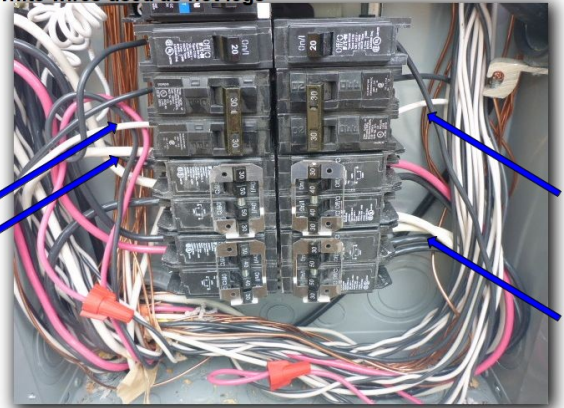
White wires (or colors other than red and black) are being used as hot legs in the panel.

white wires used as hot legs

These wires need to be labeled as hots (marked with red or black).

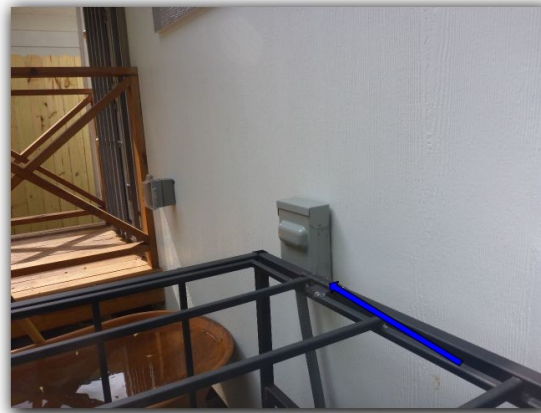
Incorrectly sized breaker -

Unit recommends maximum 15 amp breaker and oversized 30 amp breaker is installed. Change to proper size as per manufacturer.

Extend condensate drainline 3 to 5' away from foundation of house.

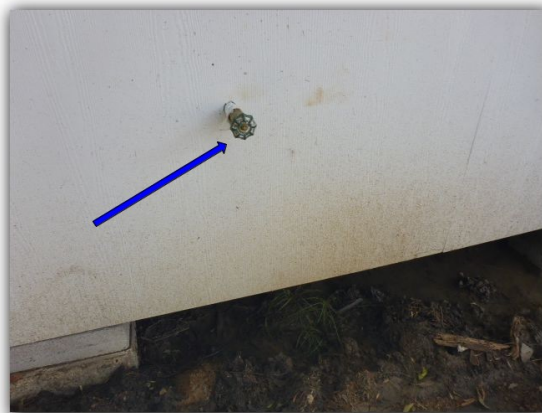
No anti-siphon protection observed on exterior hose bibs/faucets. This is a basic safety attachment to the end of faucets that will protect from a cross connection or back-flow of water into the house.

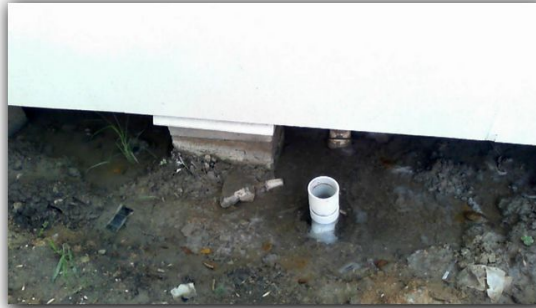
Cleanout cover is removed and sewage is coming up through cleanout. Main line appears blocked and needs repair.

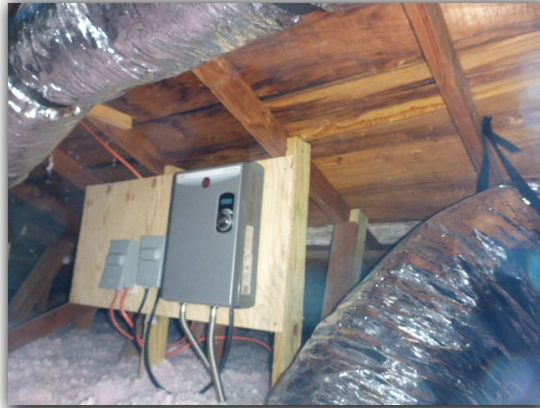
Unit is undersized to service 2 units.

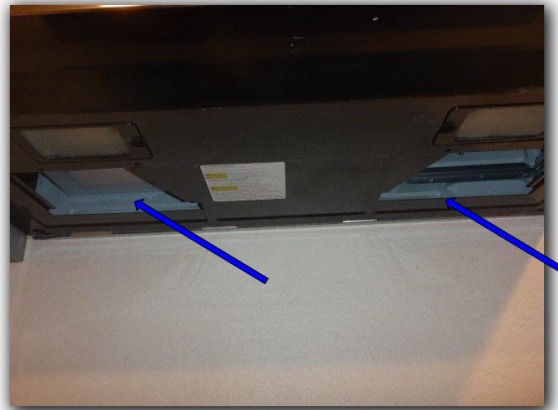
Grease filter missing.

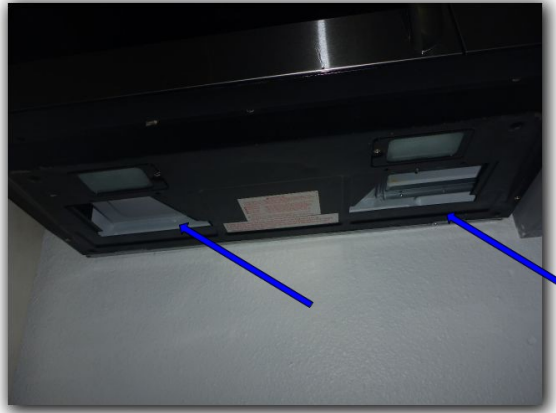
Grease filter missing.

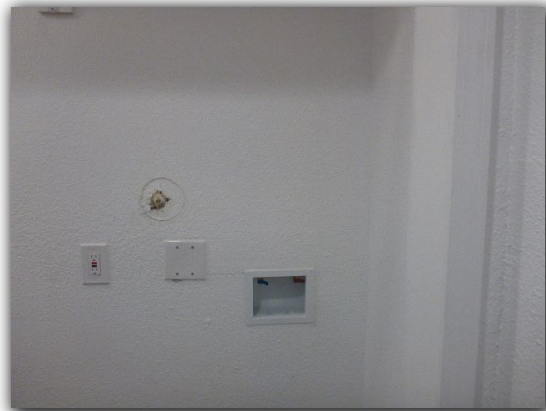
No dryer vent in either unit.
