5934 Patridge Drive

Property Inspection Report

9/26/2023

**PERFORMANCE
INSPECTIONS, PLLC**

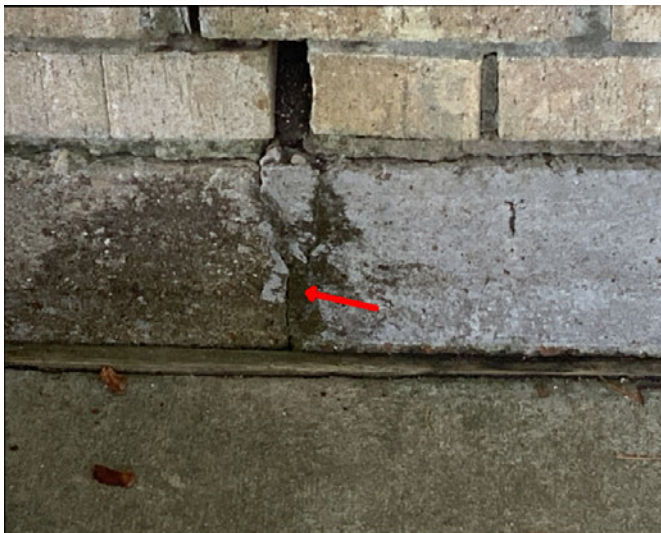
- Substantial foundation cracking was observed. This implies that structural movement of the building has occurred. The rate of movement can not be predicted during a one-time inspection. A structural engineer should be consulted to further evaluate this condition and the remedies available for correction.

Large crack at right front

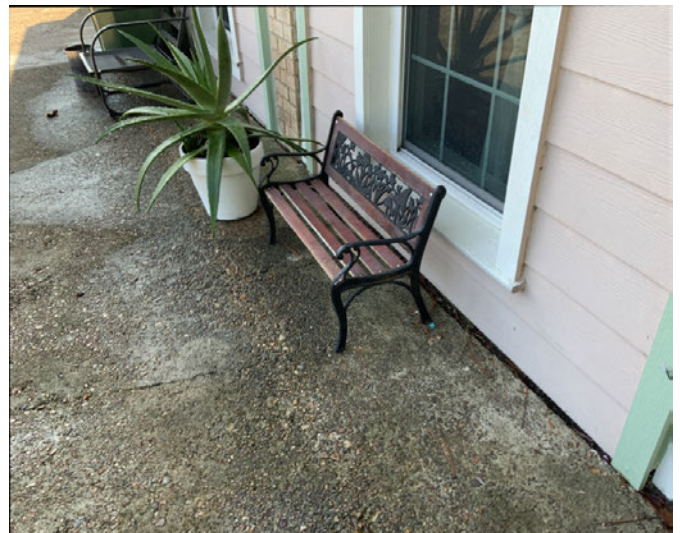
- High soil was observed in areas at foundation. Inspector was unable to view foundation condition which limits the inspectors ability to provide clear opinion of the performance of the foundation. Soil levels should be lowered as high soil levels may provide harbor areas for pests.

High soil blocking visual inspection of foundation

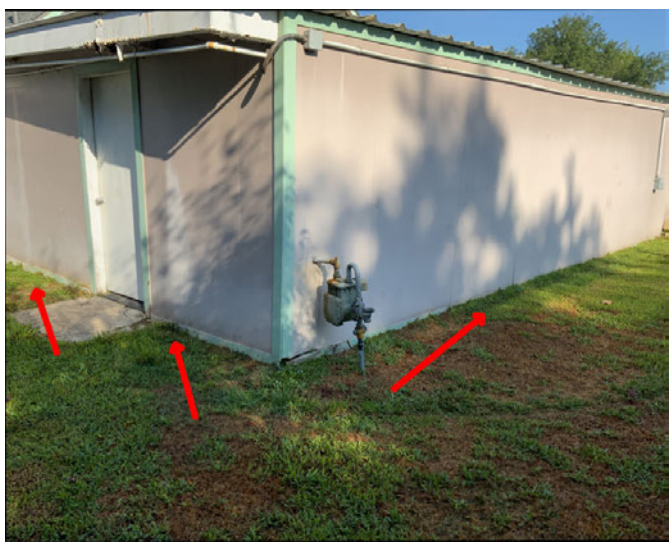
High soil blocking visual inspection of foundation

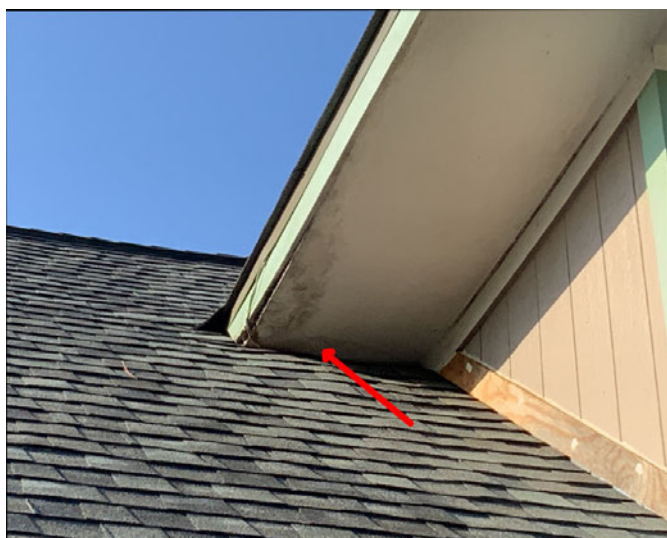
Damaged soffits

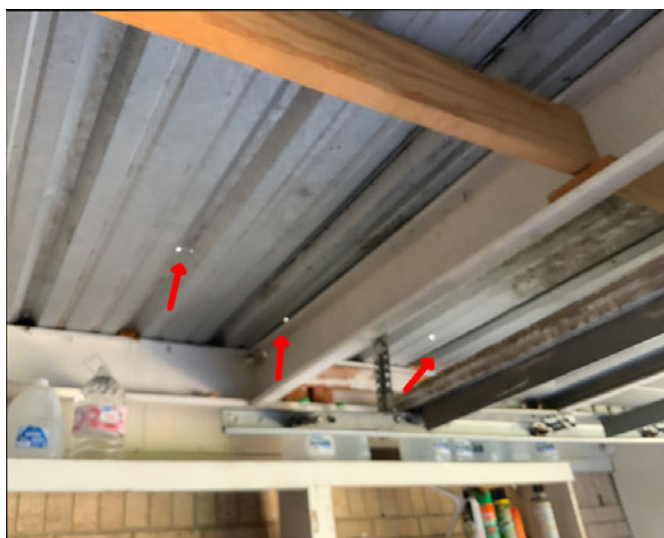
Holes in metal roof over garage. Further evaluation needed to determine level of repairs needed in this area and at leaking flat roof over patio.

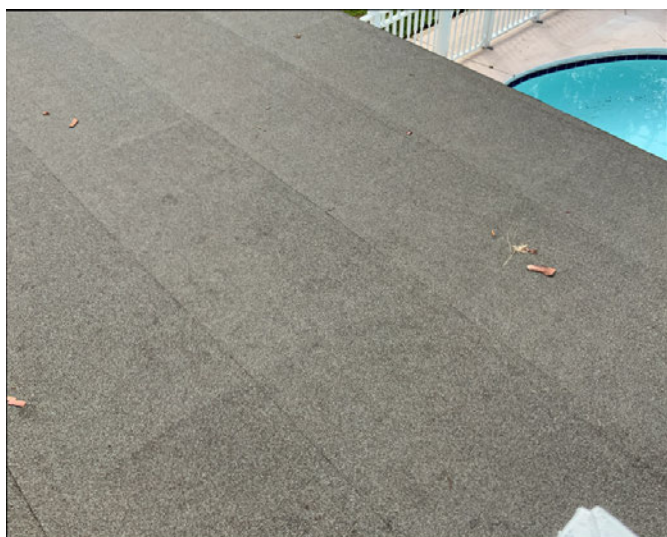
- Lifting roof jacks need to be secured by a professional roofer to reduce the risk of water and/or pest entry to the home.
- The roofing shows evidence of seam failure (the seams of the membrane coming apart). Repairs are needed by a professional roofer to reduce the risk of further damage.
- Holes in metal roof over garage. Further evaluation needed to determine level of repairs needed in this area and at leaking flat roof over patio.
- A professional roofer is recommended to further evaluate and determine level of repairs needed.

Seam seals needed

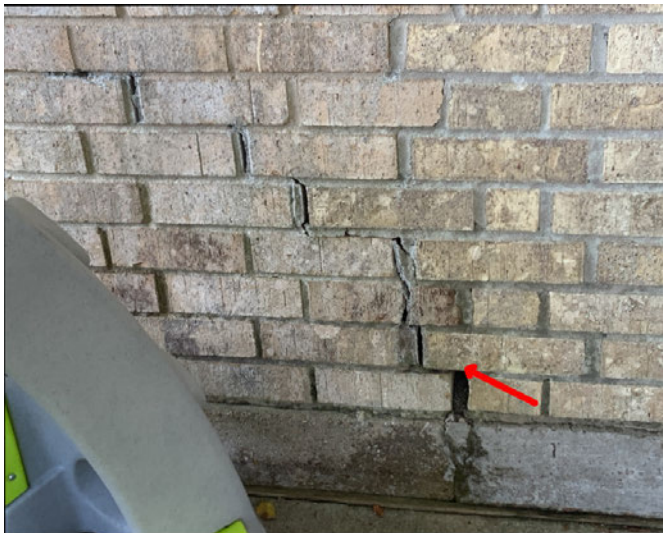
Large movement cracks at right front

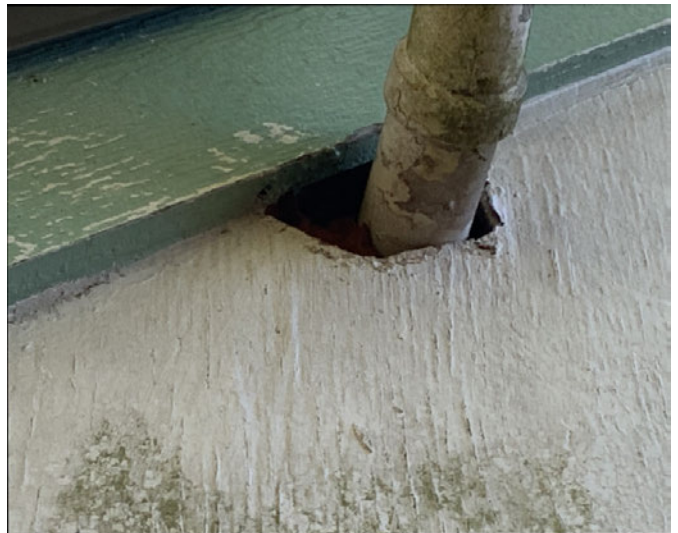
Seal all seams gaps and penetrations to home

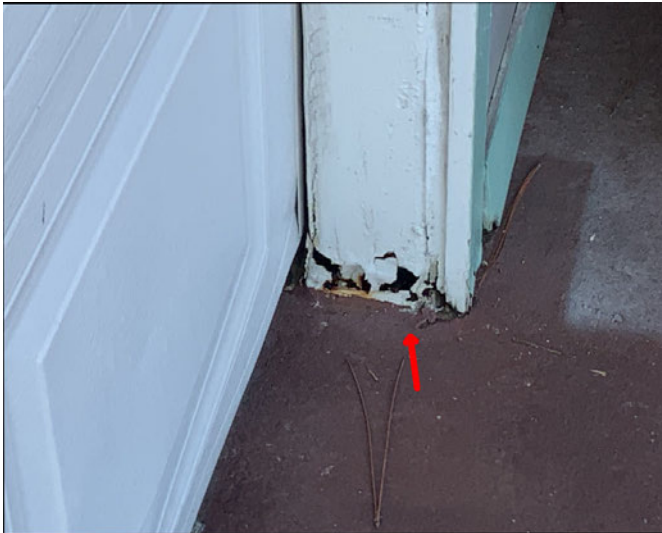
Decaying trim boards

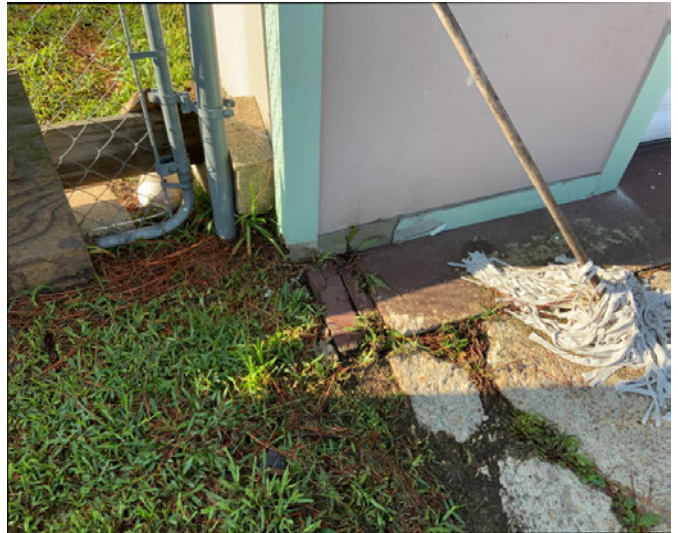
Damaged trim boards

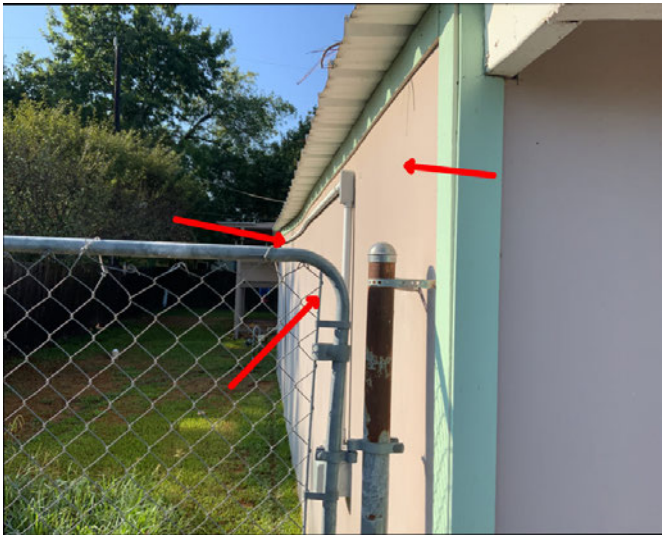
Damaged curved wall on left side

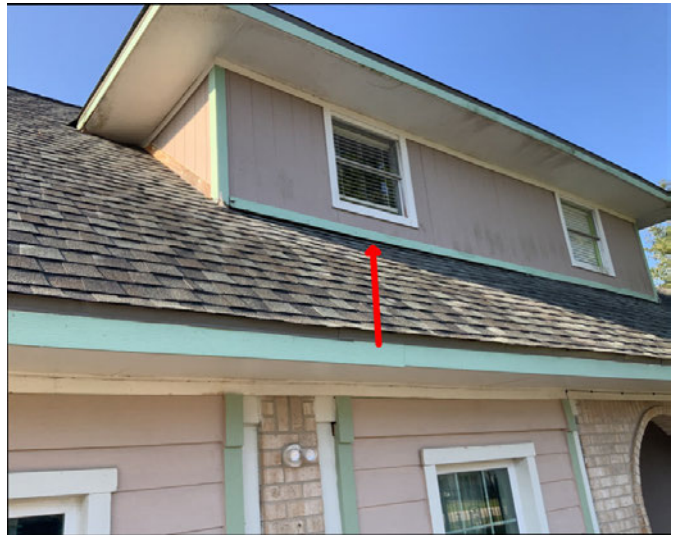
Decaying trim boards

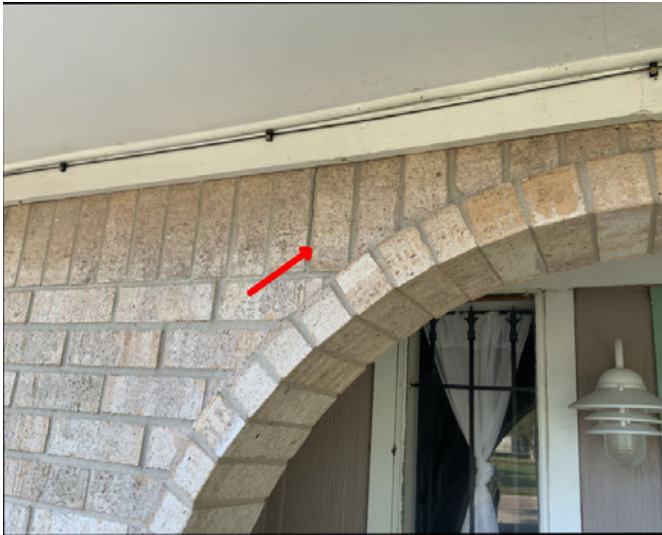
Settlement cracks in front

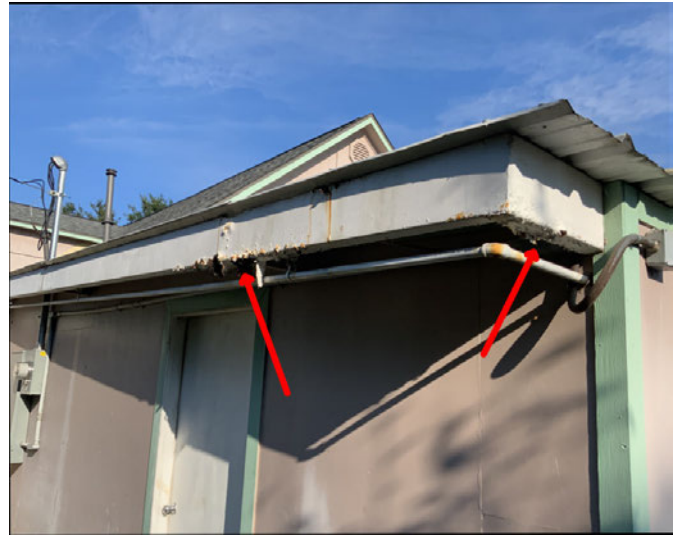
Decaying header

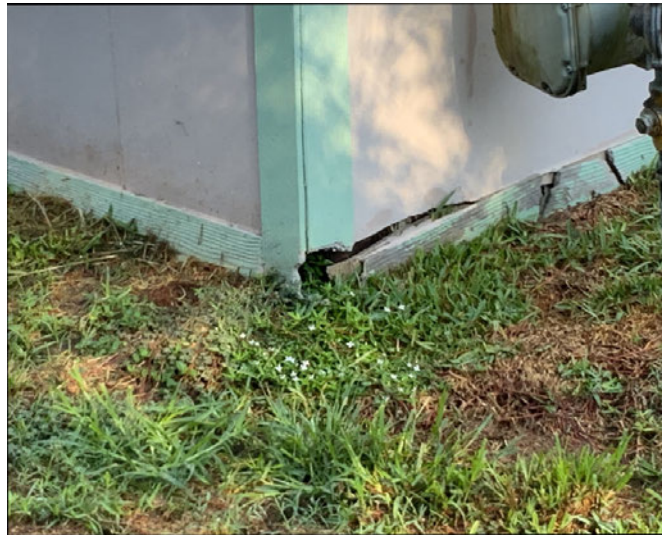
Damaged siding and trim boards

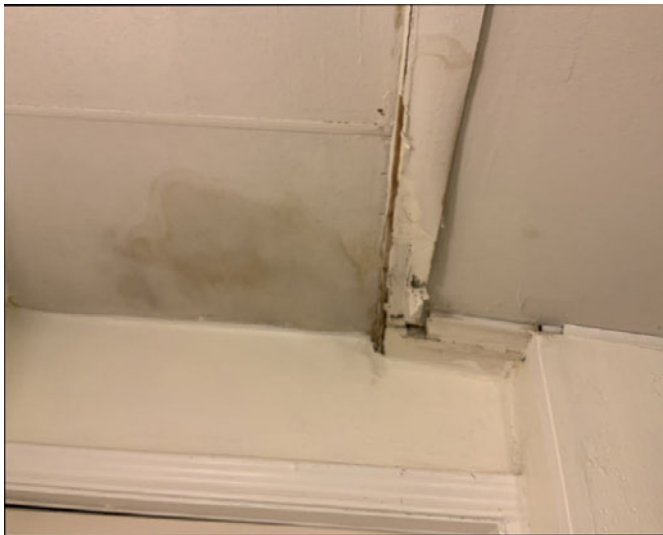
Water stains in outdoor bathroom ceiling

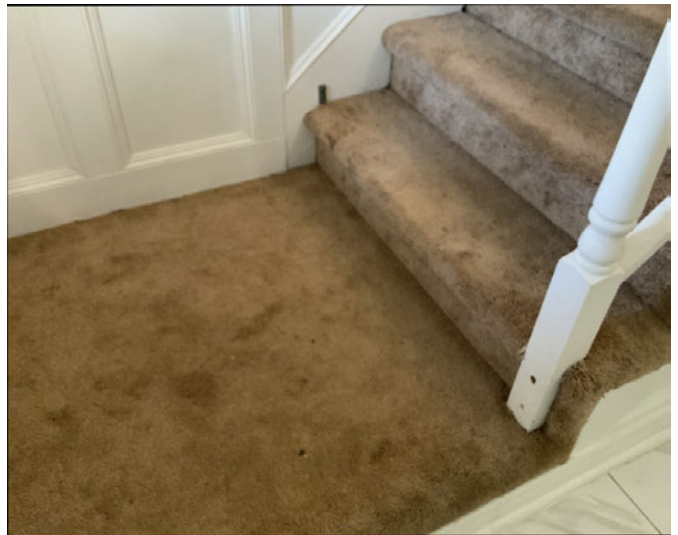
Stained carpets

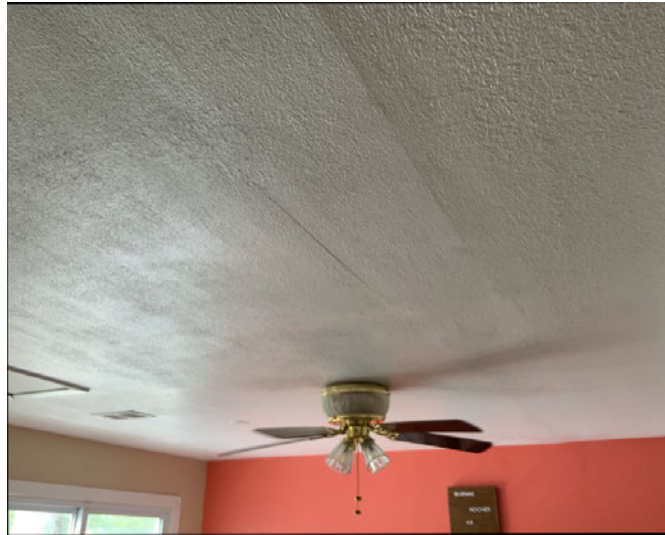
Patching in multiple areas throughout home

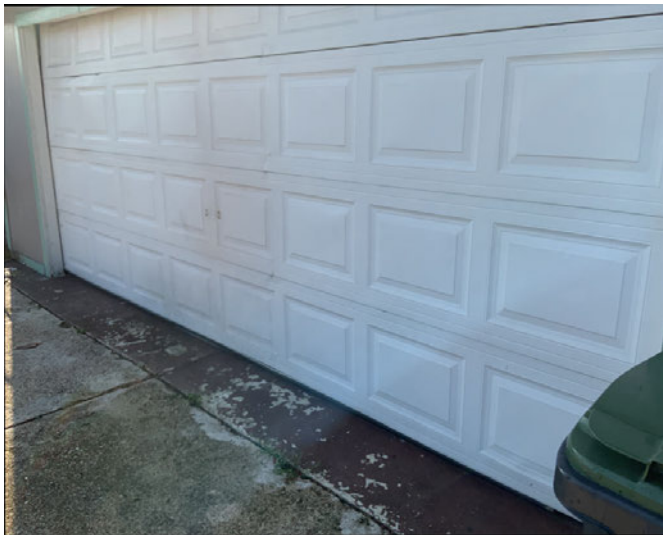
All panels are damaged

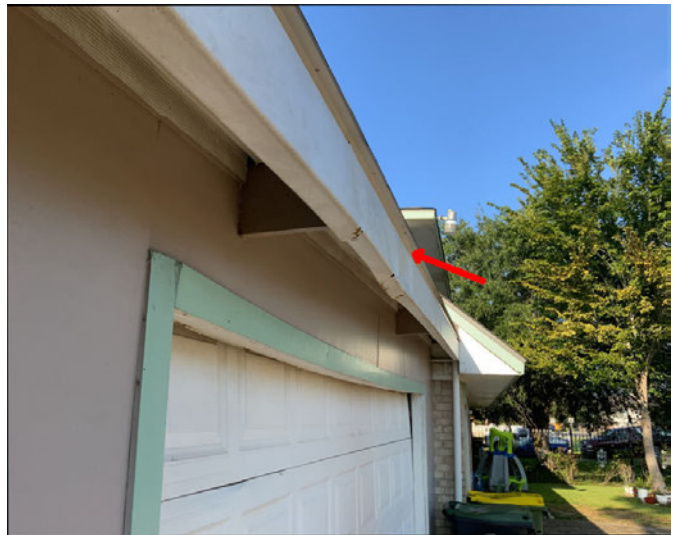
Damaged header over garage door

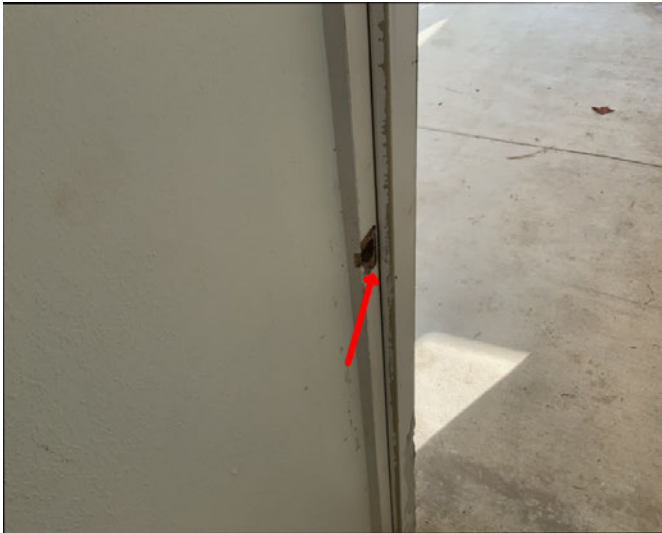
Missing hardware at outdoor bathroom

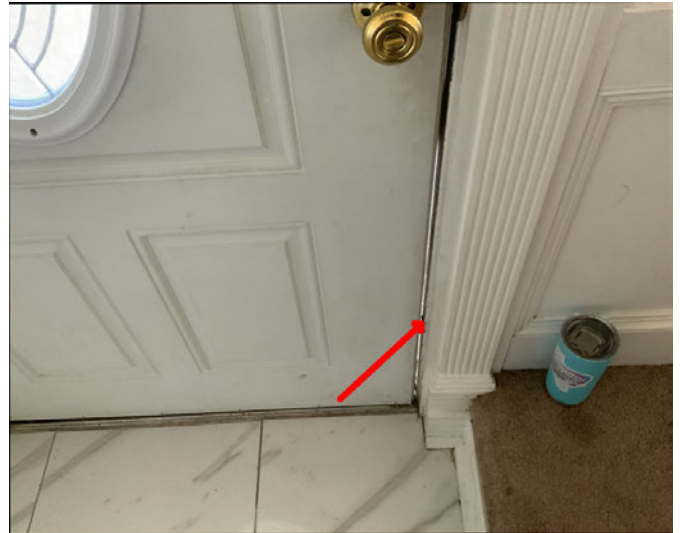
Door seals needed

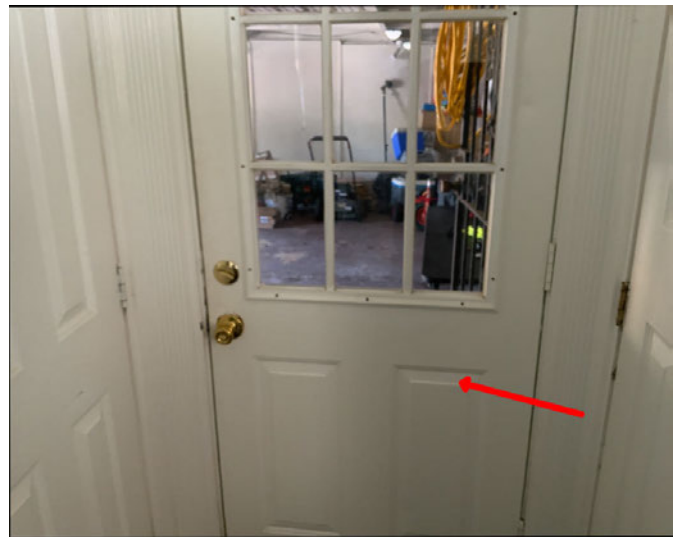
Fire rated door required from garage to home.

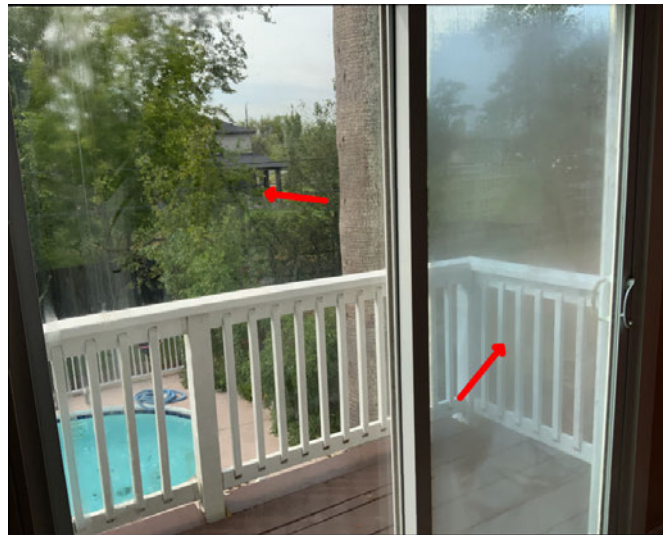
Lost seals at sliding glass doors. New glass is needed

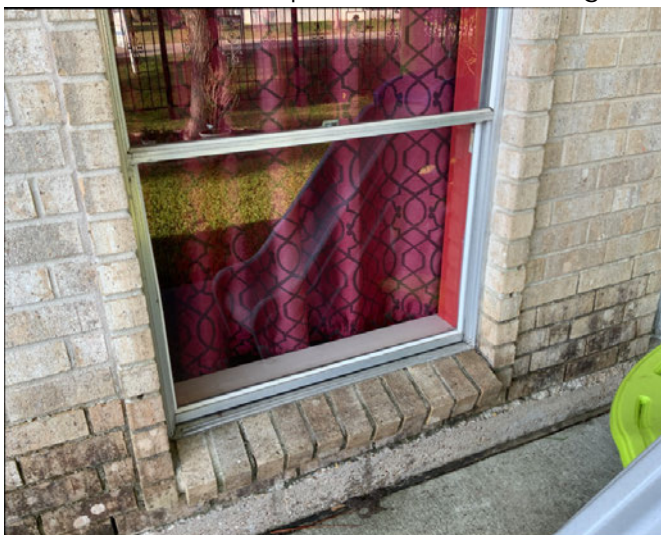
Missing screens

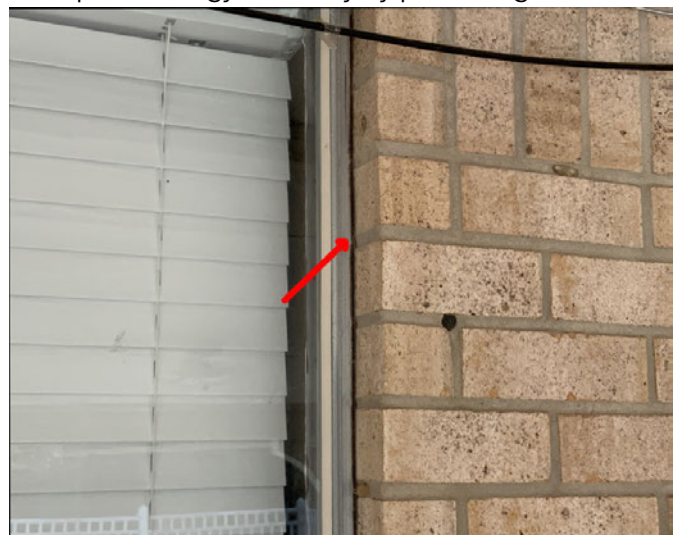
Exterior seals needed

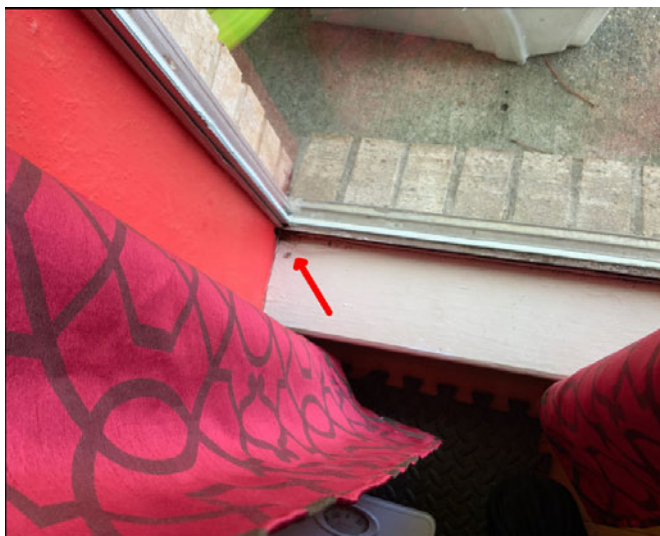
Moisture damage at sills and interior caulking needs improvements

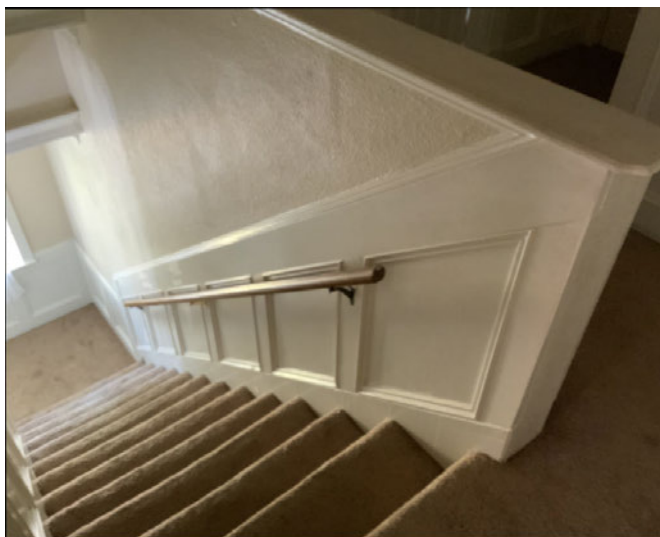
See handrail requirements and correct

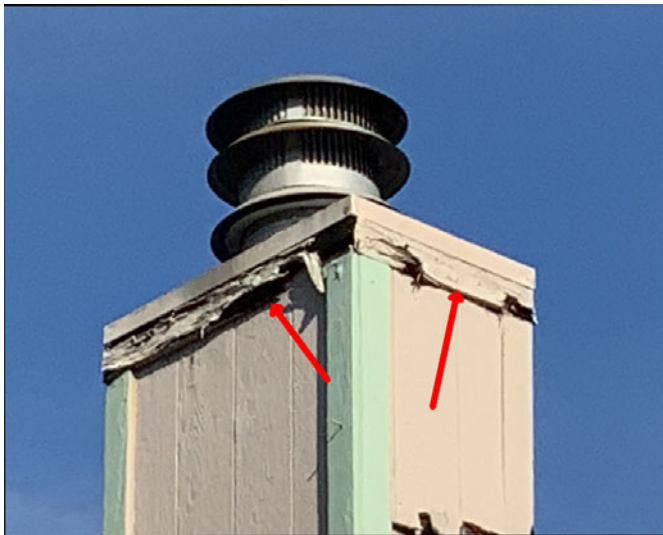
Replace all damaged and decaying trim boards and siding at chimney

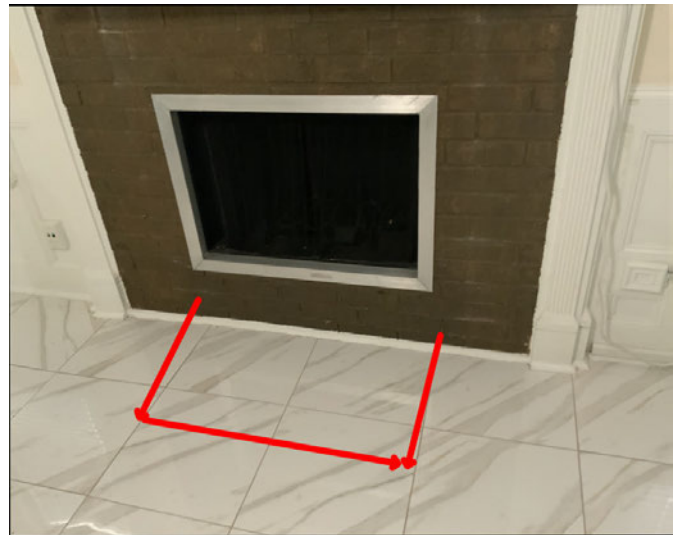
- Seal at gas pipe entering firebox is required to prevent possible hazard.
- The hearth outside the fireplace is not large enough to reduce the risk of fire, should hot embers manage to escape from the fireplace. This condition should be altered for improved safety. A firebox opening of less than 6 sq.ft is required to have a hearth extension of 16in. in front, and 8in. to each side. A firebox opening greater than or equal to 6 sq.ft is required to have a hearth extension of 20in. in front, and 12in. to each side.

Insufficient hearth

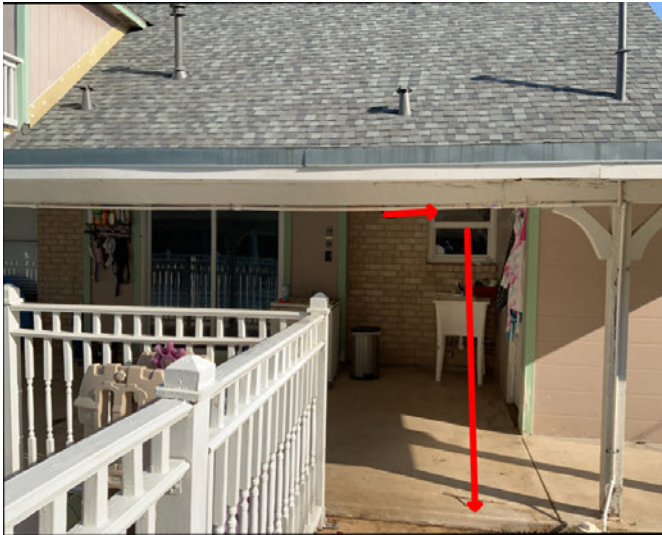
Correct height required

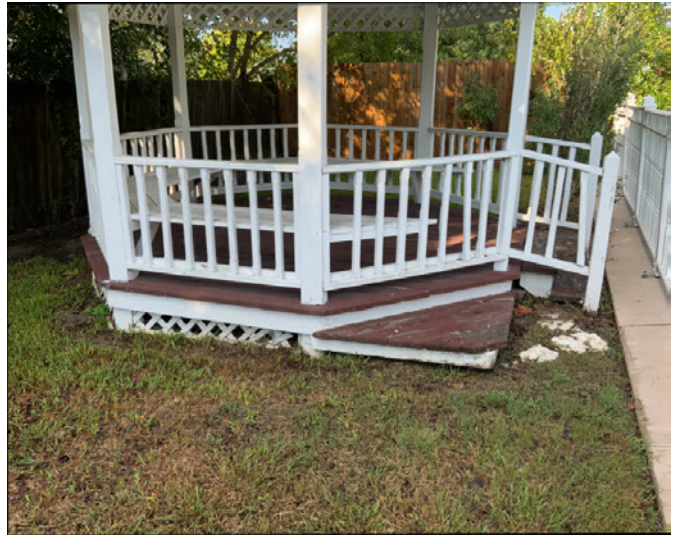
Damage pergola needs further evaluation by a professional to determine level of repairs needed

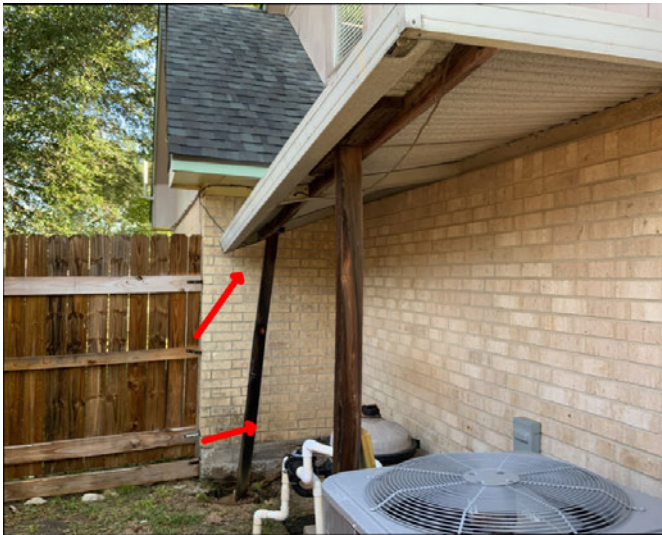
Recommend removing unsafe cover over equipment

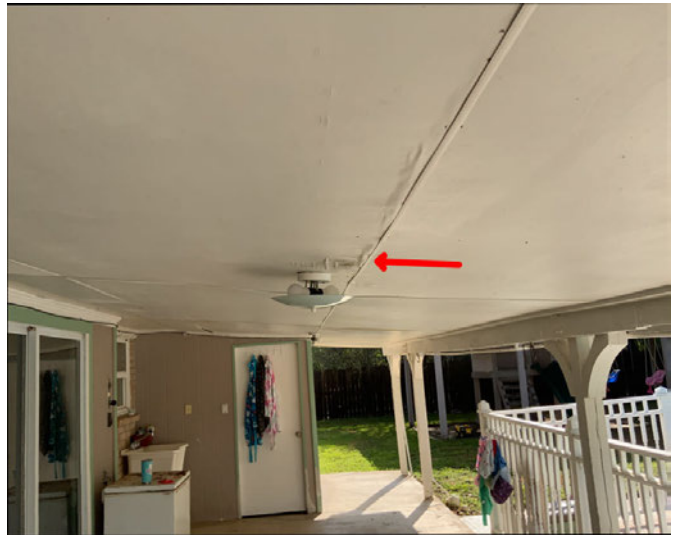
Further evaluation of patio cover needed. Leaks also observed at patio cover

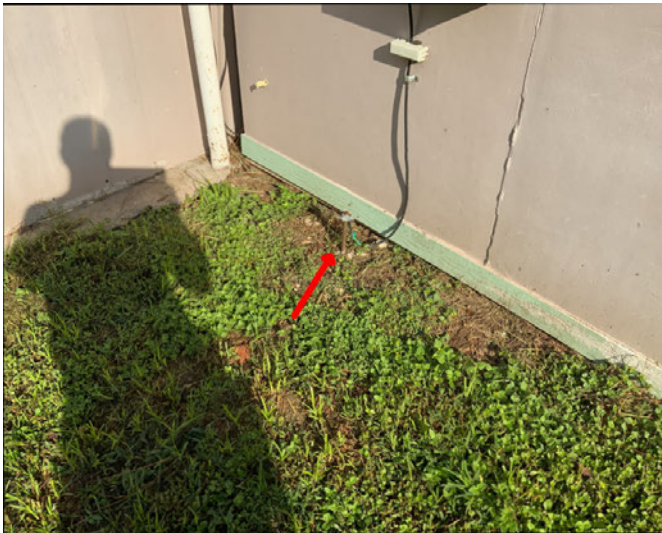
See ground rod requirements

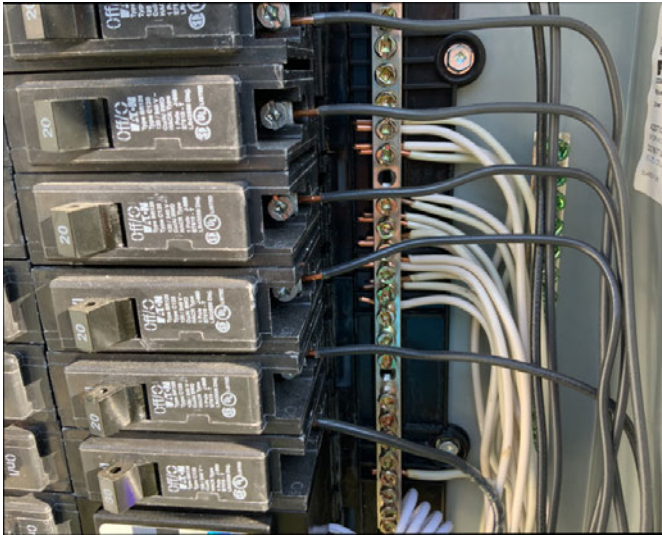
Correct all double tapping on neutral bar

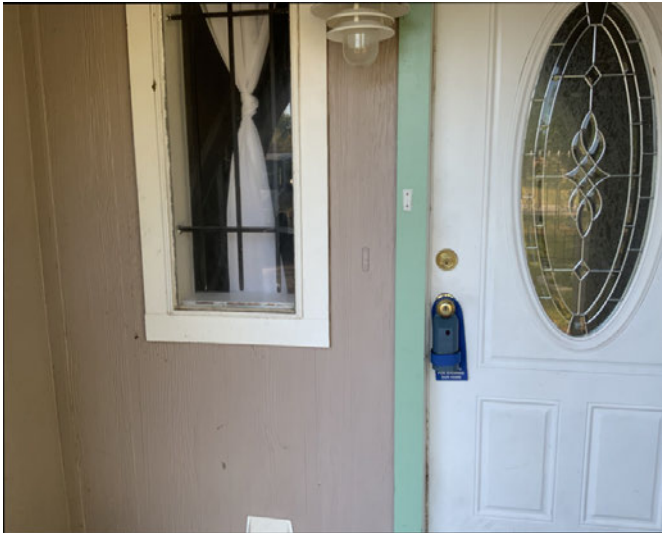
No doorbell

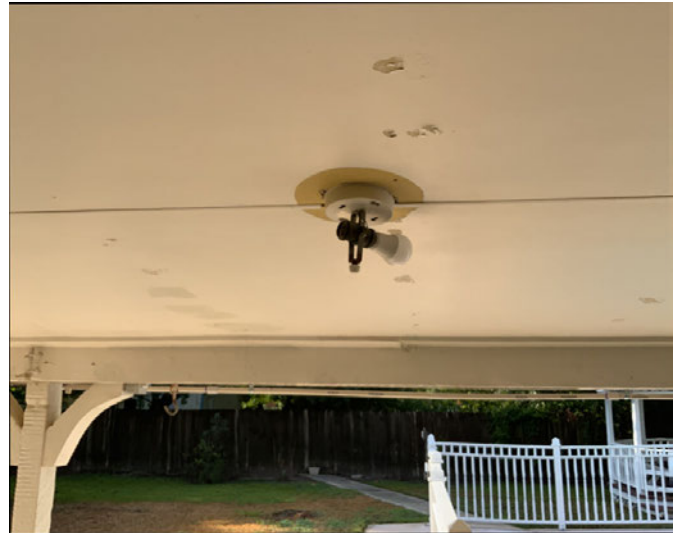
Damaged light

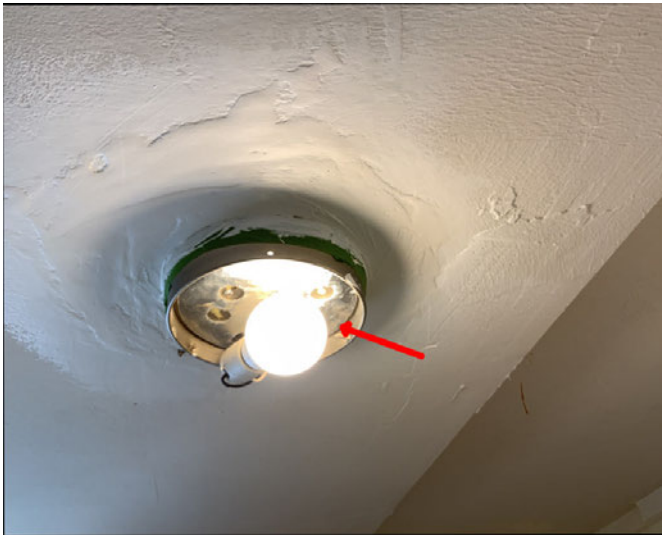
Damaged light

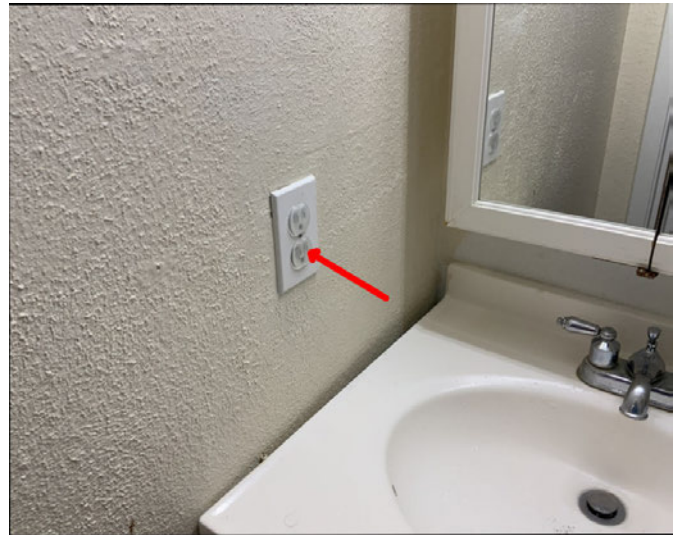
GFCI protection required

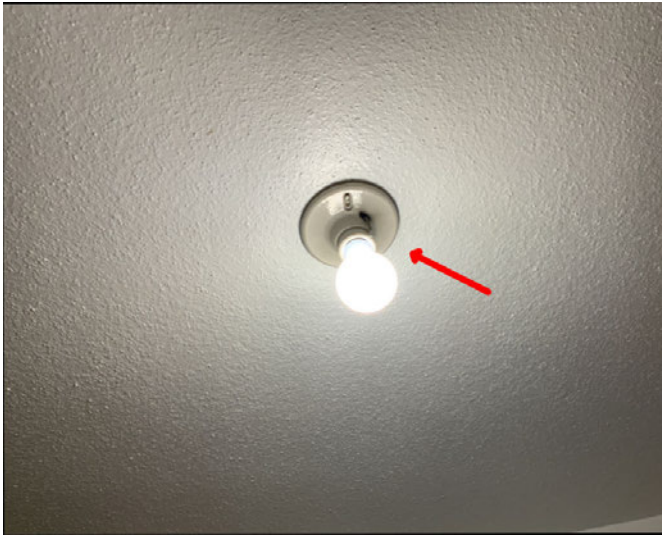
Closet bulbs are required to be protected

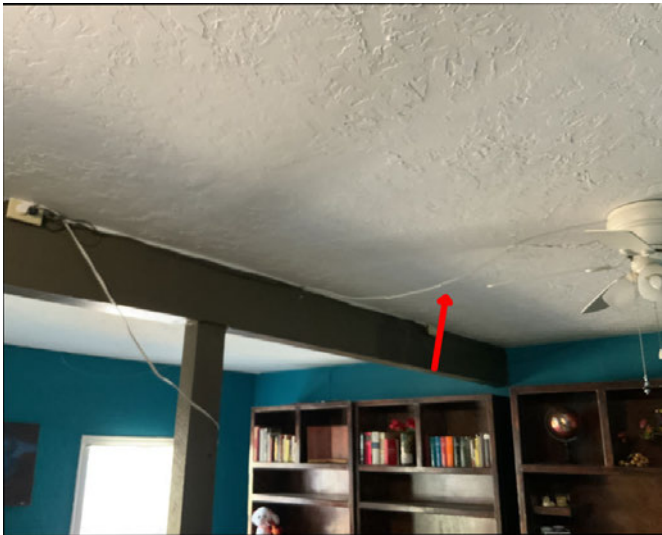
Extension cords used as permanent electrical supply is a potential hazard

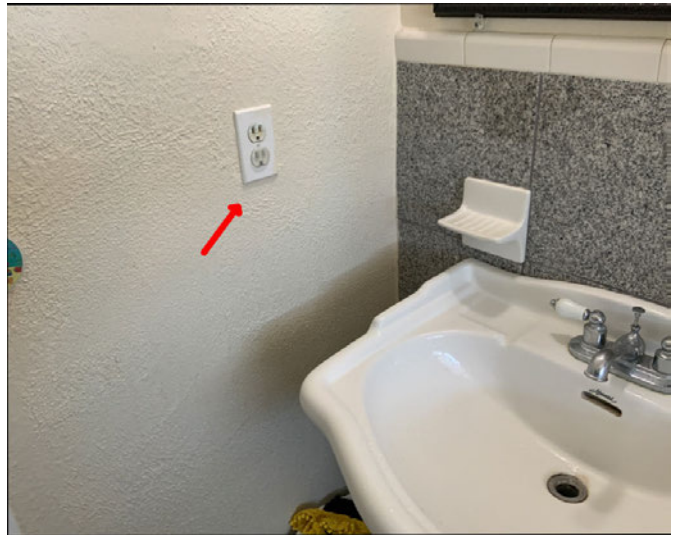
GFCI protection needed

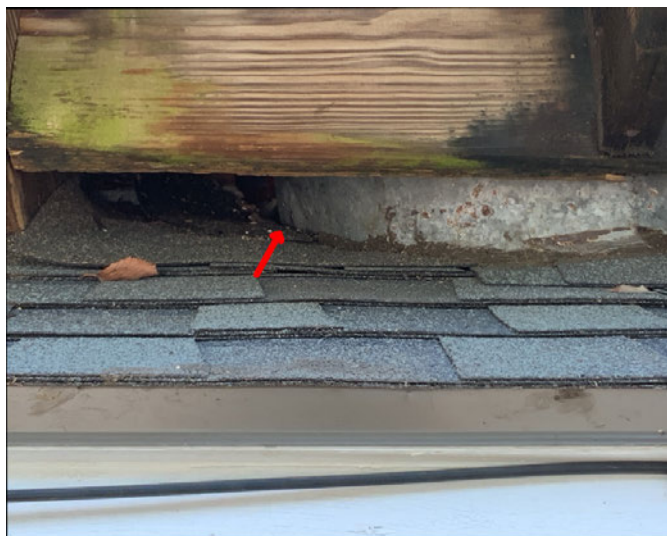
- Flue pipes are required to be secured by metal strapping to prevent movement. Corrections are required.
- There is insufficient clearance between the exhaust flue and combustible materials. This is a fire hazard. This condition should be evaluated and repaired by a qualified HVAC technician.

Correct clearance to combustibles is required

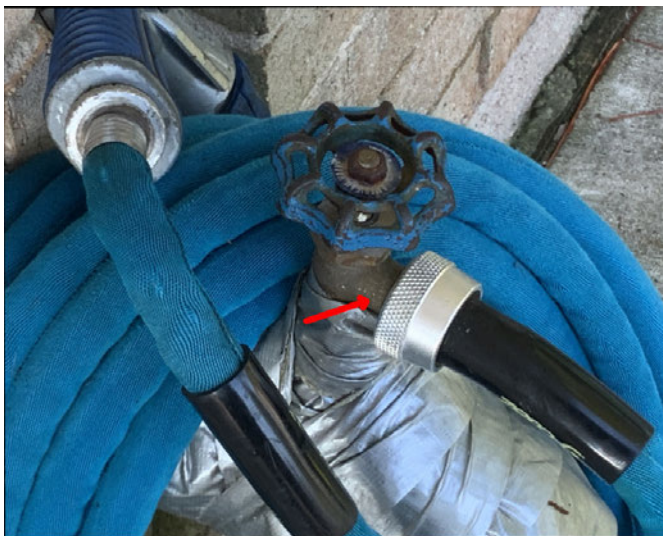
Anti siphon valves are required

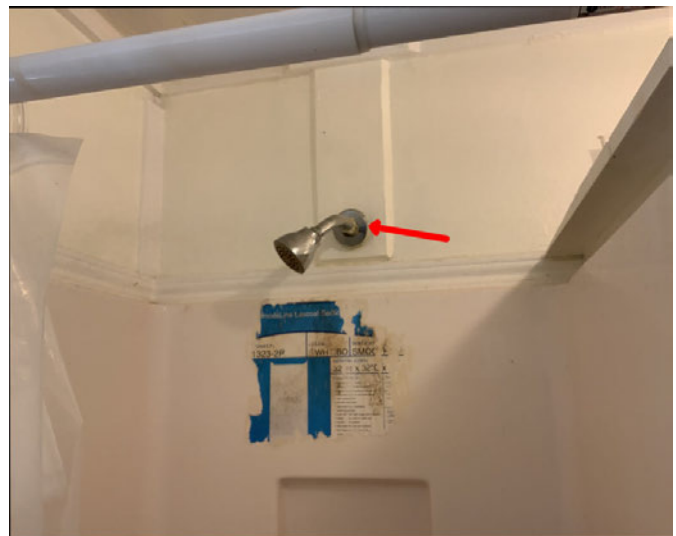
Damaged loose supply line to out door bathroom

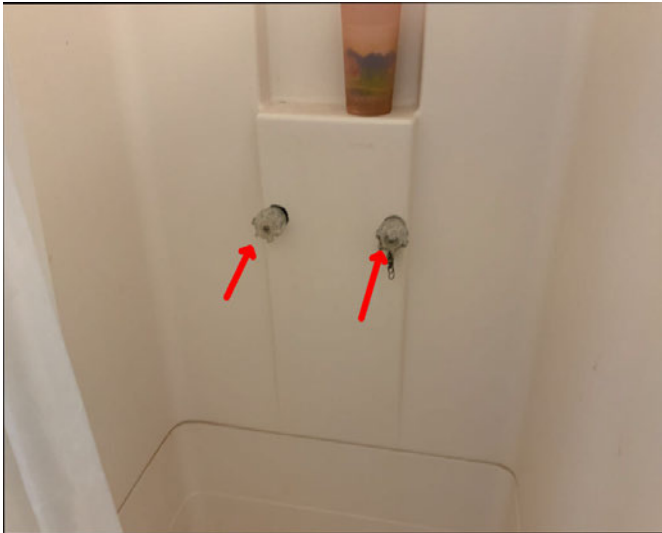
Damaged faucet

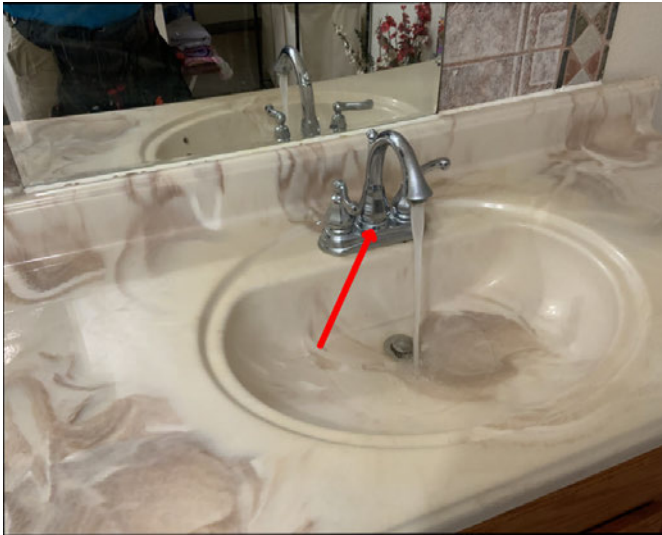
Loose faucet

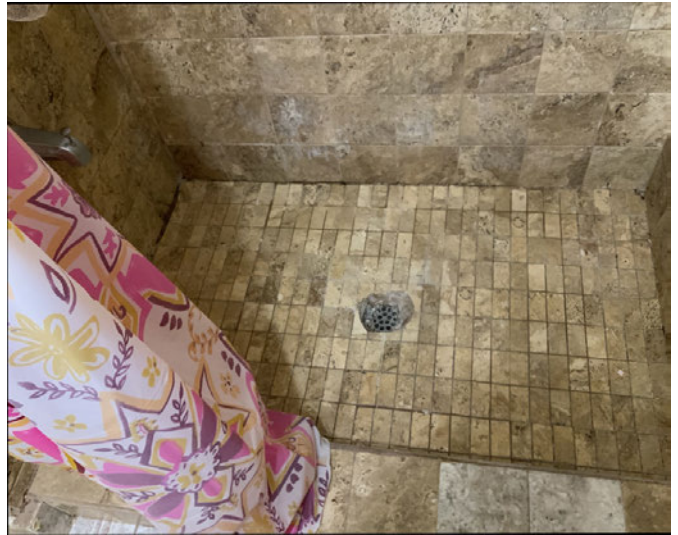
Recommend repairs at primary shower base

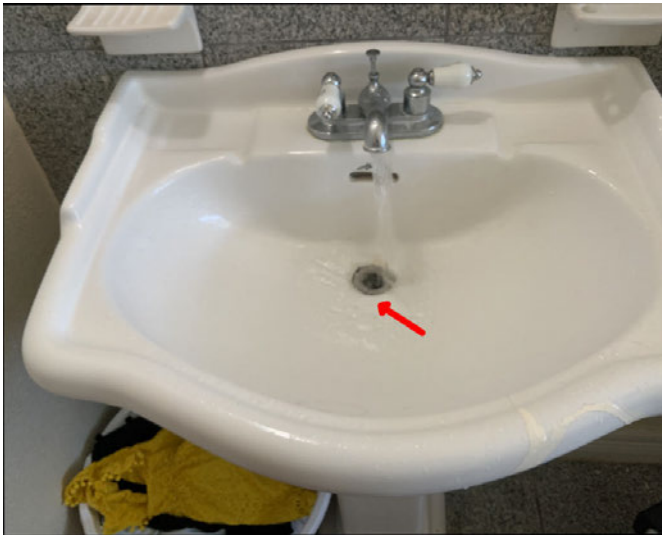
Missing stopper

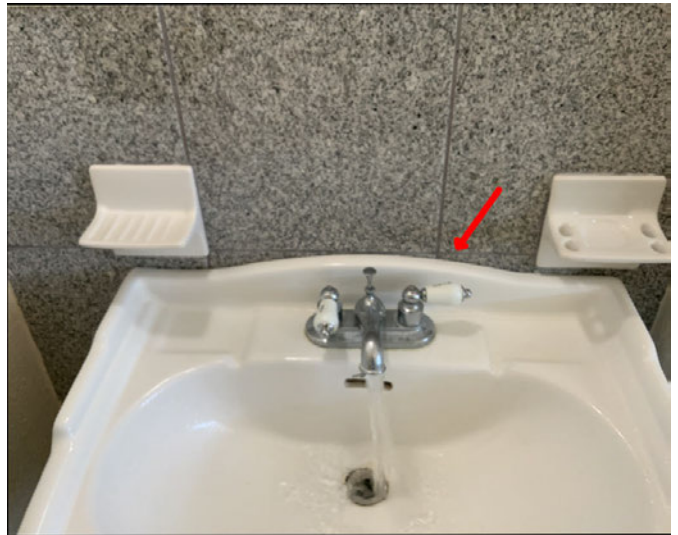
Seals needed

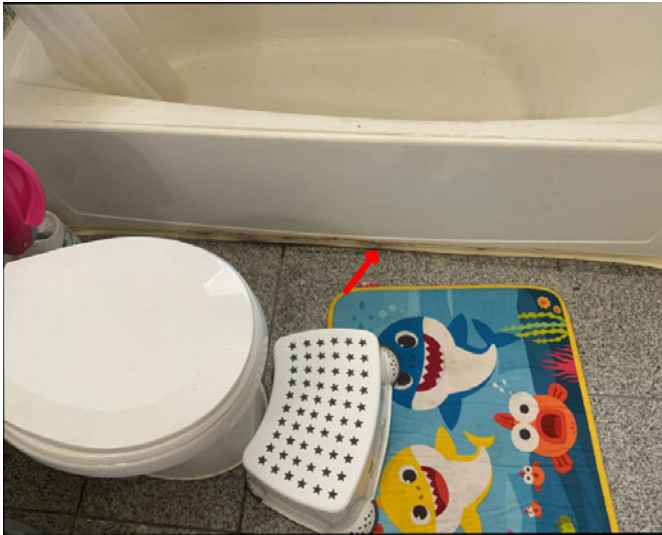
New base seal needed

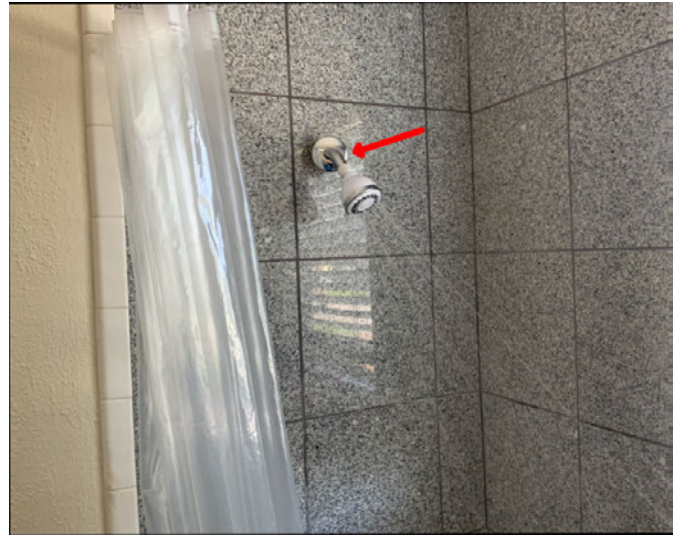
Loose supply line

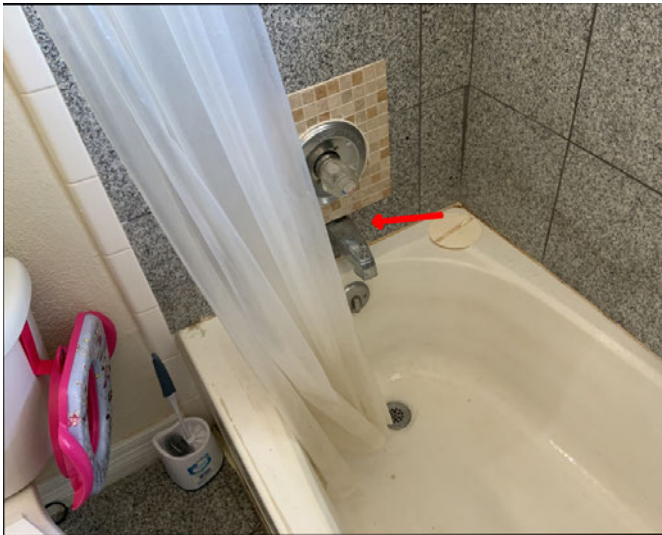
Faucet seals needed

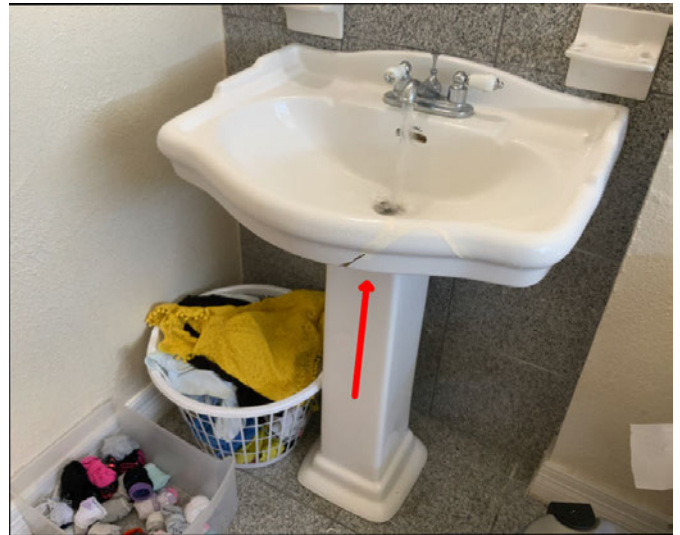
Cracked sink

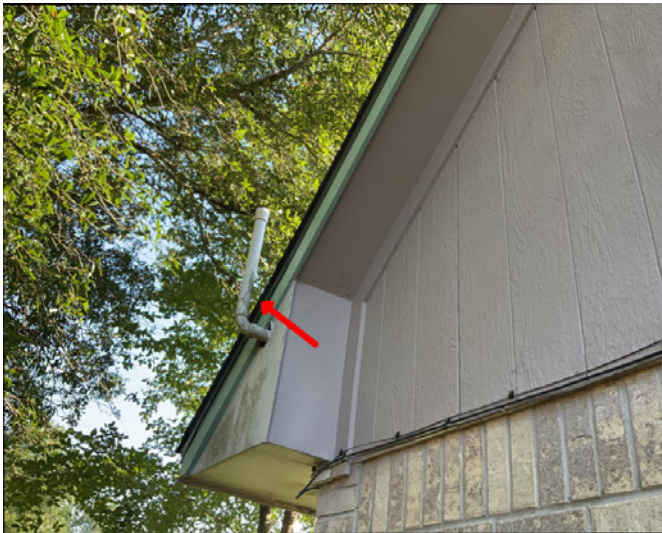
- Plumbing vents are required to terminate a minimum of 2ft. Above any openings within 10ft. Of the plumbing vent. Repairs are needed by a licensed plumber to reduce the risk of improper venting.

Proper venting required

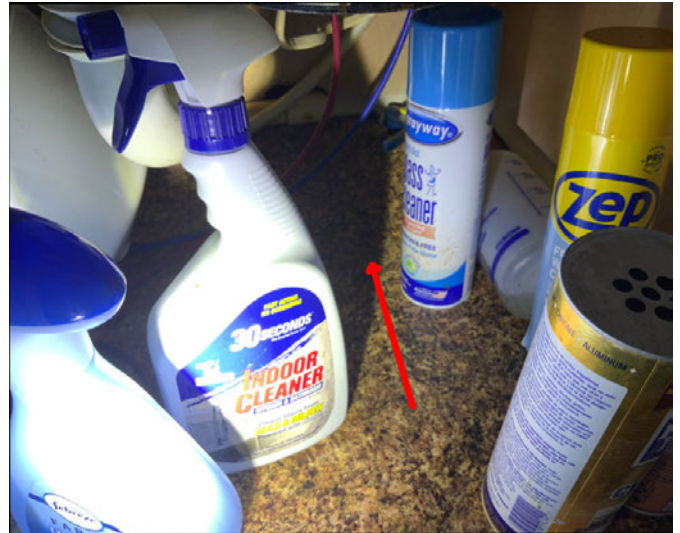
Evidence of past leaks under kitchen sink

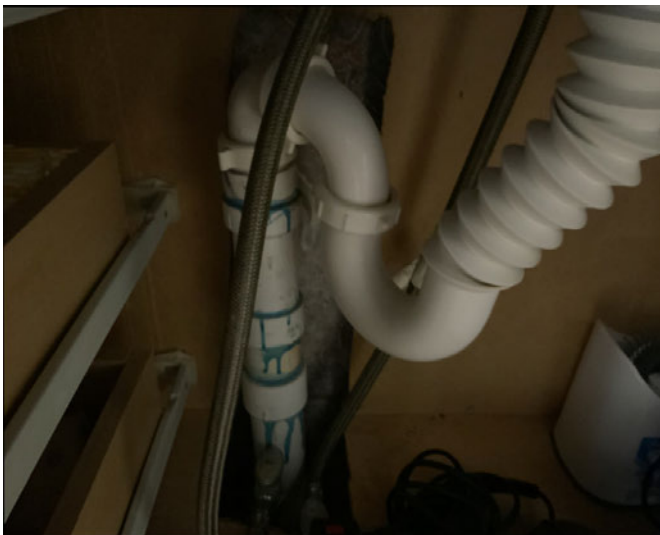
- Drain lines are required to have a smooth bore. Corrugated drains are a temporary repair only. Recommend licensed plumber to correct all plumbing vents and noted deficiencies

S trap and temporary drain material in place at primary bathroom

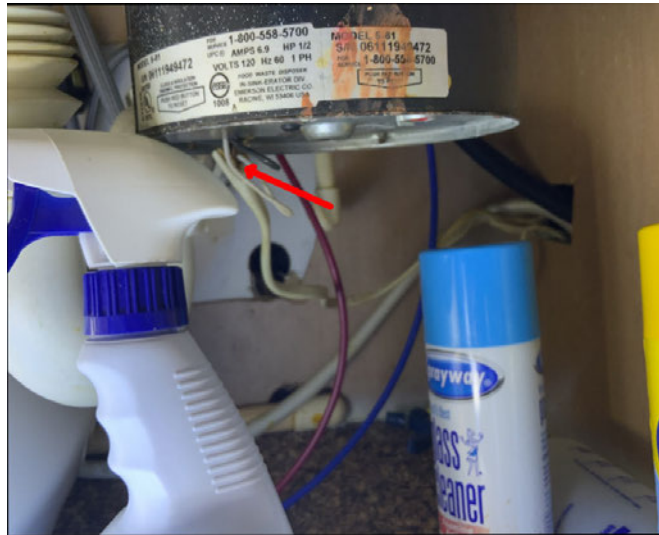
- The wires entering the garbage disposal should be secured with a wire clamp to reduce the risk of damage to the wires during operation of the disposal.

Correct connection required

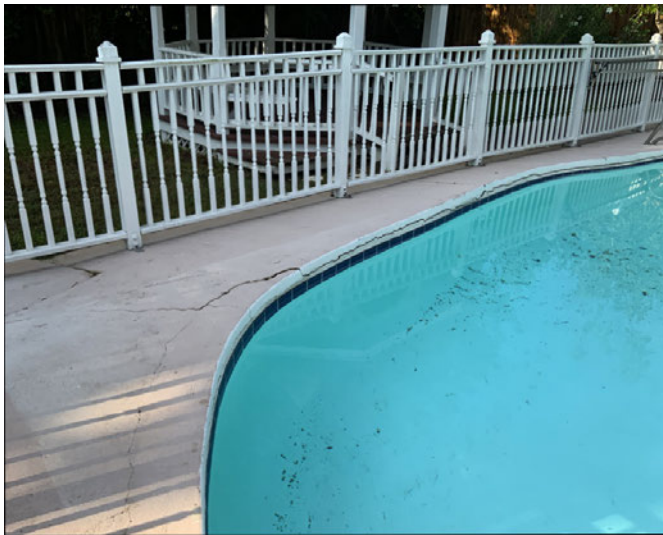
Major movement at pool deck surface and cracks at pool perimeter

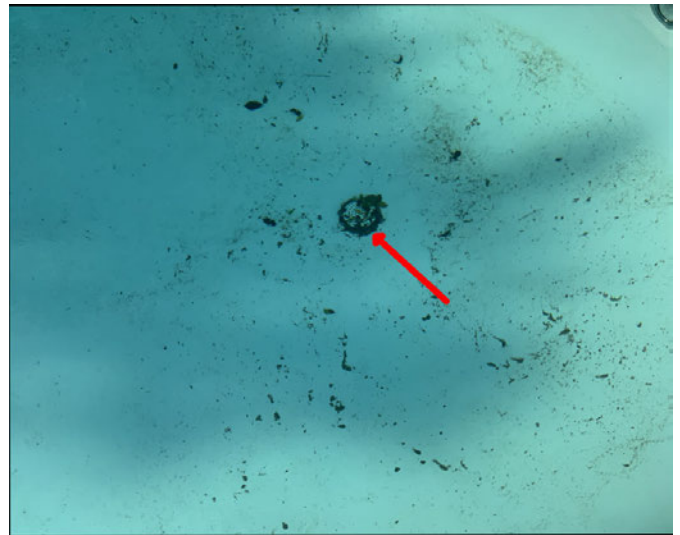
Recommend drain upgrades for safety
