5934 Patridge Drive

Property Inspection Report

9/26/2023

**PERFORMANCE
INSPECTIONS, PLLC**

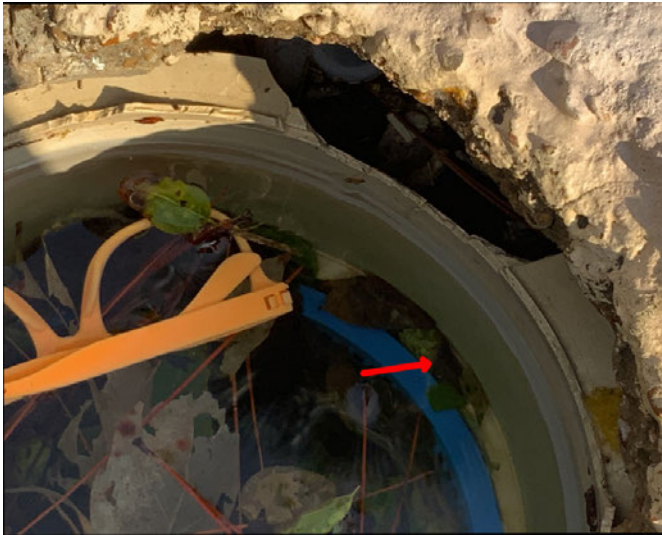
Damaged skimmer housing needs replacing

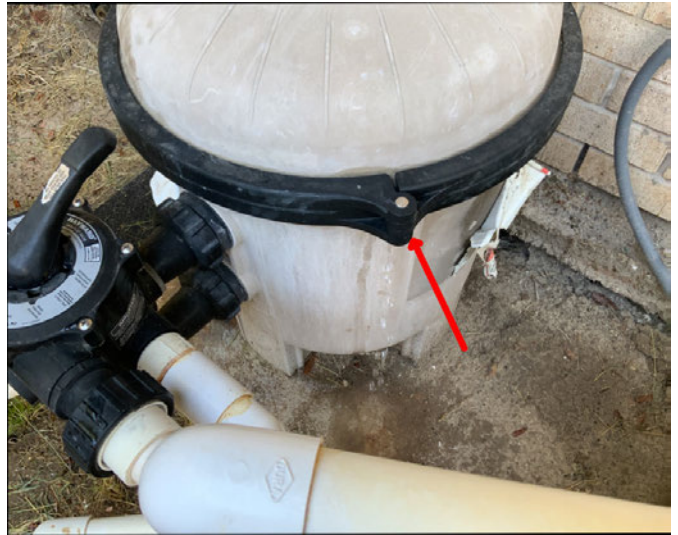
Leaking filter housing in 3 spots

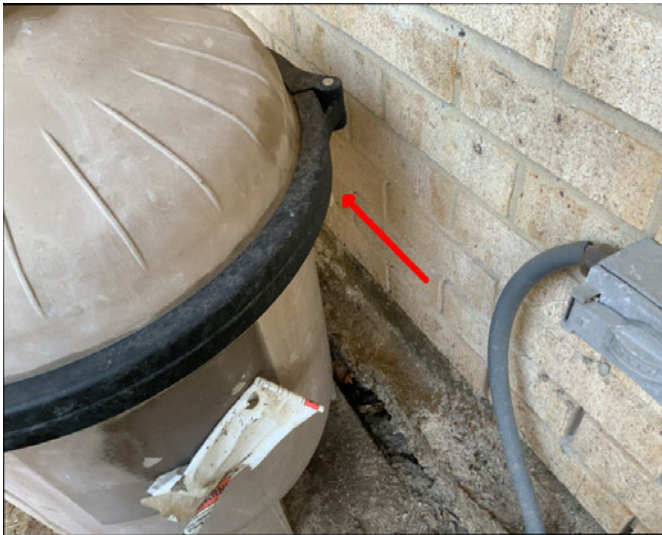
Leaking filter housing

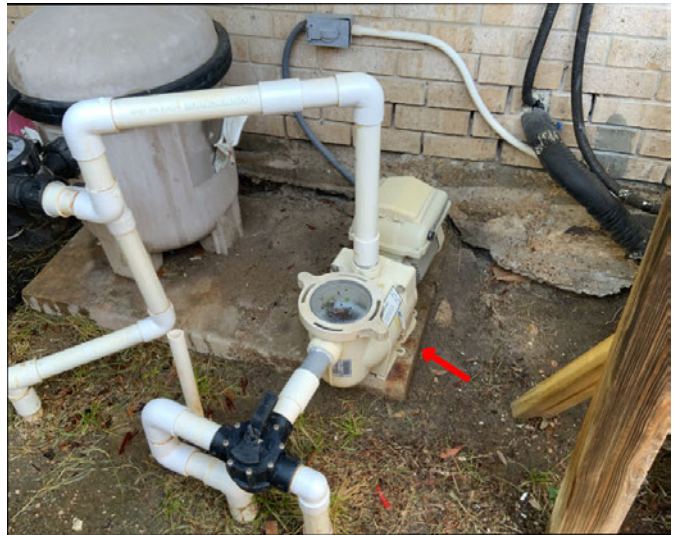
Pump bonding is required
