**From The Ground Up**  
**Professional Home Inspections**

# PROPERTY INSPECTION REPORT FORM

Rodney Spell <i>Name of Client</i>	02/20/2023 <i>Date of Inspection</i>
4795 Old Spurger Hwy, Silsbee, TX 77656 <i>Address of Inspected Property</i>	
Troy Priddy <i>Name of Inspector</i>	7259 <i>TREC License #</i>
<i>Name of Sponsor (if applicable)</i>	<i>TREC License #</i>

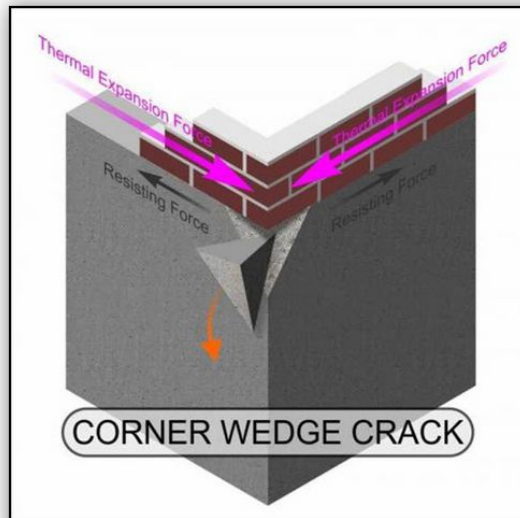
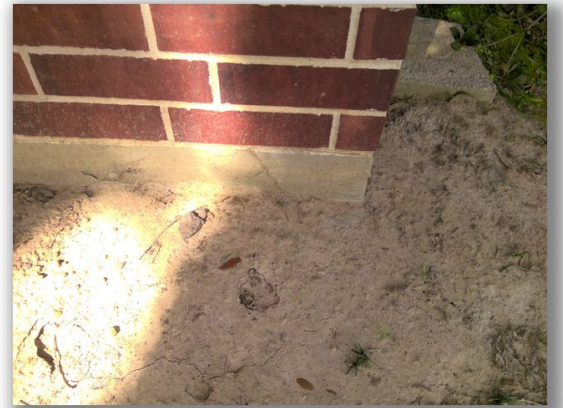
**Note:** One or more of the foundation perimeter beam corners were observed to be sheared off (corner pop). This is a common condition to observe and is due to thermal expansion and contraction of the different building materials. This condition does not adversely affect the foundation performance. However, in some cases, some cosmetic improvements may be necessary.

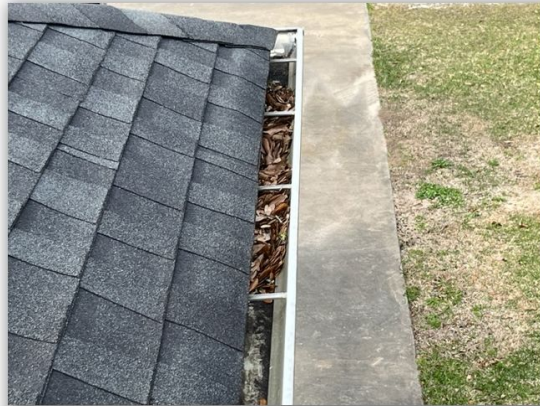
- The gutters have debris present and need cleaning.

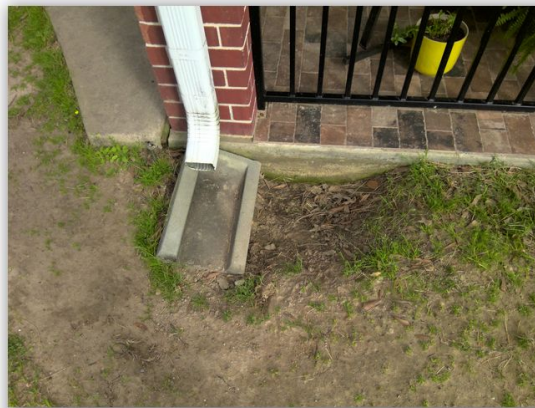
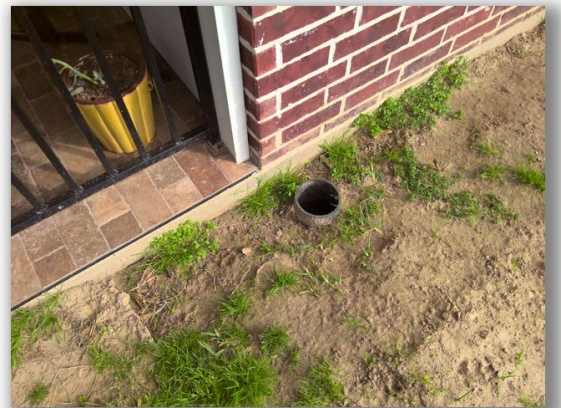
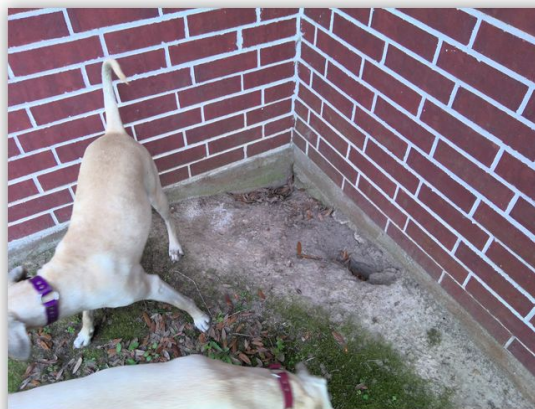
- Ground erosion was observed on the west side of the structure. Fill dirt is needed against the foundation perimeter wall where the soil line is too low to help support the foundation footer properly.

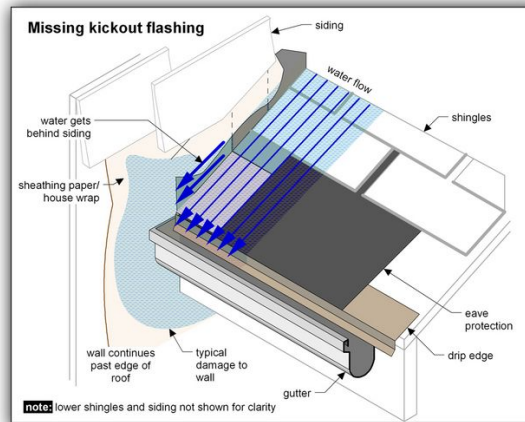
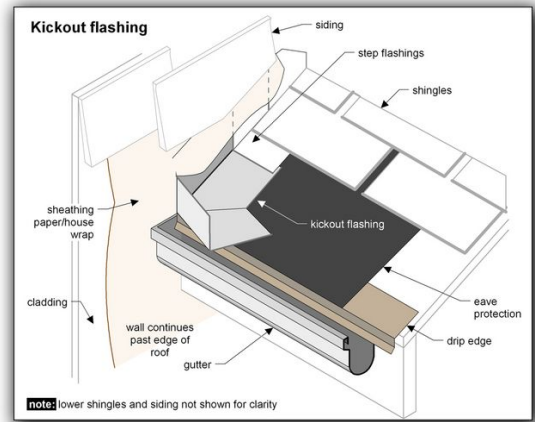
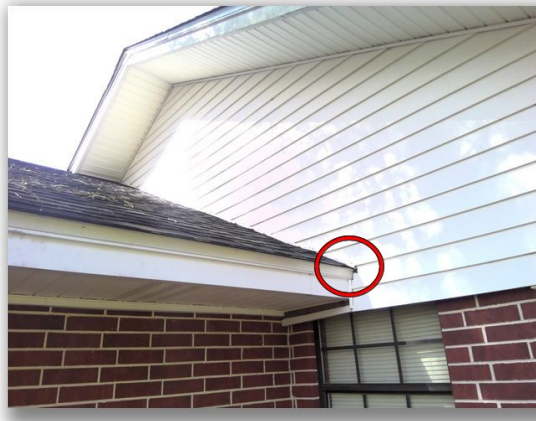
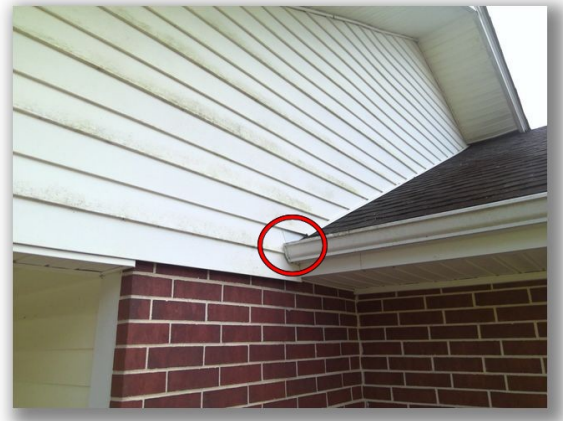
- There was no kickout flashing details observed at the lower bottom edge of the roof line interface and the sidewall that continues past the edge of the roof. The lack of this kickout flashing will allow water to penetrate at these points.

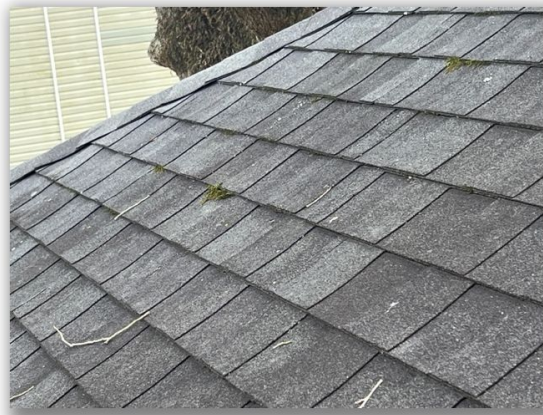
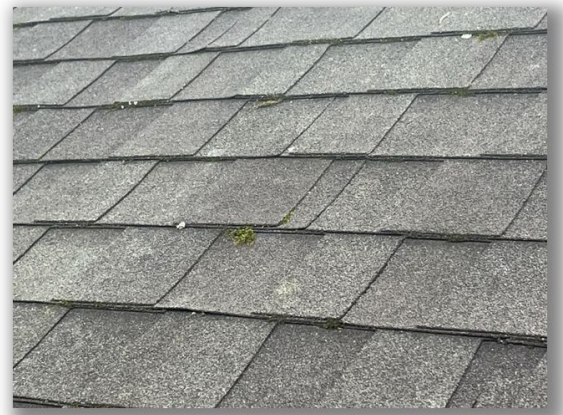
- There is excessive algae/moss growth on the roof covering on the south side of the roof covering. This can cause damage to shingles when not cleaned.

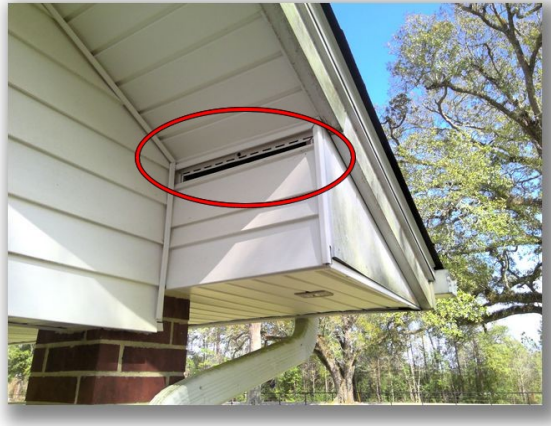
- The fascia board material has some deterioration and/or damage on the east side of the roof structure.

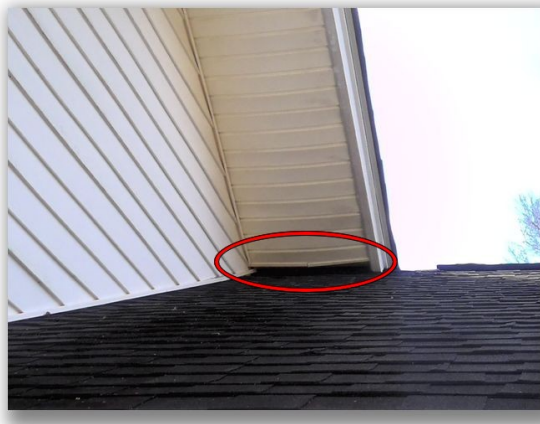
- The soffit material is sagging and/or pulling loose on the north side of the roof structure.

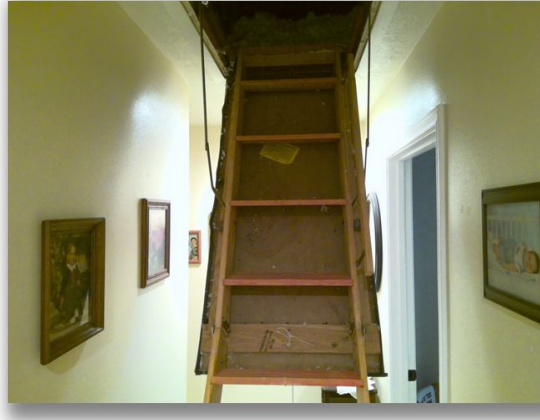
- The attic ladders in the bedroom hallway and garage are not properly installed and do not sit flush at the hinges when opened.

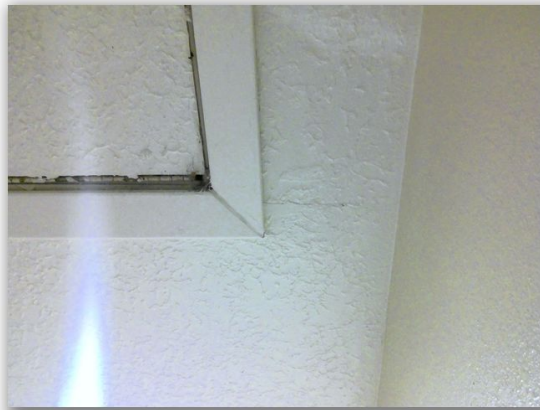
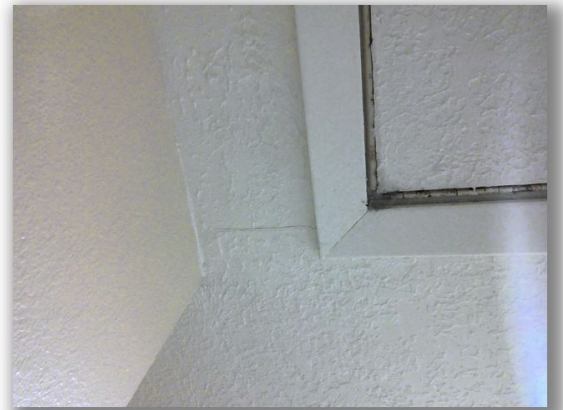
- Ceiling joint cracks were observed in the bedroom hallway.

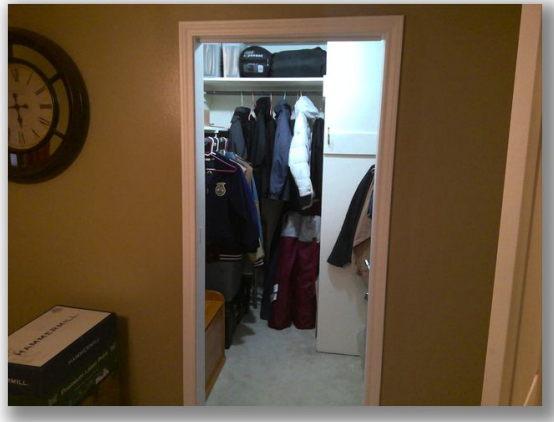
- The door is missing to the rear middle bedroom closet.

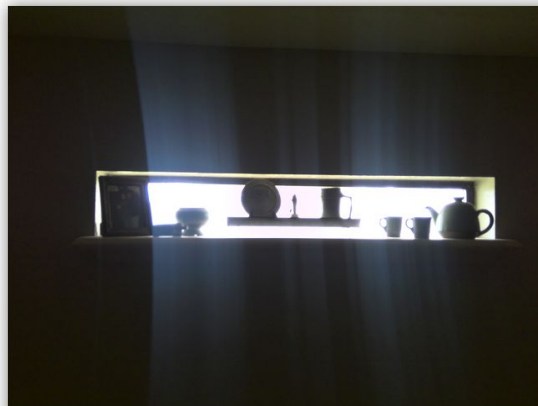
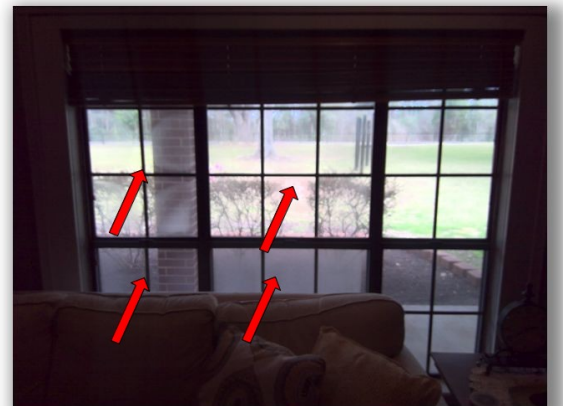
- One or more of the thermal pane windows were observed to have lost their seals. This has resulted in condensation or a fog like film to develop between the panes of glass. The thermal pane windows no longer function as designed when they loose their seal and replacement may be necessary. The windows that have noticeably lost their seals are listed but may not be limited to the following: master bathroom, hall bathroom, living room, study and front corner bedroom.

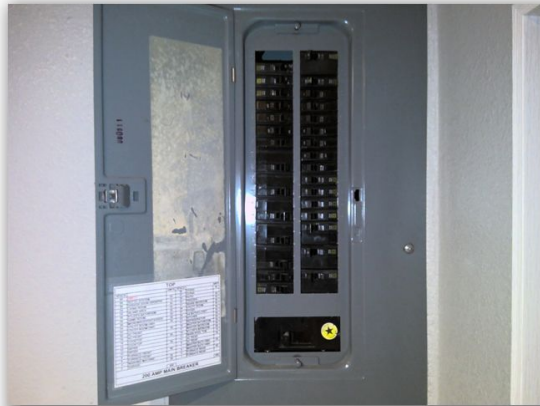
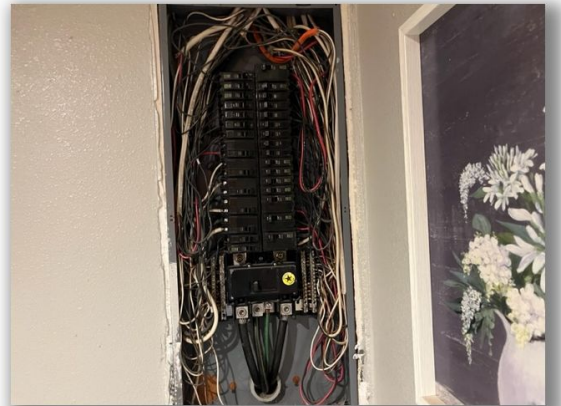
- There is no whole house surge protector present.
- None of the required dwelling unit devices, receptacle and lighting outlets (switches, receptacles and fixtures) are connected to an arc-fault circuit-interrupter (AFCI) circuit device. Under the current National Electrical Code, all of the living area devices, receptacle and lighting outlets (switches, receptacles and fixtures) should be connected to an arc-fault circuit interrupter (AFCI) device.

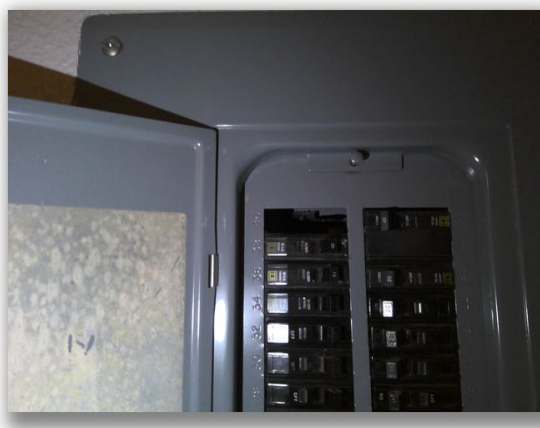
- All openings (missing knockouts) in the electrical cabinet cover plate (dead front) and /or cabinet need to have fillers.

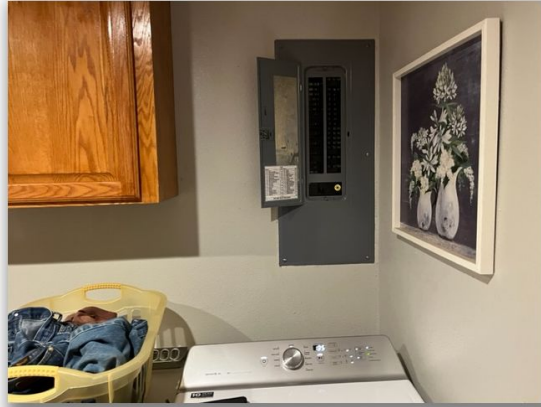
- The panel box does not have proper clearance in front of the cabinet. The panel box cover plate (Dead

Front) and/or cabinet should be readily accessible and cover easily removable at all times. Under current electrical standards, the accessible workspace around the panel box should be at least 36-inches in depth in front of the cabinet and 30-inches in width or the width of the equipment. Clothes, shelves, cabinets, foliage, etc should not block the workspace in front of the cabinet.

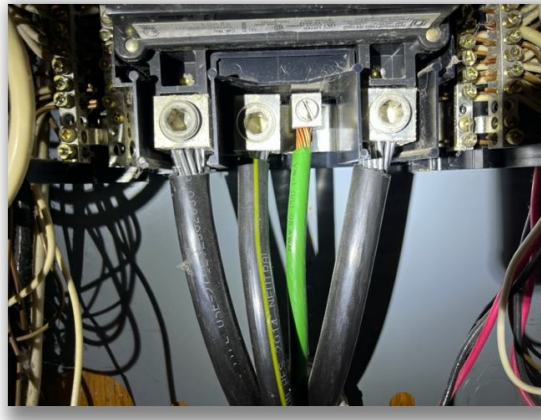
- There was no anti-oxidant gel observed on the exposed aluminum conductor terminations.
- The main service entrance lugs are not capped and properly protected.

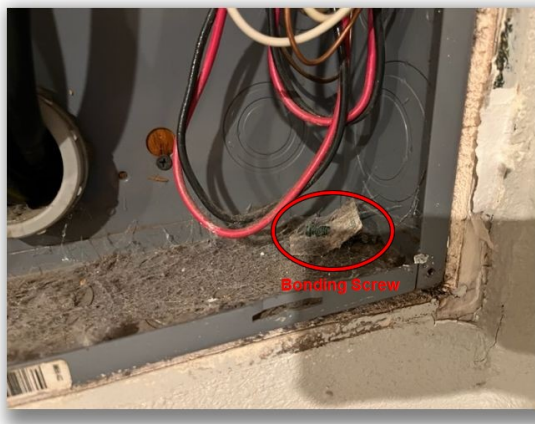
- The electrical cabinet does not appear to be properly bonded to the electrical system.

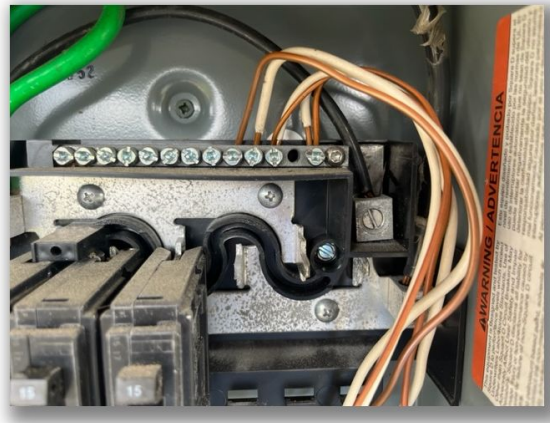
- One or more of the neutral and ground wires in the electrical cabinet were observed to be double lugged (i.e. two wires under one screw).
- The ground wires and the neutral wires are not properly separated in the sub-panel electrical cabinet. The neutral wires should be on their own isolated bus bar and the ground wires should be connected to the sub-panel cabinet. Although the sub-panel is functional, it does not meet current National Electrical Code standards.

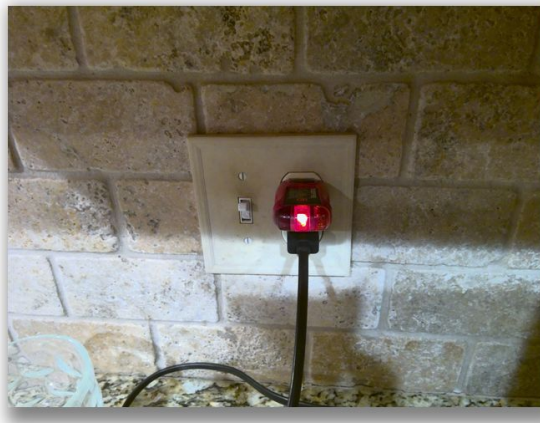
- The receptacles throughout the house are not tamper resistant receptacles. Recommend all receptacles that are within 5 1/2 feet of the floor be tamper resistant.
- The kitchen counter top receptacles do not appear to be connected to a ground fault circuit interrupter (GFCI) device. Under current electrical standards, all of the kitchen counter top receptacles and any receptacle within 6-feet of the sink should have GFCI protection.
- One or more of the receptacles were observed to have an open ground connection in the kitchen.

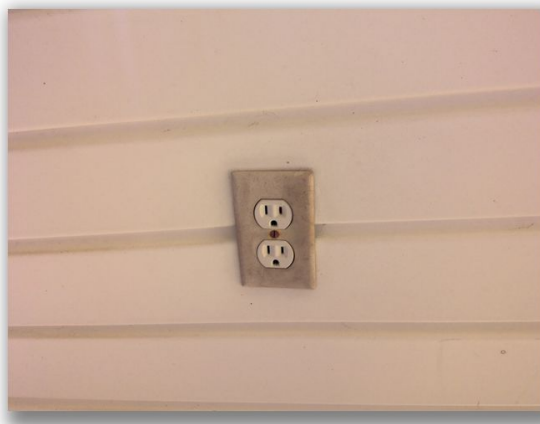
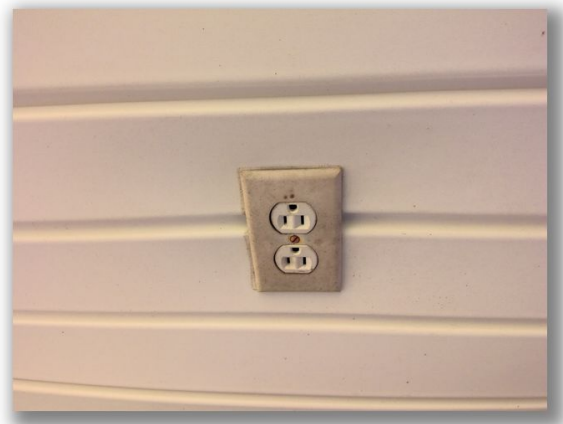
- The roof structure soffit receptacle(s) do not appear to be connected to a ground fault circuit interrupter (GFCI) device. This device may not have been required at the time the home was built. Under current electrical standards, all of the soffit receptacles should have GFCI protection.
- All exterior receptacles should have weather tight covers. The receptacle weather cover plate is damaged and/or missing on the east soffit.

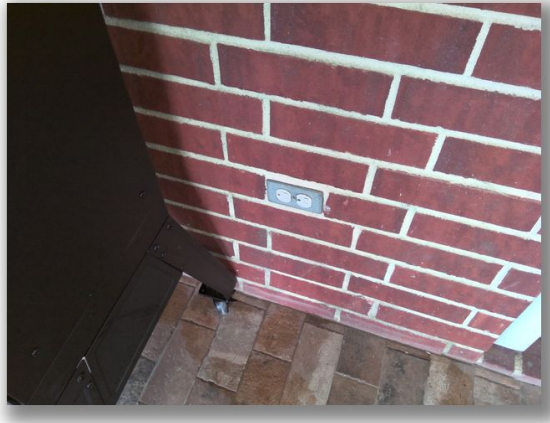
- The exterior receptacles do not appear to be connected to a ground fault circuit interrupter (GFCI)

- device. Under current electrical standards, all of the exterior receptacles should have GFCI protection.
- All exterior receptacles should have weather tight covers. The receptacle weather cover plate is damaged and/or missing on the back porch.

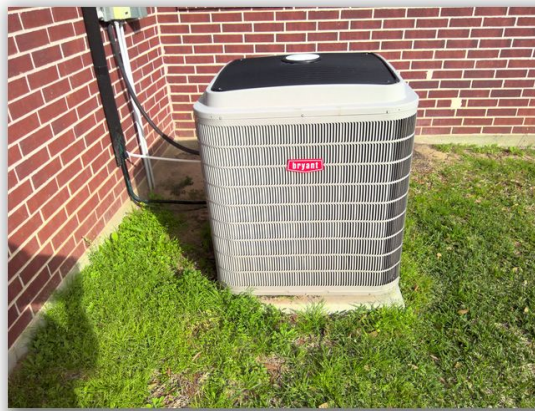
- The outdoor unit of the air conditioning system is out of level. It is recommended that the outside condenser/coils be within 1-inch of level.

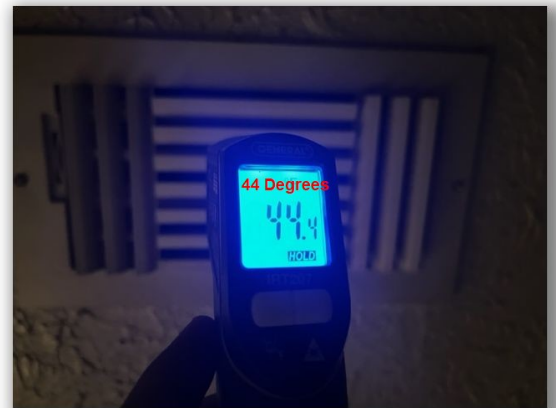
**Note:** It is the opinion of this Inspector, this component may be functioning as intended or in need of minor repairs, you should be aware that this is an older component and the future life expectancy cannot be determined. You can continue to use and service this component until replacement is necessary.

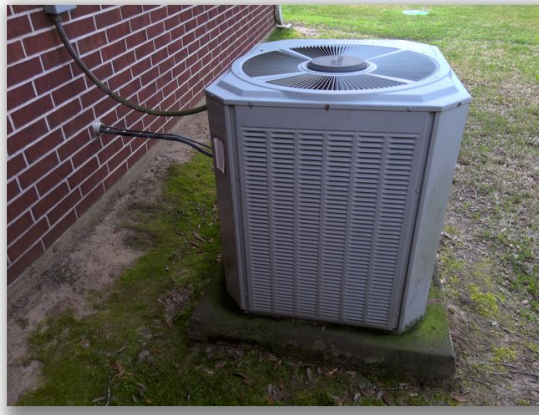
- The outdoor unit of the air conditioning system is out of level. It is recommended that the outside condenser/coils be within 1-inch of level.

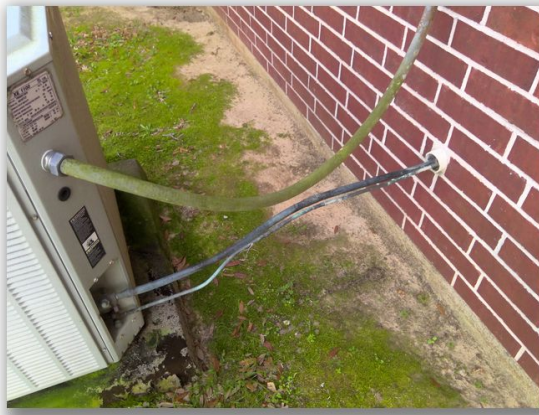
- Damaged, deteriorated and/or missing insulation on the refrigerant lines should be repaired or replaced at the outside condenser.

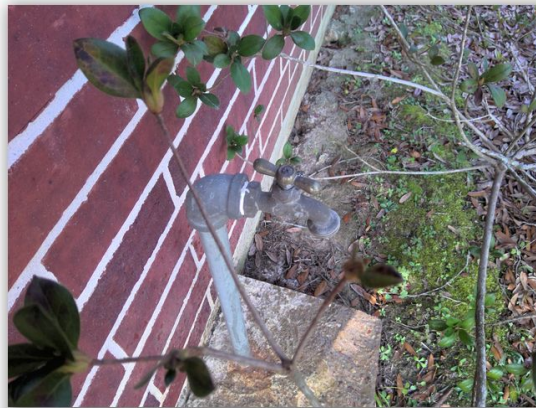
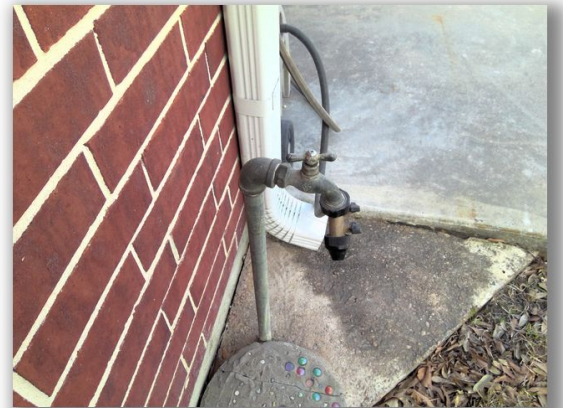
- One or more of the exterior water hose bibbs (faucet) do not have a back-flow or anti-siphon device (Vacuum Breakers) in place.

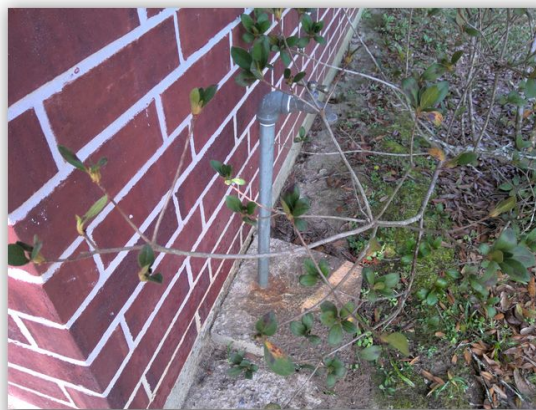
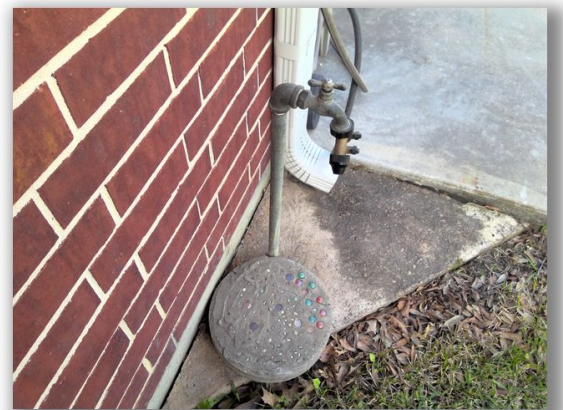
- All exposed water supply lines on the exterior should be insulated to help protect them from possible freeze damage.

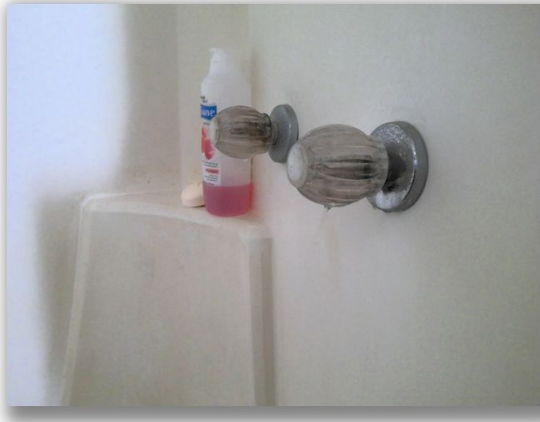
- The guest bathroom shower faucet leaks at the handles when on.

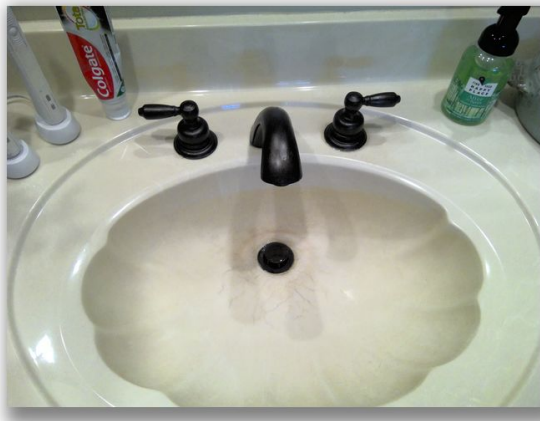
- The master bathroom sink stopper does not appear to be functioning properly.

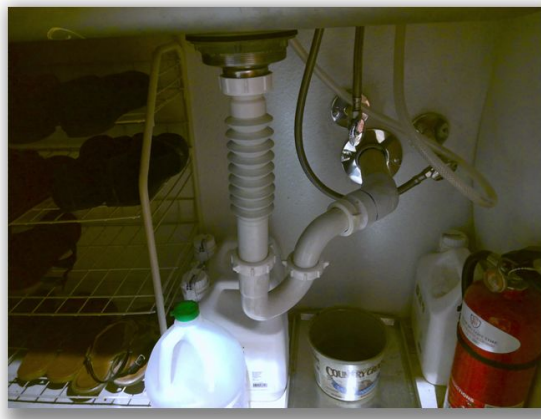
- There is a corrugated drain line under the laundry room sink. This style drain line is not recommended for this use. Recommend drain lines under sinks have smooth interior finishes.

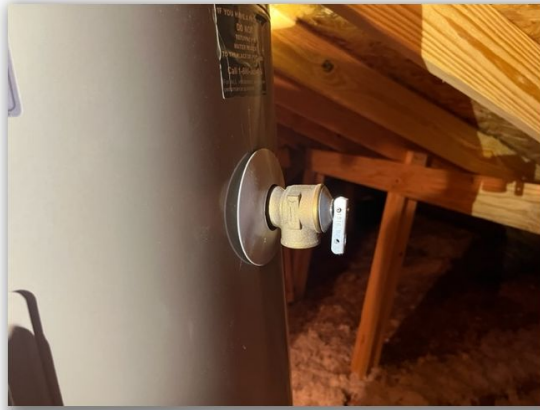
- There is no temperature and pressure relief valve (TPR) discharge pipe in place at the time of this inspection. For safety reasons, it is recommended that a TPR valve discharge pipe be installed. Under current building standards, the discharge pipe should run downward to the exterior of the structure, turn downward, and terminate within 6-inches of the ground.
