Wood Destroying Insect Report

8/6/2020

8924 Live Oak Grove Ln.

TEXAS OFFICIAL WOOD DESTROYING INSECT REPORT

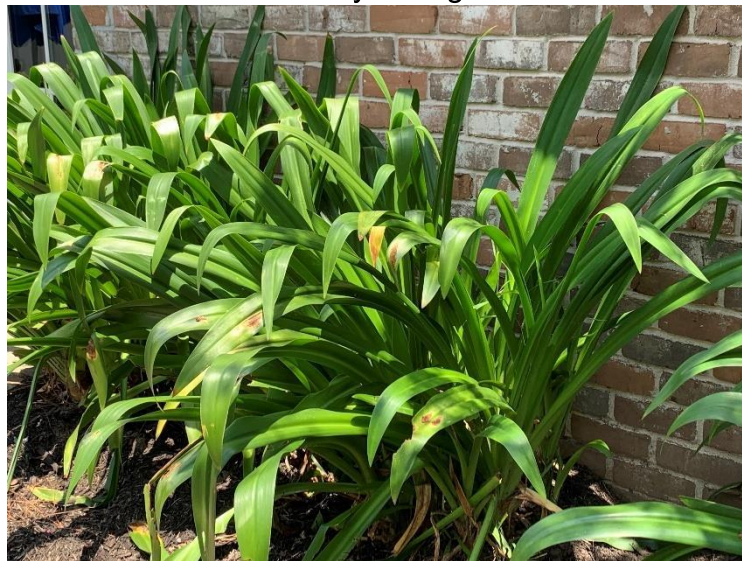
Comments: (N) Heavy Foliage – Foliage should be cut back to provide at least 3 inches of clearance to the structure.

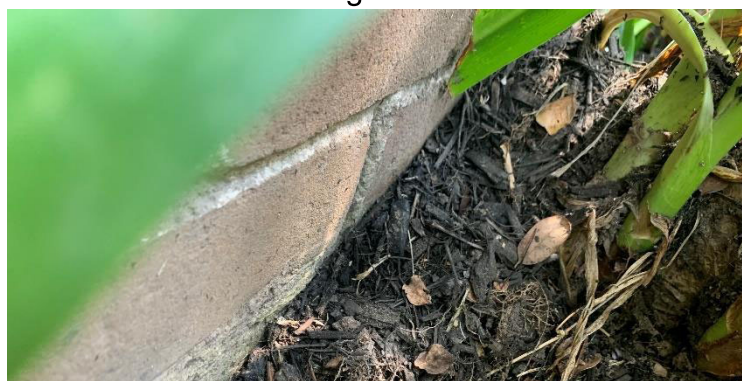
(L) High Soil – Soil should be lowered to below the top of the foundation.
