STRUCTURAL INSPECTION

8924 Live Oak Grove Lane
Houston Tx 77080

AUGUST 6, 2020

REF: CONDITION OF PROPERTY SURVEY

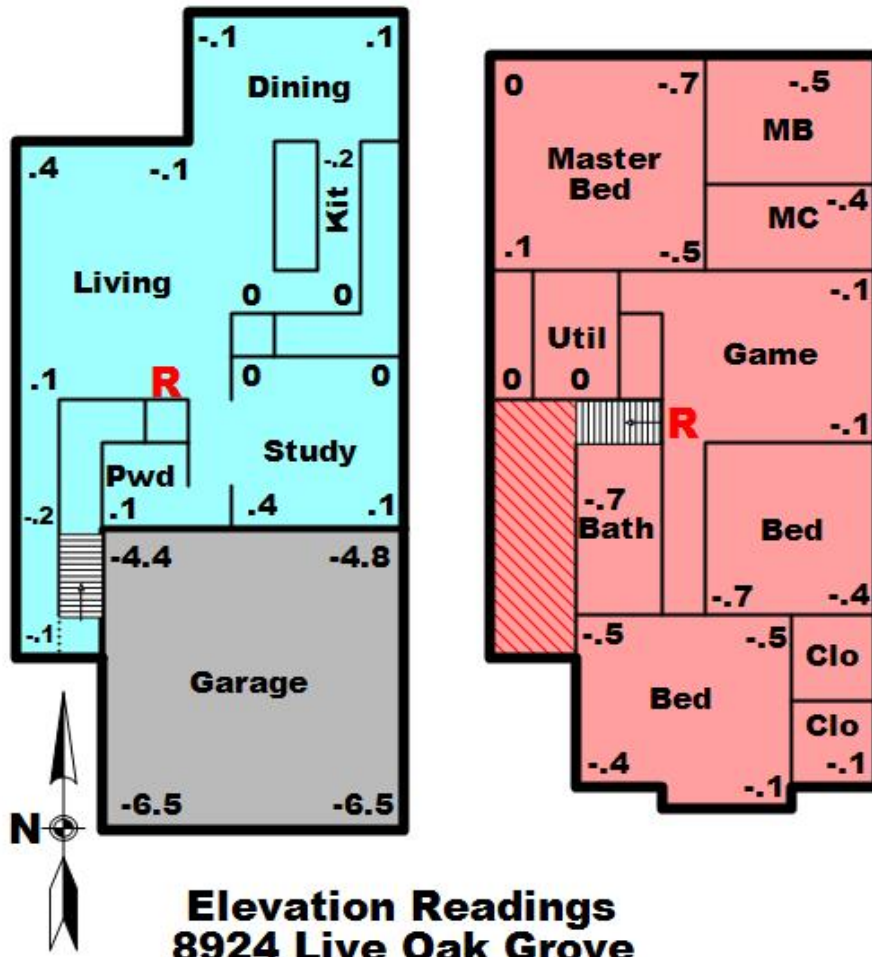
8.6.20 HEI Shackelford

Differential Movement: Reference point

See our field sketch below showing the elevation readings for this structure. Note that the "R" on the sketch is our randomly chosen starting reference point, where the elevation is 0, and all other elevation readings are taken relative to the reference point, and are measured in inches to the nearest 1/10 inch. If there is a step up or a step down into an area such as a garage, sunken room, balcony/patio area, or raised rooms, the elevation readings will have larger numbers due to the amount of the step.

The floors were checked with an electronic level, and were observed to be acceptably level throughout the house. The difference in elevation between the high point and low point was 0.6 inch. The high points were located at the study and living room, and the low points were located at the stairs and kitchen. The unlevelness takes place over a horizontal distance of approximately 15-20 feet.

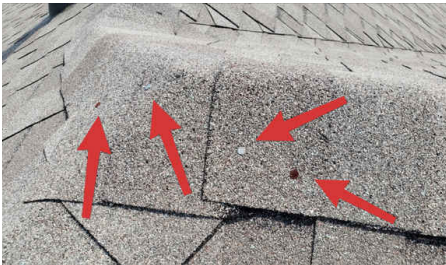
Wear and Deterioration: Composition - Some

Nail Heads not Sealed

The composition roof surface was showing evidences of some deterioration of the roof surface as described above and shown below.

The roof is in generally serviceable condition at this time with some repairs needed for the item(s) shown below under Recommendations/Repair. Have a roofing contractor provide a cost estimate to make all necessary repairs to bring the roof into a completely serviceable condition.

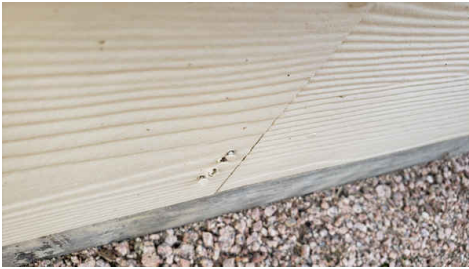
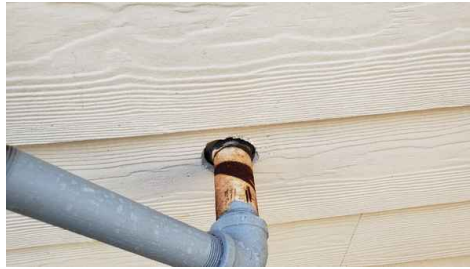
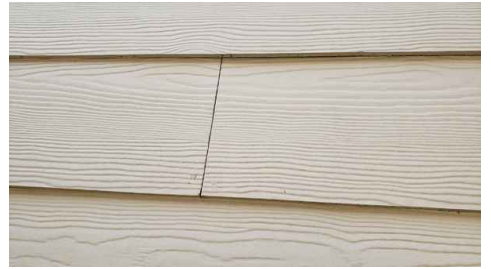
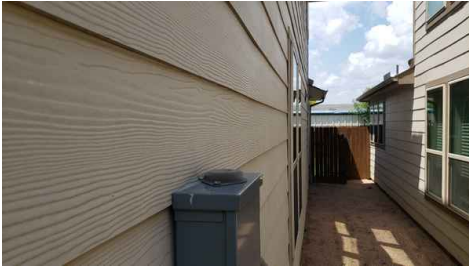
7.1.1 Water Penetration

VULNERABILITY TO WATER PENETRATION

Caulking Cracked/Missing, Electrical Disconnect, Gas Line

A substantial vulnerability to water penetration was observed at penetrations/openings through the exterior building envelope, and it is recommended that all penetrations/openings be sealed against water penetration. Typical examples on a structure may include light fixtures, air conditioning refrigerant lines, water piping, gas piping, vent caps, windows, doors, expansion joints, etc. Below is a representative sample of locations and/or photographs showing some, but not necessarily all, locations where there is a vulnerability to water penetration. Have a contractor provide a cost estimate to seal all vulnerable areas on the exterior building envelope against water penetration and/or open up any clogged weepholes in the veneer.

Contact a qualified professional.

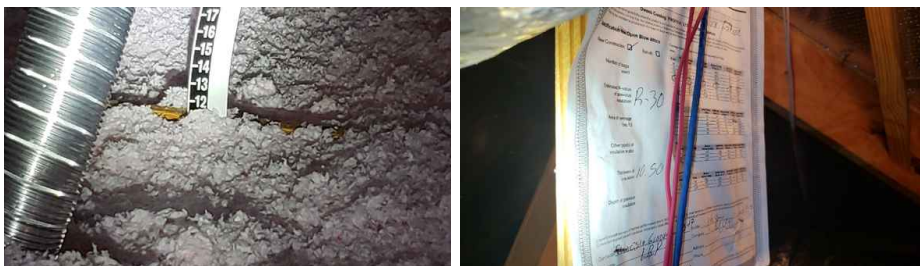
Insulation: R30 Batt

The insulation in the attic was average by today's standards. The normal amount of insulation for attics in this area is an R38 energy rating. This attic had approximately 12 inches of fiberglass batt insulation in the ceiling, which was marked as being an R30. It is pointed out that the insulation requirements according to the latest standard for new houses in this area is an R38 energy rating.

It is also pointed out that a thin layer of blown-in cellulose insulation was installed over the fiberglass batt insulation.

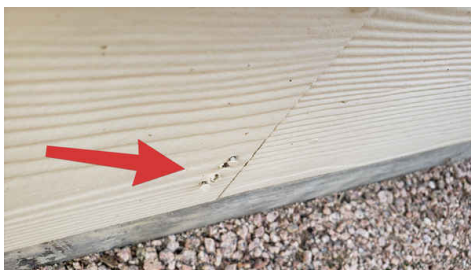
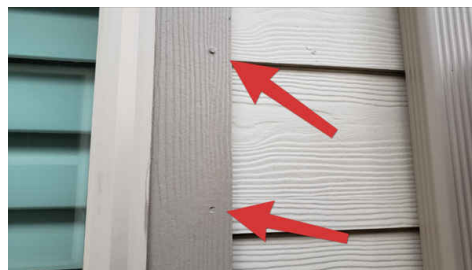
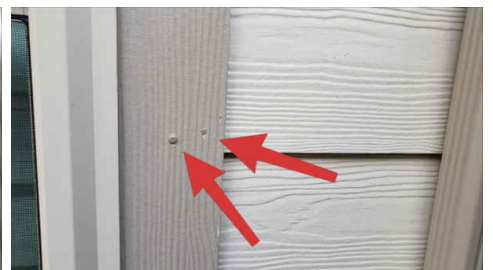
9.2.1 Fiber Cement Siding

NAILS OVERDRIVEN/UNDERDRIVEN

We observed where the nails used to secure the siding were overdriven past the face of the siding, leaving holes where water can penetrate into the siding. Further investigation with a contractor is recommended to determine if the degree of the condition is such that the siding has been compromised and needs to be renailed.

Contact a qualified professional.

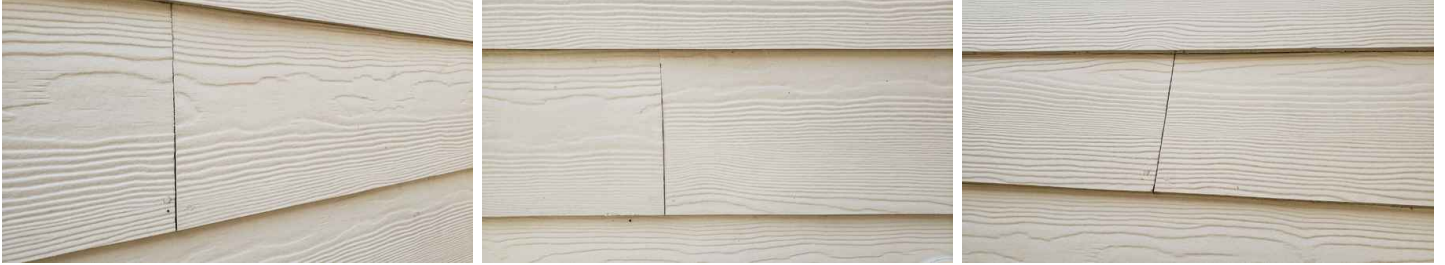
9.2.2 Fiber Cement Siding

CAULK VERTICAL JOINTS

The siding was unsealed at the vertical joints which can allow water to penetrate behind the siding. It is recommended that the vertical joints be caulked to prevent water penetration.

Contact a qualified professional.

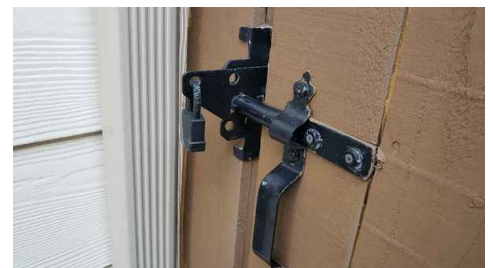
10.3.1 Gates and Fences

WOOD GATE

Locked

The wood gate was in need of some repairs.

Contact a qualified professional.

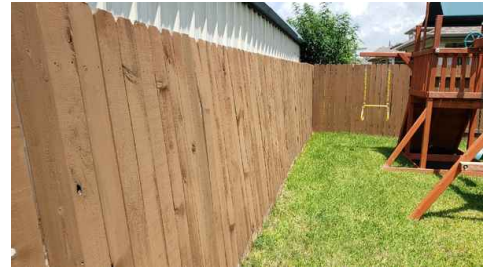
10.3.2 Gates and Fences

WOOD FENCE

Leaning

The wood fence was in need of some repairs.

Contact a qualified professional.
