PROPERTY INSPECTION REPORT FORM

TEWOGBOLA JOLAOSO <i>Name of Client</i>	12/23/2023 <i>Date of Inspection</i>
6414 KIMBALL MILL LN., Houston, TX 77084 <i>Address of Inspected Property</i>	
Stephen Perry <i>Name of Inspector</i>	7854 <i>TREC License #</i>
 <i>Name of Sponsor (if applicable)</i>	 <i>TREC License #</i>

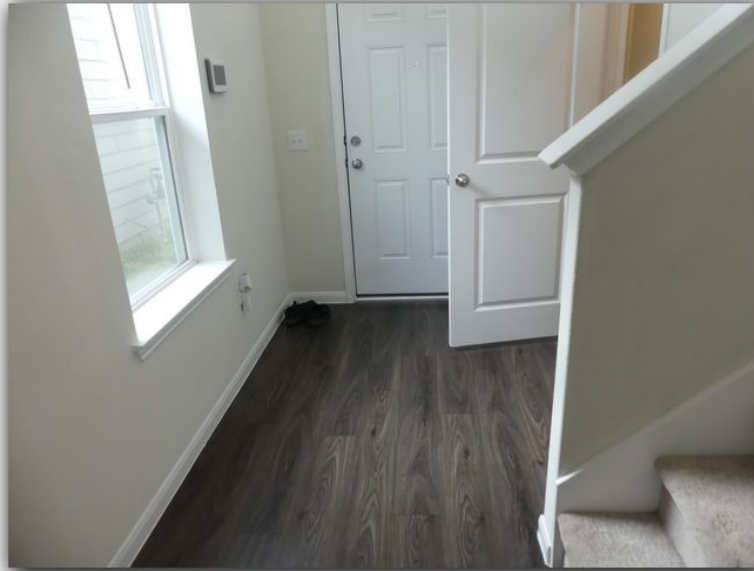
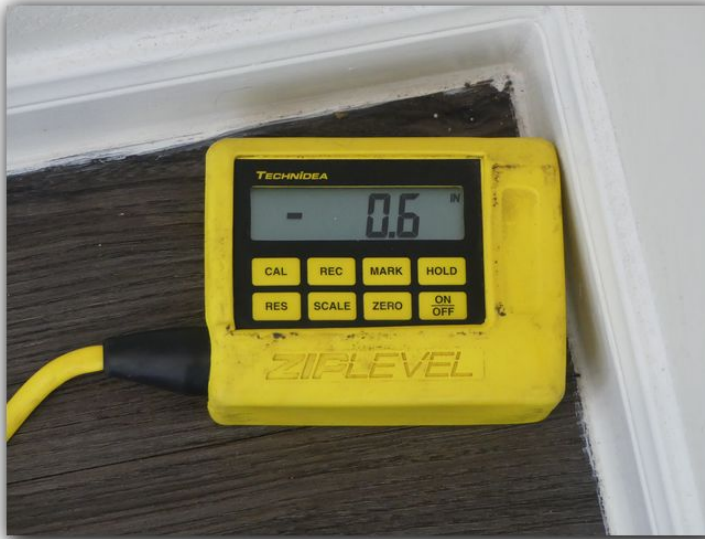
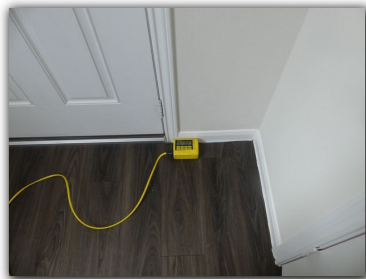
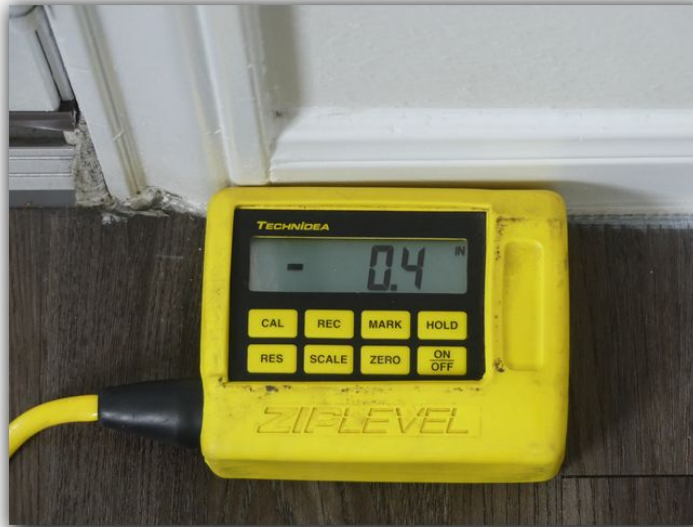
Signs of Structural Movement or Settling

- Cracks in wall(s) and / or ceiling
- Door frames out of square; laundry room door rubbing on the frame and not able to latch; hard to close

- Structural movement and/or settling noted; however, the foundation is supporting the structure at this time.**

AS PART OF THE FOUNDATION INSPECTION THE ELEVATION OF THE FLOOR WAS CHECKED FOR EXCESSIVE SLOPE WITH A "ZIP LEVEL/ PRO-2000"- ("HIGH PRECISION ALTIMETER"). A REFERENCE POINT WAS SELECTED IN THE MIDDLE OF HOUSE AND ELEVATION MEASUREMENTS WERE TAKEN IN EACH ROOM. **IT WAS DETERMINED**

AFTER CAREFUL EVALUATION OF THE DATA OBTAINED THAT THE FOUNDATION ELEVATION/SLOPE IS WITHIN ACCEPTABLE TOLERANCES. THERE WAS SHOWING -.8" TENTHS OF AN INCH LOW AT THE BACK LEFT CORNER OF THE HOME IN THE BREAKFAST AREA AND -.6" TENTHS OF AN INCH LOW ON THE FRONT SIDE OF THE HOME AT THE FRONT DOOR. THESE TOLERANCES MAY INDICATE SOME MINOR SETTLEMENT. HOWEVER, THESE TOLERANCES ARE NOT CONSIDERED EXCESSIVE. RECOMMEND MONITORING FOR ANY FURTHER SIGNS OF

STRUCTURAL SETTLEMENT.

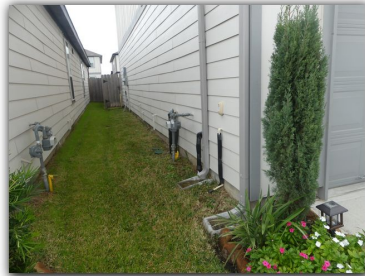
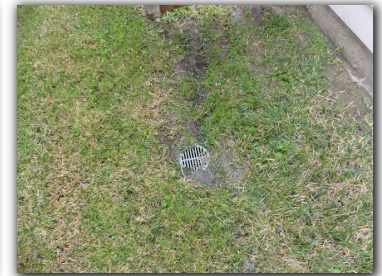
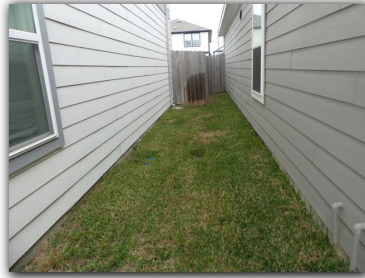
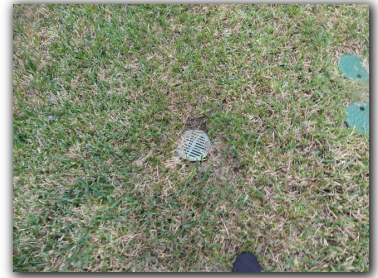
Improper drainage from foundation****(Deficiency)****

There is a French drain system present as is recommended. However, would also recommend improvements such as rocks and gravel installed on both side of the home and also around the full perimeter by a landscape and irrigation expert.**(Deficiency)******

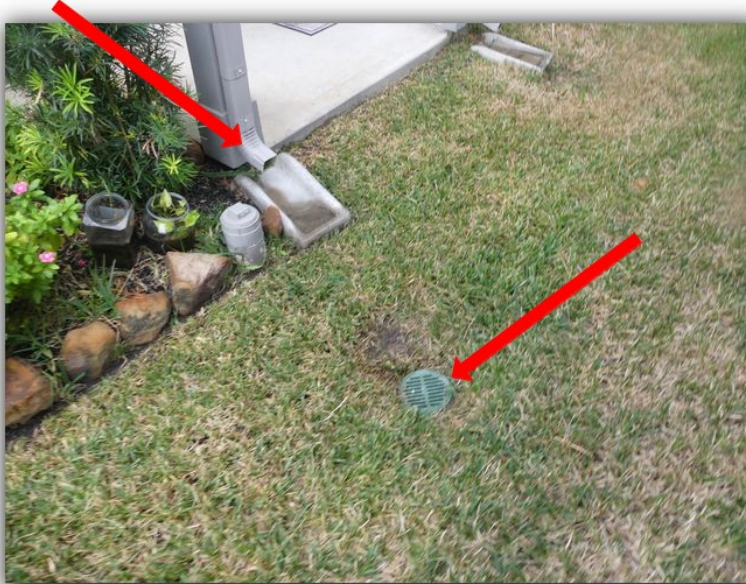
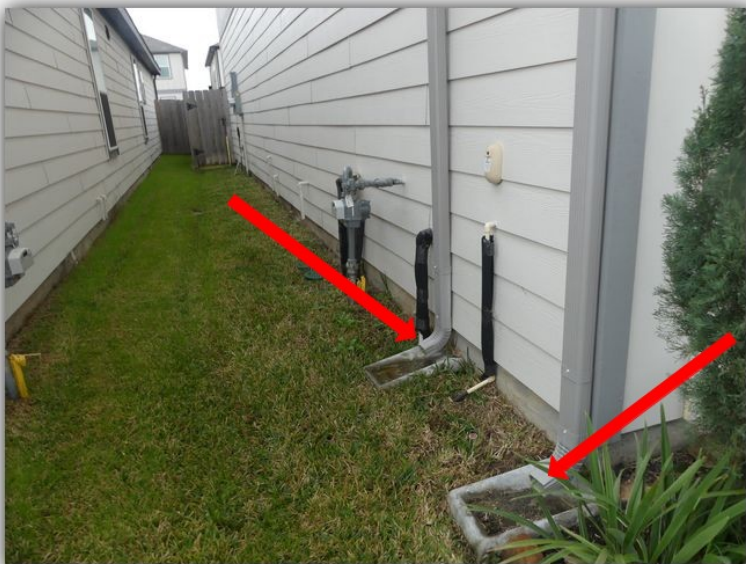
Recommend all gutter terminate directly to the French drain system for improved drainage. (Deficiency)****

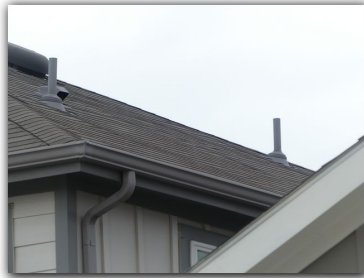
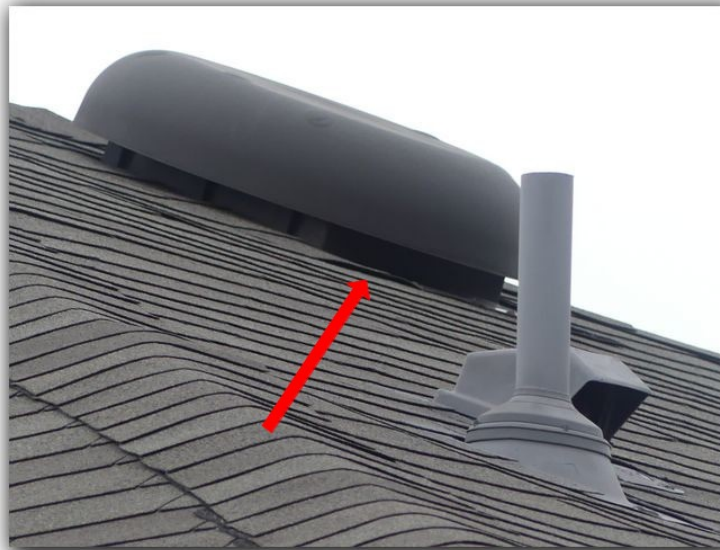
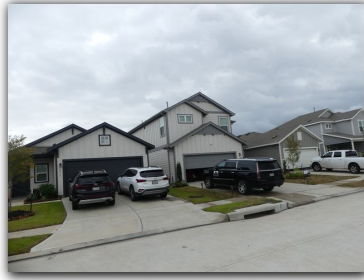
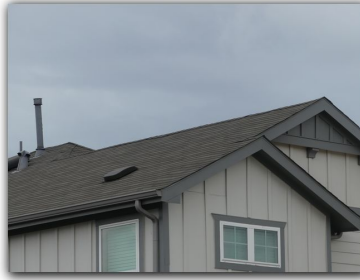
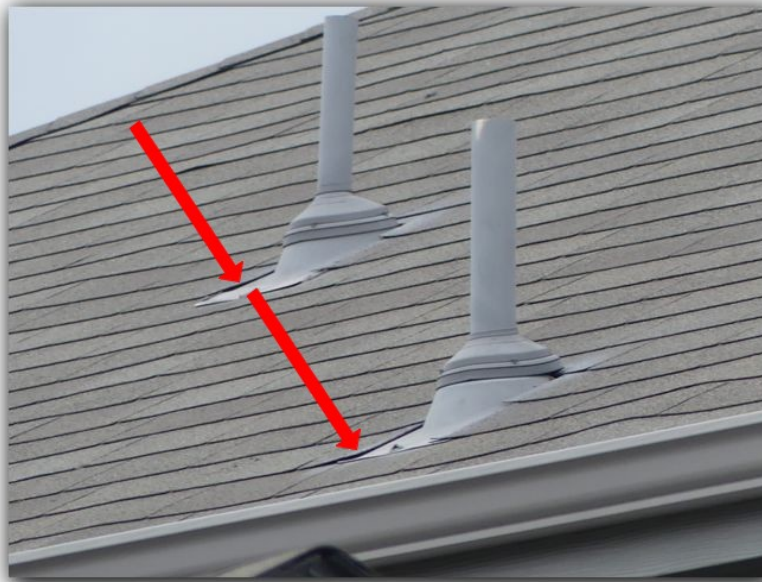
- **THERE IS VENTS AND FLUES WITH RAISED FLASHING THAT NEEDS TO BE PROPERLY SEALED DOWN BY A ROOFING EXPERT. **(Deficiency)****

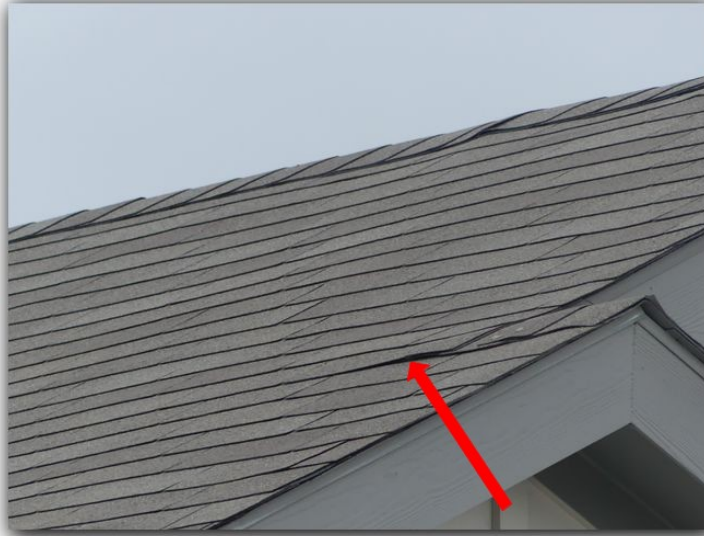
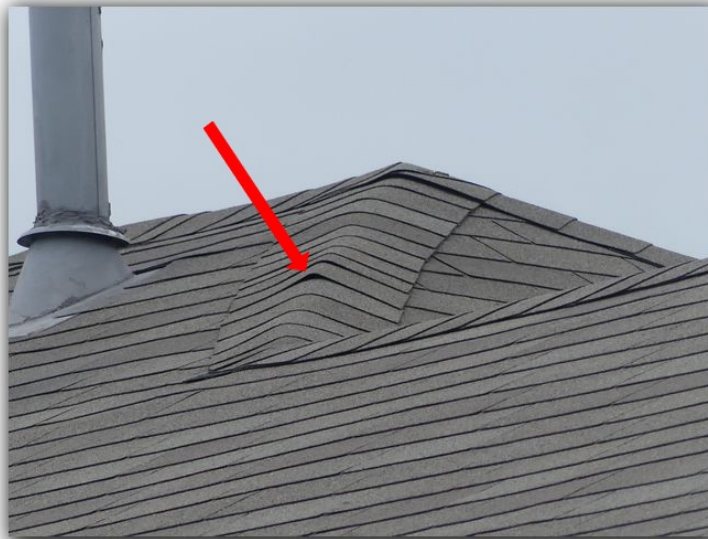
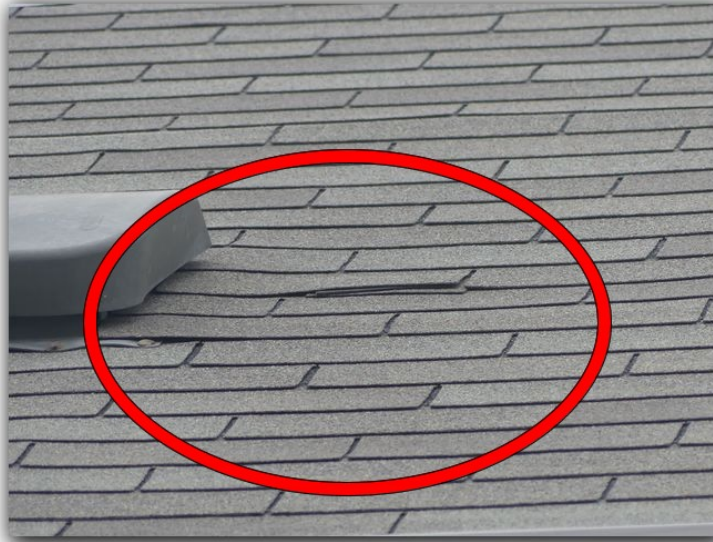
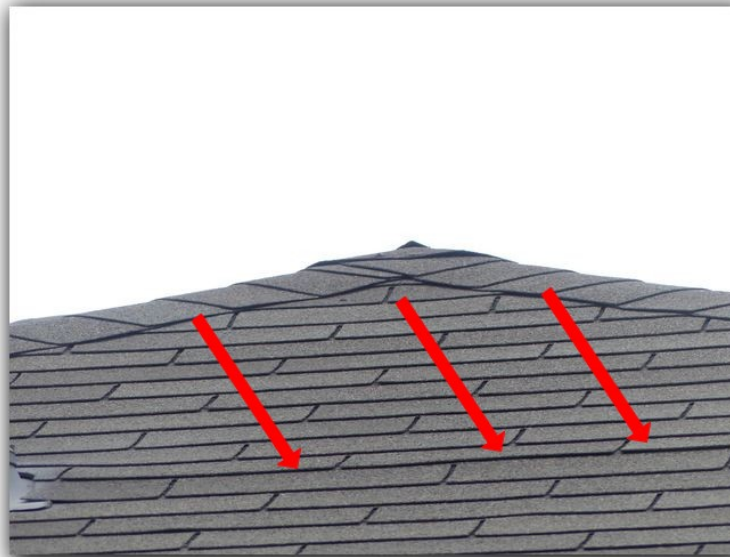
- **THERE IS SOME RAISED SHINGLES DUE TO PROTRUDING NAILS THAT NEEDS TO BE REPAIRED BY A ROOFING EXPERT.** (Deficiency)****

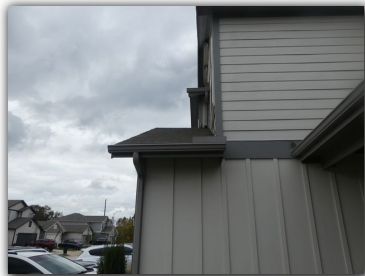
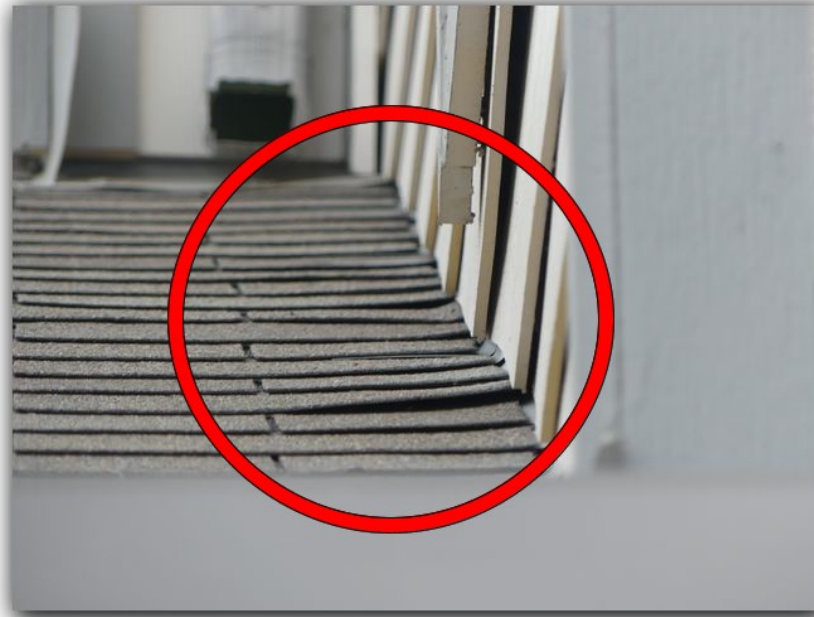
Flashing is lifting, ill configured, **** (Deficiency) ** (Step flashing at the roof and wall intersections raised up that needs repairs by a roofing expert) ** (Deficiency) ****

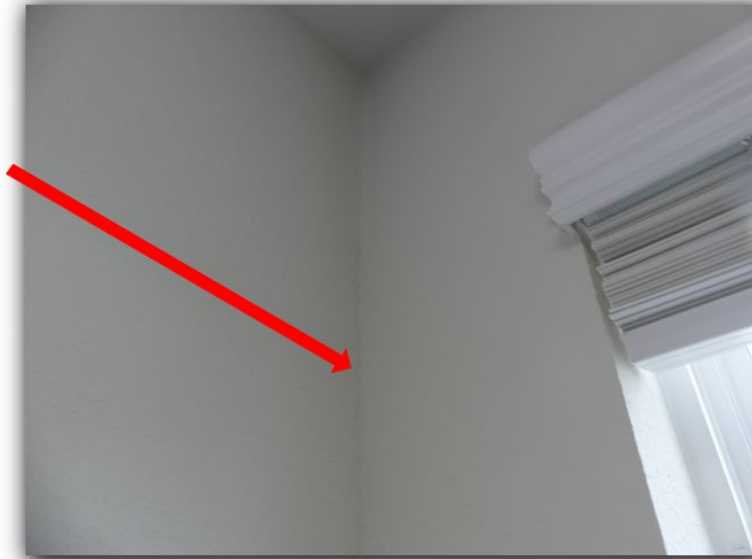
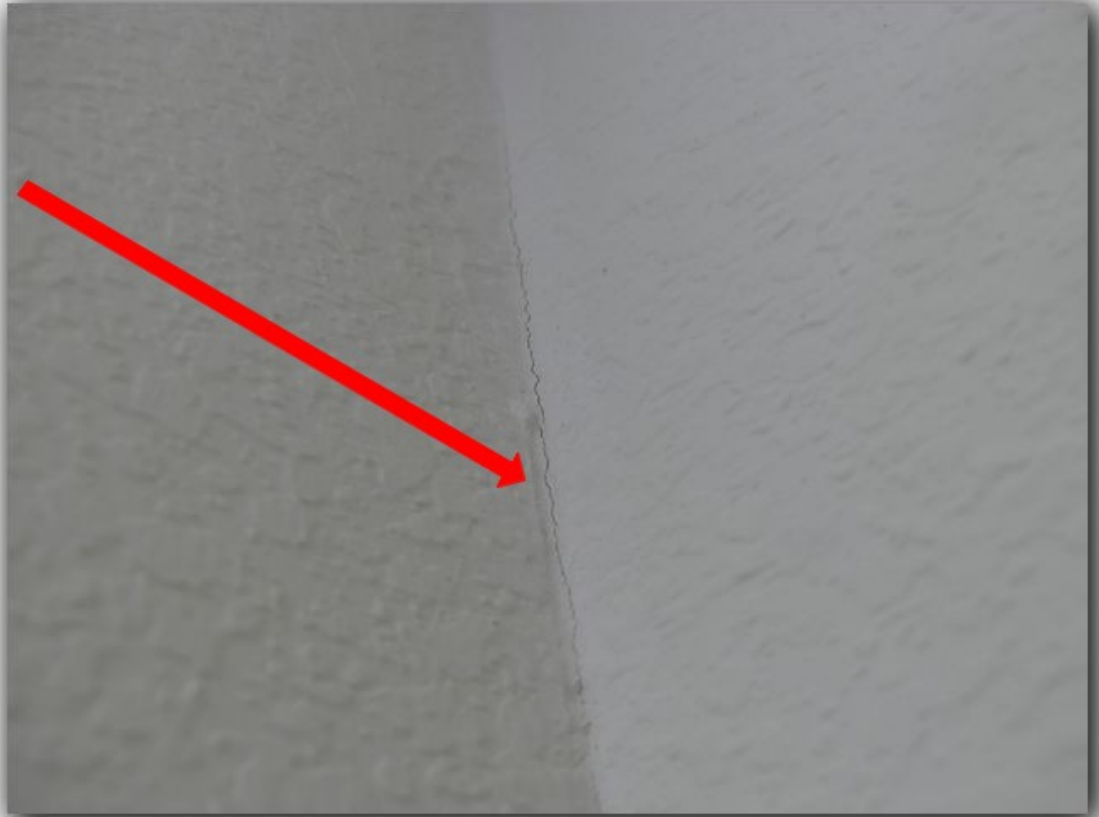
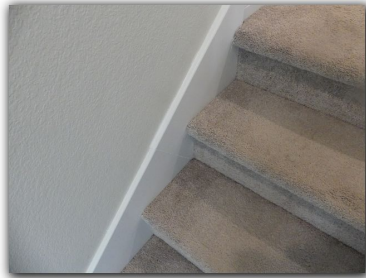
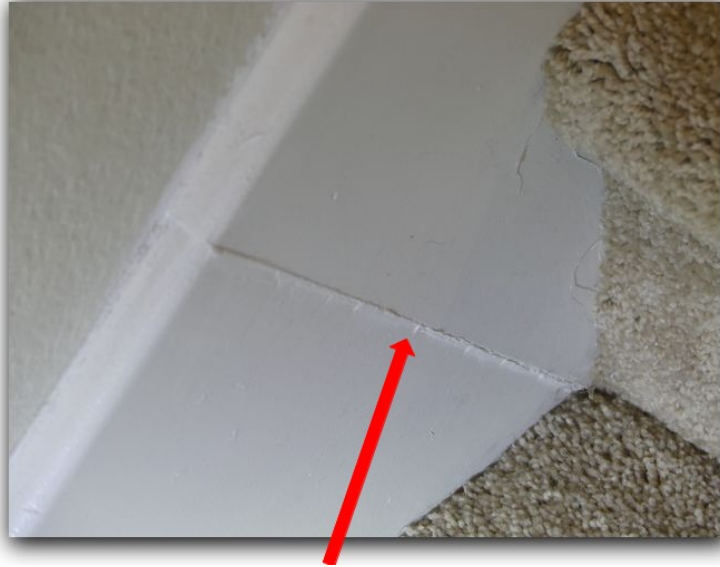
- **SOME DRYWALL CRACKS AND/OR PATCHED/PAINTED OVER CRACKS IN SOME LOCATIONS** (Deficiency)** (Upstairs secondary bedroom front corner)**
- **SEPARATIONS TRIM BOARDS, STAIRWELL** (Deficiency)****
- **INDICATING STRUCTURAL SETTLEMENT THAT NEEDS TO BE PATCHED/FINISHED/TEXTURED AND MONITORED FOR ANY FURTHER CRACKING**

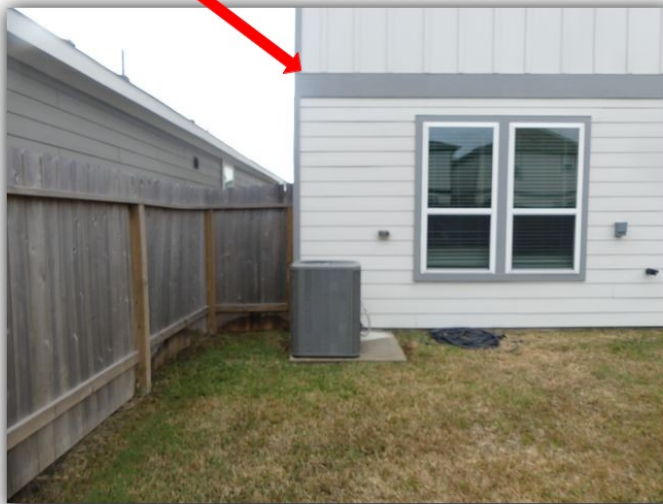
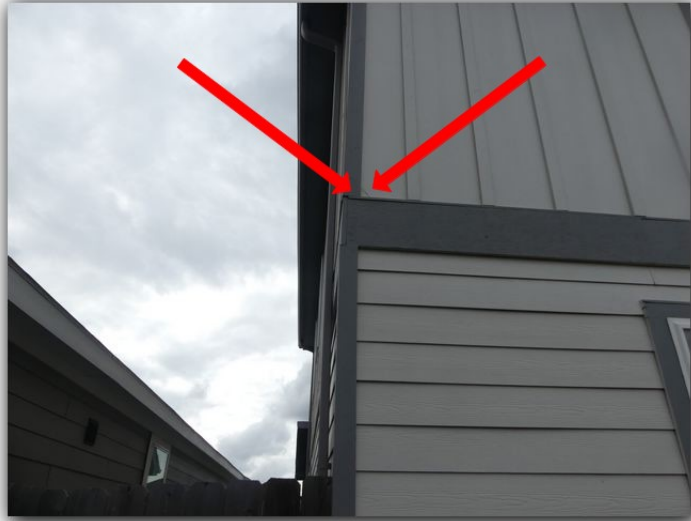
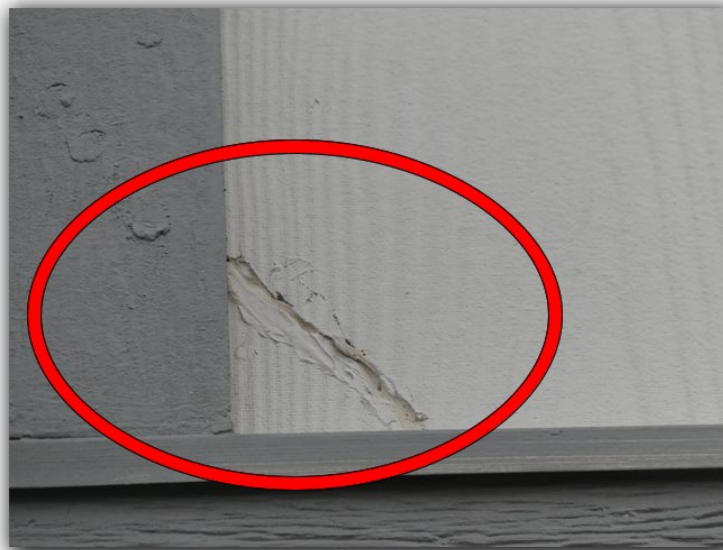
Siding is cracked; back wall at the upper back right corner that needs repairs. ** (Deficiency) **

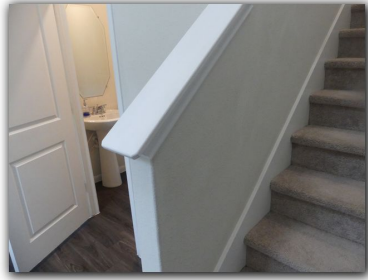
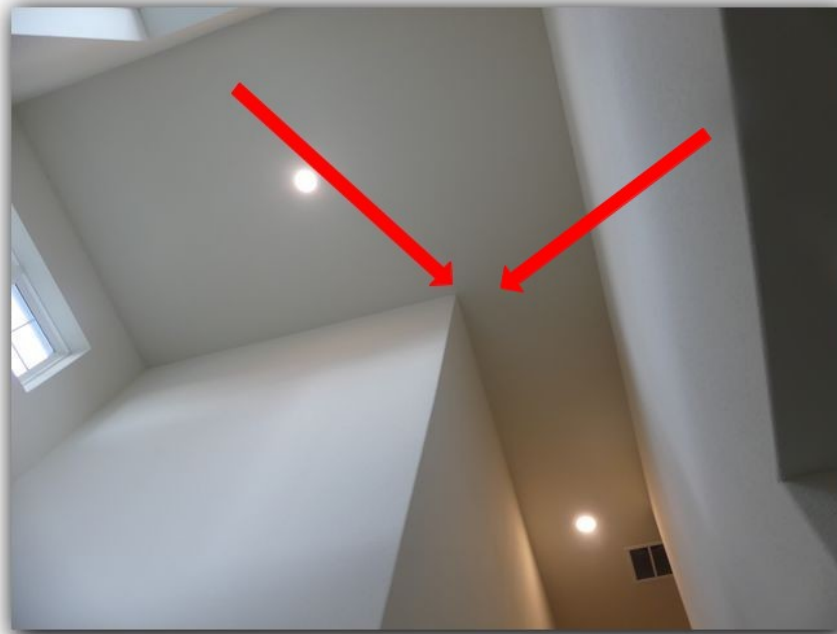
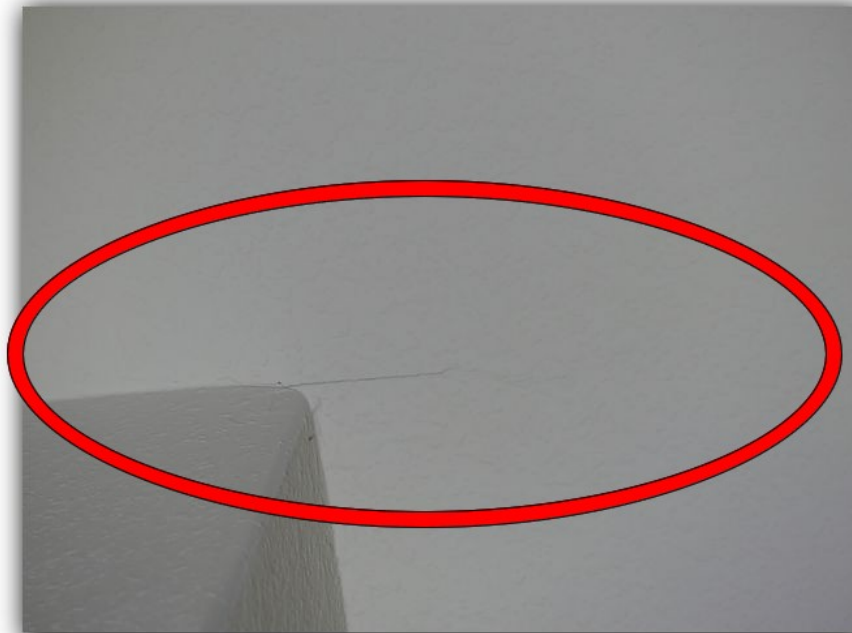
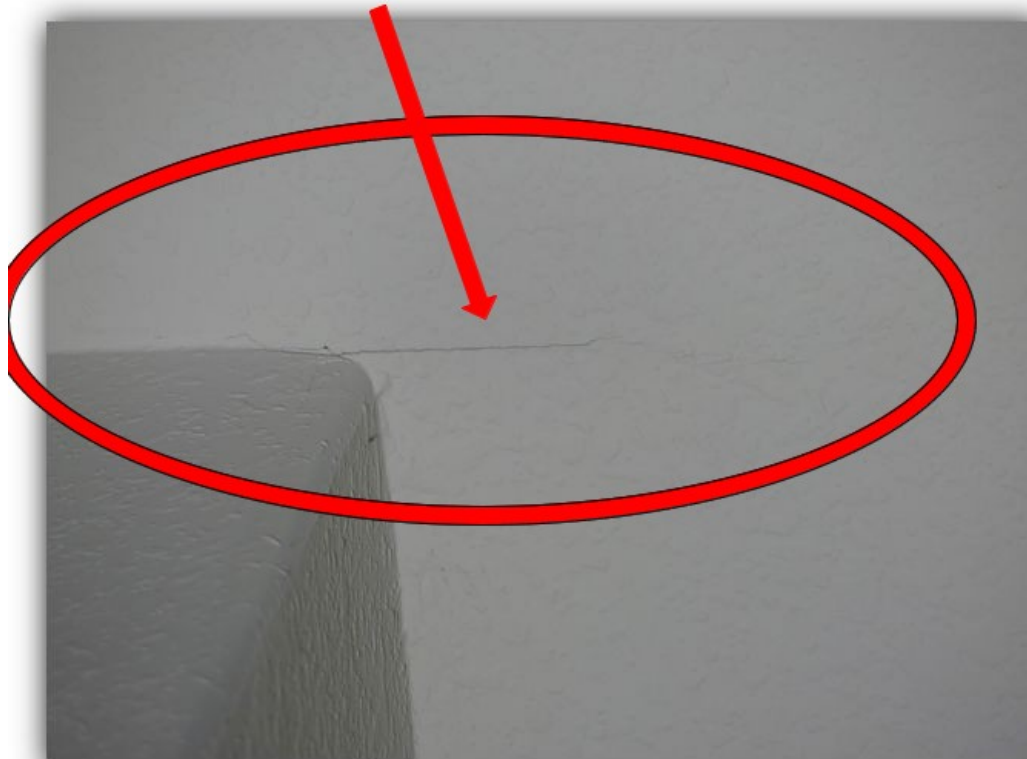
Ceiling cracks in some areas (Deficiency)****

Signs of structural settling

- **INDICATING STRUCTURAL SETTLEMENT THAT NEEDS TO BE PATCHED/FINISHED/TEXTURED AND MONITORED FOR ANY FURTHER CRACKING**

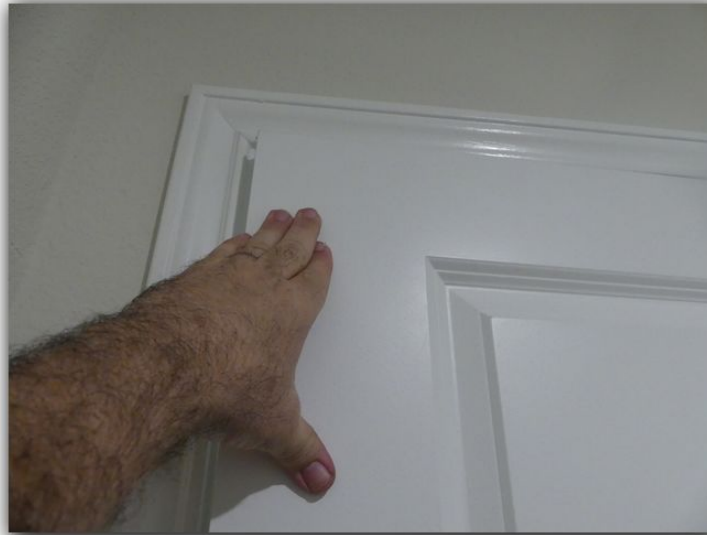
Doors rub, stick or hit frames: Laundry room door is rubbing on the frame and not latching, hard to close. In need of repair by a door repair expert and can be a sign of structural settlement and/or improper installation. ** (Deficiency) **

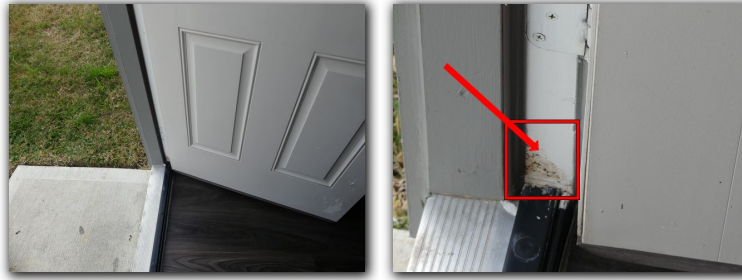
- **THE BOTTOM OF THE EXTERIOR DOOR FRAMES AT THE LOWER JAMBS NEEDS TO HAVE SMALL SQUARE FOAM RUBBER WEATHER STRIPS THAT DO PREVENT THE INSIDE JAMB FROM BECOMING ROTTED FROM WATER PENETRATIONS (DEFICIENCY)**

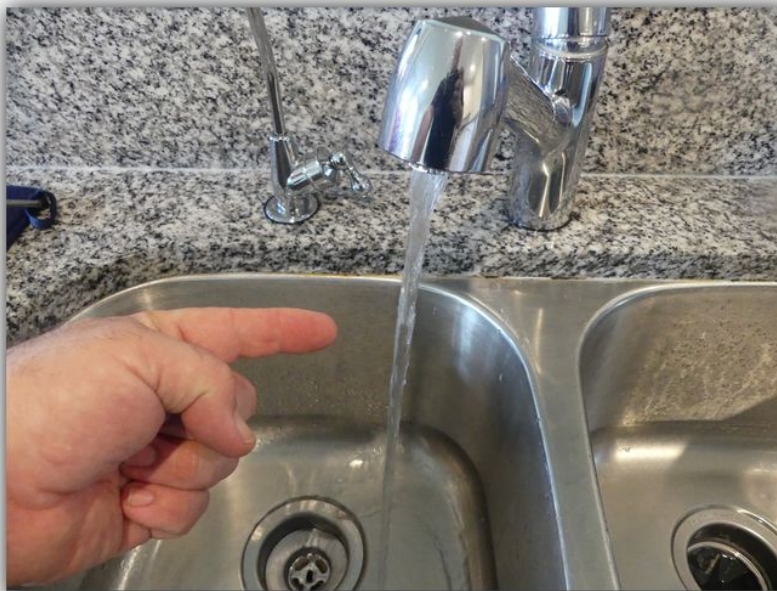
- **Low water pressure at the kitchen sink that needs repairs by a plumber **** (Deficiency) ******

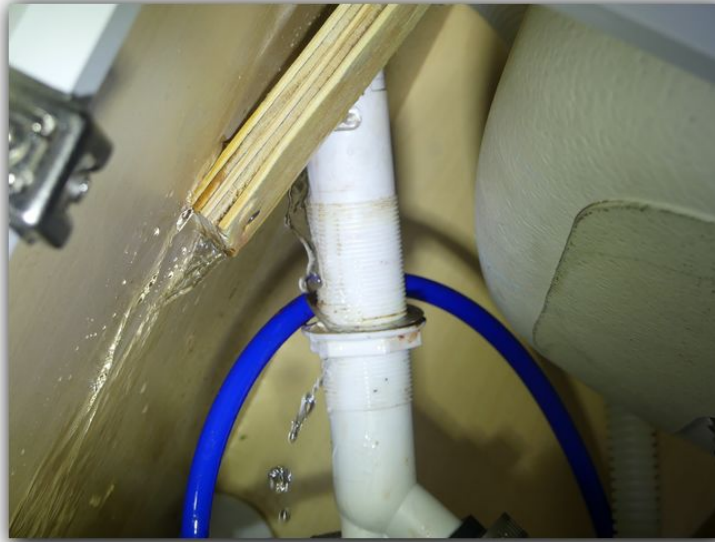
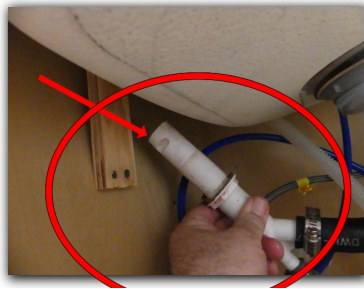
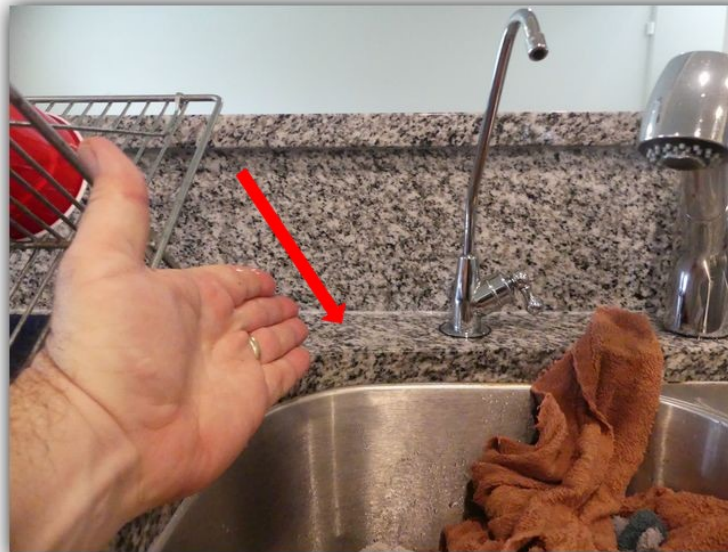
- **Drain leak under the kitchen sink that needs repairs by a plumber; dishwasher drain connection. **** (Deficiency) ******

Sink leaks into cabinet below (Deficiency)****

- **The drain line is disconnected from the original location at the sink counter top hanging loose under the sink and**

was replaced with a filtered water dispenser. When operating the dishwasher for a short period of time and/or the sink there was water draining out under the sink. In need of repair by a plumber/appliance repair expert. ** (Deficiency) **** (another hole needs to be cored through the counter top to provide for the dishwasher drain vent and the separate filtered water dispenser) **** (Deficiency) ******

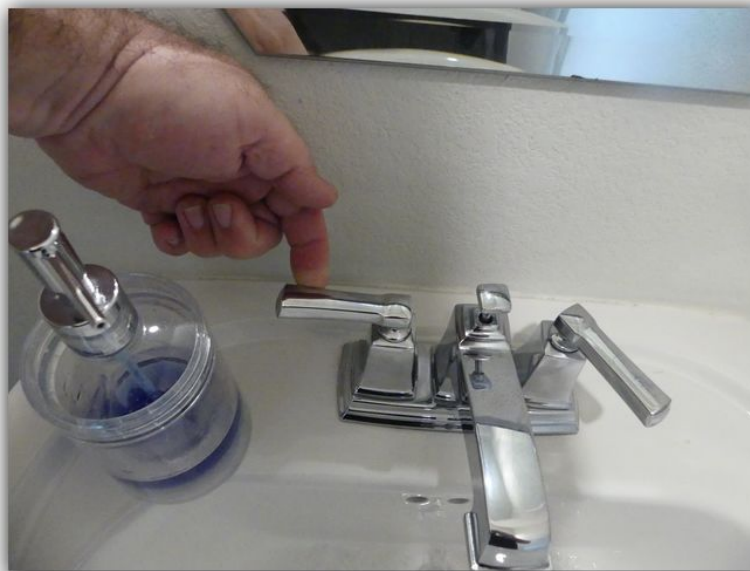
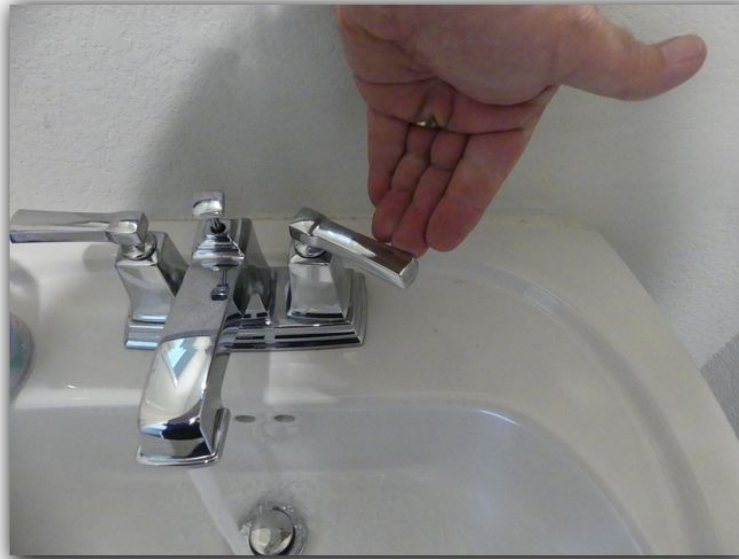
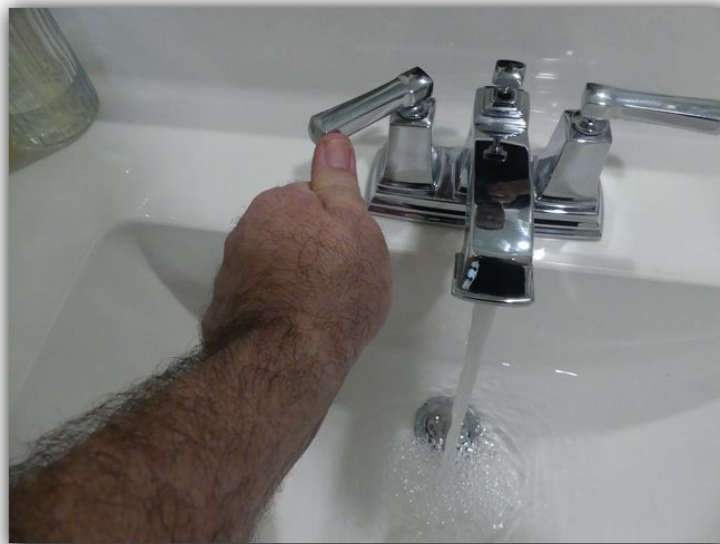
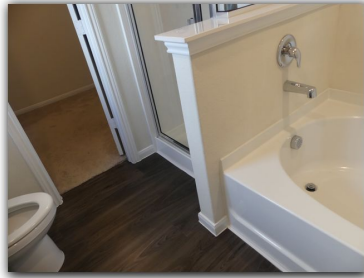
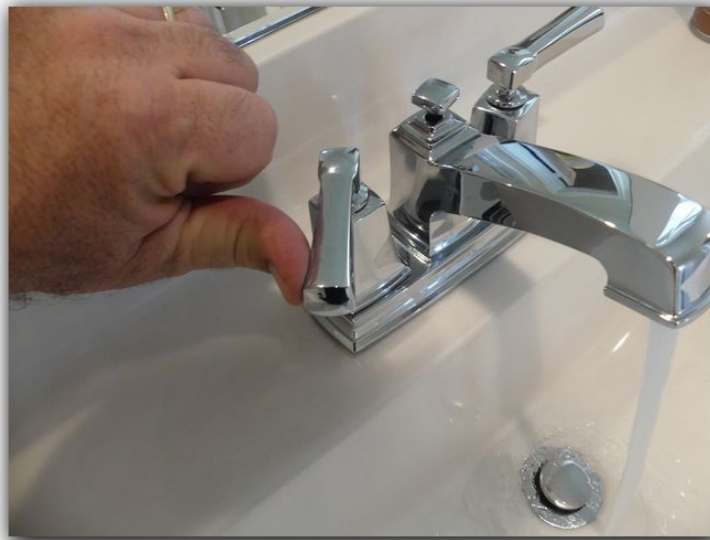
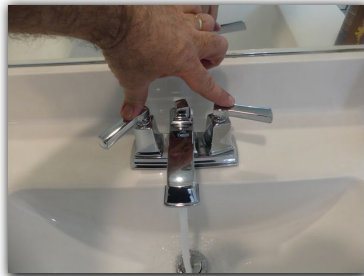
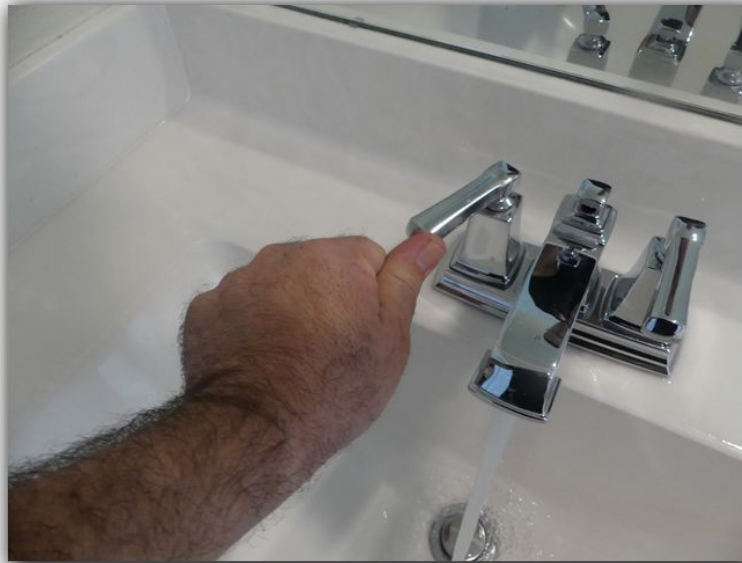
- **Sink handles are difficult to turn on and off at several sinks and the half bath hot water side was not able to turn at all. Recommend repairs or fixture replacement for the bath sinks by a plumber. **** (Deficiency) ******

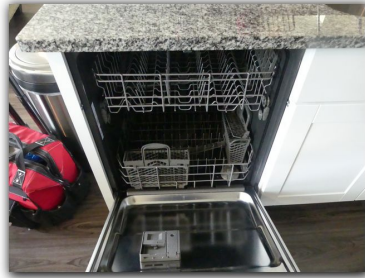
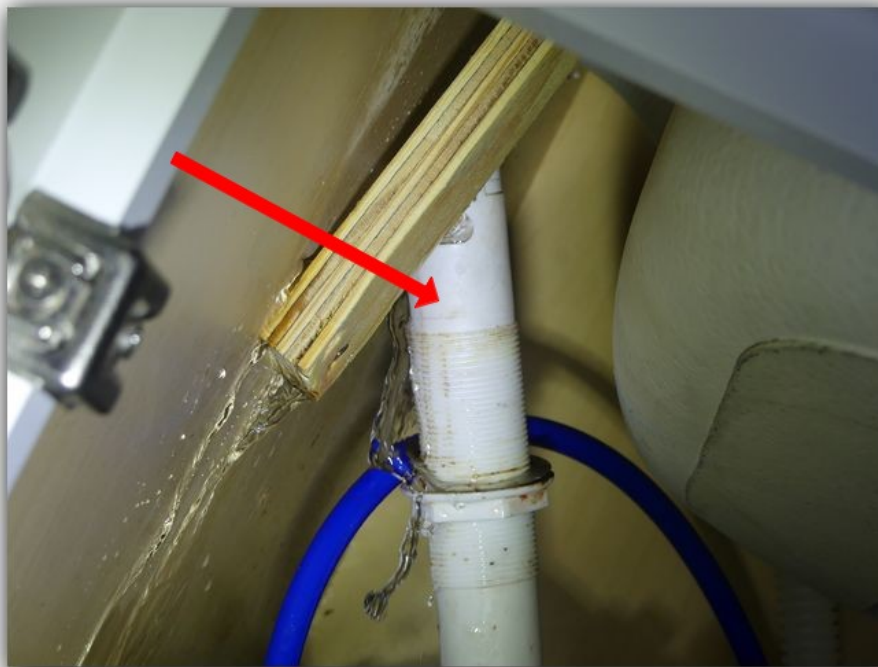
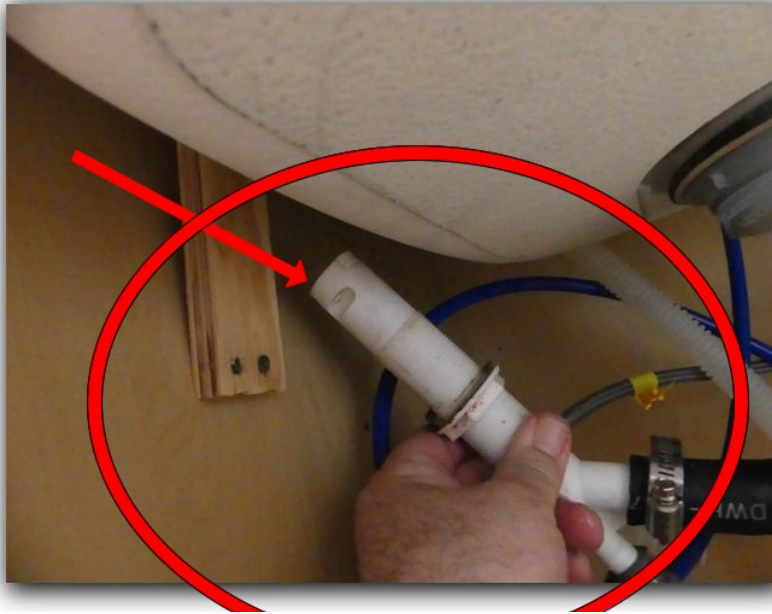
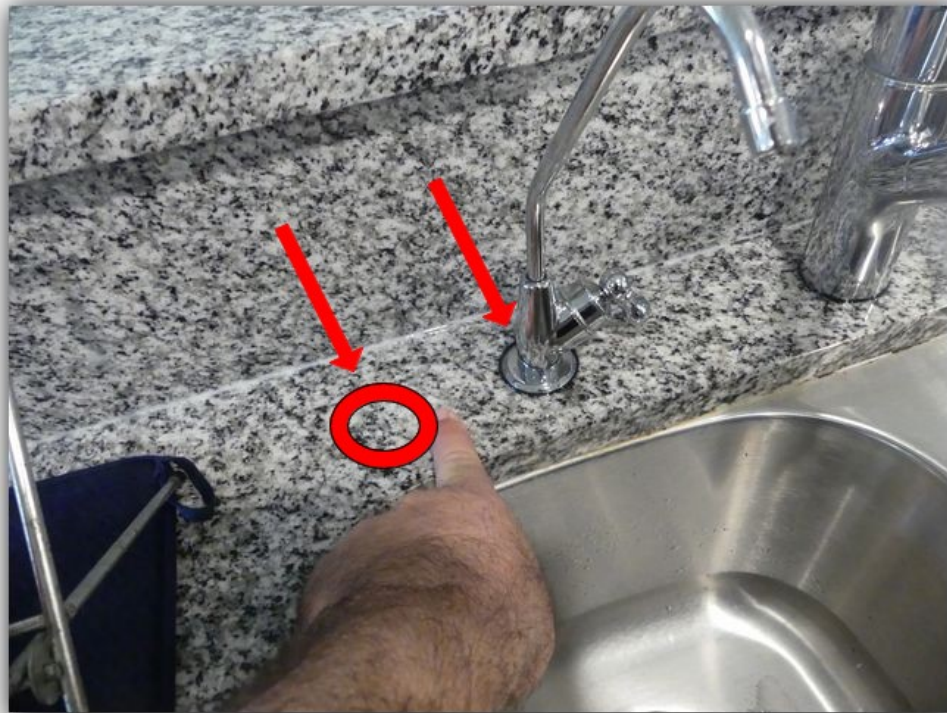
Unit leaking** (**Deficiency**)**

No anti-siphon loop at the drain line

- **The drain line is disconnected from the original**

location at the sink counter top hanging loose under the sink and was replaced with a filtered water dispenser. When operating the dishwasher for a short period of time and/or the sink there was water draining out under the sink. In need of repair by a plumber/appliance repair expert. ** (Deficiency) **** (another hole needs to be cored through the counter top to provide for the dishwasher drain vent and the separate filtered water dispenser)**

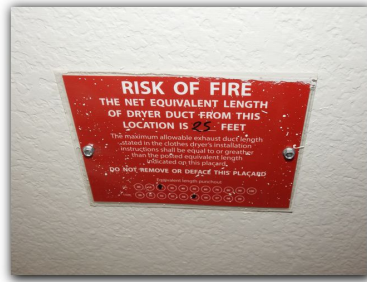
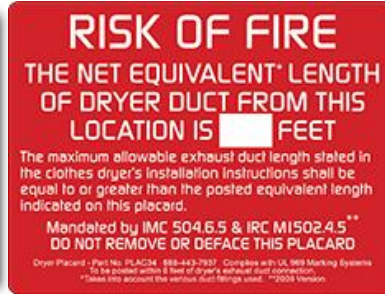
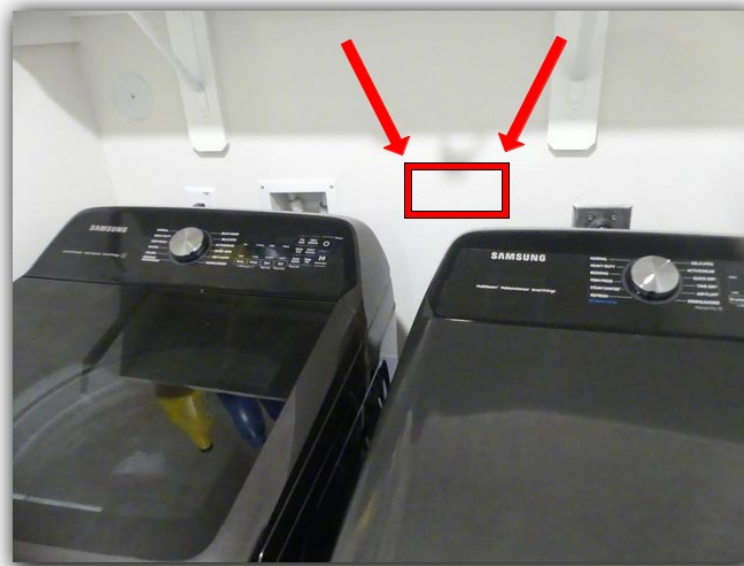
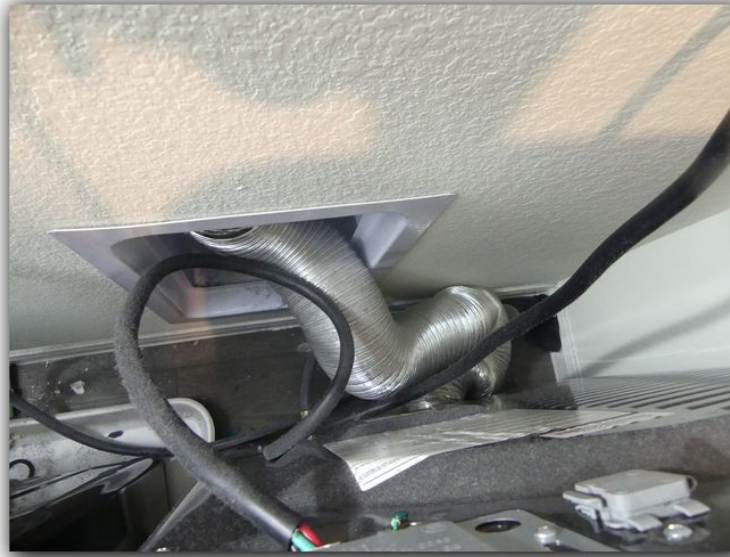
- The dryer duct is a long span that extends into the upper wall and attic and terminates to a roof vent. Long span dryer ducts are recommended to have a "booster assist fan" installed that helps prevent lint from being trapped inside the duct and provides improved clothes dryer performance as well.**
- IT IS RECOMMENDED TO HAVE THE CLOTHES DRYER DUCT PROFESSIONALLY CLEANED OUT ANNUALLY FOR IMPROVED CLOTHES DRYER PERFORMANCE AND FIRE SAFETY PROTECTION.**

☑ DEFICIENCY-IT IS NOW REQUIRED FOR NEW CONSTRUCTION TO HAVE A DISPLAYED SIGN IN THE LAUNDRY ROOM THAT SHOWS THE NET EQUIVALENT LENGTH OF DRYER DUCT DISTANCE FROM THE WALL TERMINATION IN THE LAUNDRY ROOM TO THE ROOF TERMINATION/EXTERIOR TERMINATION.
