RESIDENTIAL INSPECTION REPORT

3936 Galleon Galveston TX 77554

By: Keith Holderfield - TREC #24000 11/04/2021 9:00 am

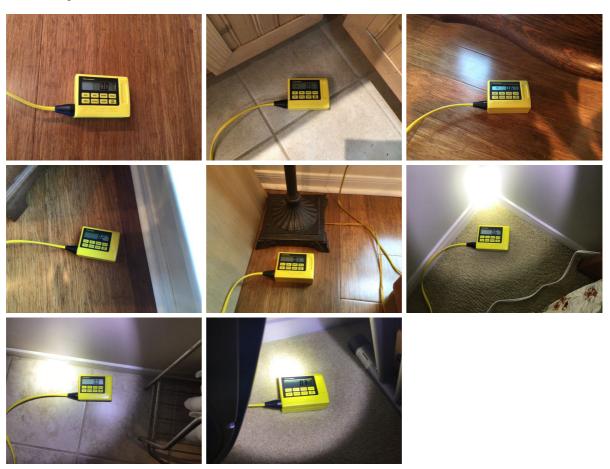
Foundation Inspected with Digital Level:

This foundation was measured with the use of an electronic digital measurement tool. Multiple elevation points were registered on the foundation throughout the property to determine if there were elevation variations that indicated excessive movement of the foundation. At the time of this inspection the

measured areas did not indicate any variations that, in this inspector's OPINION, indicated any need for invasive repairs to the foundation.

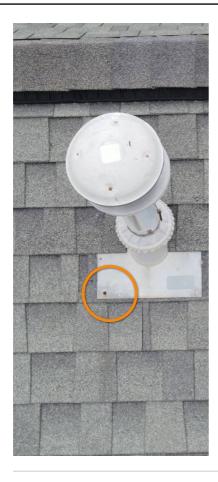
1: Exposed fasteners

Exposed fasteners were observed. Seal as needed to prevent moisture intrusion.

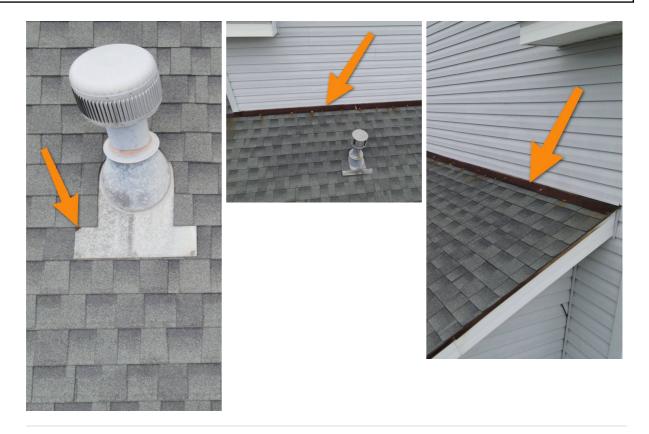
2: Flashing: Rusted flashings ©Recommendation

Multiple Locations

Rusted flashings were present. Remedy as needed.

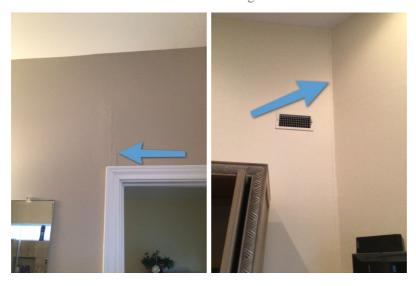
3: Interior: Hairline Cracks on Drywall

Hairline cracks were observed on the interior drywall. Hairline cracks may be related to the following:

- normal structural movement
- thermal expansion

Monitor and/or remedy as needed.

Recommendation: Recommend monitoring.

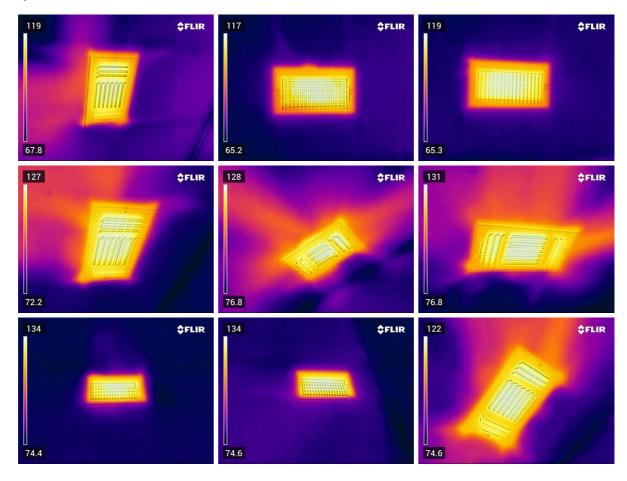
Older Equipment: Heating:

Note: Operation of the unit shows the unit was heating at the time of the inspection. Due to the age of the system, routine maintenance is recommended.

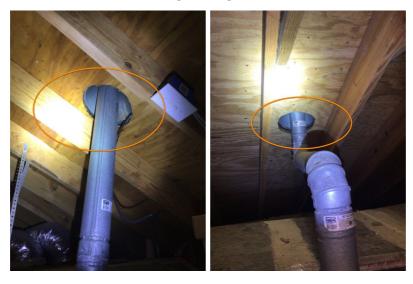
3: Venting: Missing strap

Support strapping was not installed at the furnace vent pipe. Remedy as needed.

Recommendation: Contact a qualified professional.

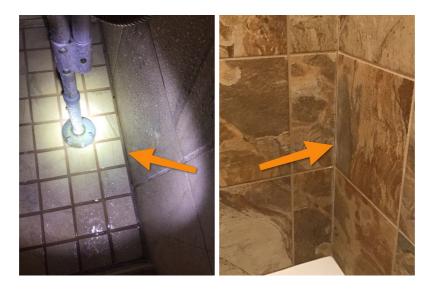
5: Shower: Missing/Deteriorated Caulking or Grout

Multiple Locations

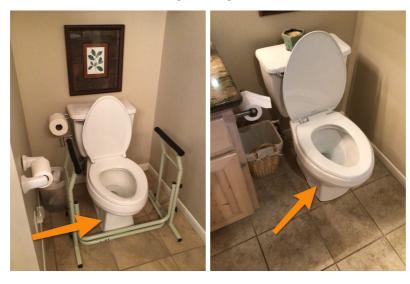
6: Toilet: Not securely Mounted to Floor Recommendation

Evaluate and remedy as needed.

Recommendation: Contact a qualified professional.
