Inspection Report

Property Address:
1200 LANGFORD DR
COLLEGE STATION TX 77840

Tucker Inspections LLC

PROPERTY INSPECTION REPORT FORM

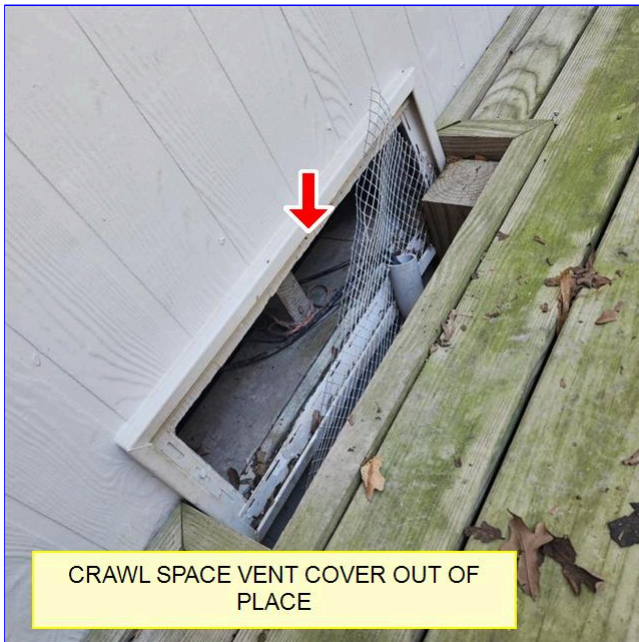
A. Item 1 (Picture)

This is an older pier and beam foundation that appears to be performing at the time of this inspection. There are some areas that are no longer level, however this is common for this type of foundation.

Note: There is what appears to be asbestos wrapped pipes in the crawlspace. When evidence of asbestos is present we are unable to enter the crawl space. The observation of components in this area was limited to the vents and the entrance. *For further evaluation of this material recommend consulting with a plumber that has experience with asbestos materials.*

Standing water was noted in areas along the right and left sides of the crawl space.

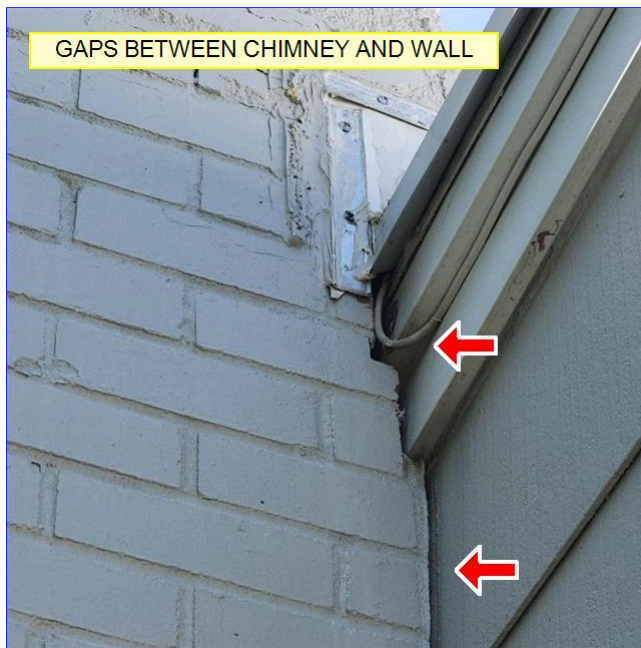
C. Item 1 (Picture)

The enclosed porch siding was decayed in areas.

Gaps were noted between the chimney and exterior wall. This is an area moisture could

penetrate. Will point out the wall covering near the interior side of the fireplace / chimney was bubbled in areas / appears to have moisture damage.

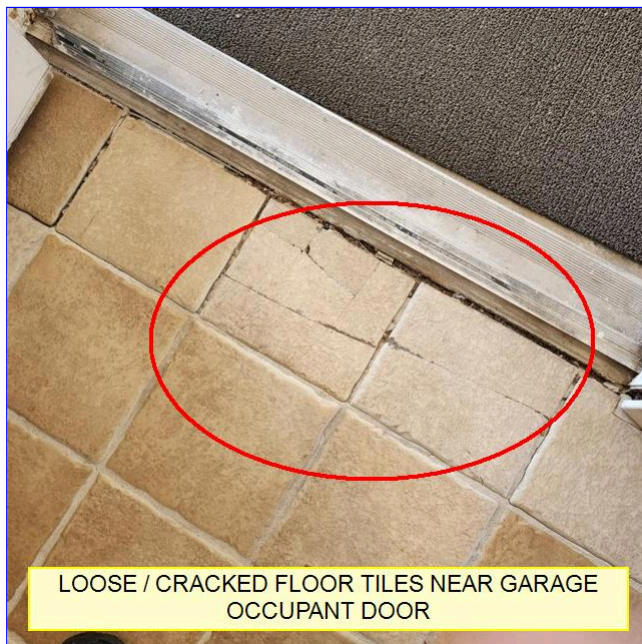
F. Item 1 (Picture)

There are loose / cracked floor tiles near the garage occupant door.

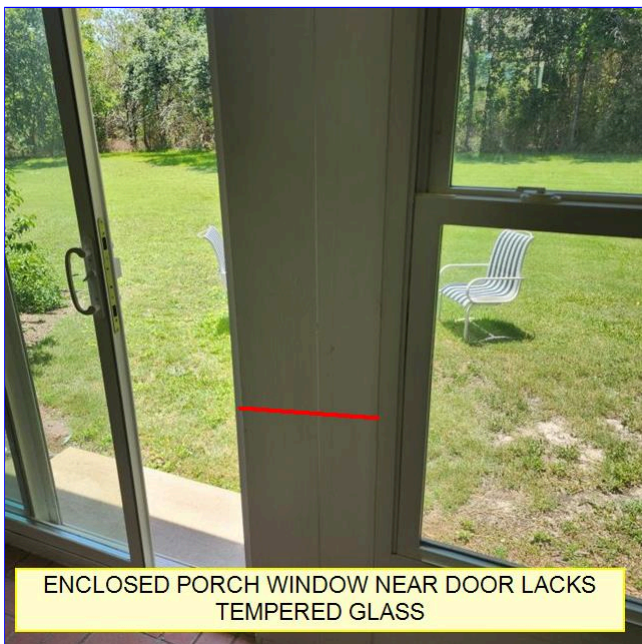
H. Item 2 (Picture)

ENCLOSED PORCH WINDOW NEAR DOOR LACKS
TEMPERED GLASS

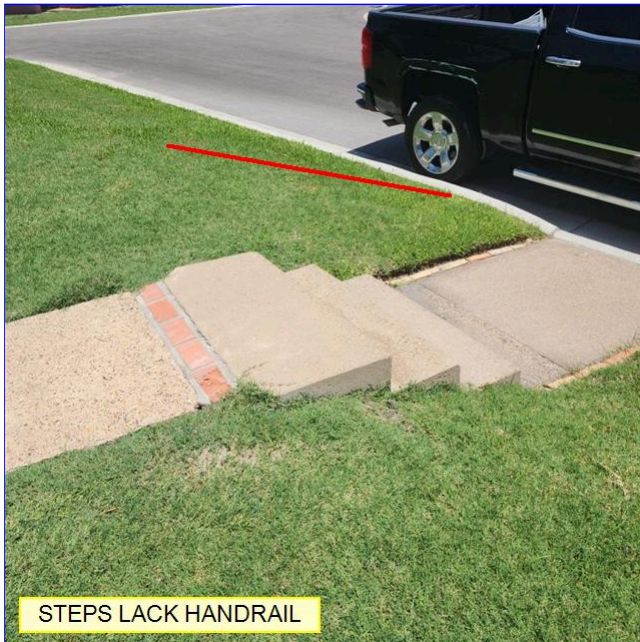
I. Item 1 (Picture)

There was no handrail present for the front and left porch steps. There was no handrail present for the front walkway steps. There was not a handrail present for the garage steps. *This would not meet current building standards.*

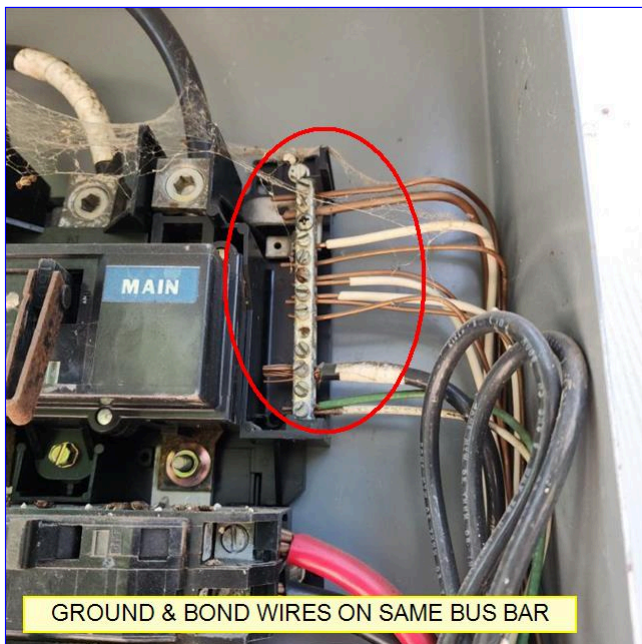
A. Item 3 (Picture)

GROUND & BOND WIRES ON SAME BUS BAR

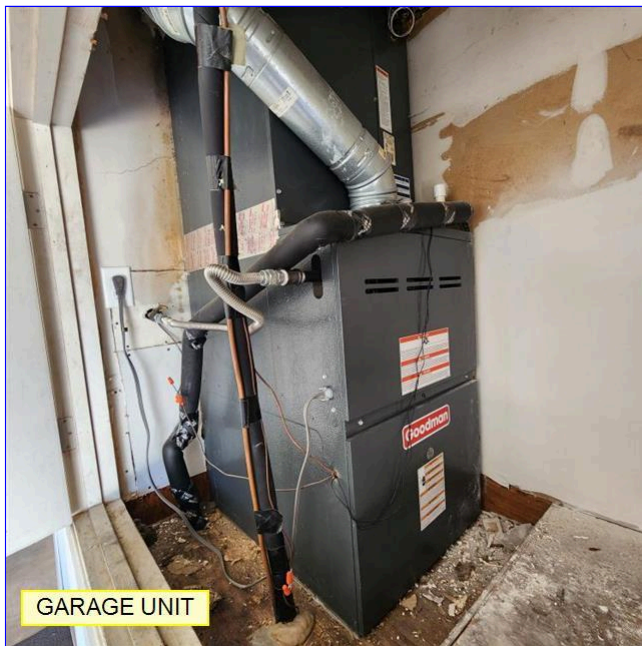
A. Item 1 (Picture)

Both units lack sediment traps on the gas supply lines. *This would not meet current building standards.*

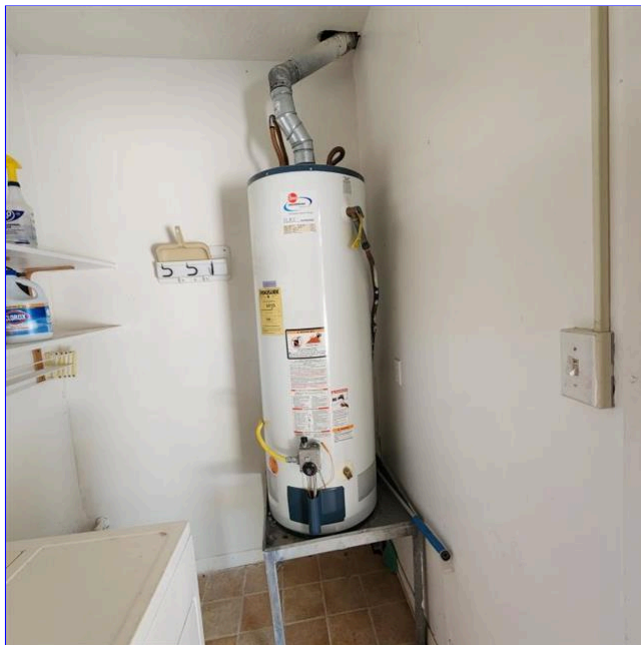
C. Item 1 (Picture)

The gas supply line lacks a sediment trap. *This would not meet current building standards.*

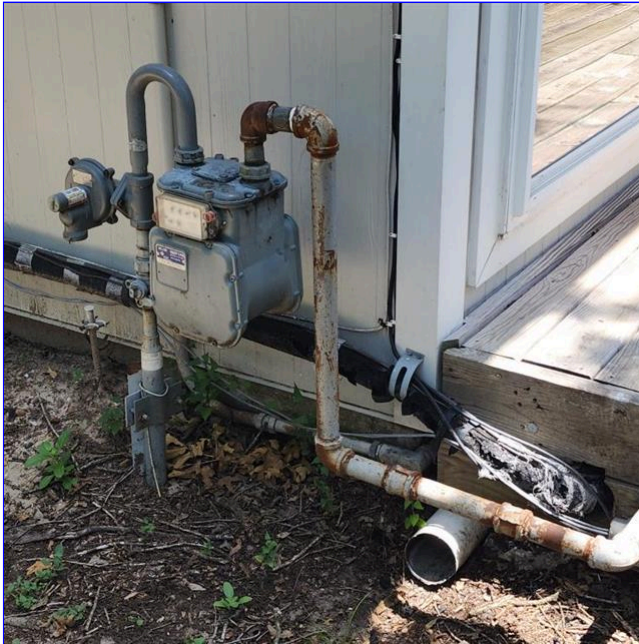
E. Item 1 (Picture)

There was older metal pipe present.

Note: Older gas pipes have been known to have leaks at the connections. Although the smell of gas was not present, with all older gas metal pipes we recommend further review by a professional plumber.

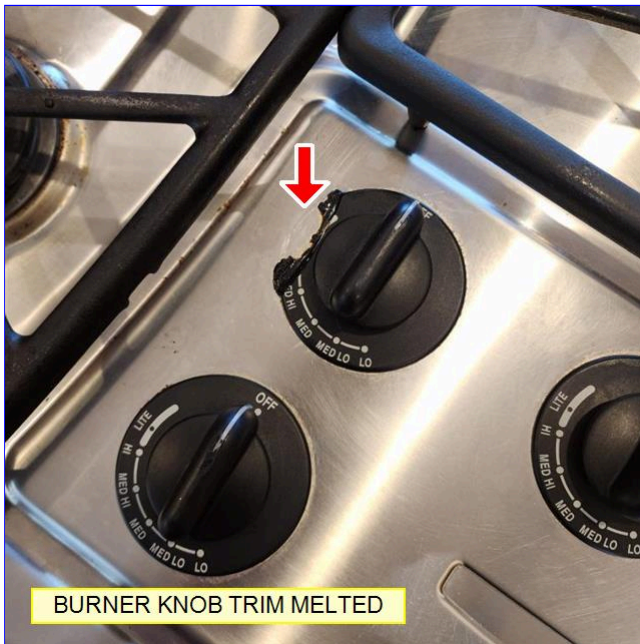
D. Item 1 (Picture)

Note: One of the burner knob trim pieces is melted.
