## PROPERTY INSPECTION REPORT

Report # 21268

Concerning: 104 Franklin St Clute, TX 77531  
(Address or Other Identification of Inspected Property)

By: Kenny Boulton November 4, 2021  
TREC Professional Inspector Lic.# 698 (Date)

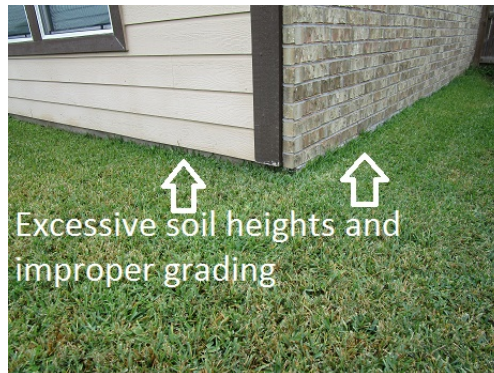
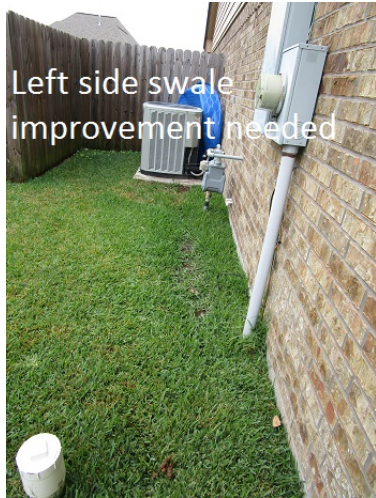
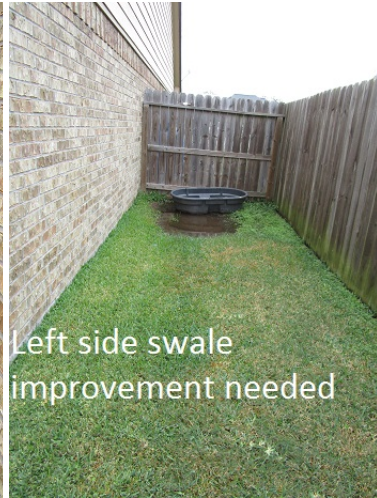
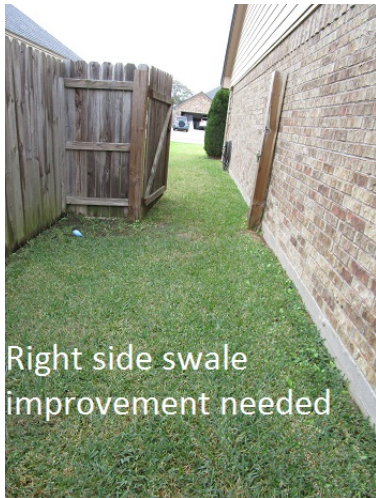
The right and left side drainage swale (in effect, wide and shallow ditches) should be improved. Drainage swales are intended to divert storm water away from the house and ultimately off the lot.

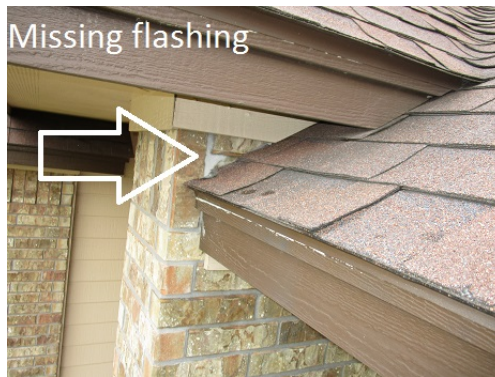
The missing flashing on the right side of the left front entry brick column to roofing connection should be installed. Roofing should not terminate at the brick without being flashed at the connections.

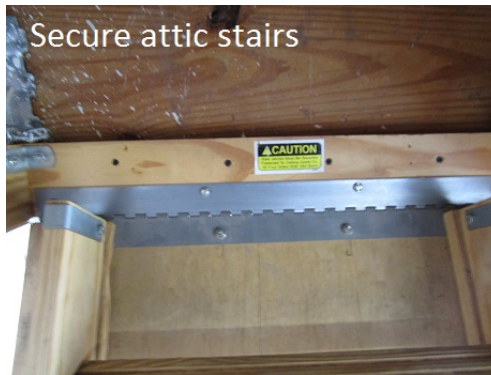
The attic stairs are marginally secured at the mount in the ceiling. The installation of 16p nails or 3" lag screws from the attic stairs into the rough-in opening is recommended instead of regular screws.

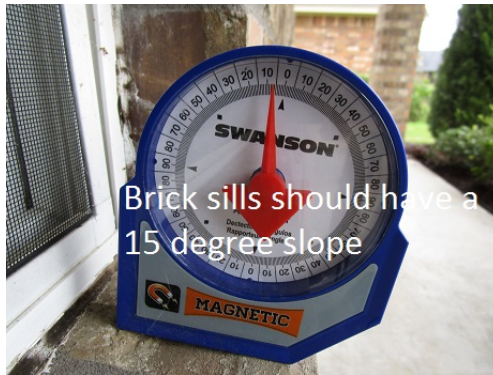
The brick window sills are now required to have a minimum slope of 15°.

Brick sills should have a 15 degree slope

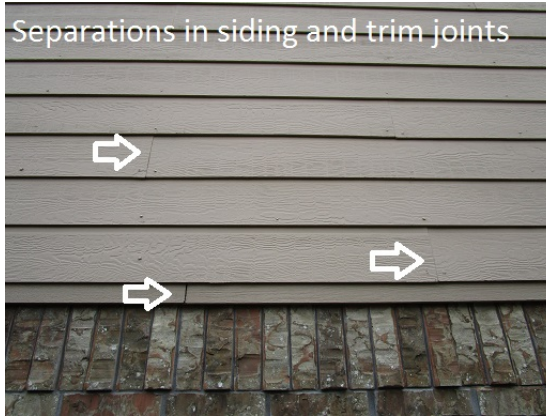
Separations in the joints in the siding and joints in the trims should be sealed.

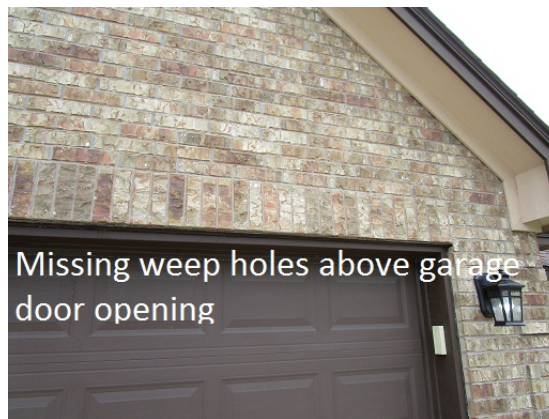
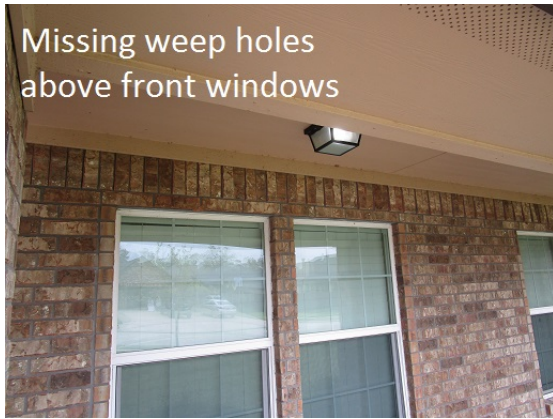
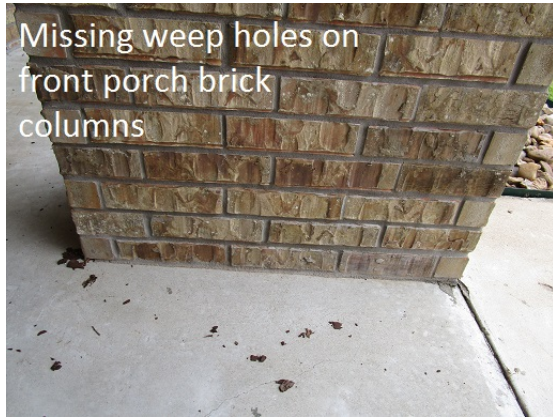
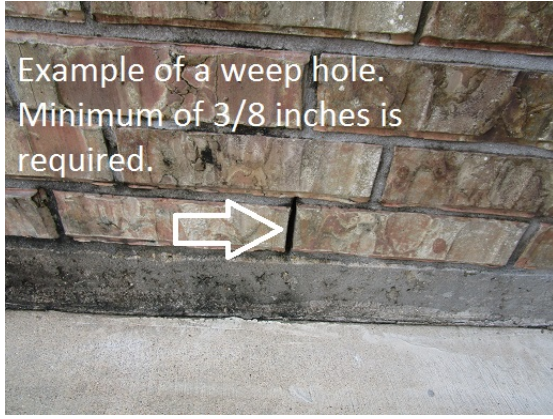
Weep holes in the brick veneer wall structure should be provided at a maximum of 33 inches of spacing on center and be a minimum of 3/8 inches in diameter. Weep holes should be located immediately above the flashing around the bottom perimeter and above windows and doors where flashings are used. The weep holes have been installed at the bottom perimeters but are missing above the garage door opening, above windows where masonry is installed and bottoms of the front brick columns.

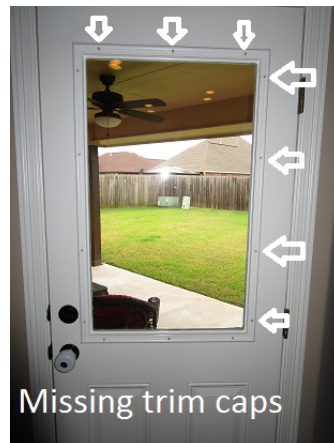
The missing window glass trim screw head trim caps on the rear exterior door should be installed.

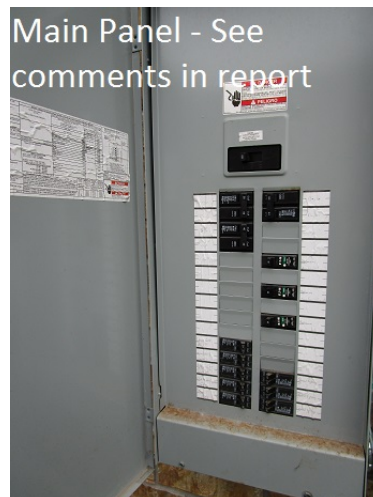
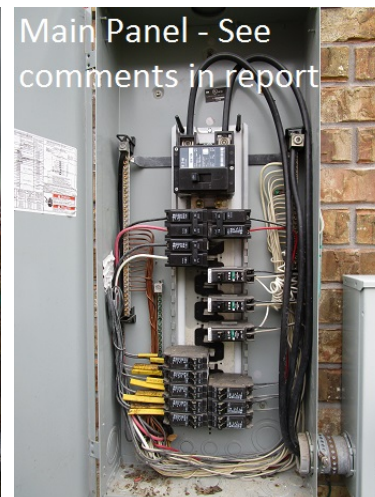
The white wire used as a line wire to the breaker marked AC should be wrapped with black or red electrical tape or marked with black or red marker at the breaker.

All circuits should be properly identified instead of the generic Lighting/Outlets. The Arc Fault Interrupter (AFI) breaker protection have been installed for the bedroom but are missing for the living areas. An arc-fault circuit interrupter is device intended to provide protection from the effects of arc faults by recognizing characteristics unique to arcing and by functioning to de-energize the circuit when an arc fault is detected.

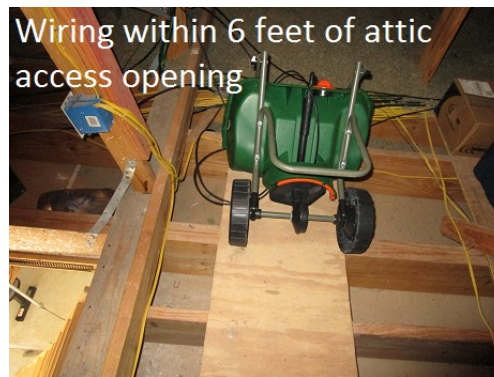
Wiring is no longer allowed to be installed on top of ceiling joists or attic flooring within six feet of the attic access opening.

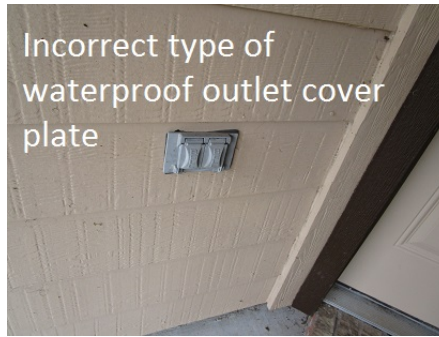
The older style exterior waterproof outlet cover plates should be replaced with in use type waterproof cover plates so the cover can be closed over the a plugged in cord.

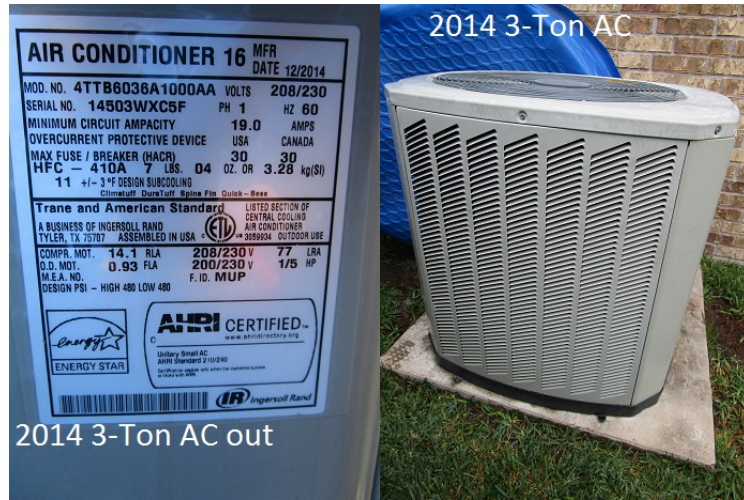
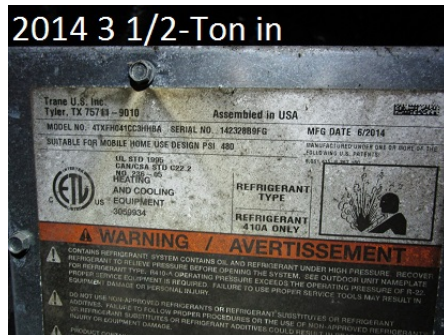
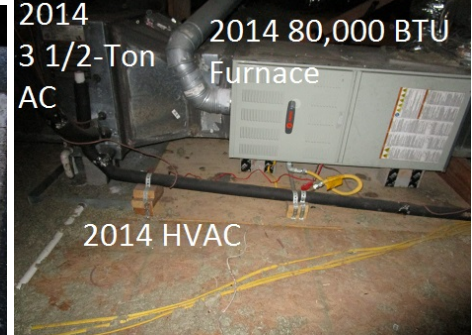
Oversized 40 amp breakers in the main panel to the outdoor unit of the central air conditioning system should be replaced with breakers sized no larger than 30 amps as per the unit data plate specifications.  
A minimum 24" walk to the central unit is required for servicing purposes.

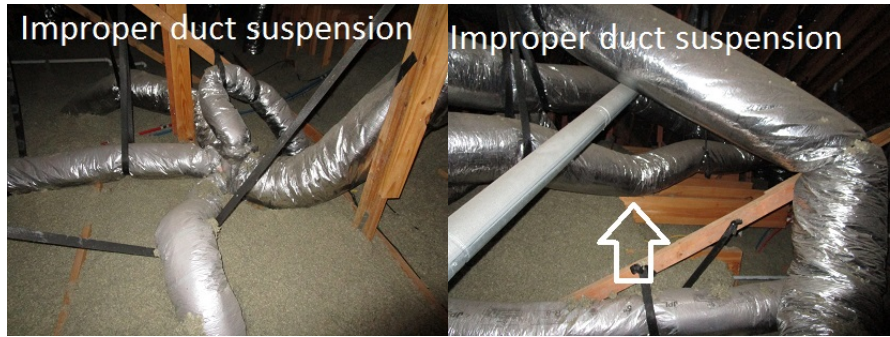
Parts of the ductwork above the master bedroom and one duct above the living room area should be properly suspended every four to five feet with no more than 1/2" of sag per foot.

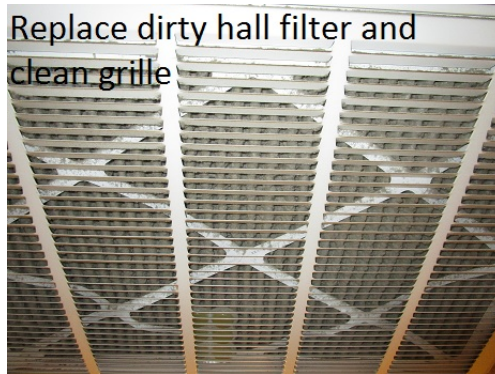
The dirty hall return filter should be replaced and the dirty grille cleaned.

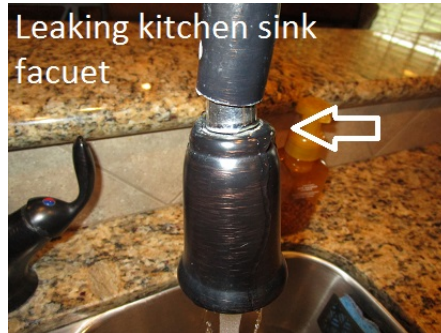
The kitchen sink faucet sprayer base leaks at the base of the sprayer and should be repaired.

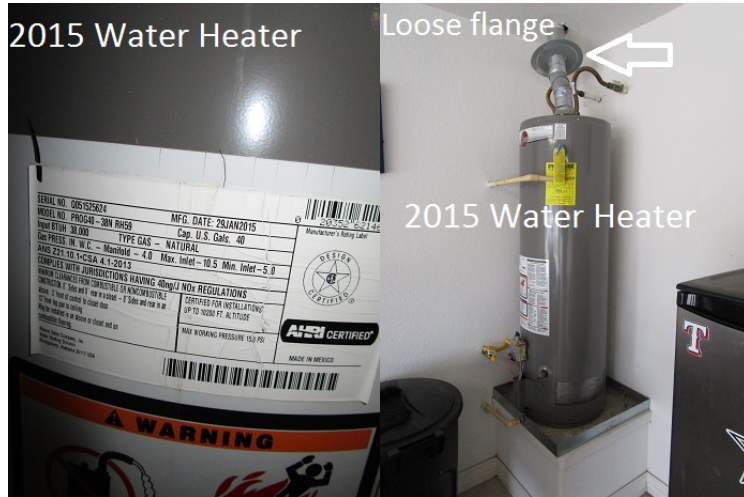
The loose metal trim for the water heater vent pipe in the garage should be secured at the ceiling.

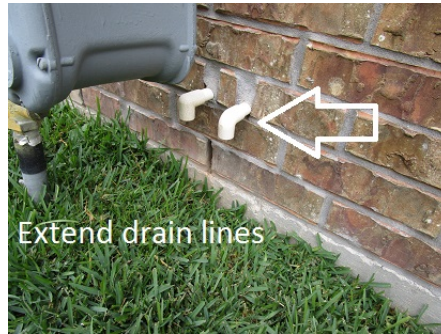
The exterior terminations for the Temperature and Pressure Relief Valve (TPR) and safety pan drain lines should be extended to terminate within 6 inches of the ground.

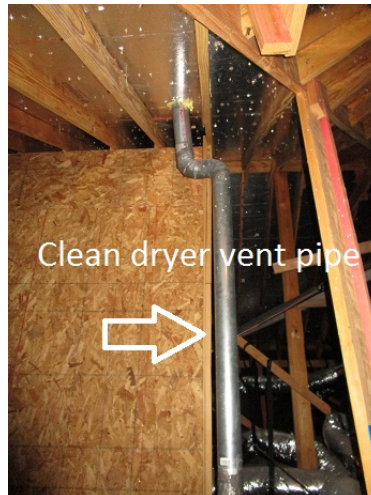
The clothes dryer vent pipe that terminates through the roof should be cleaned. Cleaning is recommended on at least a yearly basis.
