Inspection Report

**1114 W. 5th St.
Freeport, TX 775 41**

**Jeff M. Spencer, TREC #6365
6502 Spencer Drive
Freeport, TX 77541
979-482-3895
jmsinspections@att.net**

PROPERTY INSPECTION REPORT FORM

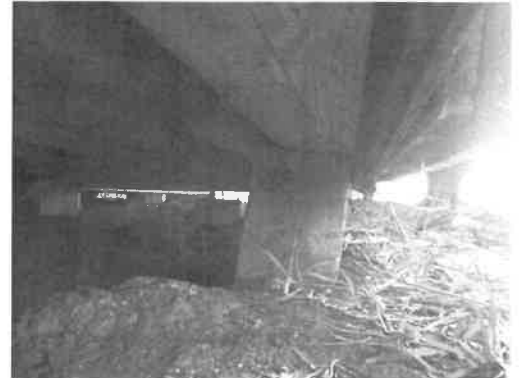
Insect shields on most visible foundation pilings are heavily corroded and are of minimal insect resistance value. Replacement is recommended.

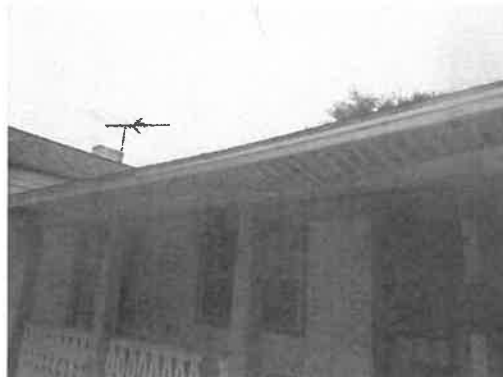
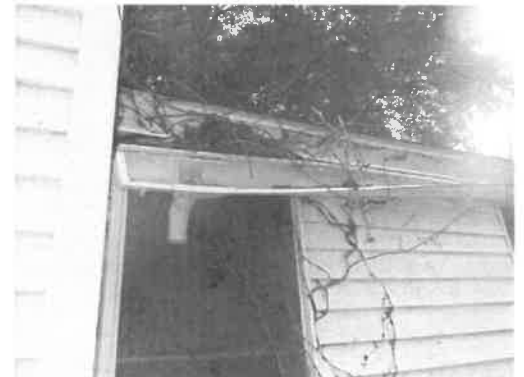
Gutters are incomplete and sagging at various points on all eaves. Incomplete downspouts are also present in multiple locations. Gutters on the west eave forward of the chimney chase and the rear eave are congested with leaf debris supporting plant growth.

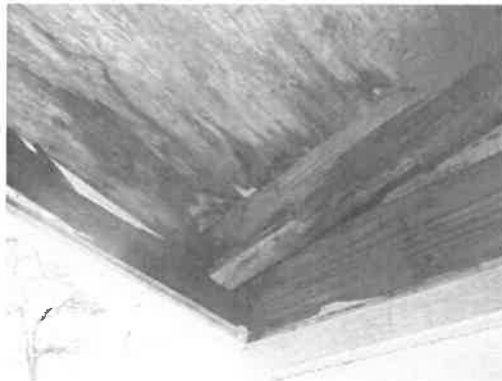
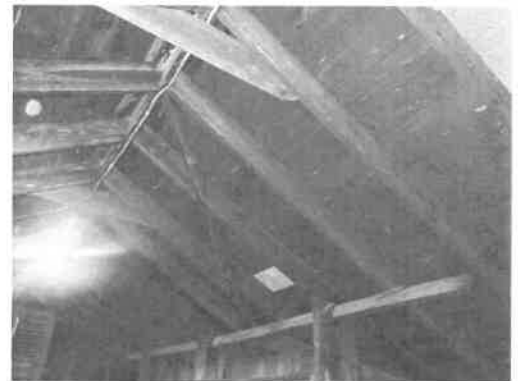
Rot is present on rafters exposed at the west end of the front porch, indicating previous water penetration of roof coverings.

NOTE: Charring is present on roof structure over the master suite/east third of the attic due to previous exposure to fire. Charring is less than 1/16 inch in depth with some areas of moderate sapping. Exposure to early stages of pyrolysis causes a minor increase in wood strength, hardness and stiffness accompanied by reduced toughness and increased brittleness. While no smoke odors were present, a fire recovery specialist should be contacted to determine if encapsulation is recommended if record of previous evaluation cannot be verified.

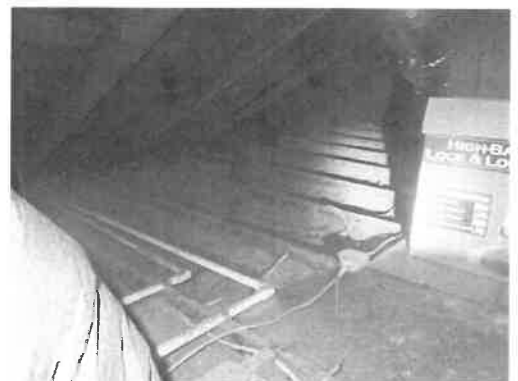
The attic is under-insulated relative to current standards, allowing increased thermal transfer between the attic and living area. Improvement to a depth of 10 inches (approximately R-30) could provide significant heating/cooling cost savings.

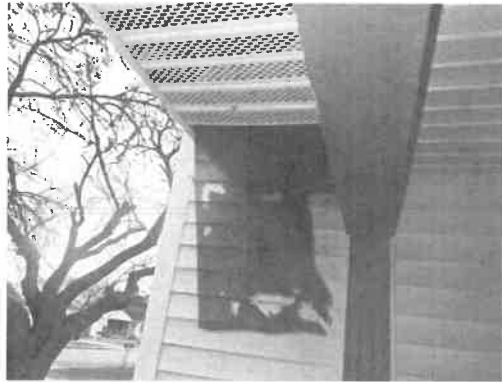
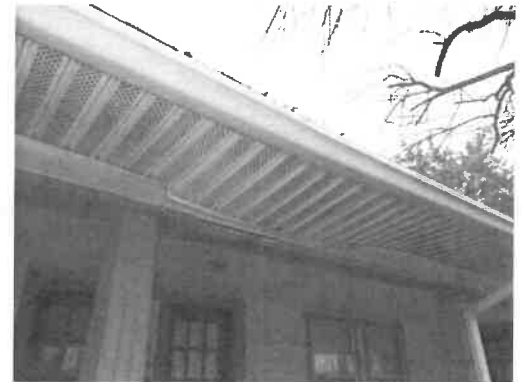
Soffit panels are sagging at the center of the front porch.

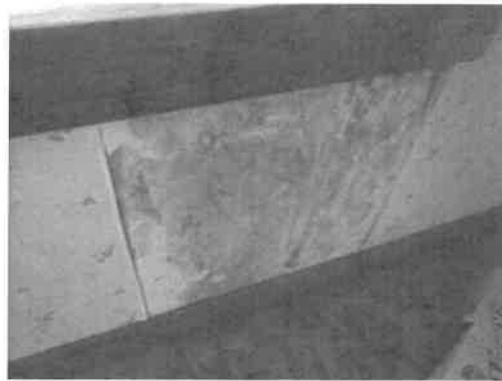
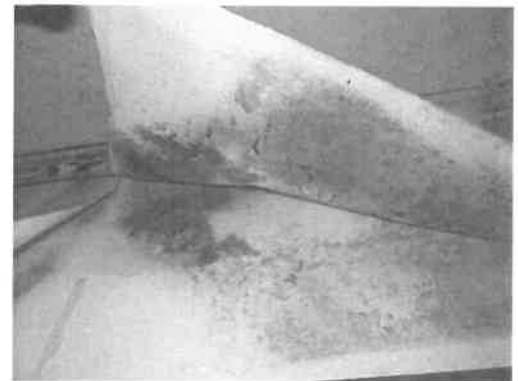
Mold growth is present behind vinyl wallpaper and multiple wall surfaces throughout the house. Presence of additional mold is probable behind wallpaper that is still adhered to wall surfaces. Removal of wallpaper and cleaning of mold is recommended.

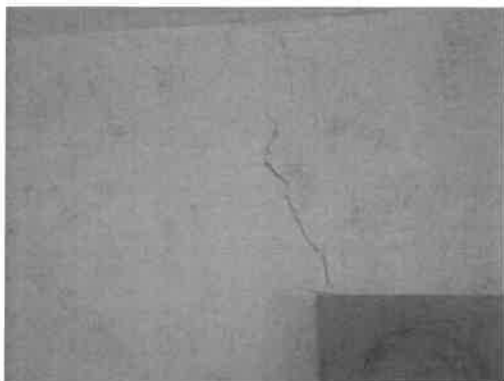
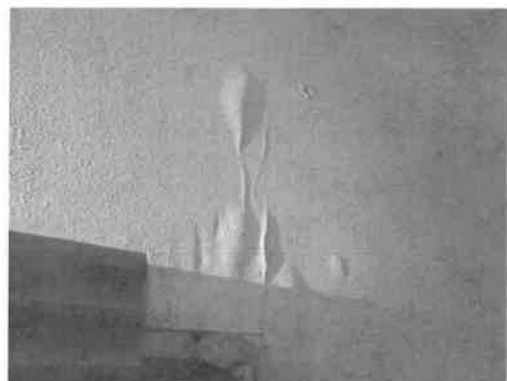
A gypsum board crack is present on the upper left corner of the door opening on the east wall of the den. A compression ridge is present at the upper right corner of the window opening on the front wall of the formal area. The conditions are types normally associated with foundation settling. Further evaluation by a foundation repair contractor or structural engineer is recommended.

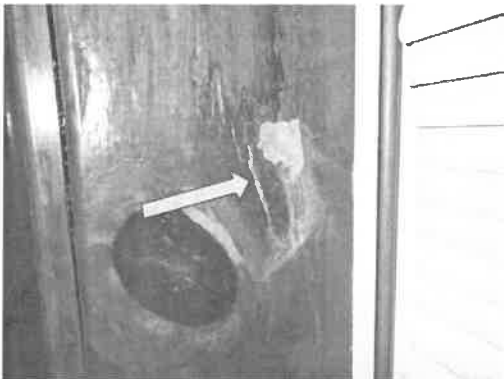
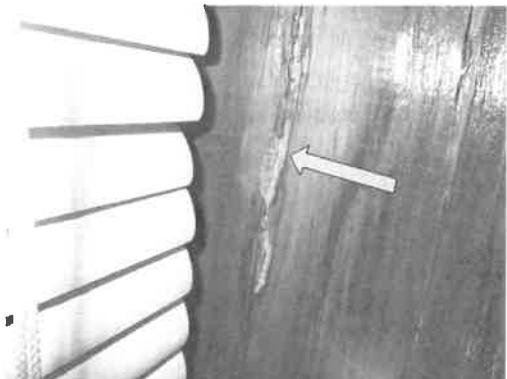
Wood-destroying insect damage is present on vertical return trim on bedroom 1 windows.

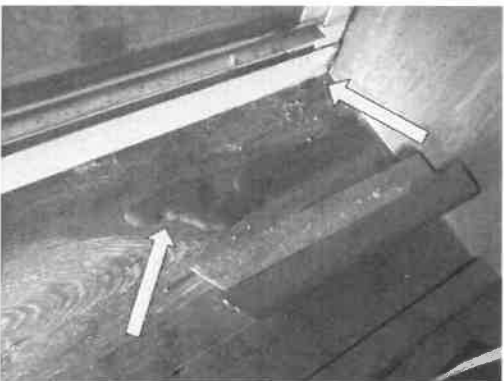
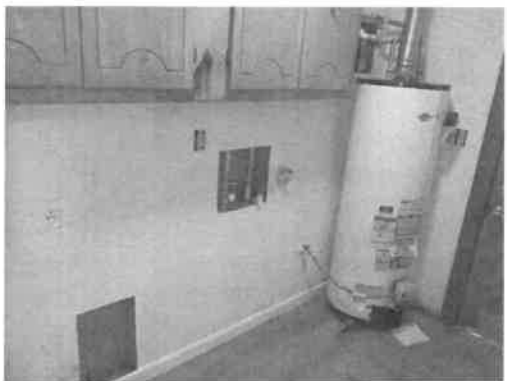
Water was standing on the sill of the left window on the front wall of bedroom 2, indicating water penetration between the window frame and the wall opening and/or dripping of excessive condensation.

Gypsum board has been removed from 4 locations on laundry room walls to facilitate plumbing repairs.

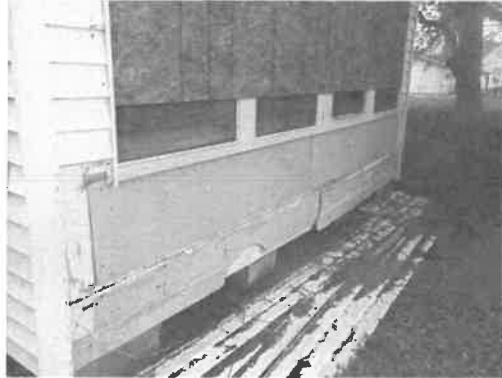
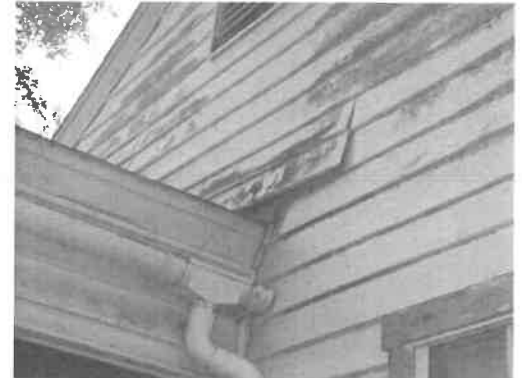
Vinyl siding panels are loose on the east gable immediately above the lower roof, creating elevated risk of displacement during windy conditions.

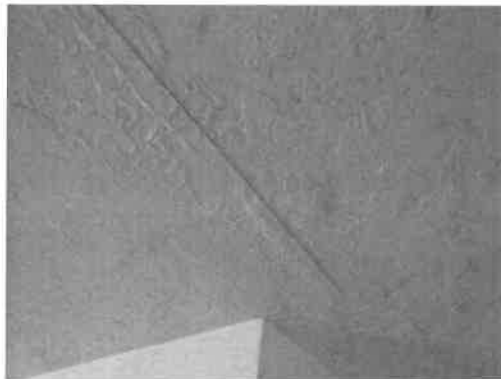
Multiple gypsum board cracks, compression ridges and panel joint cracks are present on ceilings throughout the house. The conditions are types normally associated with foundation movement. Further evaluation by a foundation repair contractor or structural engineer is recommended.

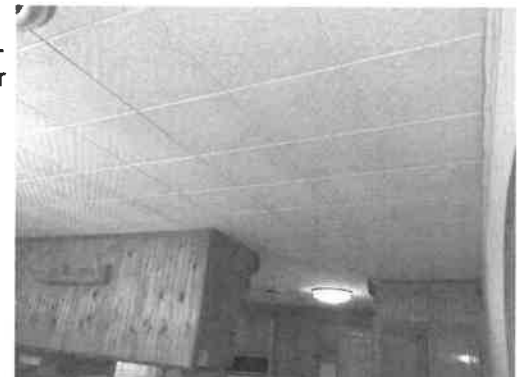
Foam/plastic tiles on dining area, kitchen and master bathroom ceilings are subject to toxic off-gassing when exposed to heat and are no longer rated for use in residential structures. Removal is recommended.

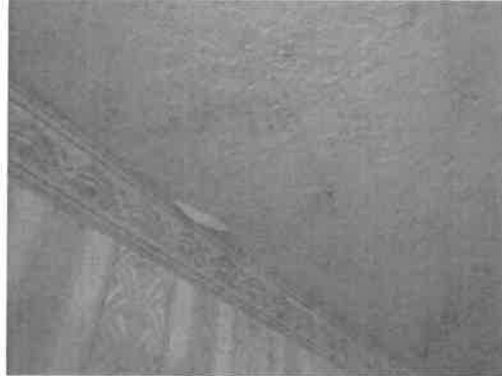
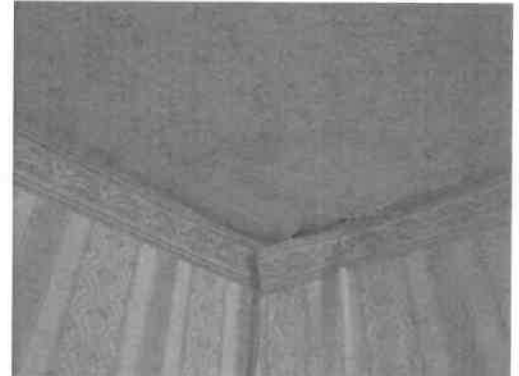
Water stains are present on ceiling surfaces near the center of the den's west wall and in the den's northwest corner.

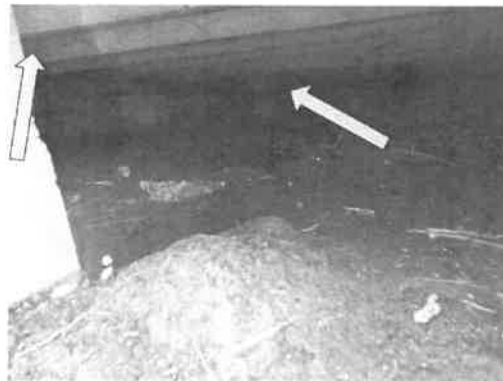
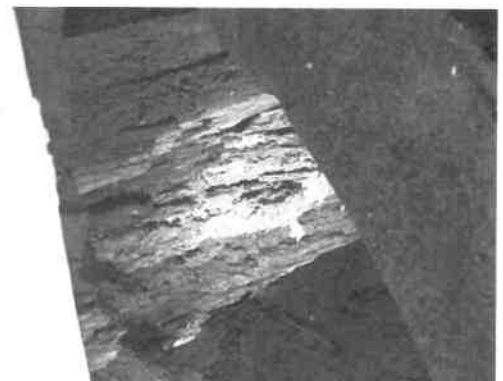
Rot is present on the north perimeter beam beneath the hall bathroom. Replacement estimates should be obtained from a foundation repair contractor.

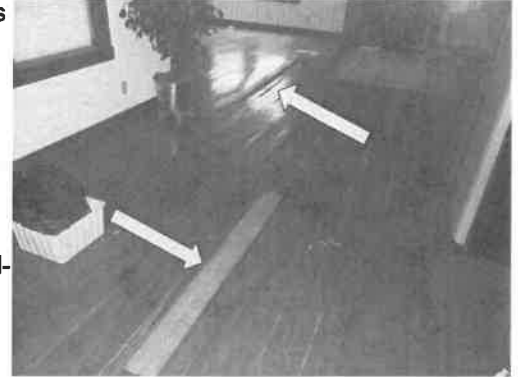
Wood plank flooring in the den and formal area is buckled in multiple locations secondary to long-term exposure to moisture/high humidity. Repair/replacement estimates should be obtained from a flooring contractor.

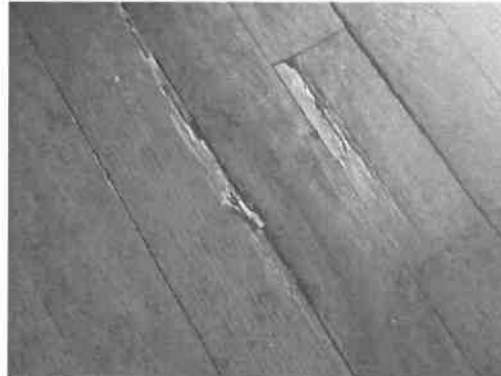
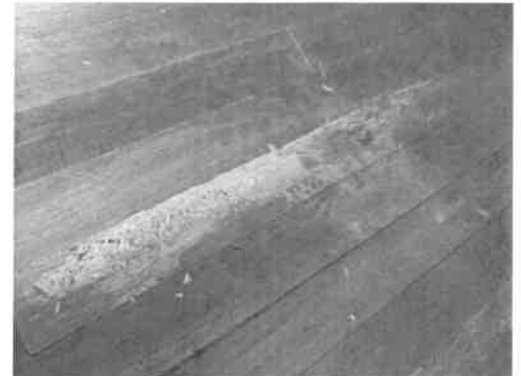
Multiple instances of deteriorated planks are present on den and formal area floor coverings. Some of the damage has characteristics of wood-destroying insect activity. Further evaluation by a licensed pest control inspector is recommended. Estimates for replacement of affected planks should be obtained from a flooring contractor.

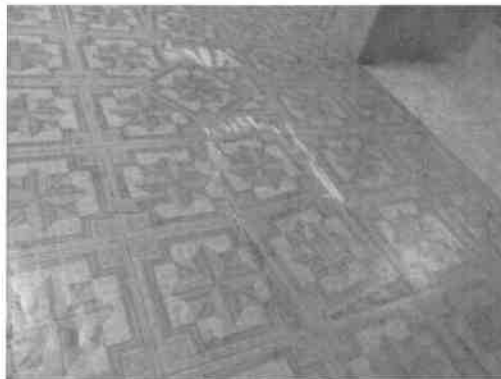
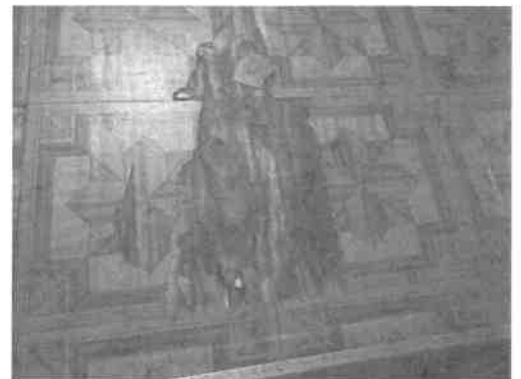
Multiple self-stick tiles in the kitchen and dining area are damaged or their adhesive has failed. Replacement estimates should be obtained from a flooring contractor.

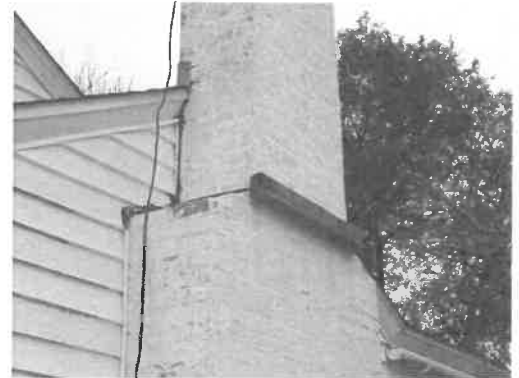
A horizontal mortar joint crack is present in the chimney chase approximately 6 feet above grade and mortar is missing from joints in 2 locations. The chase is being retained to the house by a site-built clamp installed on the gable. Further evaluation by a structural or chimney specialist is recommended to determine if the chimney is stable enough for continued use.

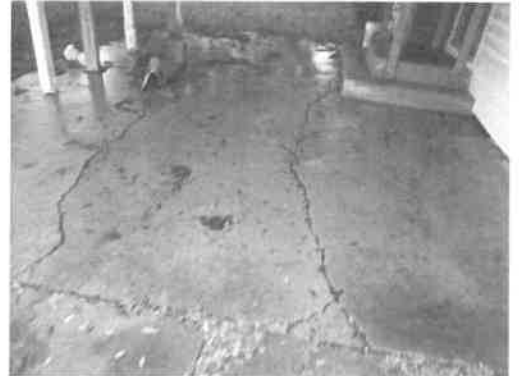
Back porch flatwork is cracked and differentially settled.

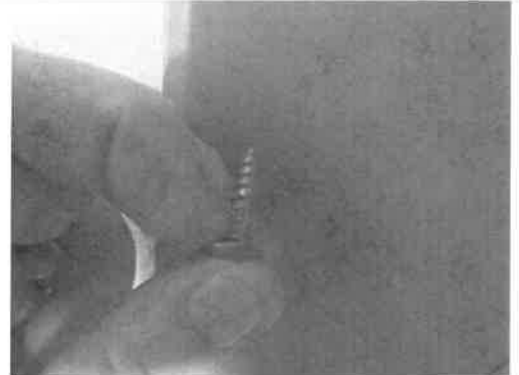
Pointed screws used to secure the dead front to the panel enclosure are not rated for use on service equipment; they are subject to penetrate wire insulation, creating risk of dead short. Replacement with blunt-tipped screws rated for use on service equipment is recommended.

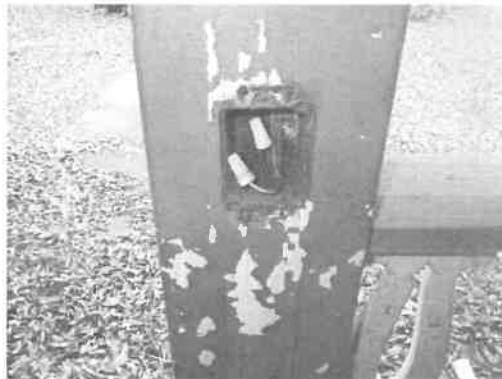
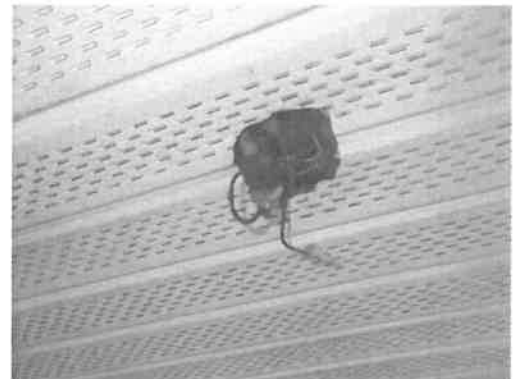
Uncovered junction boxes are present on the column immediately west of the front porch entry and on the soffit on the east side of the front porch. All wire connections should be contained in covered junction boxes that are secured to structure.

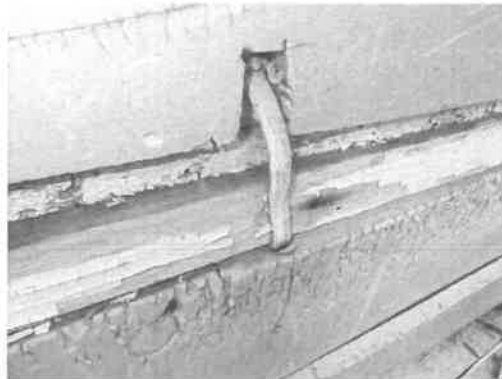
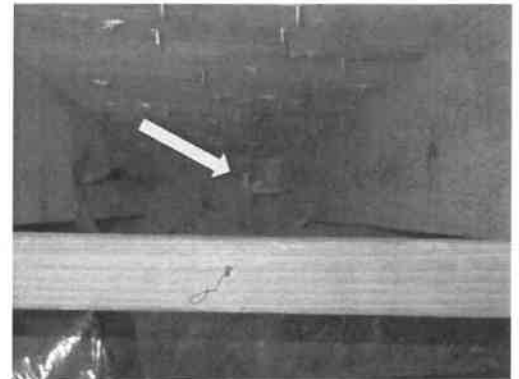
Unprotected non-metallic sheathed wire is present on the east exterior wall, located in an area where it is subject to penetration by wall covering fasteners. The wire should be contained in a conduit/conduit body or be routed within the wall cavity.

An unprotected wire connection is present in the attic over the laundry room.

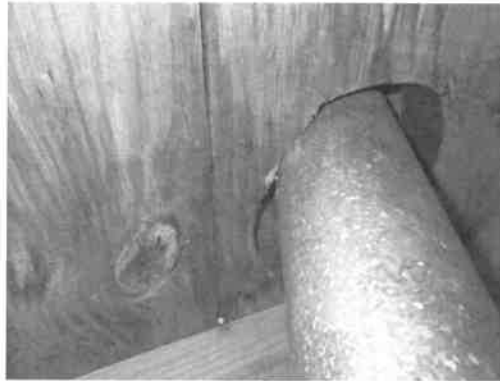
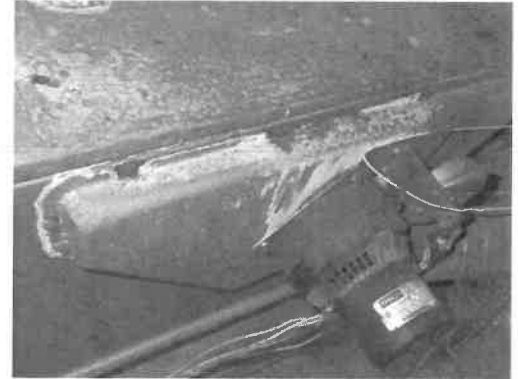
Corrosion and combustion deposits on the induction fan housing indicate failure of the heat-resistant gasket installed between the burner compartment and the housing. Escape of combustion gases creates a fire and carbon monoxide hazard.

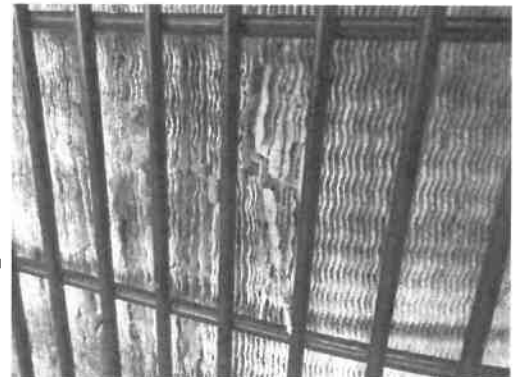
Areas of localized cooling fin corrosion are present on the condenser coil. Fins in affected areas detach in response to light touch. Corrosion buildup can impede air flow across the coils. Continued corrosion can breach coil tubing resulting in loss of refrigerant. Limited useful remaining service life can be anticipated.

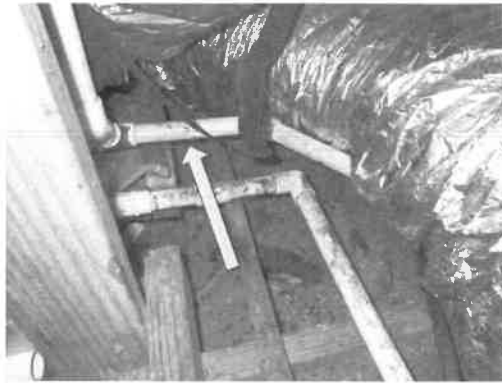
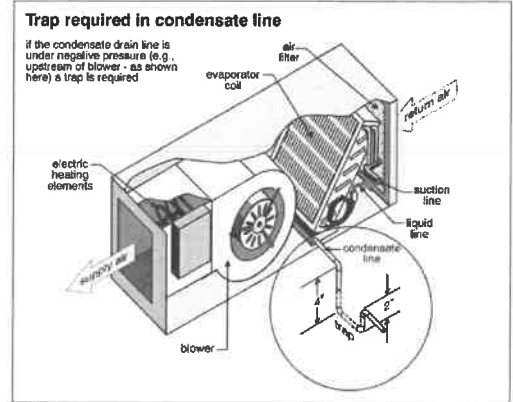
The primary condensate drain is not insulated, creating conditions conducive to formation of condensation that can cause water damage and mold growth in attic insulation and on ceiling sheetrock. Installation of insulation is recommended.

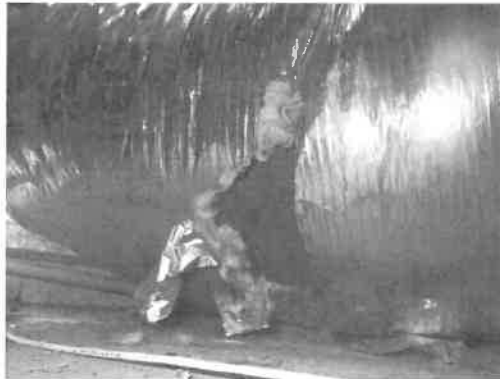
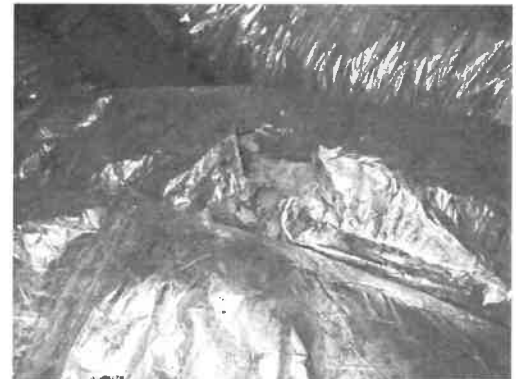
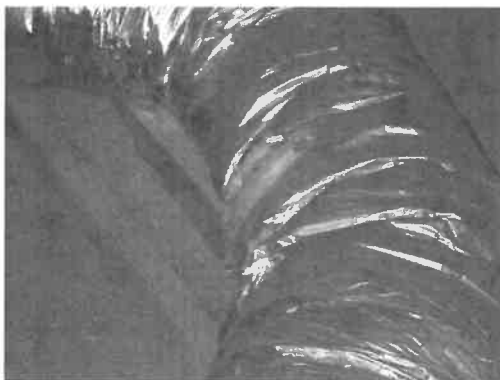
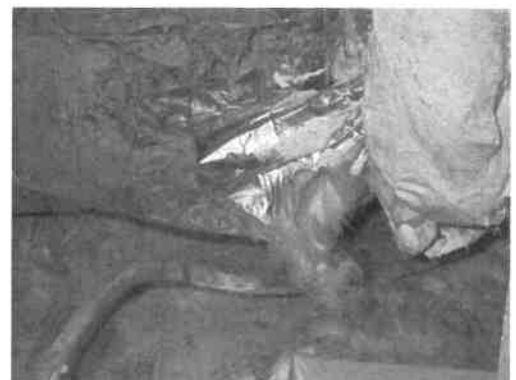
Insulation is damaged on the return duct. Repair is recommended to prevent condensation that can damage attic insulation and ceiling gypsum board.

Three supply ducts have been damaged by animals. Replacement is recommended.

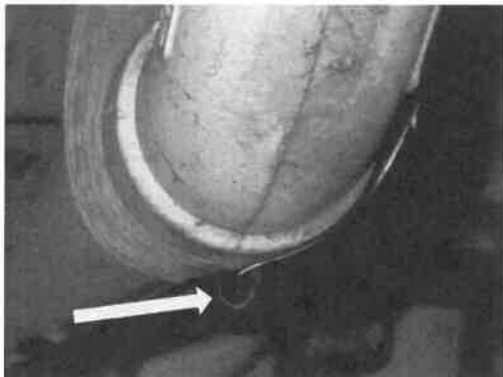
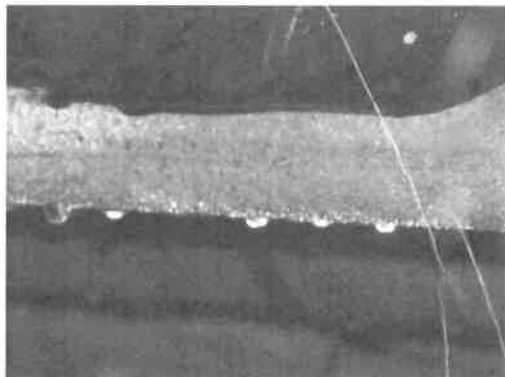
A lavatory is not installed in the hall bathroom.
 The shower head is missing from the hall bathroom.

B. Drains, Wastes, and Vents
Comments: Exclusions enumerated in section IV.A above are also applicable drain, waste and vent plumbing. Inaccessible drains are not inspected.
 Drip leaks were observed on kitchen and hall bathroom drain plumbing. Master bathroom drain plumbing was not visible or accessible. Further evaluation by a licensed plumber is recommended.

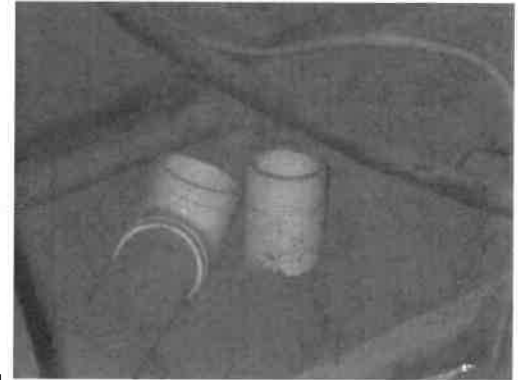
A drain vent terminates in the attic, allowing discharge of sewer gases in the attic. The vent should terminate to open air a minimum of 4 inches above the roof's surface.

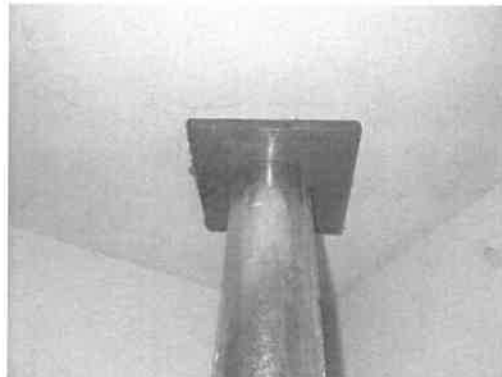
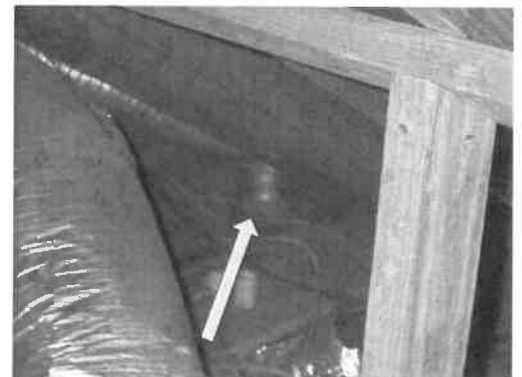
The water heater flue is in contact with attic insulation. Prolonged contact can create a hot spot that impedes flue drafting or cause premature failure of the flue wall. The flue should be protected by a metal shield that terminates a minimum of 2 inches above insulation materials.

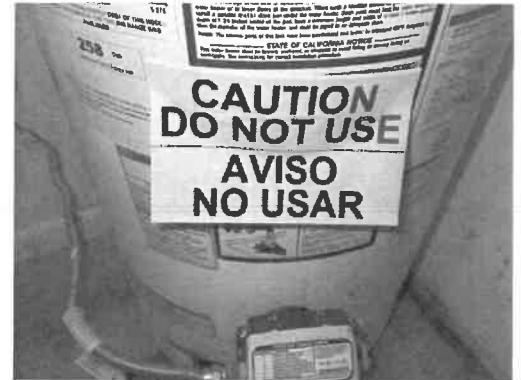
Water heater operation was not attempted due to presence of DO NOT USE notices from the gas utility. It could not be determined if repairs required by the utility have been undertaken. Further evaluation by a licensed plumber is recommended.

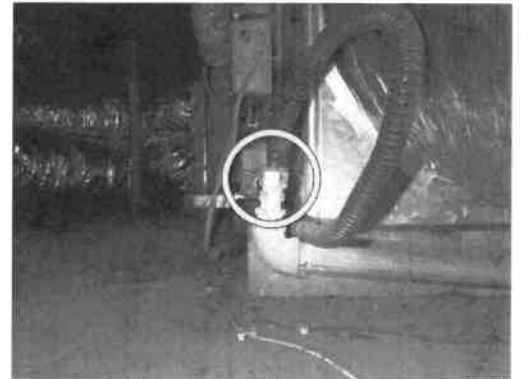
A stop valve is not installed on gas supply plumbing serving the furnace as required. The stop valve should be installed between gas supply plumbing and the flexible connector.

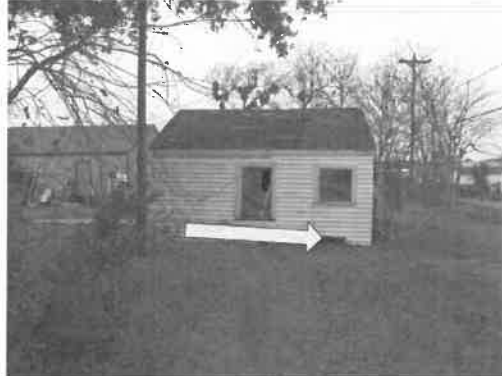
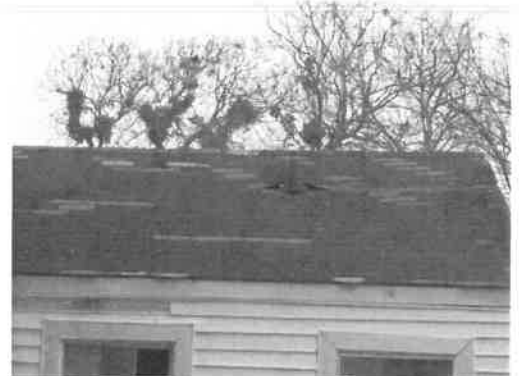
The detached garage's foundation has settled downward toward its north perimeter. Shingles have failed; multiple tabs are missing.

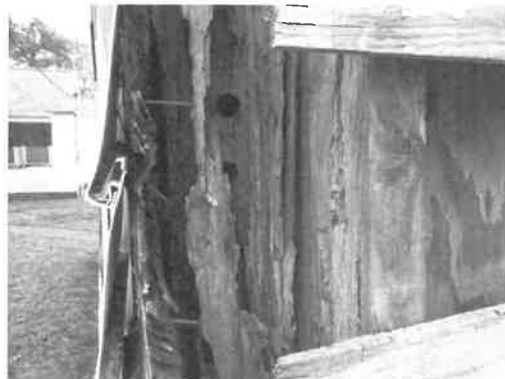
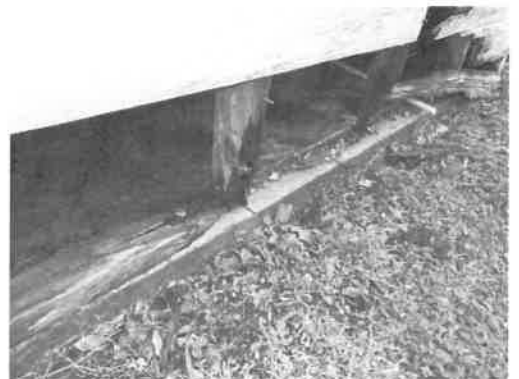
Advanced structural decay caused by water exposure and wood-destroying insect activity is present on detached garage structure. It may be more economical to demolish the garage rather than undertake repairs. Estimates should be obtained from a general construction contractor.
