Proposed Repair Plan
 1115 West 5th
 Freeport, TX

PRELIMINARY FOUNDATION INSPECTION REPORT: JOB NO. 24-F025

LOCATION: 1114 West 5th
Freeport, TX

DATE OF INSPECTION: January 25, 2024

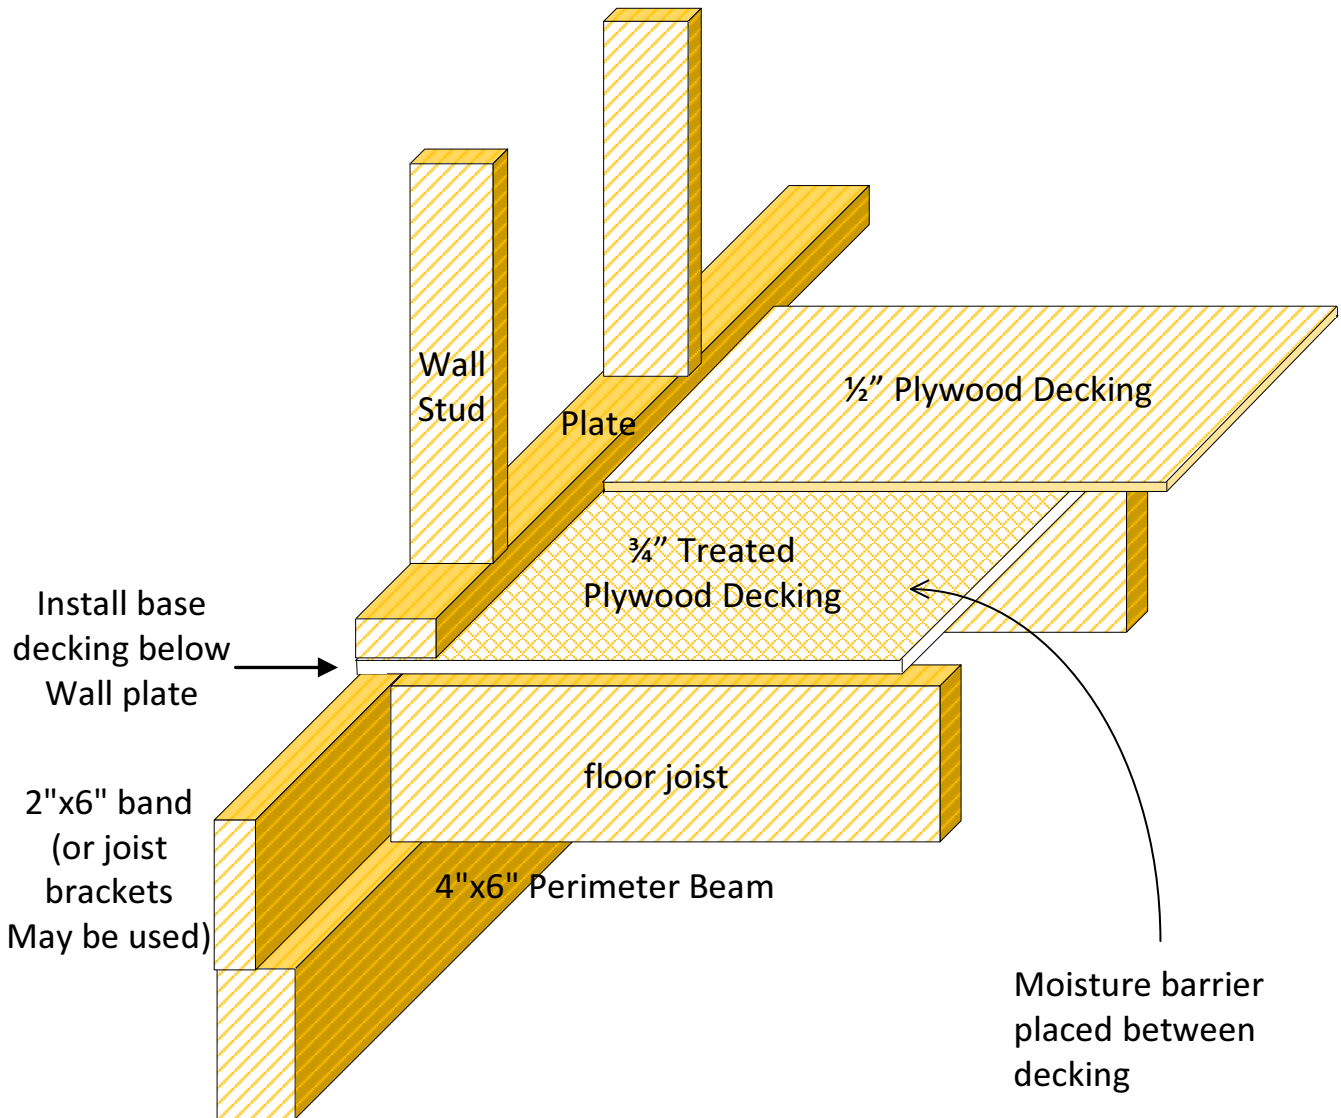
Decking Recommendation

Decking – Decking along the west portion of the structure has enough rot that it will require replacement. The exact scope will be set once the rotten sections are removed. The attached drawing highlights the areas with the most concern. See drawing 24-F025-04 detailing the decking installation recommendations.

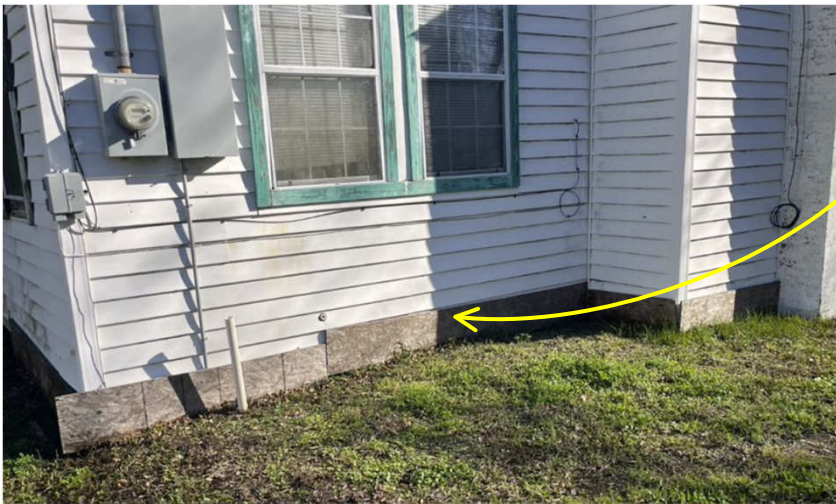
Siding blocking off ventilation along side and back of structure

Remove all siding extending past the base of the beam blocking the ventilation

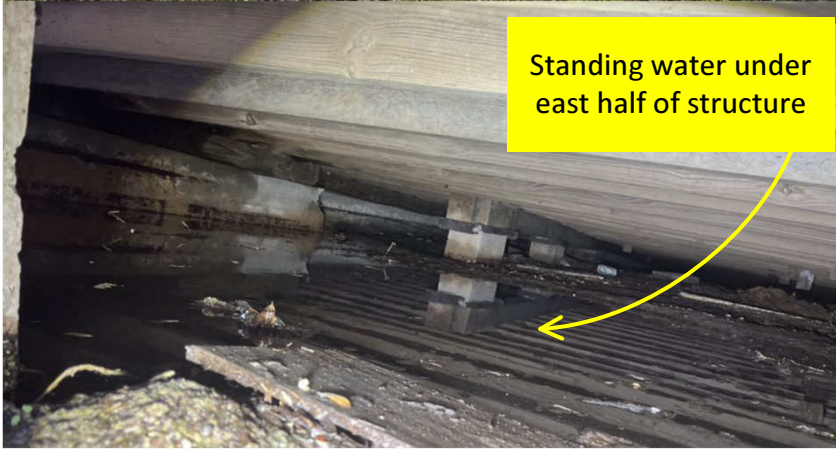
Standing water under east half of structure

Drainage – Sections of grade under the structure contained standing water at the time of inspection due to recent rains. Long term, the caretakers of the structure should strongly consider re-grading the dirt or installing drainage leading water away from under the structure. If not addressed, this will lead to premature failure of the foundation due to wood rot regardless of any of the new repairs and ventilation improvements.

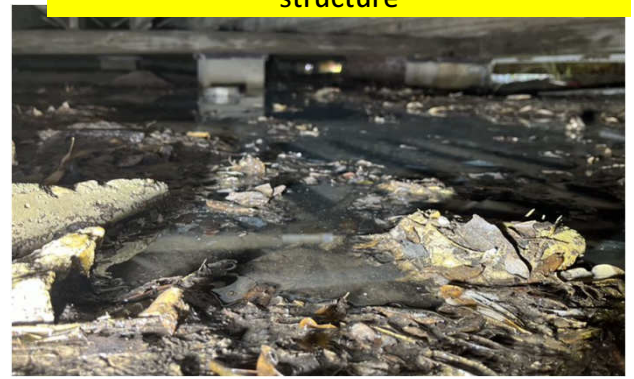
Standing water under west half of structure

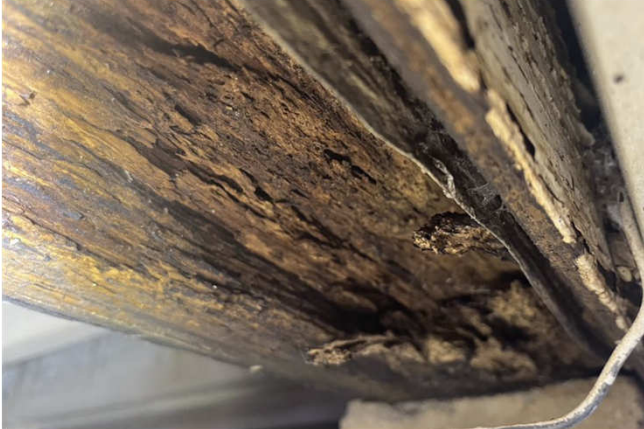
Rotten beam along east perimeter

Beams – The front concrete perimeter beam is functioning as designed. However, the side and back perimeter beams are covered in siding. In spot sections, that were visible, the perimeter beams contain significant rot and will have to be replaced. The existing beam layout spacing is adequate except where a 10' section of beam is needed along the east end of the structure as shown on the attached drawing. All rotten beam and new beam installed should be replaced with a minimum of 4"x6" treated wood construction connected by lap joint flanges with supports at each end point. It is projected approximately 100' of beam will have to be replaced. This value may increase once access under the structure is gained.

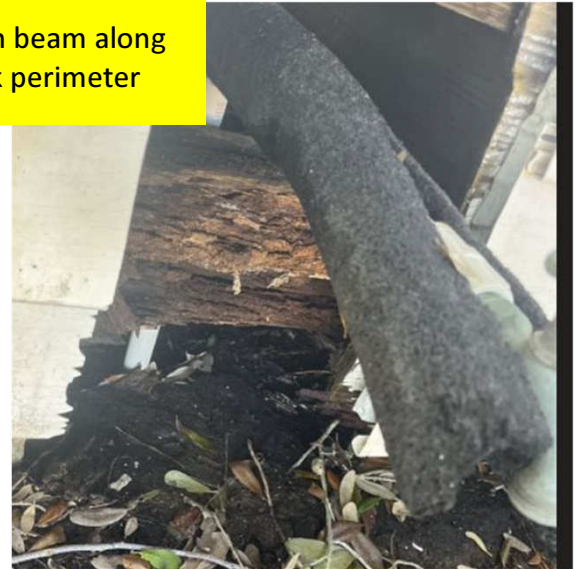
Large sections of back perimeter beam are rotten and will have to be replaced

Rotten beam along back perimeter
