REDSTAR RESIDENTIAL INSPECTION

PROPERTY INSPECTION REPORT

Concerning: 23307 Yellow Larkspur, Katy TX 77493

By:Robert Ramirez - TREC# 10013

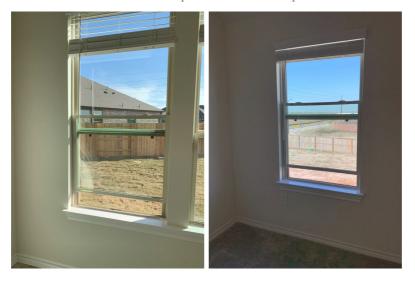
Dining room, Second floor side middle bedroom

1: Improper Installation

Windows appear to not be operating properly due to substandard installation. The window is not securely attached in the guide.Recommend window specialist evaluate.

Recommendation: Contact a qualified window repair/installation contractor.

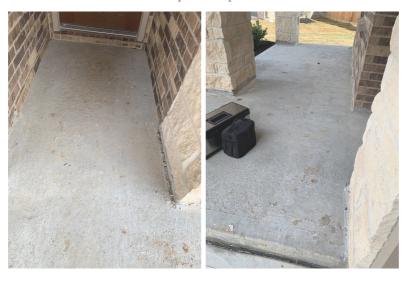
Front entrance

1: Damage Patio

The concrete patio at the front entrance was observed to have damage to the surface area. Recommend further evaluation and repair as needed.

Recommendation: Contact a qualified professional.

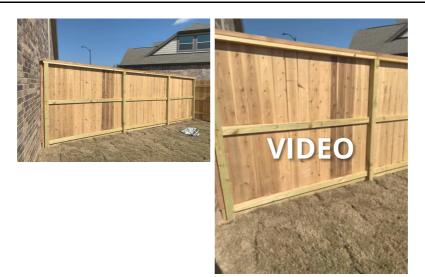
Left side

1: Fence: Loose, Damaged and Missing Boards

Loose fence at the left side of the property. The fence was unstable and could possibly be damaged under High winds. Repair as needed for security and privacy purposes.

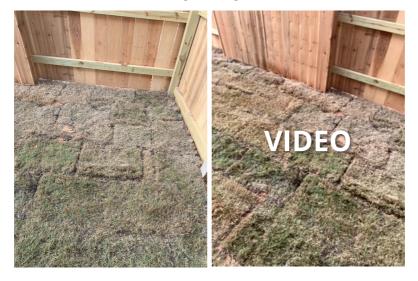
Backyard near gate

1: Area of grass not be in irrigated

Inspector observed one or more areas not be in irrigated by the sprinkler system. Zone six was not irrigating in the back corner near the gate. Recommend further evaluation and repair as needed to irrigate the lawn properly.

Due to conditions observed at the time of the inspection, I recommend you consult with a qualified irrigation contractor to evaluate further and determine the extent of necessary repairs.
