# PROPERTY INSPECTION REPORT FORM

| Laverne Pivonka<br>Name of Client | 02/08/2024<br>Date of Inspection | |
|---|---|--|
| 3025 Rosefield Drive , Houston, TX 77080<br>Address of Inspected Property | | |

PROPERTY INSPECTED: 3025 Rosefield Drive Houston, TX 77080 DATE OF INSPECTION: 02/08/2024 Inspection No. 52965-1-929

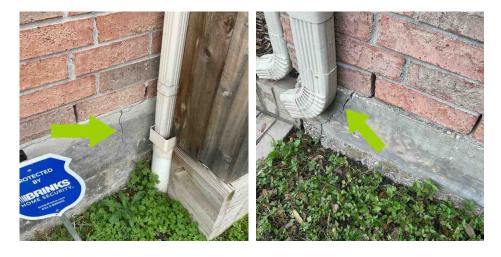
· Corner Pops Present. Small cracks were observed in the foundation at several corners of residence, commonly called a ""corner-pop"" (see photos). NOT A STRUCTURAL ISSUE. This type of crack is guite common on foundations of this type. No recommendations necessary. However, sealing of cracks eliminates the possibility of treating cracks with poisons to kill termites. Recommend further evaluation by a gualified pest control company to determine proper method of treating condition. SUGGESTED CARE AND MAINTENANCE - Due to the highly expansive soil conditions that are prevalent to the Texas Gulf Coast Area, proper moisture control and drainage maintenance to all types of foundations should be on-going during the life of the structure. Drainage patterns should be directed away from all sides of the foundation with graded slopes directing run-off away from foundation. It is important to note that the inspection of the foundation performed today is not a structural engineering survey nor was any sub-grade or sub-slab plumbing or electrical systems evaluated during the performance of this visual inspection as these are specialized processes requiring excavation. In the event that structural movement is observed in the future, client is advised to consult with a structural engineer who can isolate, identify causes, and determine what corrective measures should be considered to either correct and/or stop structural movement.

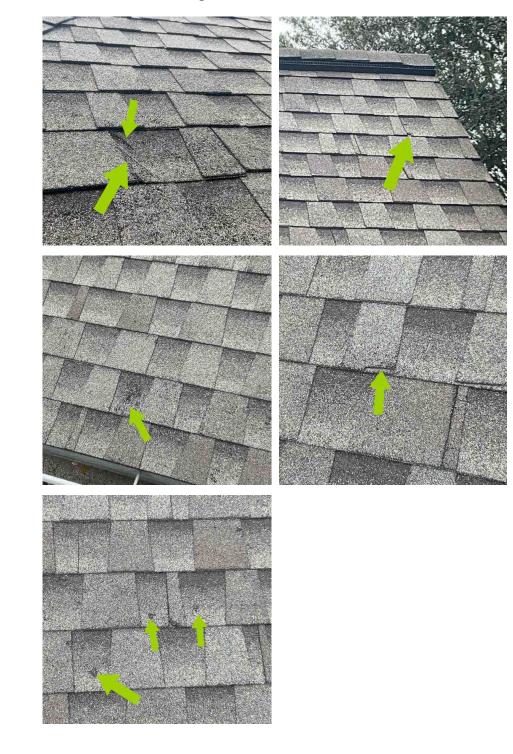
• Scarred/damaged shingle tabs on roof covering, damaged shingles will not wear evenly with rest of roof covering.

Recommend having a qualified roofing contractor evaluate and rectify all affected areas as necessary to restore intended operation and function of roof covering.

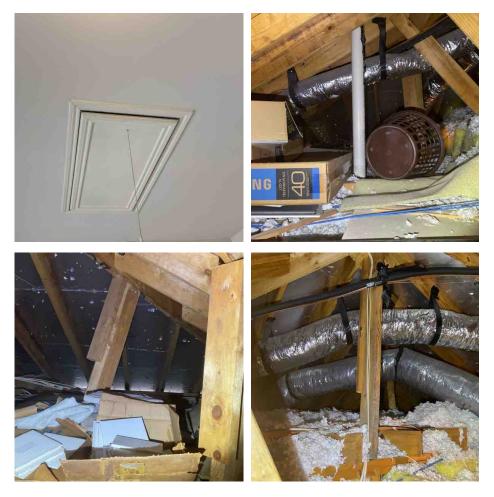
- I = Inspected NI = Not Inspected NP = Not Present D = Deficient
  - I NI NP D\*
- Cracked purlin brace. Recommend licensed contractor repair.

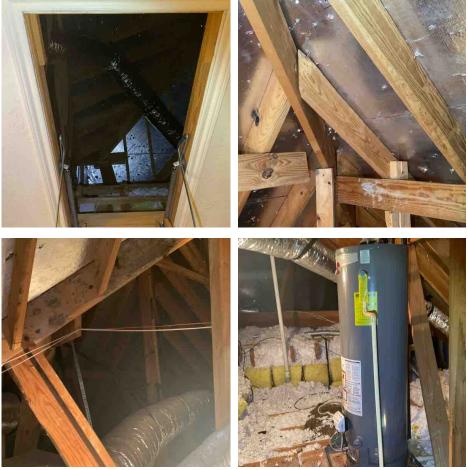
• SAFETY NOTE: Attic stairs are high and heavy. Most people will require a ladder to unfold and return the stairs after use. Recommend a qualified attic ladder contractor evaluate and provide a solution to opening and closing the stair unit without the use of another ladder.

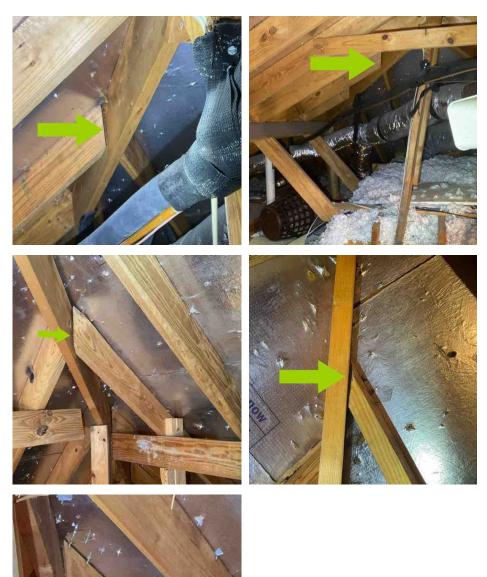
- I = Inspected NI = Not Inspected NP = Not Present D = Deficient
  - I NI NP D\*
- Rafters cut too short or not at the proper angle. Recommend licensed contractor repair.

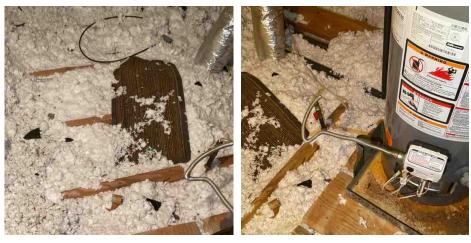
necessary to promote better overall efficiency and reduce energy costs.

Recommend adding/replacing-missing insulation in areas as

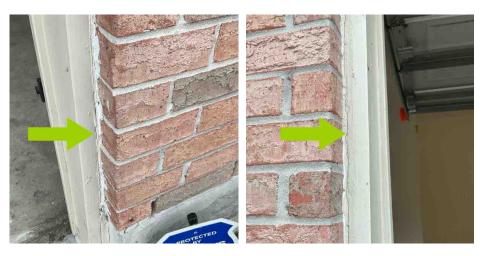
• Seal all open joints, gaps, and penetrations to prevent moisture or pest intrusions.

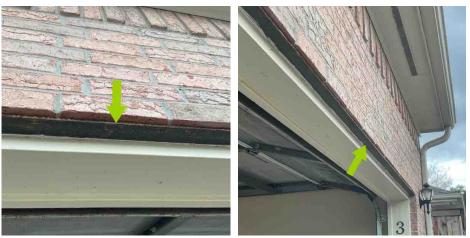
• Lentils are rusted. Recommend sanding and painting to prevent further rusting.

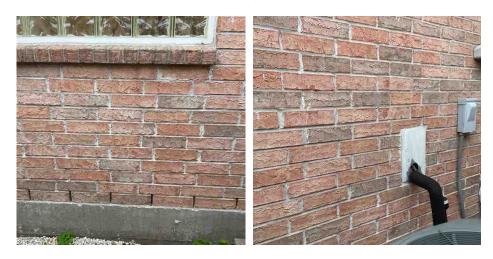
• Mortar repairs were observed. Throughout.

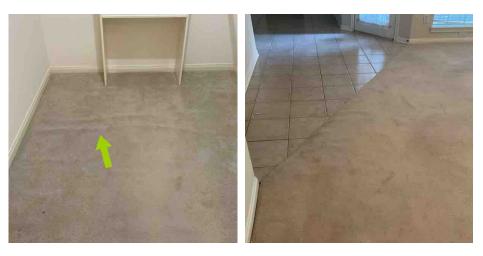
• Carpet is wrinkled in several areas. This could be a trip hazard. Recommend re-stretching or replacing carpet.

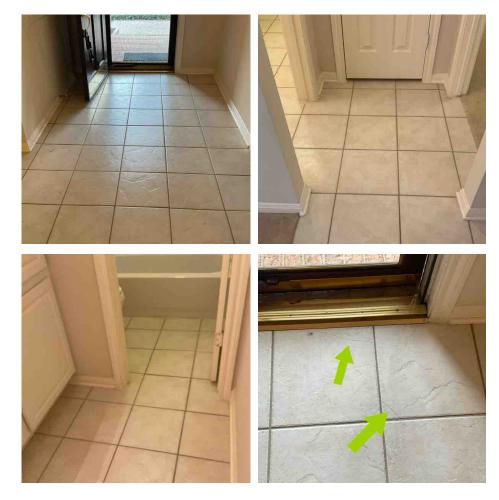
• Loose and cracked tiles noted in several areas. Recommend licensed flooring contractor evaluate and repair or replace tile.

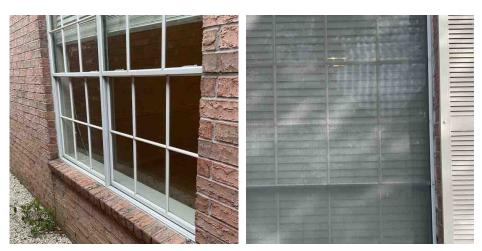
• Some window screens missing or damaged.

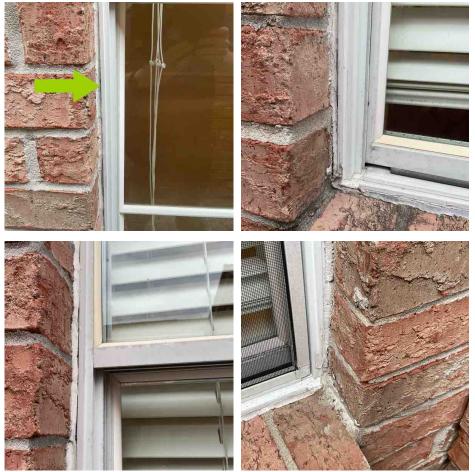
- I NINP D\*
- Seal and/or caulk joints and gaps around windows to reduce air exchange water penetration and subsequent damages.

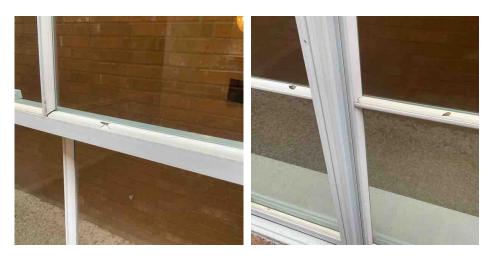
• Damage dripping noted around windows. Recommend licensed contractor replace damaged stripping.

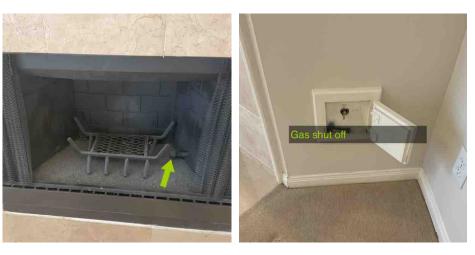
• Fireplace is wood/gas burning, damper not tested. Draw of the fireplace was not tested and could not be determined at the inspection. The interior of chimneys and their flue liners are not visible on our visual inspection. You are advised to obtain the services of a qualified chimney sweeper or other qualified personnel to perform a complete inspection and tune up of your fireplace prior to using the appliance. Operation of log-lighter was not tested. Gas line was capped.

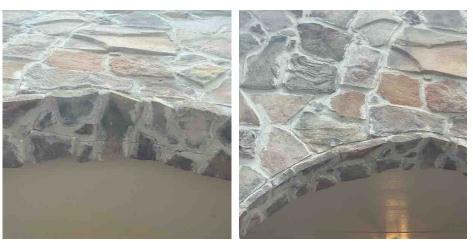
- I = Inspected NI = Not Inspected NP = Not Present D = Deficient
  - I NI NP D\*
- Archway at front porch is showing signs of settlement cracks.
   Recommend licensed contractor repair.

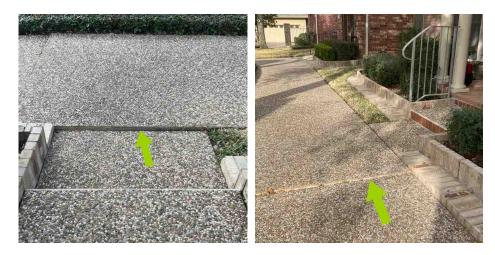
• Walkway is uneven and could pose a tripping hazard.

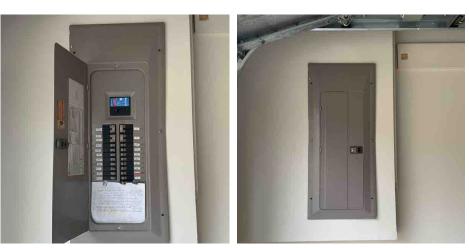
Missing panel screws.

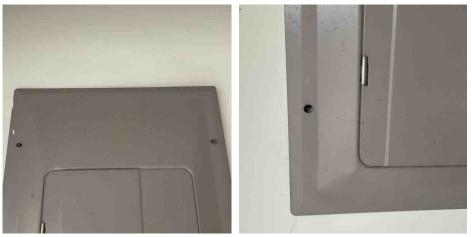
• Non-standard screws being used to hold inner security cover, screws have sharp points and can pose a wire intrusion issue.

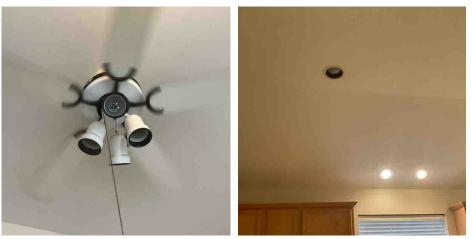
• Light fixtures did not illuminate or light bulbs were missing. Recommend replacing broken bulbs and installing bulbs where missing. Consult with a licensed electrician if fixtures continue to not work properly to evaluate and make repairs to protect circuits and prevent shock hazard. (Garage)

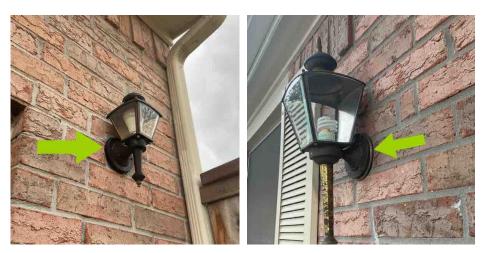
• Sealants observed missing at exterior wall mount light fixtures around perimeter of residence (see photo). Recommend applying good exterior-grade sealant to tops and sides of fixtures, leaving bottoms un-sealed.

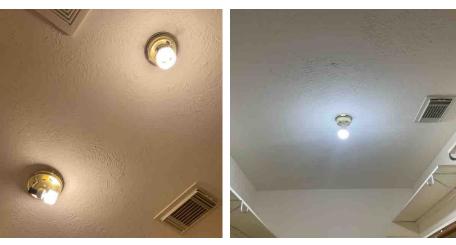
- I = Inspected NI = Not Inspected NP = Not Present D = Deficient
  - I NI NP D\*
- All light fixtures require covers to prevent injury and shock.

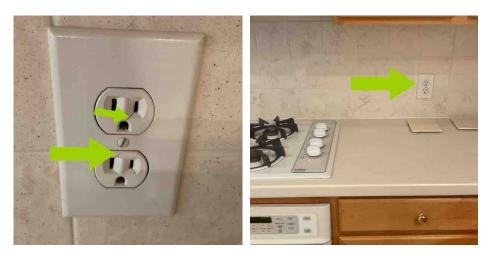
• Recommend licensed electrician replace damaged receptacle. Kitchen.

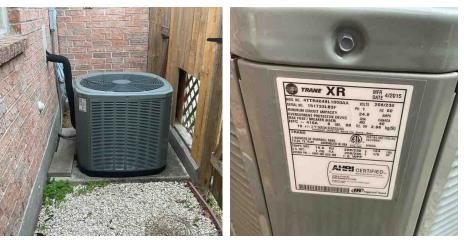
- NP = Not Present D = Deficient I = Inspected NI = Not Inspected
  - I NI NP D\*
- 2015 R-410A max breaker 40 amps.

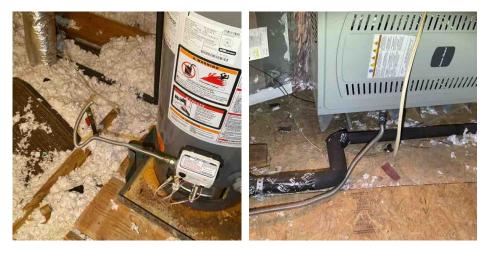
• "No sediment traps and/or drip legs noted on the natural gas lines at the mechanical equipment. Due to a change in construction standards, recommend plumber evaluate and repair as needed to meet todays standards."

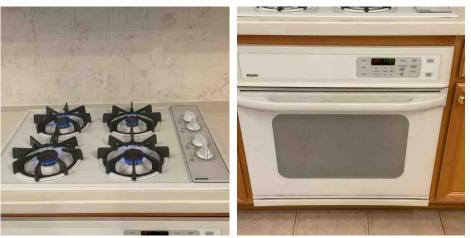
Oven Temperature was 348 degrees when set at 350 within the 25 degree tolerance.

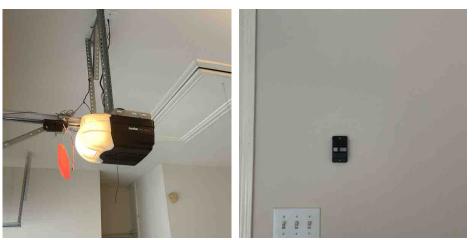
• The garage door opener was tested and the door opens and closes normally. The reversing function tested satisfactorily.

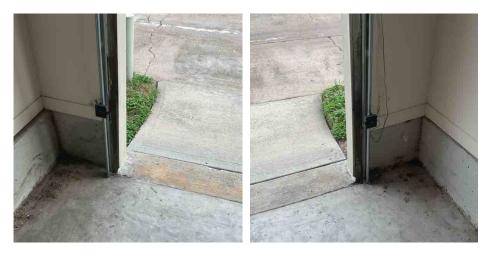
• Sensors for overhead garage door are installed too high.

Recommend having a garage door contractor service/repair/adjust as necessary to restore intended function and reduce possible safety related issues.
