3814 Knollcrest Dr
Montgomery, TX 77356

PROPERTY INSPECTION REPORT

Concerning: 3814 Knollcrest Dr, Montgomery, TX 77356
(Address or Other Identification of Inspected Property)

By: Hunter Lamb, Lic # 24864 09/09/2021
(Name and License Number of Inspector) (Date)

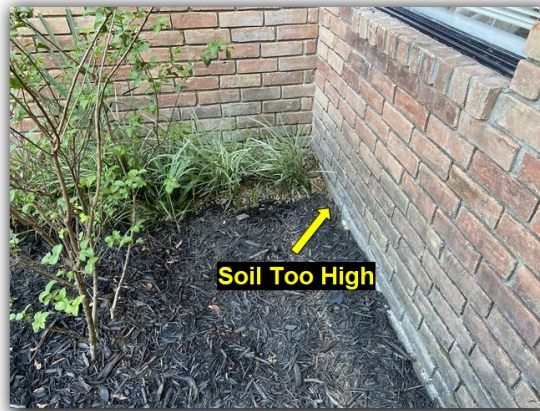
Observed soil levels too high around the foundation in one or more areas. High soil levels are considered a conducive condition to termite activity and water penetration.

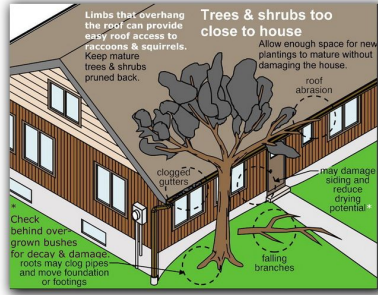
Recommend vegetation be cut back away from exterior of home to prevent damage.

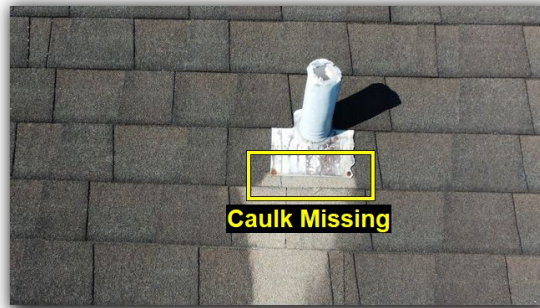
Observed one or more exposed nail heads that need to be caulked.

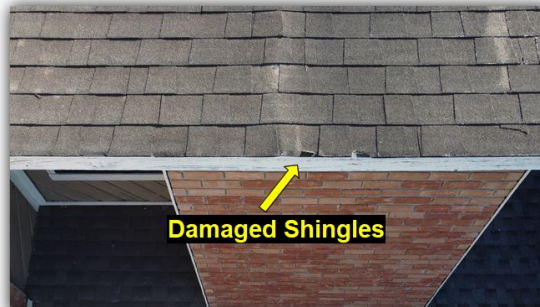
Observed damaged shingles in one or more areas of the roof. Recommend further evaluation by a professional roofing contractor.

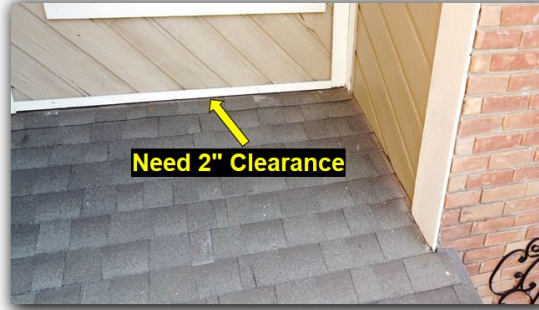
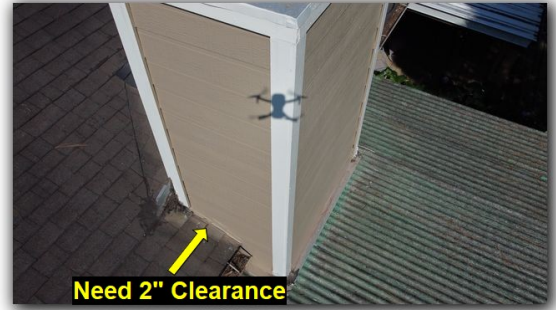
Observed siding touching shingles multiple areas of roof. Common industry practice calls for at least a two inch separation from bottom edge of siding and roof surface. The two inch separation helps prevent moisture from being trapped which can cause deterioration.

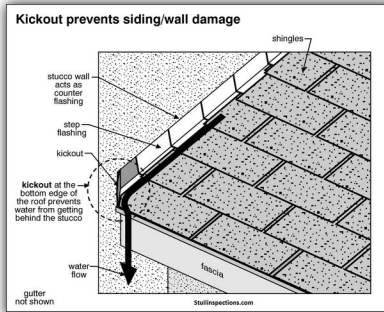
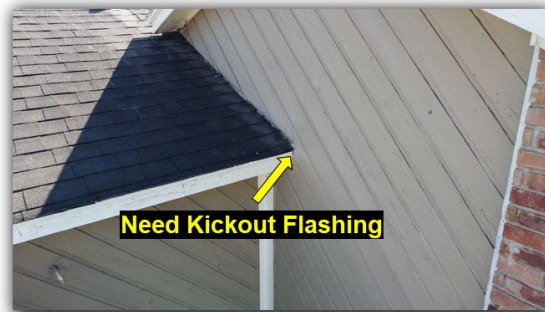
Did not observe kick out flashing installed in one or more areas. Current standards call for kick out flashing to be installed to help prevent water from getting behind the wall which can cause damage.

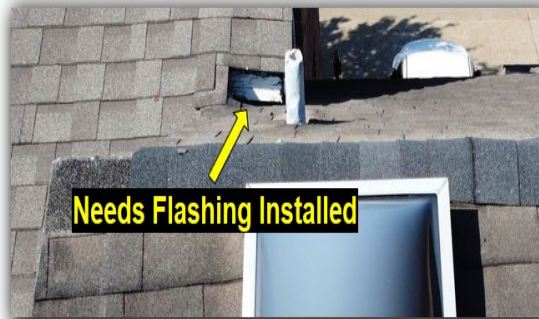
Observed a dead valley on the right side of the roof. There is no flashing installed to divert water away from the valley. Recommend a contractor evaluate and repair as needed.

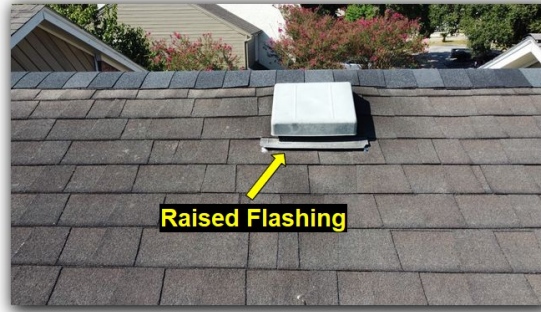
Observed bent/raised flashing in one or more areas. Recommend securing all flashing to prevent water penetration from wind driven rain.

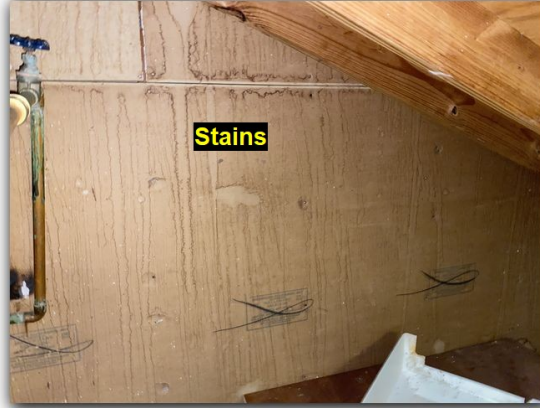
Observed water stains on the roof decking in the attic in one or more areas. Moisture readings were low at time of inspection which usually indicates the stains are from previous leaks, but I could not be certain. Recommend asking the seller about previous leaks that may have been repaired or having further evaluation by a contractor.

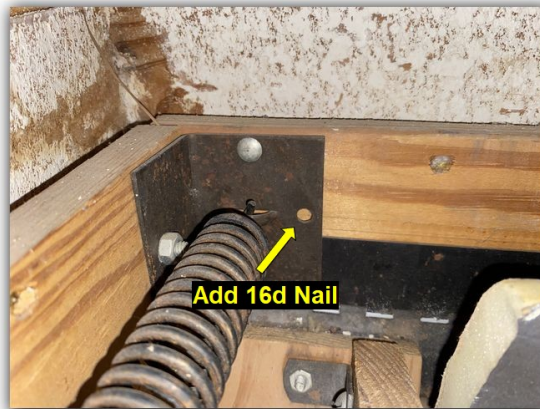
Observed one or more nails missing from attic access ladder frame. Recommend installing a 16d nail or 1/4 inch diameter lag screw to properly secure stairway frame to ceiling.

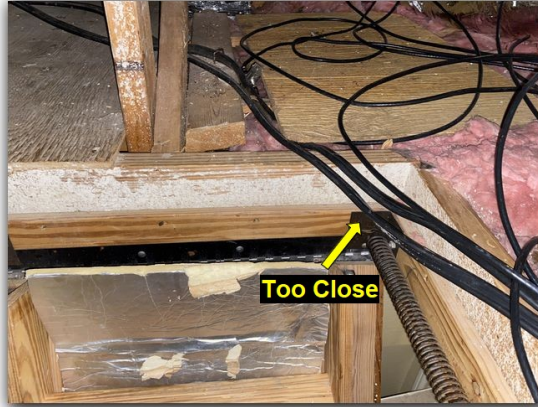
Observed wiring too close to attic access opening. Wiring should be at least 6 feet away from attic opening. One reason for this code is that someone falling from the access ladder might grab onto an electrical wire. Usually securing the wiring so that it can not be grabbed will alleviate this danger.

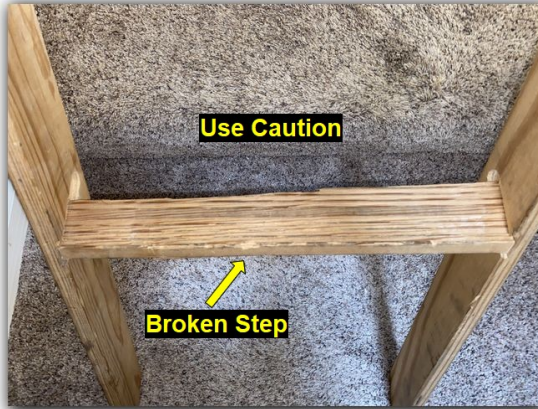
Observed a broken step on the attic access ladder. In need of repair.

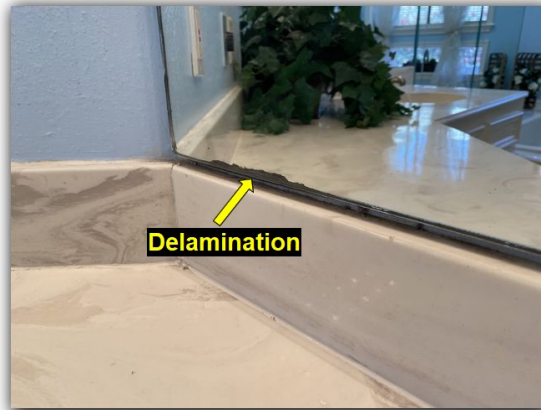
Observed mirror delamination on one or more bathroom mirrors. Cosmetic issue.

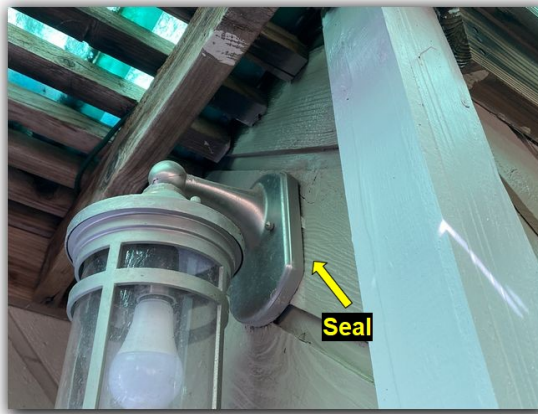
Recommend sealing/caulking around all holes, gaps, cracks and exterior siding penetrations to prevent water / insect entry.

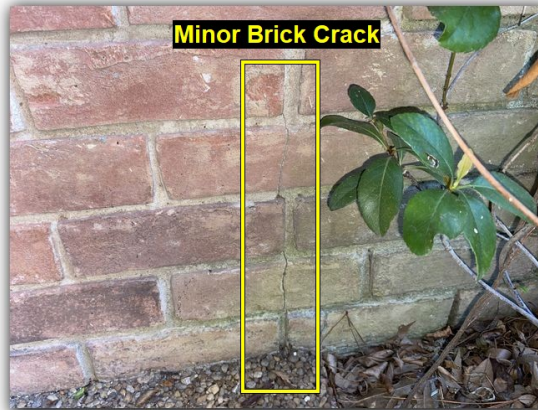
Observed minor cracks in the brick and mortar around the exterior in one or more areas. Recommend repairing or sealing all cracks to prevent water entry.

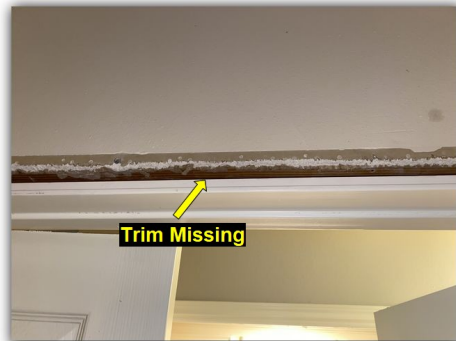
Observed trim missing above the door in the small room across from the laundry room.

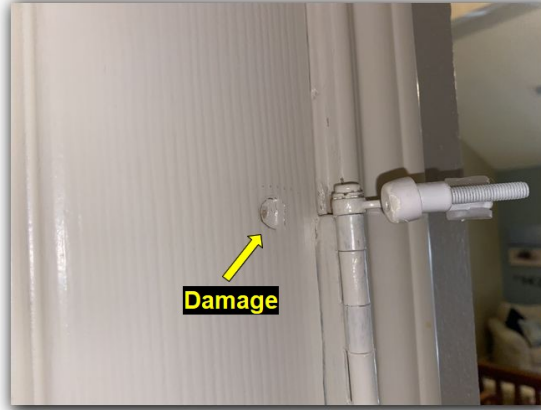
Observed damage to multiple doors / door frames.

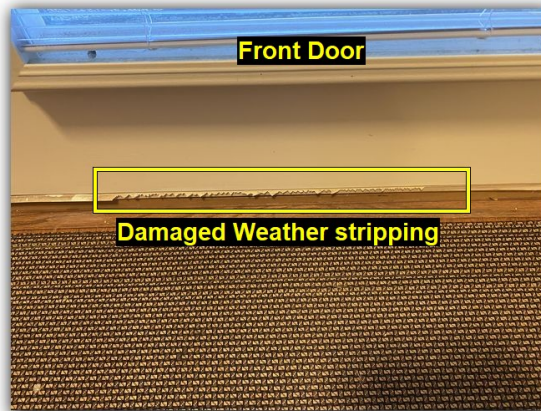
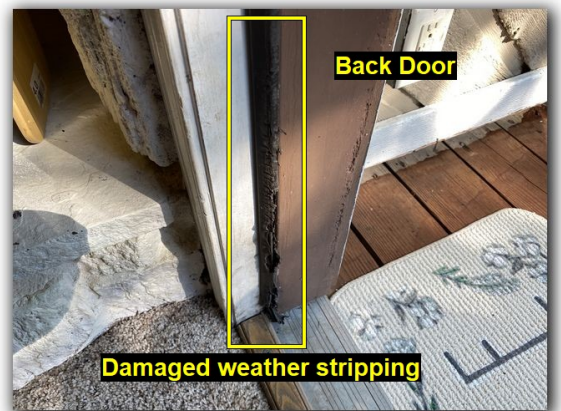
Observed missing / damaged weatherstripping on the front and rear entrance doors. In need of repair.

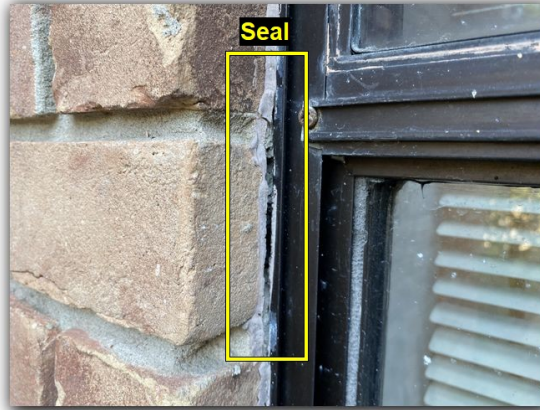
Recommend sealing around the exterior of all windows.

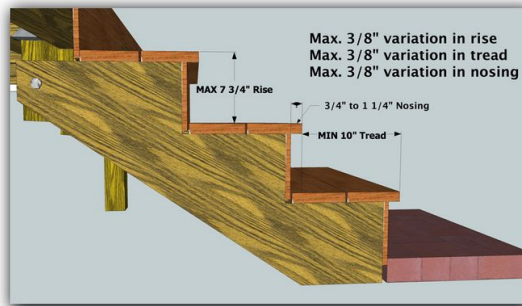
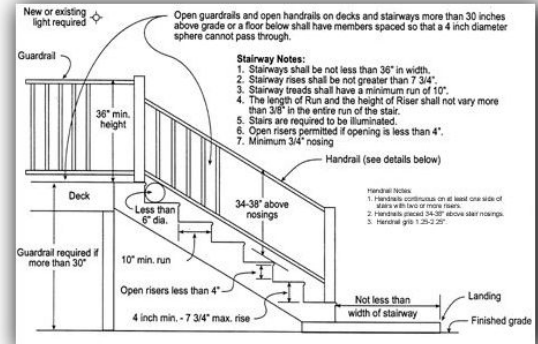
Observed the stairs were not up to current standards with deficiencies that may include, but are not limited to; riser height, riser variance, improper handrail and tread depth. Note: Standards for stairs have changed significantly since time of construction.

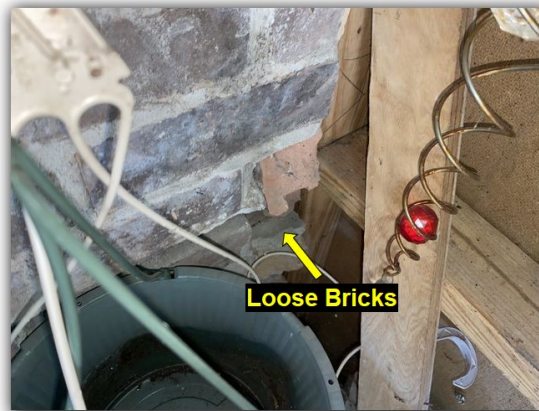
Observed loose / cracked bricks on the rear side of the masonry chimney.

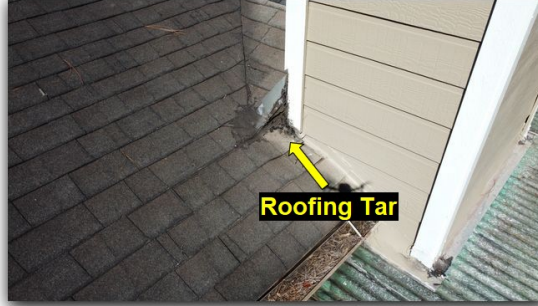
Observed roofing tar used to seal around the flashing of the chimney in one or more areas. Roofing tar is a temporary repair. Recommend a contractor evaluate and properly repair if needed.

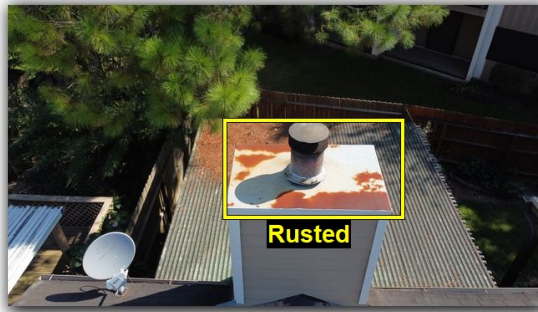
Rust observed on the top of the chimney. Recommend coating with rust resistant paint to help slow the rusting process and preserve the integrity of the metal.

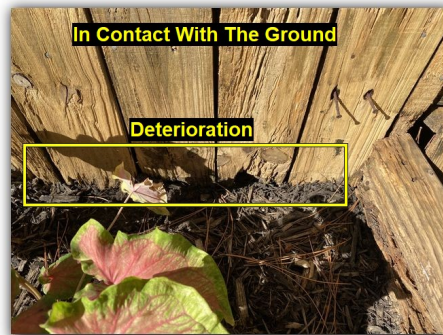
Observed the wooden deck was in contact with the ground. This is a conducive condition for wood destroying insects and will cause premature deterioration of the deck.

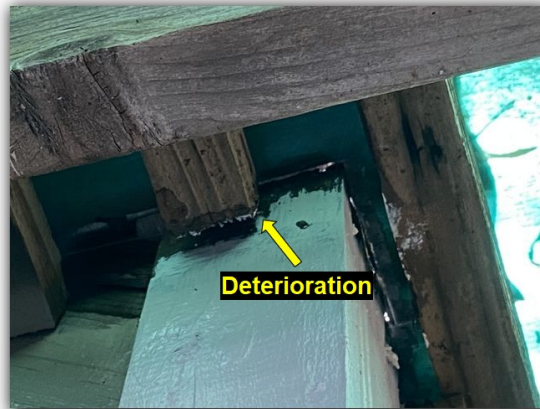
Observed multiple areas of wood deterioration on the pergola.

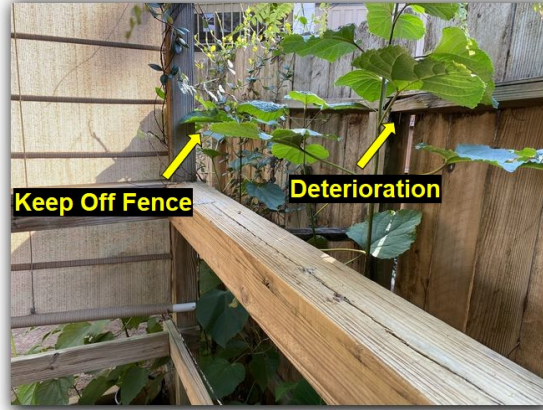
Observed damaged and/or deteriorated pickets on the fence in one or more areas.

Recommend keeping vegetation cut away from the fence to prolong the life expectancy of the wood.

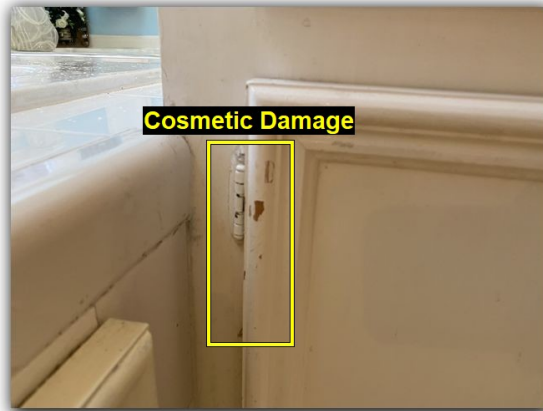
Observed cosmetic damage to cabinets in multiple areas.

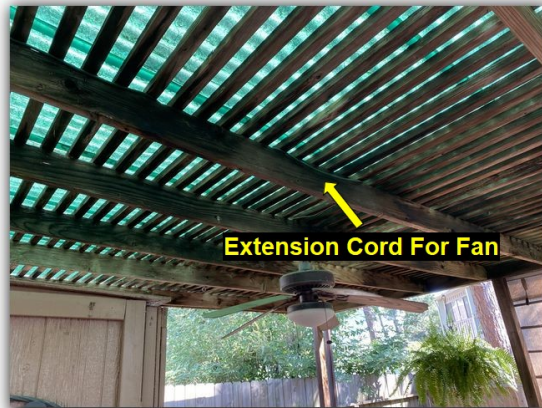
Observed extension cords being used as permanent wiring in one or more areas. Extension cords are for temporary use only.

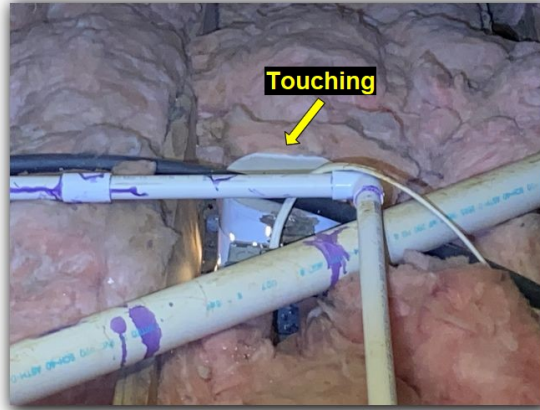
Did not observe an IC (insulation contact) rating for the can lights in the attic. Most can lights require a 3 inch clearance from all combustibles, including insulation. Recommend moving insulation away from the can lights at least 3 inches to reduce the risk of fire.

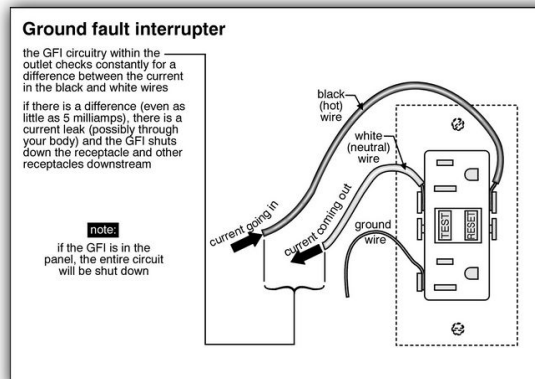
Did not observe GFCI protection for all outlets in required locations including, but not limited to; all laundry, bathrooms, kitchen and exterior areas. Current standards call for GFCI protection for all outlets in kitchen, bathrooms, laundry room, garage, exterior and any outlet that is within 6 feet of a water source. This is a recognized safety hazard.

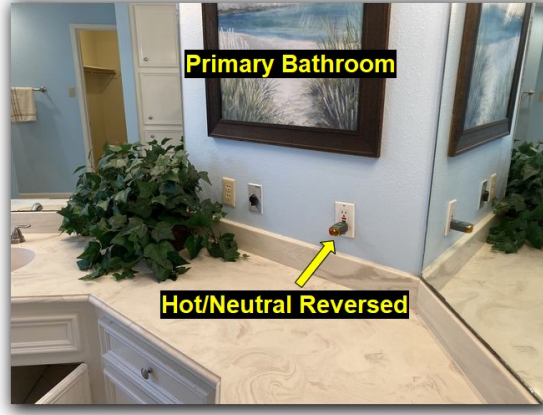
Observed the hot and neutral wire were reversed one outlet in the primary bathroom. Recommend licensed electrician evaluate and repair as needed.

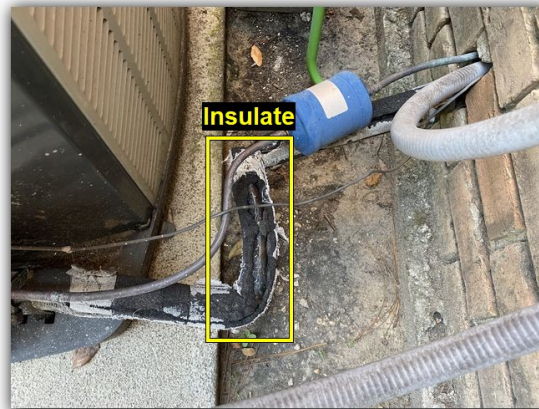
Observed the suction line is missing insulation. For optimum energy efficiency I recommend re-insulating the suction line.

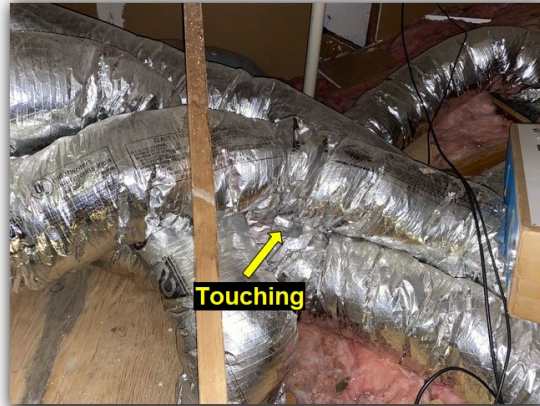
Observed ducts touching in one or more areas in the attic. This can allow condensation to form between the ducts which can drip onto the attic floor or ceilings below. Recommend separating the ducts or placing a piece of insulation between the ducts to prevent condensation from forming.

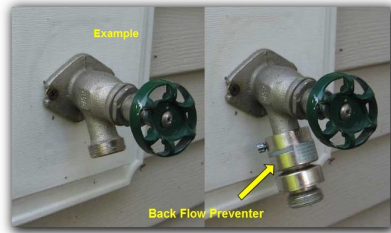
Some exterior hose spigot(s) do not have code approved anti-back flow devices installed. Note: Back flow preventers cost approximately \$5.00 and are easy to install.

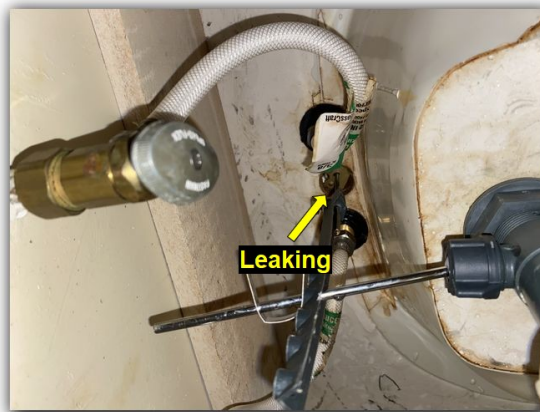
Observed a leak at the primary bathroom right sink drain. Recommend further evaluation by a licensed plumber.

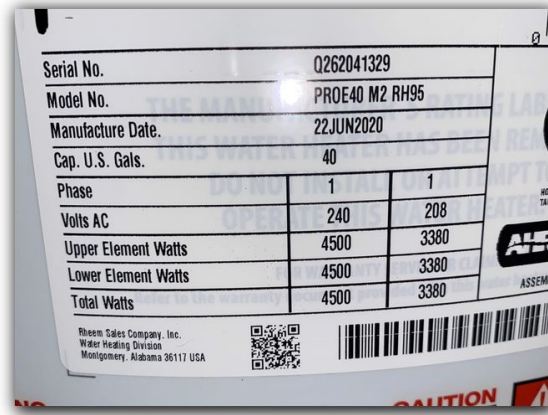
Did not observe a drain line for the drain pan. Recommend installing a drain line to help prevent the pan from overflowing and to help alert you that the water heater is leaking.

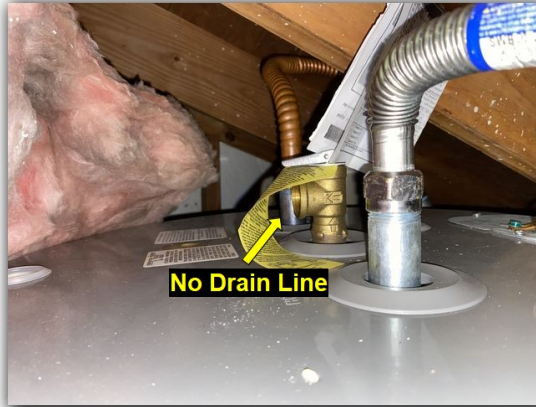
Did not observe a drain line for the TPR valve. Current standards call for the TPR valve to have a drain line that terminates to the exterior or into a drain.

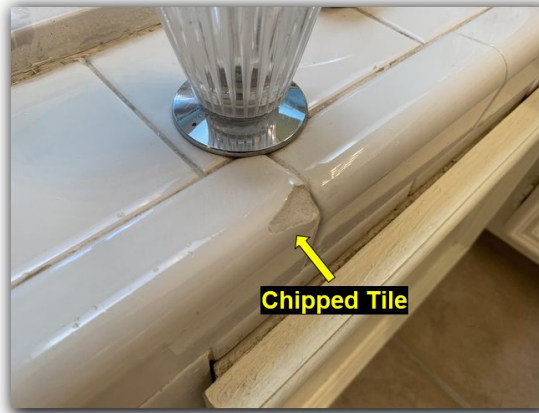
Observed a chipped tile on hydro massage tub.

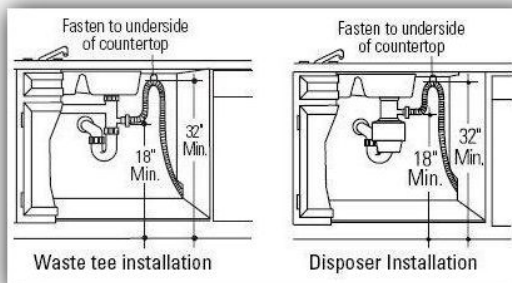
Did not observe a high loop or air gap installed for the dishwasher. The high loop or air gap prevents gray (dirty) water from backing into the dishwasher if the disposal or drain becomes clogged.
