MPerme Home Inspection Services Property Inspection Report

2639 Pine Village Dr, Houston, Texas 77080 Inspection prepared for: Dave Bauchelle Date of Inspection: 12/13/2023 Age of Home: 55 Size: 1984

Inspector: Marcelo M. Perme

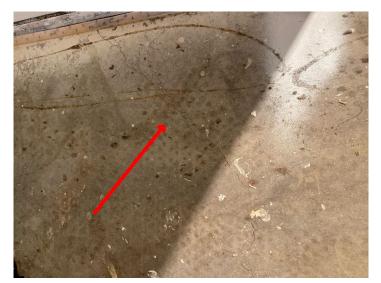
Small crack on the slab in the office

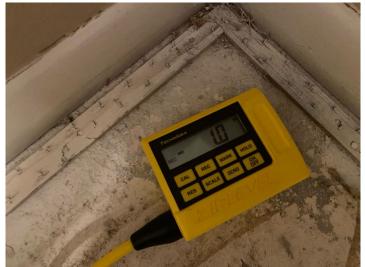
Small crack on the slab in the primary bedroom

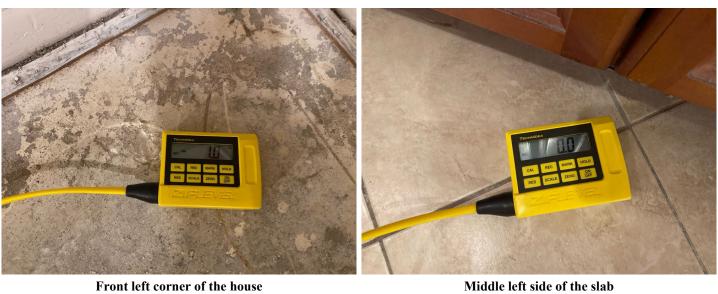
• Foundation shows evidence of minor previous movement, nothing major at this time for the age of the home. The movement is evidenced by findings that may include but not be limited by settlement cracks in interior walls, insufficient clearance between the wall siding and ground, cracks/gaps on exterior siding, cracks on the slab. A slab elevation reading indicated that the slab has a deflection of 1.5 inches from the center point to the right front corner.

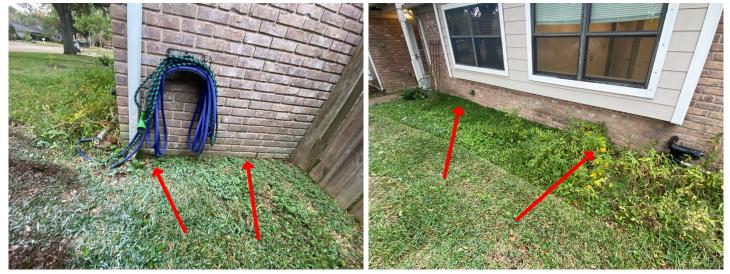
• High soil observed in areas around the exterior walls of the home promoting earth to wood contact. High Soil, or grass could cause moisture damage, or possible wood destroying insect damage to the walls. No signs of existing damage was found visually and/or with the use of a FLIR moisture meter at the time of the inspection. It is recommended to maintain a clearance of 4- 6 inches between the ground and wall when possible.

High Soil, Insufficieant clearance to siding

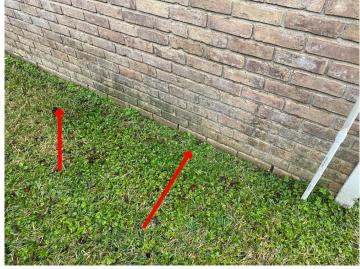
High Soil, Insufficieant clearance to siding

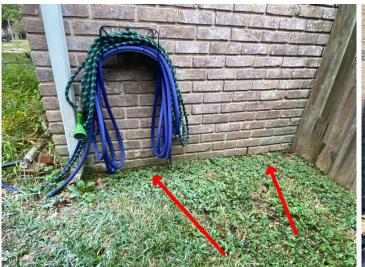
• Insufficient clearance ground to siding - Some areas around the home to have soil/mulch/grass in contact with siding. This can allow water to penetrate the wall causing damage. Recommend removal of all high areas that are in contact with the exterior walls. Recommend having 4 to 6 inches of foundation showing around home.

Insufficient Clearance from Ground and Wall Siding

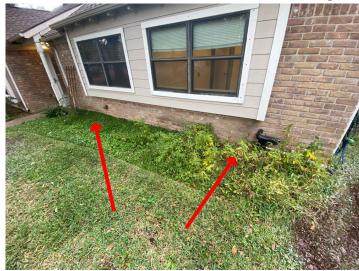
Insufficient Clearance from Ground and Wall Siding

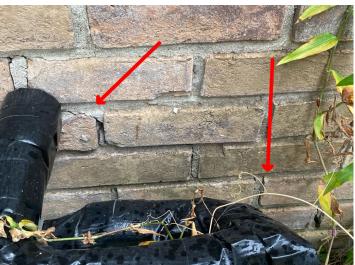
• Some cracks were found on the exterior brick siding. Nothing major at this time. Mortar improvements are required on the exterior masonry veneer to prevent further cracking.

Mortar Crack - front right side of the house

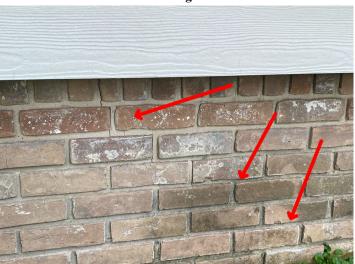
Crack on the brick siding at the front of the house

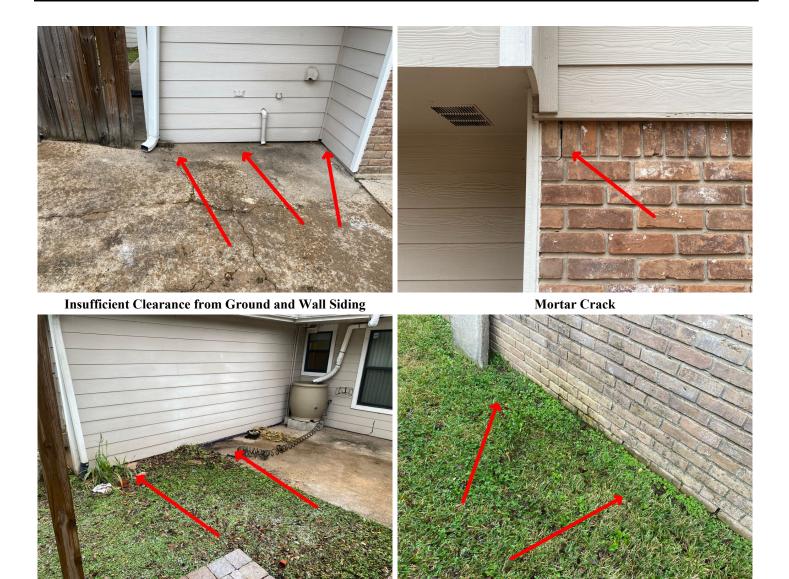
Insufficient Clearance from Ground and Wall Siding

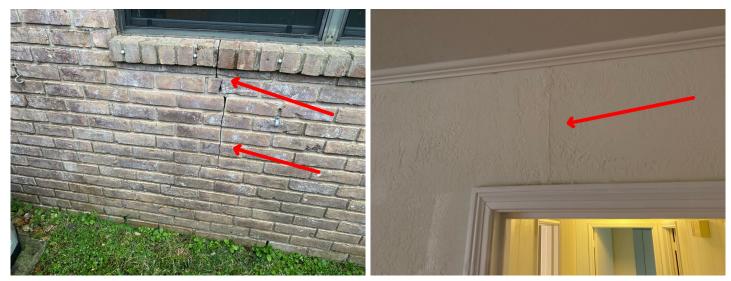
• Cosmetic hairline cracks were observed in areas of the drywall of the home. These cracks are normal with wood structure homes in our area. Hairline drywall cracks are typically caused by settling and/or the expansion and contraction of the ground, framing, and finishes.

Crack on the brick siding on the right side of the home

Crack on the drywall in the living room
