KELLY INSPECTION SERVICES RESIDENTIAL INSPECTION

12863 Westhorpe Dr Houston, TX 77077

PROPERTY INSPECTION REPORT FORM

Wendy Smith Name of Client 12863 Westhorpe Dr, Houston, TX 77077	12/16/2023 8:00 am Date of Inspection
Address of Inspected Property Ricardo Hughes Name of Inspector	TREC# 25816 TREC License #
Name of Sponsor (if applicable)	TREC License #

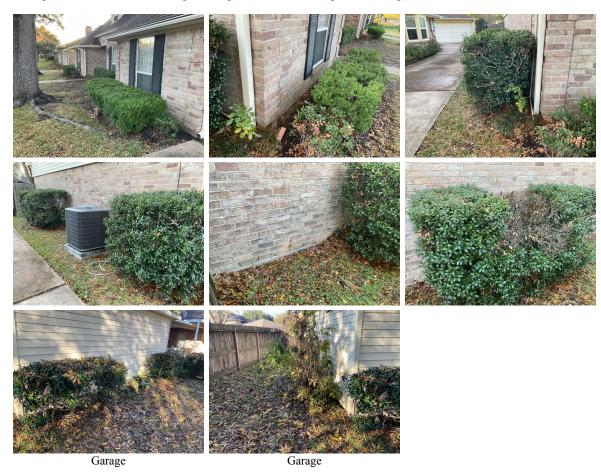
Foundation is covered from view:

Siding, structures, veneer, or vegetation prevent a visual inspection of a portion of the foundation.

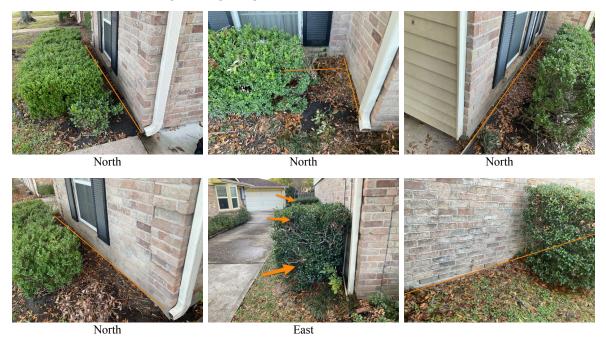
2: Grade too close to siding

Foundation walls minimum 6 in. above earth (4 in. if masonry veneer used) IRC 404.1.6

Recommendation: Contact a qualified grading contractor.

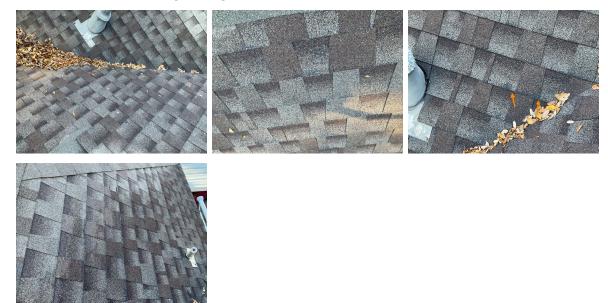
4: Granular loss

Granules Protect the shingle from UV light and direct rain off the roof.

Recommendation: Contact a qualified professional.

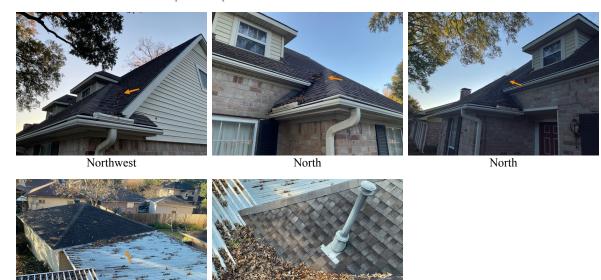
6: Excessive buildup of leaves

One or more areas of the roof have an excessive build up of leaves. This condition will trap excessive moisture in these areas, leading to an earlier than expected failure of the roof covering. We recommend a qualified handyman remove the leaves. Also consider trimming trees in the area to avoid this issue as well as the potential for damage to the house if the tree were to fall into the structure.

Recommendation: Contact a qualified professional.

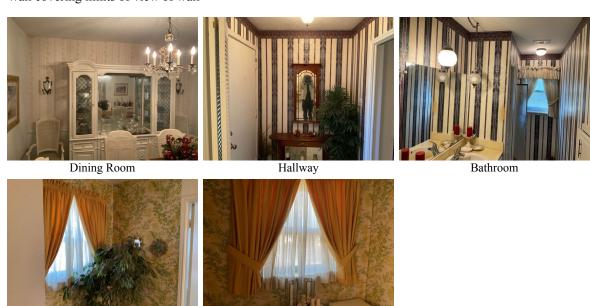
Wall paper covering limits of view of wall: Wall covering limits of view of wall

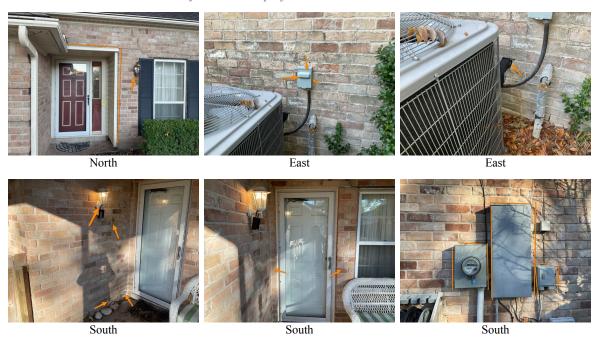
The expansion joints in one or more locations are missing the proper caulking to shield it from the exterior elements. Have a qualified professional evaluate all expansion joints and apply appropriate caulking as needed.

Recommendation: Contact a handyman or DIY project

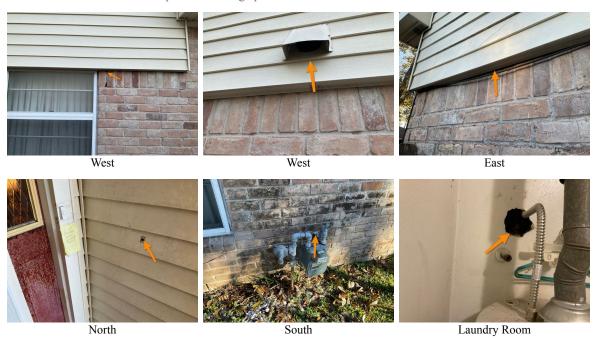
4: Open wall penetration

Exterior

One or more areas of the exterior of the house has damage creating an opening in the wall system, and reducing the effectiveness of the protection that drywall provides as well as compromising the building envelope that contributes to an efficient HVAC system. Have a qualified professional repair all penetrations.

Recommendation: Contact a qualified siding specialist.

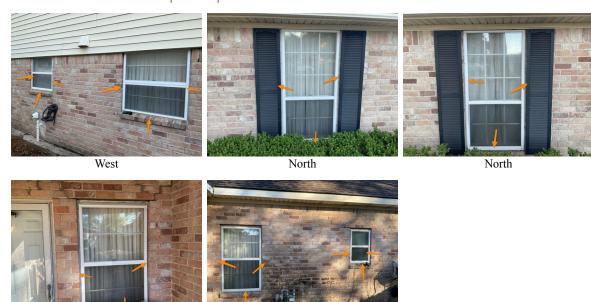
2: Failure of exterior window caulking

The exterior windows at various points on the north side showed signs of cracking and not maintaining exterior seal. I recommend a qualified person re-caulk all windows.

Recommendation: Contact a qualified professional.
