Property Inspection Report

3806 Country Rd, Pasadena, TX, 77505

Inspection Date: 2/28/2024

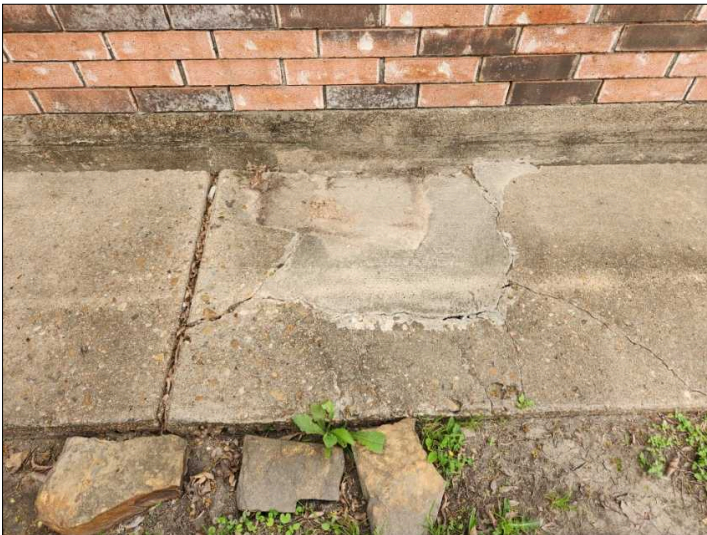
There are indications of previous foundation repair. We recommend you refer to the structural engineer's report if available for further information of repairs, warranty and proper maintenance of the foundation. There is often a transferable warranty after work has been completed, recommend contacting the homeowner for more information.

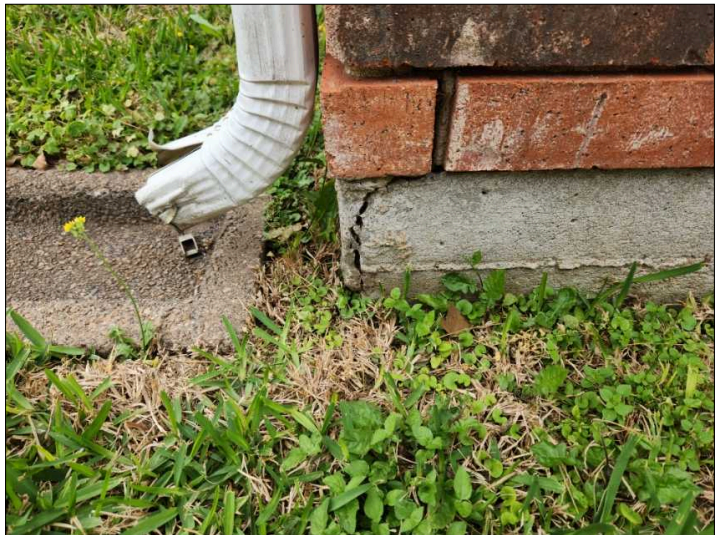
Corner pops were noted on one or more corners of the foundation. These are usually considered cosmetic in nature unless other movement is noted. Recommend sealing all cracks to help prevent further deterioration.

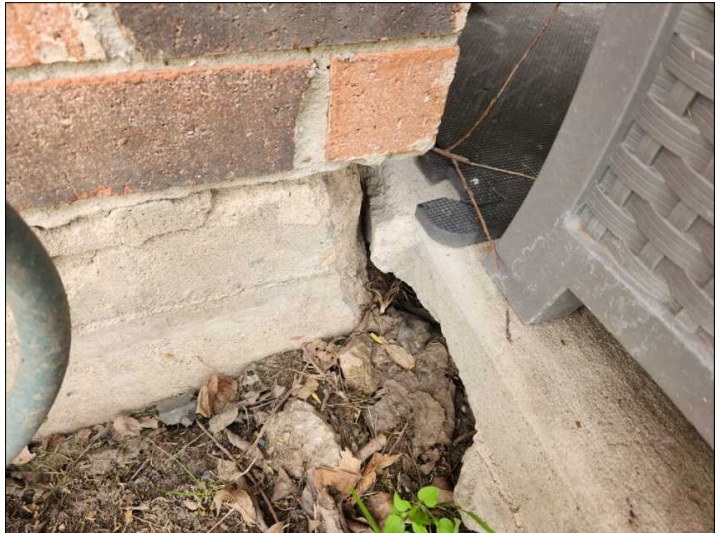
Corner chips or breaks were noted on the corner(s) of the foundation. These are usually considered cosmetic in nature unless other movement is noted. Recommend patching or repairing to help support corner above. Mainly at - rear

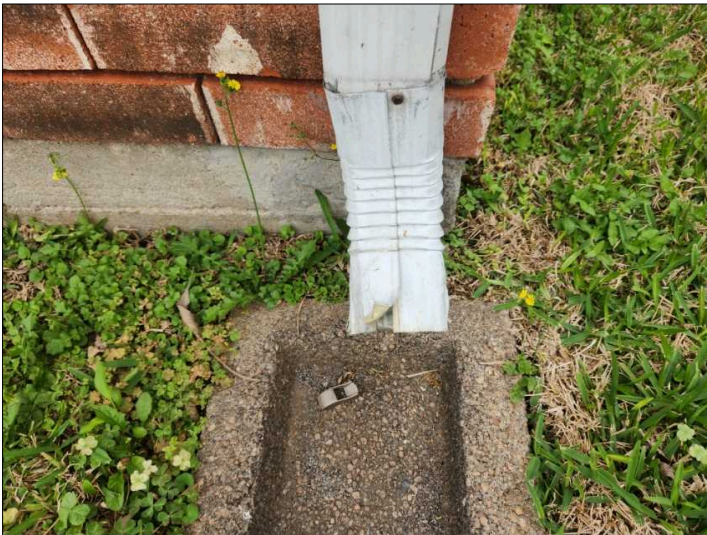
The 90 on the downspout was damaged. Mainly at - front

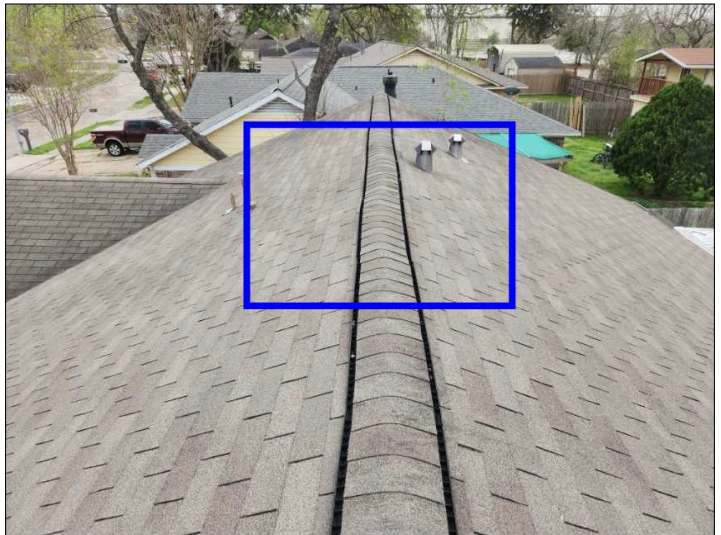
There are indications that there is deteriorated decking under the roof covering due to a soft spot under the shingles, recommend contacting a roof specialist to evaluate and repair as needed and check entire roof for other issues that may be of concern.

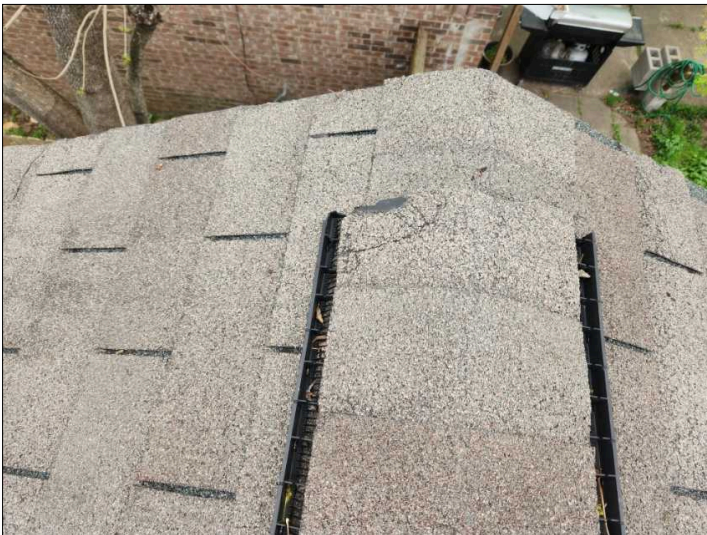
There are damaged or missing ridge shingles on the roof, recommend repairs or replacement of damaged ridge shingles.

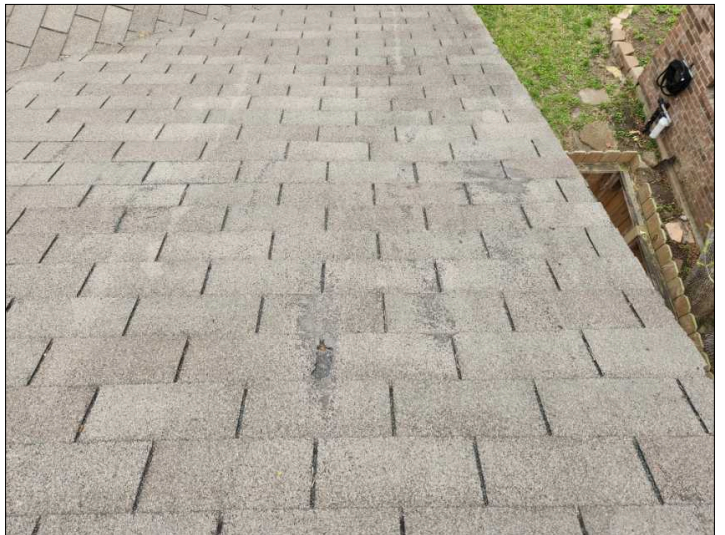
Due to the excessive granular loss on the roof covering the roof may age prematurely. We recommend further review of the roof system for a better understanding of the present condition.

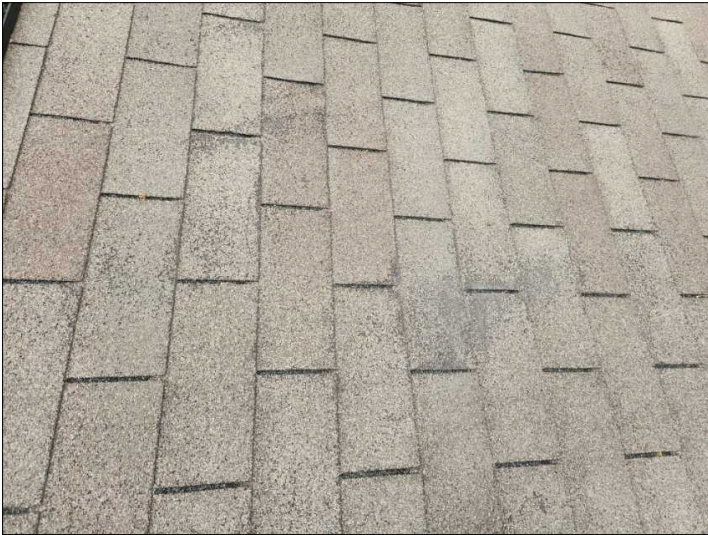
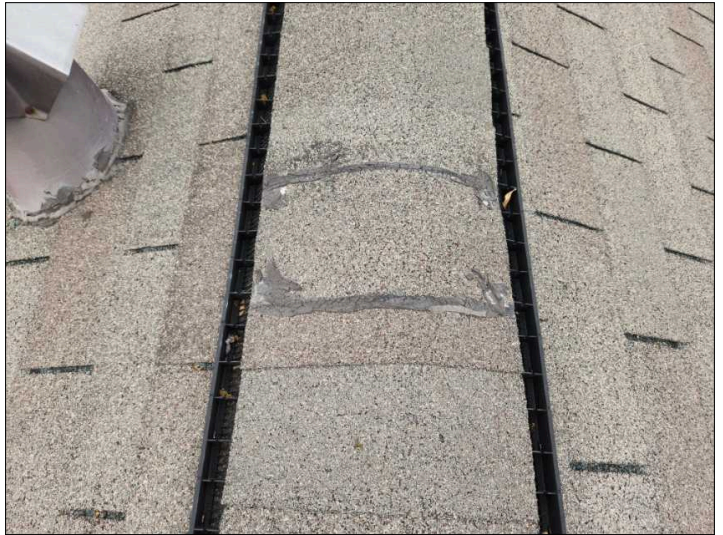
Due to the excessive granular loss on the roof covering the roof may age prematurely. We recommend further review of the roof system for a better understanding of the present condition.

Signs of previous repairs were noted on the roof. Indications are that they are working as intended at time of inspection.

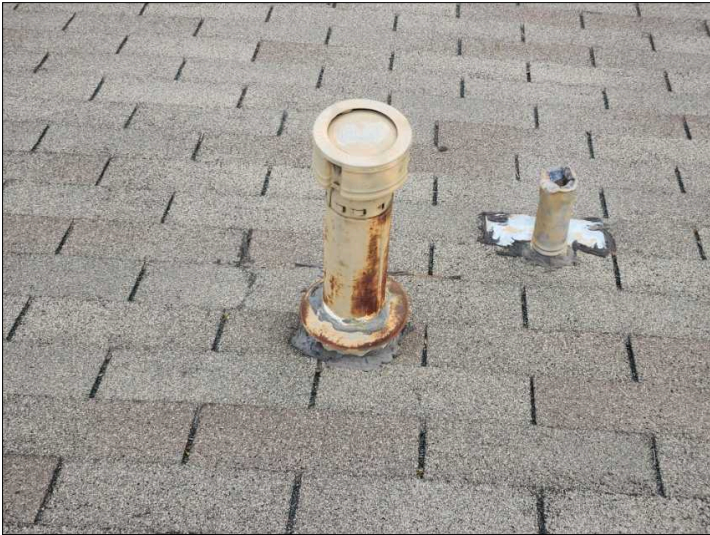
There are signs of rusted vents or flashing on the rooftop. We recommend painting or replacing all rusted or deteriorated vents or flashing as needed.

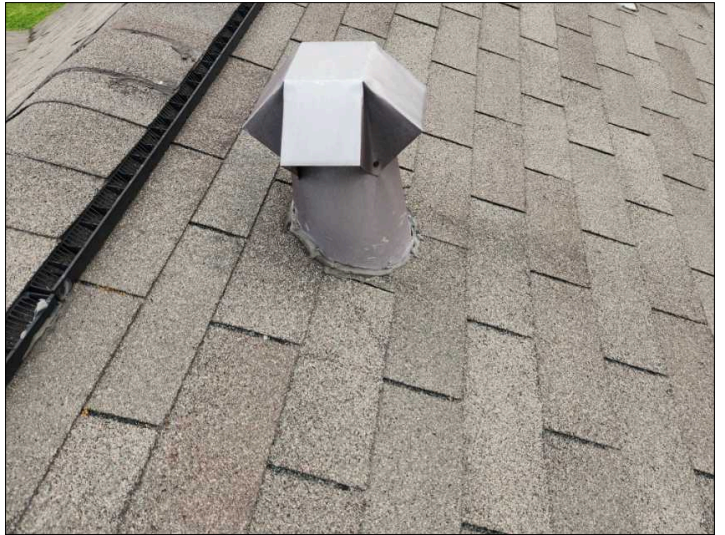
Improperly installed vent flashing

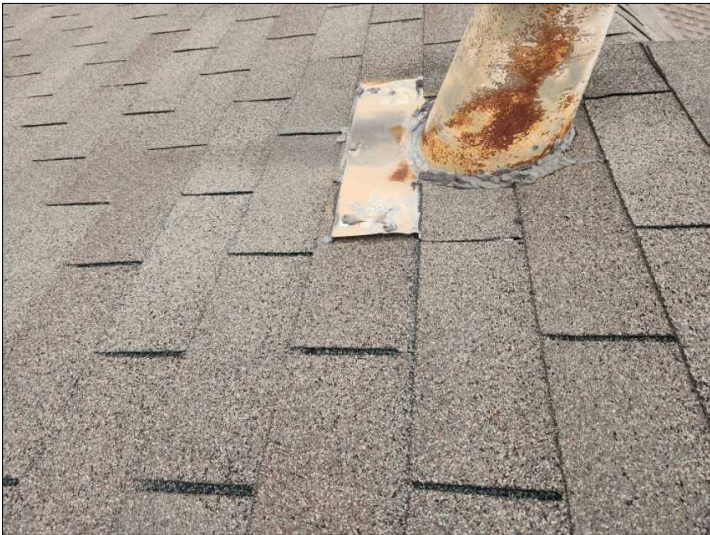
The roof flashing is lifted. Recommend securing all loose or lifted flashing and sealing nails to help prevent water penetration.

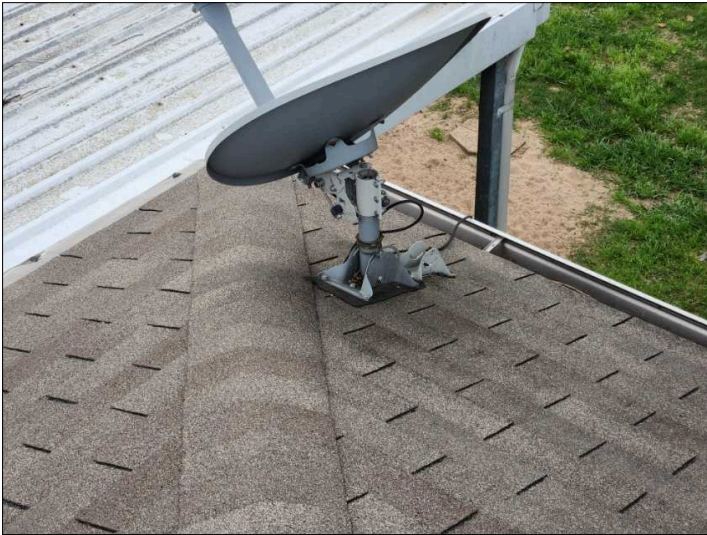
There is/was a satellite dish mounted to the roof structure. It is recommended that the Satellite dish be properly mounted at the siding of the home or on a stand-alone base in the yard. Recommend sealing the mounting hardware to help prevent water penetration.

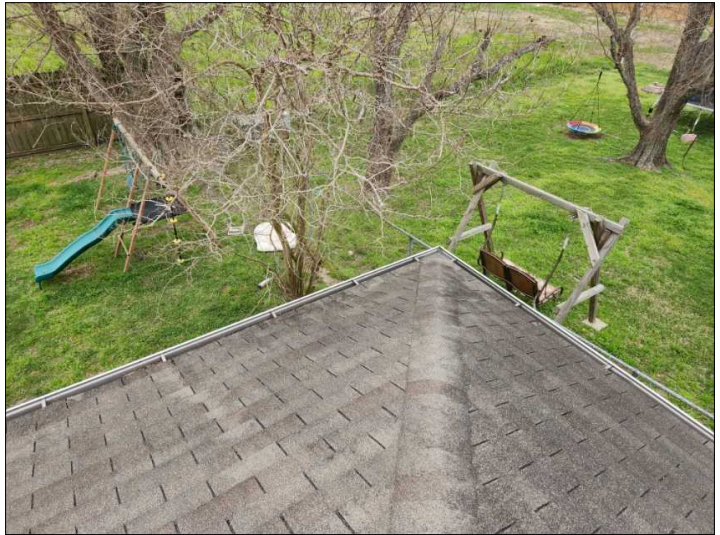
Tree limbs should be kept trimmed at least 5' from roof to help prevent damage to the roof during windy conditions.

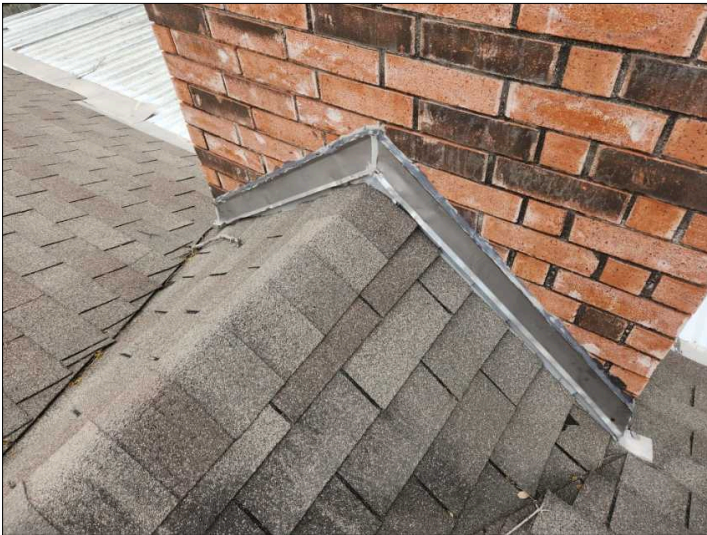
One or more of the vents and or flashing is unpainted, recommend painting all unpainted vents and flashing to help prevent damage due to UV rays or rust.

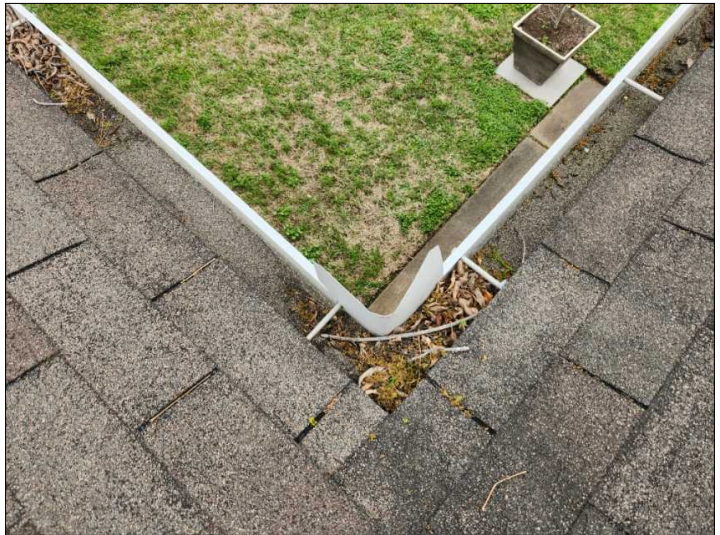
There is debris in the gutters, recommend cleaning gutters to restore to proper operation.

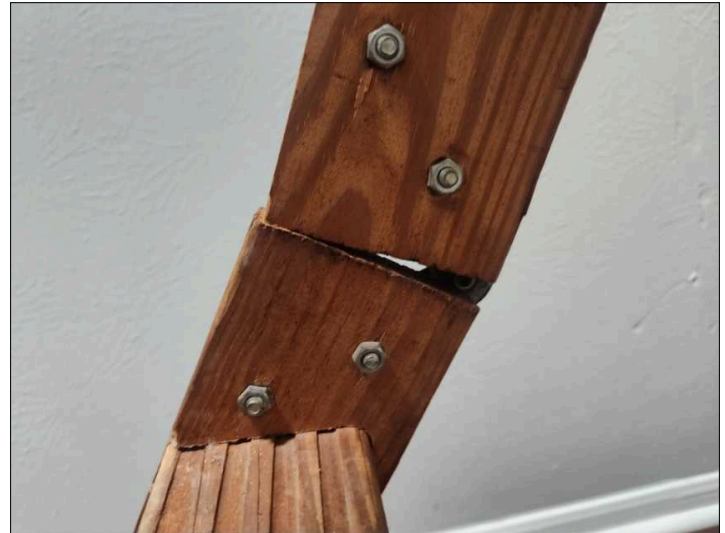
Attic stairway not cut properly to the floor, recommend cutting ladder so the ladder is a straight line when in the down position, otherwise it will put undue stress at the hinge and can cause ladder to fail.

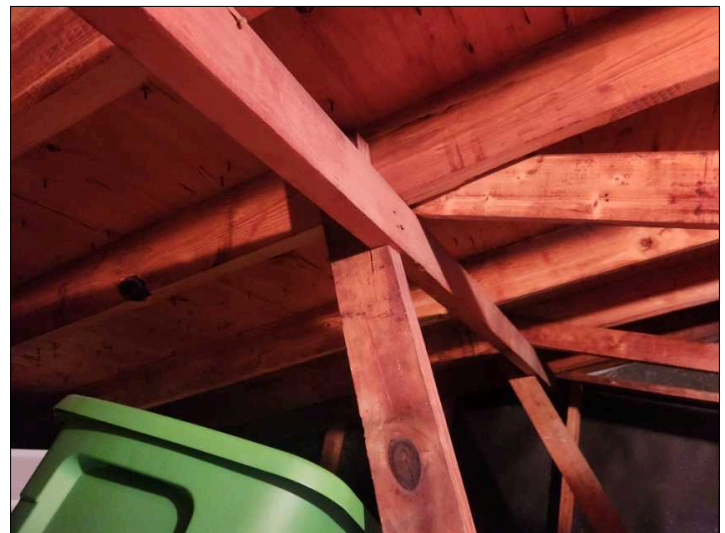
The purlin should be at least as large as the rafters they support the purlin braces should be no more than 4' apart and purlin braces should not be notched. This is a common occurrence in older homes, however if sagging is noted you may want this evaluated by a contractor or structural engineer as more support may need to be added.

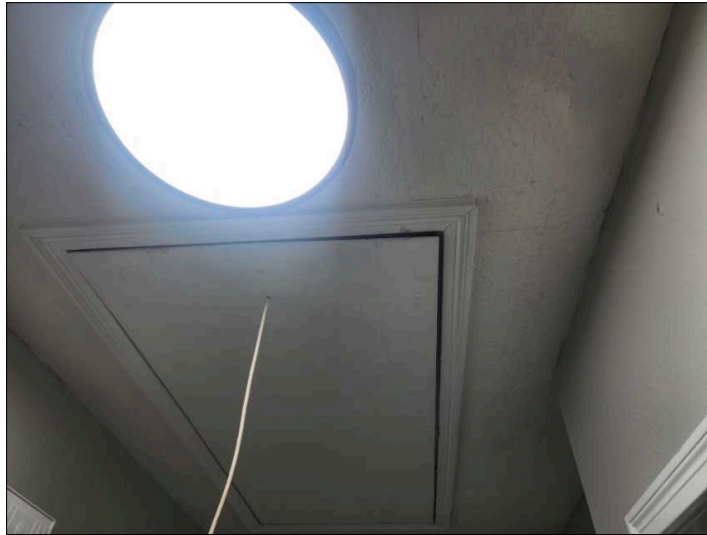
The attic pull-down stairs do not close properly, allowing conditioned air to be lost into the attic or attic air into conditioned space of the home.

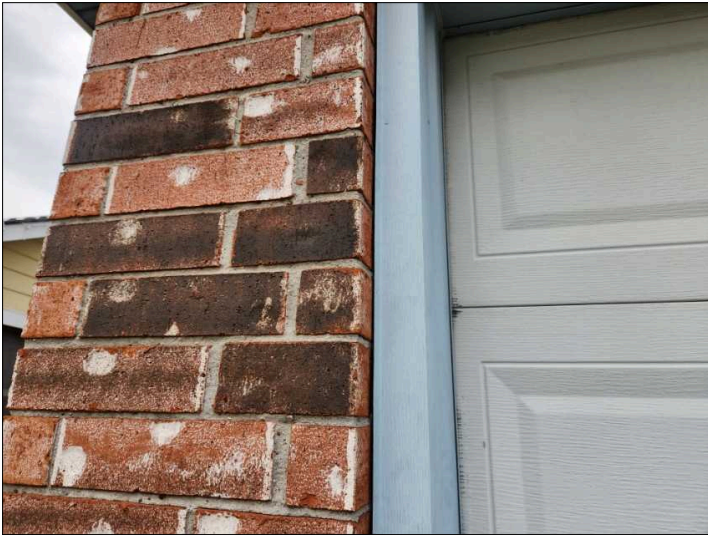
Recommend sealing between the trim and brickwork to help prevent water penetration. Mainly at - front

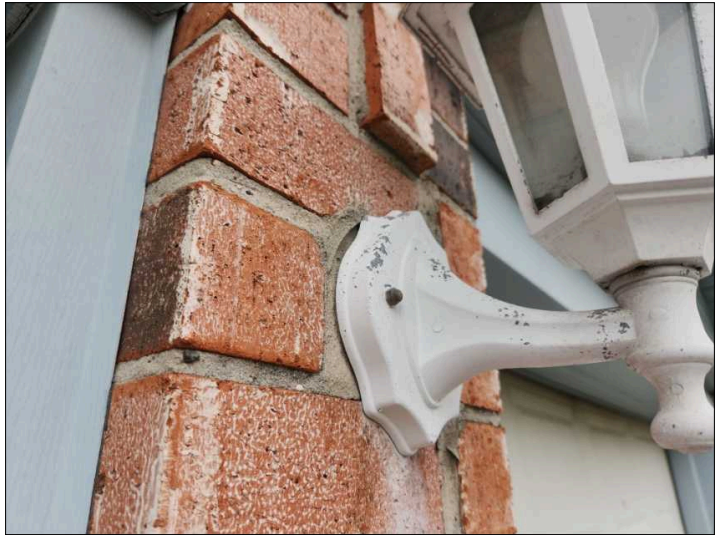
Seal all electrical lighting fixtures at wall connection to help prevent water penetration. It is a good idea to leave a small opening at the bottom to allow any water penetrating to escape.

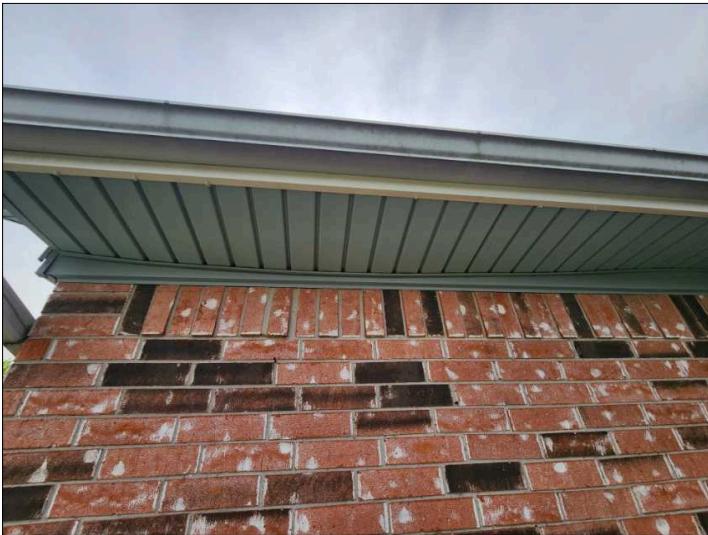
There is loose soffit material at the eave, recommend securing to help prevent damage and water penetration. Mainly at - front

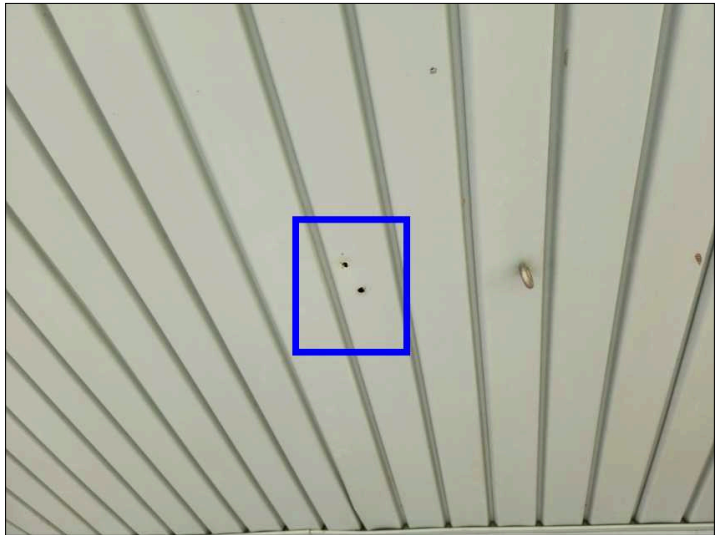
Seal gaps and holes in soffit to help prevent water penetration and rodent intrusion. Mainly at - front patio

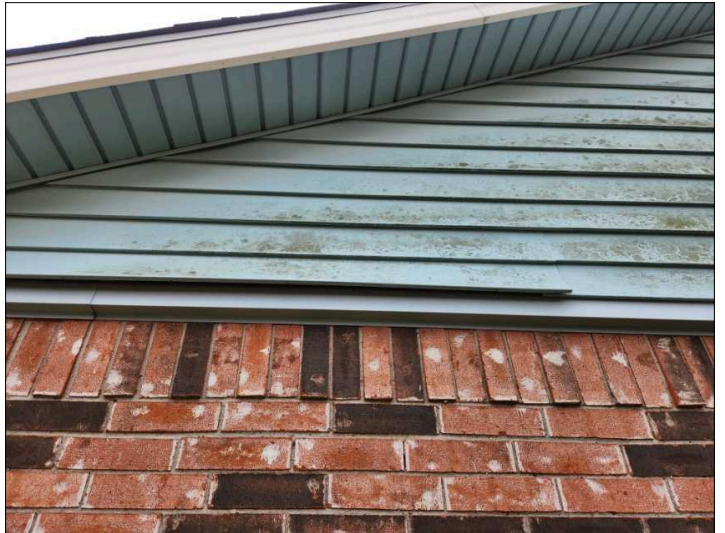
There is loose siding on the home, recommend securing all loose siding to help prevent damaged and water penetration. Mainly at - right

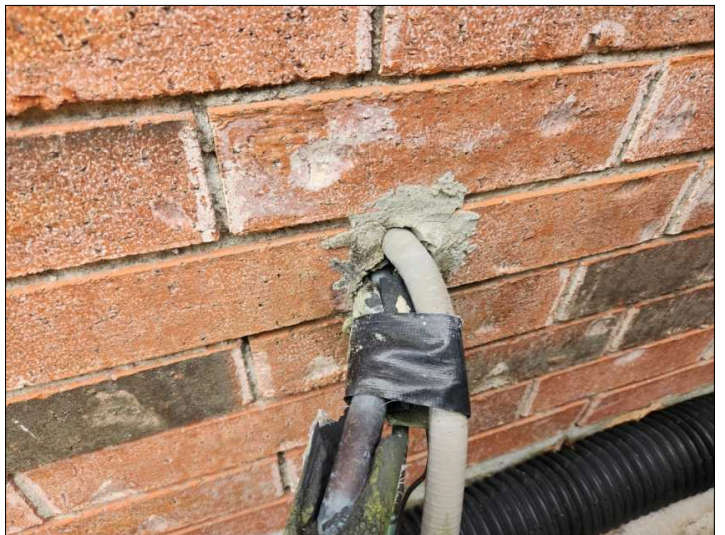
Seal A/C line entry at wall connection to help prevent water penetration.

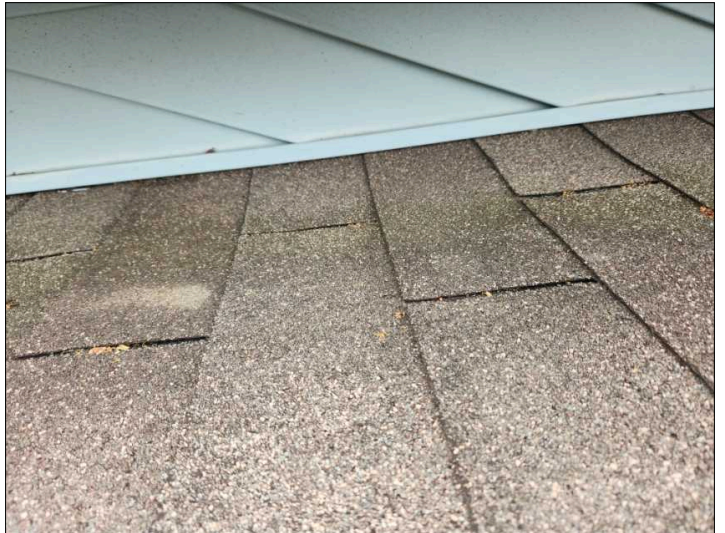
The siding is closer than recommended or in contact with the roof. It is recommended that there be a separation to help prevent water from wicking up into the siding material causing deterioration.

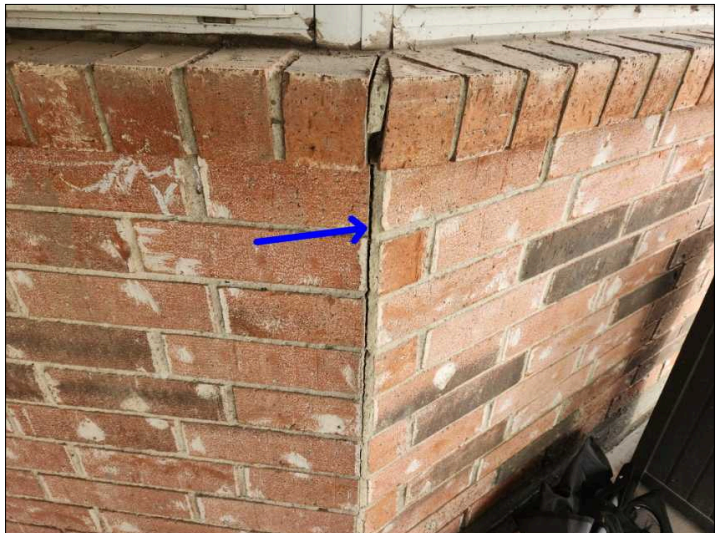
Settlement cracks were noted in the brickwork. Mainly at - rear

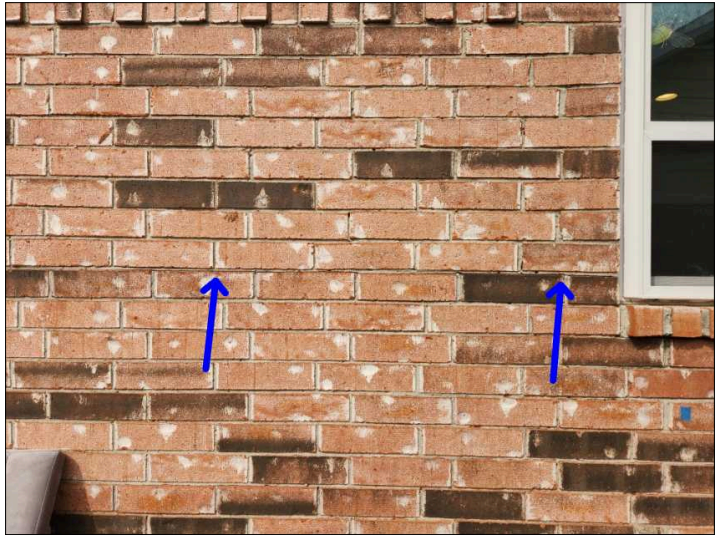
There is a separation at the brickwork which is an indication of settlement or foundation movement. This may require further attention if other movement is noted. Mainly at - rear

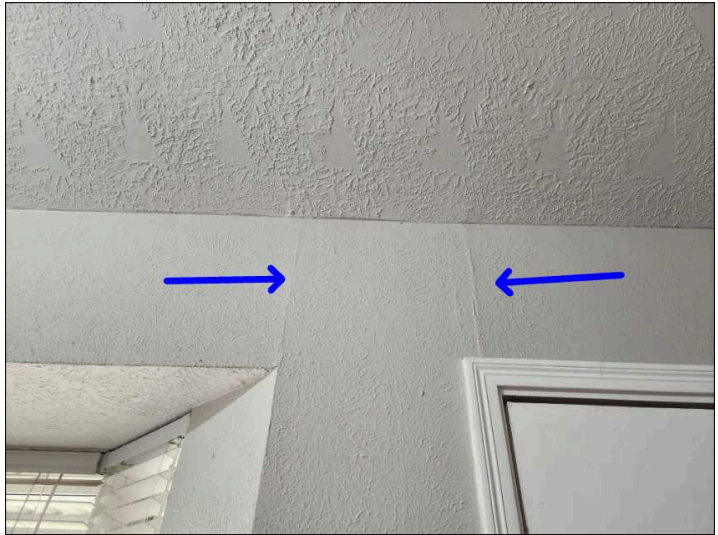
Settlement cracks were noted at the tape joint in the drywall. Mainly at - dining room

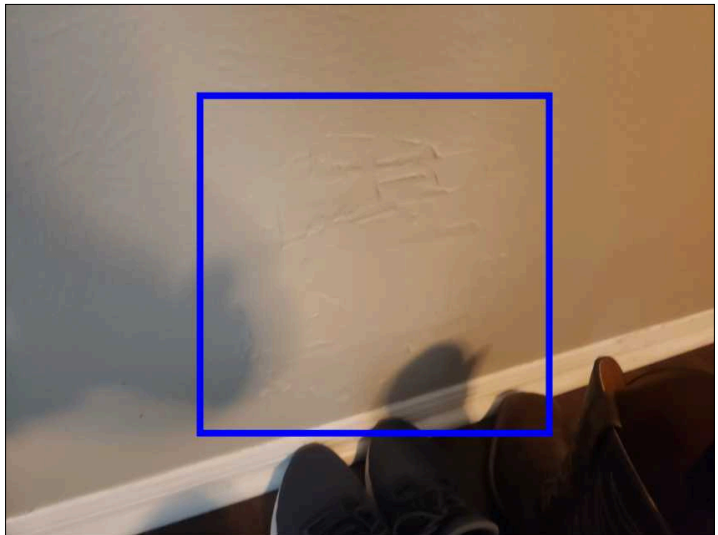
There is evidence of previous patch work and or painting on the interior finishes. Recommend contacting homeowner for more information. Mainly at - primary bedroom

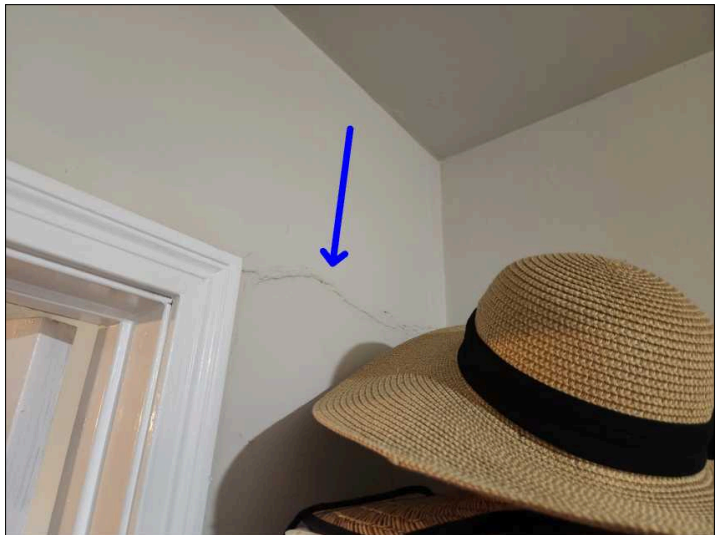
Settlement cracks were noted in the drywall.
Mainly at - primary closet

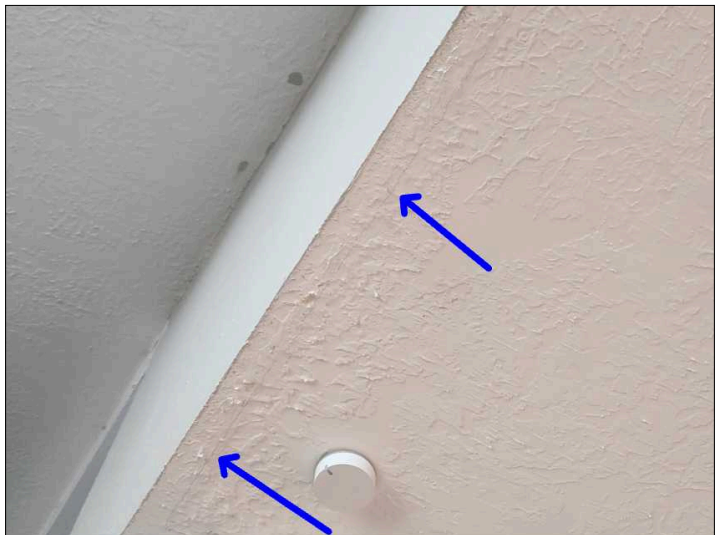
Settlement cracks were noted at the corner bead/tape joint in the drywall. Mainly at - kitchen

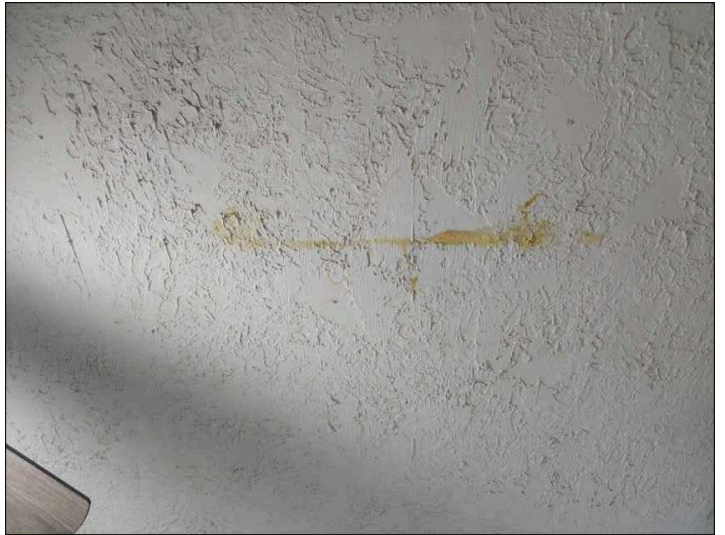
Settlement cracks were noted in the drywall. These are generally considered cosmetic only, unless otherwise noted. Mainly at - hallway

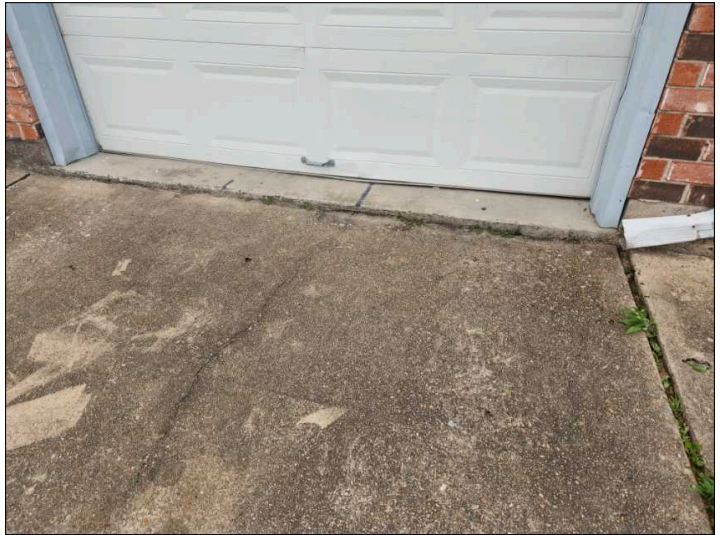
Uneven pavement was noted, recommend repairs to help prevent tripping. Mainly at - driveway

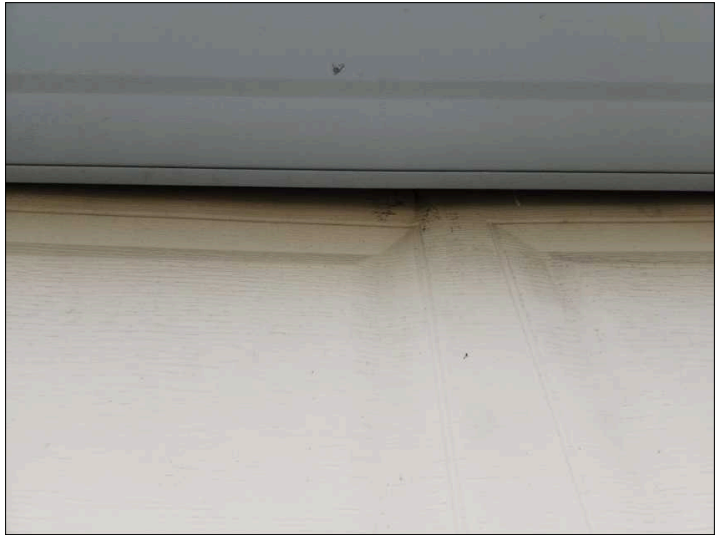
Garage door is dented.

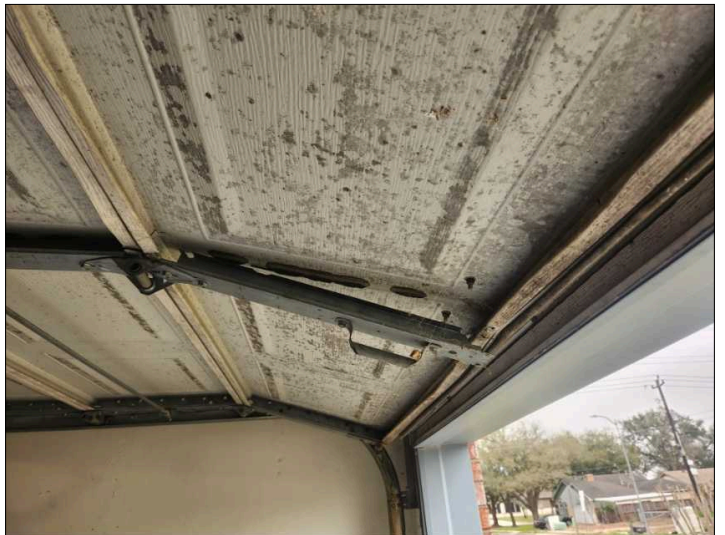
Garage door hardware is loose.

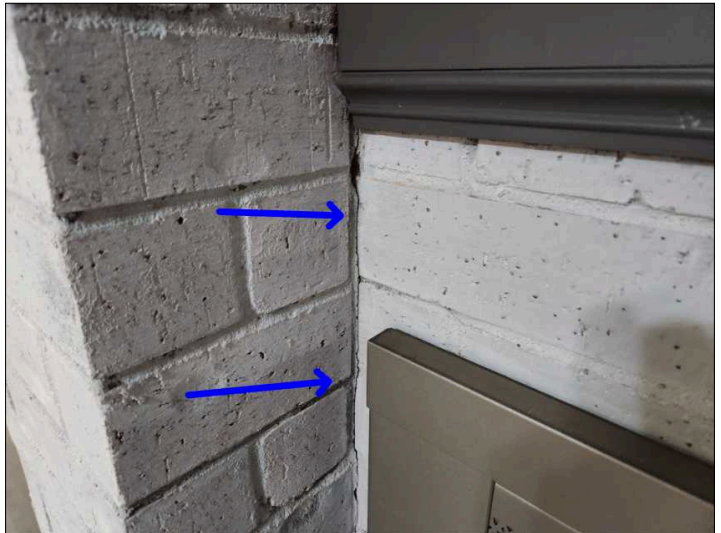
There are cracks present in the materials surrounding the fireplace firebox. Recommend repairs to seal the finished materials to prevent further deterioration.

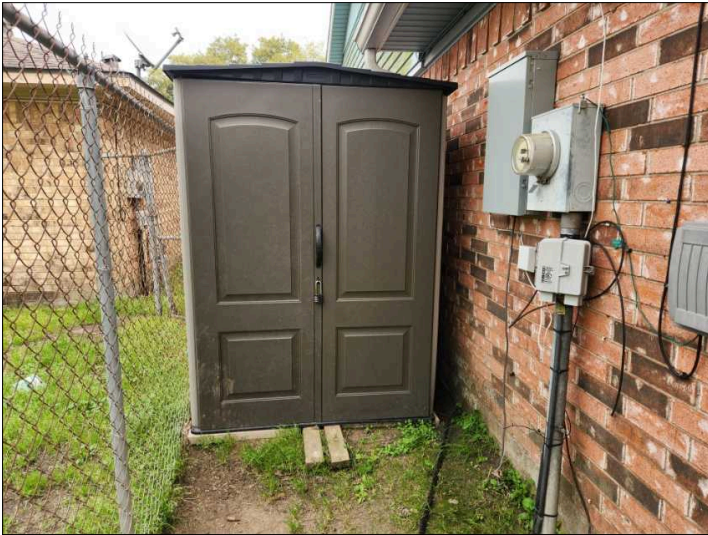
Wood or other debris is stacked against the house. Recommend all wood or other materials be separated from the structure to help prevent conducive conditions for wood destroying insects.

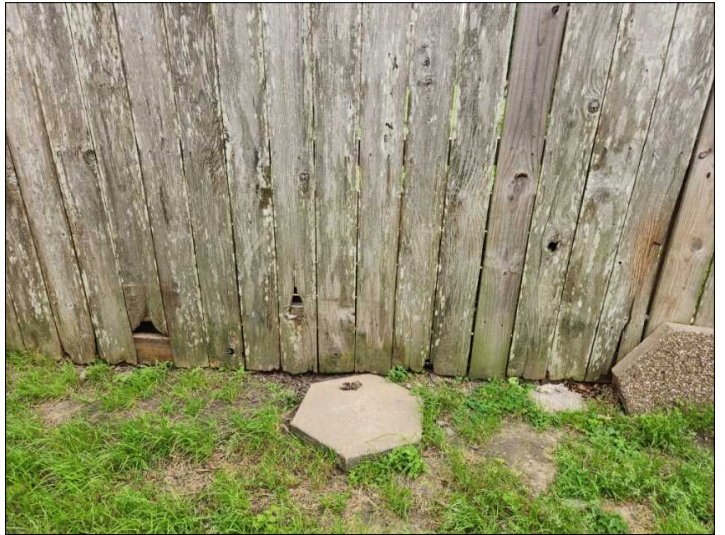
Although fences are not inspected it was noted that the fence is showing some signs of damage or deterioration.

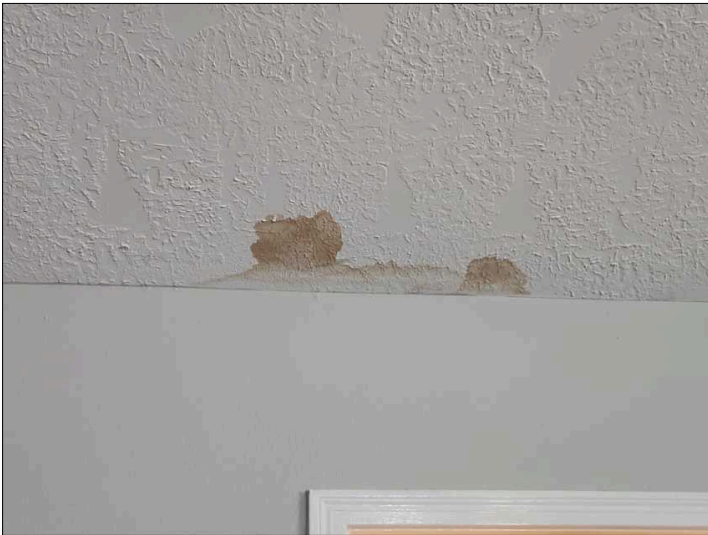
There are indications of water penetration to the ceiling evident mainly by staining. Unable to determine condition of the underlying materials. Mainly at - living room

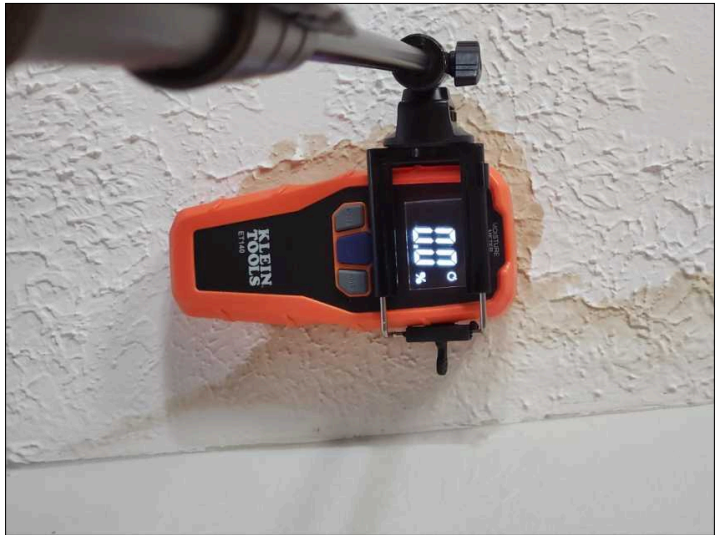
Checked water stain with a moisture meter and found it to be at a normal level. Unable to determine condition of the underlying materials. Mainly at - living room

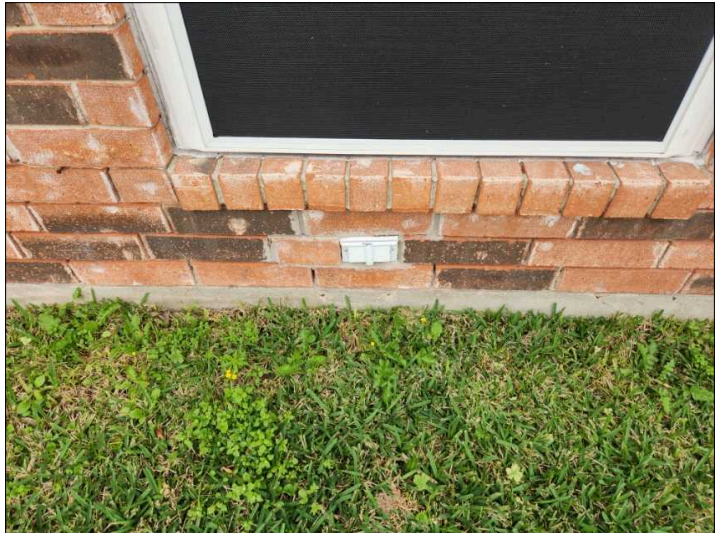
Recommend replacing all wet area exterior receptacle covers with the code approved bubble style cover.

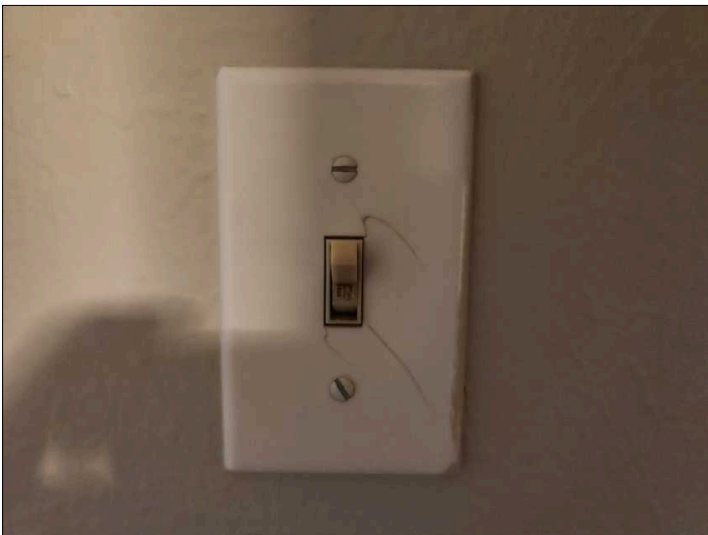
Switch plate is broken or missing, recommend replacing covers to help prevent electrical shock. Mainly at - primary bedroom

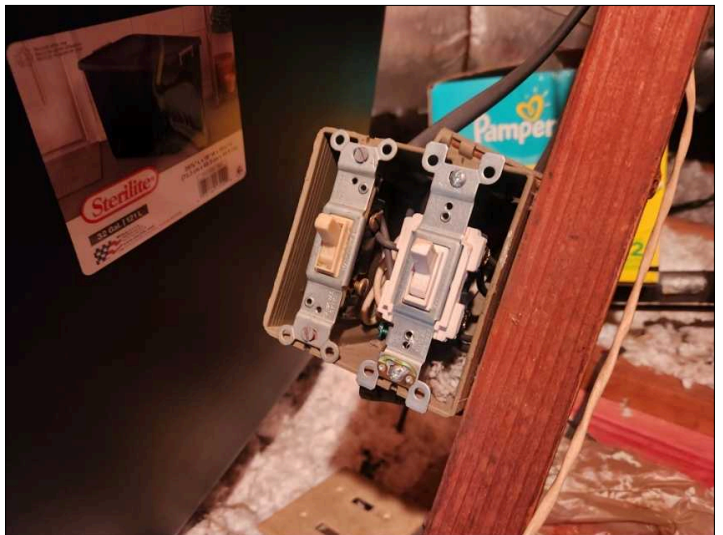
Switch plate is broken or missing, recommend replacing covers to help prevent electrical shock. Mainly at - attic

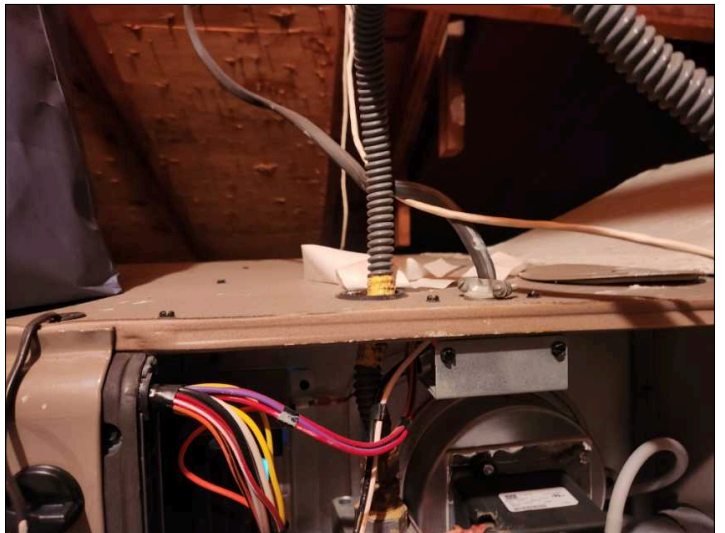
The flexible gas line for the gas-fired furnace passes through the air handler which could cause damage to the gas line and a possible leak this is a life safety issue and should be repaired immediately, it is recommend that the gas line be hard piped out of the unit to help prevent damage to the flex line.

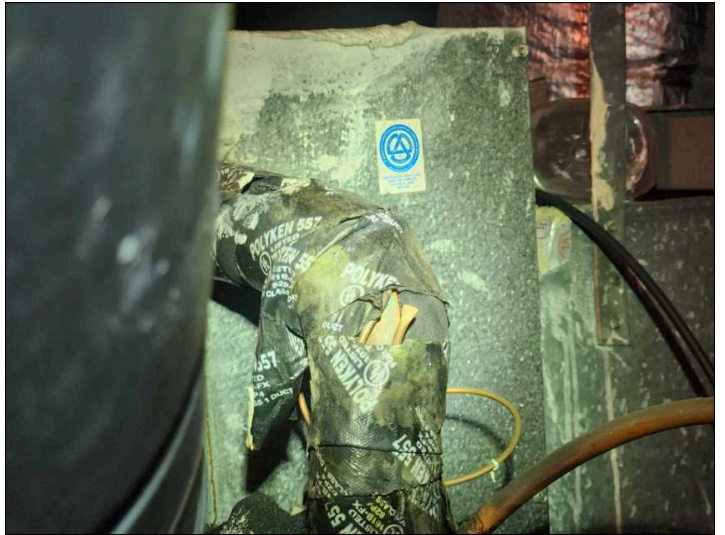
The insulation on the A/C condensation or low pressure refrigerant line is missing at the evaporator unit. Recommend insulating to prevent moisture damage to ceiling surfaces.

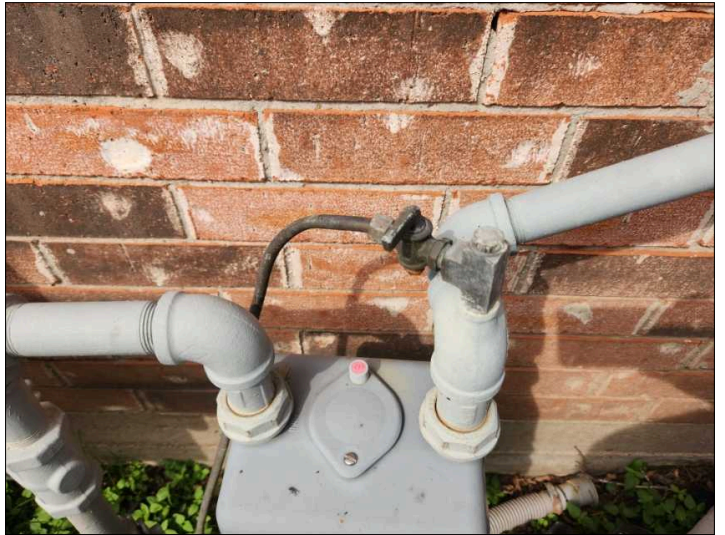
Unapproved gas valves were noted, recommend changing all unapproved gas valves. These valves are designed with a spring at the bottom of the valve which weaken over time causing gas to leak when operated. Although they may not be leaking at the time of inspection they have a high likely hood of leaking when operated. Mainly at - gas meter

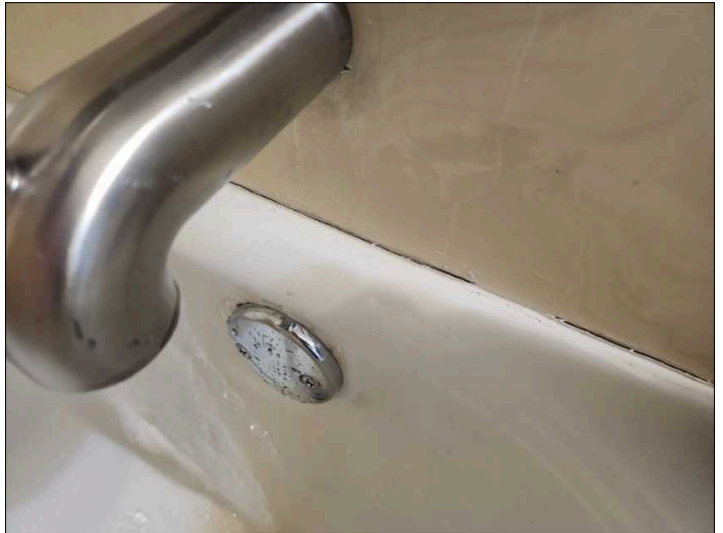
Recommend sealing the tub/shower surround to help prevent water penetration to underlying materials. Mainly at - hall bath

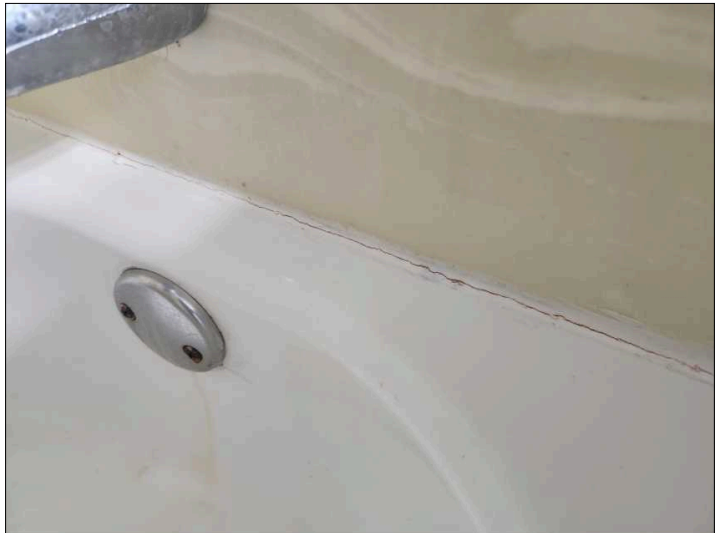
Recommend sealing the tub/shower surround to help prevent water penetration to underlying materials. Mainly at - primary bath

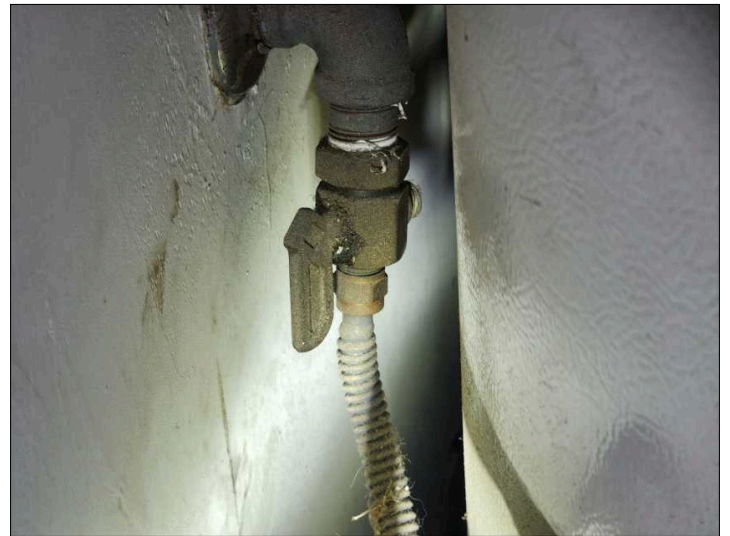
There is an unapproved gas valve installed at the water heater. Although they may not be leaking at the time of inspection they have a high likelihood of leaking when operated.

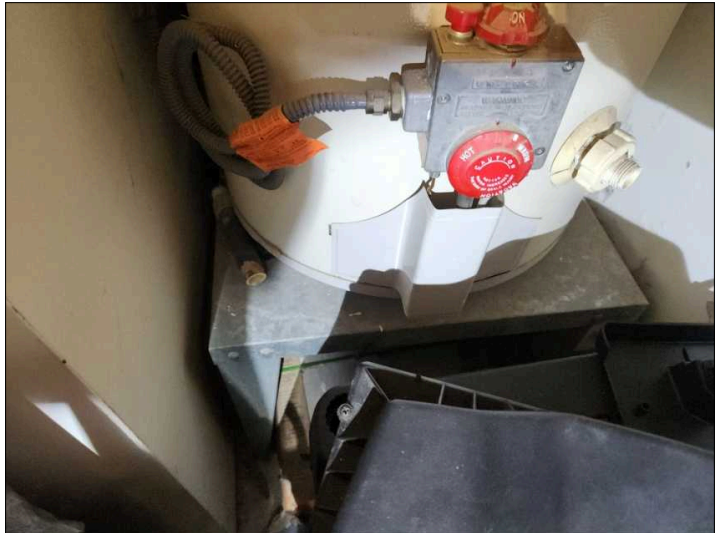
There is no drip pan for the water heater installed in the garage. It is recommended that if the water heater is installed in the home or attic that a pan be installed and drain to the exterior of the home. If the water heater is installed on the upper level of the garage it should drain to the exterior or at least drain to the lower level of the garage to help prevent the water heater from flooding the home in case of a failure.
