# Harry H. Jones Inspection Service

## PROPERTY INSPECTION REPORT

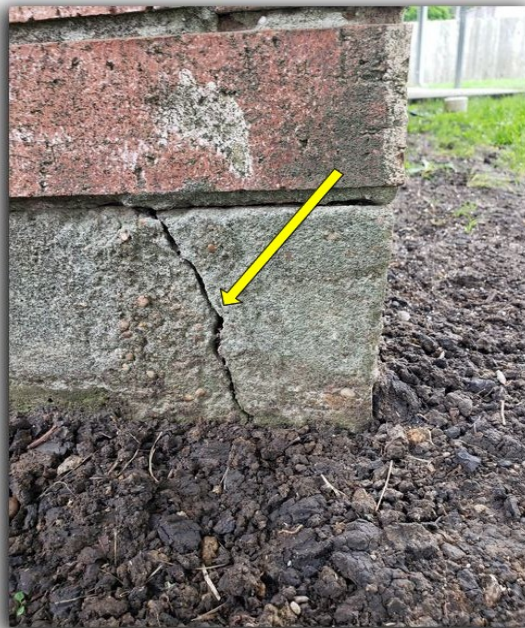
*NOTE: there were one or more observed "corner cracks" at the foundation grade beam. These are usually the result of thermal expansion of the brick veneer wall exerting pressure on the foundation grade beam corners where there is little or no reinforcing steel. This is typically not a structural problem, but should be monitored.*

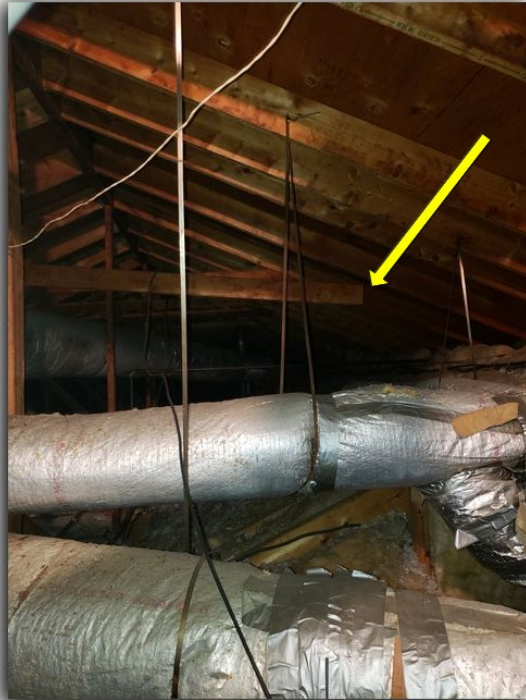
Collar tie not fastened at one end.

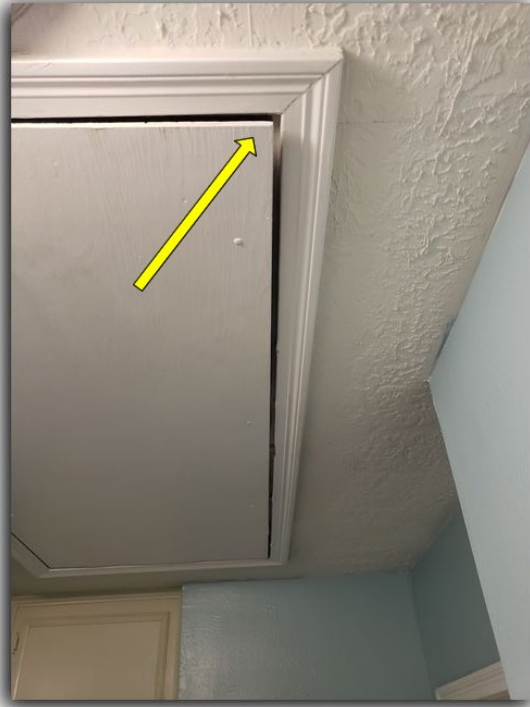
Attic pull-down stairway does not fit/close/seal properly. This will allow cooled or heated air from the residence to escape into the attic and/or allow hot air from the attic to enter the residence. This will also allow insects such as mosquitoes and wasps to enter the residence from the attic.

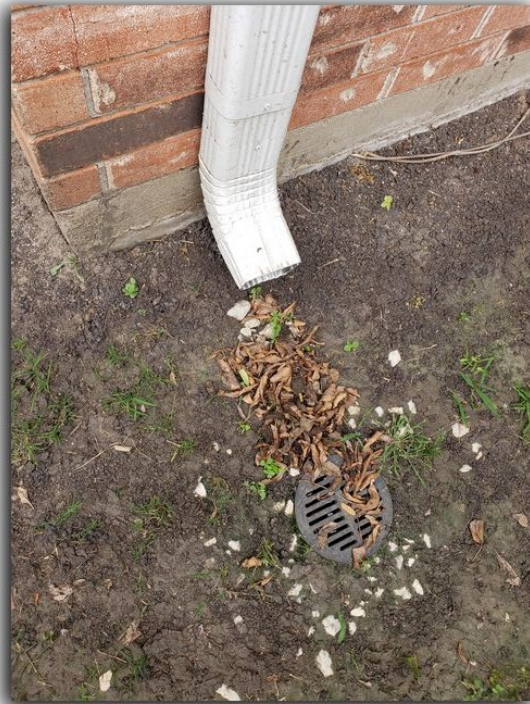
Splash block missing at one or more downspouts. The primary purpose of splash blocks is to direct rainwater at least 18" away from the foundation.

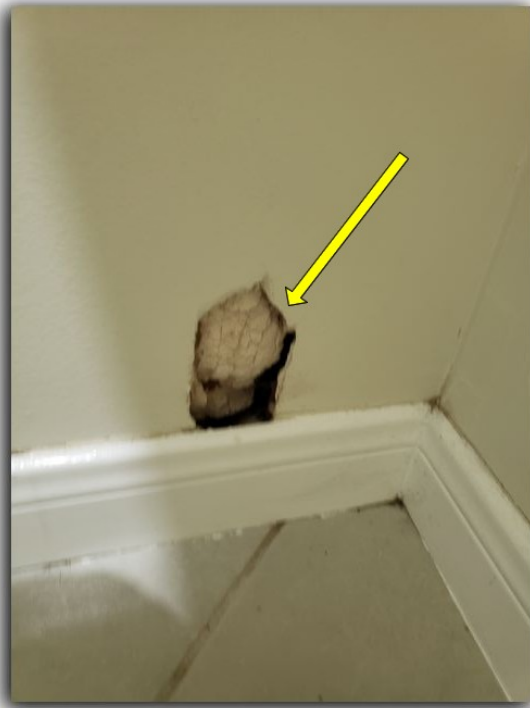
One or more holes observed at wall surfaces (example, kitchen pantry).

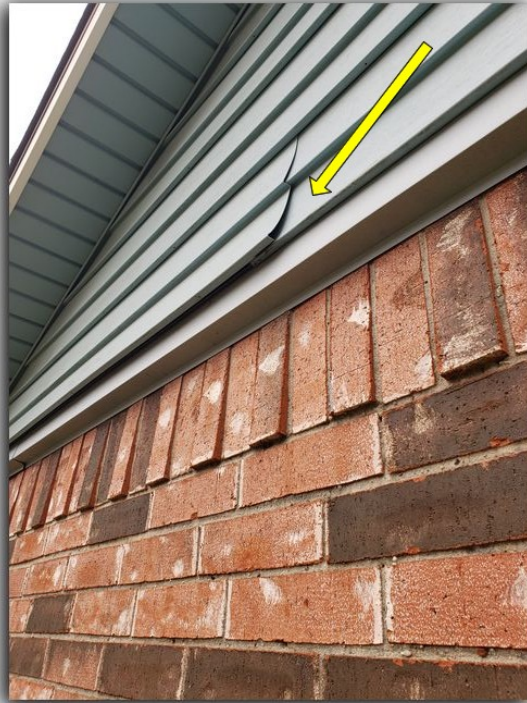
Exterior siding loose.

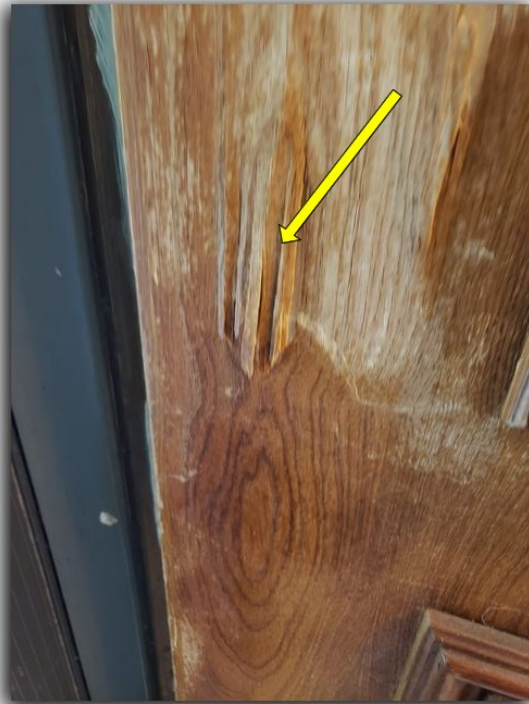
Door damaged: front entry door.

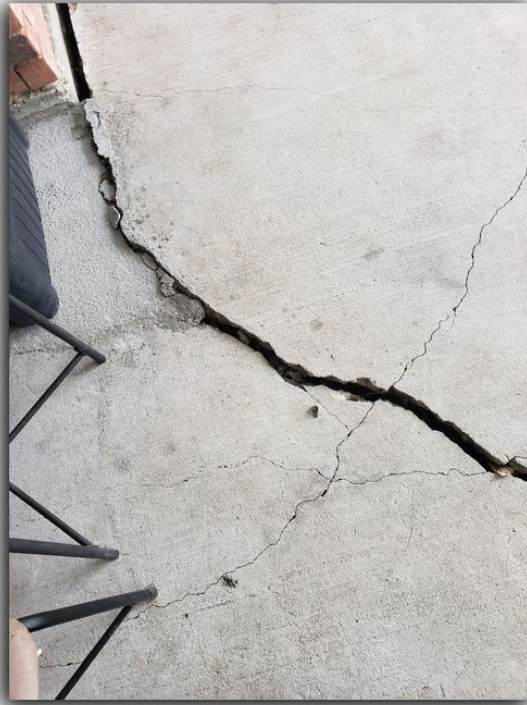
The concrete deck flooring was deteriorated/damaged (large cracks).

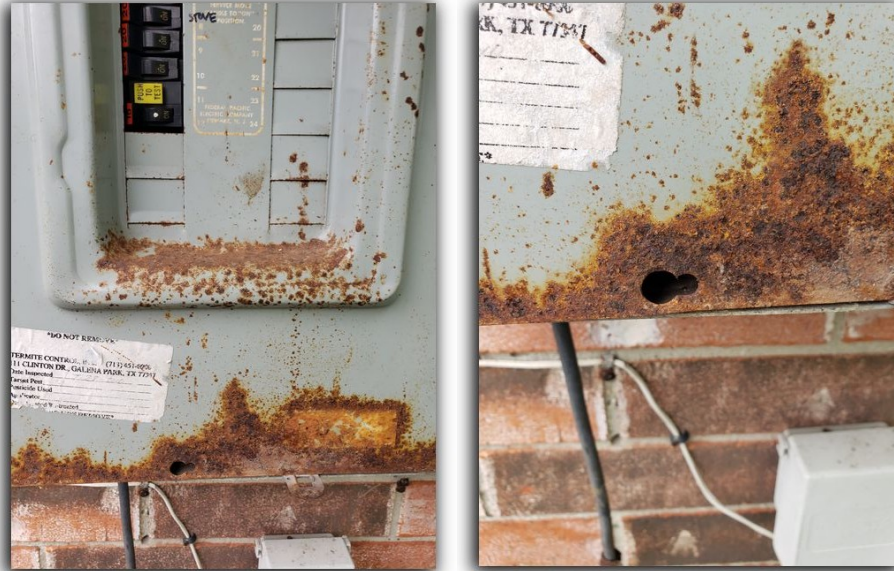
The panel was excessively rusted.

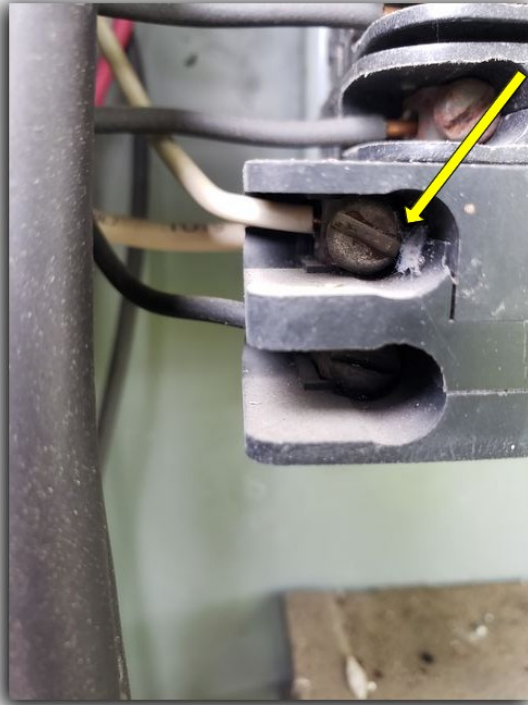
Inner panel not secured (bolt rusted).

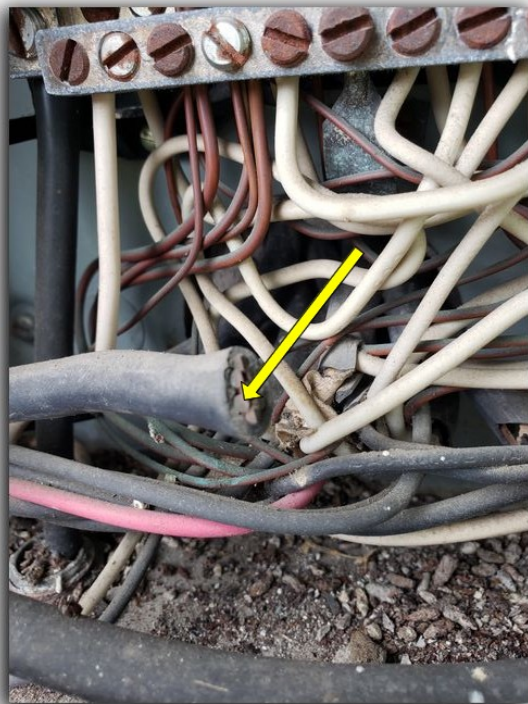
Abandoned wiring (national code says abandoned wiring should be removed from the panel).

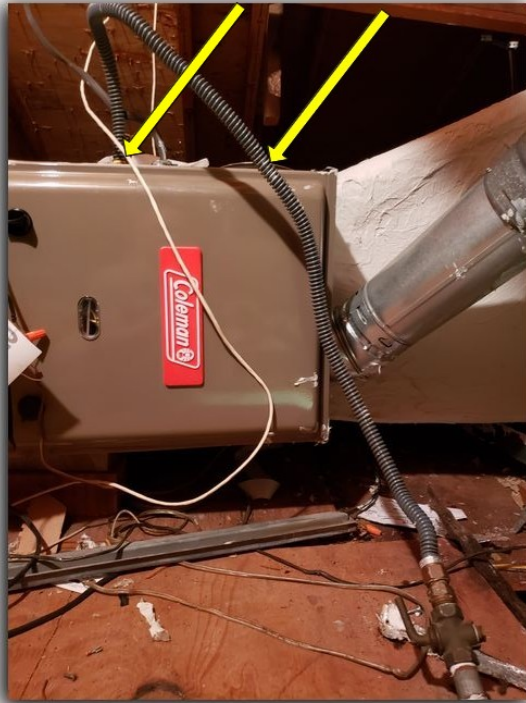
The flexible appliance gas connector was inserted through the heating unit cabinet wall. This may damage the connector resulting in a gas leak.

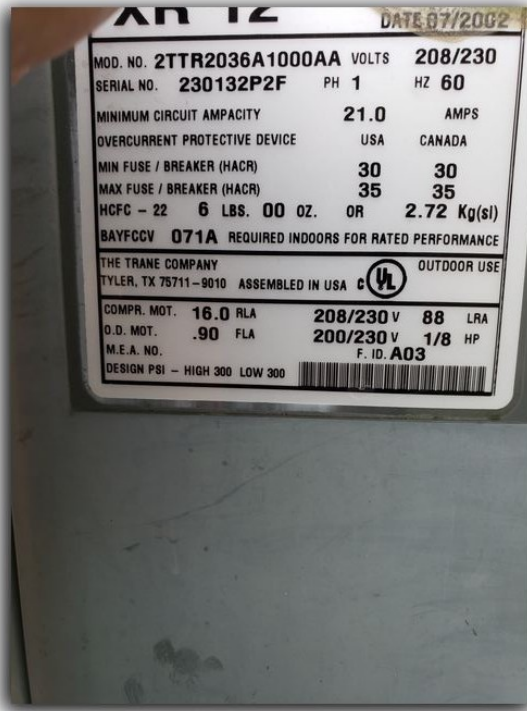
The exterior compressor unit was manufactured by Trane. The unit was manufactured July 2002 (18 years old). **Per normal industry recommendations, this unit is likely at the end of its useful life and you should plan for replacement.**

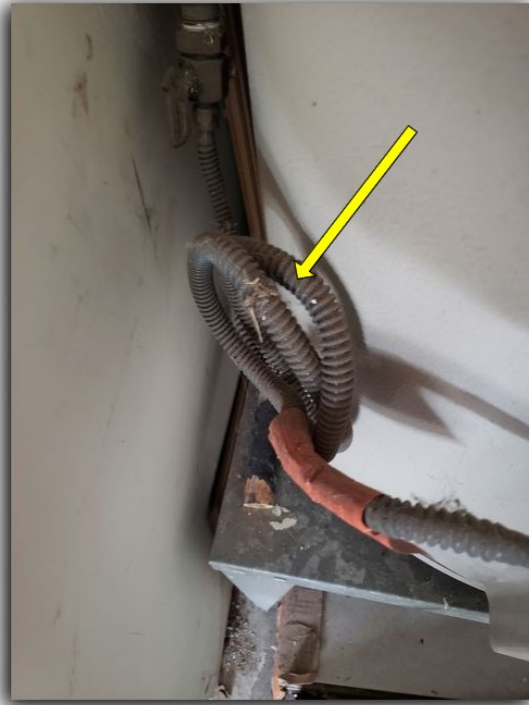
The flexible appliance gas connector (CSST) was not properly bonded.

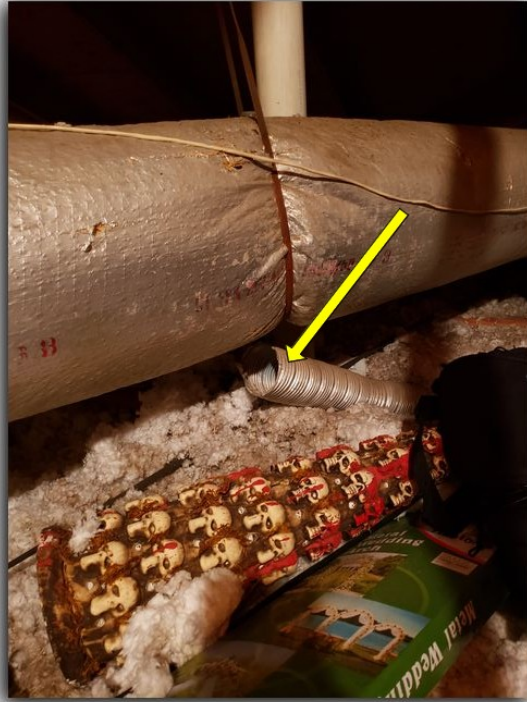
Bathroom exhaust fans vented into the attic. Exhaust fans should be vented to the exterior of the structure.
