Inspection Report

Property Address:
23146 Tranquil Springs Ln
Katy Texas 77494

PROPERTY INSPECTION REPORT FORM

12/8/2023

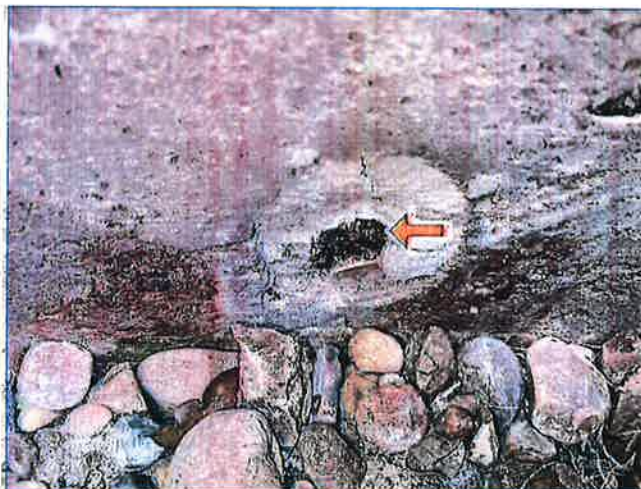
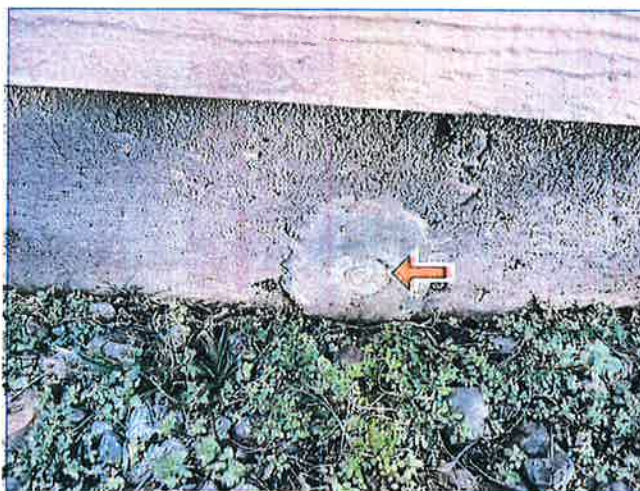
(1) Post tension cable ends are exposed to the elements at the right side and rear of structure. Recommend filling the exposed areas with a mastic compound to prevent the further deterioration of the cable. Exposed cables can rust, thus expand, damaging the surrounding foundation. This is a small repair.

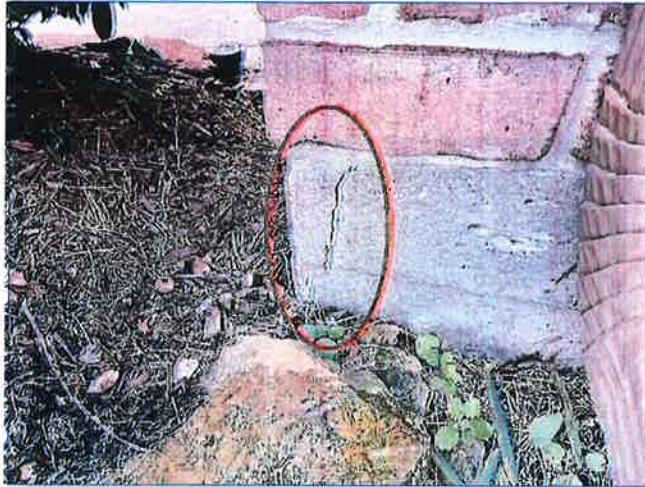
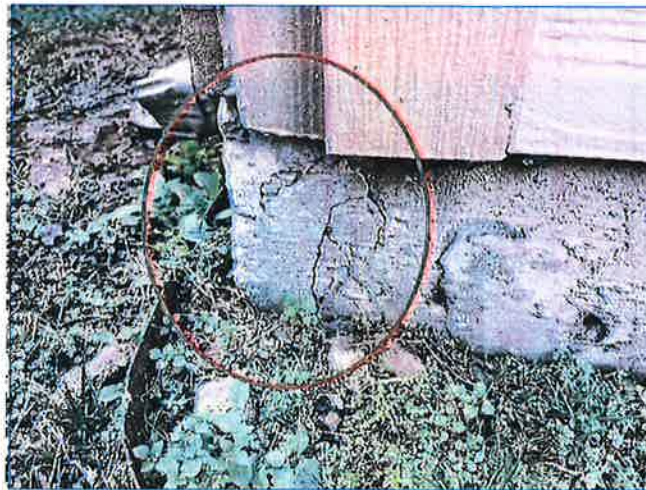
(2) There are typical corner cracks in the concrete slab occurring at the front, rear and sides of structure. Many homes have hairline or settlement cracks which have no effect on the function of the slab. These areas should be properly prepped and sealed with a concrete patching material. It is recommended that you monitor periodically.

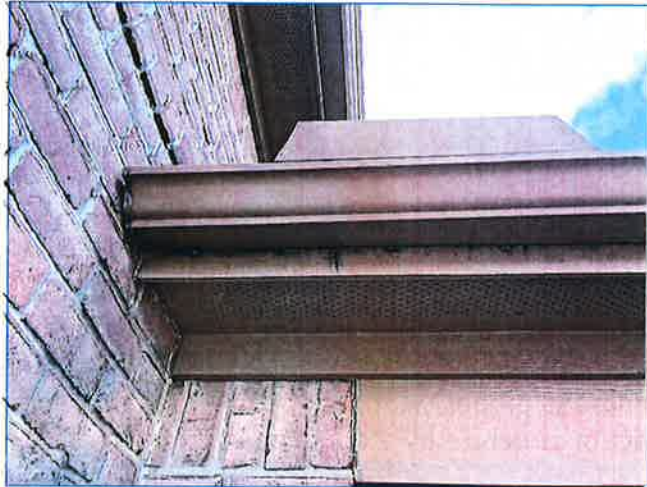
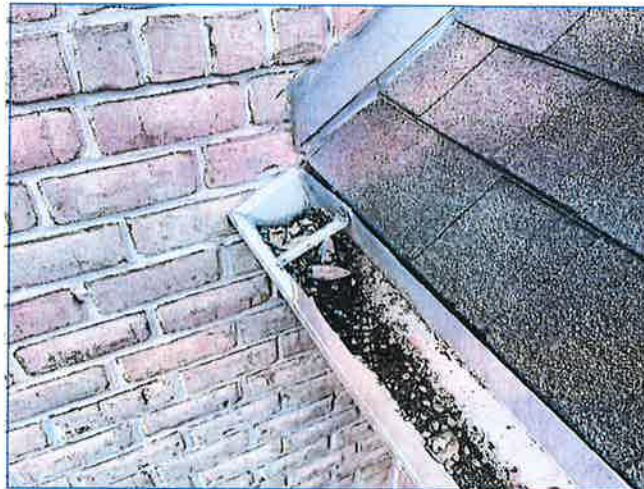
(1) There is evidence of water and debris flowing behind gutter at left side of garage. Once on roof, we were able to see gutter is loose and pulling away from fascia. Recommend further evaluation and repair of gutter system by a qualified contractor.

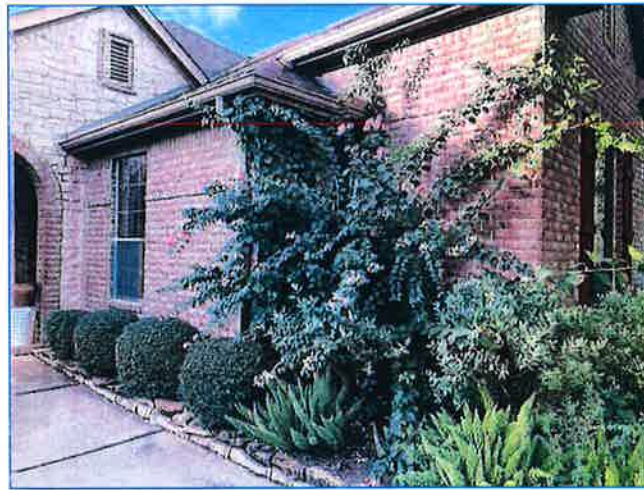
B. Item 4(Picture)

(2) There is vegetation growing against structure at front left. This can lead to premature deterioration of siding components, and provides ease of access for insects and other pests. Recommend proper clearance be provided, here and at any other bushes that are in close contact of structure by a qualified contractor.

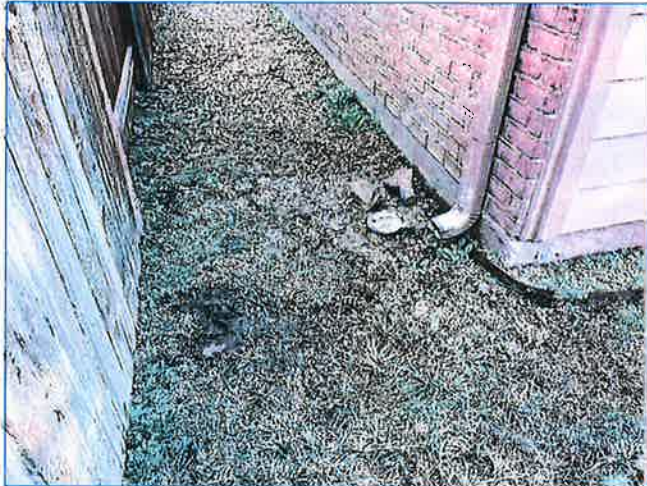
B. Item 6(Picture)

(4) There is standing water at right rear corner of structure, and area is significantly saturated relative to rest of yard. There are sprinkler shut off valves in area, and signs of recent work. Recommend further evaluation for likely leak by a qualified contractor.

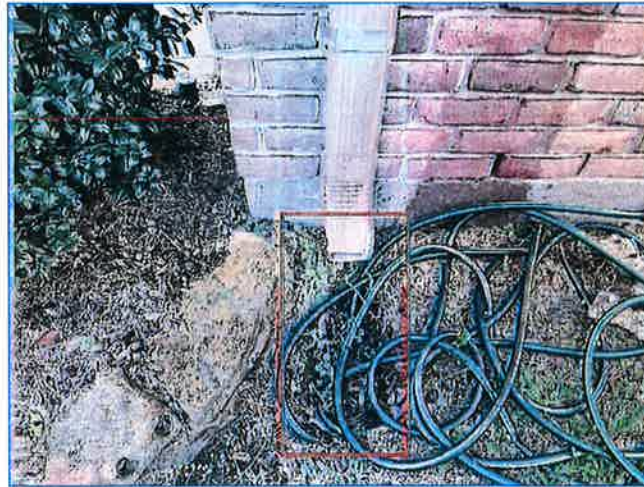
B. Item 8(Picture)

(5) There are no splash blocks present for end of downspouts at the front, rear and sides of structure. Splash blocks are needed to help divert rain water away from foundation, and prevent erosion or water pooling in the area. Recommend repair by a qualified person. This is a small repair.

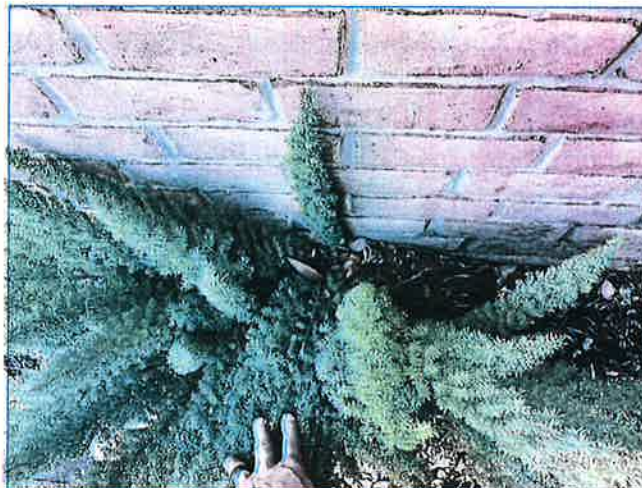
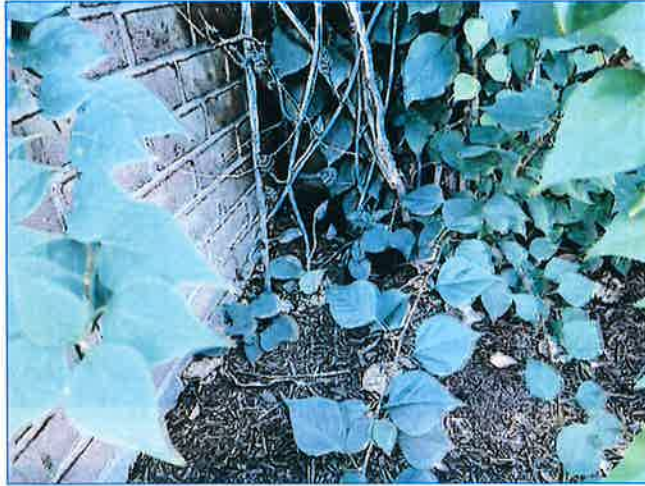
(6) The mulch/soil level at the front and rear of structure is too high and will encourage water and insect intrusion into the home. It is recommended that an overall exposure of 4-8" be maintained at the entire perimeter beam of the foundation, prior to the first course of bricks or siding on the home. If this distance is not able to be achieved by removing the offending soil or mulch, it is recommended that a trench be dug, lined with weed blocking fabric and filled with river rock or other substance to achieve the separation necessary between the actual soil and the first course of siding material. This will help to achieve the desired results.

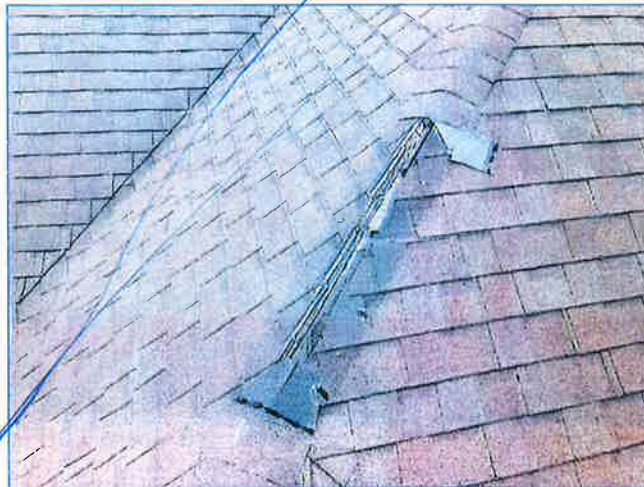
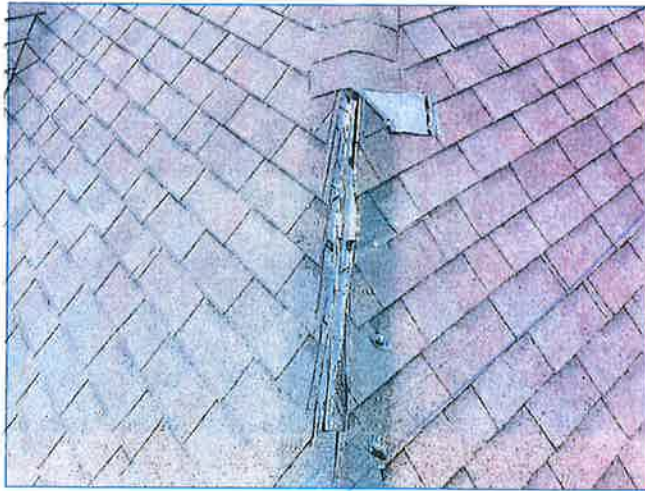
(1) Left hip above garage has damaged/missing shingles. This is leaving exposed wood decking and is an entry point for water into attic space. Recommend immediate repair of area by a qualified contractor. **Based on age, other noted issues, and overall condition of roof covering, a general replacement should be considered.**

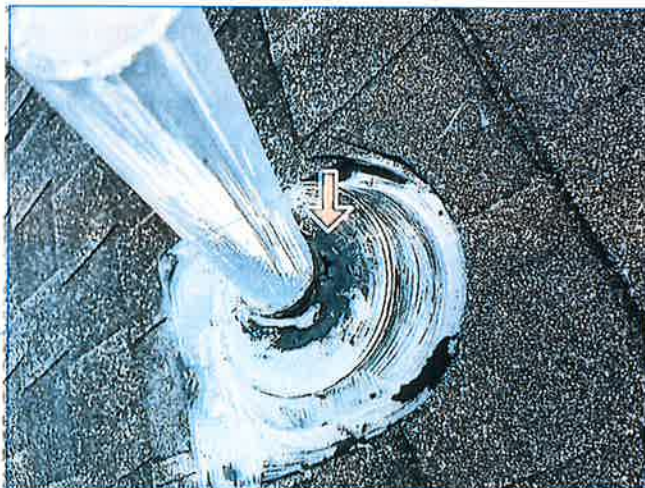
C. Item 4(Picture)

(2) Plumbing vent boot at right side of structure has deteriorated to point of holes that rainwater can penetrate into attic space. Recommend replacement by a qualified contractor.

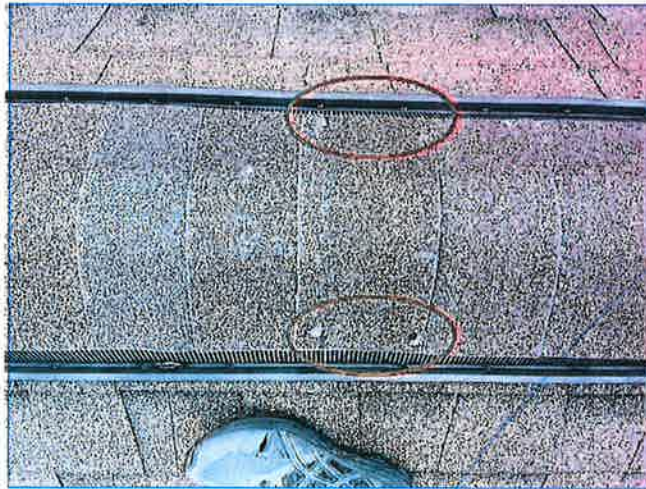
C. Item 7(Picture)

- 🏠 (4) The roof covering has exposed nail heads at multiple locations . Exposed nail heads can let water seep into the roof structure leading to further issues. A qualified person should seal as needed. This is a small repair and will be periodical maintenance item.

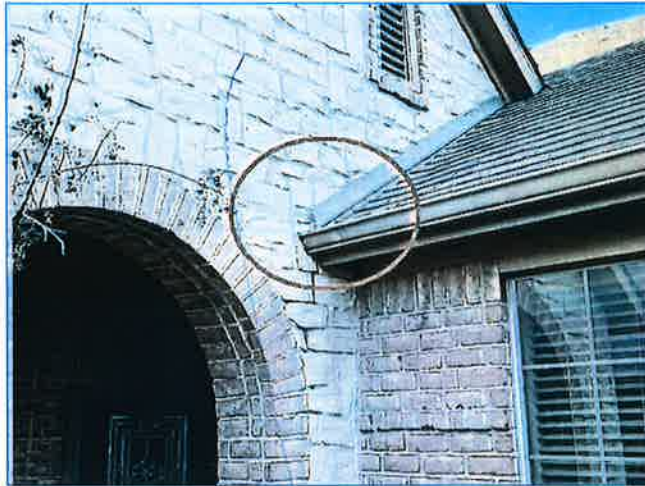
C. Item 10(Picture)

(5) Kickout flashing is missing at front of structure. Kickout flashing is required where roof surface ends parallel with wall surface. This flashing prevents water leaks, damage, and discoloration of the walls. Recommend repair by a qualified contractor.

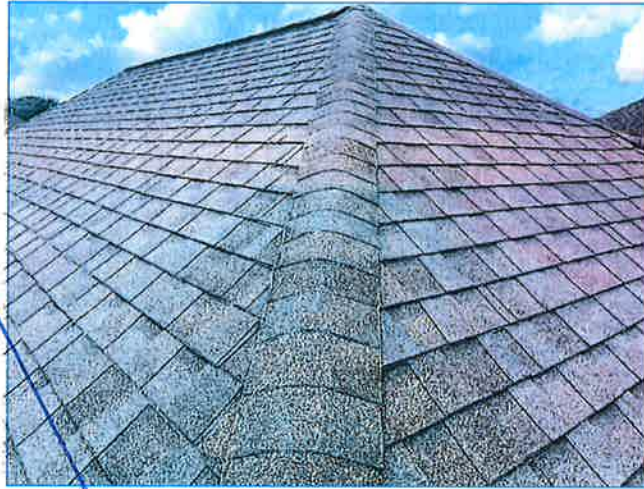
C. Item 13(Picture)

🏠 (6) The roof shingles show a moderate loss of granular covering. Granules play an integral role in protecting the roof shingles from UV light. Once granules begin to fall from the roof, the UV light will begin to degrade the shingle surface and eventual failure will occur. We are unable to determine the remaining life expectancy of the roof in question, however, preparations should be begun to replace the roof within the next few years.

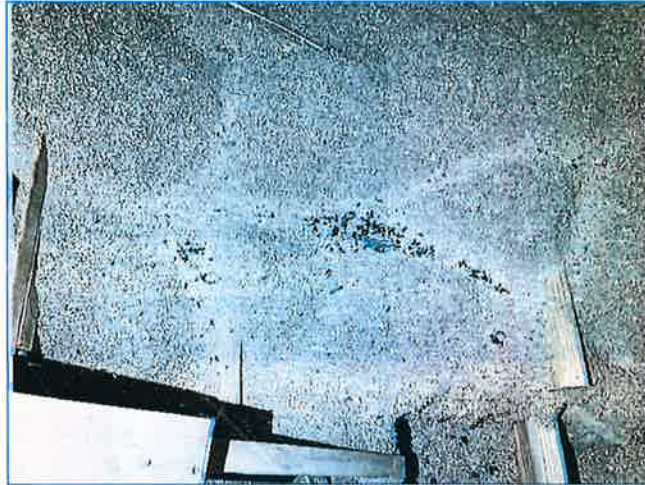
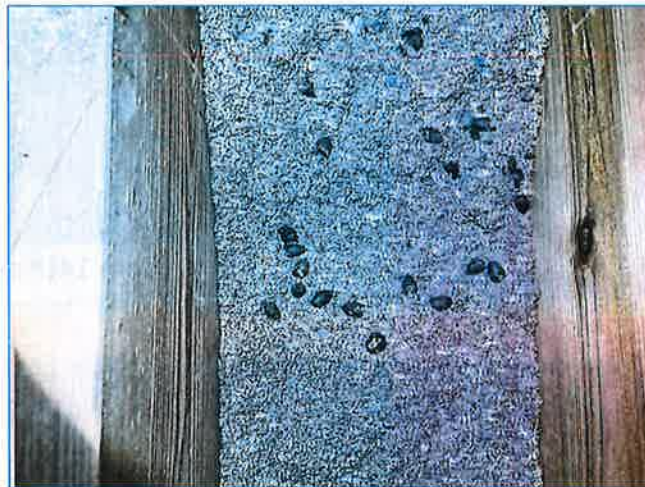
- 🏠 (1) There is evidence of a rodent/pest being in attic space. Recommend further evaluation as desired by a qualified exterminator.

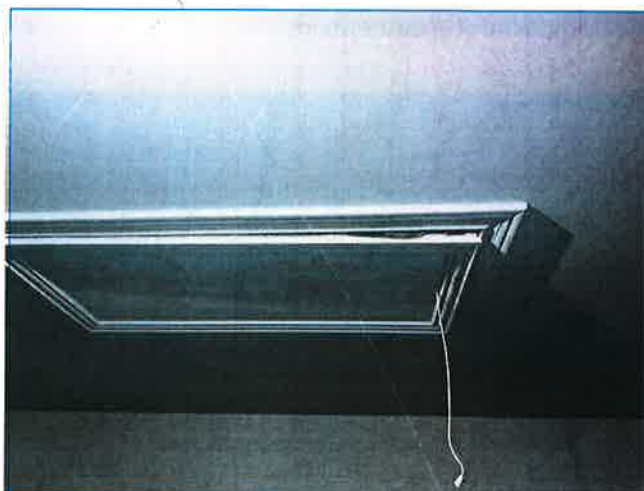
D. Item 4(Picture)

(3) Attic access door is not shutting tightly. Recommend adjustment by a qualified contractor.

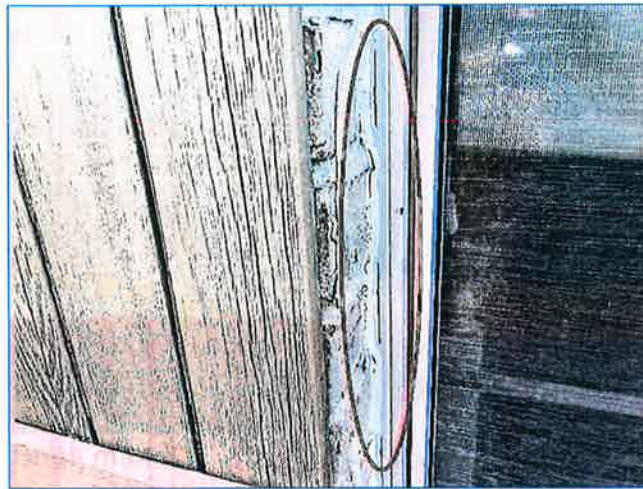
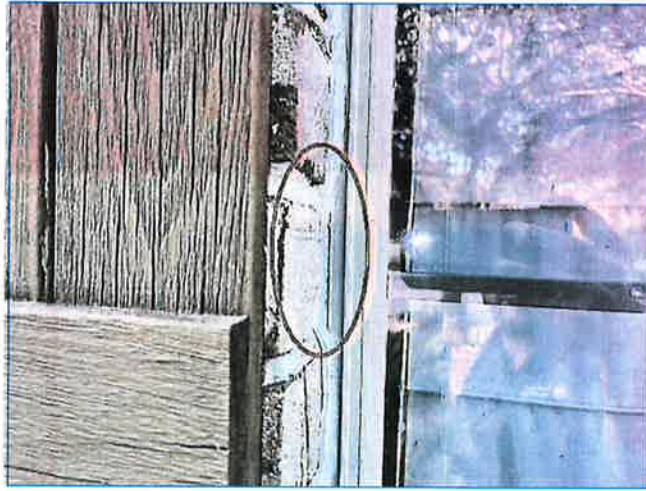
(2) At several windows and around door openings, the caulk beads have begun to deteriorate and have gaps that will allow moisture to penetrate. Seal all openings thoroughly. This is a small repair. Continue to monitor periodically and reapply sealant as needed. This will be a periodic maintenance item.

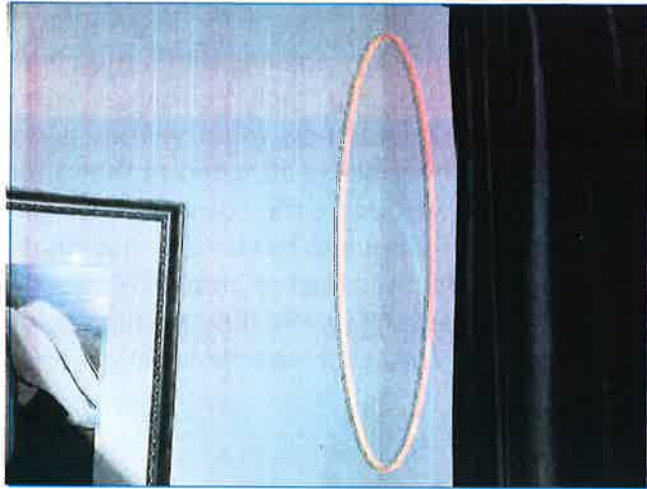
E. Item 7(Picture)

(4) There are hairline cracks present on walls surfaces in a few locations throughout interior (*most notable in master bedroom corner*).. This is considered cosmetic and is common on a structure of this age. We recommend that you repair as desired, but also continue to monitor for further cracking.

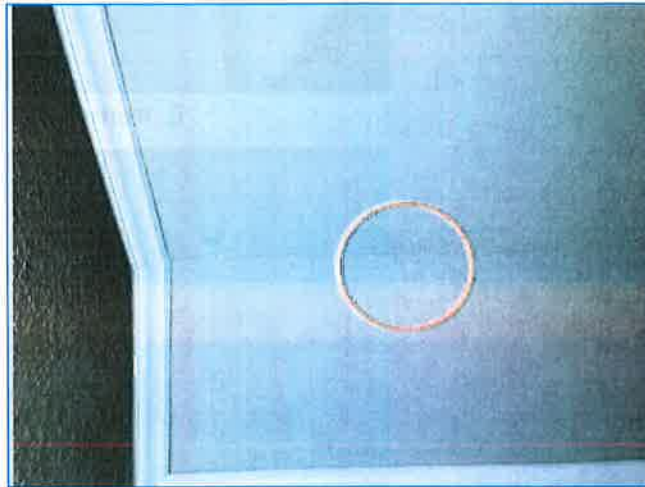
F. Item 1(Picture)

🏠 (1) Gambrel ceilings are present within the home. It is typical that these ceiling structures will, as the home settles and "racks" or moves with high winds, develop cracks and nail pops at the corner area which intersects with the vertical wall surface below. The cause is generally accepted that the sheetrock is attached to the rafters and as the roof flexes, the sheetrock moves as well. This will cause the cosmetic issues mentioned earlier. In any case, the structure allows sheetrock is to move to the extent that small cracks will form. The solution to these cracks is to simply fill the affected area with a caulk or floating compound, prep and paint. This is not a condition that effects the functionality, safety or integrity of the structure and is mostly cosmetic in nature. This is for your information. Recommend repair as desired.

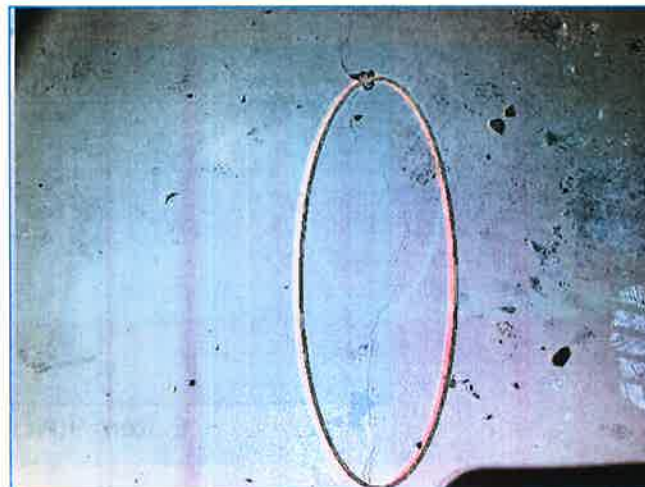
F. Item 2(Picture)

🏠 (2) The concrete floor of garage is cracked in areas. These cracks do not appear significant and seem typical. Small (1/8" or less in width) and non-shifted cracks in the floor of a garage are commonly known as stress fractures. These cracks typically have no effect on the overall performance of the foundation and are not structural in nature. It is important to monitor cracks such as these and to correct as needed.

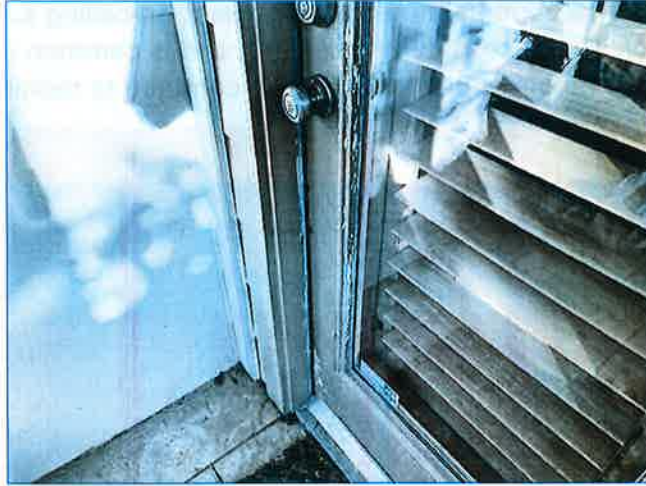
G. Item 1(Picture)

(1) Weatherstripping and finish at rear entry door are damaged from previous pet. Recommend repair by a qualified person or contractor. This is a small repair.

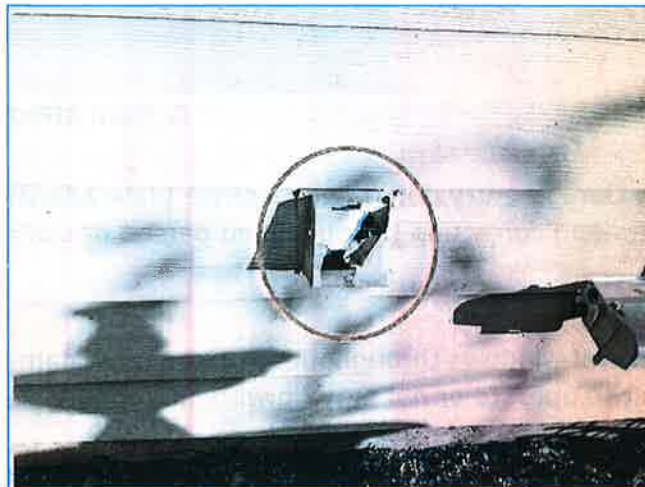
J. Item 1(Picture)

(1) Air intake vent covering for fireplace is damaged at rear of structure. Recommend replacement by a qualified contractor. This is a minor repair.

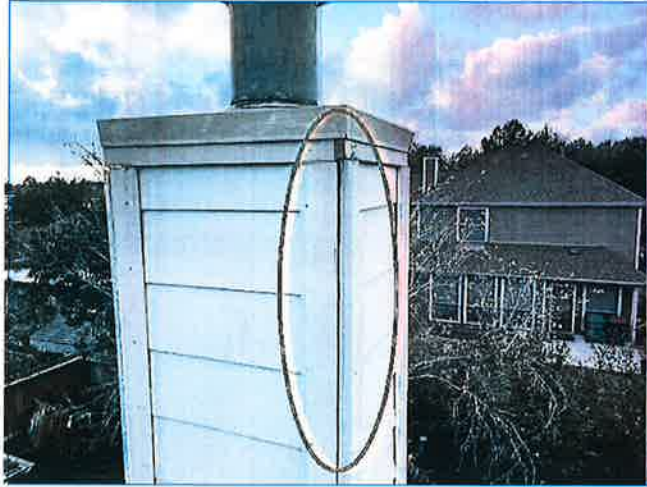
J. Item 2(Picture)

(2) Trim boards at chimney are loose and deteriorated at areas. Recommend replacement by a qualified contractor.

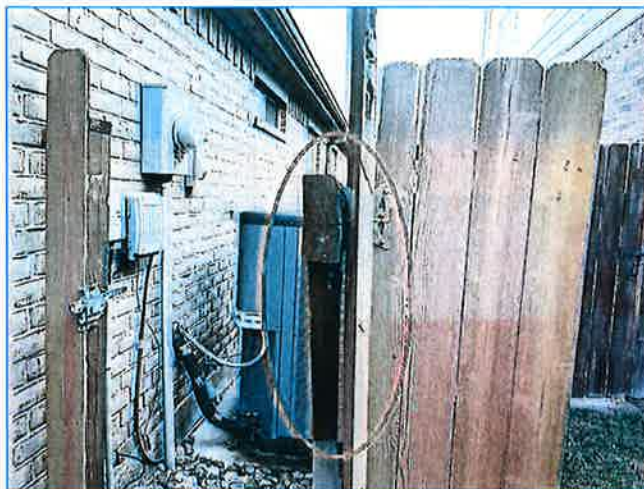
L. Item 1(Picture)

(1) Gate at right side of structure has loose pickets and is difficult to operate. Recommend repair by a qualified contractor.

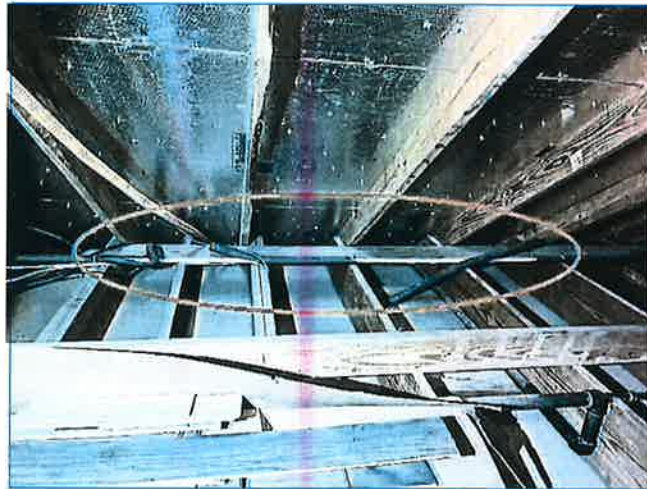
A. Item 1(Picture)

(1) Water supply pipe insulation is missing or damaged at front of attic space. Ensure all exposed piping is covered to prevent damage during freezing temperatures. This is a small repair.

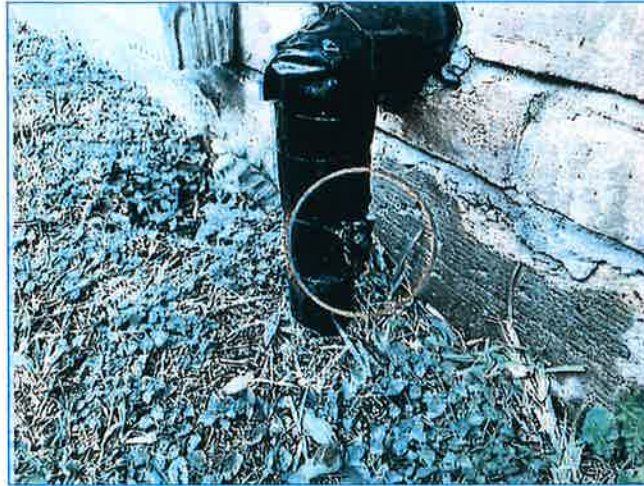
A. Item 2(Picture)

(2) Main water shut off valve at left side of structure is damaged. This could lead to difficulty shutting off supply in the event of an emergency. Recommend repair by a qualified contractor.

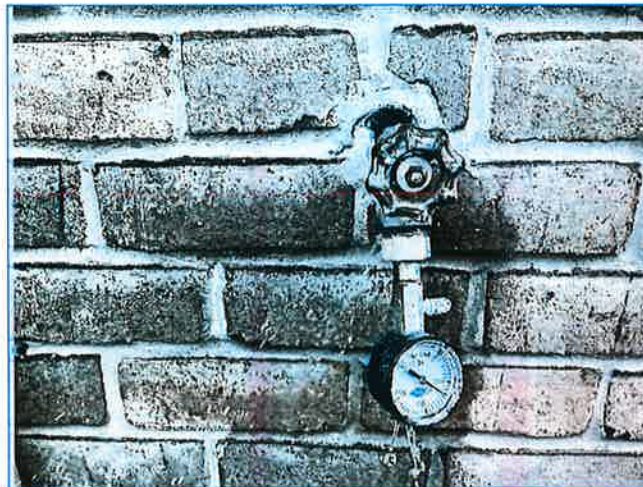
A. Item 3(Picture)

(3) All hose bibs around structure are leaking, whether at threads itself, or at vacuum breakers. Recommend replacement by a qualified contractor. This is a small repair.

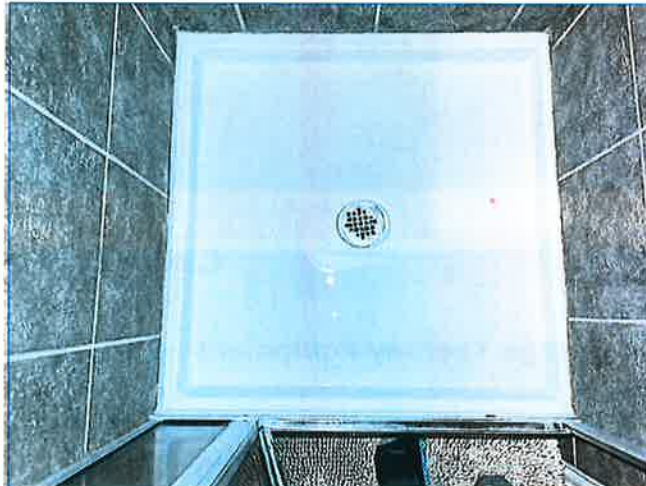
B. Item 2(Picture)

(2) Shower pan is not properly installed. Water pools at front corner of shower pan and does not drain. Recommend correction by a qualified plumber.

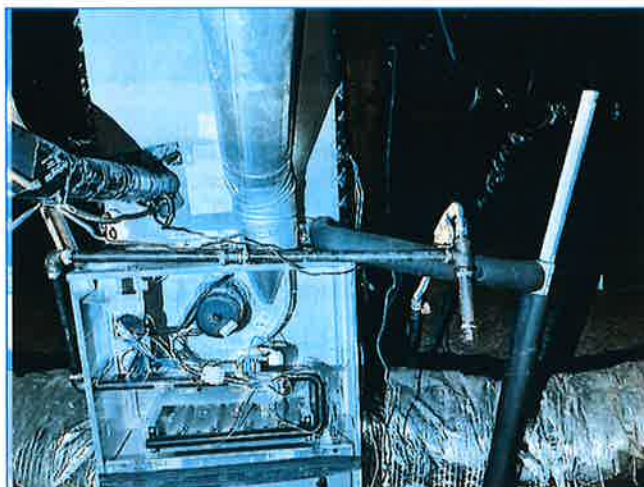
E. Item 1(Picture)

- (1) Gas supply pipe to furnace is not properly secured/supported. Currently, weight of pipe is resting on primary condensate drain line and furnace cabinet. Recommend a better arrangement by a qualified contractor.

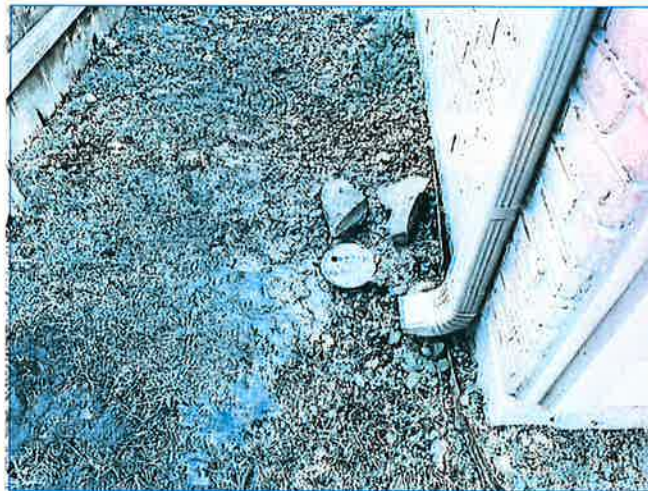
A. Item 1(Picture)

(1) Sprinkler valve at right rear corner of structure appears to be leaking. Recommend further evaluation and repair by a qualified contractor.
