# PROPERTY INSPECTION REPORT

**Concerning:** 19807 Summerset way, Houston, TX 77094

**By:** S. Brad Williams TREC# 23549 / Sunbelt Inspections 4/15/2021

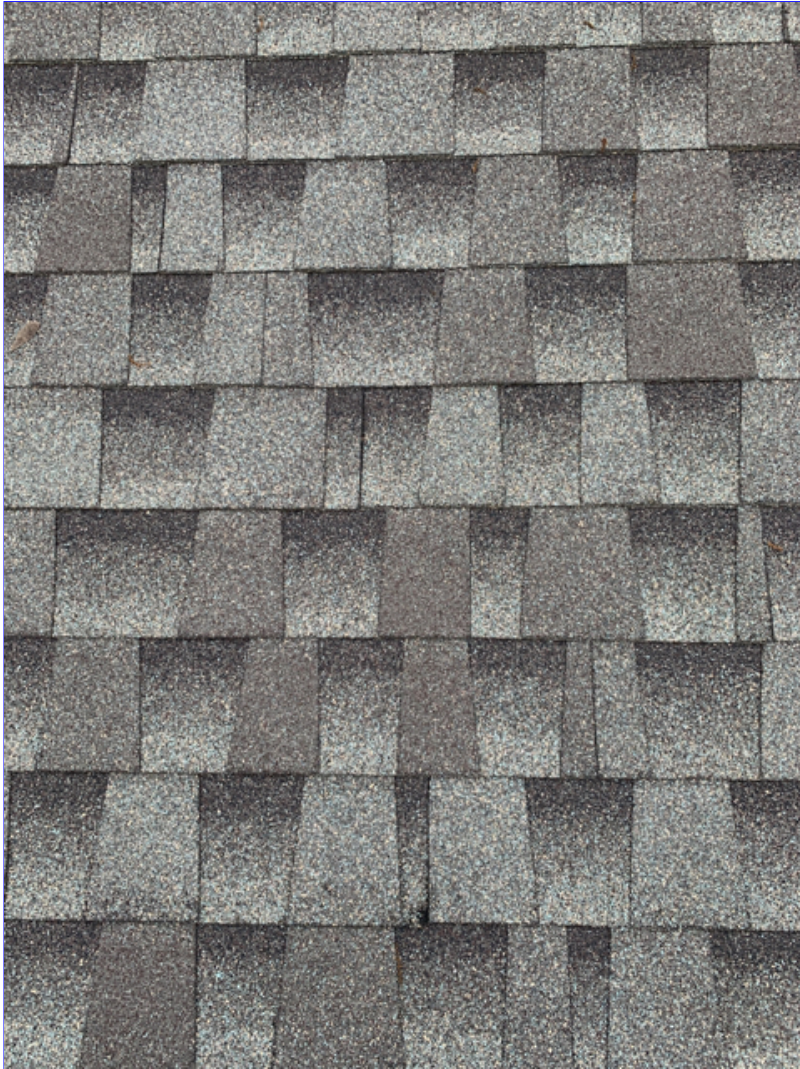
C. Photo 1(Picture) This roof is an Architectural style shingle that will typically last 20 years in this climate.

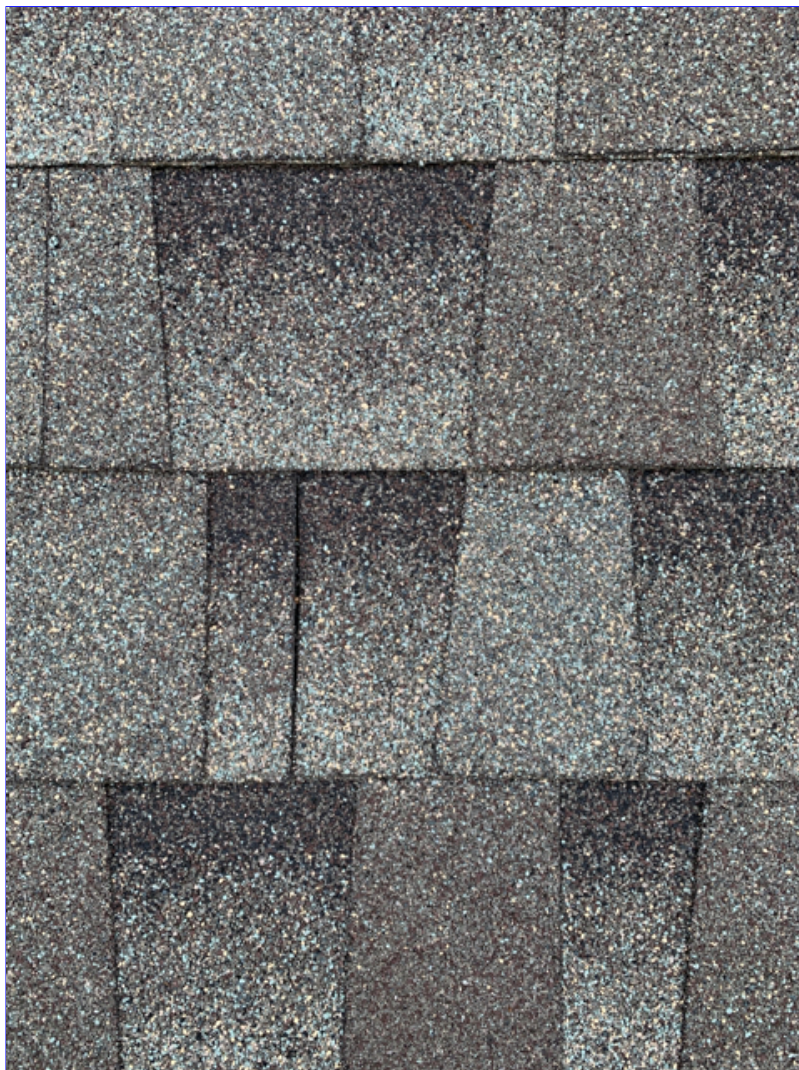
C. Photo 2(Picture) This roof is an Architectural style shingle that will typically last 20 years in this climate.

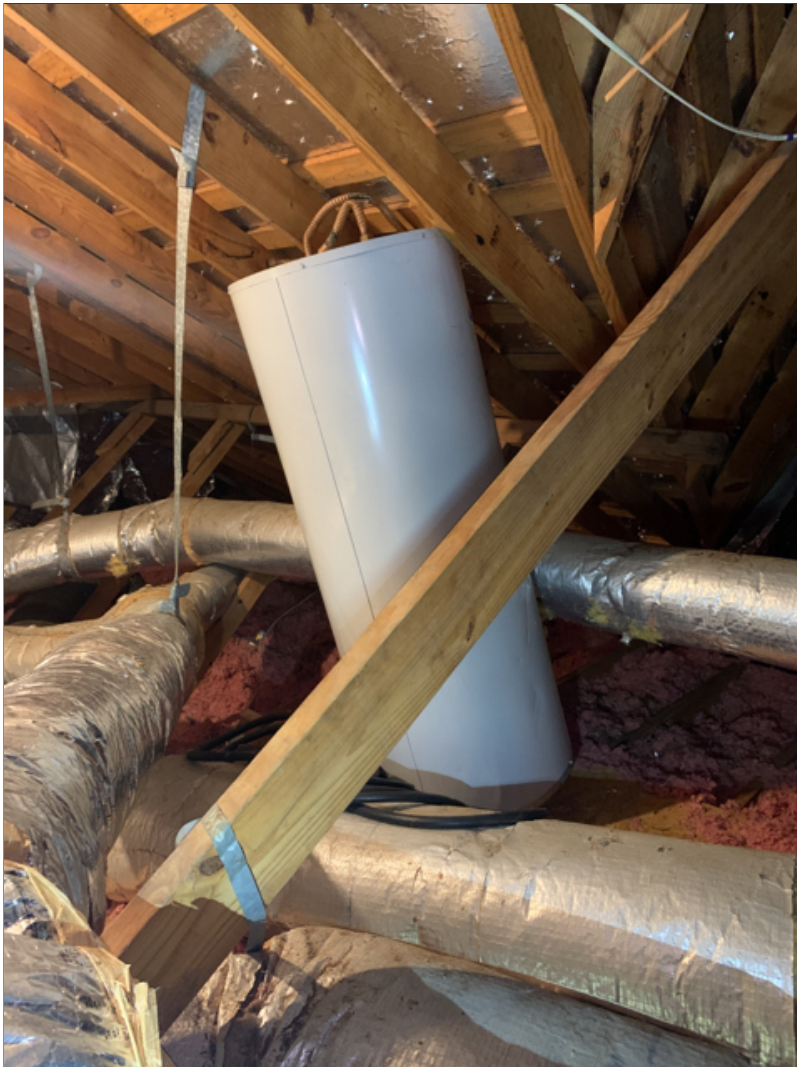
One of the old water heaters has been abandoned in the attic. Recommend the water heater be secured and strapped down.

D. Photo 1(Picture) One of the old water heaters has been abandoned in the attic. Recommend the water heater be secured and strapped down.

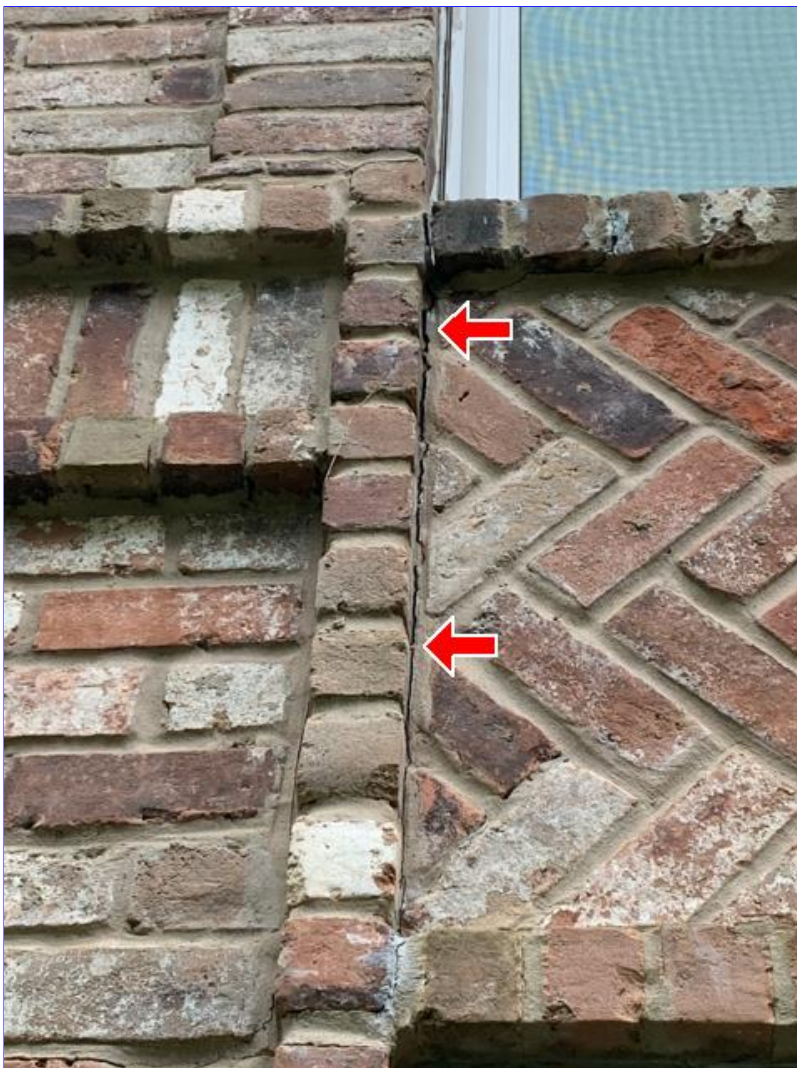
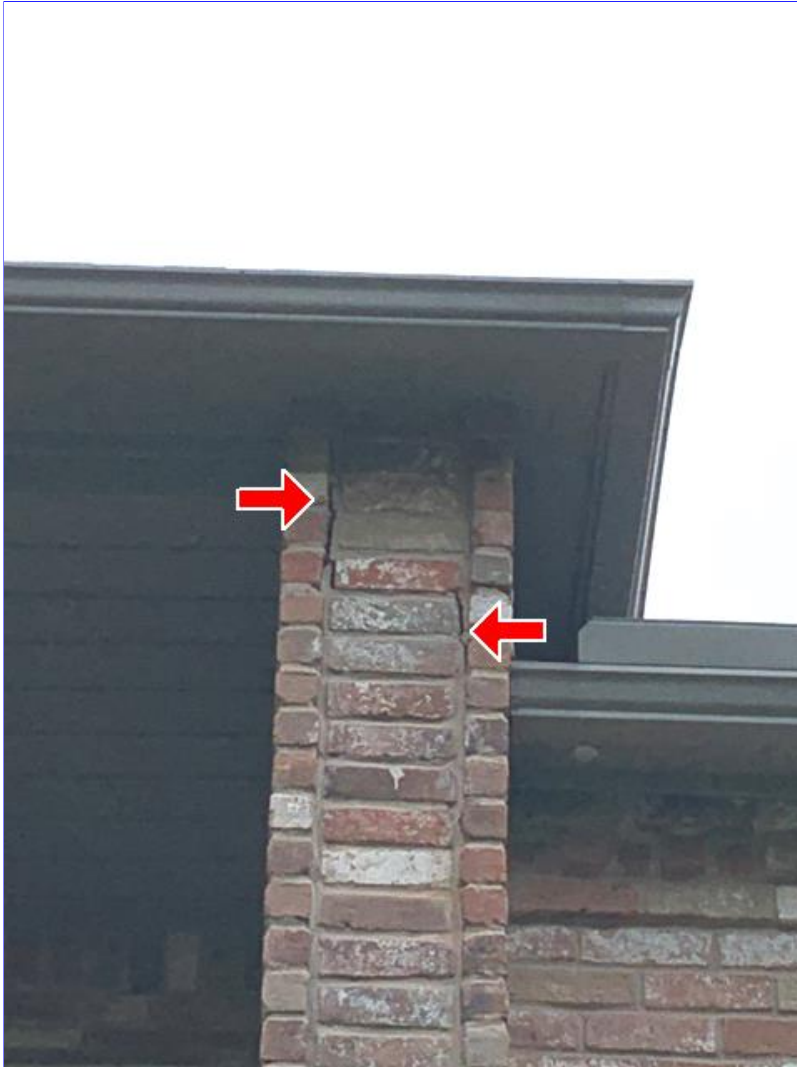
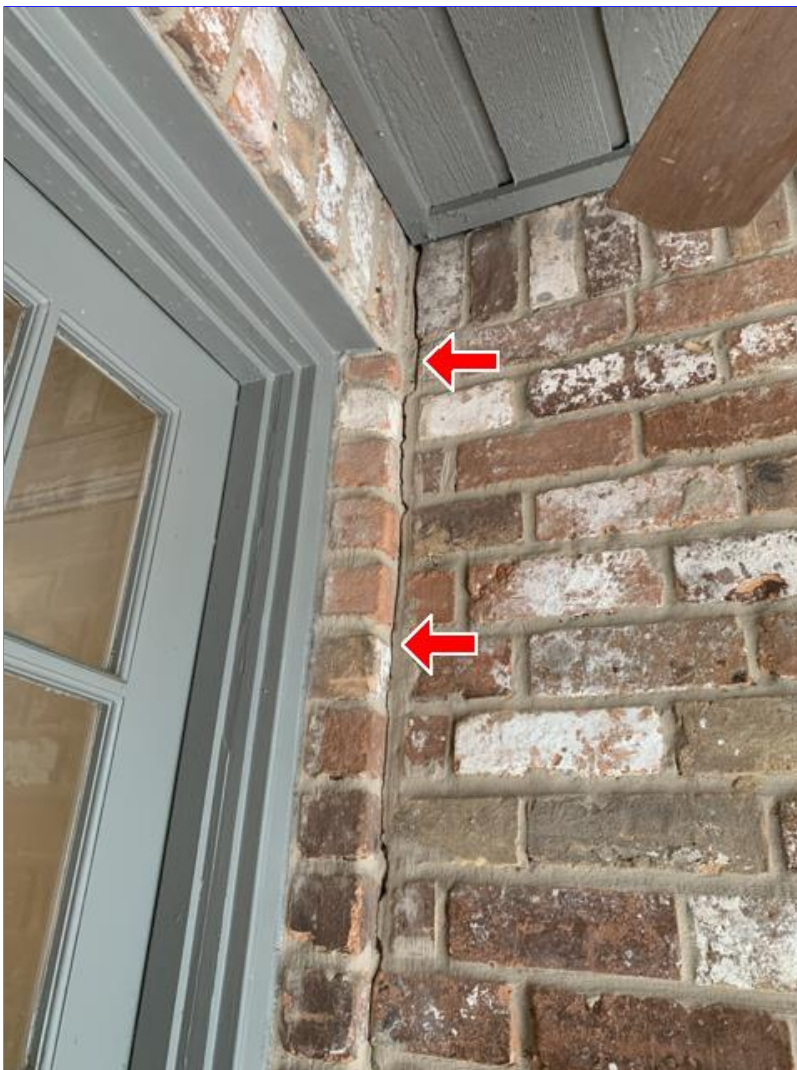
(1) Brick veneer mortar cracks were observed. This condition is cosmetic in nature and not structurally significant. The cracking of the brick veneer is likely due to flexing of the foundation during repeated seasonal changes. The expansive clay soil in the area is prone to excessive swelling during rainy periods and shrinkage during dry periods.

E. Photo 1(Picture) Brick veneer mortar cracks were observed. This condition is cosmetic in nature and not structurally significant. The cracking of the brick veneer is likely due to flexing of the foundation during repeated seasonal changes. The expansive clay soil in the area is prone to excessive swelling during rainy periods and shrinkage during dry periods.

E. Photo 2(Picture) Brick veneer mortar cracks were observed. This condition is cosmetic in nature and not structurally significant. The cracking of the brick veneer is likely due to flexing of the foundation during repeated seasonal changes. The expansive clay soil in the area is prone to excessive swelling during rainy periods and shrinkage during dry periods.

E. Photo 3(Picture) Brick veneer mortar cracks were observed. This condition is cosmetic in nature and not structurally significant. The cracking of the brick veneer is likely due to flexing of the foundation during repeated seasonal changes. The expansive clay soil in the area is prone to excessive swelling during rainy periods and shrinkage during dry periods.

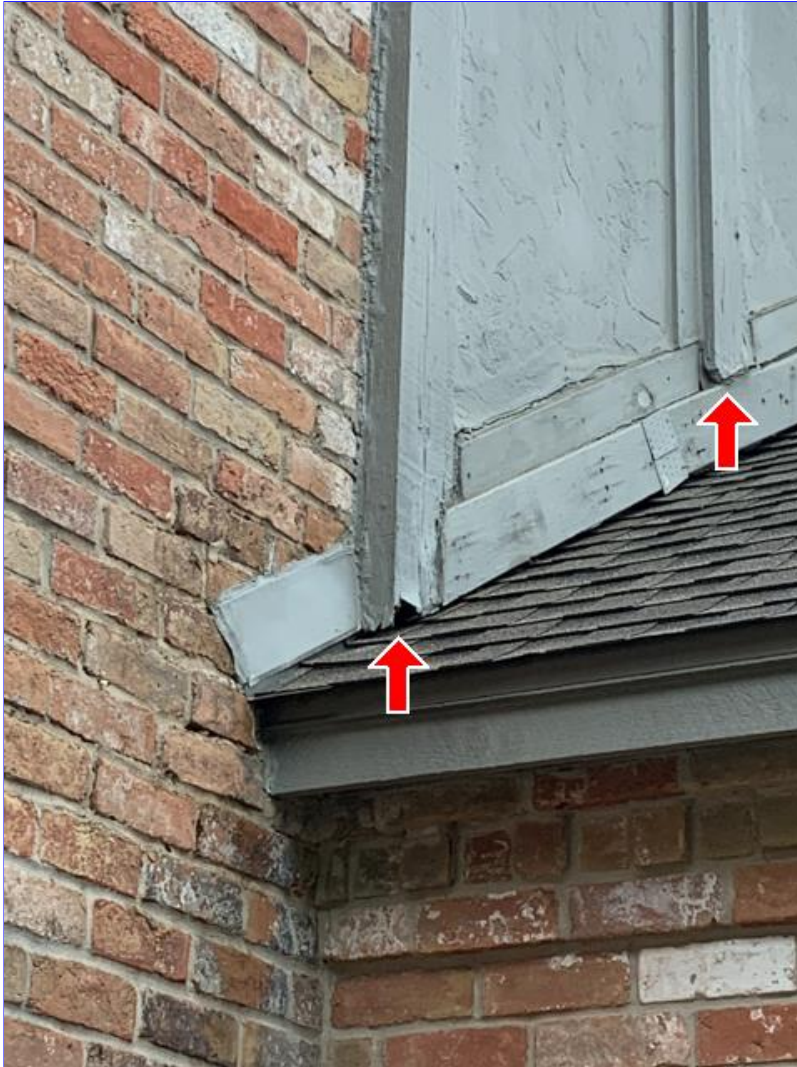
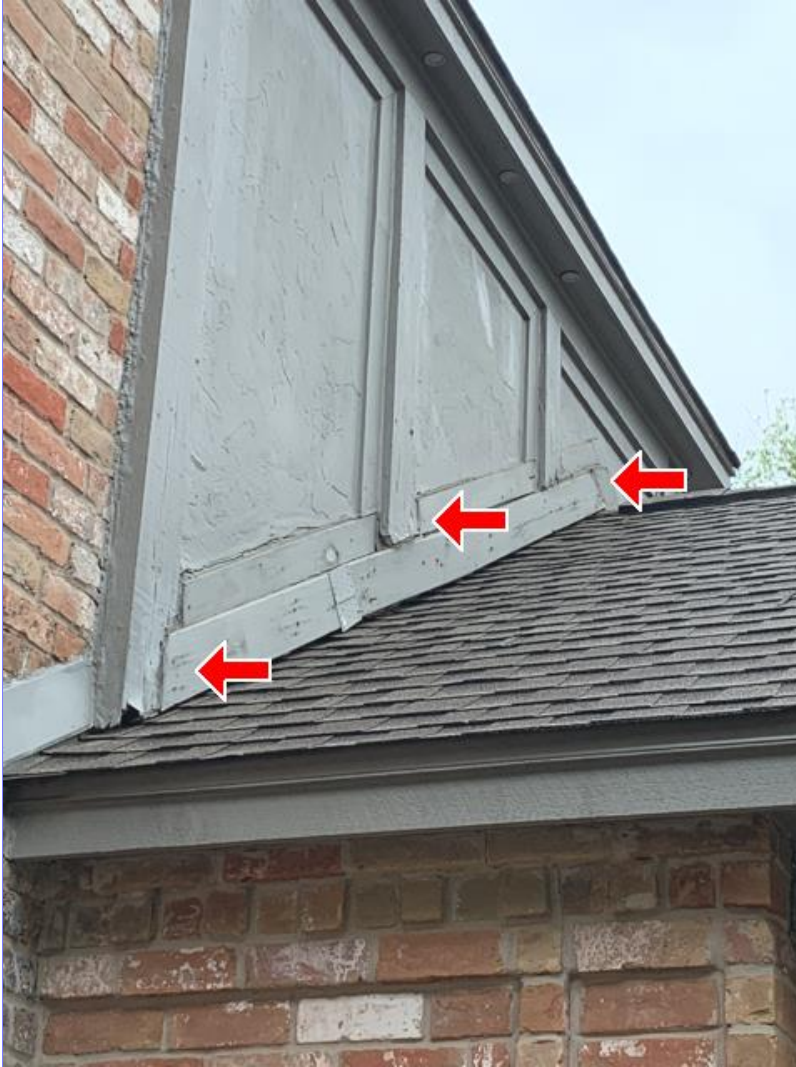
(2) Wood rot was observed on the wood above the Porte Cochere on the left.

E. Photo 4(Picture) Wood rot was observed on the wood above the Porte Cochere on the left.

E. Photo 5(Picture) Wood rot was observed on the wood above the Porte Cochere on the left.

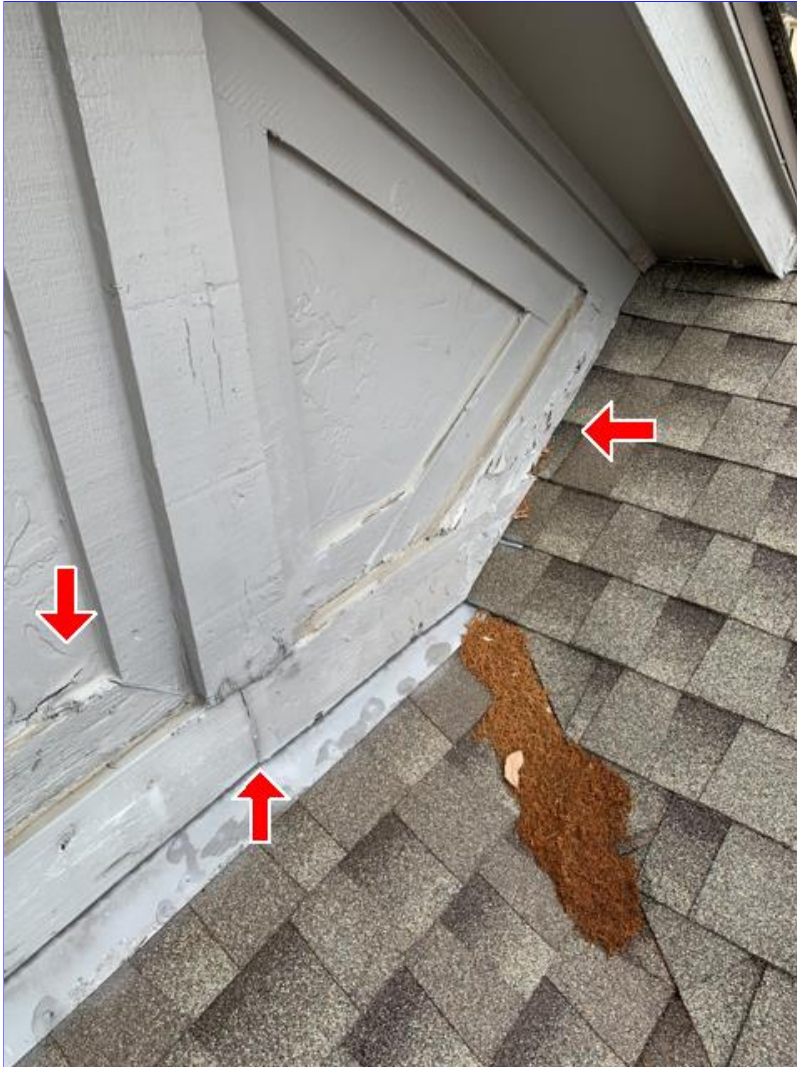
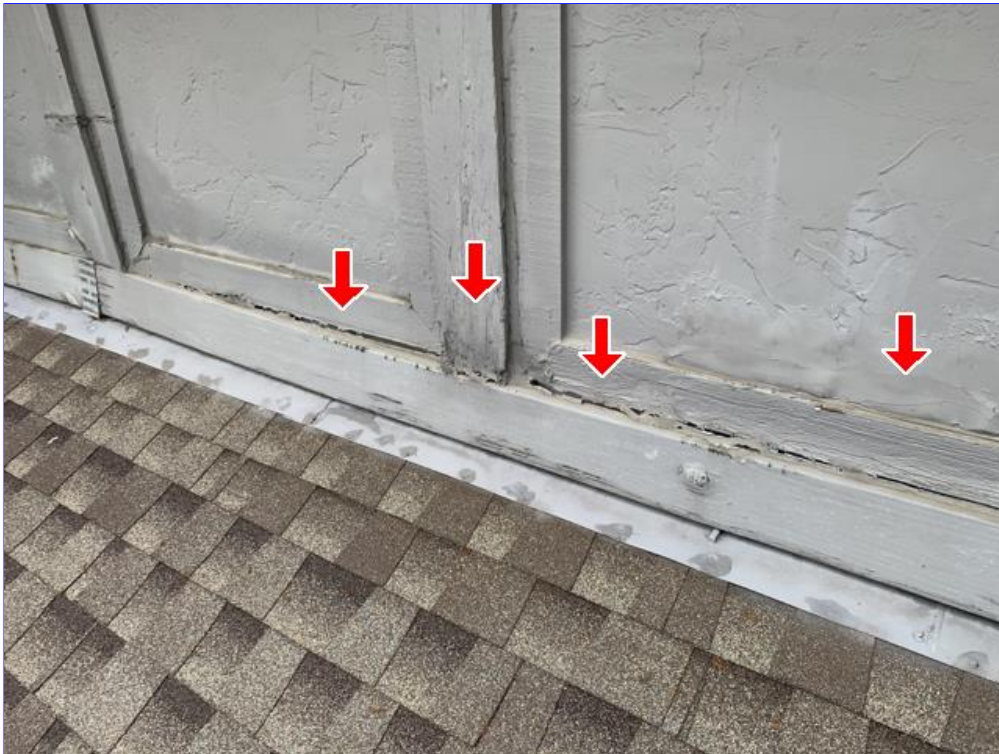
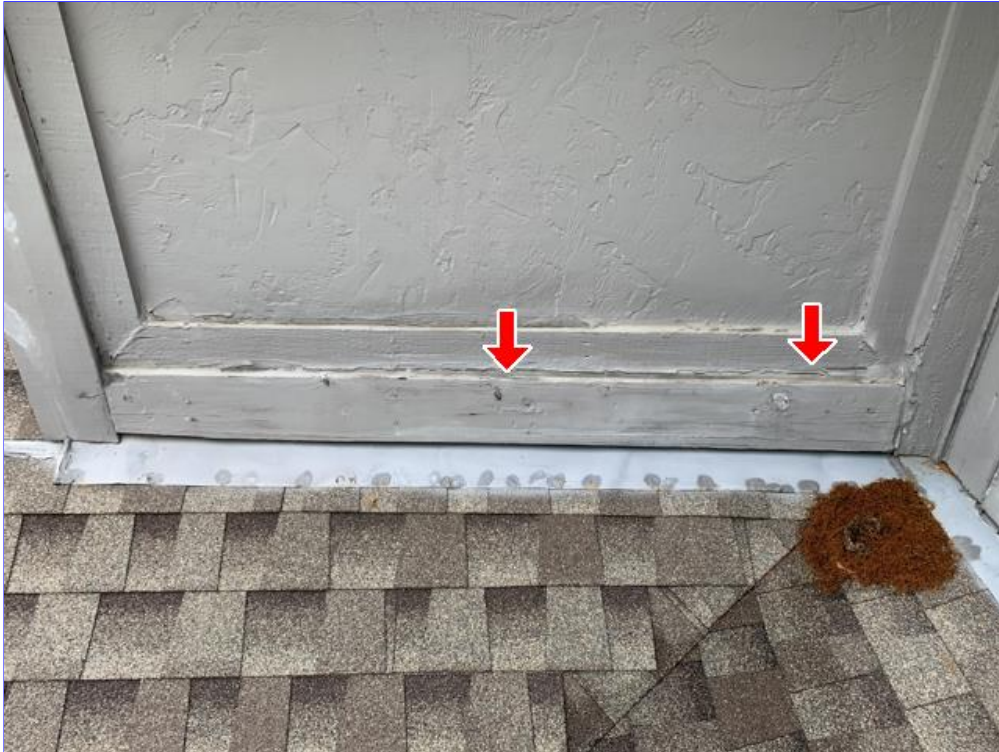
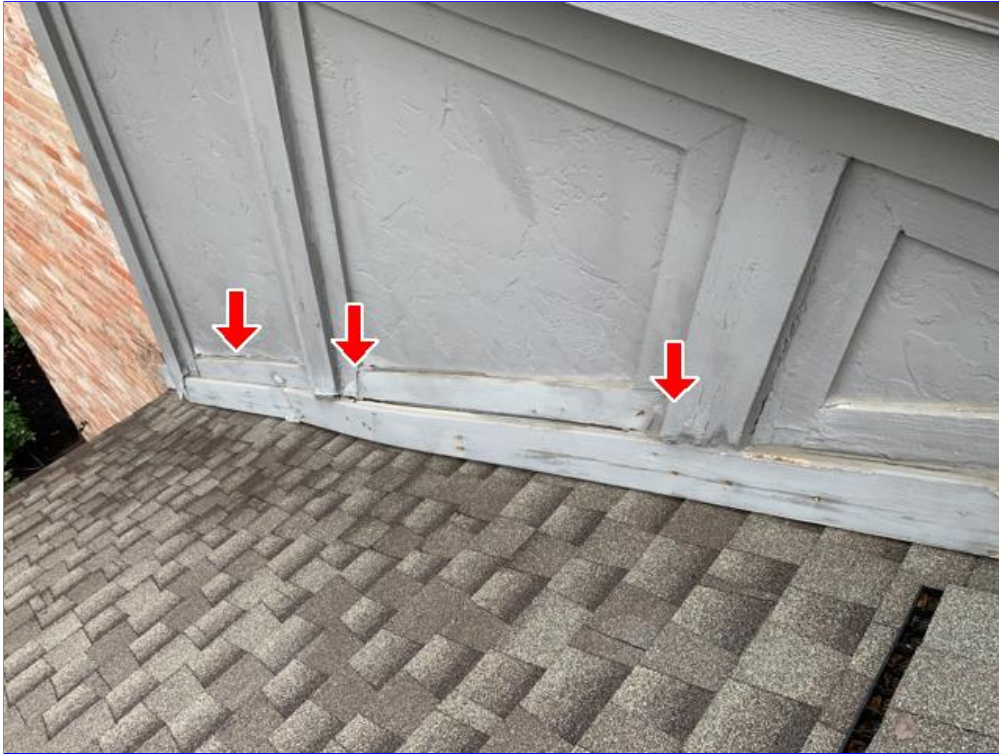
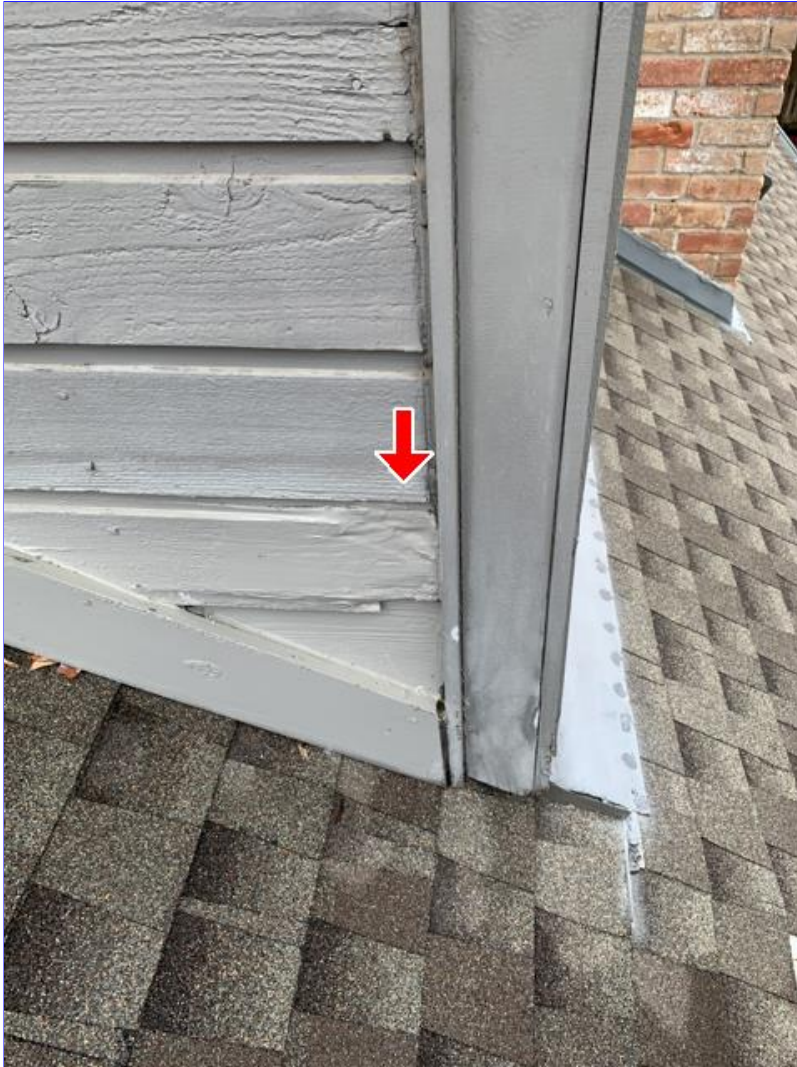
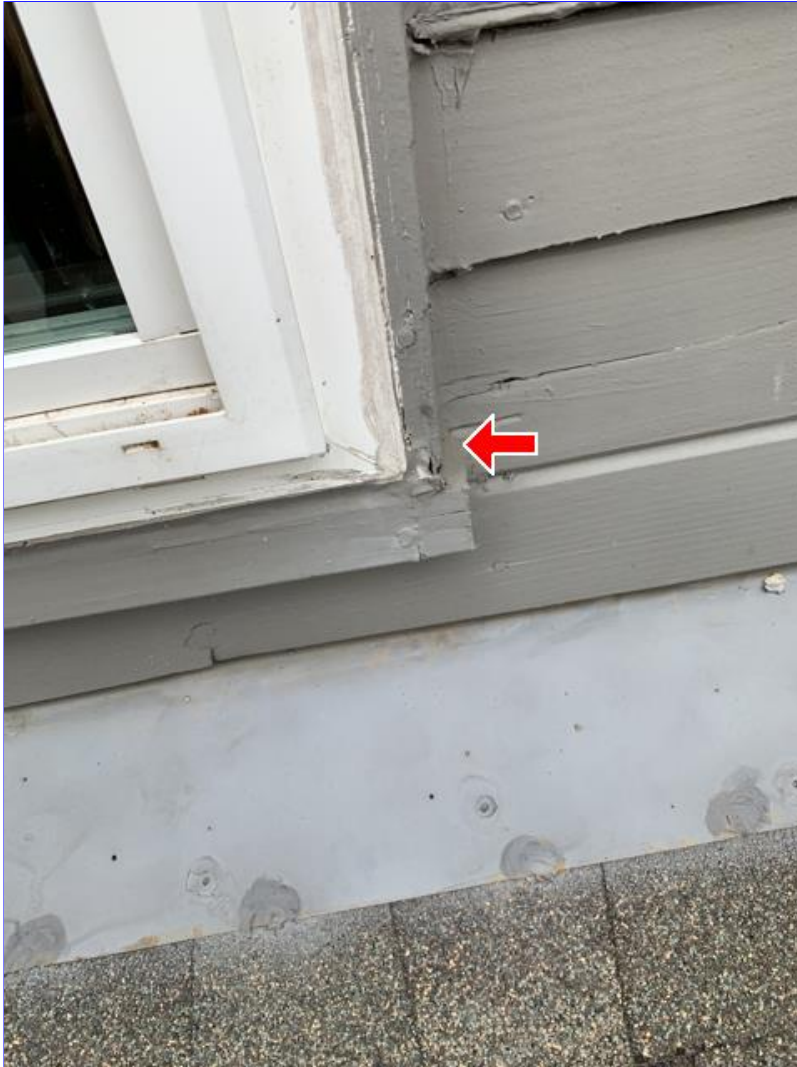
(3) Wood rot was observed in areas of the siding and trim on the upper back side of the house.

E. Photo 6(Picture) Wood rot was observed in areas of the siding and trim on the upper back side of the house.

E. Photo 7(Picture) Wood rot was observed in areas of the siding and trim on the upper back side of the house.

E. Photo 8(Picture) Wood rot was observed in areas of the siding and trim on the upper back side of the house.

E. Photo 9(Picture) Wood rot was observed in areas of the siding and trim on the upper back side of the house.

E. Photo 10(Picture) Wood rot was observed in areas of the siding and trim on the upper back side of the house.

E. Photo 11(Picture) Wood rot was observed in areas of the siding and trim on the upper back side of the house.

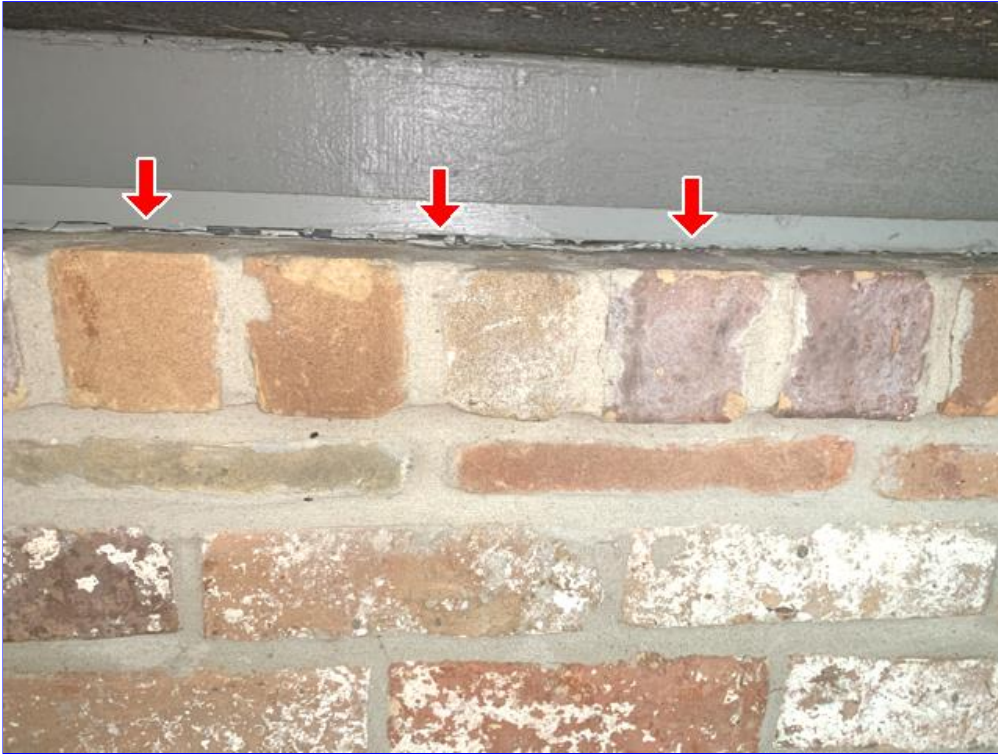
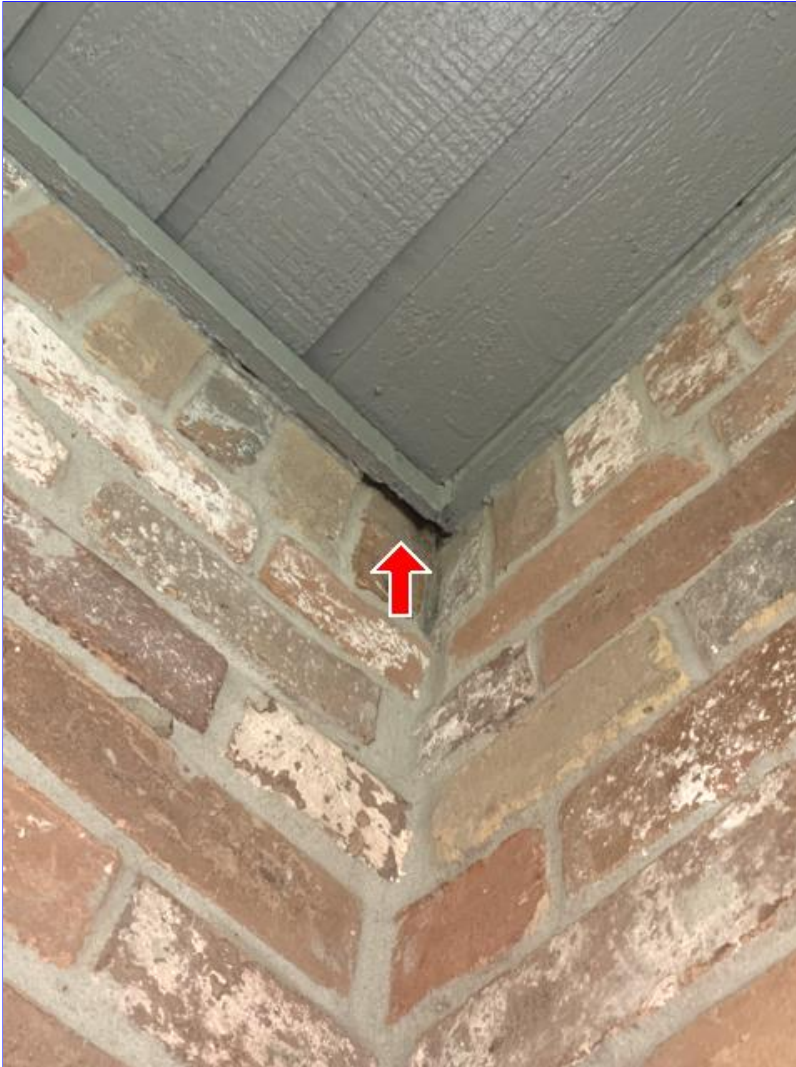
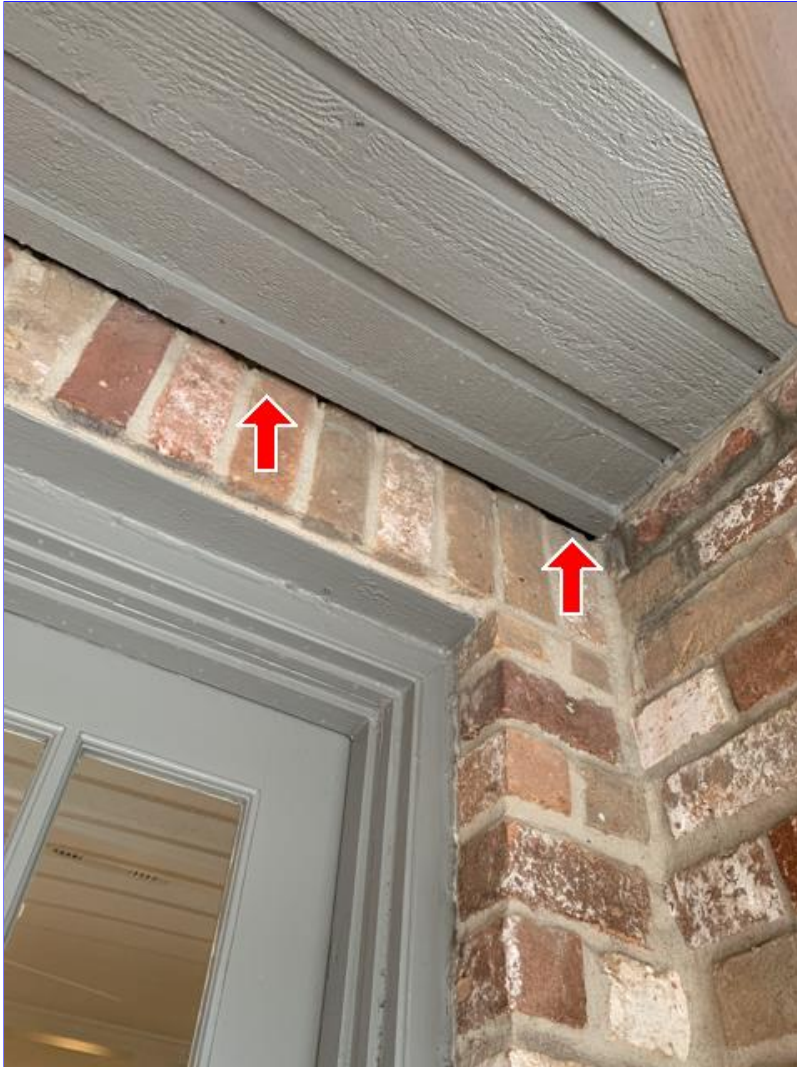
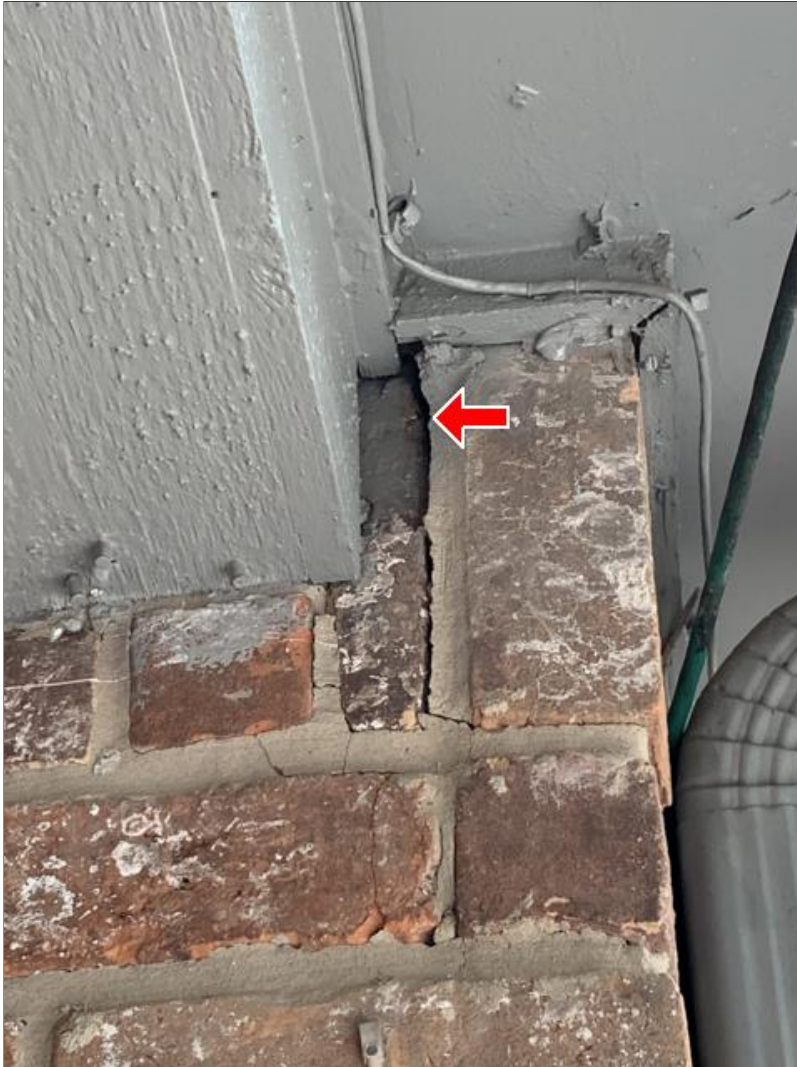
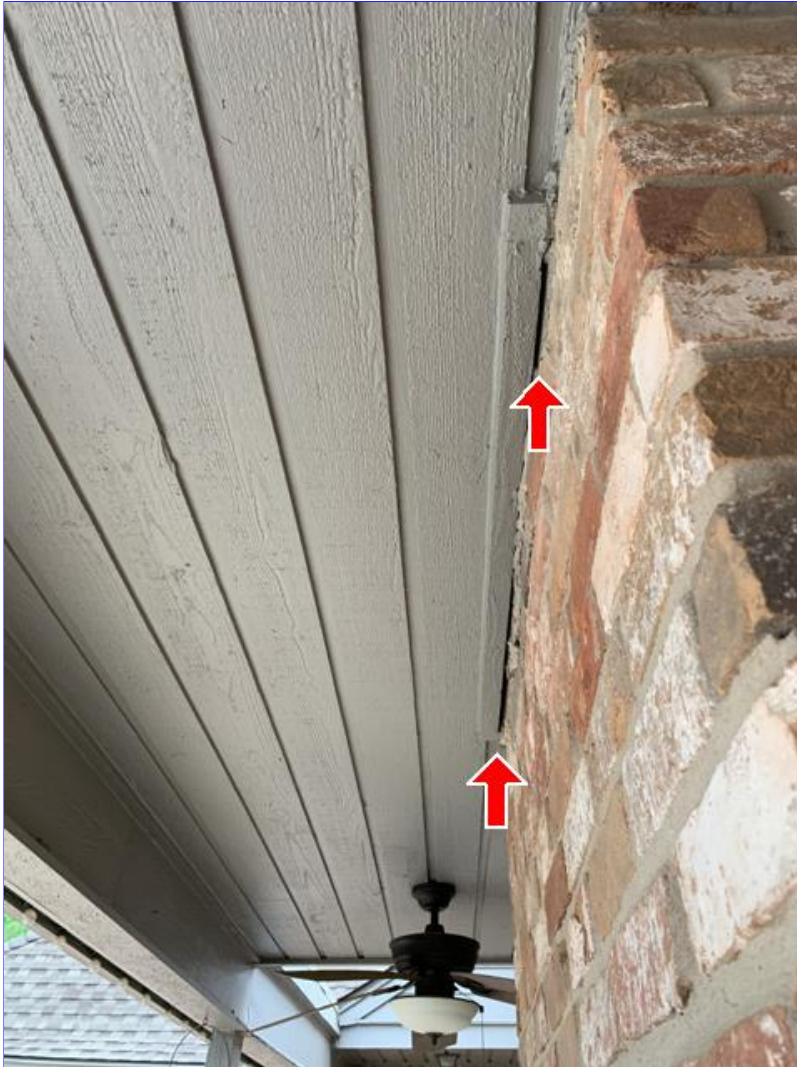
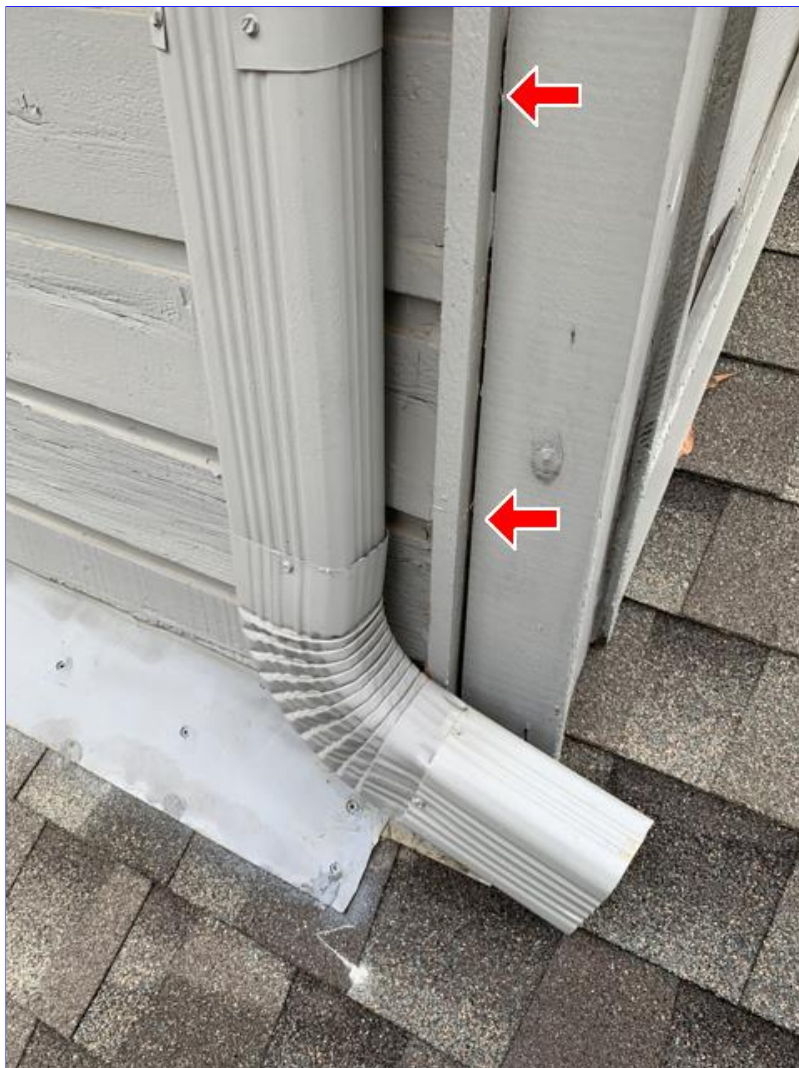
(4) Areas were observed, where the brick, siding and/or trim needs to be resealed.

E. Photo 12(Picture) Areas were observed, where the brick, siding and/or trim needs to be resealed.

E. Photo 13(Picture) Areas were observed, where the brick, siding and/or trim needs to be resealed.

E. Photo 14(Picture) Areas were observed, where the brick, siding and/or trim needs to be resealed.

E. Photo 15(Picture) Areas were observed, where the brick, siding and/or trim needs to be resealed.

E. Photo 16(Picture) Areas were observed, where the brick, siding and/or trim needs to be resealed.

E. Photo 17(Picture) Areas were observed, where the brick, siding and/or trim needs to be resealed.

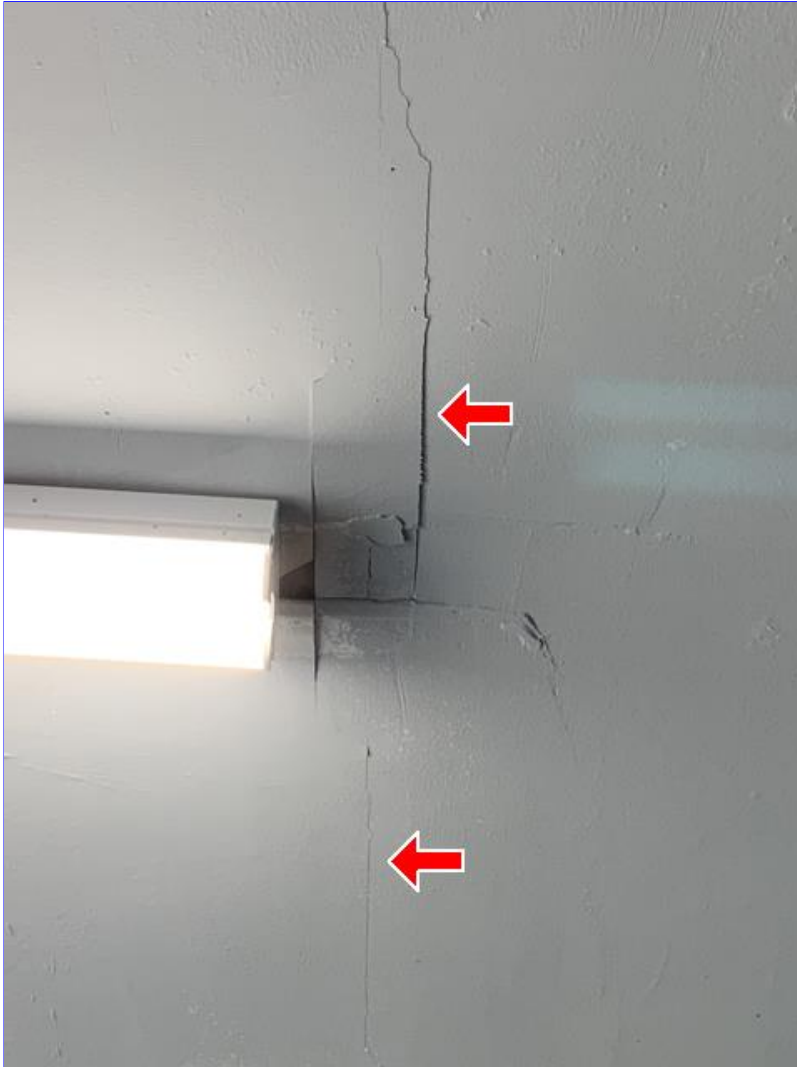
(1) Drywall tape joint cracks and/or nail pops were observed around the home. These are cosmetic in nature, and can be repaired as needed.

F. Photo 1(Picture) Drywall tape joint cracks and/or nail pops were observed around the home. These are cosmetic in nature, and can be repaired as needed.

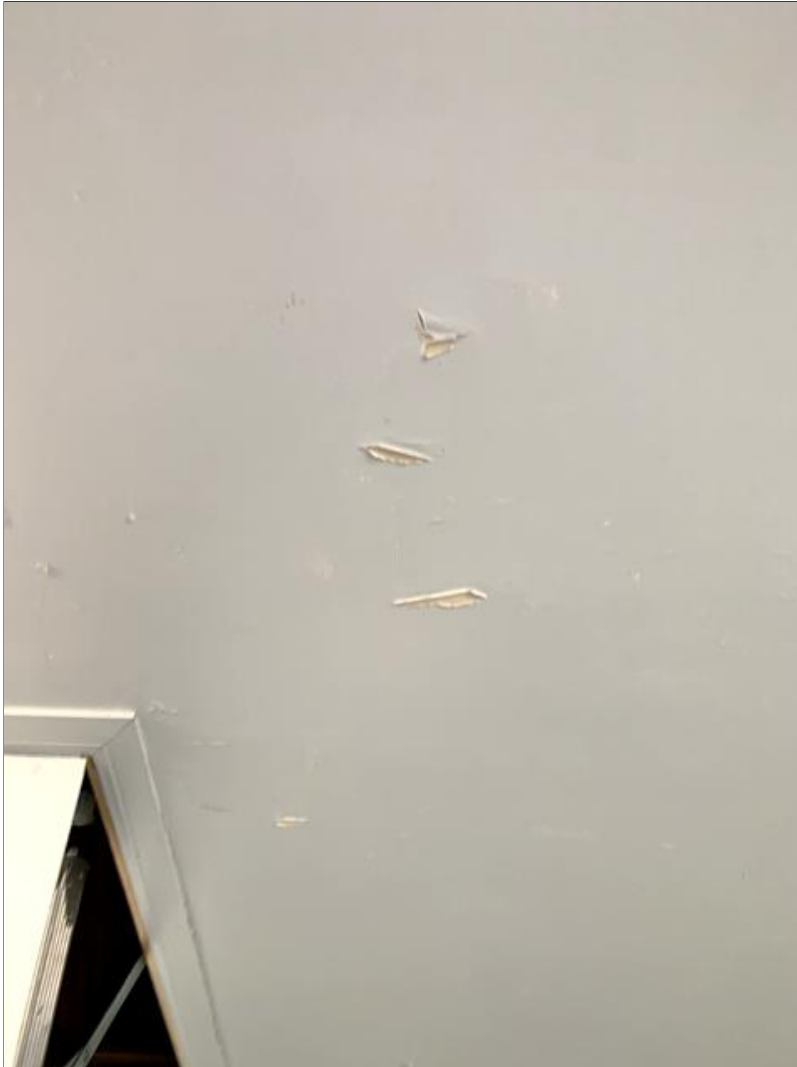
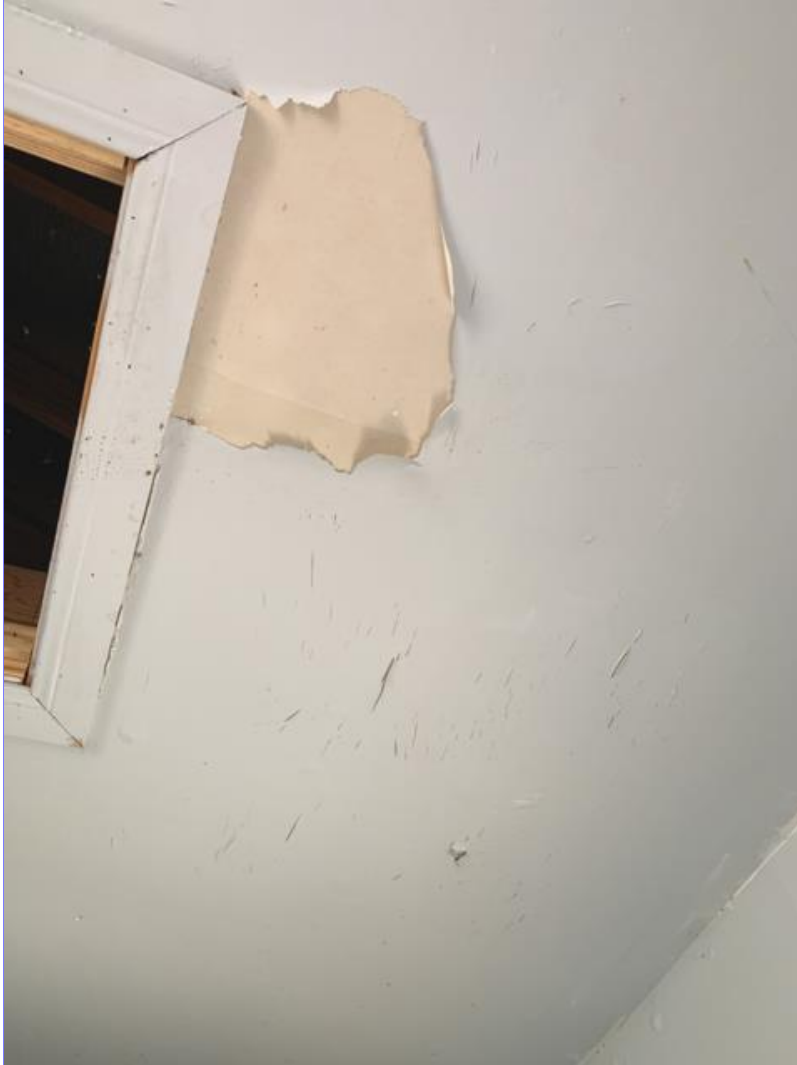
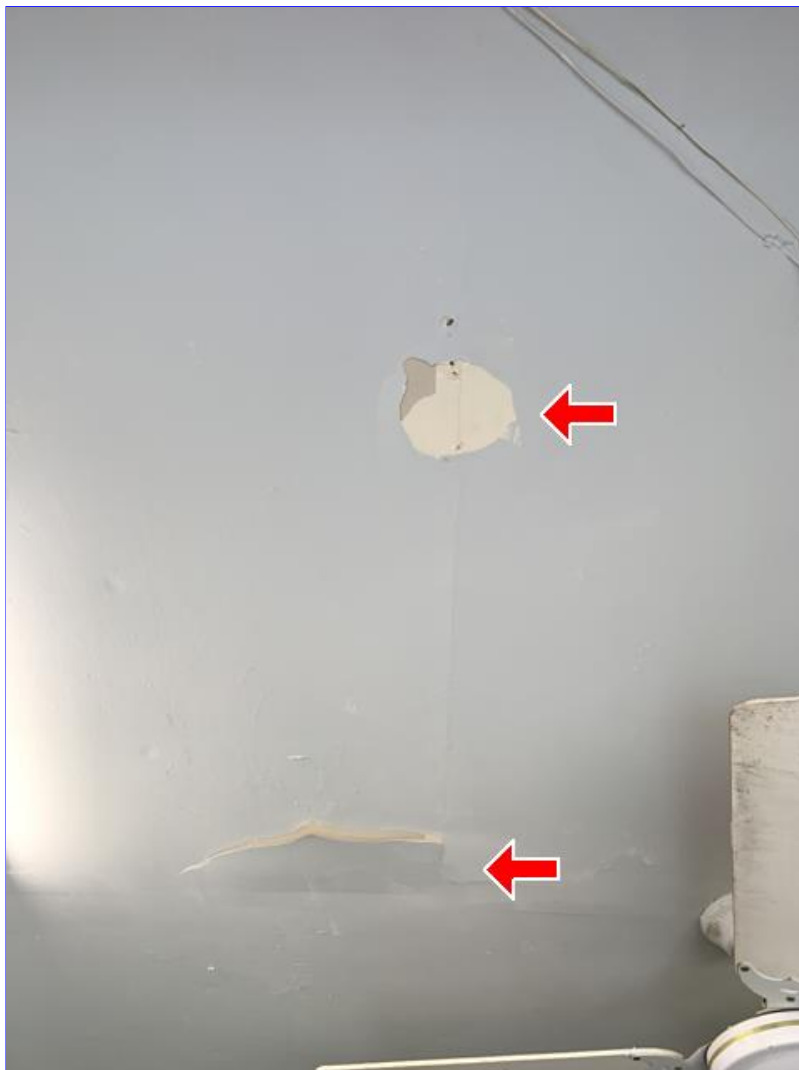
(2) In the garage, areas were observed where the paint has failed on the ceiling.

F. Photo 2(Picture) In the garage, areas were observed where are the paint has failed on the ceiling.

F. Photo 3(Picture) In the garage, areas were observed where are the paint has failed on the ceiling.

F. Photo 4(Picture) In the garage, areas were observed where are the paint has failed on the ceiling.

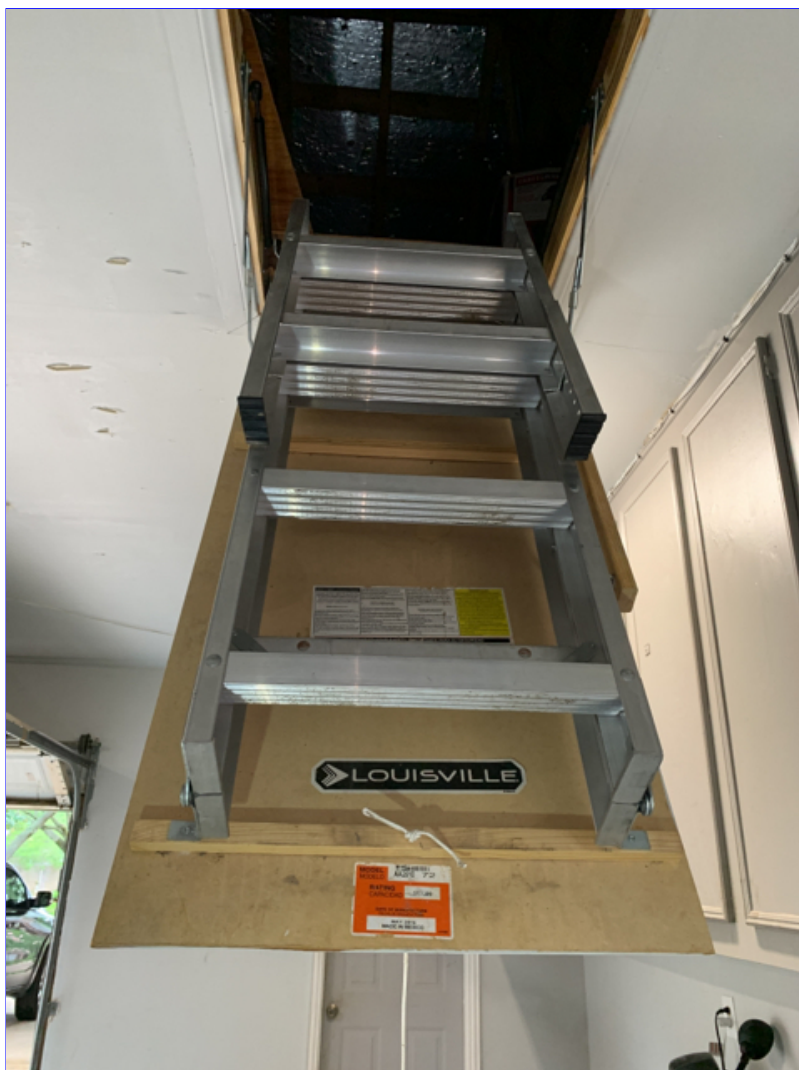
(1) The garage attic access door (pull down stairs), is not marked as being fire rated. This door is part of the fire separation from the garage to the main living space and needs to be fire rated. Recommend correction for safety purposes.

G. Photo 1(Picture) The garage attic access door (pull down stairs), is not marked as being fire rated. This door is part of the fire separation from the garage to the main living space and needs to be fire rated. Recommend correction for safety purposes.

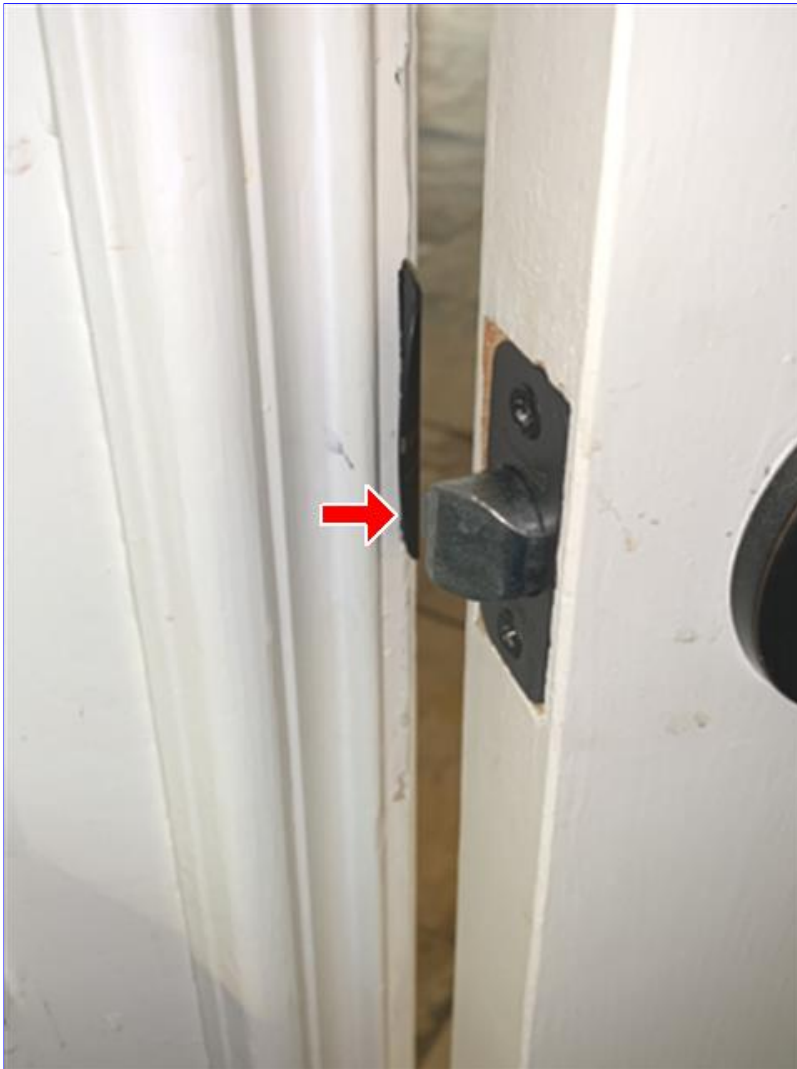
(2) The door hardware at the wet bar location is installed backwards.

G. Photo 2(Picture) The door hardware at the wet bar location is installed backwards.
