# PROPERTY INSPECTION REPORT

**Concerning:** 19807 Summerset way, Houston, TX 77094

**By:** S. Brad Williams TREC# 23549 / Sunbelt Inspections 4/15/2021

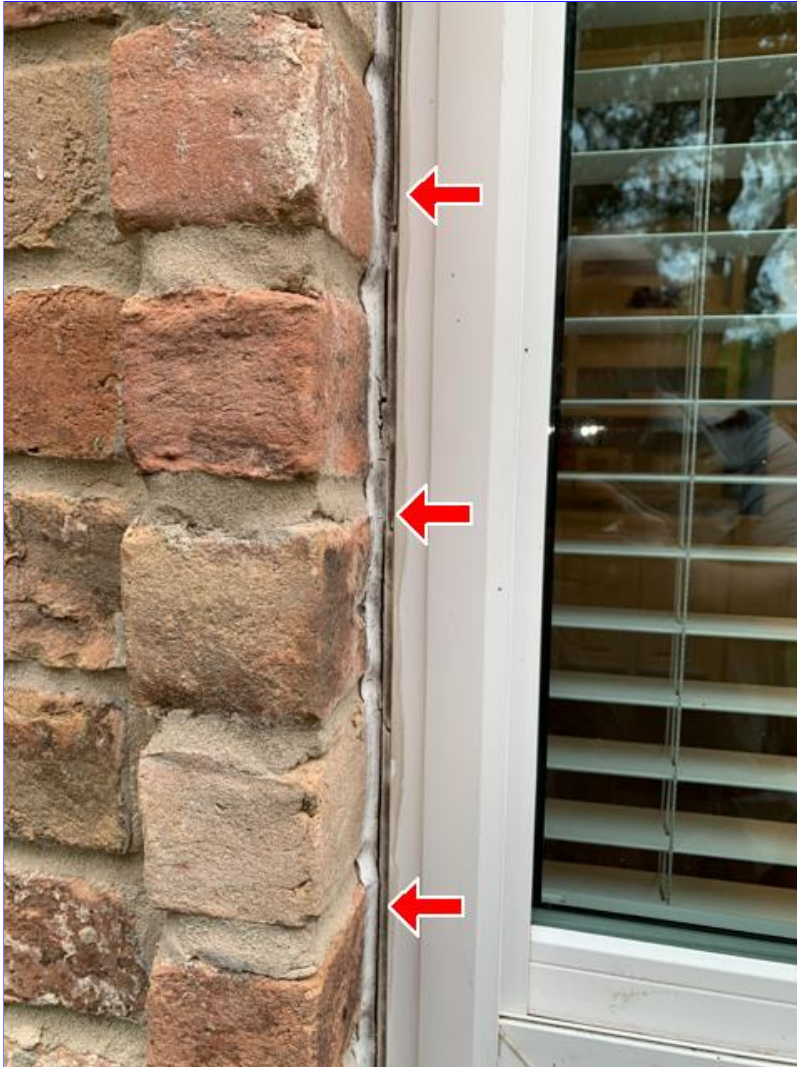
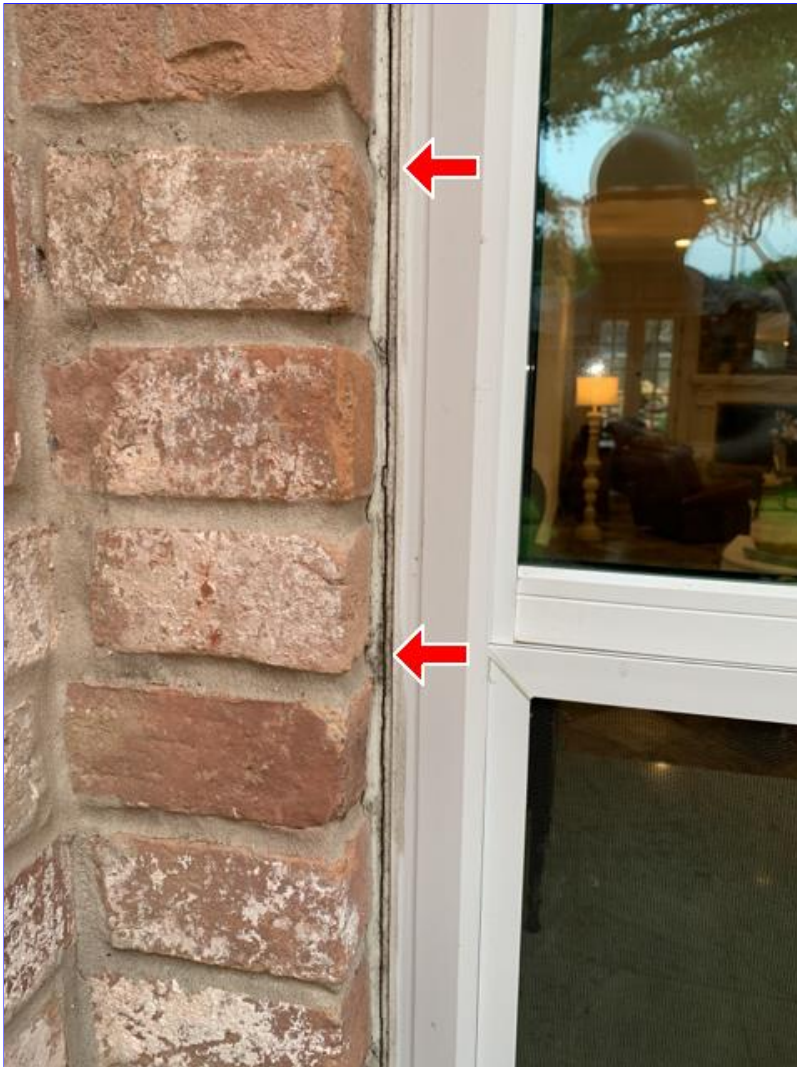
(1) The perimeter sealant, has failed on some windows.

H. Photo 1(Picture) The perimeter sealant, has failed on some windows.

H. Photo 2(Picture) The perimeter sealant, has failed on some windows.

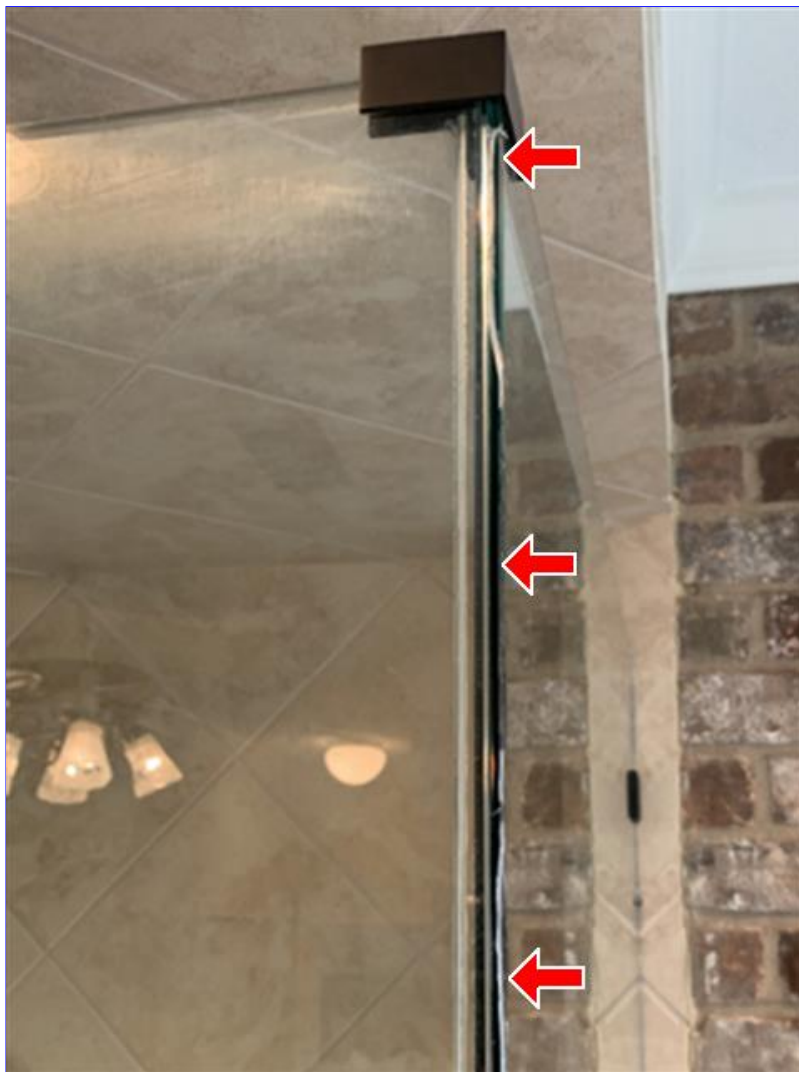
(2) In the master bathroom, the shower glass is loose at the corner and has shifted towards the glass door. Recommend correction.

H. Photo 3(Picture) In the master bathroom, the shower glass is loose at the corner and has shifted towards the glass door. Recommend correction.

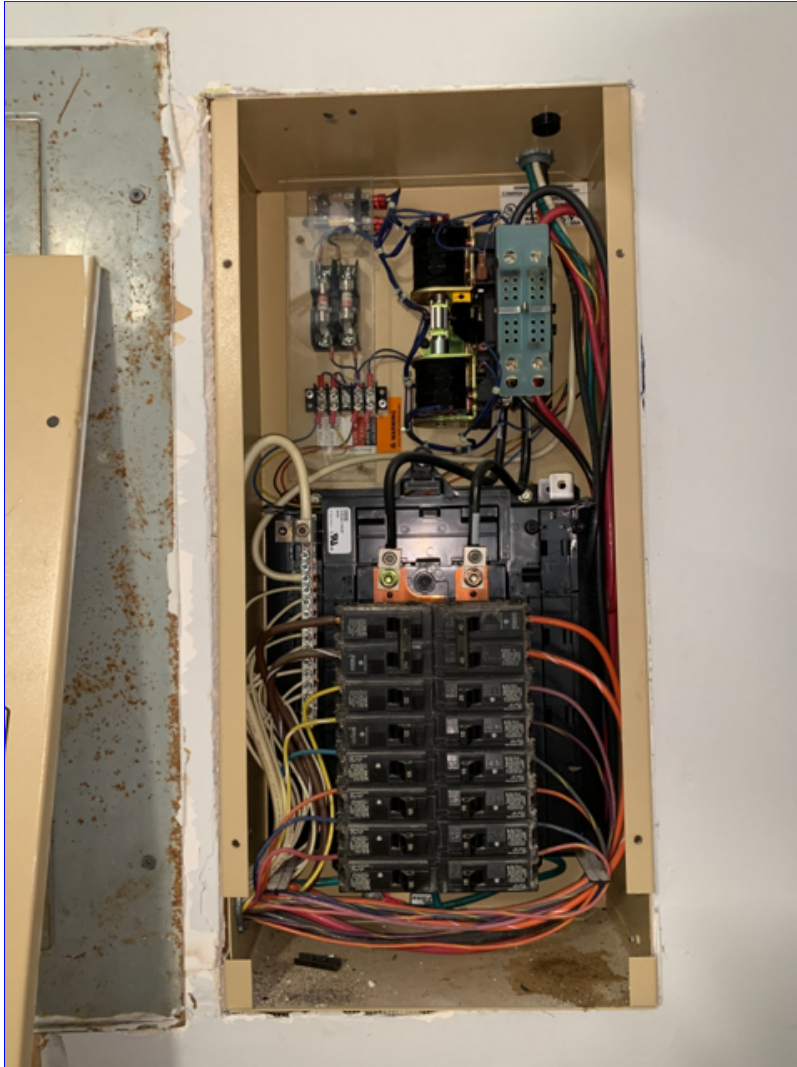
A. Photo 3(Picture) The Generator electrical service panel, shown with dead front cover removed for inspection purposes. The panel inspected okay.

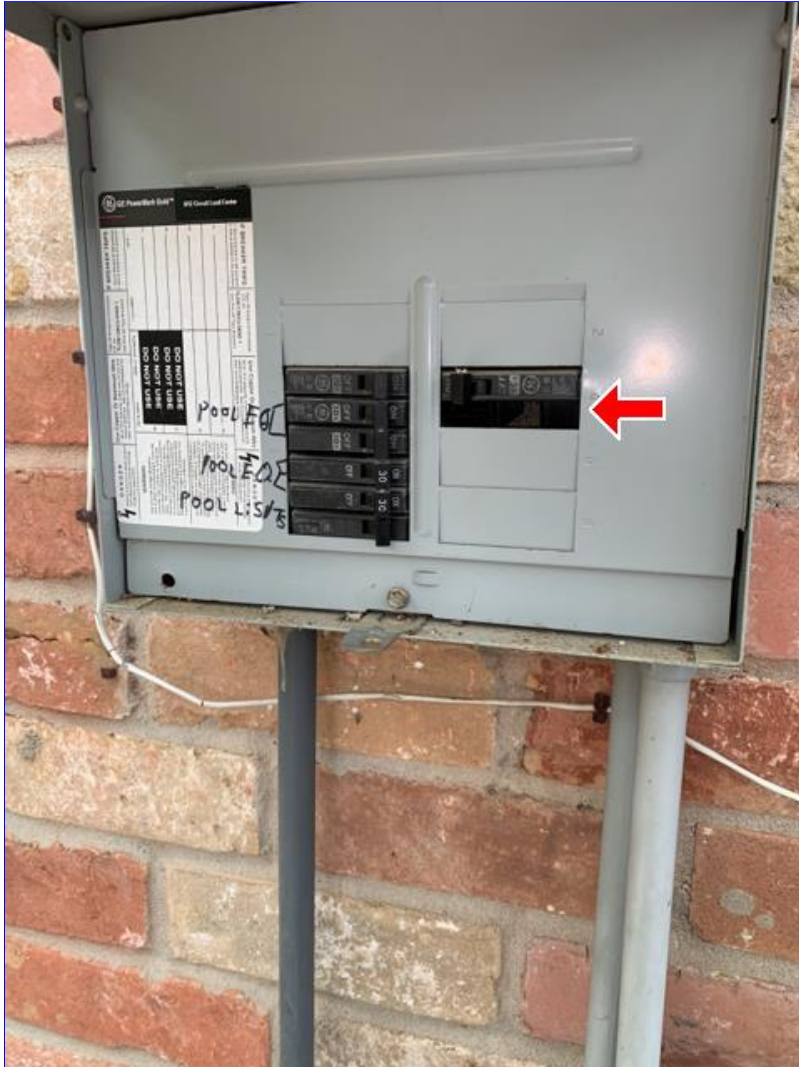
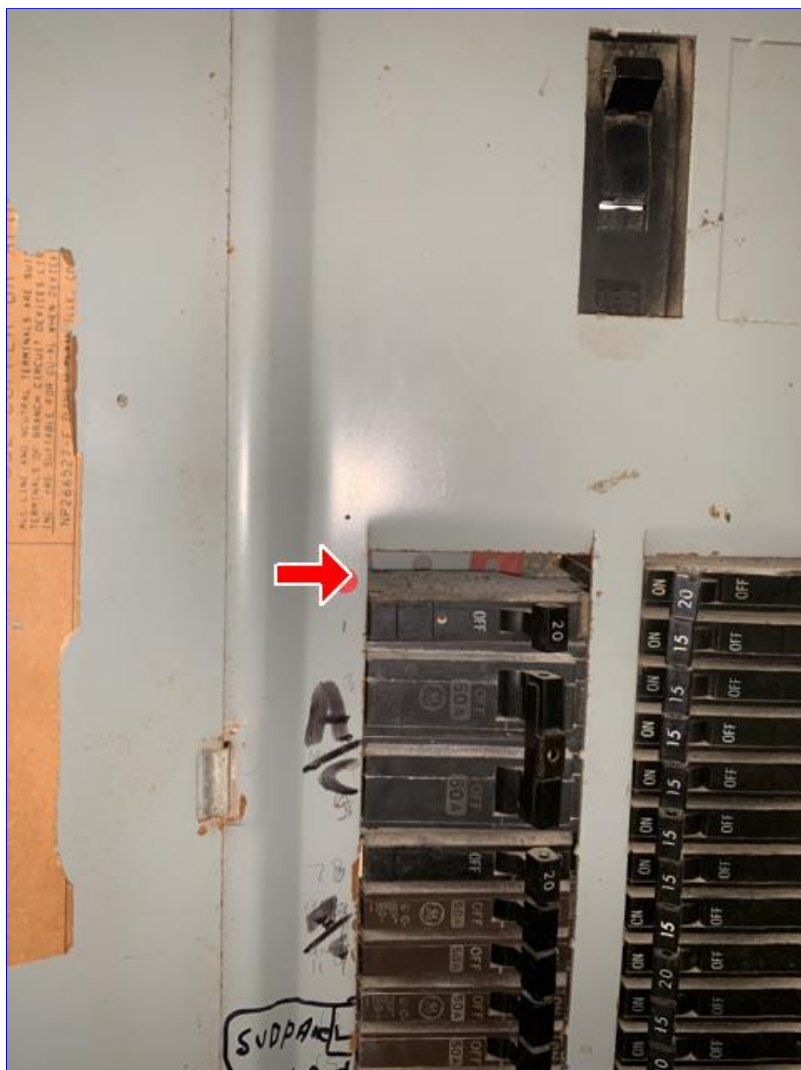
(4) Open breaker knockouts need filler plates installed. Recommend correction.

A. Photo 4(Picture) Open breaker knockouts need filler plates installed. Recommend correction.

A. Photo 5(Picture) Open breaker knockouts need filler plates installed. Recommend correction.

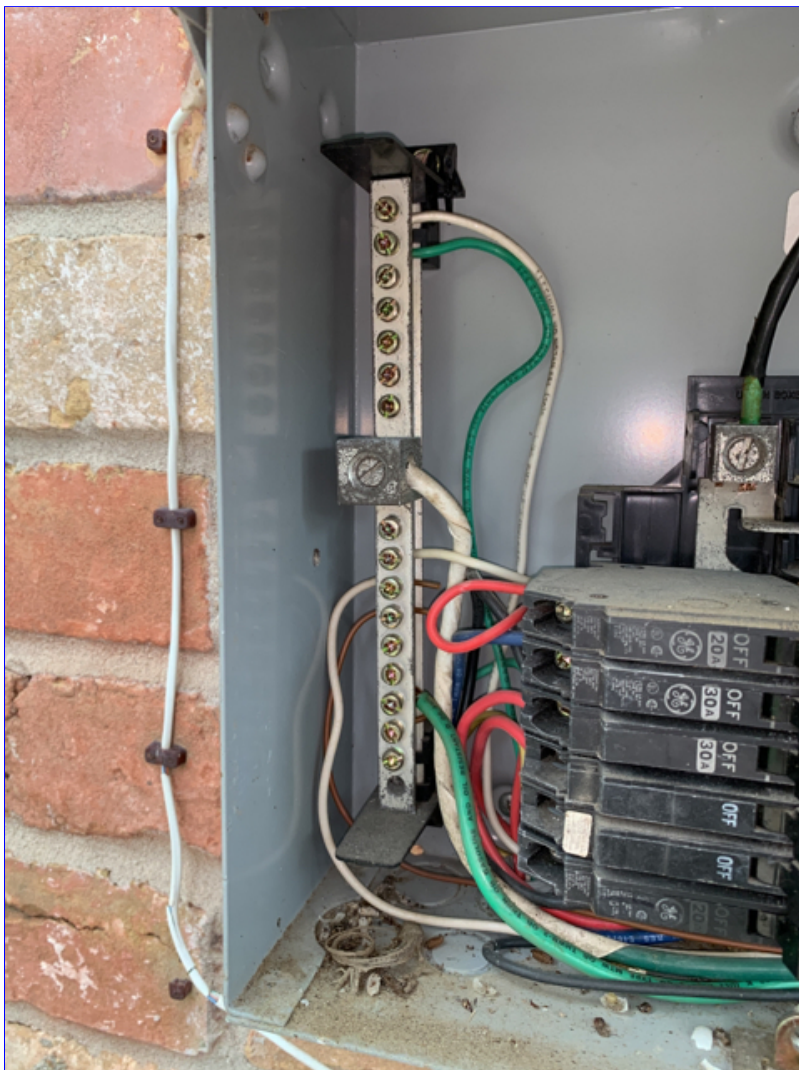
A. Photo 6(Picture) In the Pool electrical sub-panel, the ground and neutral conductors, are not separated onto their own busses and the bonding strap is not removed or cut as required. Grounds and neutrals inside sub-panels need to be isolated.

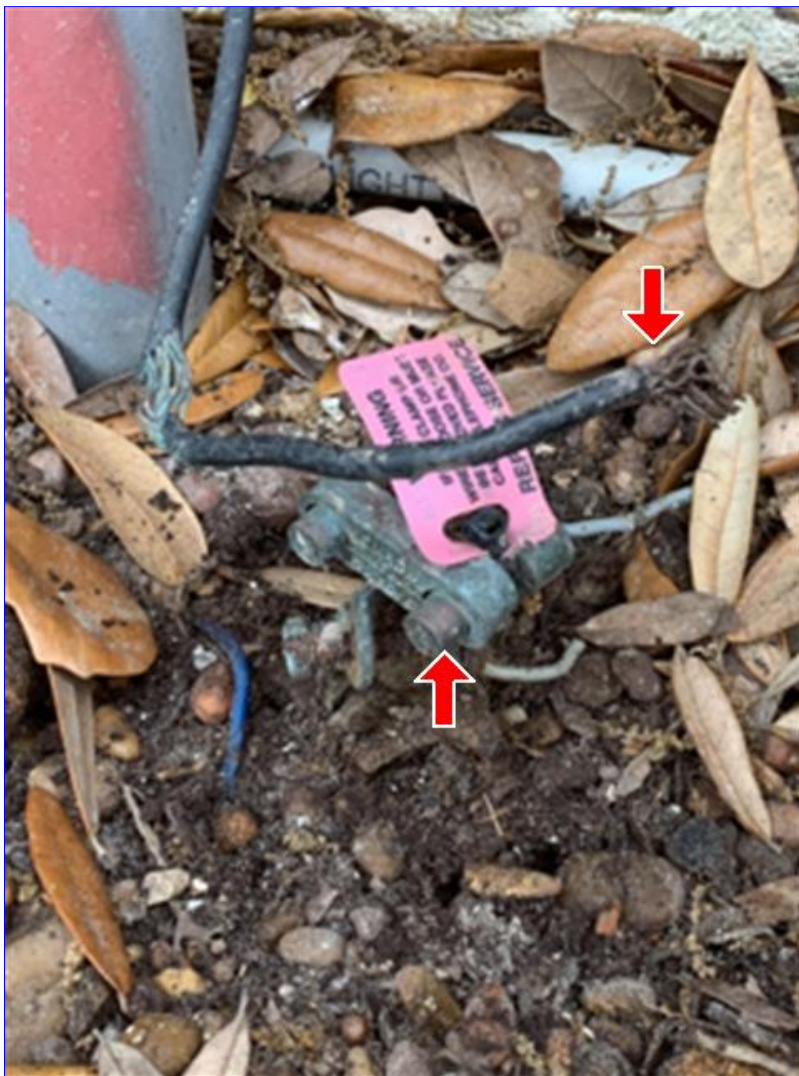
(6) The system ground wire, is loose from the ground clamp or the ground clamp, is loose on the ground rod (electrode).

A. Photo 7(Picture) The system ground wire, is loose from the ground clamp or the ground clamp, is loose on the ground rod (electrode).

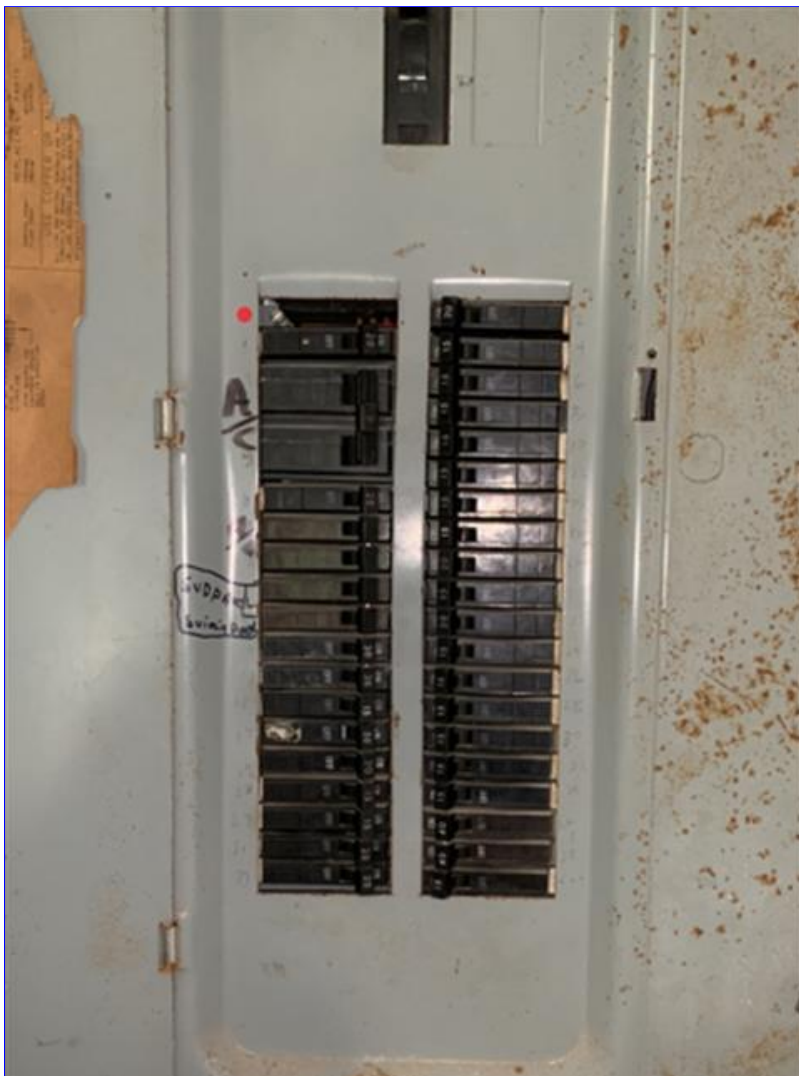
(7) Some labels are present, but are illegible or confusing. I recommend correcting for safety reasons.

A. Photo 8(Picture) Some labels are present, but are illegible or confusing. I recommend correcting for safety reasons.

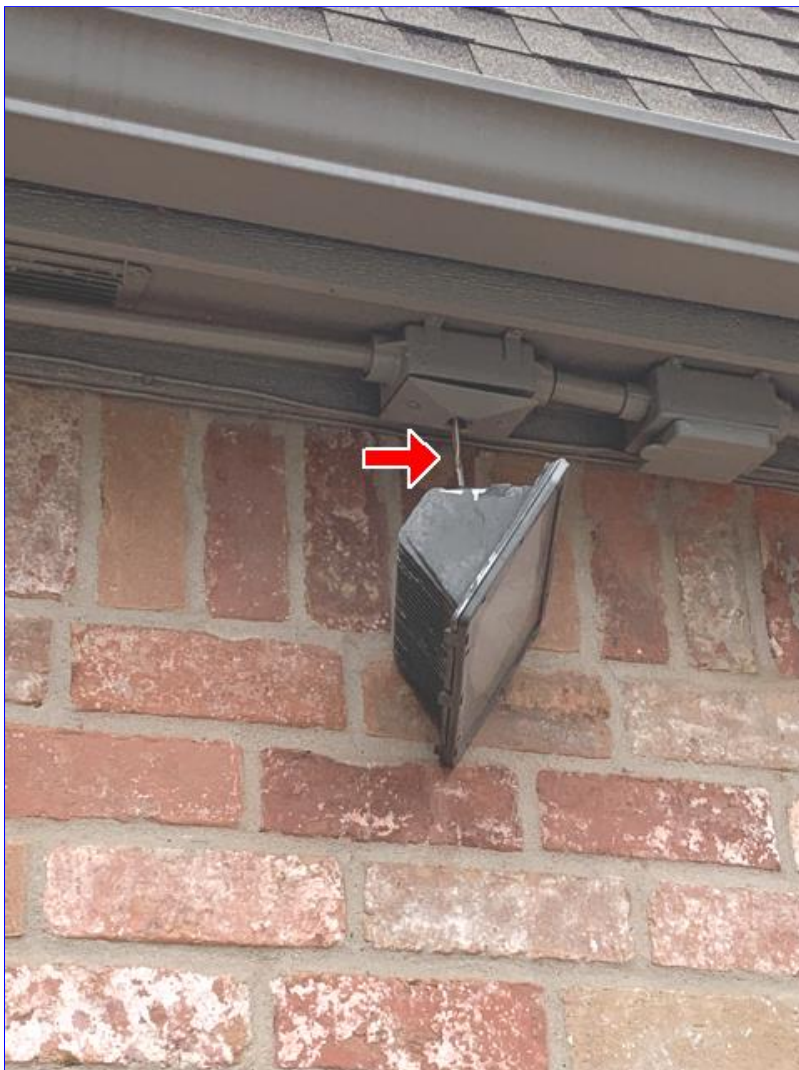
(1) The back porch flood light is damaged and hanging by the electrical wiring.

B. Photo 1(Picture) The back porch flood light is damaged and hanging by the electrical wiring.

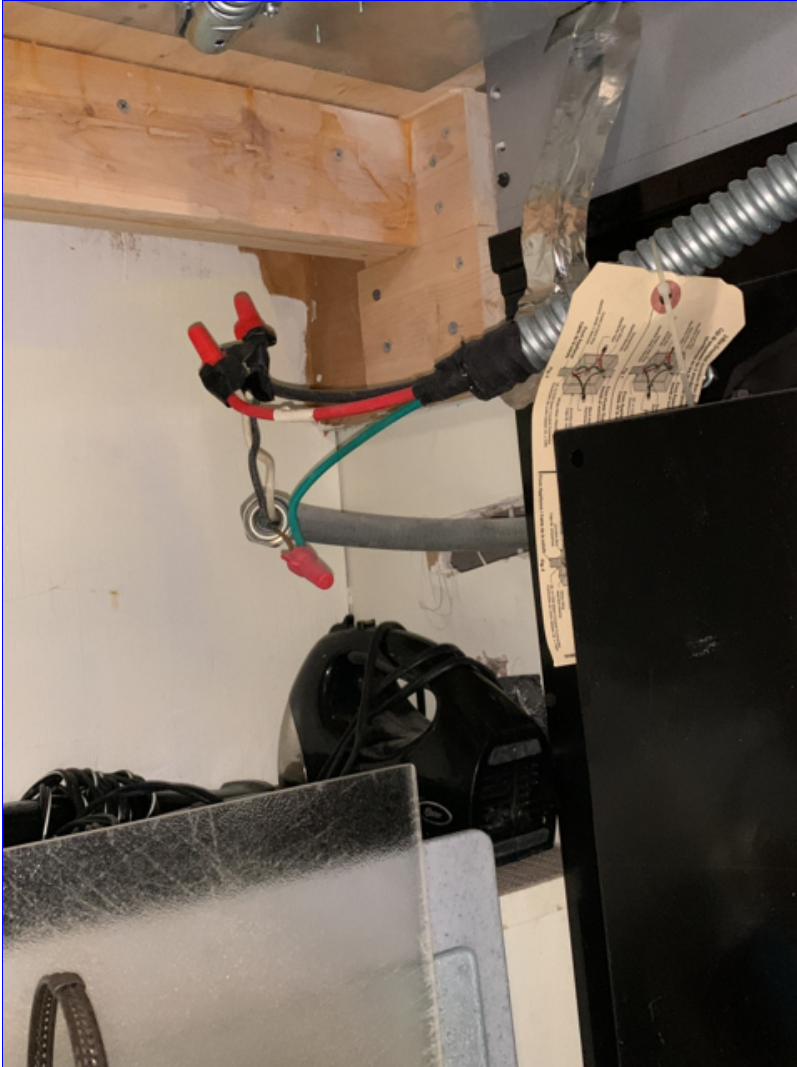
(5) Exposed electrical connections were observed at the kitchen range. Recommend correction for safety purposes.

B. Photo 2(Picture) Exposed electrical connections were observed at the kitchen range. Recommend correction for safety purposes.

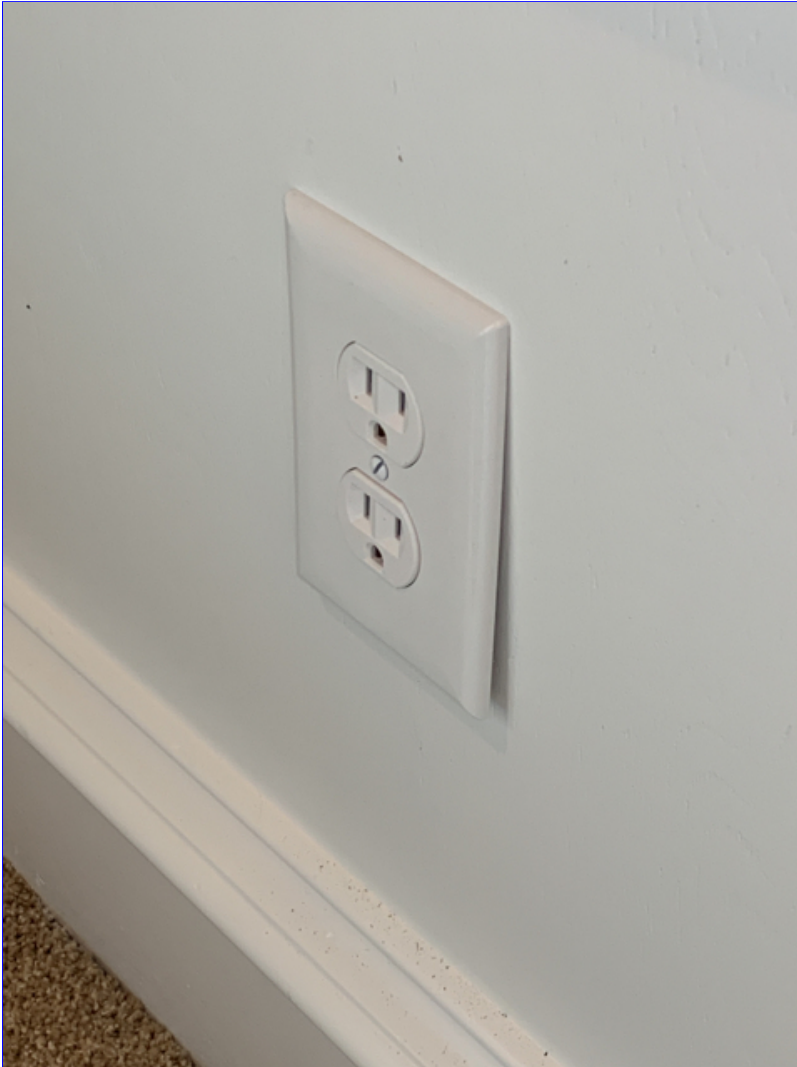
(6) In the upstairs family room, an electrical outlet was observed, that needs to be re-secured at the wall.

B. Photo 3(Picture) In the upstairs family room, an electrical outlet was observed, that needs to be re-secured at the wall.

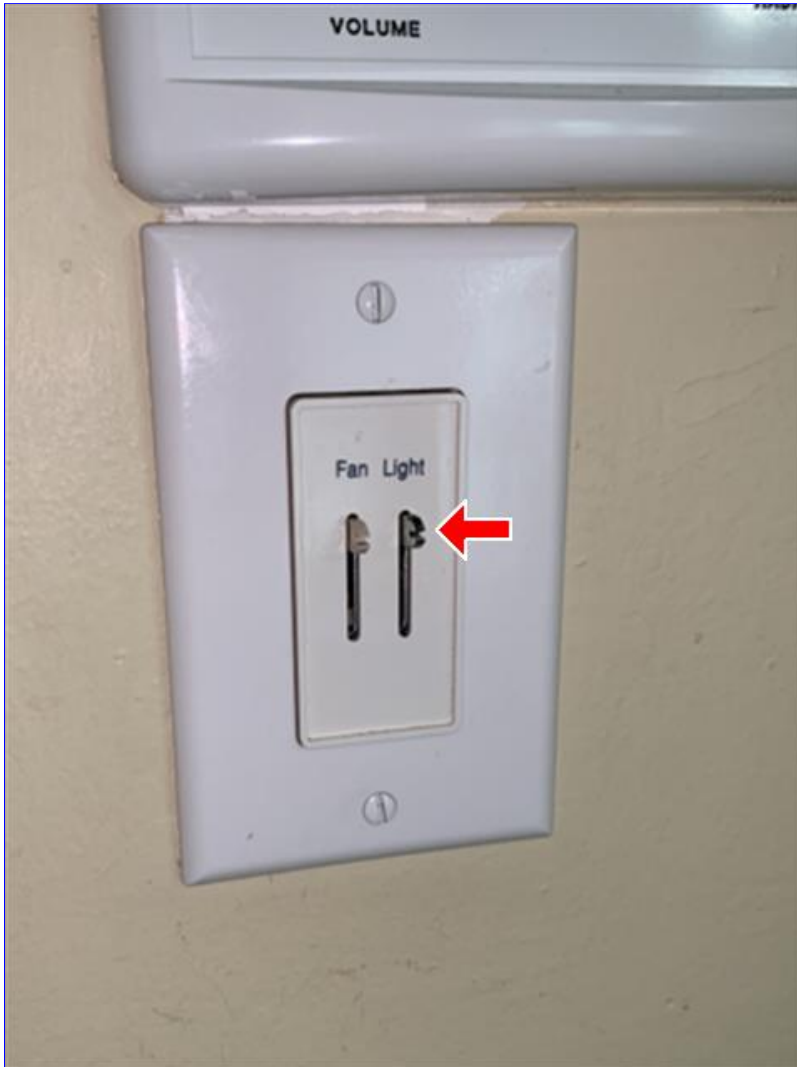
(7) Several of the dual dimmer style light switches are missing the caps.

B. Photo 4(Picture) Several of the dual dimmer style light switches are missing the caps.

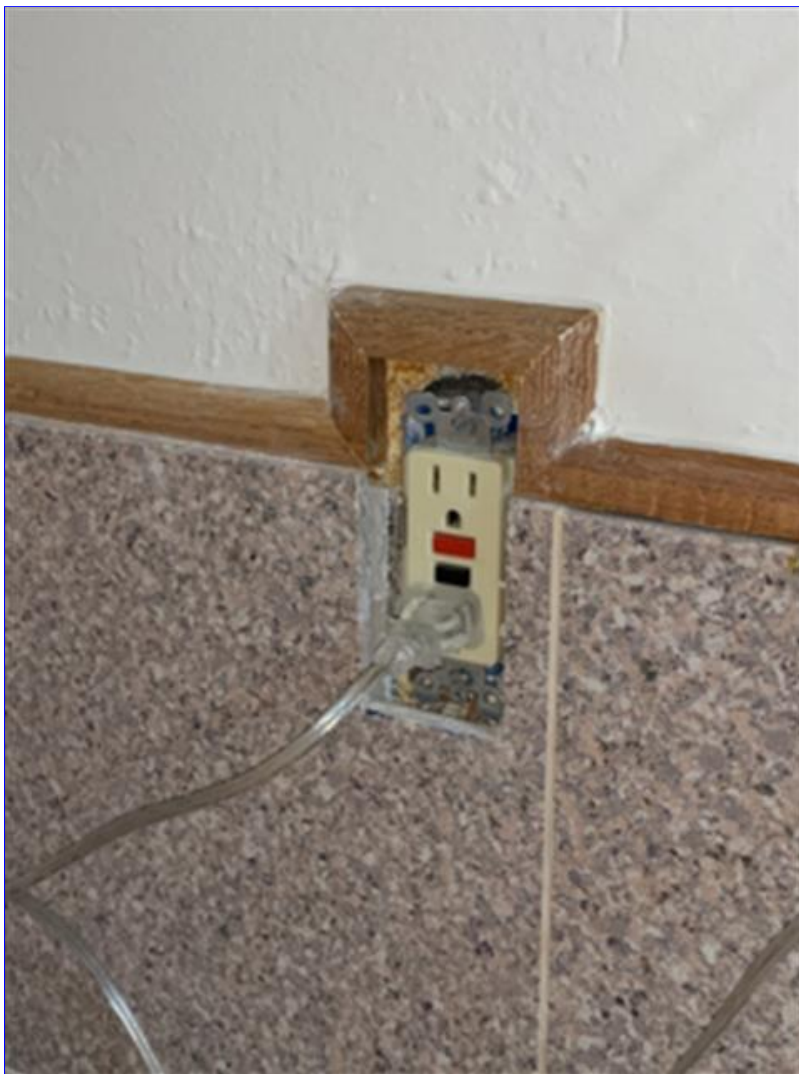
(8) At the wet bar, a missing receptacle cover plate was observed. These plates should be replaced for safety reasons.

B. Photo 5(Picture) At the wet bar, a missing receptacle cover plate was observed. These plates should be replaced for safety reasons.

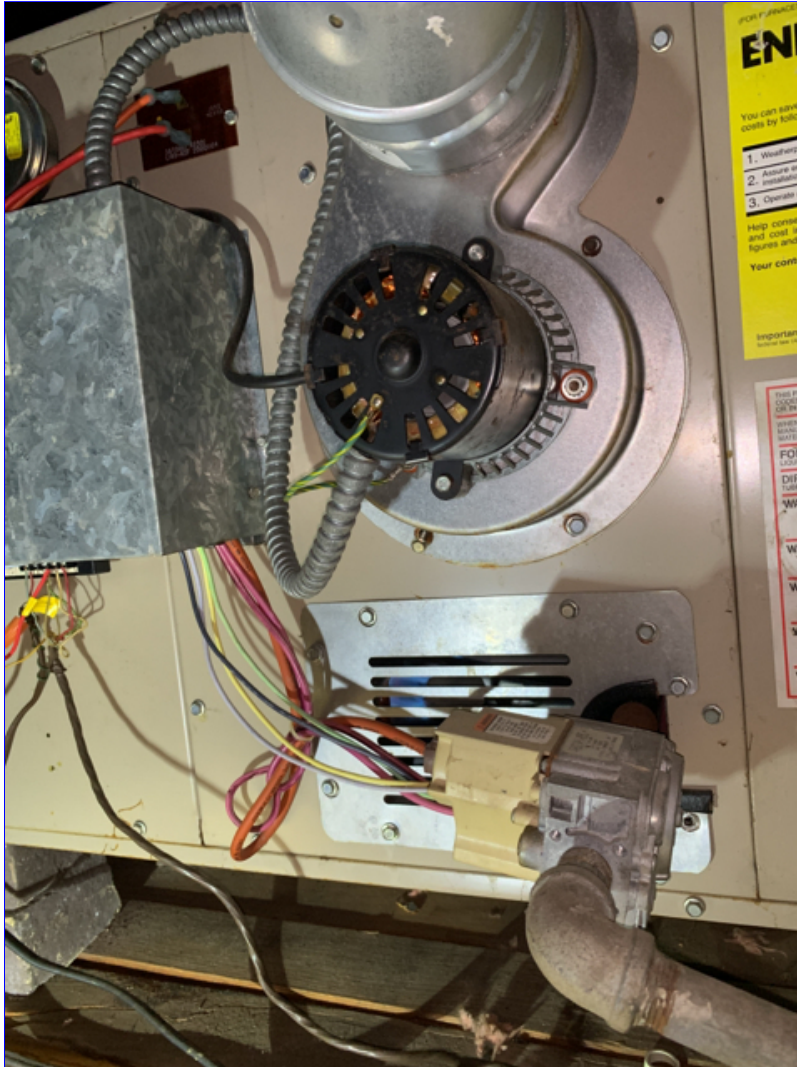
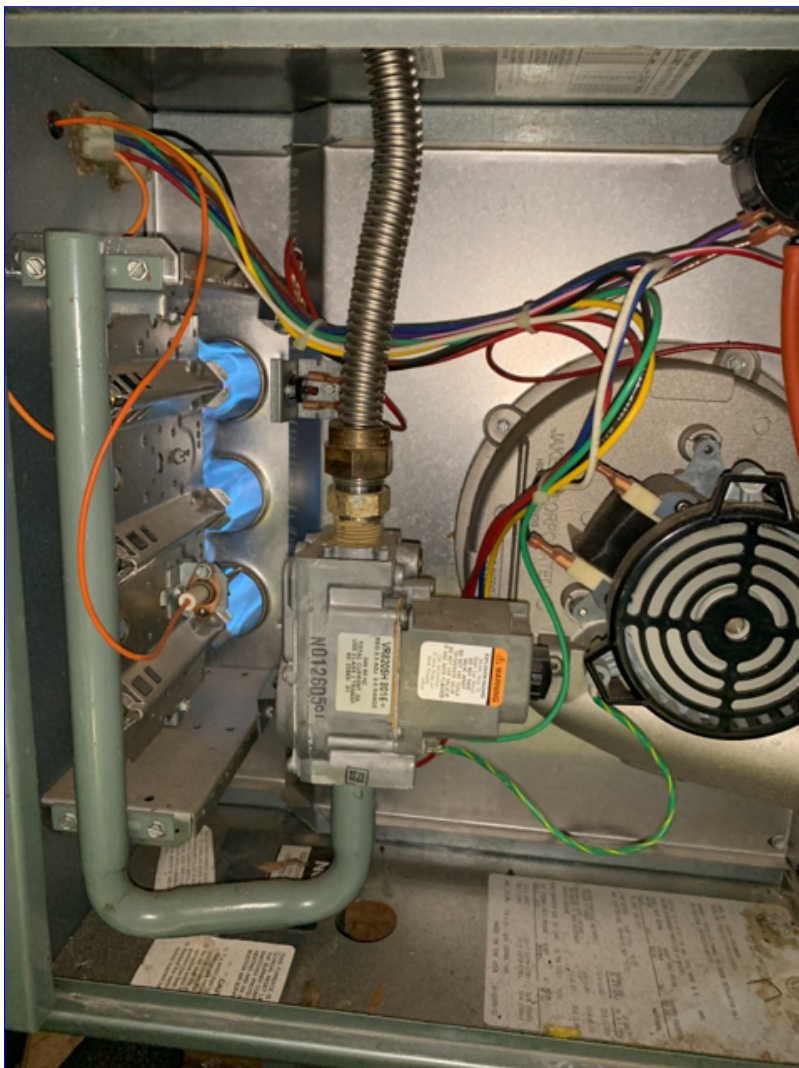
A. Photo 1(Picture) The unit appeared to operate normally using the standard controls. I could not determine if the heat exchanger is cracked or not without dismantling the furnace. Dismantling of components is outside of the scope of a standard home inspection.

A. Photo 2(Picture) The unit appeared to operate normally using the standard controls. I could not determine if the heat exchanger is cracked or not without dismantling the furnace. Dismantling of components is outside of the scope of a standard home inspection.

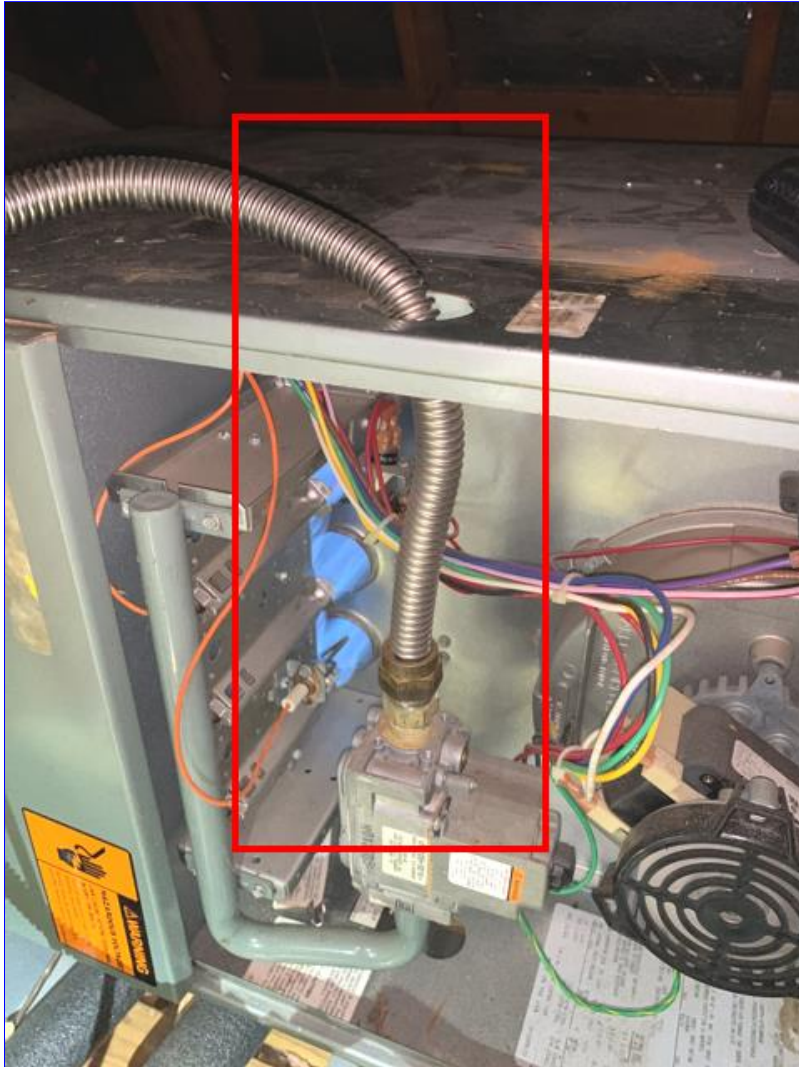
A. Photo 5(Picture) The flexible gas appliance hose is connected inside the unit. A hard gas line needs to be connected and extended outside the unit for the flexible gas line connection.

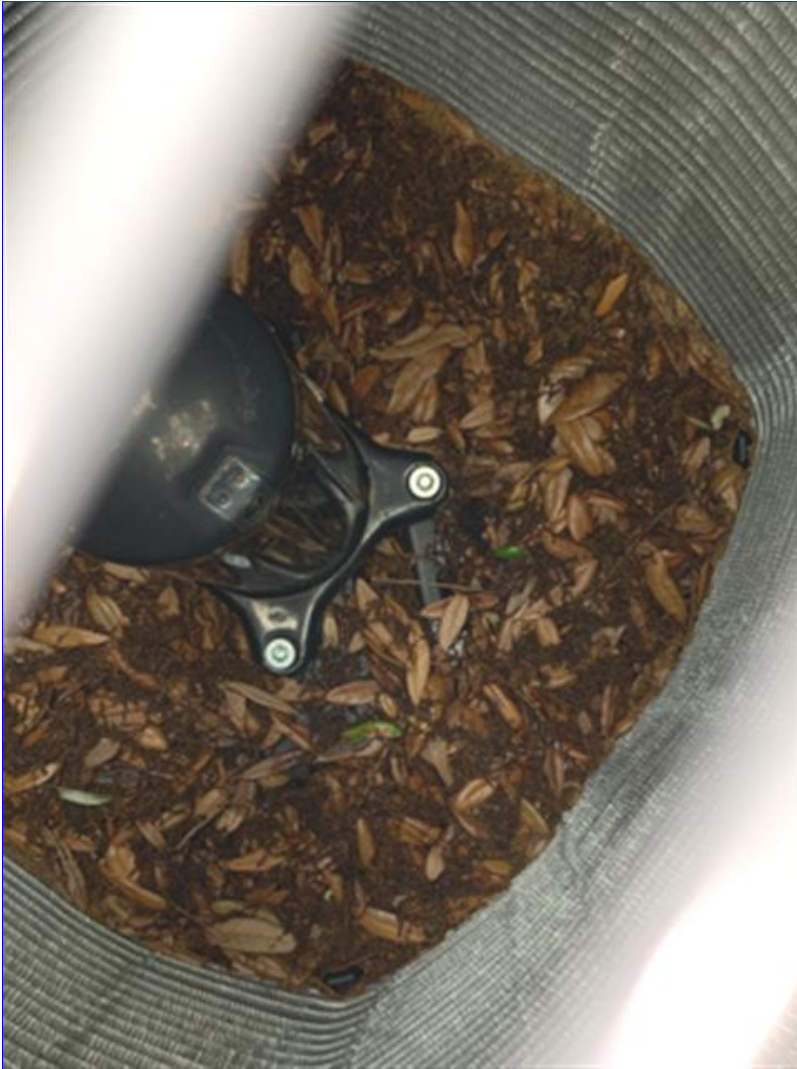
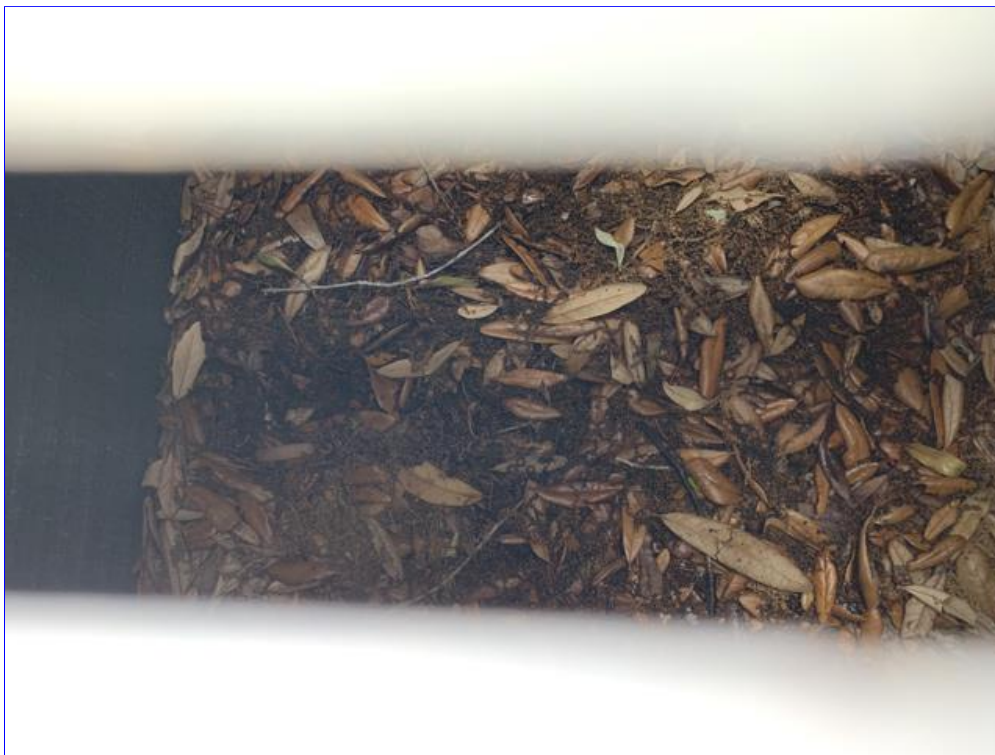
B. Photo 3(Picture) Debris and leaves need to be removed from the inside of the outside air conditioning units.

B. Photo 4(Picture) Debris and leaves need to be removed from the inside of the outside air conditioning units.

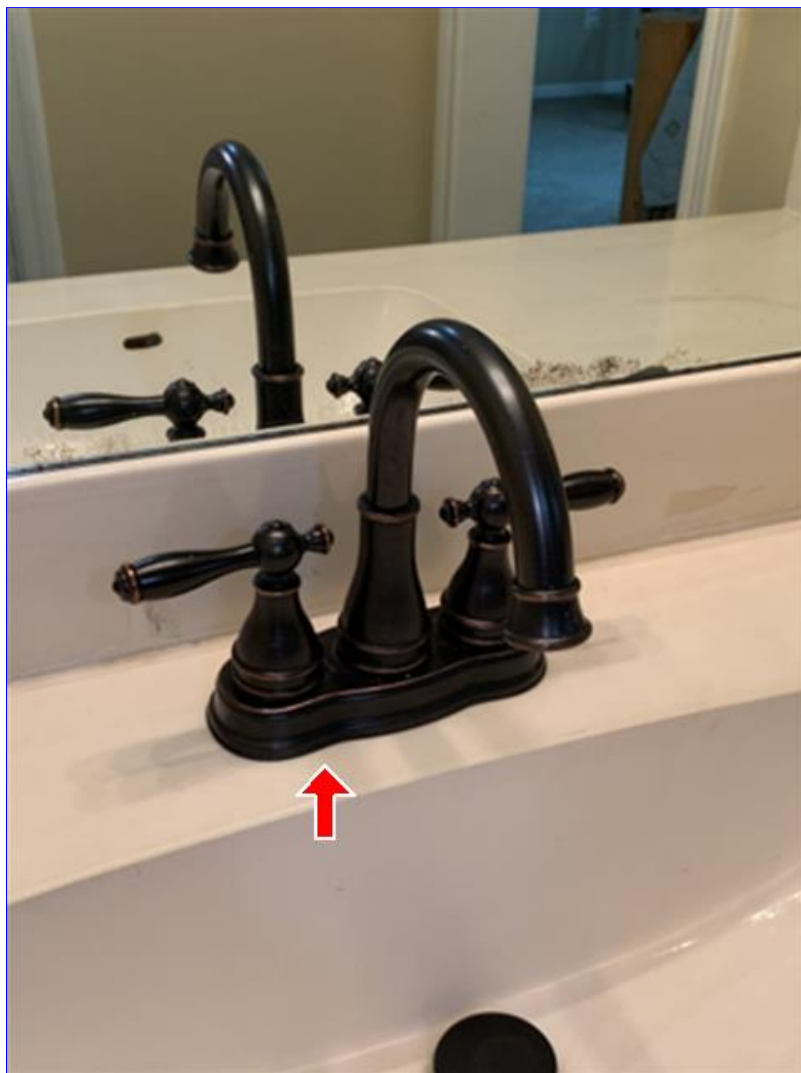
(1) In the upstairs bathroom on the right, one of the sink faucets is loose at the vanity countertop.

A. Photo 1(Picture) In the upstairs bathroom on the right, one of the sink faucets is loose at the vanity countertop.

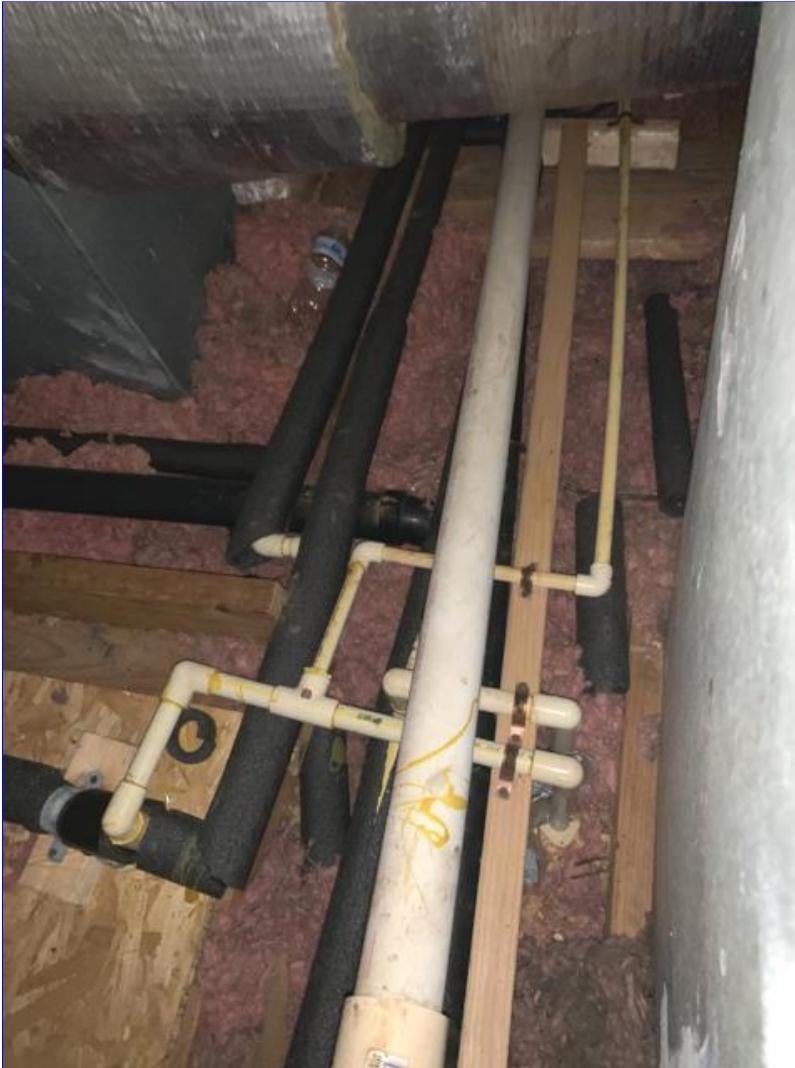
(2) Exposed water pipes observed in the attic space are not properly protected from freezing. Water pipes should be buried under the insulation or properly wrapped to prevent breakage from freezing.

A. Photo 2(Picture) Exposed water pipes observed in the attic space are not properly protected from freezing. Water pipes should be buried under the insulation or properly wrapped to prevent breakage from freezing.

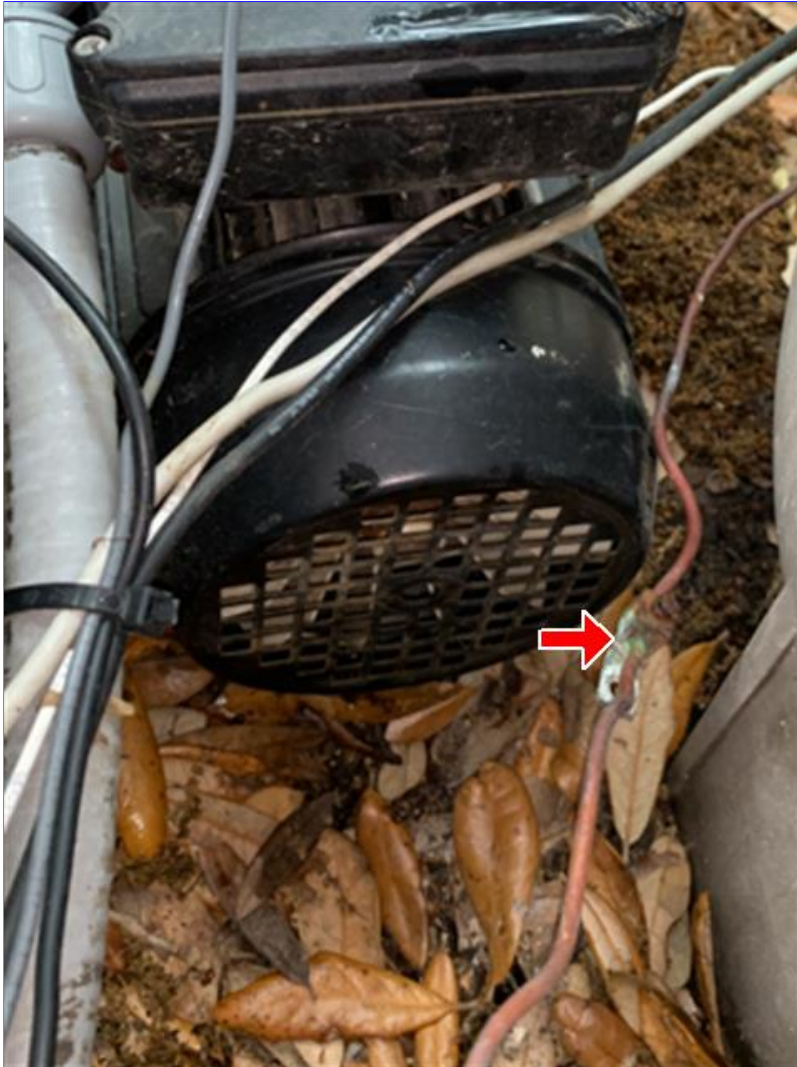
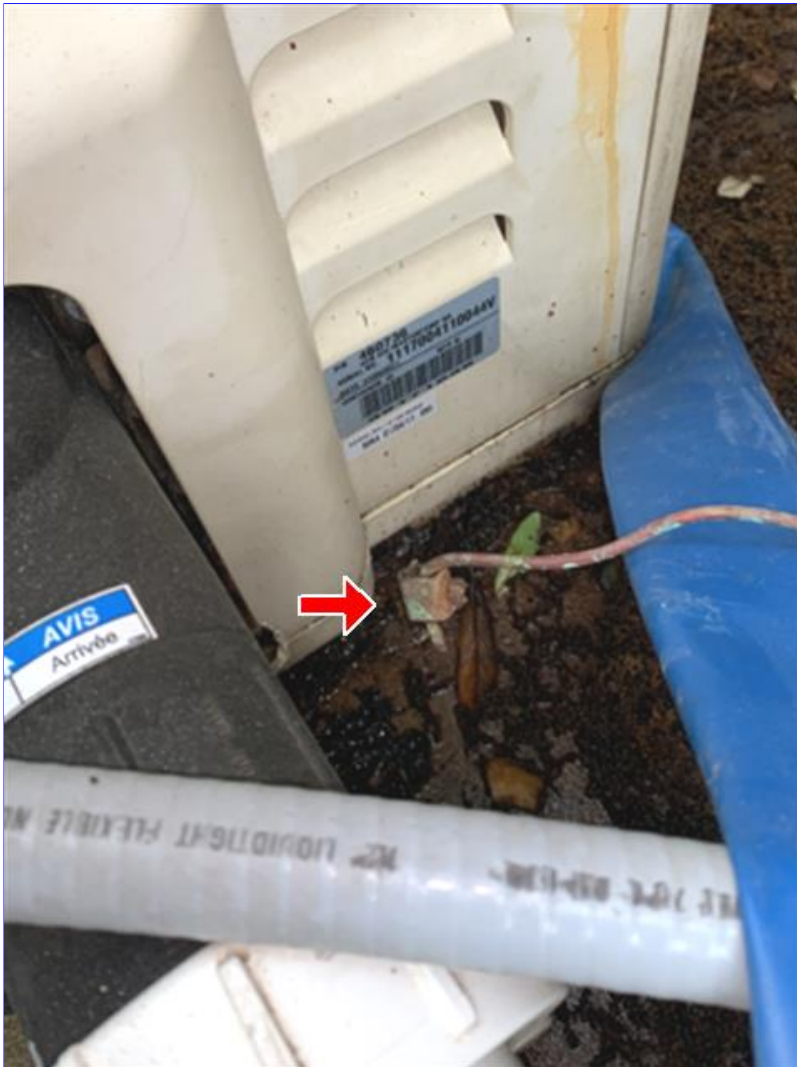
B. Photo 3(Picture) The cleaner pump motor housing and the Pool/ Spa Heater are not bonded to ground. Recommend correction.

B. Photo 4(Picture) The cleaner pump motor housing and the Pool/ Spa Heater are not bonded to ground. Recommend correction.

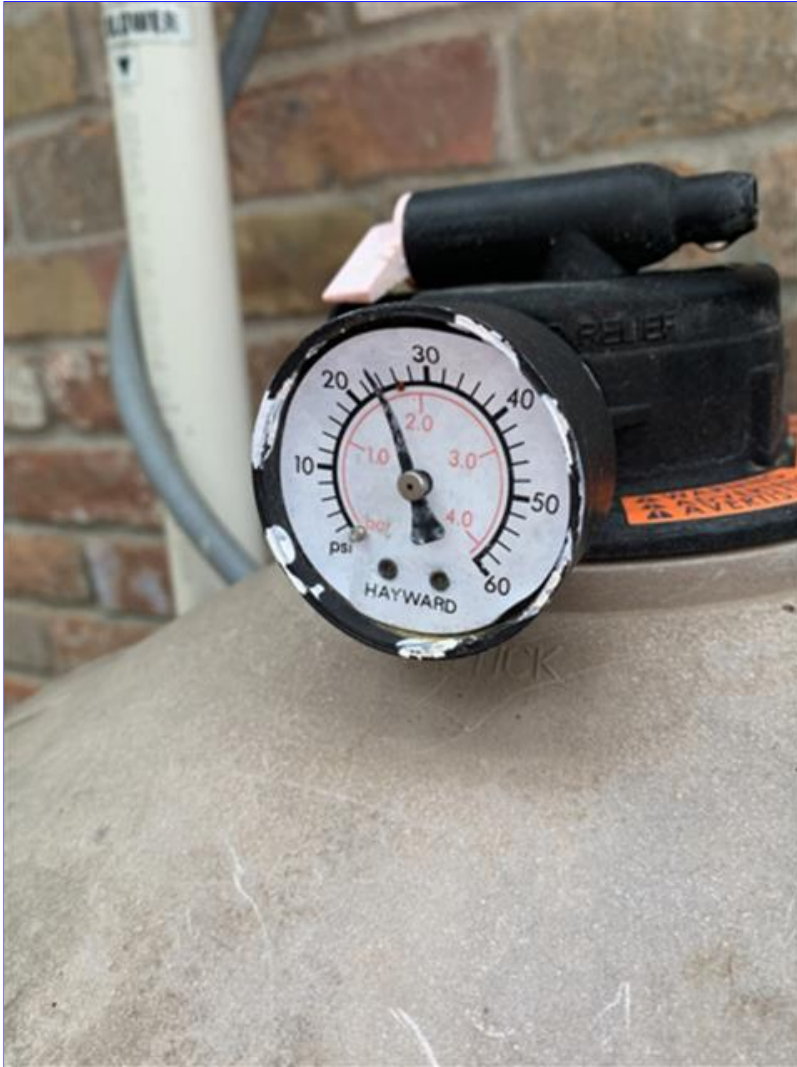
C. Photo 1(Picture) The pressure gauge is damaged. Recommend repair or replacement.

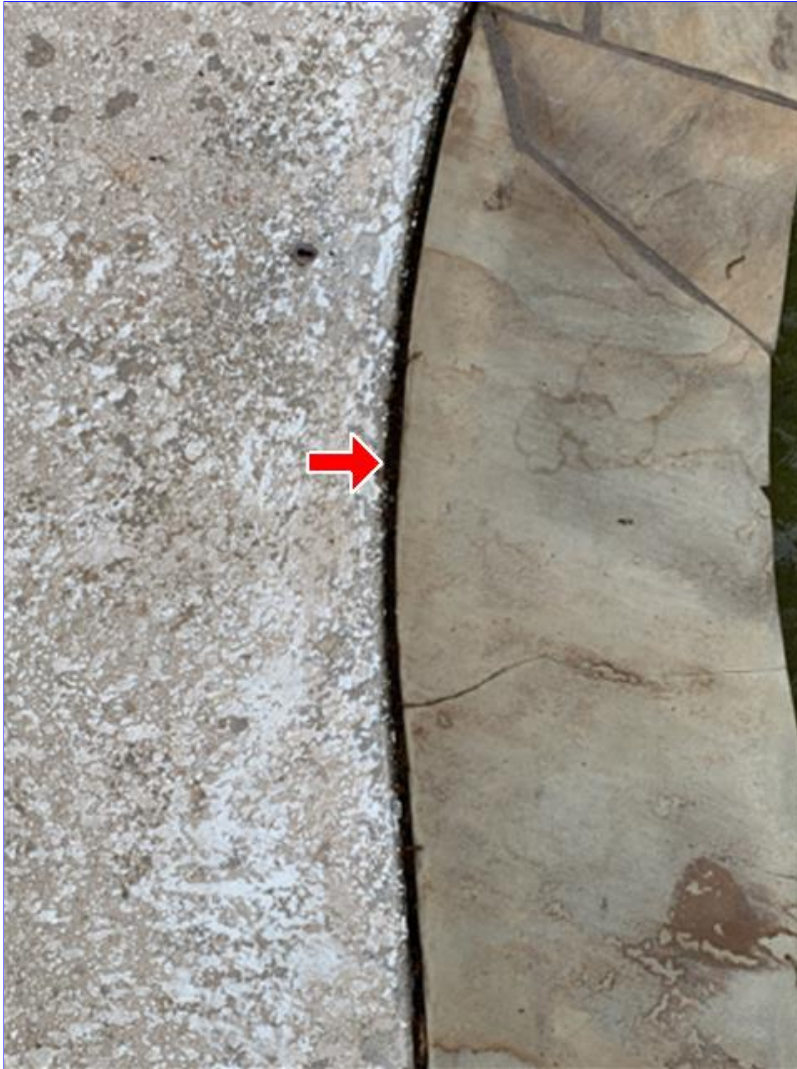
E. Photo 1(Picture) The sealant between the coping and the pool deck has failed.
