# PROPERTY INSPECTION REPORT

**Concerning:** 19807 Summerset way, Houston, TX 77094

**By:** S. Brad Williams TREC# 23549 / Sunbelt Inspections 4/15/2021

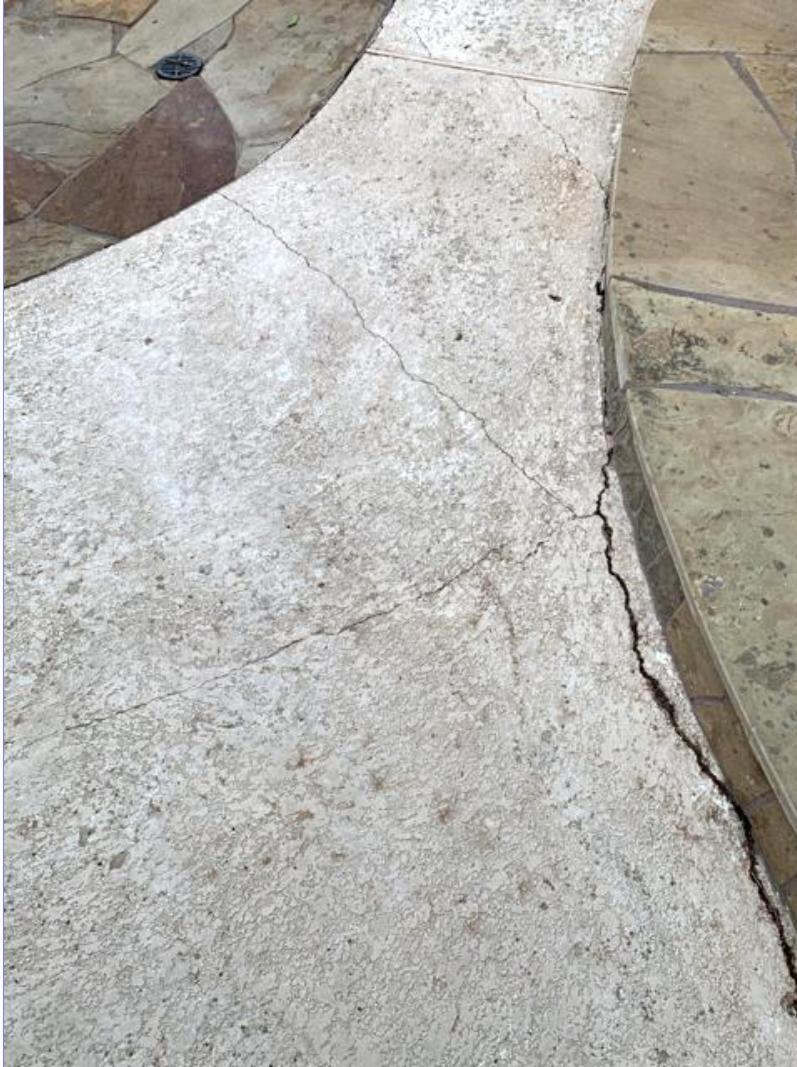
E. Photo 2(Picture) Concrete cracks were observed in the flat work around the pool.

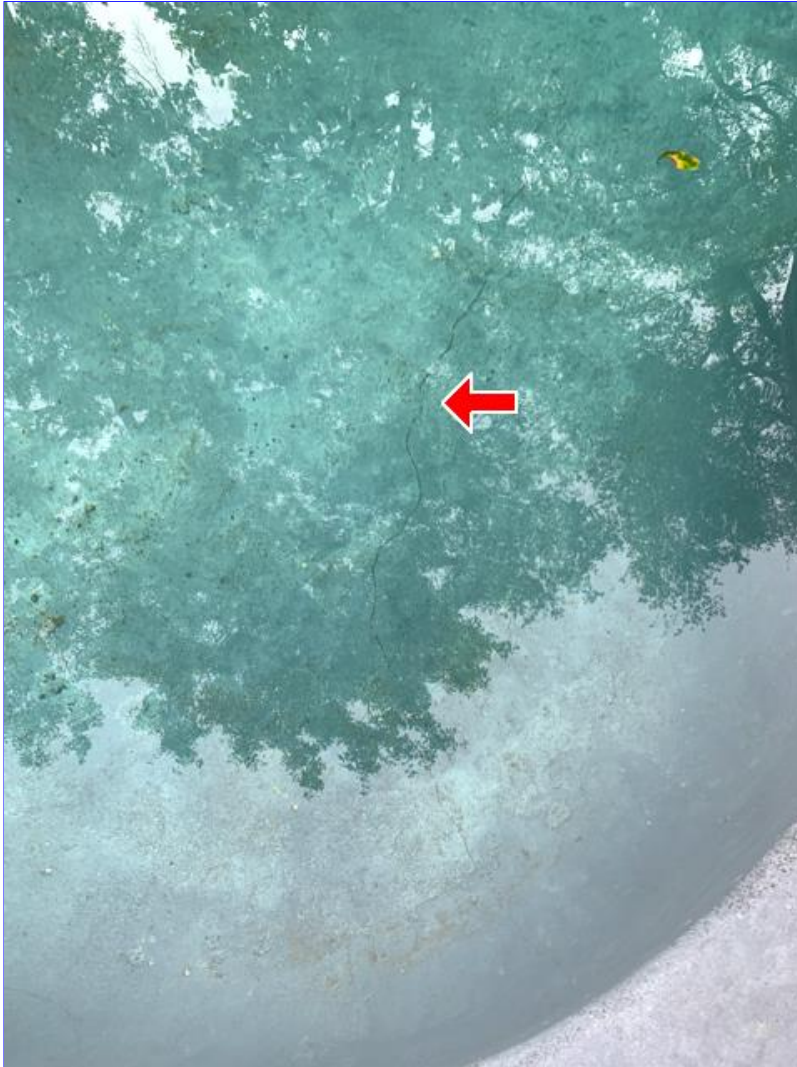
F. Photo 3(Picture) Crack observed in plaster finish. Recommend correction.
