# Inspection Report

19215 Candlebrook Cir, Spring, TX 77388

## Princess Quality Inspections

# PROPERTY INSPECTION REPORT FORM

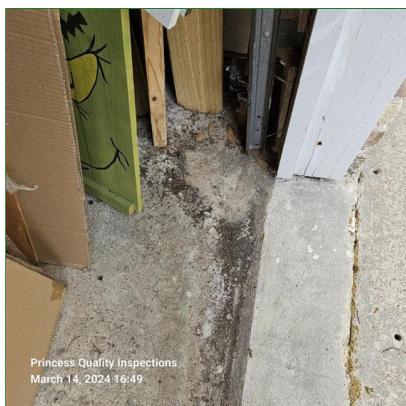
A. Item 19(Picture) Evidence of possible past bonding water observed at two locations along garage openings. FYI

(2) Evidence of possible past bonding water observed at two locations along garage openings. FYI

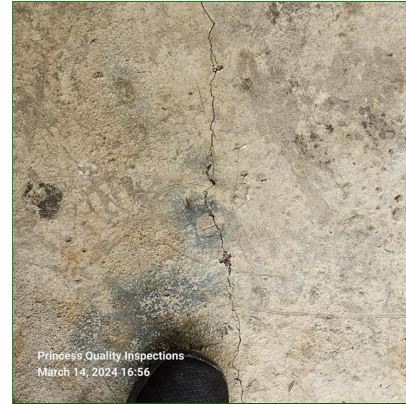
A. Item 22(Picture) Cracks observed in garage floor were cosmetic at the time of inspection and recommend monitoring for changes in size and shape and repair if necessary.

(3) Cracks observed in garage floor were cosmetic at the time of inspection and recommend monitoring for changes in size and shape and repair if necessary.

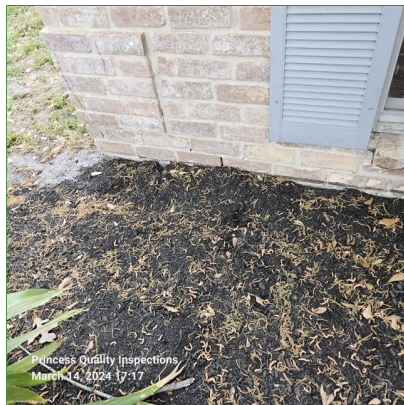
A. Item 29(Picture) Soil or flower beds obscure Foundation and or damage from View

(5) Soil/Garden level too high around areas with brick or siding. Common industry practice requires a clearance of 4 inches from bottom of brick/siding to soil. High garden or soil level near brick/siding may obscure wood destroying insect activity and may promote moisture intrusions.

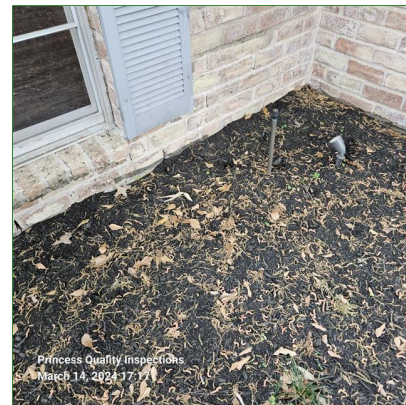
A. Item 30(Picture) Soil or flower beds obscure Foundation and or damage from View

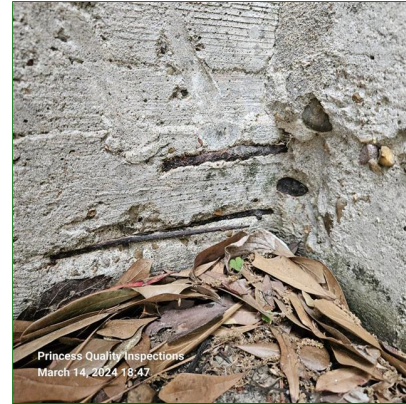
A. Item 40(Picture) Exposed metal Foundation support observed at right front corner and on right side under window with cracked the glass and recommend patching with a high strength concrete patch to prevent premature deterioration of metal Foundation support.

(10) Exposed metal Foundation support observed at right front corner and on right side under window with cracked the glass and recommend patching with a high strength concrete patch to prevent premature deterioration of metal Foundation support.

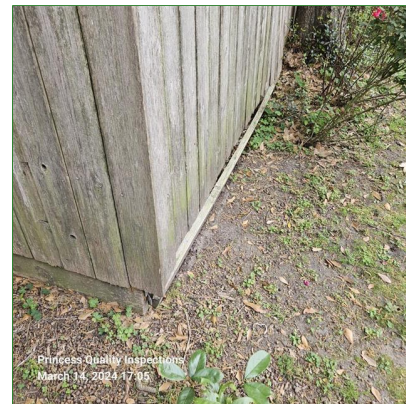
B. Item 2(Picture) Damaged fencing materials observed at various locations with some areas in need of repair to prevent further leaning or damage.

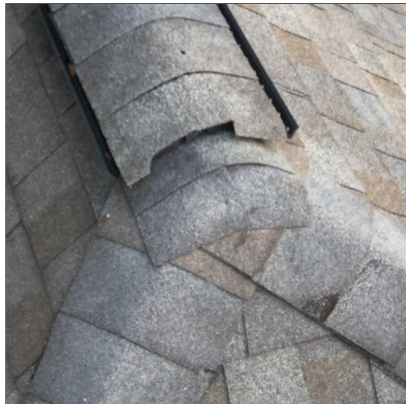
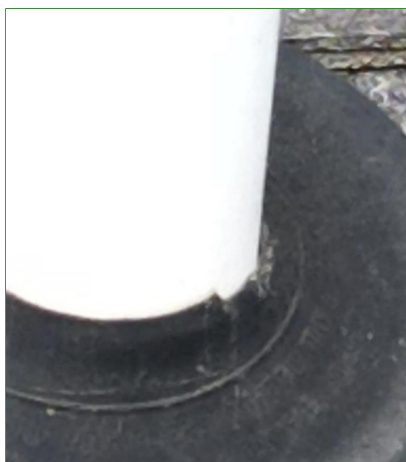
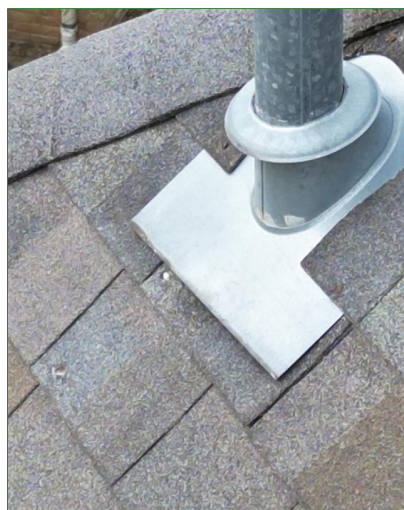
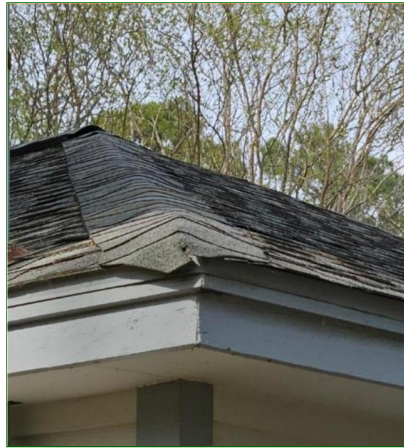
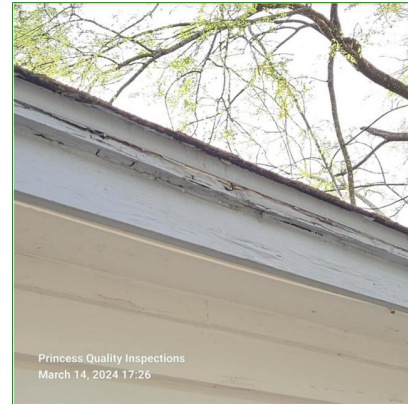
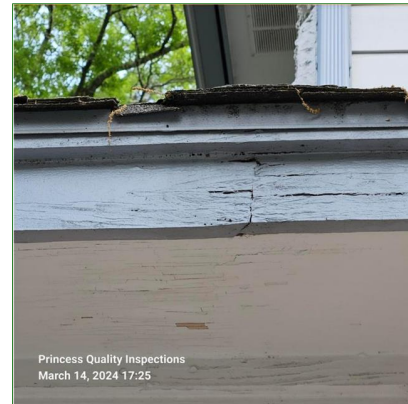
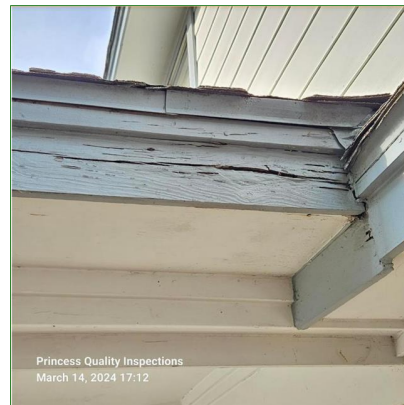
C. Item 7(Picture) Roof covering materials damage

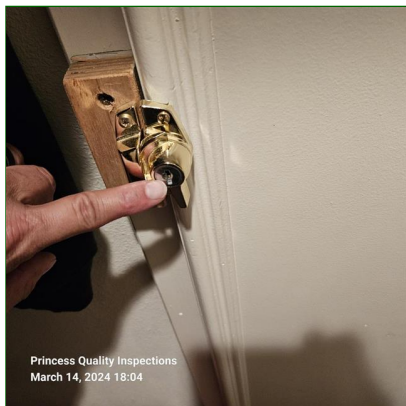
D. Item 1(Picture) The attic access door at left front second floor closet was locked and therefore not inspected for deficiencies.

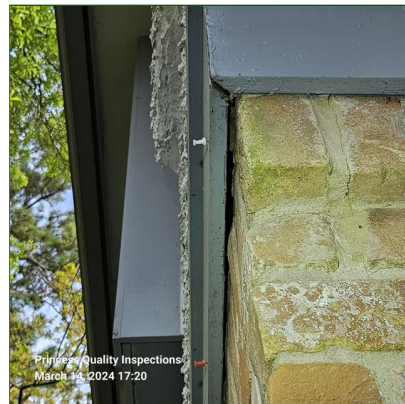
E. Item 8(Picture) Gaps in frieze boards large enough for flying insect entry observed and recommend reducing the size of cracks to prevent flying insect and or Vermin nesting within the structure.

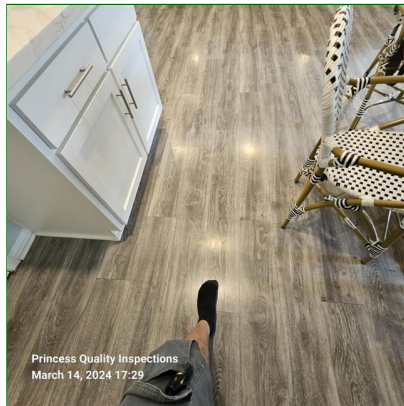
F. Item 1(Picture) Uneven floor covering installation observed causing hollow sound as you walk around. FYI

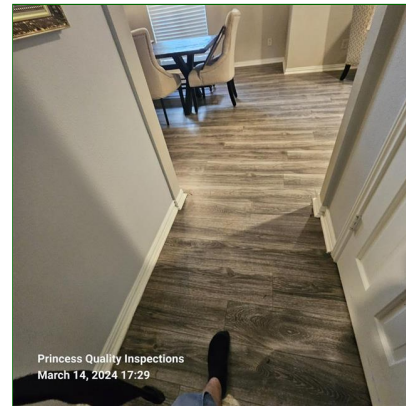
F. Item 2(Picture) Uneven floor covering installation observed causing hollow sound as you walk around. FYI

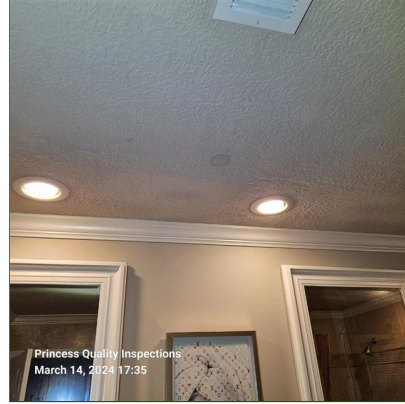
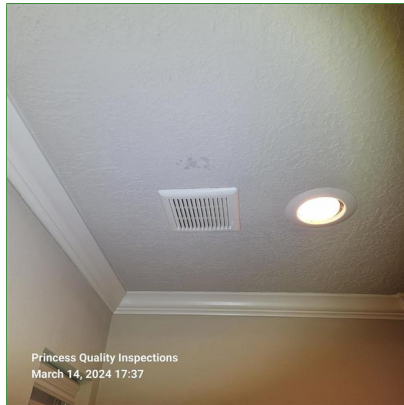
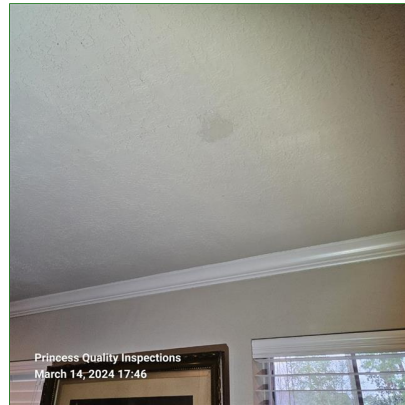
F. Item 4(Picture) Moisture stains observed in drywall ceilings at various locations.

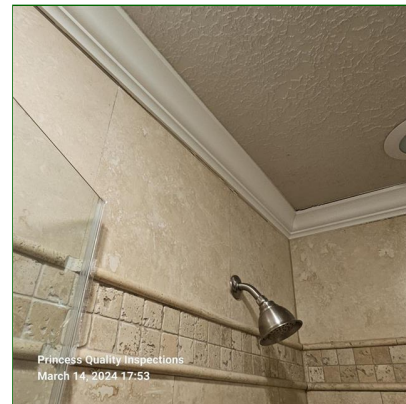
F. Item 9(Picture) Gaps/ separation in crown molding observed at master bathroom.

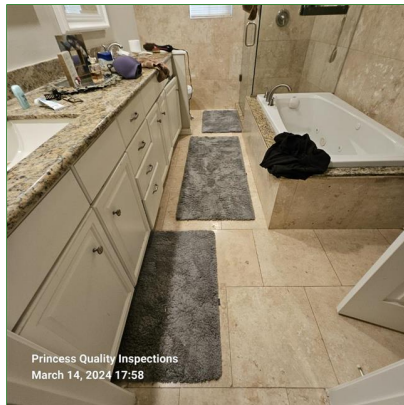
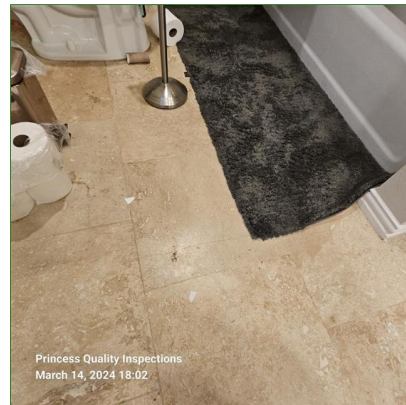
F. Item 13(Picture) Chipped and cracked tiles observe in master bathroom. the inspector did not move floor carpeting to look for more damage. FYI

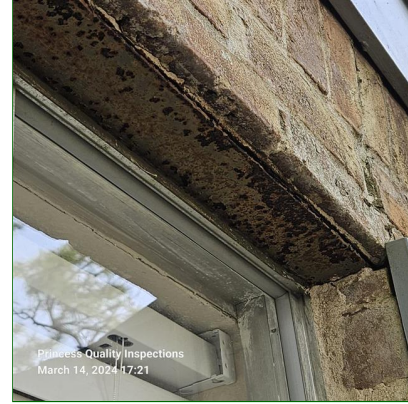
H. Item 5(Picture) Corrosion observed on metal load-bearing lintels above exterior windows and recommend removal of rust and treat with a rust inhibitor to prevent further deterioration of load bearing lintels.

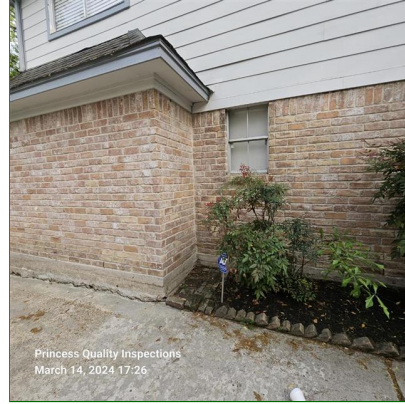
H. Item 8(Picture) Broken glass location

H. Item 7(Picture) Broken glass observed on window at right side of Home facing rear and recommend replacing broken glass.

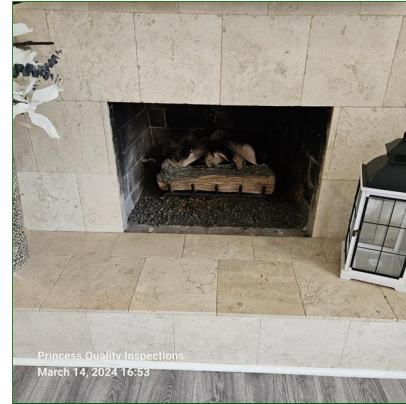
J. Item 1(Picture) Gas logs are present in the fireplace. However, the inspector did not locate a valve that will open gas to the logs and recommends asking the seller for its location and testing for gas pressure. If necessary, repair it.

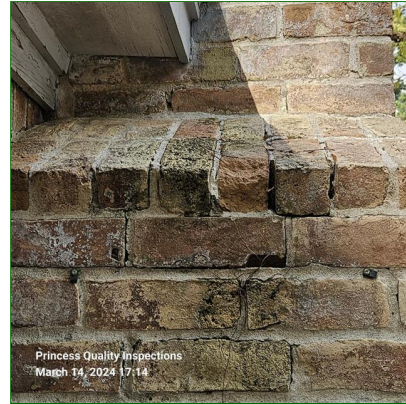
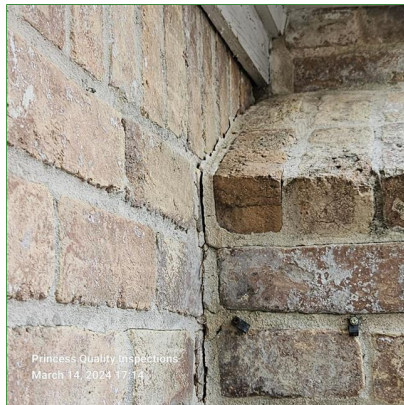
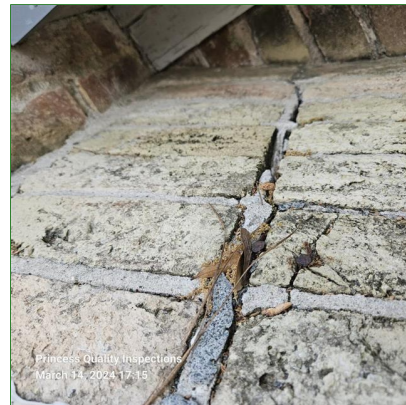
J. Item 6(Picture) Gaps in brick and mortar observed on chimney exterior and recommend repair of all gaps and cracks to prevent moisture seepage.

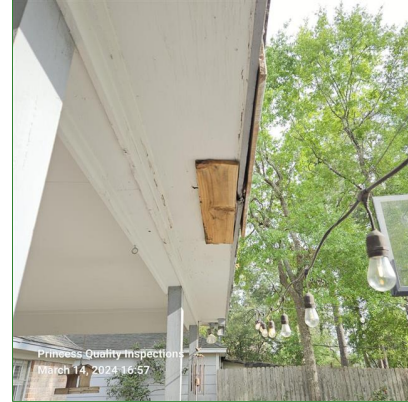
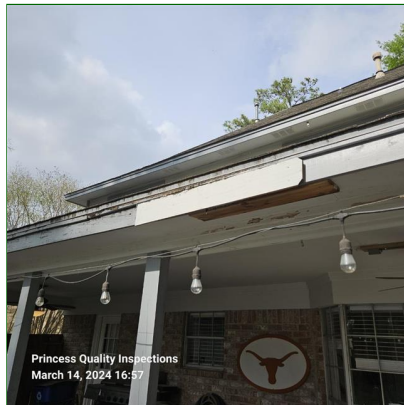
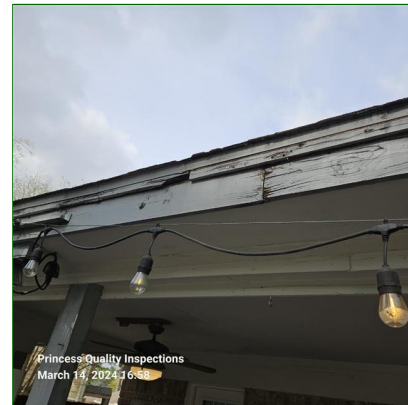
K. Item 2(Picture) Moisture damage observed at rear patio structure and mostly at fascia and recommend repair to prevent from creating an environment conducive to wood destroying insect activity.

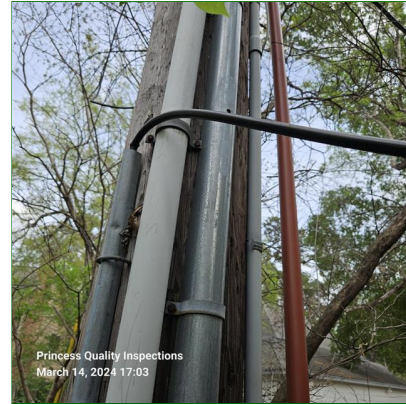
A. Item 13(Picture) A loose cable observed at the right rear corner of property and recommend further examination to identify the cable and correct as necessary.

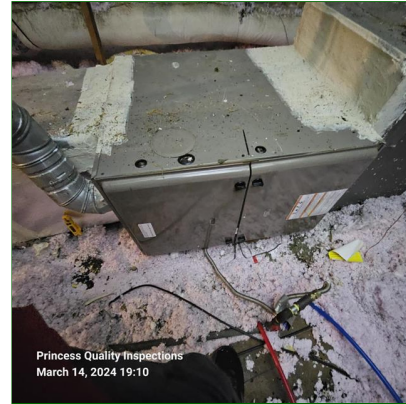
A. Item 2(Picture) The gas furnace is located in the attic. A solid service platform that extends 30 in to the front of the Furnace and evaporator is recommended and was required to be installed at last appliance installation.

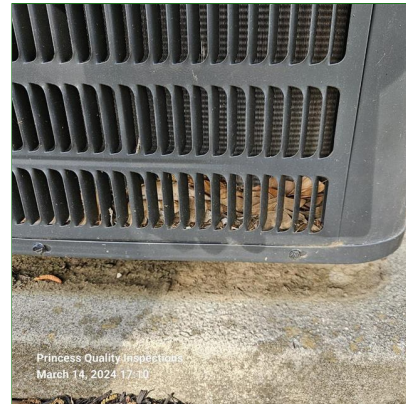
B. Item 6(Picture) Debris observed inside condenser housing and service or repair by a qualified HVAC contractor to prevent reductions inefficiency from debris blockages.

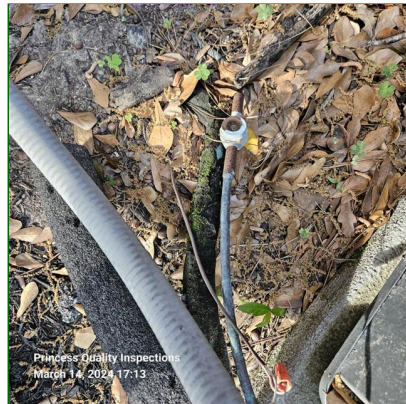
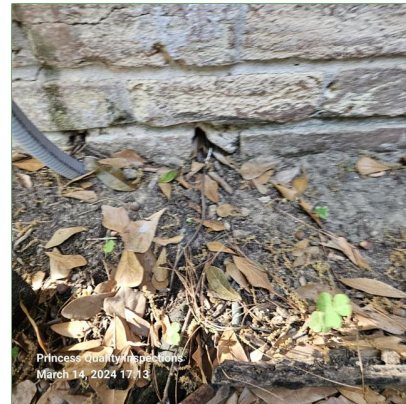
B. Item 9(Picture) The cooling system lineset is missing foam insulation and enters wall uncommonly low in wall and recommend repair of insulation and seal wall penetration to prevent vermin entry.

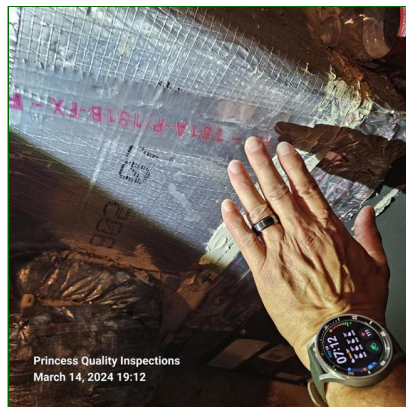
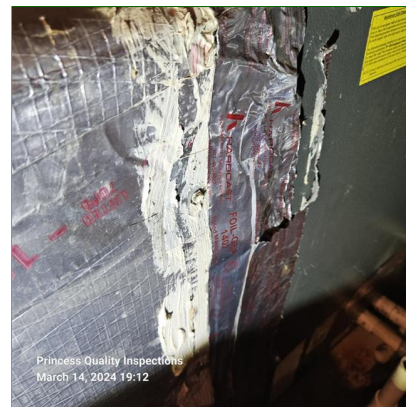
B. Item 12(Picture) Air leaks in air handler seams observed at various locations and recommend further examination by a qualified HVAC contractor and repair all air leaks to prevent condensation and moisture damage.

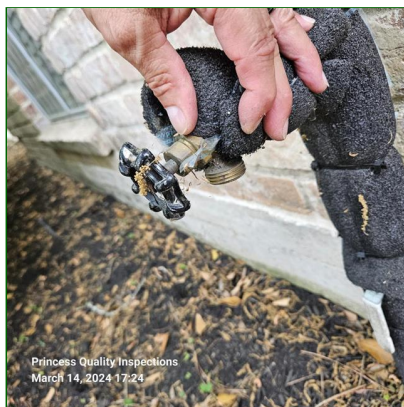
A. Item 4(Picture) Anti-siphon devices were not present and recommend installing anti-siphon devices.

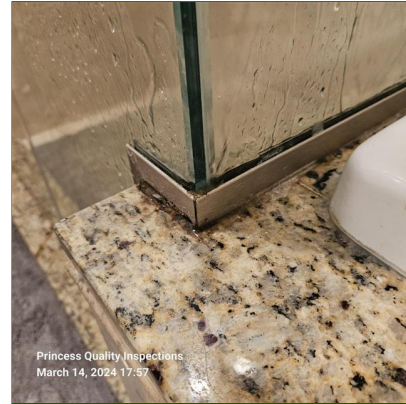
A. Item 13(Picture) Shower enclosure leaks observed at 2 or locations of Master shower and recommend repairing leaks to prevent moisture damage to materials.

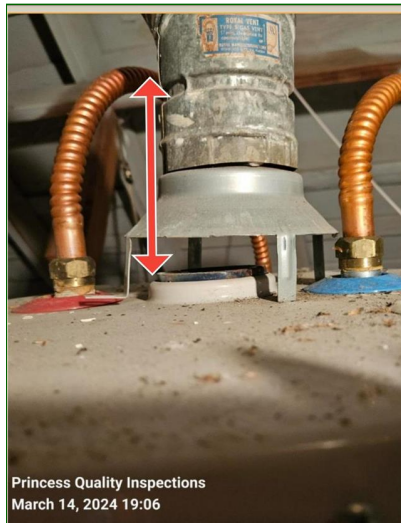
C. Item 5(Picture) The water heater exhaust draft Hood is not centered over exhaust outlet and recommend adjustment or repair by qualified plumbing contractor to prevent exhaust gases for entering attic space.

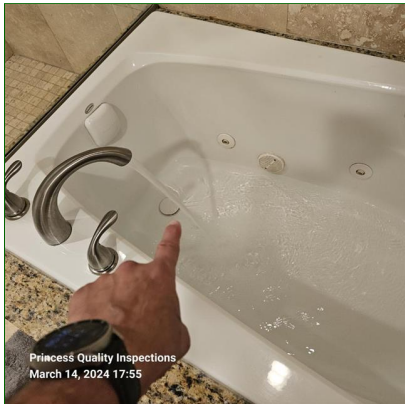
D. Item 1(Picture) The jetted tub drain stop would not hold water with the drain stop engaged in the closed position.

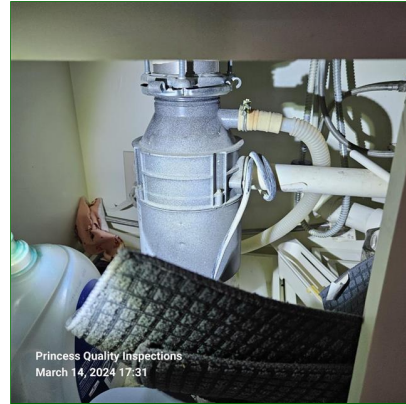
A. Item 2(Picture) The dishwasher drain line was installed without the benefit of an air gap or high loop in drain line to prevent food particles from reentering dishwasher.

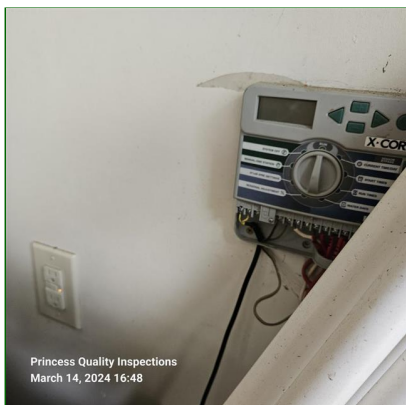
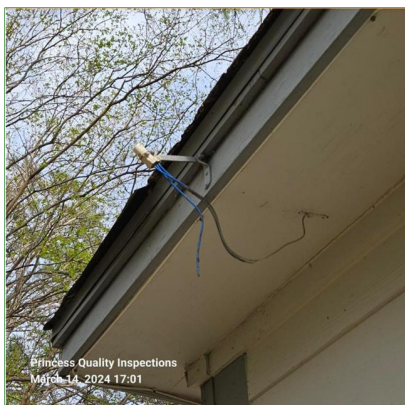
A. Item 1(Picture) The lawn sprinkler system did not respond to testing at the time of inspection. The rain sensor is out of adjustment and has a loose wire, and a backflow preventer was not observed. The inspector recommends further examination of the lawn sprinkler system and repair as necessary to perform its intended function.
