STRUCTURAL REPORT

9743 Rockwell Dr
Willis, TX 77318

JANUARY 17, 2024

REF: CONDITION OF PROPERTY SURVEY

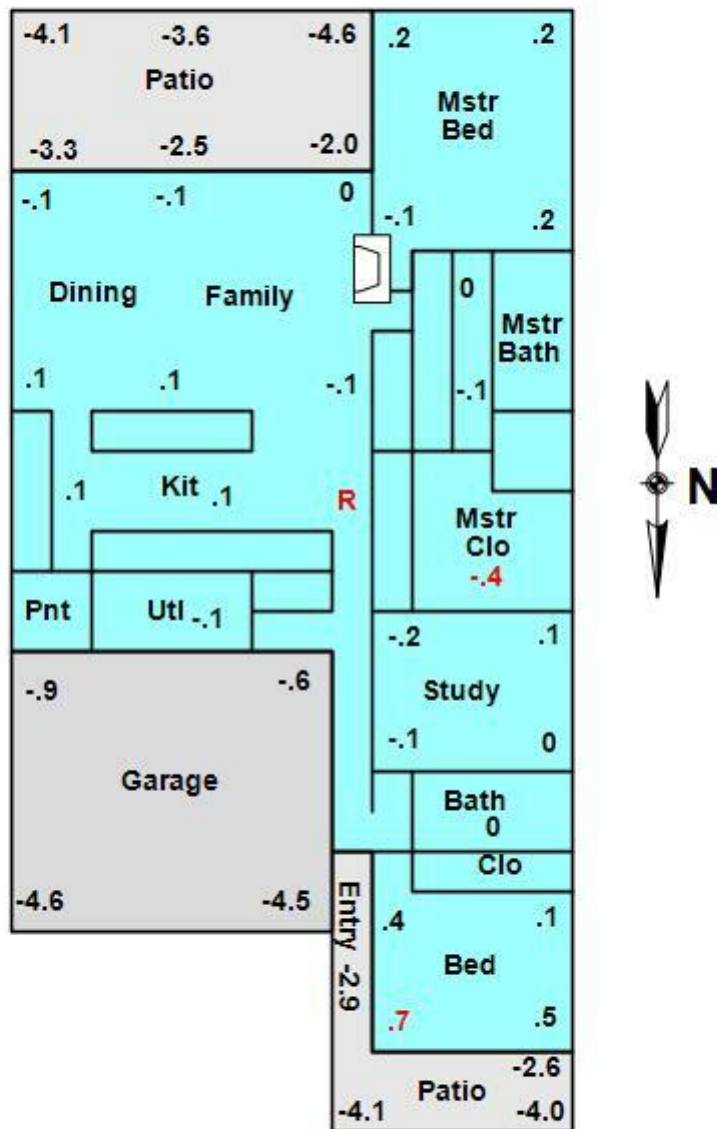
Elevation Readings 9743 Rockwell Drive

See our field sketch below showing the elevation readings for this structure. Note that the "R" on the sketch is our randomly chosen starting reference point, where the elevation is 0, and all other elevation readings are taken relative to the reference point, and are measured in inches to the nearest 1/10 inch. Height adjustments were made for variations in the height or thickness of the various floor coverings. If there is a step up or a step down into an area such as a garage, sunken room, balcony/patio area, or raised rooms, the elevation readings will have larger numbers due to the amount of the step.

The floors were checked with an electronic level, and were observed to be acceptably level throughout the house. The difference in elevation between the high point and low point was 1.1 inches. The high point was located at the front bedroom, and the low point was located at the master closet. The unlevelness takes place over a horizontal distance of approximately 35 to 40 feet.

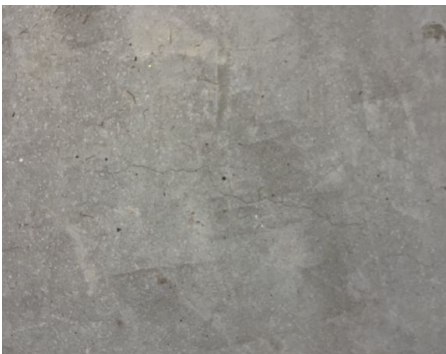
Differential Movement: Concrete Cracks - Garage

Cracking of the foundation concrete exists in virtually all foundations. It is pointed out that cracking is a normal property of concrete and other brittle materials, and Hedderman Engineering, Inc. assumes no responsibility should cracks be found that are not mentioned in this report. Some cracking was observed in this concrete foundation, including at the garage floor.

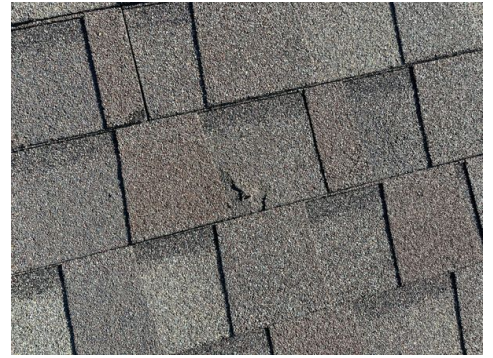
SHINGLES DAMAGED

Shingles were observed to be damaged and the roof is in need of repair. Contact a roofing contractor to obtain a cost estimate for repairs.

Contact the Builder

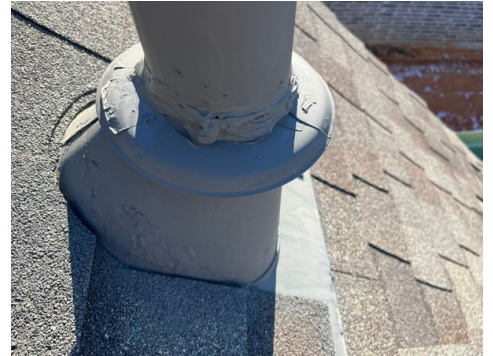
5.8.2 Roof Details

METAL VENT PIPES

Storm Collar Sealant Deteriorated

We observed metal vent pipe(s) that were in need of repair, including the conditions listed above.

Locations include: Water Heater Vent Pipe, Furnace Vent Pipe, Chimney Vent Pipe

Contact the Builder

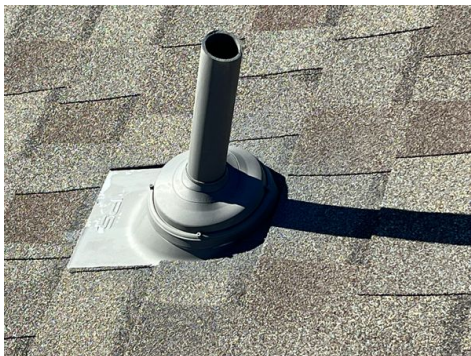
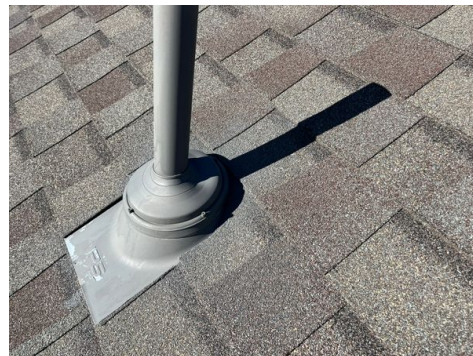
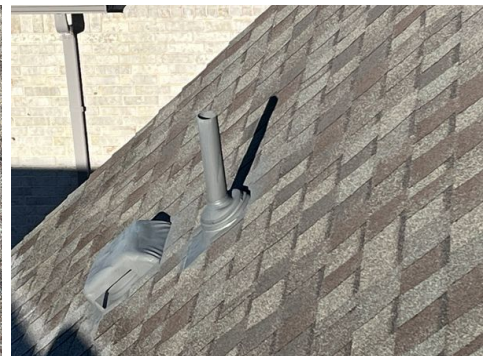
5.8.3 Roof Details

ROOF JACKS

The roof jacks at the plumbing vent pipes were observed to have the conditions as described above. Further investigation with a roofing contractor is recommended to make all needed repairs.

Contact the Builder

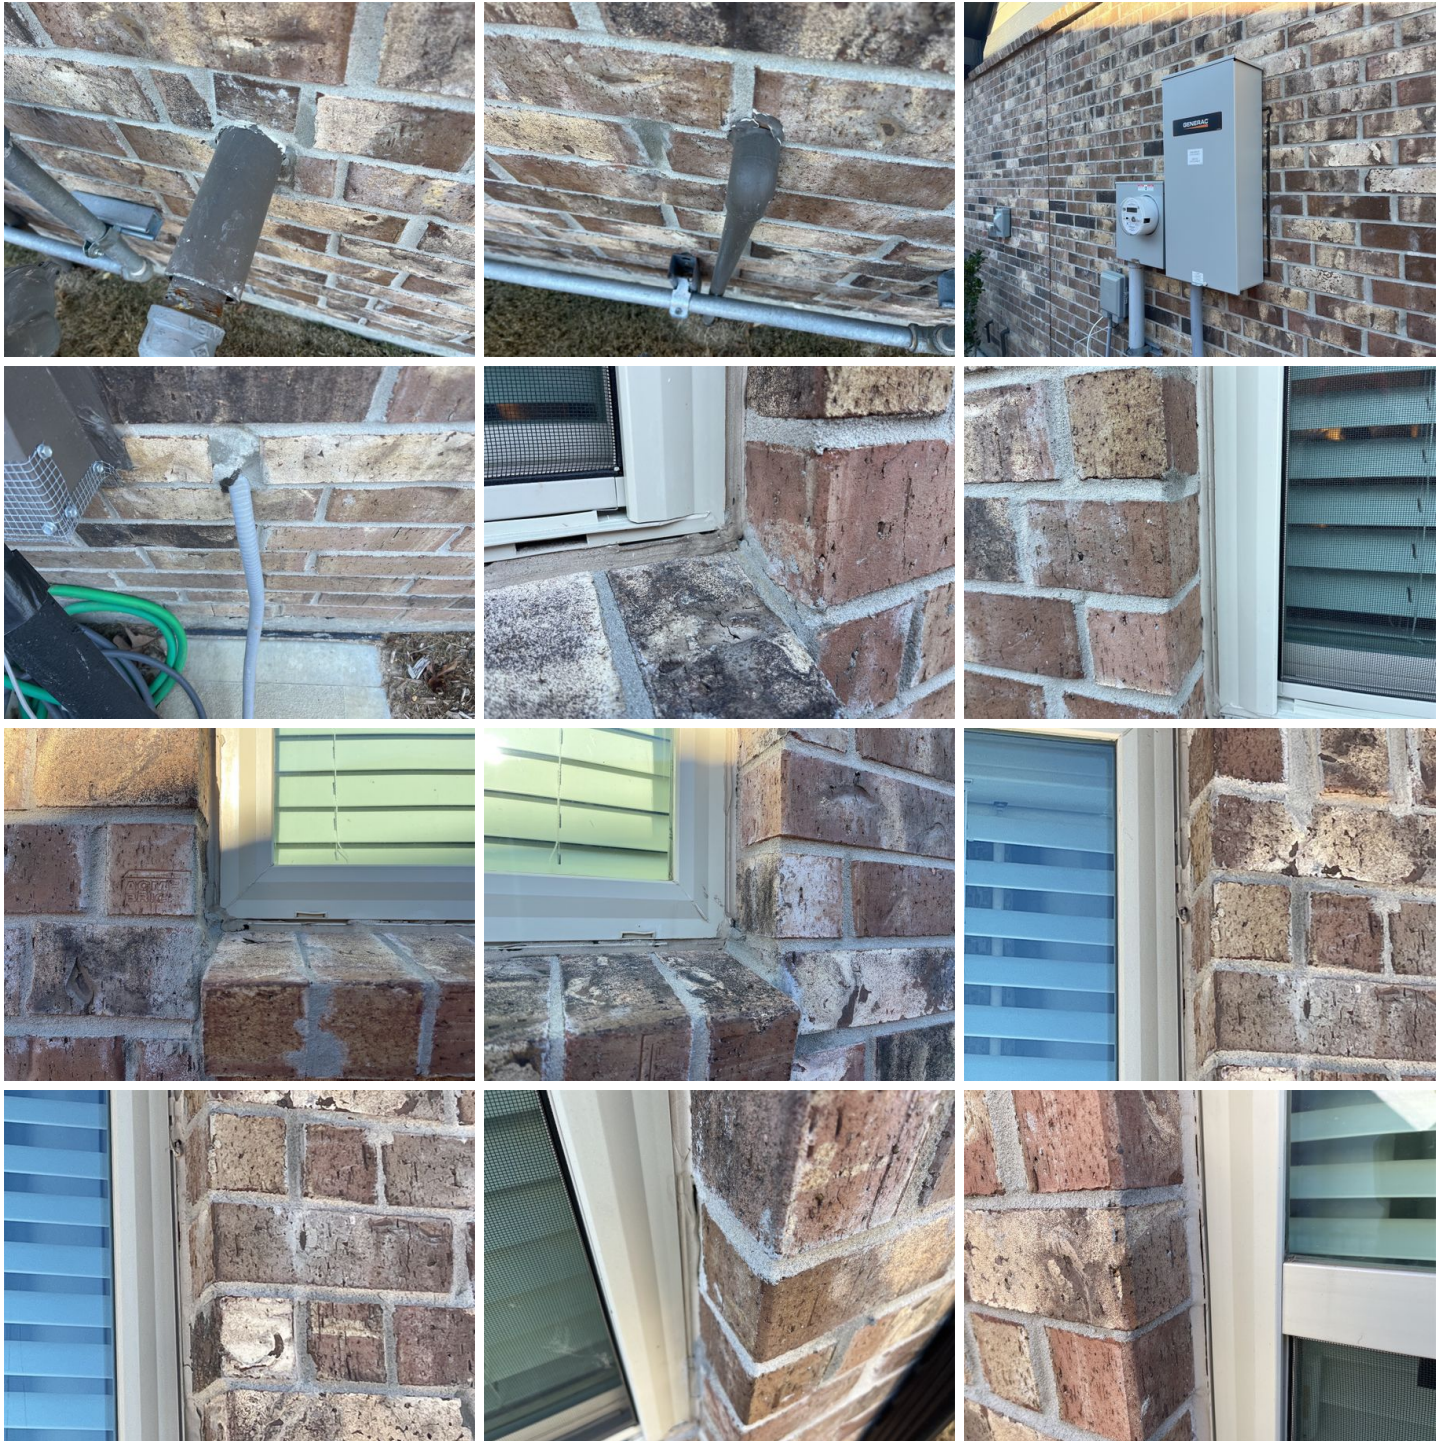
Sealants deteriorated/missing, Window sealants, Hose Bibb, Gas Line, Electrical Box, Piping

A substantial vulnerability to water penetration was observed at penetrations/openings through the exterior building envelope, and it is recommended that all penetrations/openings be sealed against water penetration. Typical examples on a structure may include light fixtures, air conditioning refrigerant lines, water piping, gas piping, vent caps, windows, doors, expansion joints, etc. Below is a representative sample of locations and/or photographs showing some, but not necessarily all, locations where there is a vulnerability to water penetration. Have a contractor provide a cost estimate to seal all vulnerable areas on the exterior building envelope against water penetration and/or open up any clogged weepholes in the veneer.

Contact the Builder

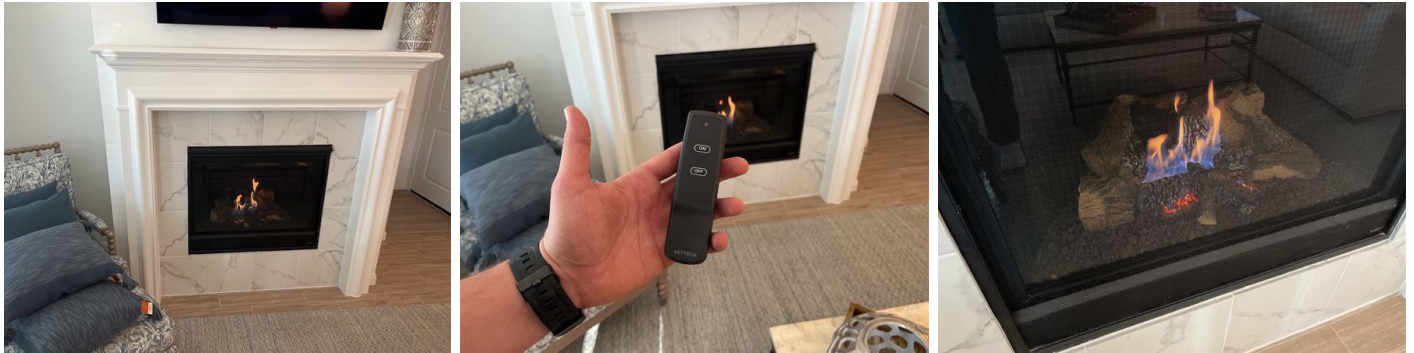
8.2.1 Metal Fireplace

The owner had disclosed that they had experienced a bout of dizziness when the fireplace was on for an extended period of time during the latest cold snap. This condition can be a possible indication of a leak within the fireplace system. Further investigation with a fireplace service company is recommended to perform further testing to ensure the safety of the continued use of this fireplace.

Further Investigation is Recommended

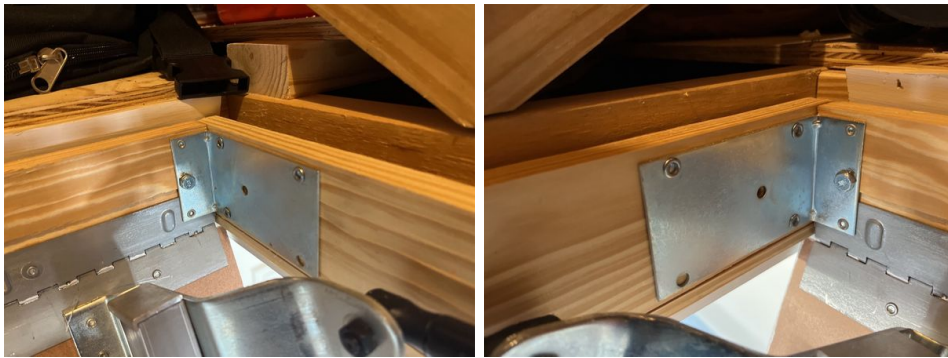
LADDER ATTACHMENT IMPROPER

Nail(s) missing in corner bracket(s), Less than sixteen 16d nails or 1/4 X 3" lag screws

The stair assembly was not properly installed or secured to the framing members, and repair is needed for safety purposes. The condition(s) can be a safety hazard, and repair is needed, as an improperly installed stair assembly can possibly collapse.

Contact the Builder

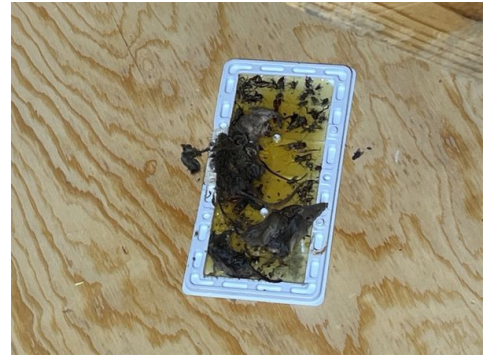
We observed evidence of rodent infestation in the attic, including the item(s) listed above. Although HEI disclaims inspections for rodents and other pests, it is recommended that further investigation be done to find the source of entry of the pests into the attic, and to make all needed repairs to remove the pests, clean and/or sanitize the attic from any fecal/urine material and nesting materials. It is recommended that further investigation be done with the homeowner and/or you contact a pest control company concerning this condition.

Contact the Builder

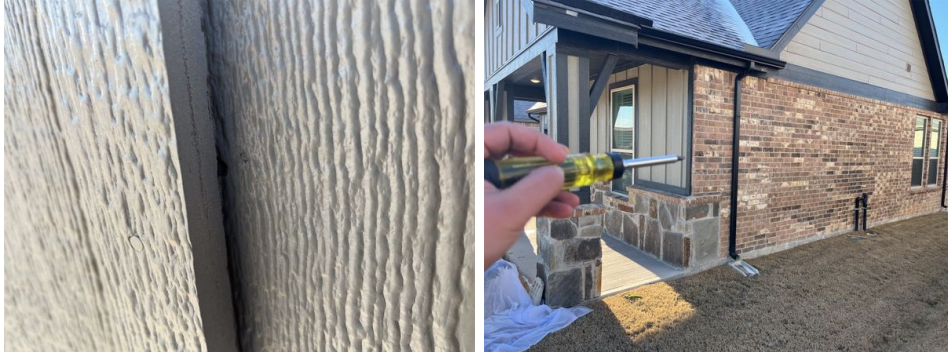
10.7.1 Fiber Cement Siding

We observed where the nails used to secure the siding were overdriven past the face of the siding, leaving holes where water can penetrate into the siding. Further investigation with a contractor is recommended to determine if the degree of the condition is such that the siding has been compromised and needs to be renailed.

Contact the Builder

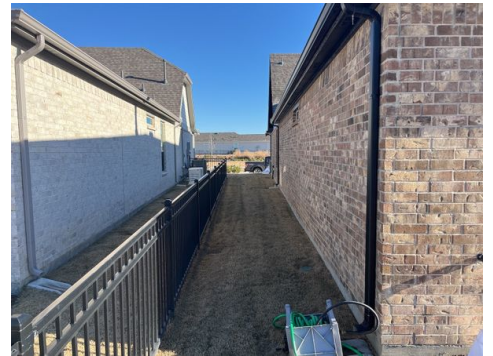
Missing at front

The wrought iron fence was in need of some repairs.

Contact the Builder

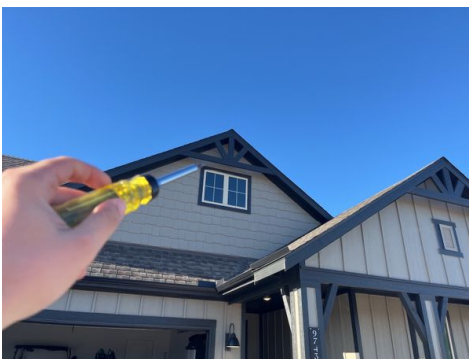
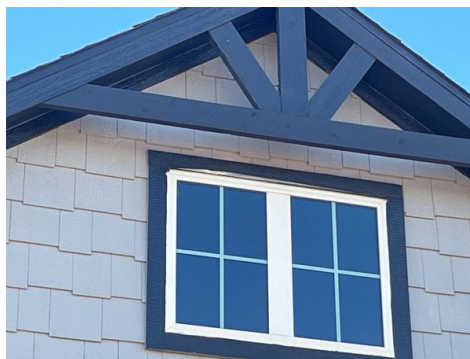
11.9.1 Flashings

FLASHING LIFTED/DAMAGED

The flashing at the front window was lifted/damaged, and is in need of repair.

Contact the Builder

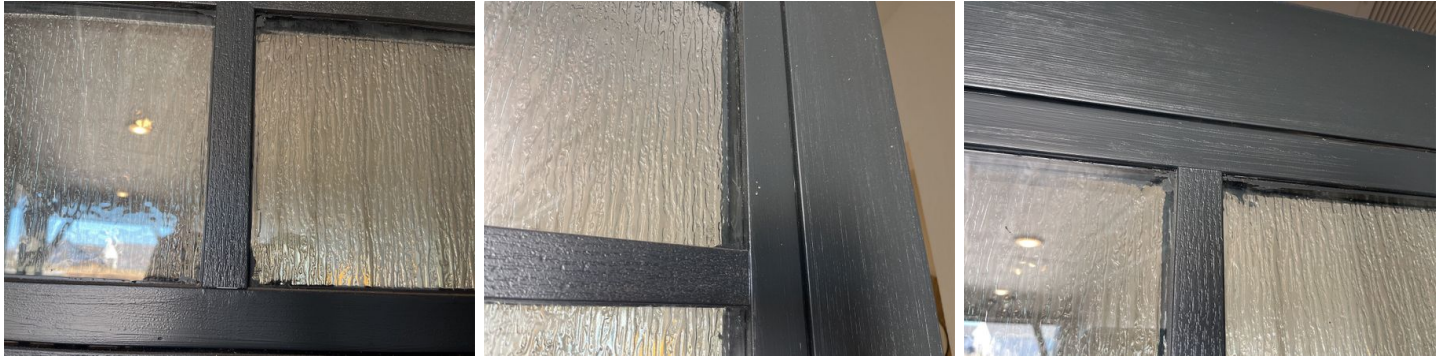
11.10.1 Other Exterior Observations

PAINT TOUCH-UPS

Paint touch-ups were observed to be needed at the exterior of the house.

Contact the Builder

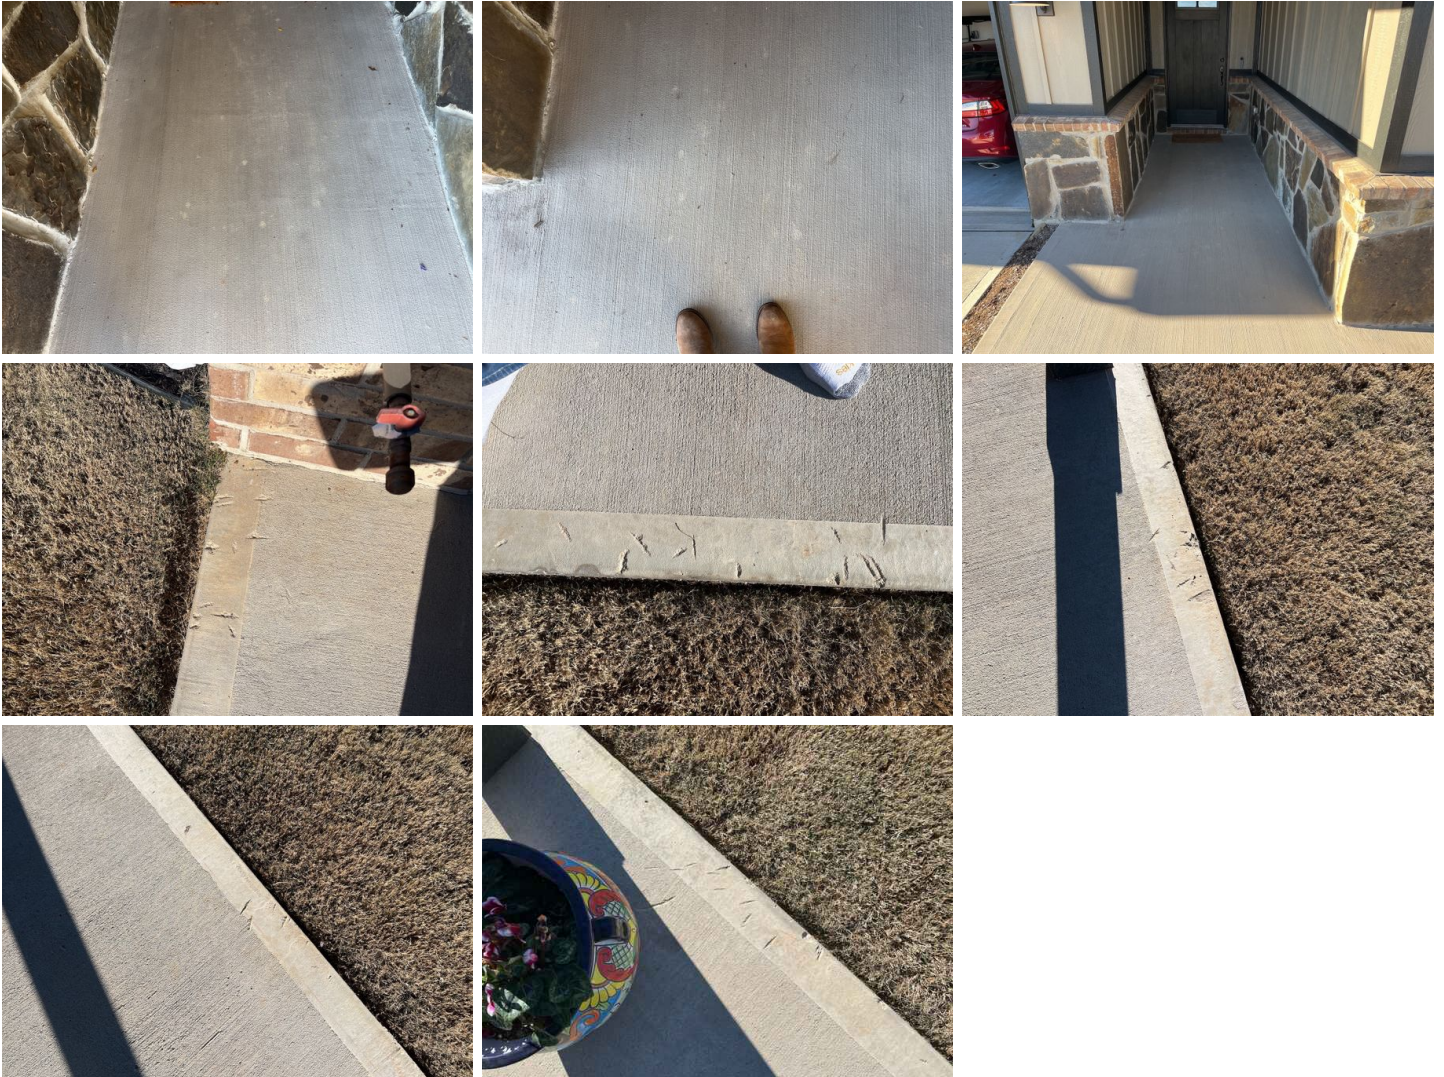
11.10.2 Other Exterior Observations

CONCRETE FINISH IMPERFECTIONS

Imperfections were observed in the finishing of the front and back patio concrete. Further investigation with the builder is recommended regarding the cause of this condition, and to provide an appropriate means of repair.

Contact the Builder

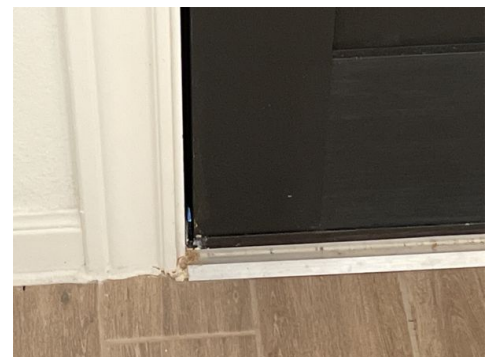
We observed daylight at the exterior door when in the closed position, and the condition needs to be repaired.

Contact the Builder

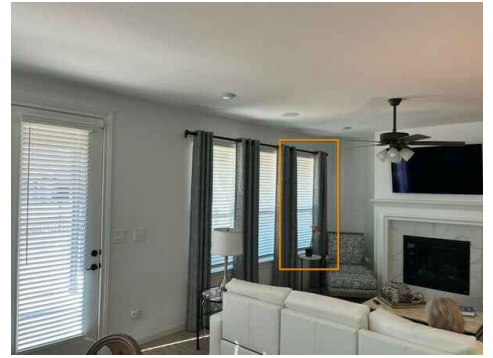
12.3.1 Windows

WINDOW DIFFICULT TO RESET

The set-pin was difficult to reset on a window in the family room. Further investigation with a service company is recommended to determine the cause of the condition, and to make the appropriate repairs.

Contact the Builder

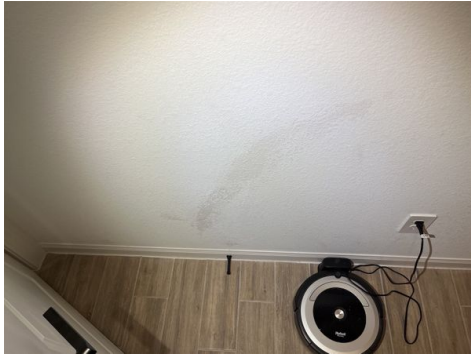
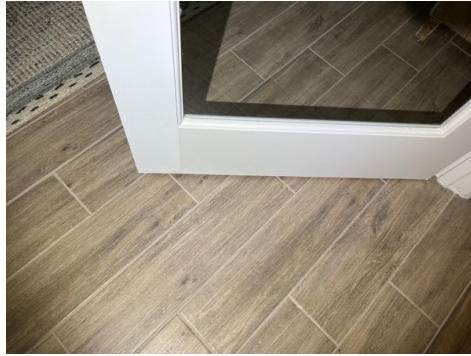
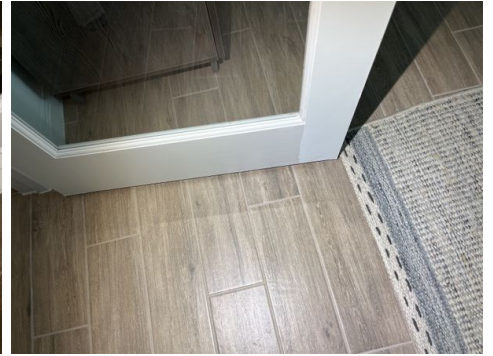
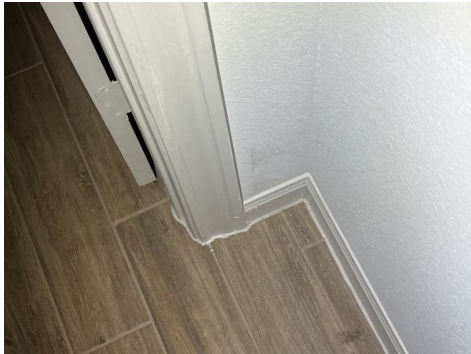
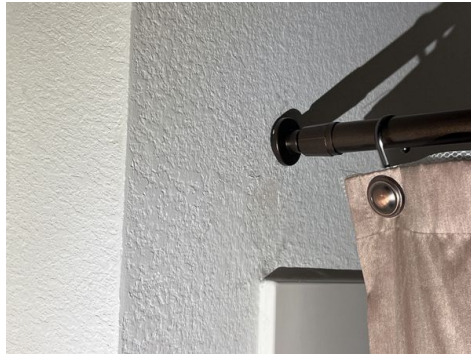
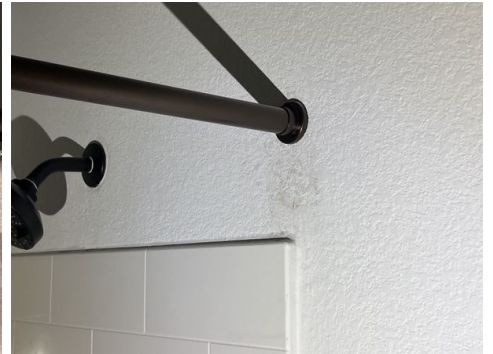
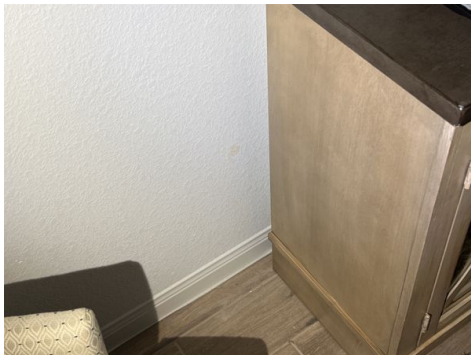
12.10.1 Other Interior Observations

PAINT TOUCH-UPS

Paint touch-up were needed and further investigation with a painter is recommended.

Contact the Builder

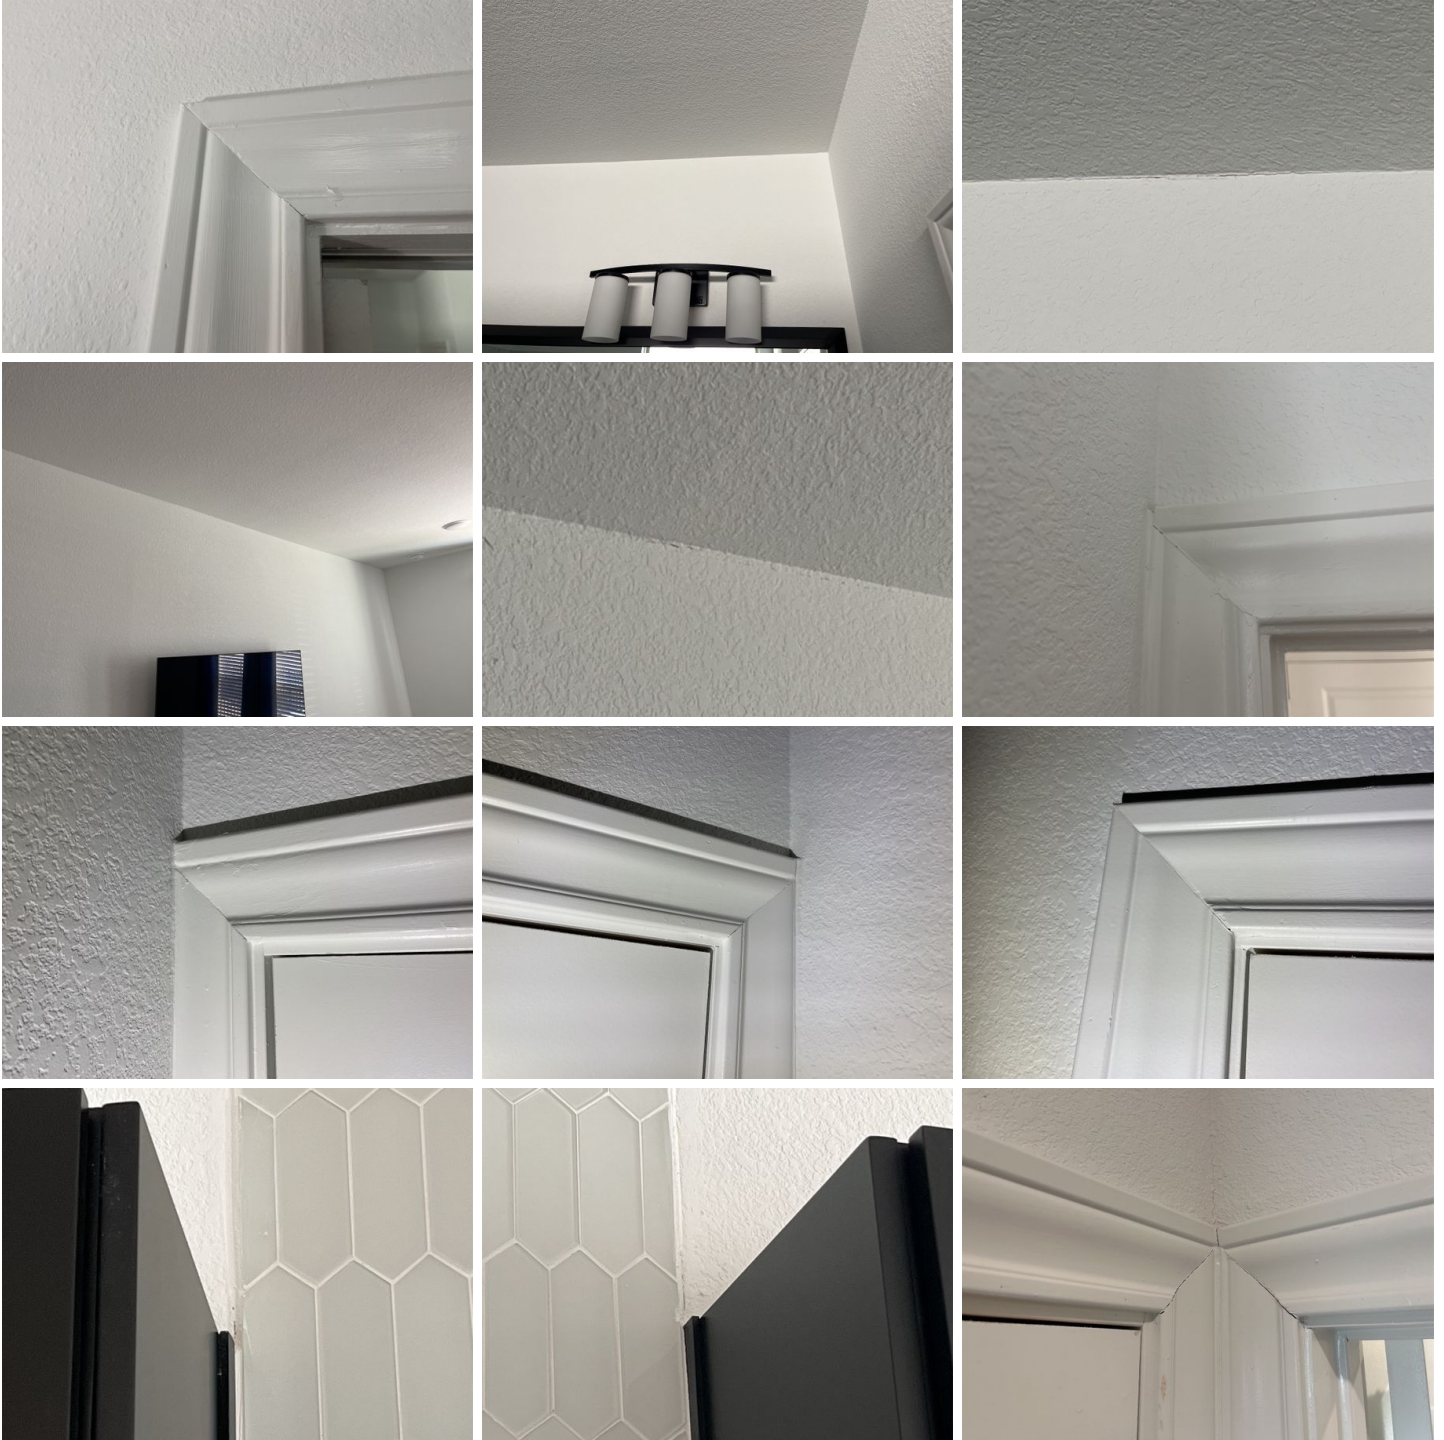
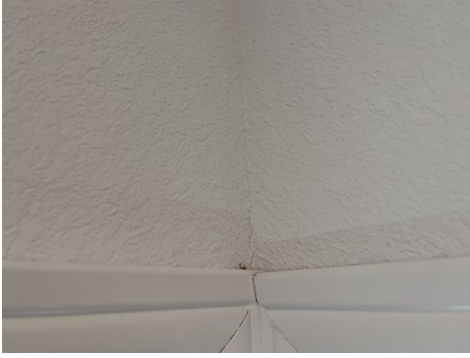
12.10.2 Other Interior Observations

CAULKING SEPARATIONS

We observed separations of materials that need to be caulked. Have a contractor provide a cost estimate for repairs at the above locations.

Contact the Builder
