HEDDERMAN SERVICES

MECHANICAL REPORT

9743 Rockwell Dr
Willis, TX 77318

PROPERTY INSPECTION REPORT FORM

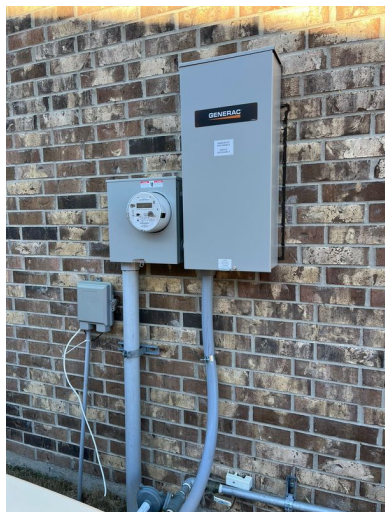
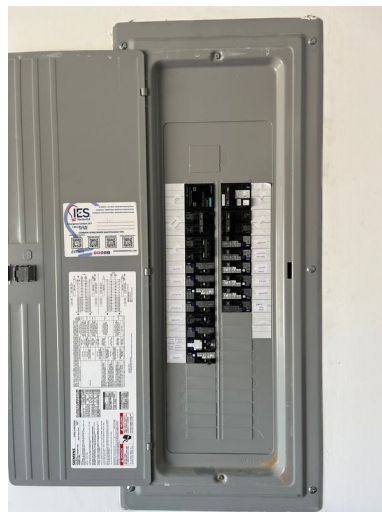
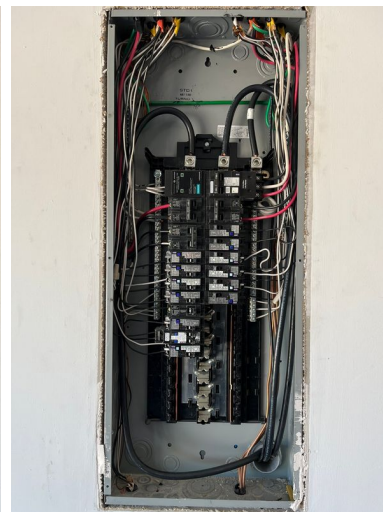
Breaker Panel Equipment - Acceptable:

The interior of the breaker panel equipment was inspected and the breakers were all properly sized for the circuits they were protecting, the grounding and bonding were properly connected, no knockout clips were missing, and the wiring appeared to be in acceptable condition at the time of the inspection.

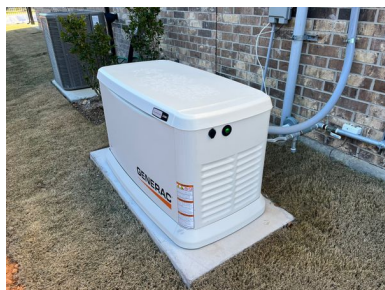
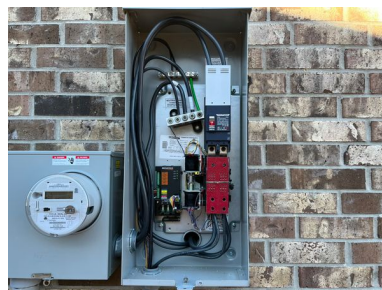
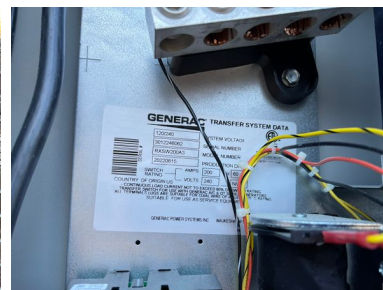
The electrical system was equipped with a natural gas powered backup generator with the automatic transfer switch. Backup generators are beyond the scope of this inspection, and the generator and switching panel were not operationally checked. It is recommended that an electrician be contacted to operationally check all aspects of the backup generator and switching panel.

Further investigation is recommended

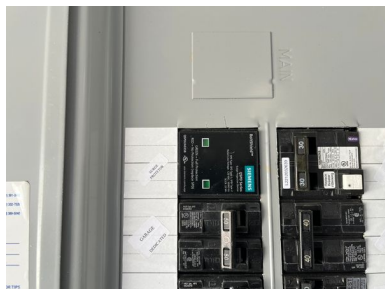
A surge protector was installed in the breaker panel and device appears to be operating properly according to the illuminated green operation light on the device.

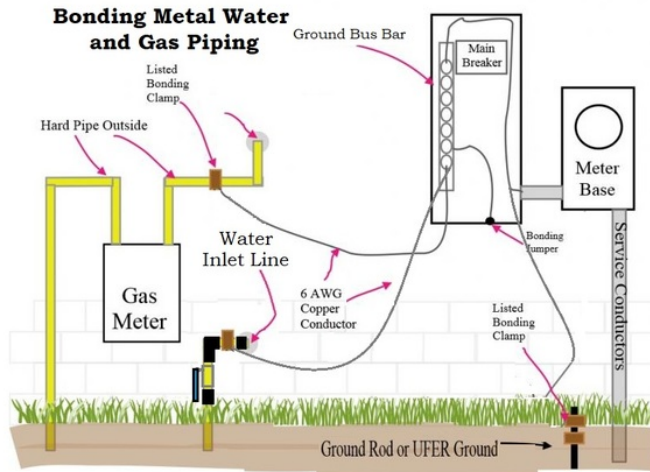
The location where the gas supply piping was bonded back to the electrical ground system was not visible at the time of the inspection. It is recommended that an electrician be contacted to determine if the plumbing in the house is properly bonded and to make any needed repairs.

Obtain Cost Estimate

Recommendation: Contact a qualified professional.

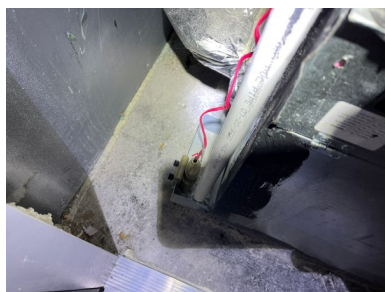
Overflow Pan - Water sensor present:

The overflow pan under the evaporator coil was equipped with a water sensor that is intended to shut off the air conditioning equipment if the pan fills with water.

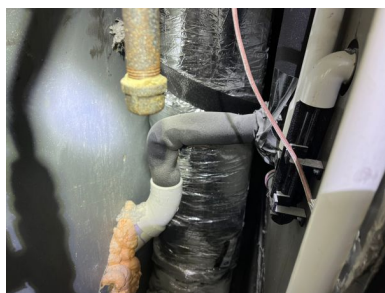
Primary Drain - Terminated properly:

The primary condensate drain line was properly terminated into the P-trap at a plumbing fixture drain at the interior of the property.

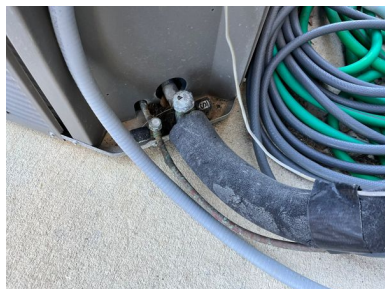
Tamper Proof Refrigerant Caps : Tamper proof caps installed at each A/C unit -

Tamper proof refrigerant caps are currently required to be installed at the refrigerant ports on the A/C condensing unit to prevent refrigerant leaks and/or improper venting.

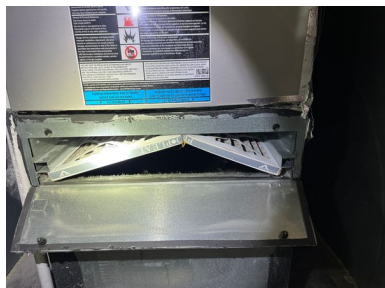
The filter was dirty and needs to be replaced. A dirty filter can allow the evaporator coil and air ducts to become dirty, which can affect the performance of the system.

Obtain Cost Estimate

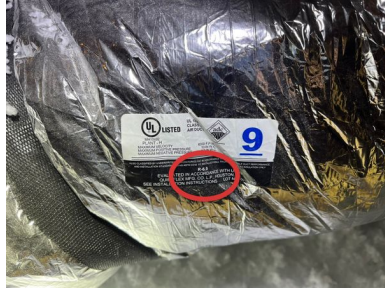
2: R-6 Air Ducts in Attic - Alternate design method

The insulation on the air ducts in the attic was observed to be an R-6, which would normally inadequate for ductwork in an attic space outside the thermal envelope according to the prescriptive method of HVAC design. However, there is an alternative method for HVAC design (R405 Simulated Performance Alternative of the IECC 2015 code), and further investigation is recommended with the builder to determine if the HVAC system was designed according to the prescriptive method or the alternative (performance) method. It is recommended that you obtain a copy of the Home Energy Rating Certificate (HERS) from the builder to determine if the R6 insulated air ducts are adequate for this HVAC system.

Contact Builder

Recommendation: Contact a qualified professional.

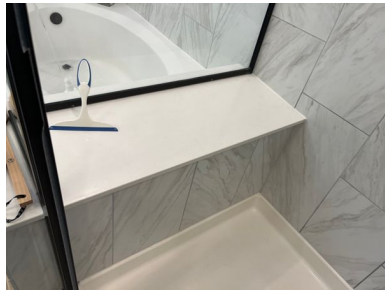
Shower - Built-in Seat:

It has been our experience that plumbers do not always extend the shower pan material from the bottom of the shower, up over the shower seat area. This condition can allow water to migrate through the shower seat tiles into the wall cavity. It could not be determined if the shower seat(s) was properly wrapped with shower pan material at the time of the inspection. It is recommended that you keep the shower(s) well caulked and a sealer be applied to the seat to help prevent water penetration through the seat. If further investigation is desired, it is recommended that a service contractor be contacted.

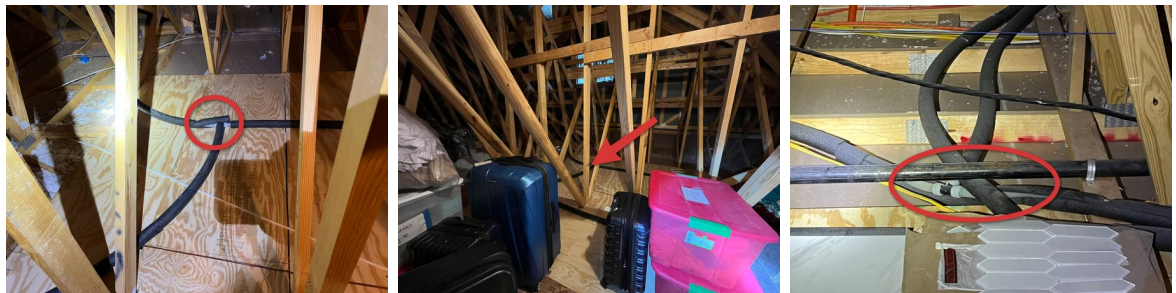
Attic water piping that was not properly insulated was observed. It is recommended that the piping be properly insulated.

Obtain Cost Estimate

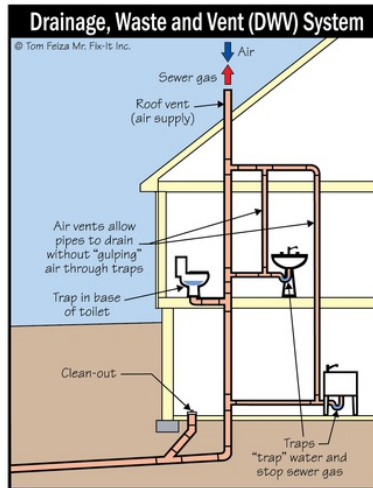
Sewer System - Functional:

No evidences of a system wide problem were observed when the system was operationally checked by running water through each of the plumbing fixtures during the duration of the inspection. It is noted that most of the drain waste system in the walls, under the floors, and in the ceilings is not visible. If further investigation is desired, it is recommended that a plumber be contacted to perform an in depth survey with a camera or hydrostatic test.

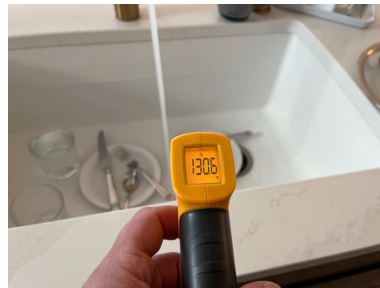
The generally recommended maximum temperature setting for a hot water heater, to prevent accidental scalding, is 120-125 degrees. It is recommended that the water heater thermostat be adjusted to and maintained in this temperature range.

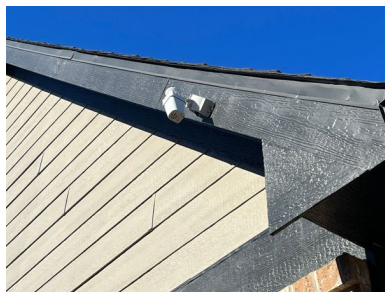
Rain Sensor: Rain Sensor - Present -

It is currently required for automatic sprinkler systems to be equipped with a rain sensor device that will prevent the sprinkler system from operating during and shortly after a significant rain.
