PROPERTY INSPECTION REPORT

23502 Greenwood Springs Place, Katy Texas 77493

February 23, 2024

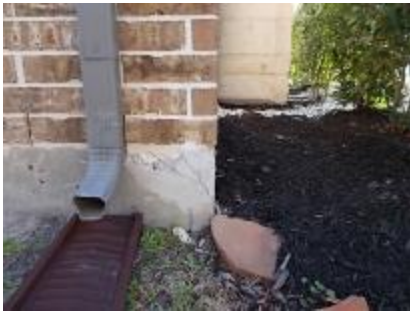
Front left

Comments: corner pops/cracks at front left, right rear, right rear, rear left. exposed cable ends at rear and left. have contractor seal corner pops and exposed cables.

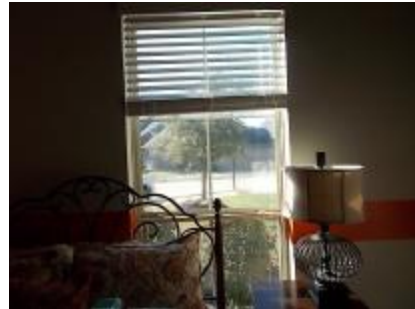
- H. Windows –**
 Comments: front left bedroom window is fogged. have window contractor repair window.
 Fogged windows yes no

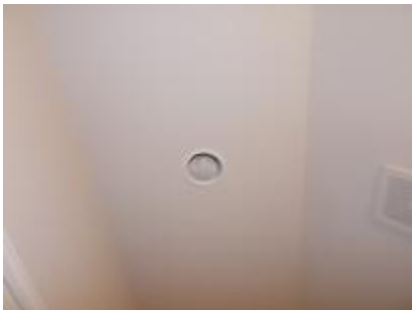
J&J bathroom light

- Lights, Fans, Etc.) light above jack and jill bathtub not working. repair light.
- Smoke detectors near kitchen in bedroom in halls to bedrooms
- Ark fault Circuit Interrupter(s) present yes no
- Ground Fault Circuit Interrupter(s)
- Bathroom(s) Kitchen Garage Exterior Pools Other

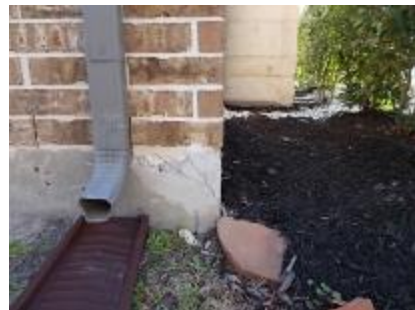
front left corner pop

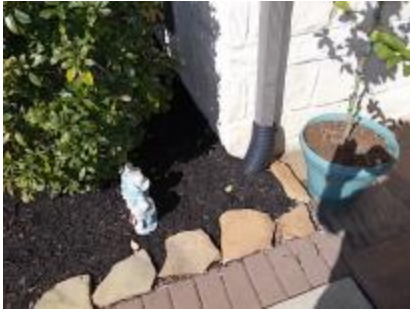
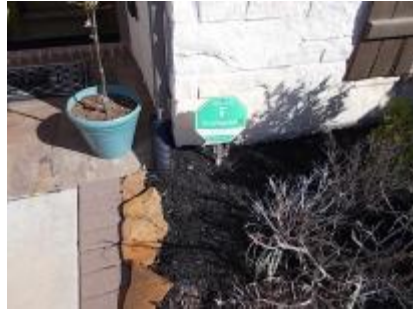
Front soil level

Comments: soil is above brick ledge at front. lower soil level.

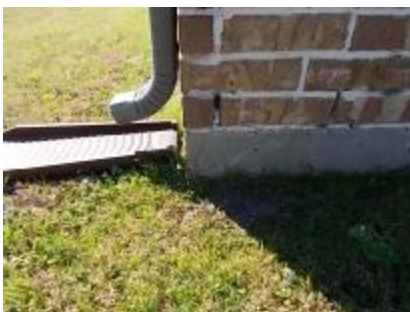
Rear right pop

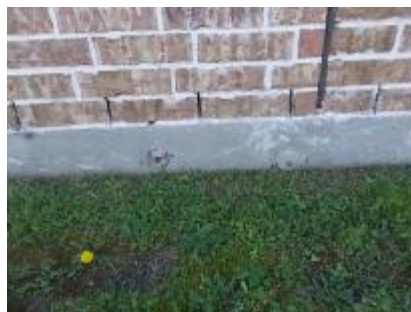
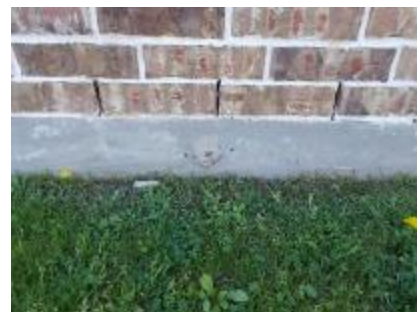
exposed cable end

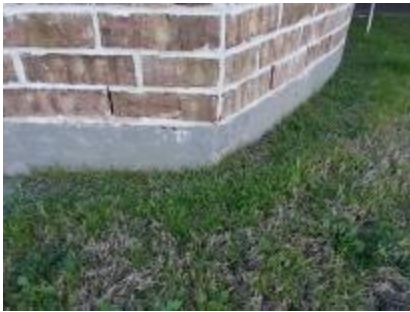
Rear right corner pop

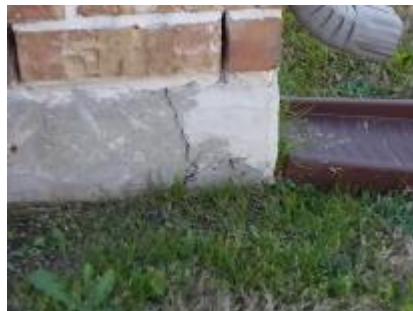
rear right pop

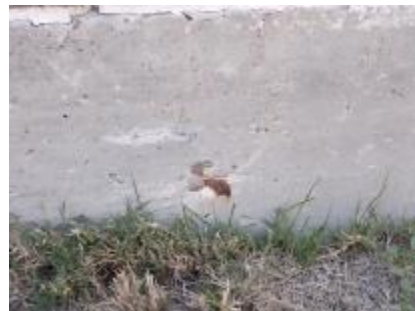
left side exposed cable end
