RESIDENTIAL INSPECTION REPORT

8526 Stones Throw Ln
Missouri City, TX 77459

PROPERTY INSPECTION REPORT FORM

8526 Stones Throw Ln, Missouri City, TX 77459
Address of Inspected Property

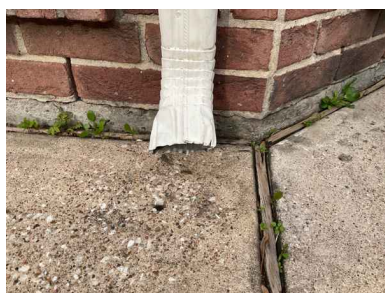
Rear

Downspout Damaged:

Damage was noted on the downspout but as this did not appear to affect the drainage, it is noted for your information.

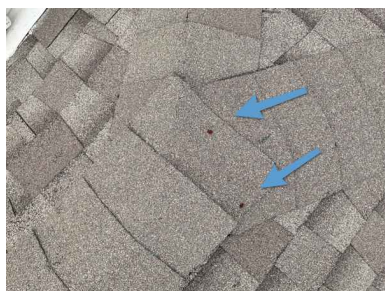
Garage Roof Level

Exposed fasteners were noted. Over time, the nails could rust and allow water to penetrate into the structure causing damage. I recommend all exposed fasteners be sealed with the appropriate roof sealant.

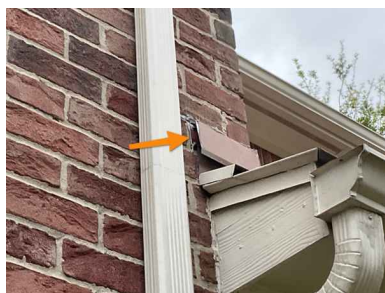
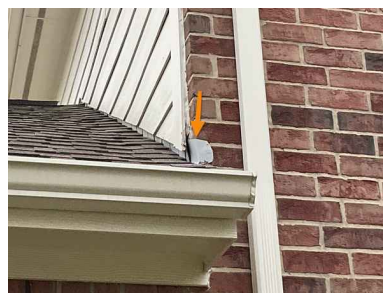
2: Flashing - Sealant Missing

The flashing sealant is missing or was not installed and is no longer providing the appropriate level of water protection. I recommend the flashing side be sealed on the side to prevent possible water intrusion.

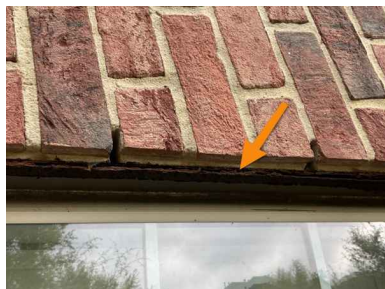
Front

Rusting steel lintels were noted above the windows and/or doors in one or more places. Steel lintels are used to support the brick above the openings and should be protected from the elements by a coat of paint. Failure to maintain the integrity of the lintels could allow them to rust and expand which will eventually crack the brick and mortar around the lintels. As no damage was noted at the time of the inspection, this is noted as a maintenance item for your information. I do recommend the removal of existing rust and the lintels be primed and painted to maintain the structural integrity of the lintels.

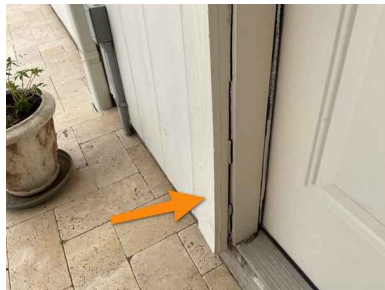
Garage

The exterior trim is loose. It should be re-secured to prevent further damage.

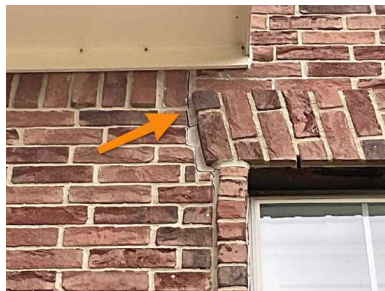
Front

4: Cracking - Normal Settlement

Exterior cracking was noted in the exterior masonry veneer. These cracks appeared to be due to normal settlement and can be considered cosmetic in nature at this time. This assessment is based on the lack of discernible displacement in the cracking and the lack of other indicators in the home. The cracks should be monitored and if they grow in length or width, a masonry contractor and/or a licensed professional engineer should assess further and determine if repairs are needed.

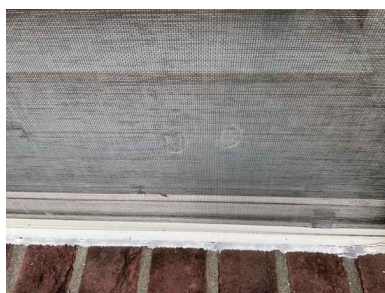
Right Side

One or more damaged screens were noted around the home and should be replaced as desired.

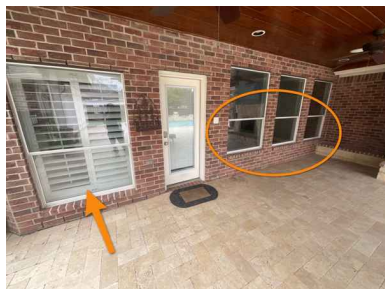
Rear

3: Screen - Missing

One or more missing screens were noted around the home. While it is common for screens to be removed for aesthetic purposes, I am required to note the missing screens as deficient as per the TREC standards of practice. Screens may be installed as desired.

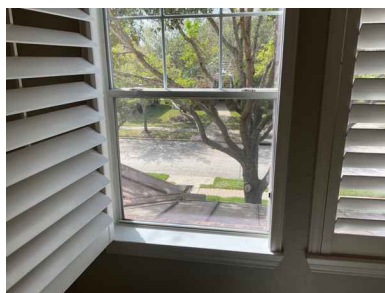
2nd Floor Front Bedroom

One or more of the windows would not remain in the open position. This is generally due to a damaged or broken guide or rail in the frame of the window. This is a potential safety issue and the windows should be repaired or replaced.

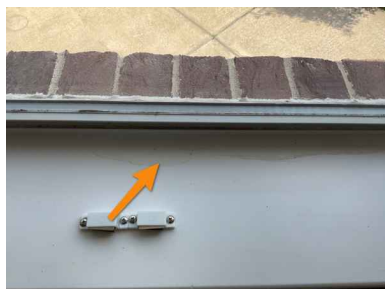
2nd Floor Bedroom

6: Sill - Water Stain

It should be noted that this was the window that would not fully close.

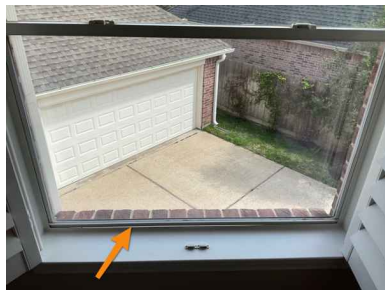
2nd Floor Bedroom

One or more of the windows will not completely shut. This could lead to water intrusion, as well as loss of energy efficiency. The window should be repaired or replaced.

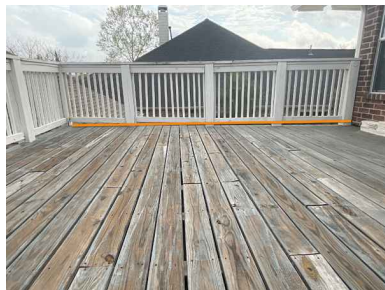
Slope to House

The balcony floor/flatwork appears to be a flat roof roofing material that may not be properly sloped away from the structure. It may hold water, or worse, direct the water against the structure. I am not sure as the wood decking may be sloped towards house but the underlayment may be correctly sloped away. I recommend an appropriate contractor assess and repair if needed.

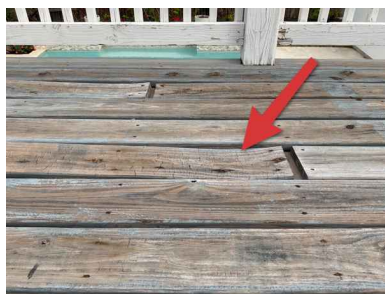
Rear

3: Deck Flooring - Warped

One or more of the deck boards were noted to be warped to the point that they are a safety hazard and should be corrected.

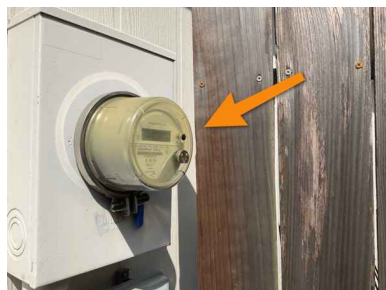
1: Fence - Gate Installation

While fences are not inspected during the course of a home inspection, I did note the gate did not function properly.

Will not open

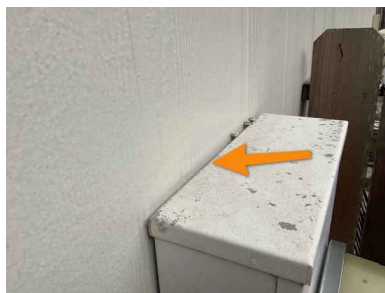
Right Side Garage

The meterbase is not sealed to the wall. This could allow water to infiltrate between the meter base and the exterior wall allowing the water to enter into the wall structure. The meterbase should be sealed with the appropriate exterior grade caulk to prevent water infiltration.

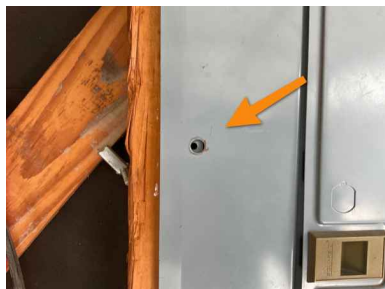
Panel Box

The panel cover was missing screws. They should be replaced with the appropriate blunt-tip panel screws only. Other screws can cause damage and pose an electrical hazard.

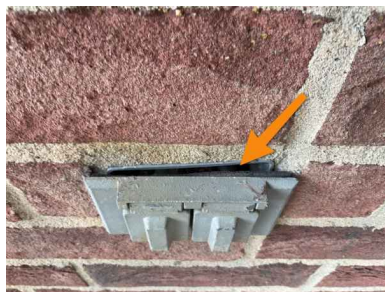
Rear

The exterior weather-proof receptacle cover is not secured and no longer provides the level of water protection recommended at this location. The cover should be secured.

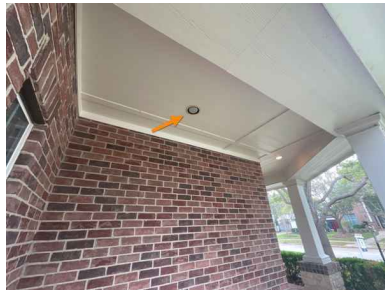
Front

One or more of the light fixtures did not appear to function properly at the time of the inspection. I am unable to determine if this is a wiring issue, a fixture issue or simply a burnt out or missing bulb. I recommend the bulb be replaced first as it is the simplest and cheapest possible repair.

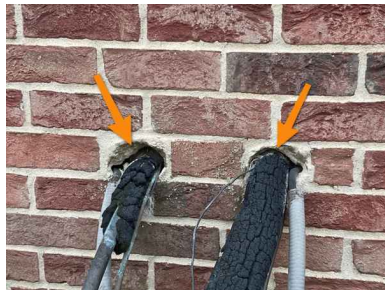
AC Condensers

The hole in the exterior wall should be sealed with sealant or liquid foam where the AC refrigerant lines enter the home to prevent air loss and pest infiltration.

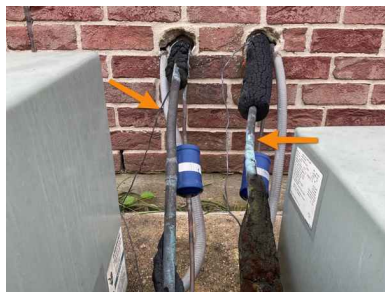
AC Condensers

3: AC Lines - Insulation Missing

The foam sleeve on the suction line is missing or deteriorated. Missing foam on the suction line can cause energy loss and condensation. A foam sleeve should be installed where missing or deteriorated.

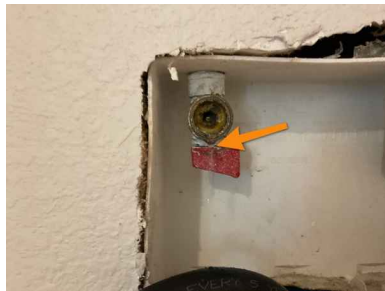
Laundry Room

One or both of the laundry connections was noted to be leaking at the time of the inspection. Leaking water could cause damage to the surrounding building materials and could be an indicator that the fixture is failing. The leaking fixtures should be replaced.

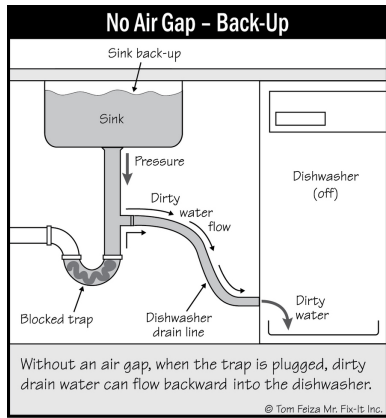
The dishwasher drain hose does not have backflow prevention installed. An air-gap, or high-loop, provides backflow prevention to protect the potable water supply. The simplest repair is to create a high-loop by securing the dishwasher drain hose to the underside of the cabinet.

P143
No Air Gap or High-Loop

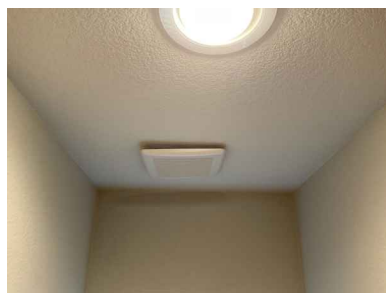
2nd Floor Bathroom

The mechanical exhaust fan operated when tested but the cover was loose. The cover should be secured.

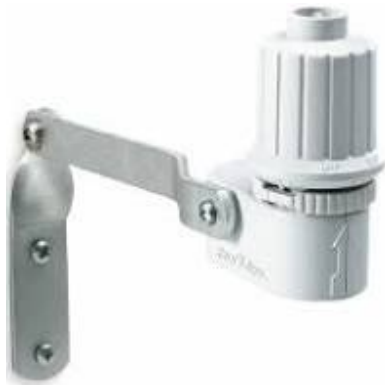
An installed rain sensor was not located. Rain sensors are required by the Texas Commission on Environmental Quality (TCEQ) on every lawn sprinkler system. They also conserve water by preventing automatic irrigation systems from operating when the lawn has received sufficient rain. While the system will operate without a sensor, TREC standards of practice requires the lack of a sensor to be reported as deficient.

Rain Sensor Example
