Total Home Inspection

Property Inspection Report

13322 Southshore Dr, Conroe, TX 77304
Inspection prepared for: Brook Mead
Real Estate Agent: -

Date of Inspection: 3/14/2024 Time: 9:00-11:30AM
Age of Home: 1968 Size: 1792
Weather: 70's clear
Order ID: 3696
Pre listing inspection. Home was occupied.

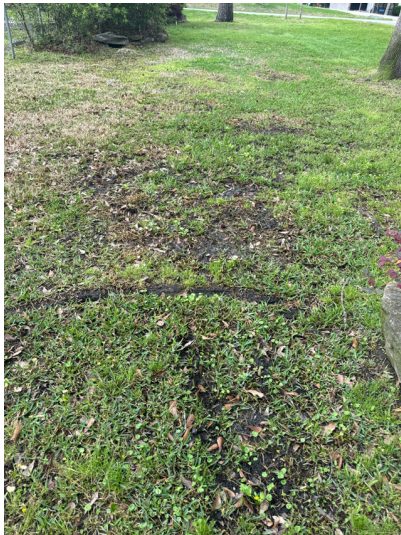
There was a wet area in the right front section of the yard and may be related to the septic system.

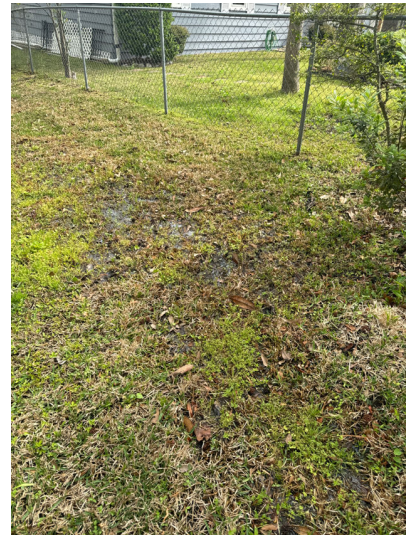
There was a wet area in the right front section of the yard and may be related to the septic system.

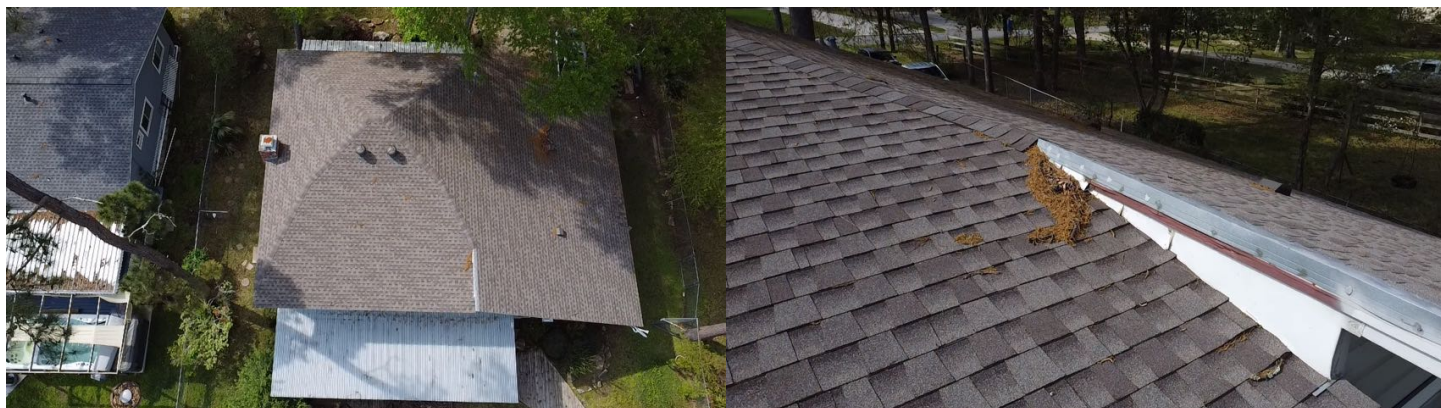
Pine needles and tree debris should be cleared from valleys and walls, to allow unimpeded flow of rain water.

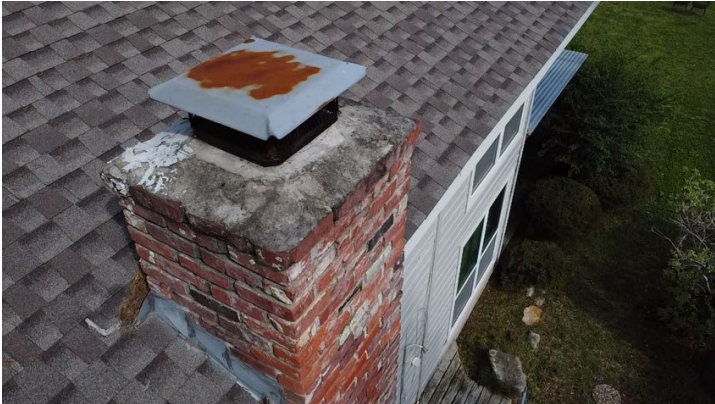
The chimney cap was rusted and should be sealed to stop oxidation.

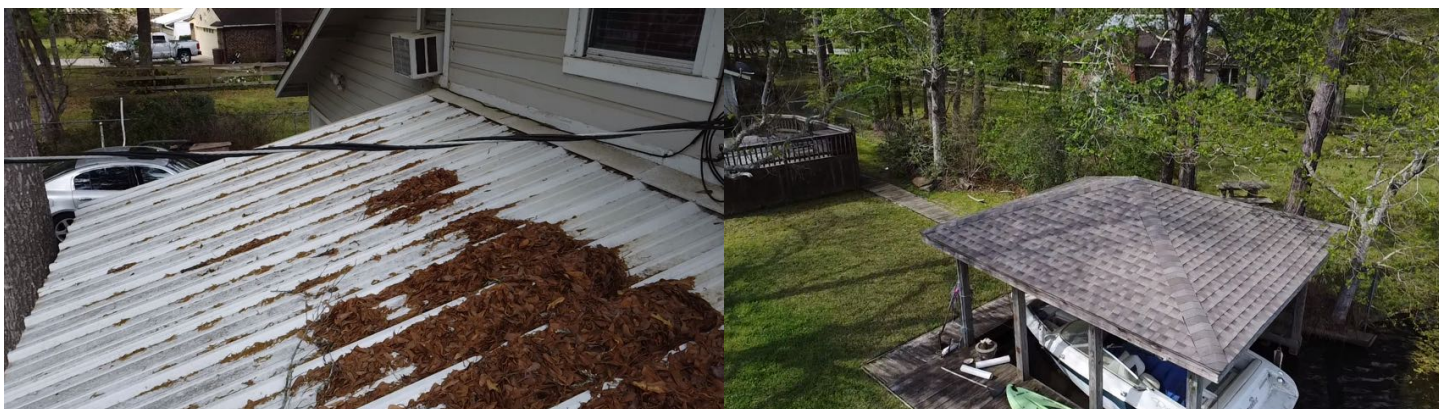
Pine needles and tree debris should be cleared from valleys and walls, to allow unimpeded flow of rain water.

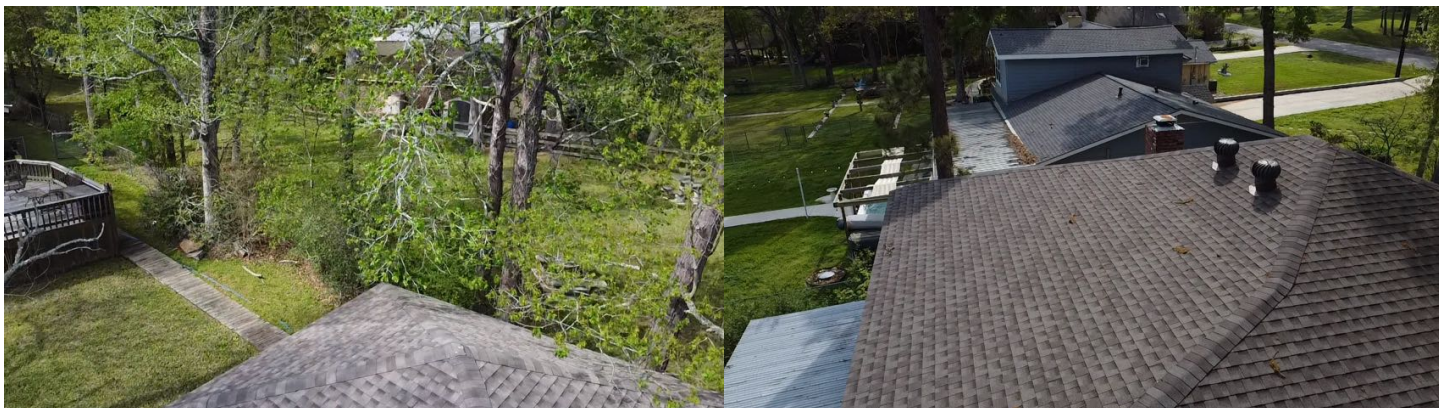
Trees were contacting the the boat house roof surface. Tree limbs and vegetation may prematurely wear or damage shingles.

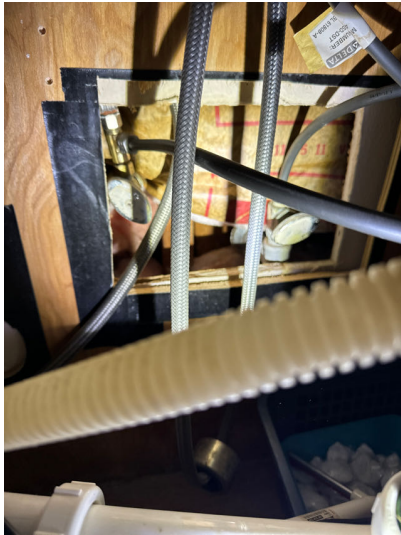
The wall under the sink should be covered with drywall.

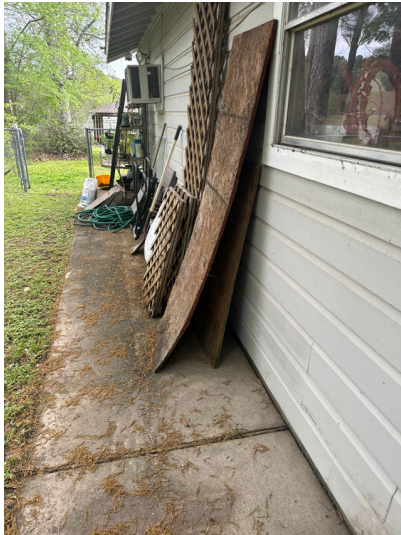
Building material and personal items should be moved away from the exterior walls.

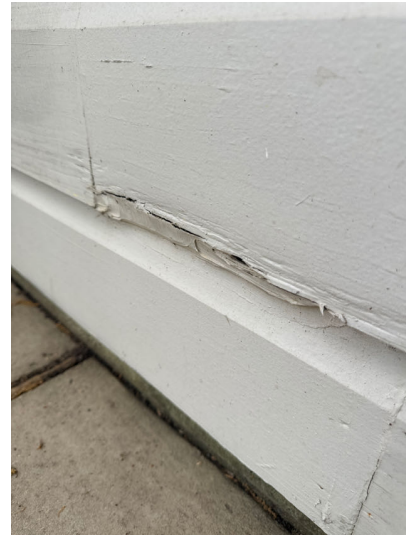
Wood deterioration was noted at some areas of siding including the left side of the garage and the right side wall.

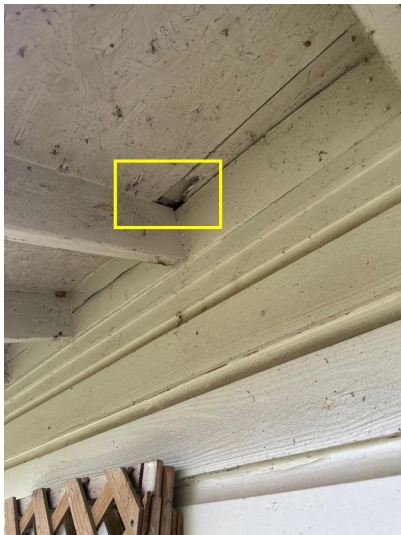
Wood deterioration was noted at some areas of siding including the left side of the garage and the right side wall.

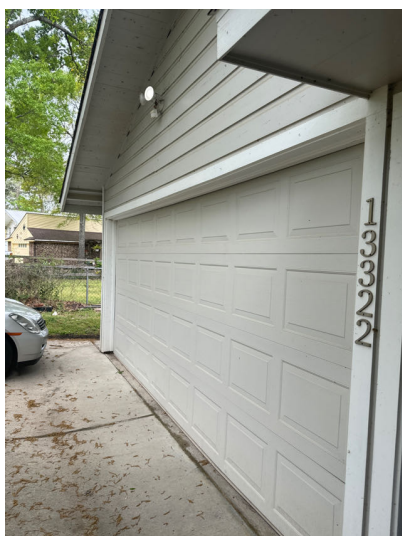
Wood deterioration was noted at some areas of siding including the left side of the garage and the right side wall.

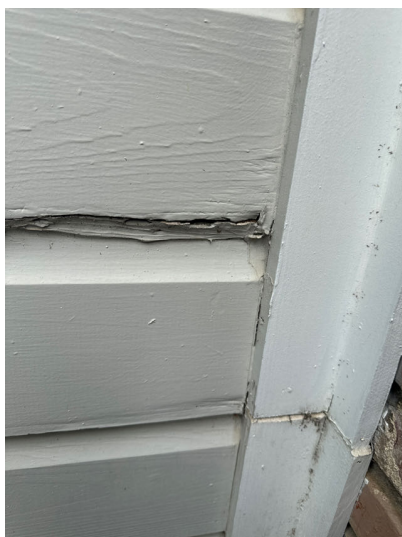
Wood deterioration was noted at some areas of siding including the left side of the garage and the right side wall.

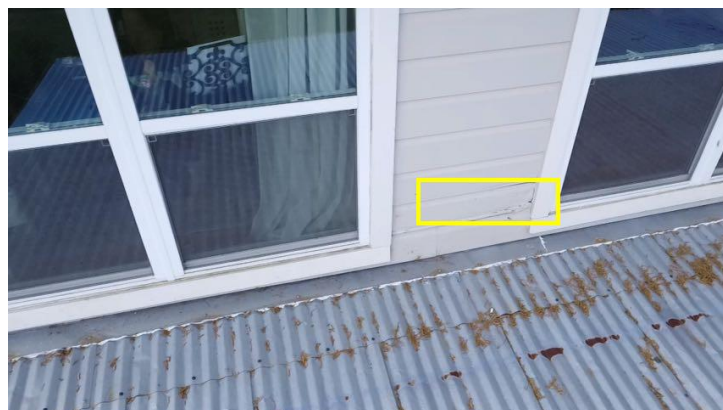
Wood deterioration was noted at some areas of siding including the left side of the garage and the right side wall.

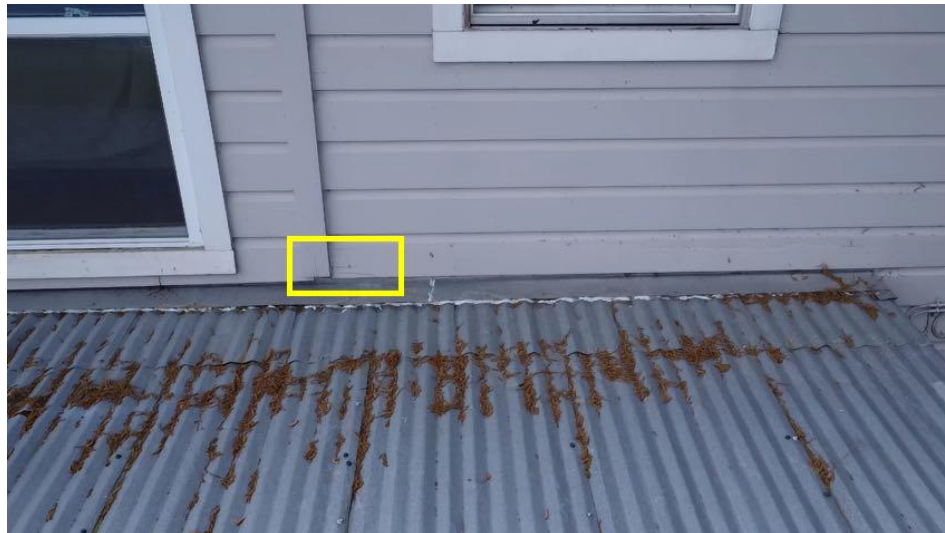
Wood deterioration was noted at some areas of siding including the left side of the garage and the right side wall.

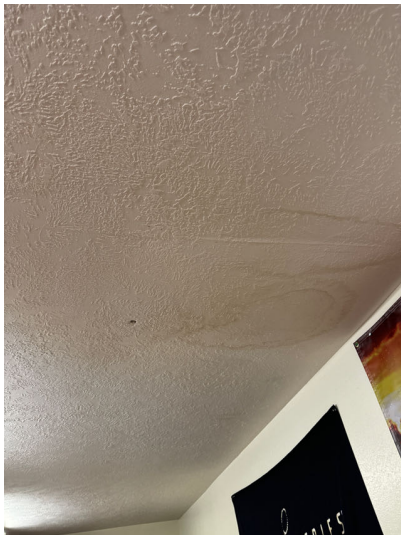
Ceiling stains were noted in the lower bedroom. No moisture was detected at the time of inspection.

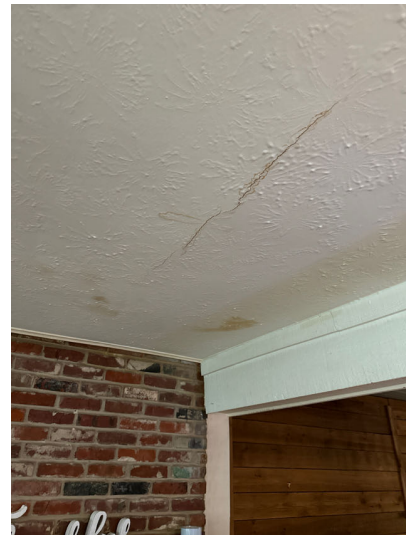
Ceiling stains were noted in the lower bedroom and the lower living area. No moisture was detected at the time of inspection.

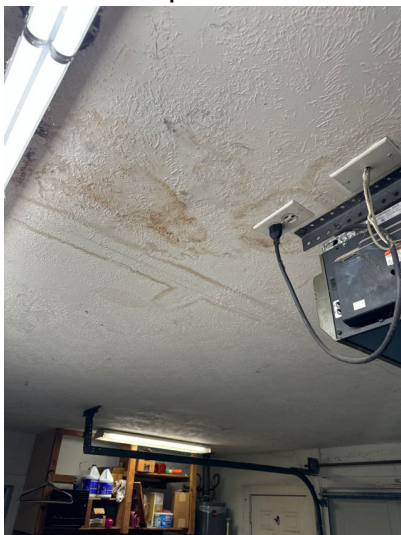
Ceiling stains were noted in the lower bedroom and the lower living area, the garage. No moisture was detected at the time of inspection.

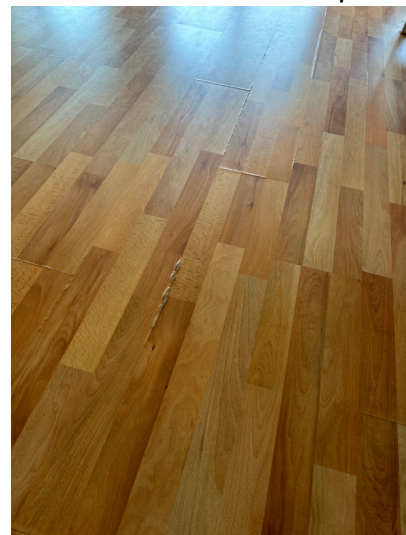
Small areas of water damage was noted on the upper level living area.

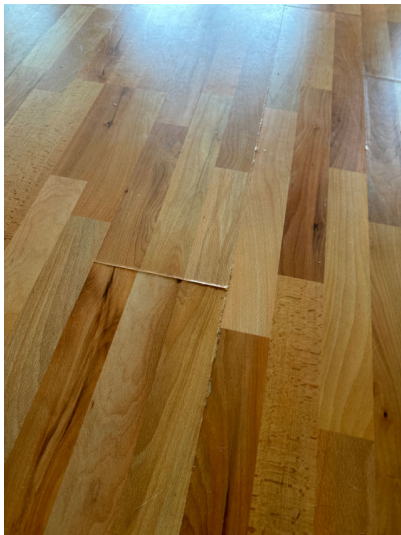
Small areas of water damage was noted on the upper level living area.

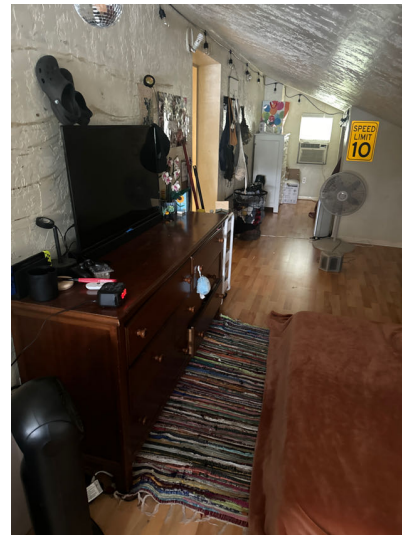
The limited height of the ceiling decreases the usable living space in the upper left bedroom.

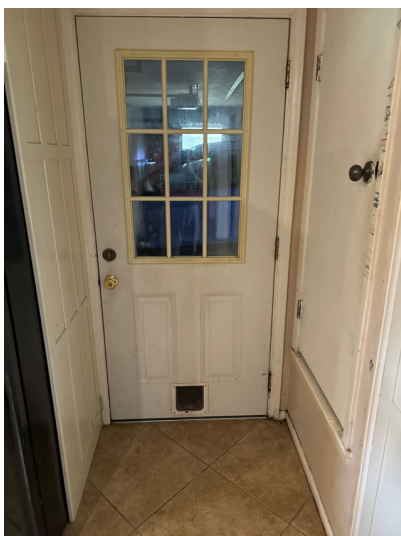
The garage pedestrian door fire separation was compromised with a pet door.

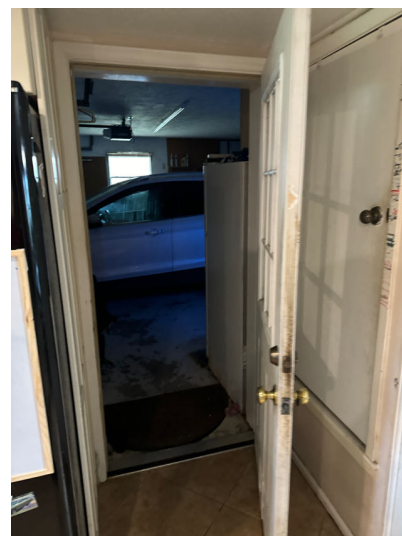
Self closing hardware was missing or ineffective at the garage pedestrian door.

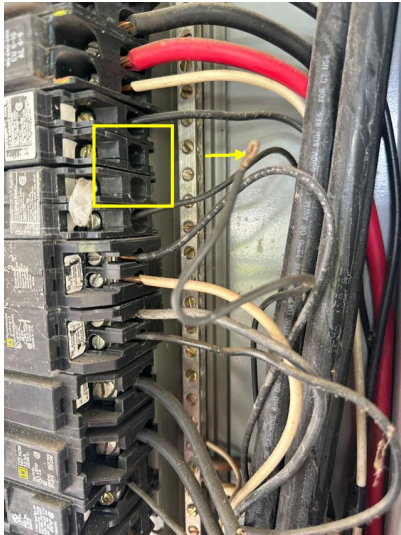
There were loose wires in the panel and breakers that did not control a circuit.

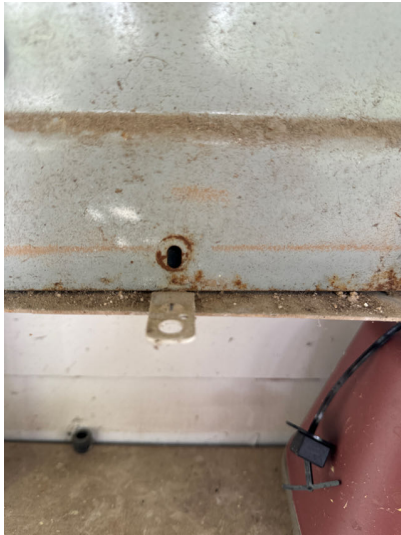
The panel cover was missing its fastener.

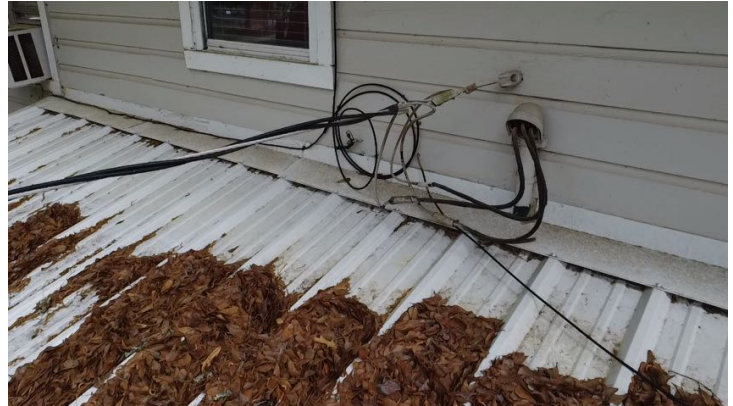
Drip loops on the service entry cable should be kept from touching the metal roof.

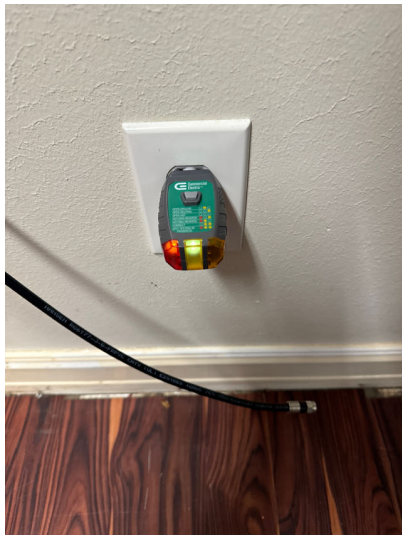
Outlet wiring in the lower bedroom was not correct.

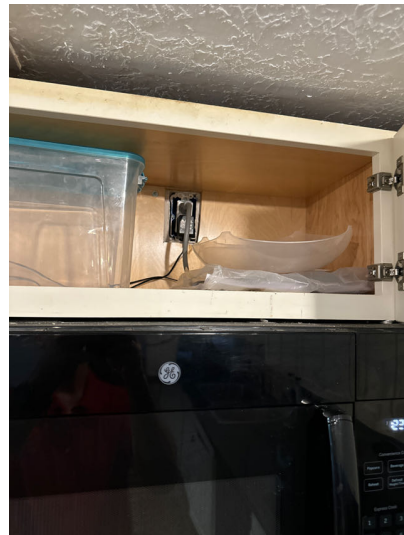
Outlet cover was missing above the microwave and at the disposal.

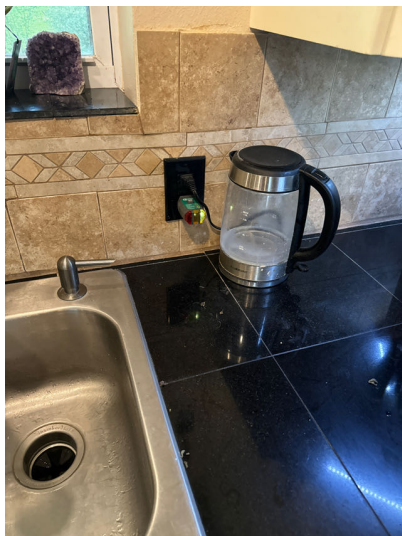
GFCI outlets were not present and functioning on the, (I)bathroom receptacles;
 (II)garage and accessory building receptacles;
 (III)outdoor receptacles;
 (IV)crawl space receptacles and lighting outlets;
 (V)basement receptacles;
 (VI)receptacles that serve kitchen countertops;
 (VII)receptacles that are located within six feet of the outside edge of a sink, shower, or bathtub;
 (VIII)laundry area receptacles;
 (IX)indoor damp and wet location receptacles;
 (X)kitchen dishwasher receptacle; and
 (XI)electrically heated floors;

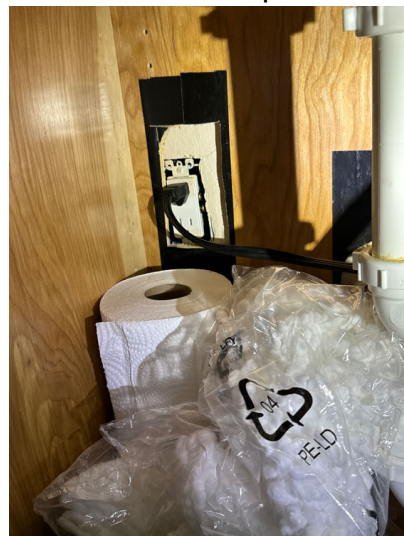
Outlet cover was missing above the microwave and at the disposal.

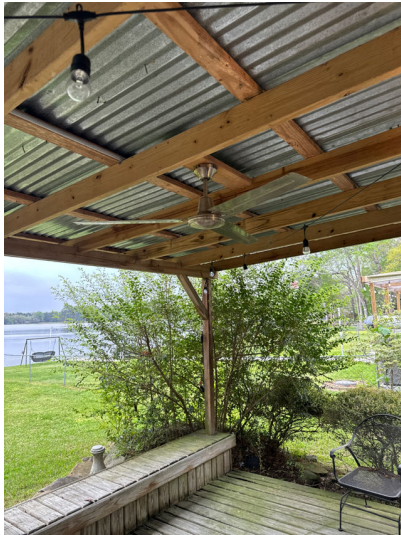
The right side patio fan did not operate.

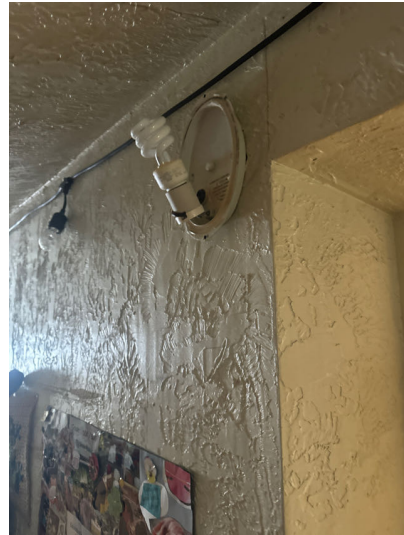
The fixtures in the upper left bedroom were damaged.

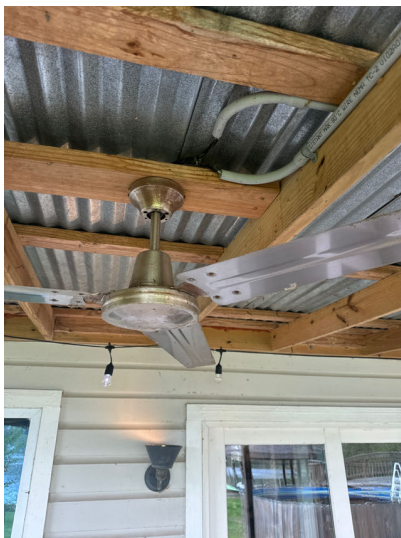
Conduit should continue to the ceiling fan junction boxes.

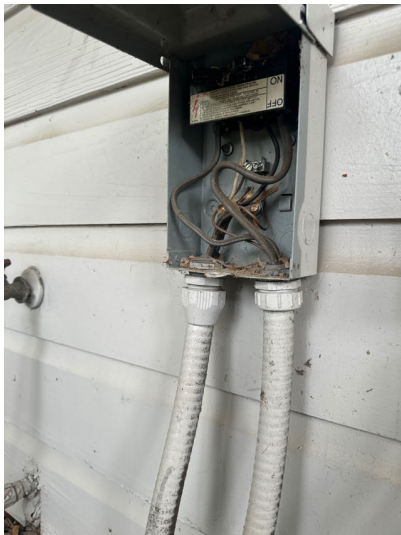
One AC disconnect was missing its cover.

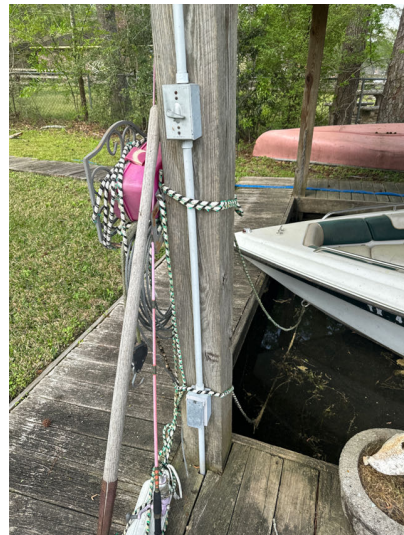
The boat dock electrical receptacles and motors did not appear to be GFI protected.

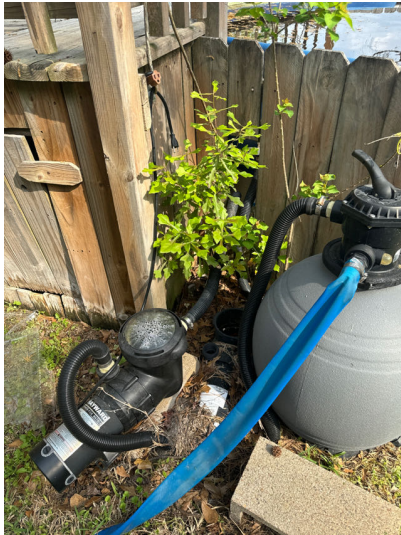
The pool equipment was not connected and did not appear to be operable.

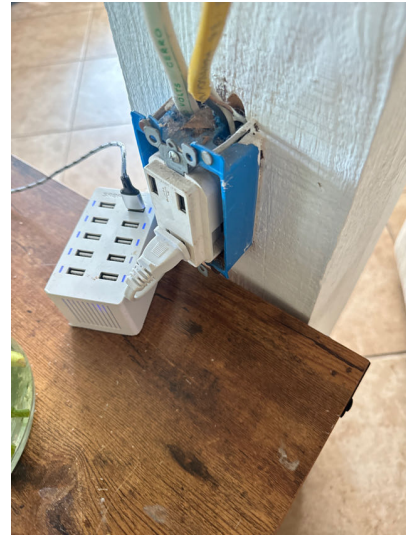
The exposed romex in the living room should be in conduit.

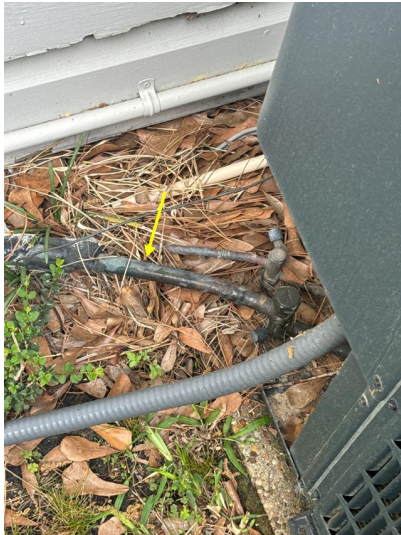
Insulation was deteriorated on the freon suction lines, in the attic/exterior.

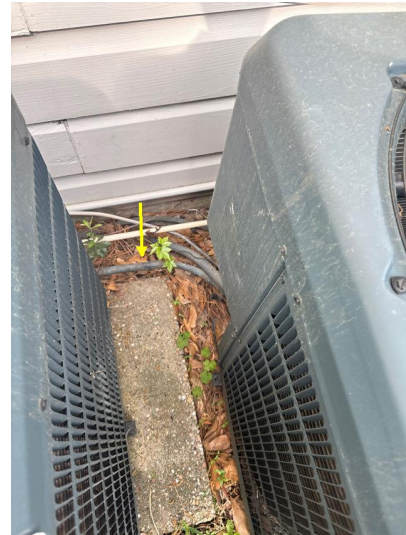
Insulation was deteriorated on the freon suction lines, in the attic/exterior.

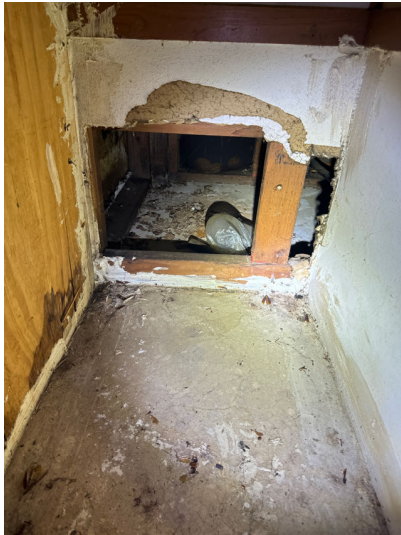
Air filters and chase were dirty. Advise to check records for service of these units. If records are not available we recommend cleaning and service by an HVAC professional.

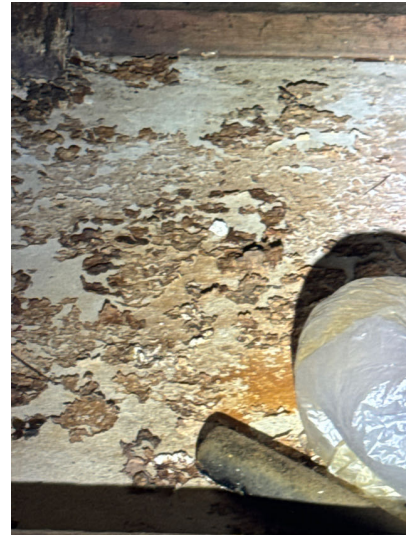
Air filters and chase were dirty. Advise to check records for service of these units. If records are not available we recommend cleaning and service by an HVAC professional.

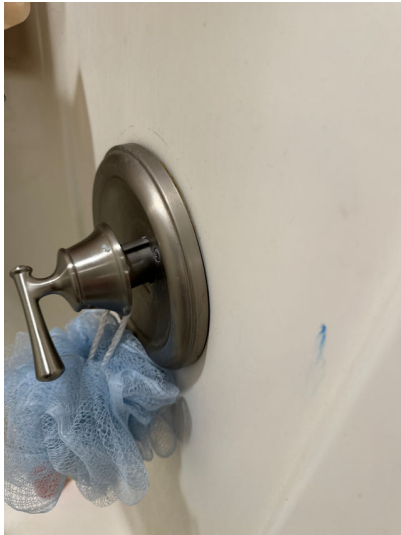
Plumbing fixtures in the shower were not sealed.

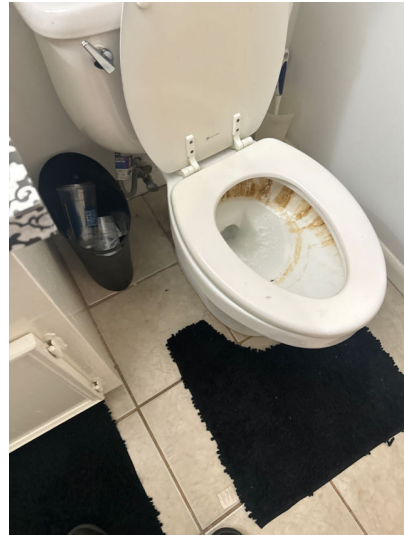
Toilet was loose in the upper guest bathroom . Examine flange and replace wax ring and seal toilets to the floor.

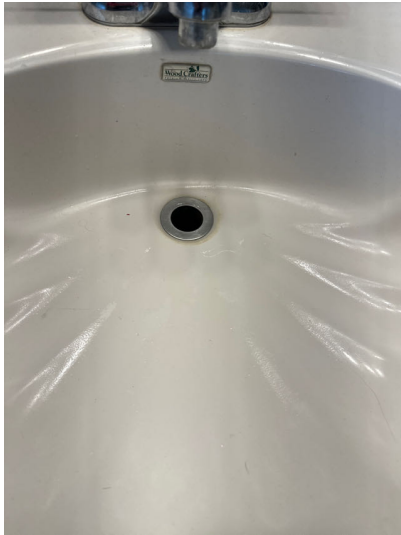
Sink stopper were not present in the primary bathroom.

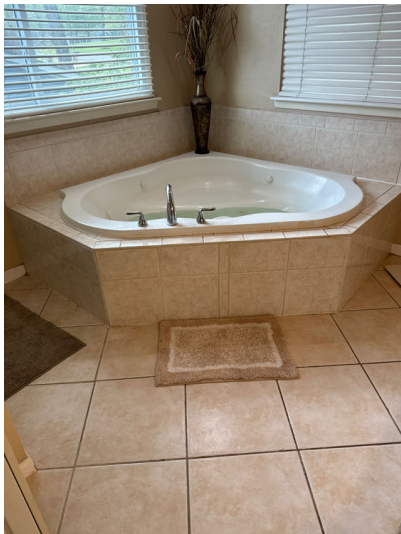
It did not appear that the hydro-massage equipment was GFCI protected.

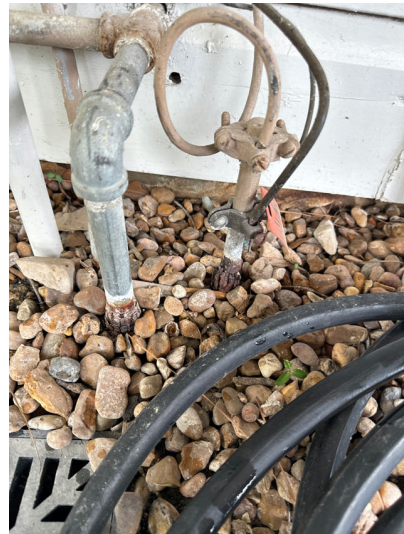
Gas supply pipe near the electric panel contained significant rust.

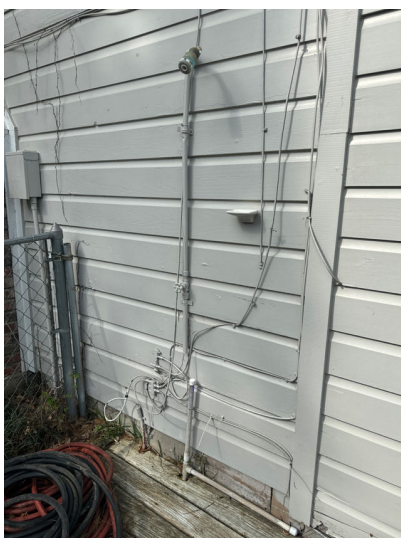
The outdoor shower has been disconnected.

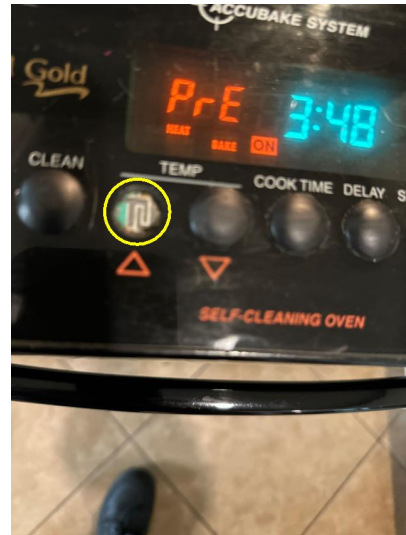
Temperature control button was worn.

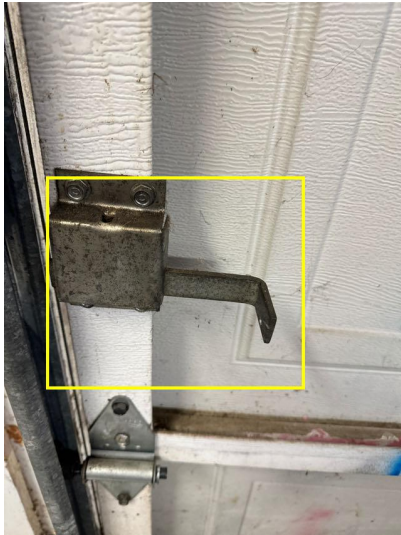
Door lock should be disabled since opener is present.

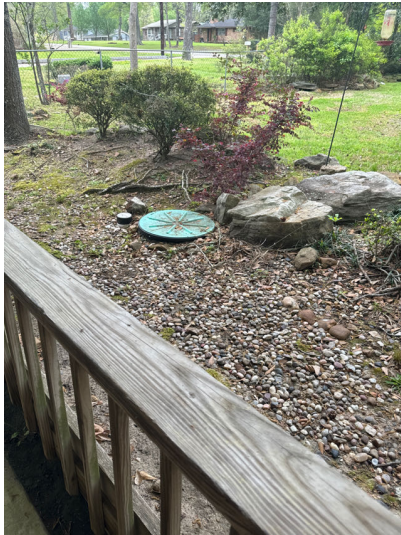
Recommend inspection by septic tank company

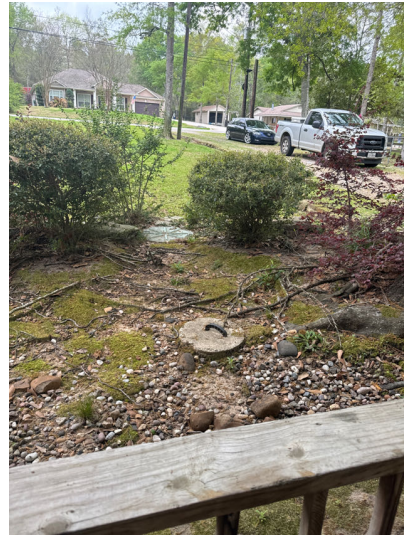
Recommend inspection by septic tank company
