# PROPERTY INSPECTION REPORT FORM

VISTA PROPERTY INSPECTION GROUP LLC  
 3430 County Road 89, Pearland, TX 77584  
 281-642-1516, vista.insp@gmail.com

<u>Alfredo Rosales</u>	<u>03/28/2024</u>
<i>Name of client</i>	<i>Date of Inspection</i>
<u>6638 Carly Park Way, Houston, TX 77084</u>	
<i>Address of Inspected Property</i>	
<u>Felix D. Angel</u>	<u>20185</u>
<i>Name of Inspector</i>	<i>TREC License #:</i>
<u>N/A</u>	<u>N/A</u>
<i>Name of Sponsor (If applicable)</i>	<i>TREC License #:</i>

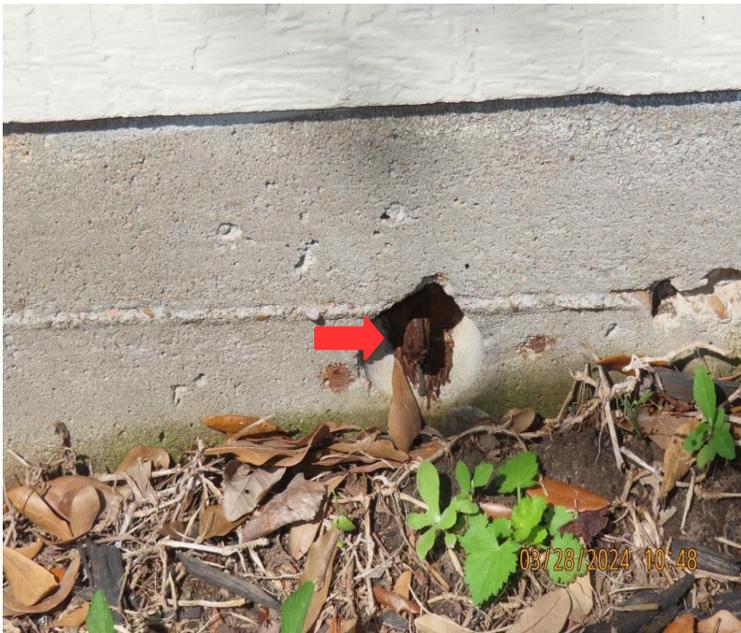
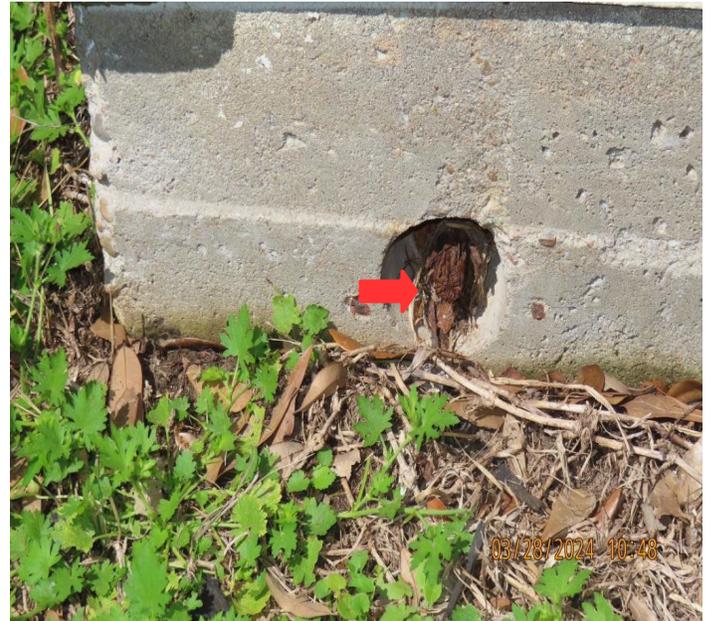
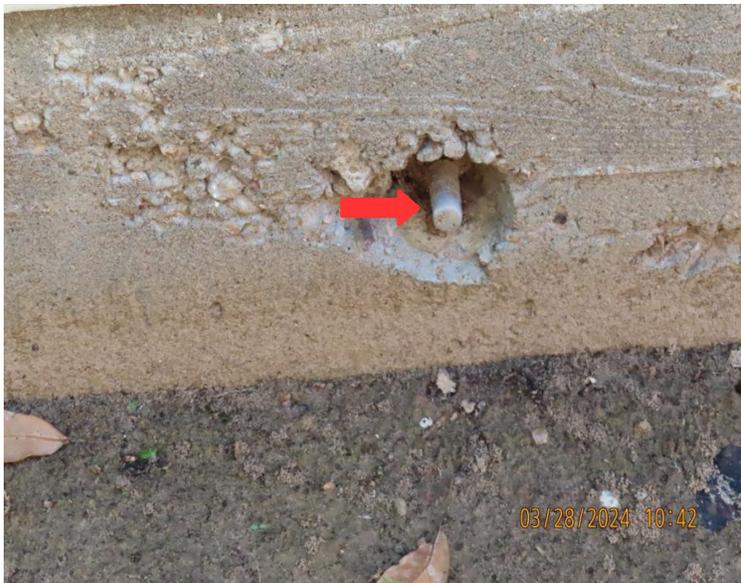
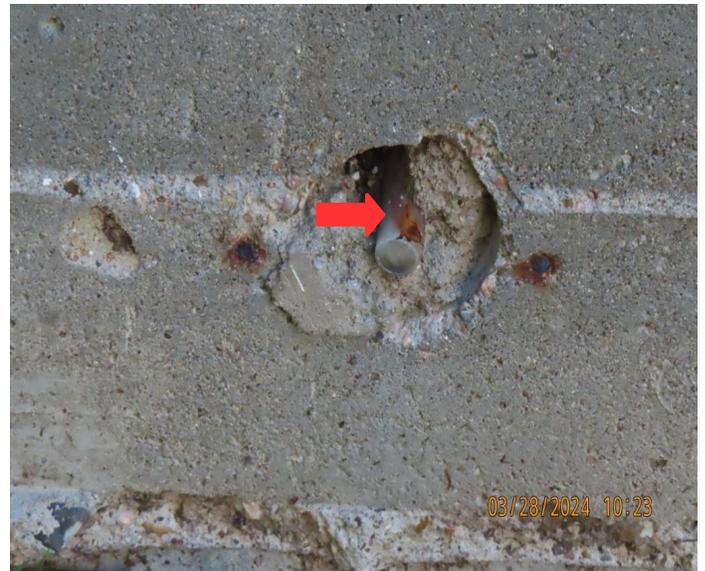
- Noted exposed post tension cable ends in more than four locations . Note: Steel when rusted will expand pressing against the concrete putting it in tension and causing it to crack and pop off. Recommend to properly clean and reseal to prevent deterioration of slab.

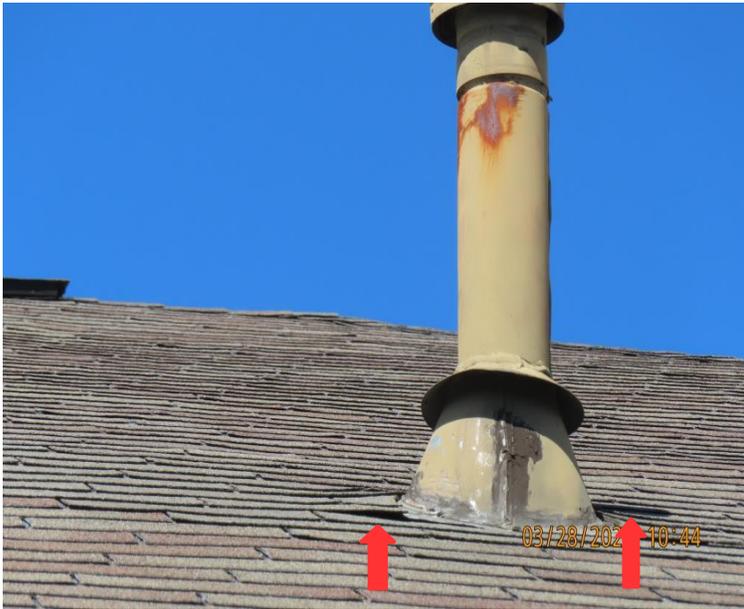
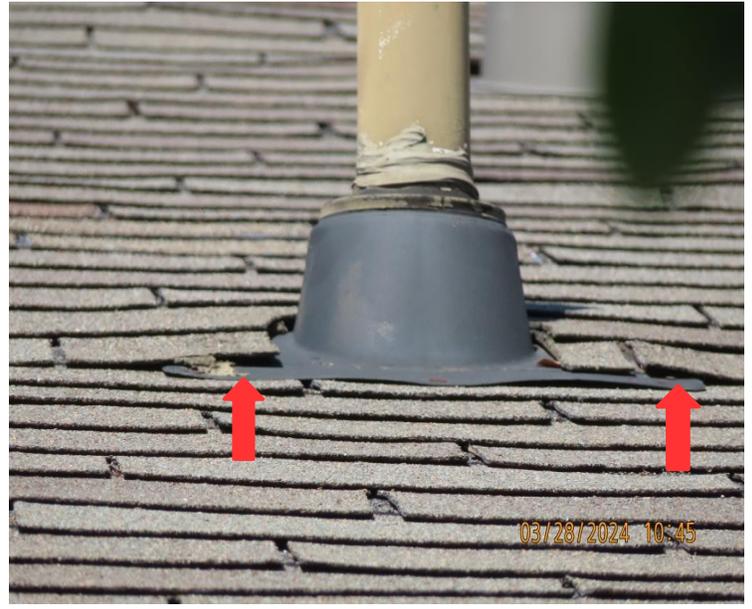
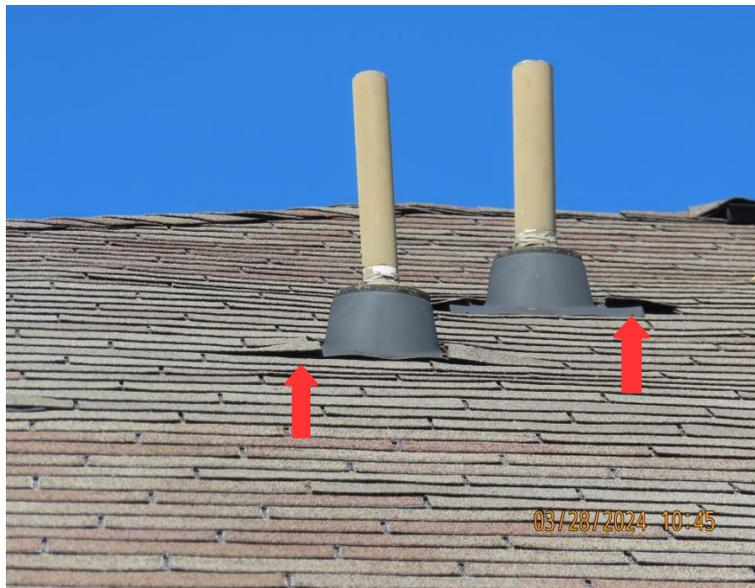
- Observed lifting shingles at the vents and exhausts. Properly repair to avoid further deterioration and possible water intrusion

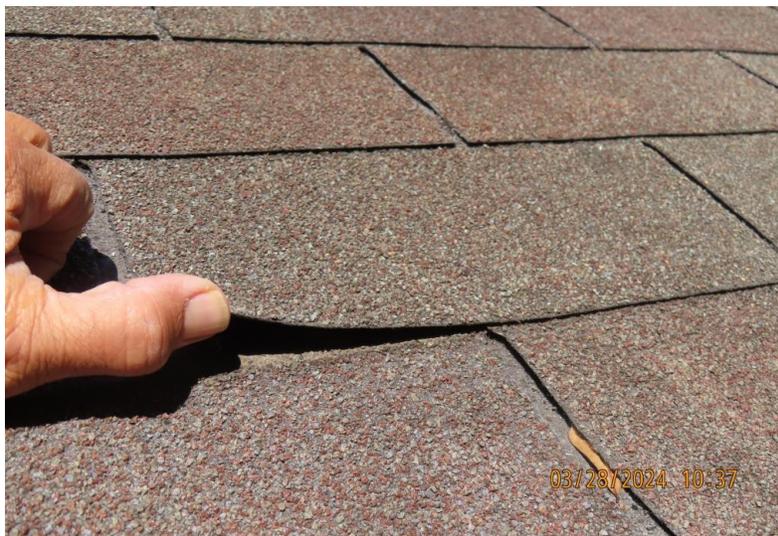
- Observed weak adhesive on multiple shingles. Monitor over time and conduct proper repairs as needed

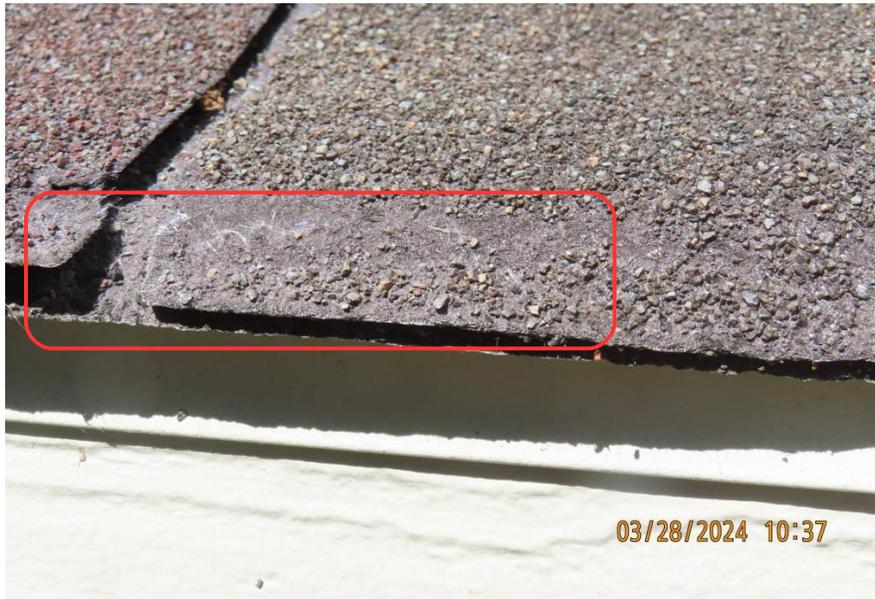
- Damage shingles noticed on the rear drip edge. Recommend reviewing other areas with similar condition and conduct proper repairs to prevent damage

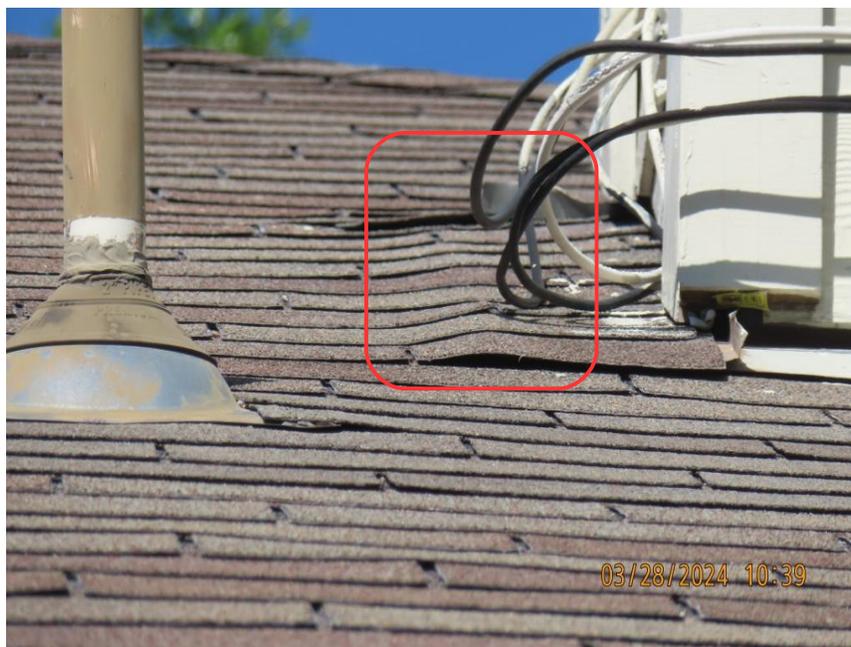
- The flashing at chimney wall-to-roof areas appeared to be hemmed (also known as “J”) or “L” flashing. In need of proper repair and or replace for the correct flashing type
- Noticed antenna cables going through or under the shingles or flashing. Recommend the removal of cables to prevent damage and water intrusion

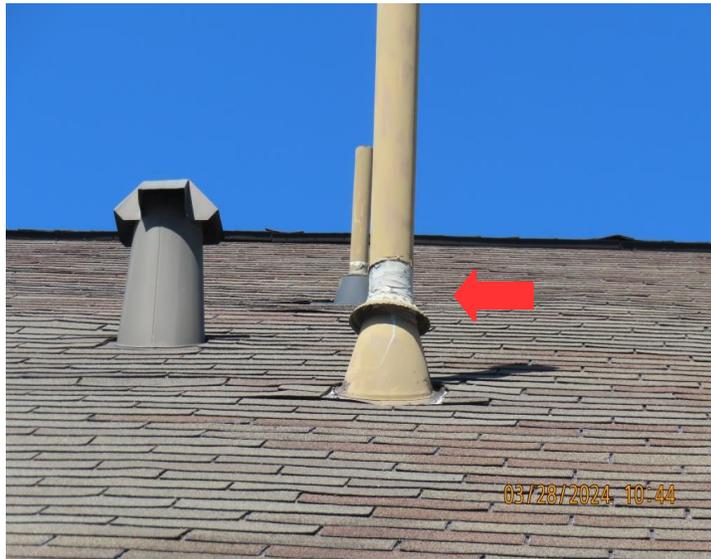
- An exhaust on the rear side appeared to be pulled out of its original position. Investigate further and repair as needed

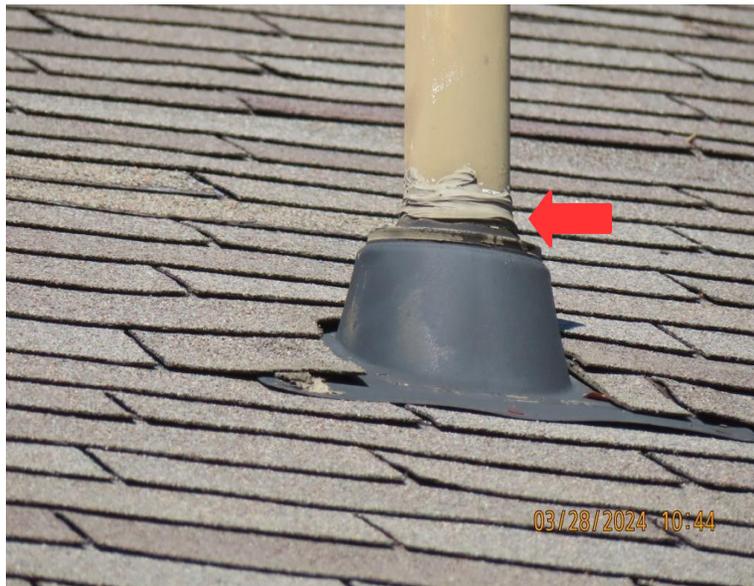
- Recommend inspection and or replacement of deteriorating roof jacks and or the caulking between the pipe and roof jack to prevent possible water infiltration

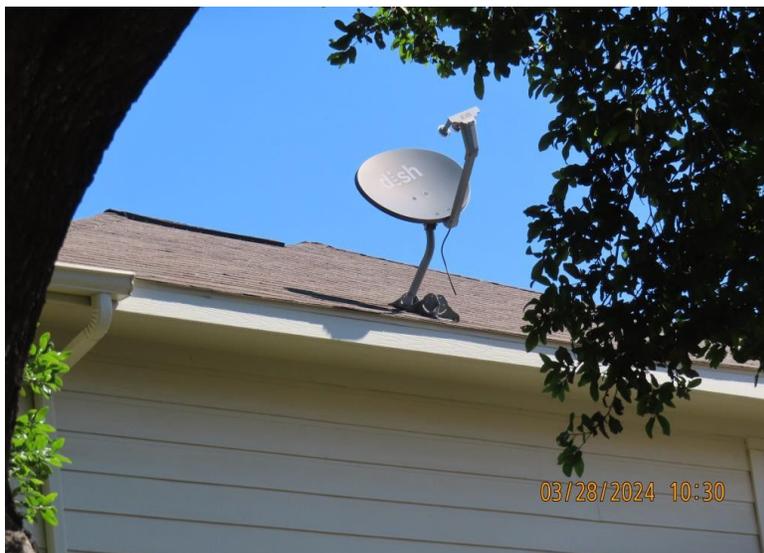
**Note:** Dish type antennas were secured to the roof. Drilling holes through the roof damaged the roof cover and the gasket, caulk or sealant applied is not a guarantee against moisture penetration. Items mounted to the roof such as satellites, antennas, etc., may allow water penetration. As these items move, screws and bolts may **enlarge mounting holes. We recommend closely monitoring these areas and making repairs when necessary.**

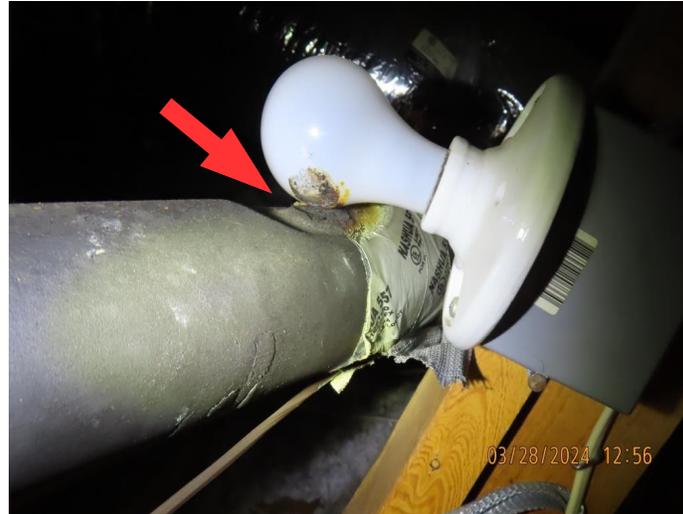
- The AC refrigerant line insulation is in contact with the attic light bulb and is burnt. In need of proper repair for safety.

Note: Inspector had loosen the light bulb to eliminate further damage or fire

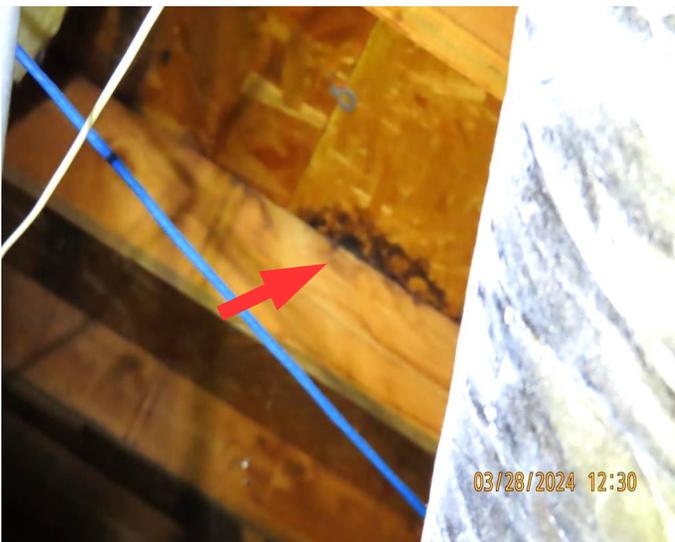
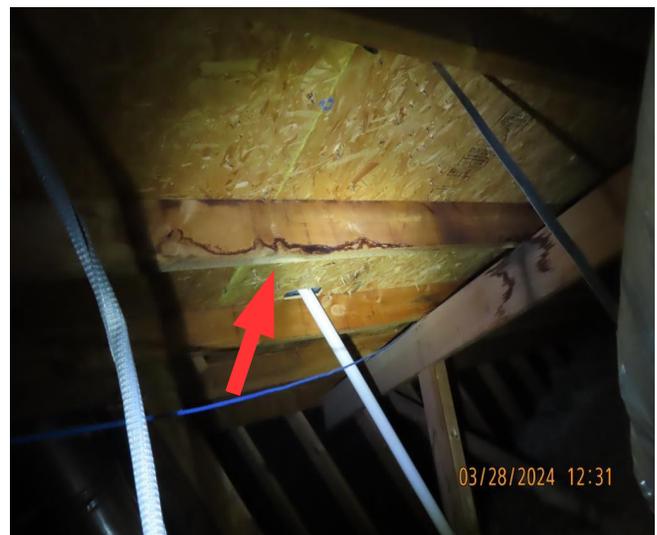
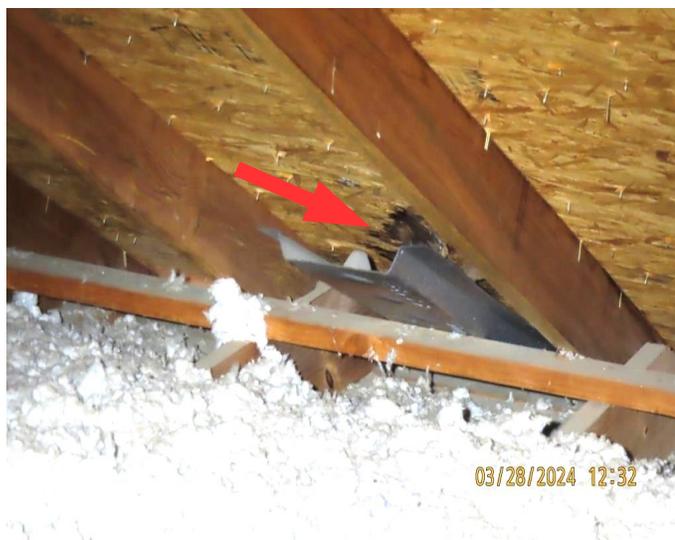
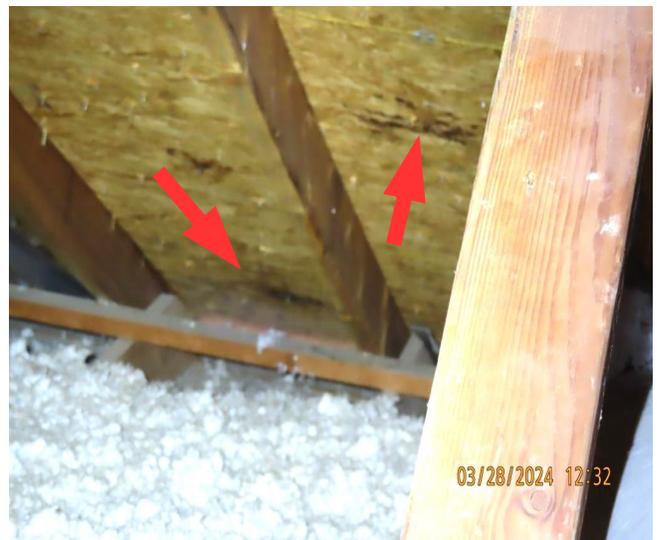
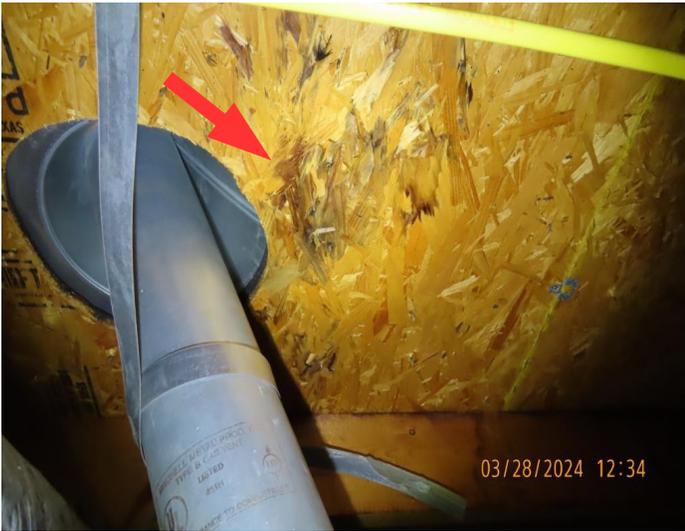
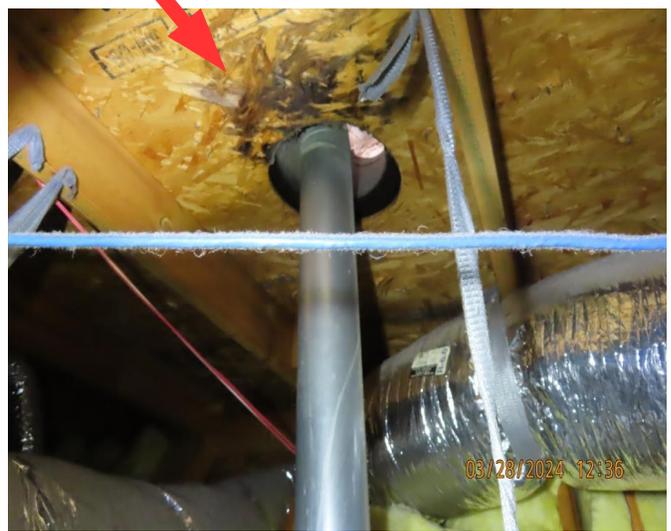
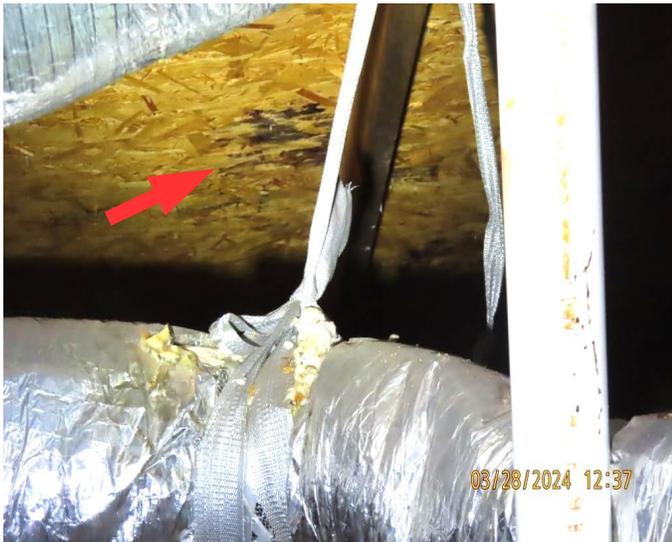
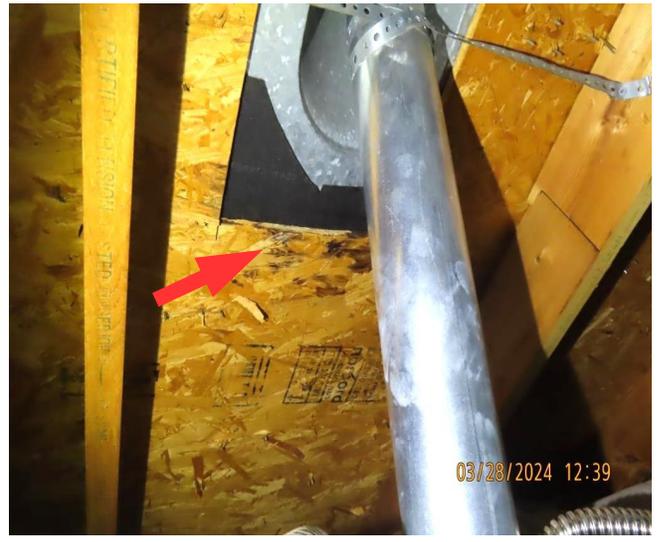
- There is evidence of what appeared to be water intrusion at various locations on the roof deck. Some water marks appeared to be recent. Thoroughly investigate root cause and perform proper repairs by a qualified contractor to stop or prevent property damage

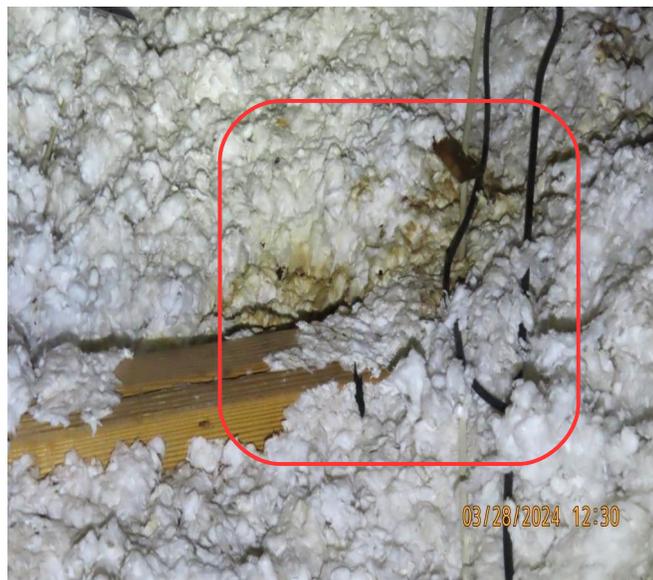
- Noticed discoloration on insulation underneath one of the areas where water appeared to be infiltrating. Investigate further and repair root cause.

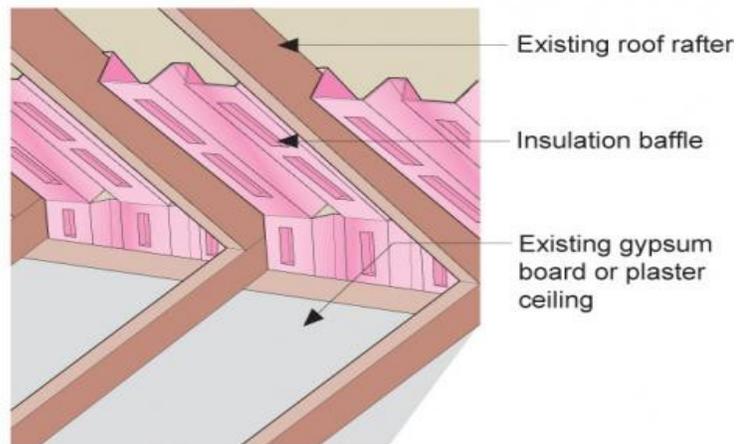
- Baffles were not evident. **Note:** Baffles provide a channel for air to flow through certain parts of the attic drawing air from outside. Install for proper attic ventilation

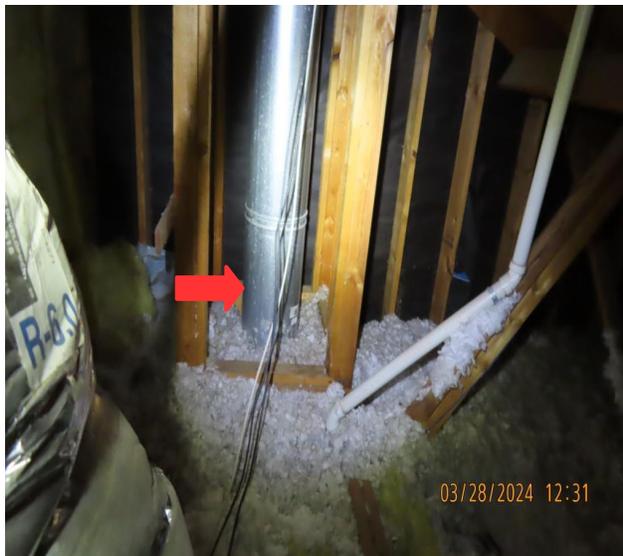
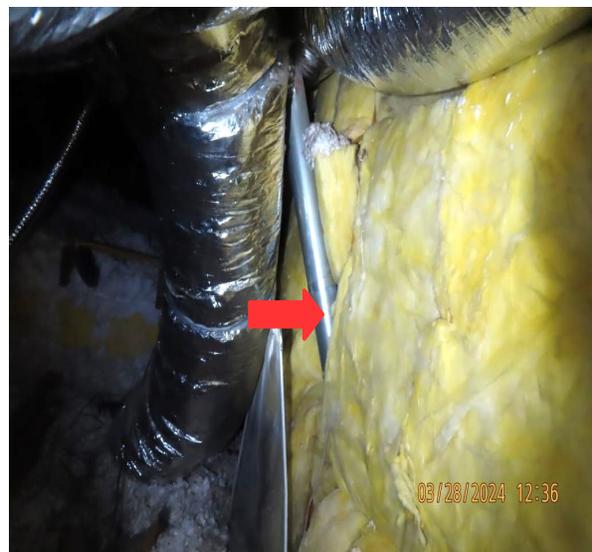
- Observed insulation in contact with two exhausts. There should be a min clearance of 1" for double wall/type "B". Properly repair

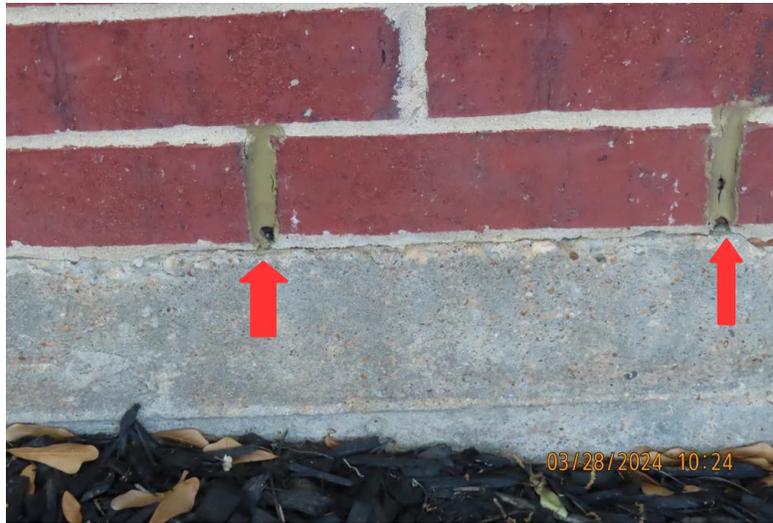
- Observed clogged weep holes. These are openings that allow entrapped water/condensation to drain out. Also these provide ventilation in the space between the brick and frame wall.  
Min. 3/16" immediately above flashing and at every 33" on center

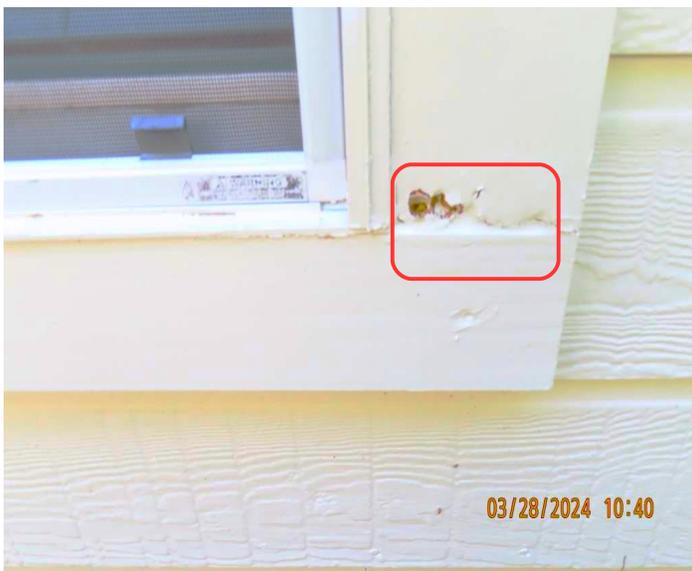
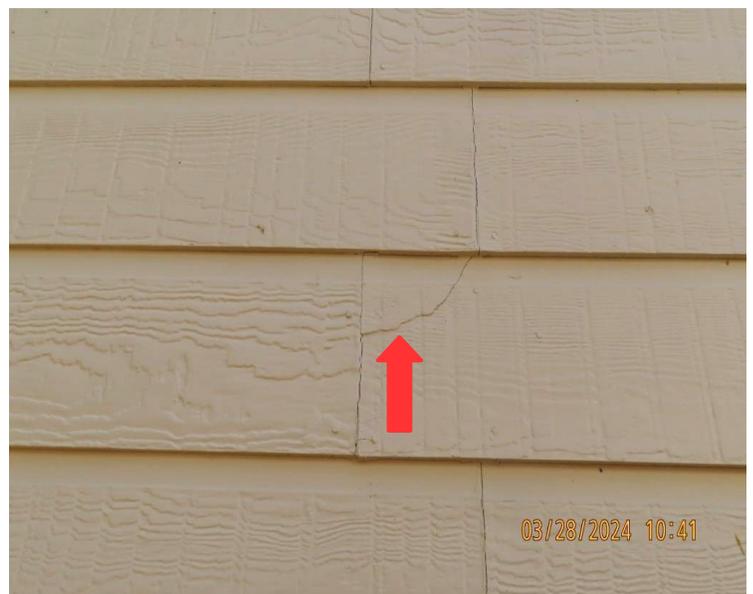
- Rotting note on a left rear window frame. Properly repair to prevent further deterioration
- Repair also cracks on at least two siding boards to avoid further deterioration and water intrusion

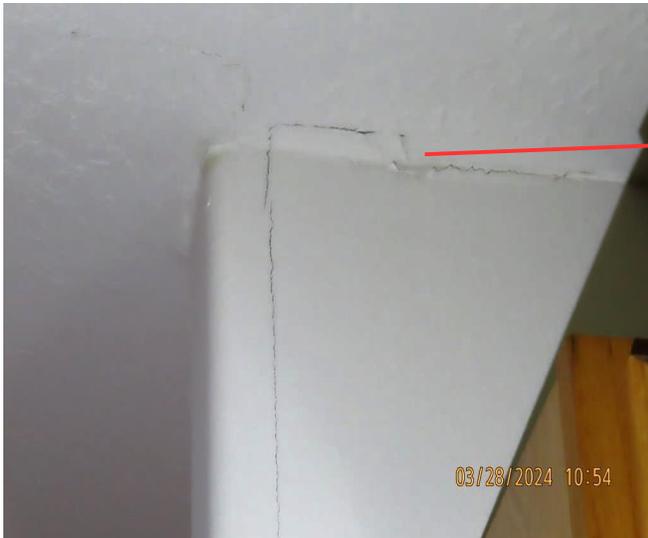
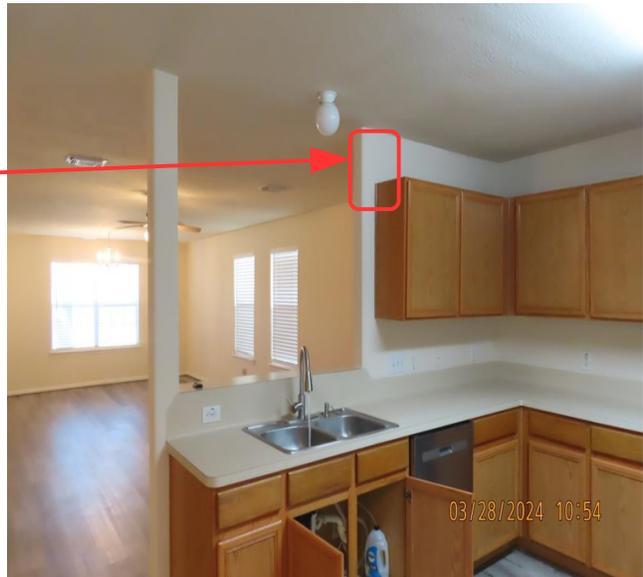
- Crack noticed on the kitchen wall. Possibly caused by normal settlement or poor workmanship. Monitor over time and contact a professional should the existing condition deteriorates further

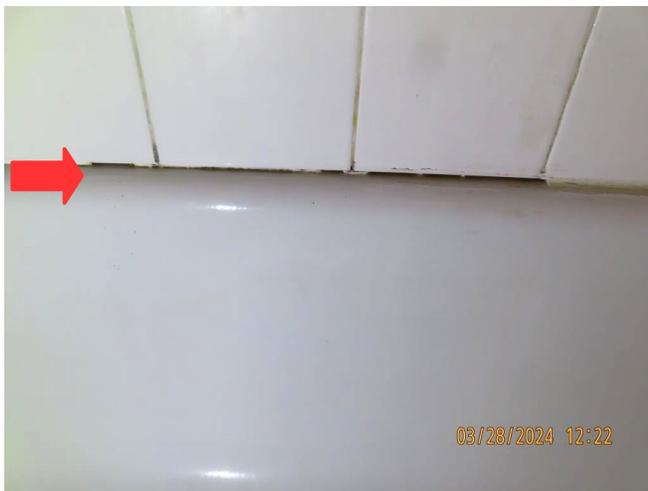
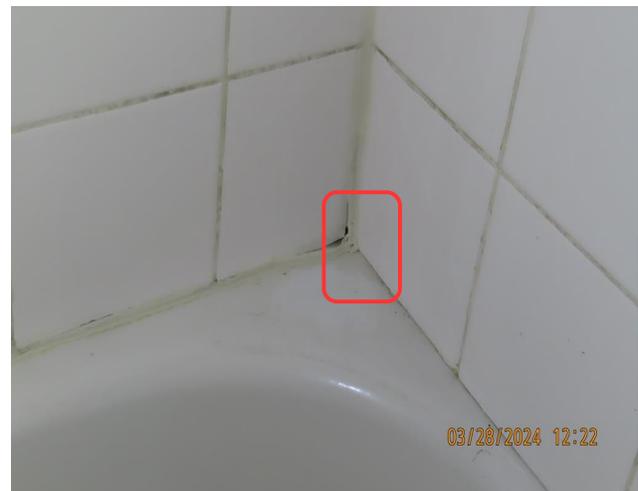
- Where needed, properly seal cracks/replace deteriorated grouts on shower enclosures to prevent water infiltration

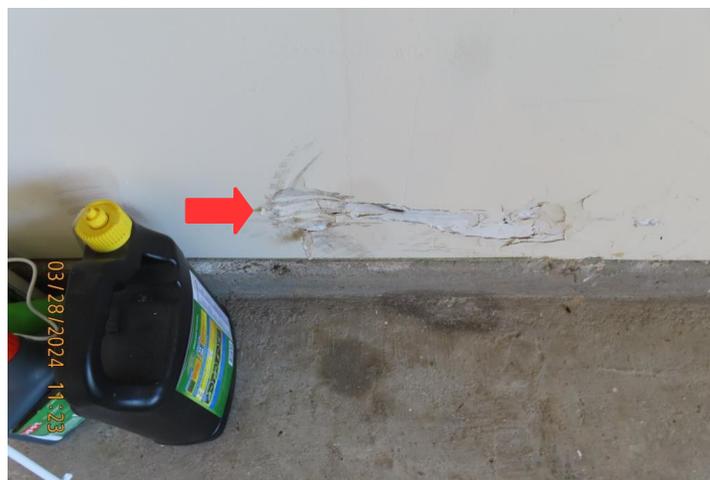
- Cosmetic: As needed, repair drywall damage in the garage

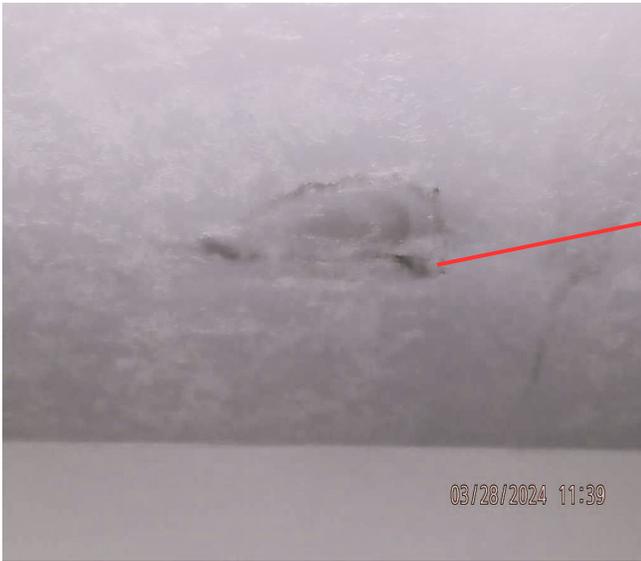
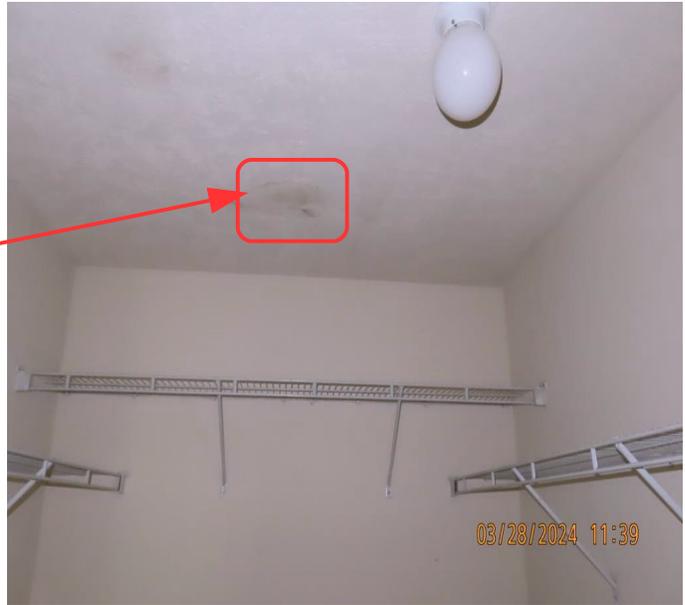
- Evidence of waster damage inside the master bedroom closet. Possibly associated with the various water infiltration locations located in the roof deck. Confirm that root cause and all affected areas such as but not limited to: drywall, insulation, lumber, etc have been properly repaired and or treated by a qualified contractor. If not properly repaired/treated, it can lead to microbial growth.

Noticed elevated moisture levels at the ceiling

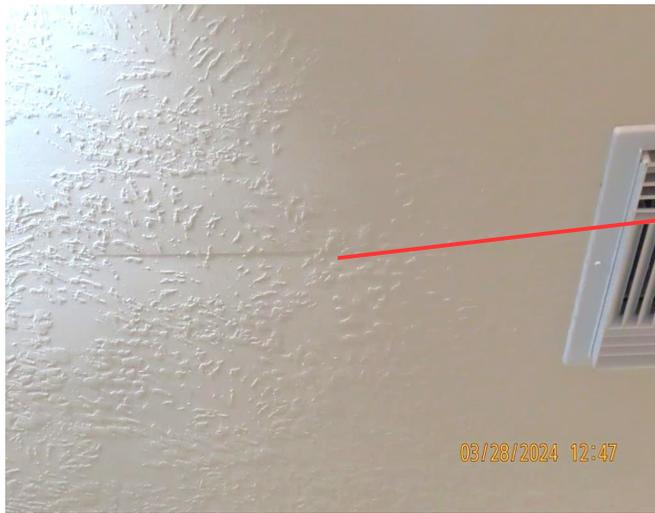
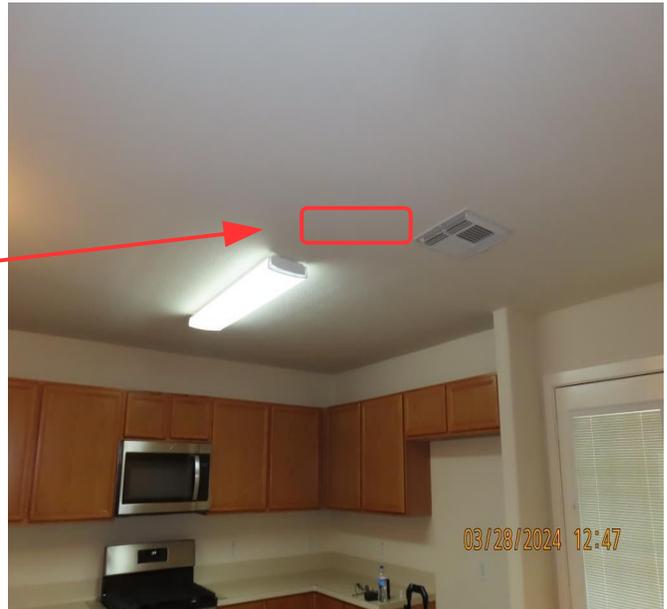
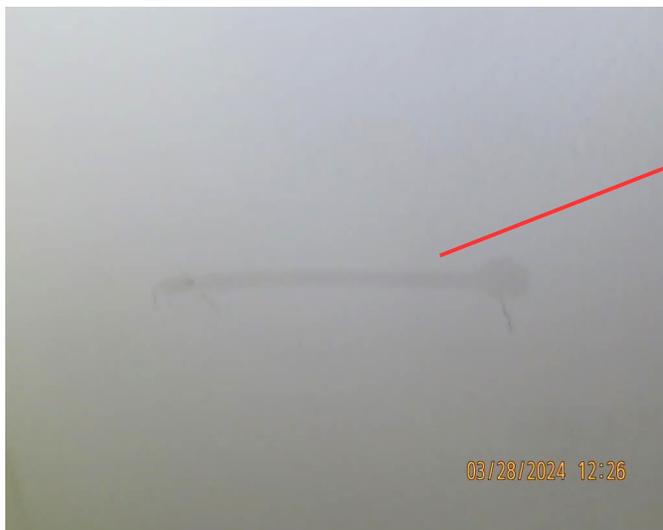
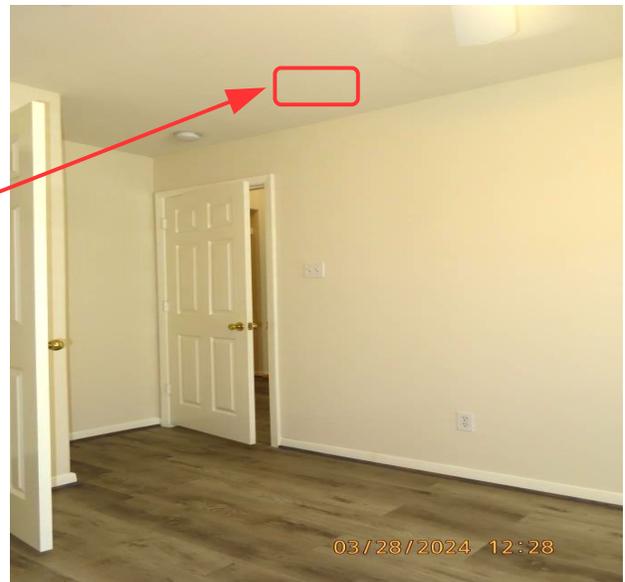
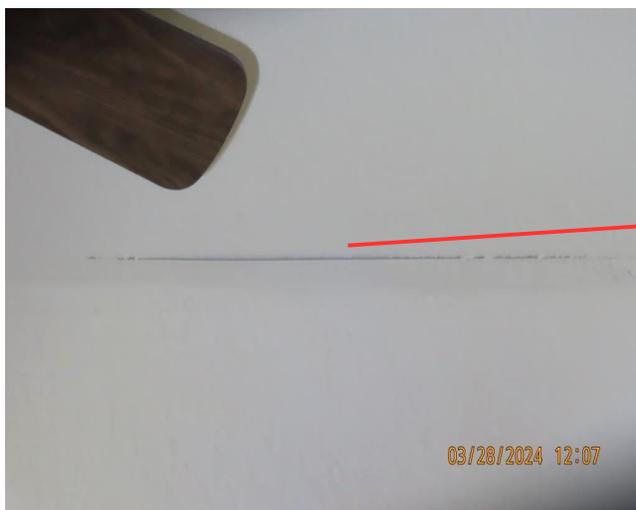
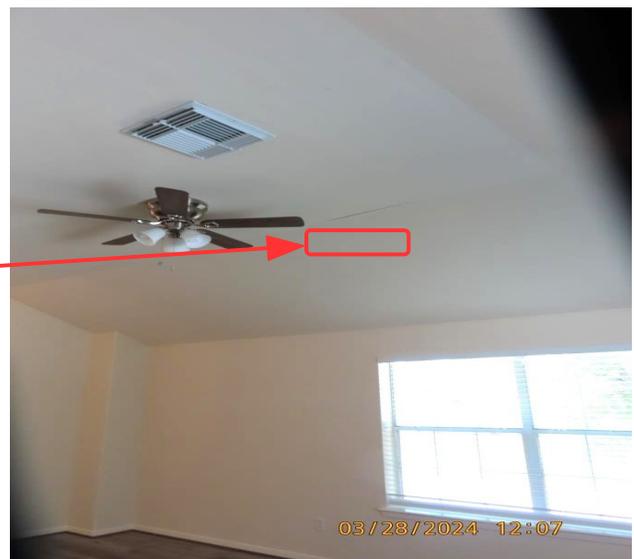
- Evidence of ceiling repairs on at least the kitchen area, room above the living area and in the game room. Investigate root cause for possible water intrusion and conduct proper repairs by a qualified contractor

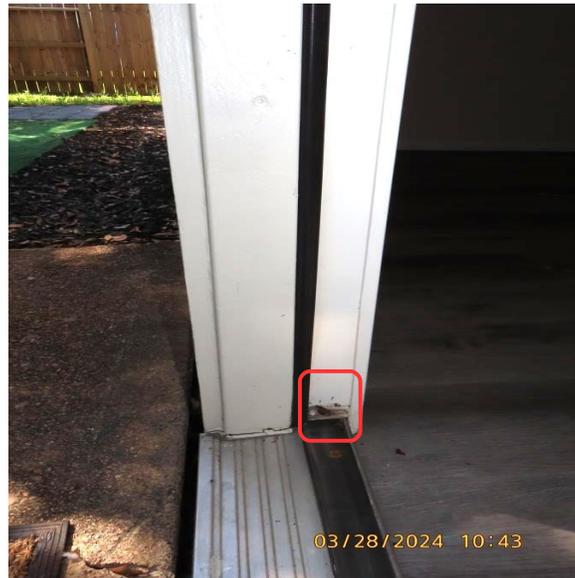
- Light rotting was observed on the jambs of the rear exterior door. Recommend proper repair of affected areas and installation of an overhang to protect from water.

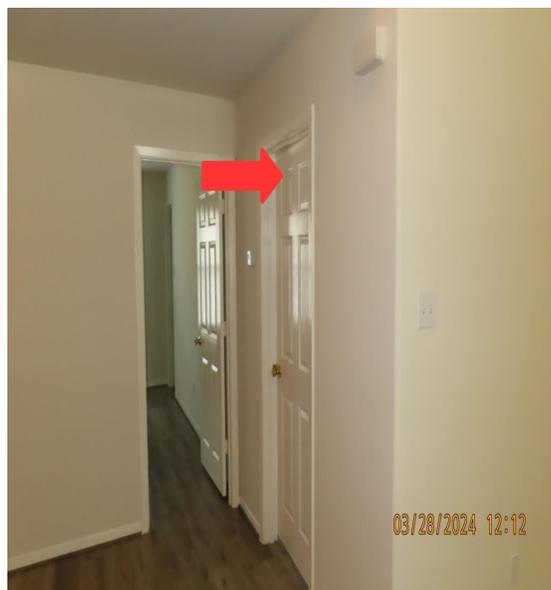
- The entry door of the room above the garage won't shut. Investigate root cause and properly repair

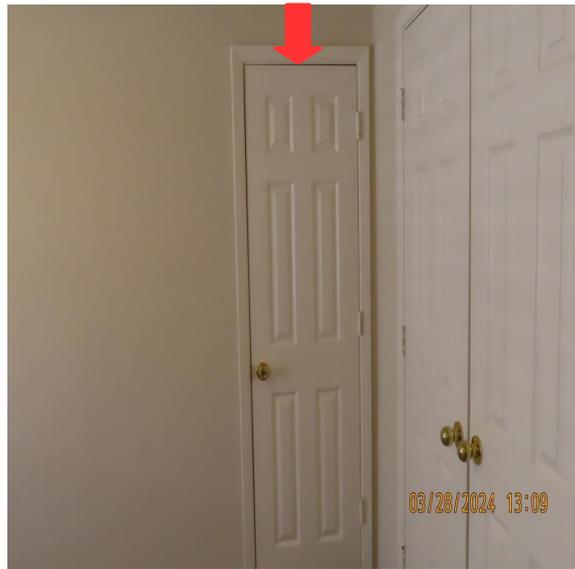
- The lower attic access door has self-closing hinges but, these are not functional. In need of proper repair

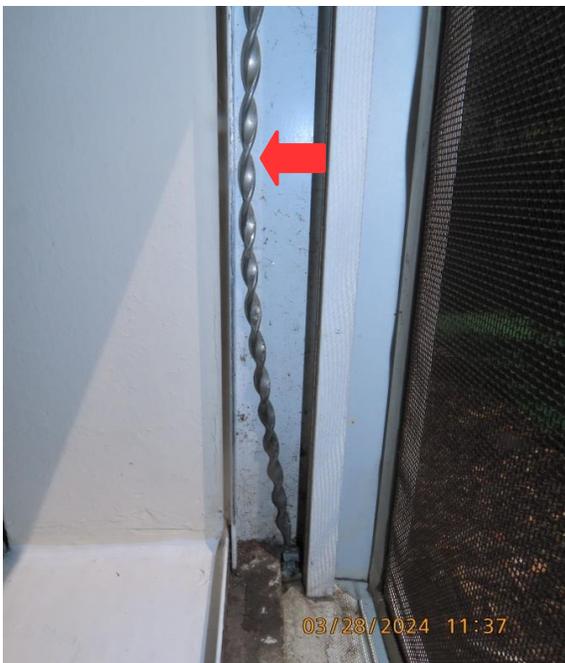
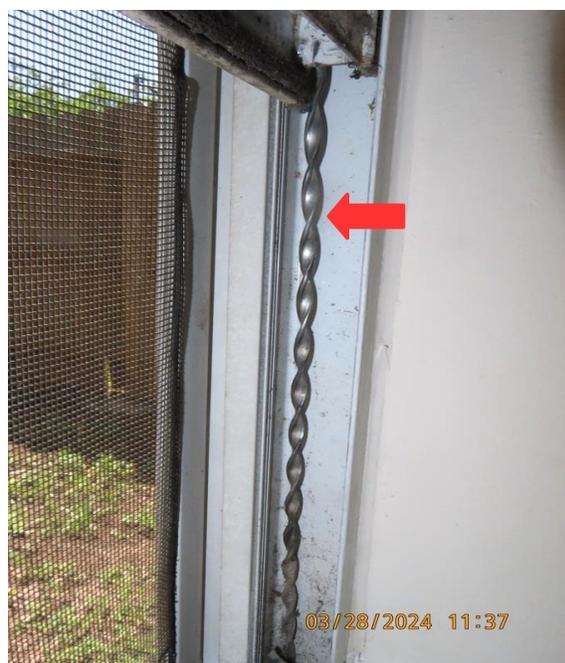
- Observed window stiffness throughout: some windows, won't open, some others won't stay up/open, etc. (samples) most of the issues are caused by defective balance (spiral springs). Note: All windows should be functional at all times to ease the egress in case of emergency. Properly repair for personal safety

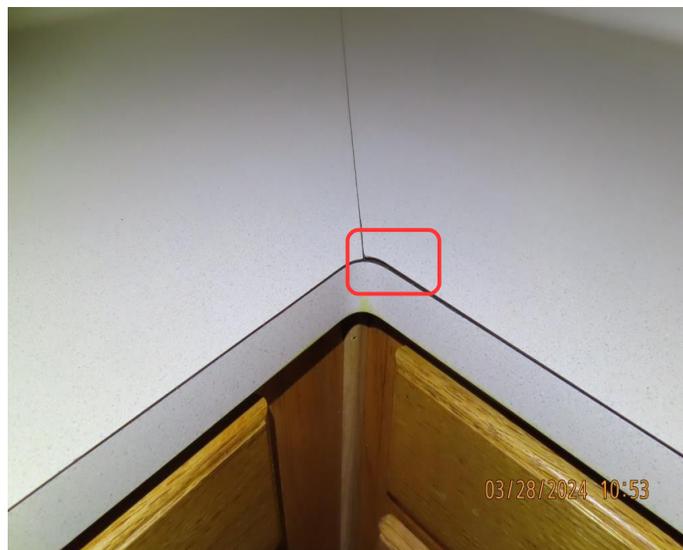
- Noticed deteriorating (lifting) formica on the kitchen countertop. Repair as needed

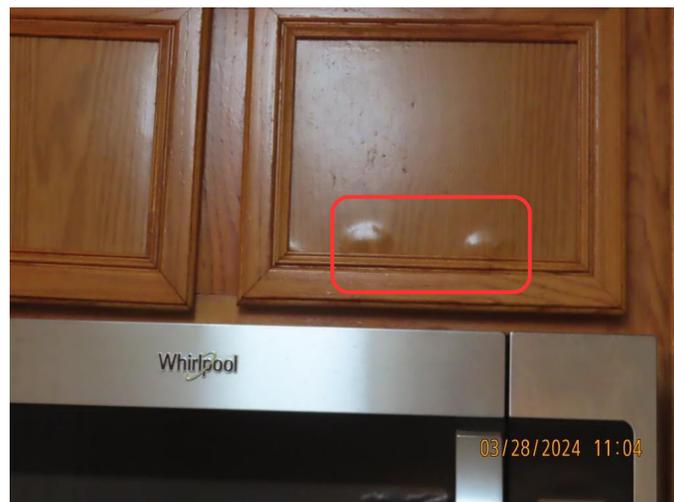
- Cosmetic: Noted bubbling surface on the cabinet door above the microwave. Repair as needed

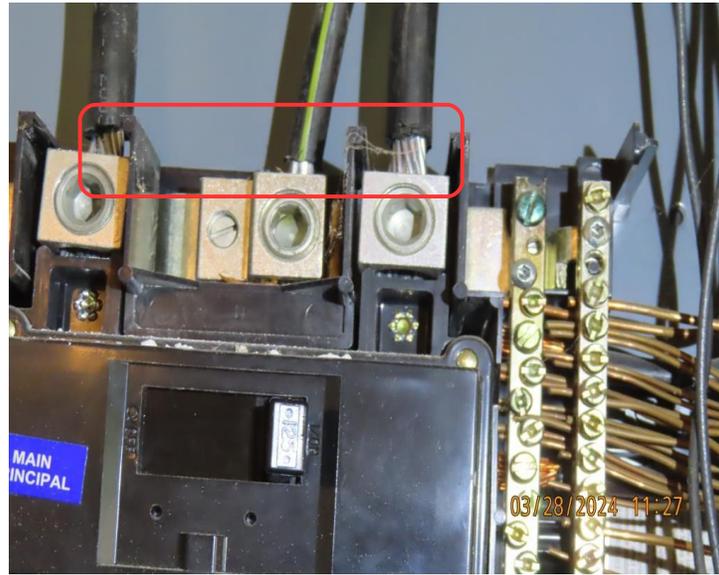
- No anti-oxidant compound on feeder aluminum cables. As oxide builds and continues to build on aluminum wires, it also builds up resistance.

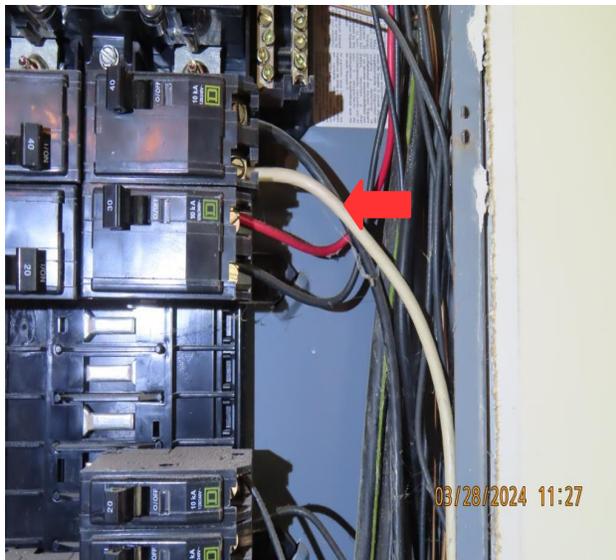
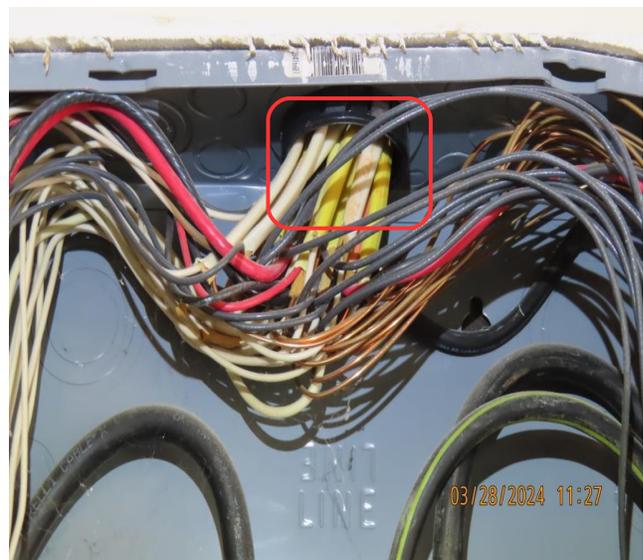
- Neutral wire is used as HOT wire (connected directly to a c. breaker). Note: Neutral wires can be used as HOT wires when these are properly identified: Use of colored tape such as black, red etc is acceptable
- Branch conductors were bundled and pass through a single penetration in the panel cabinet. Such constriction of conductors may generate excessive heat and de-rate the amperage of the cables. **Recommend 1~3 wires per knockout.**

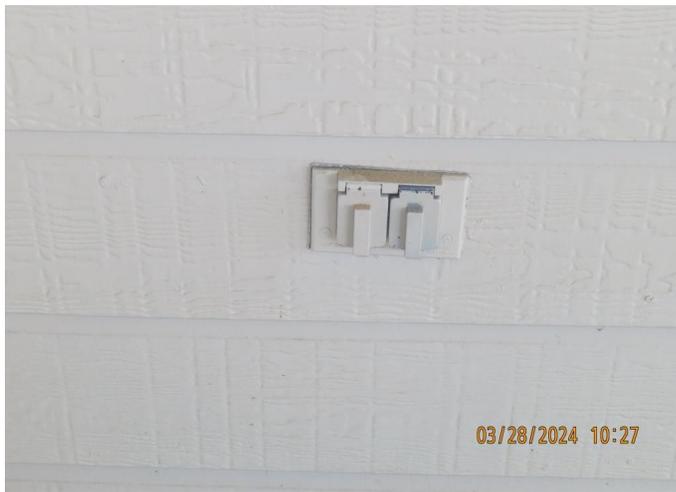
- Improper outlet cover on exterior outlets. In wet locations, outlets should be equipped to prevent moisture from entering or accumulating within the box. Receptacles should have an enclosure that weatherproof whether or not the attachment plug cap is inserted.

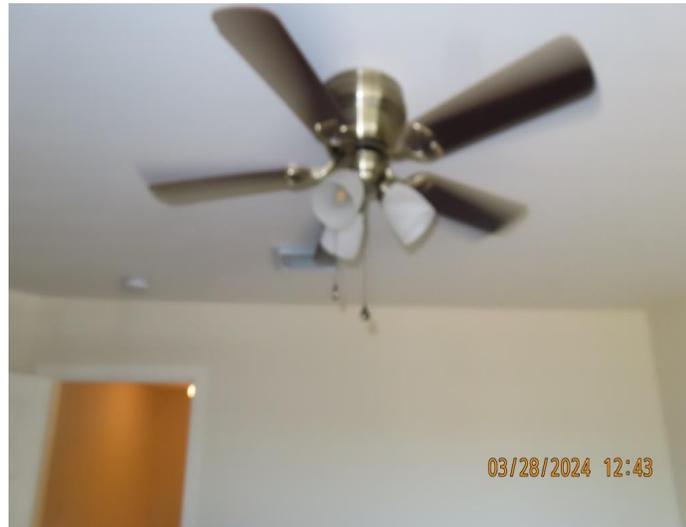
- Upstairs room above the garage , fan hit on a component while testing. In need of repair

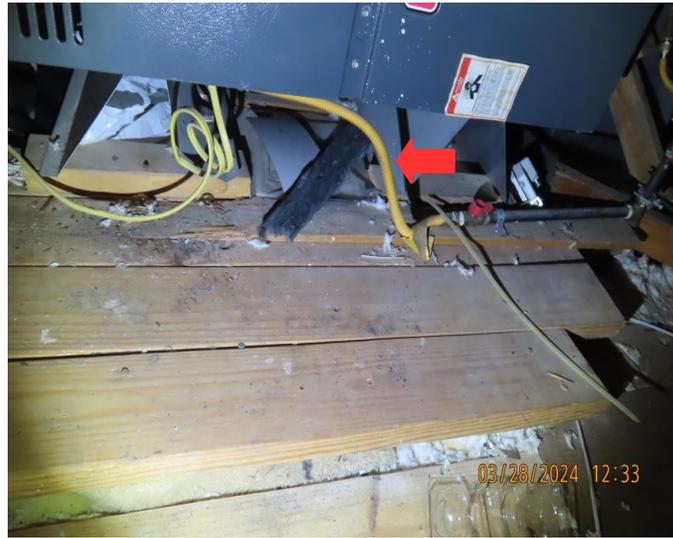
- The heating equipment was tested in the normal heating mode at 85° F for approximate 20 minutes. The heating equipment performed as intended at the time of inspection. No immediate evidence of deficiency was observed. **Avg Temp: 109° F**
- Note: The furnace appeared to be making an abnormal noise during testing. Repair as needed
- The electrical bonding on gas piping was not evident during this inspection. Recommend installation by a licensed electrician for personal safety.  
Note: The flexible gas connection between the iron gas pipe and the appliance (Any Gas Appliance) must have a #6 copper "Bonding Jumper" Installed from the end connected to the black gas pipe, to the other end connected to the appliance. Consult a licensed electrician for assessment and proper repair
