# PROPERTY INSPECTION REPORT FORM

VISTA PROPERTY INSPECTION GROUP LLC  
 3430 County Road 89, Pearland, TX 77584  
 281-642-1516, vista.insp@gmail.com

<u>Alfredo Rosales</u>	<u>03/28/2024</u>
<i>Name of client</i>	<i>Date of Inspection</i>
<u>6638 Carly Park Way, Houston, TX 77084</u>	
<i>Address of Inspected Property</i>	
<u>Felix D. Angel</u>	<u>20185</u>
<i>Name of Inspector</i>	<i>TREC License #:</i>
<u>N/A</u>	<u>N/A</u>
<i>Name of Sponsor (If applicable)</i>	<i>TREC License #:</i>

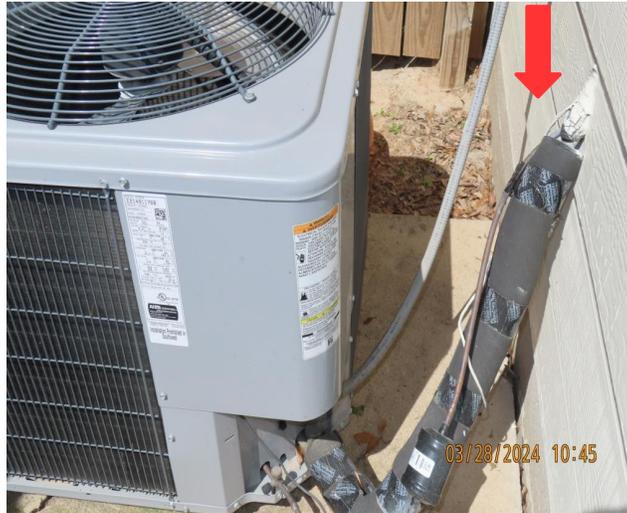
- Corrosion-resistant flashing required at the penetrations utilized by the A/C refrigerant lines was not evident. Such flashing should be provided in the exterior wall envelope in such a manner as to prevent entry of water into the wall cavity or penetration of water to the building structural components. The flashing should extend to the surface of the exterior wall finish and should be installed to prevent water from reentering the exterior wall envelope.

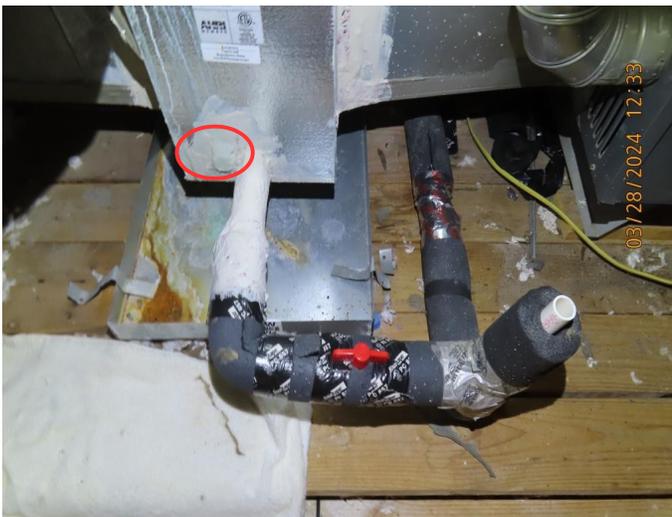
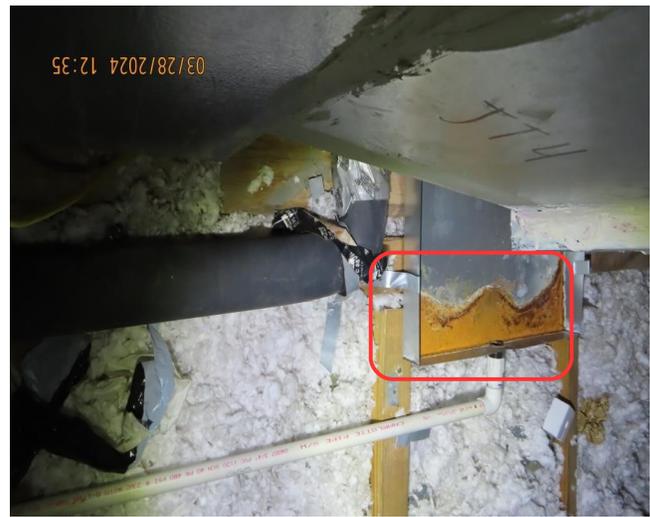
- Observed rust in the emergency drain pan: Usually caused by condensation from failing evaporator coil. Further investigate and service/repair as needed
- Secondary drain line on evaporator coil is not evident. Install drain line and elbow it down to drain pan using correct materials

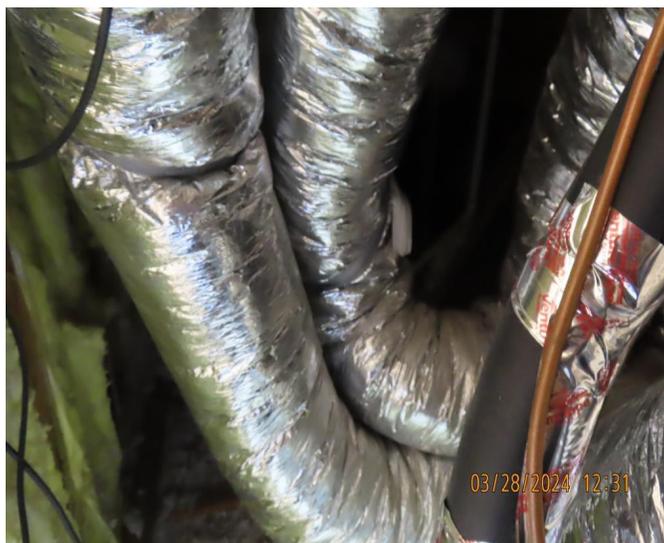
- Observed ducts in contact with each other. Provide sufficient clearance between ducts to prevent condensation

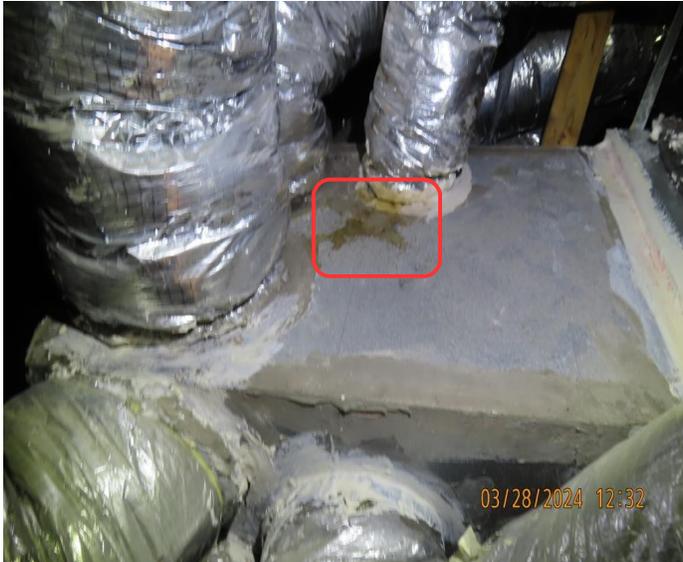
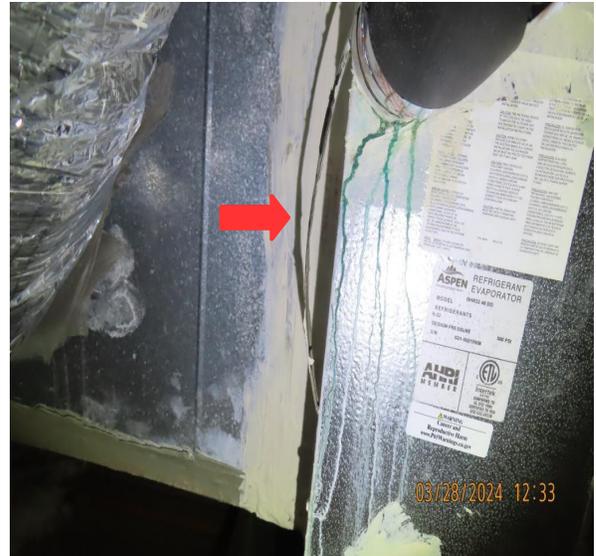
- Observed what appeared to be microbial growth on top of the cabinet. Investigate root cause and repair as needed
- Noted a loose/damaged metal trim on the left side of the. In need of repair

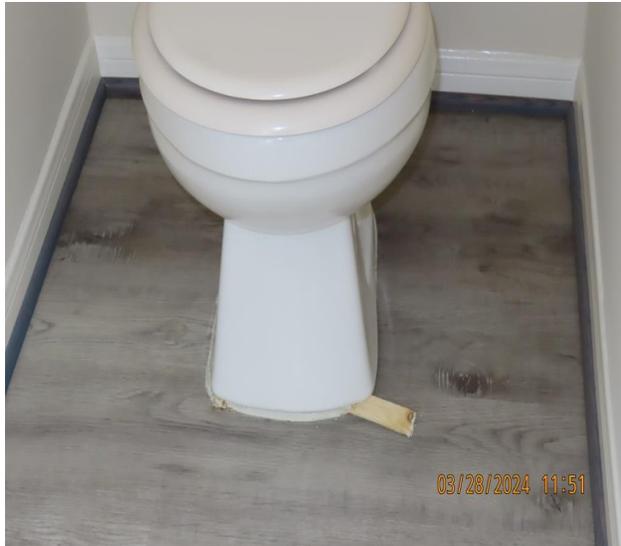
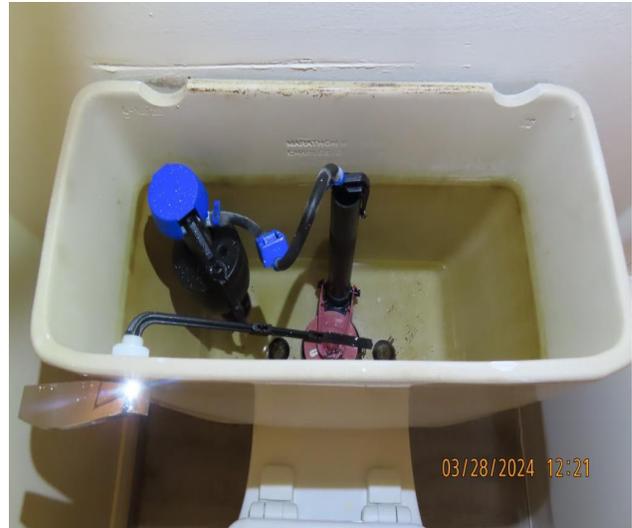
- Noted loose and shimmed toilet in the master bathroom. Investigate further and repair appropriately. Note: Toilet was not tested to prevent water leaks and damage to the property
- Upstairs toilet tank was empty therefore, toilet function could not be verified. Investigate and repair

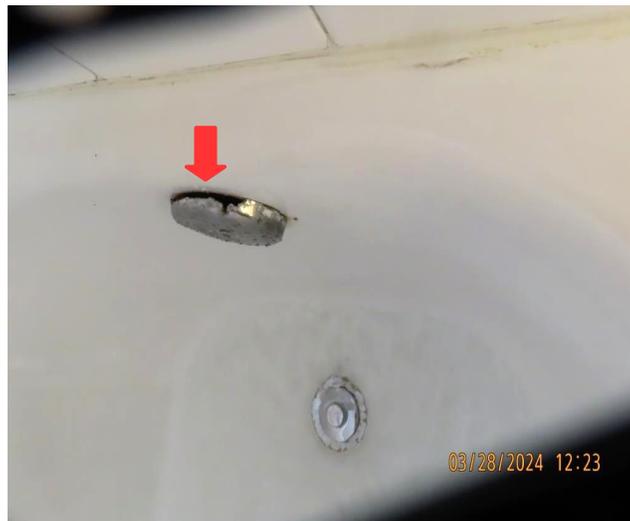
- The slot in the tub overflow should be pointing downward. In need of repair

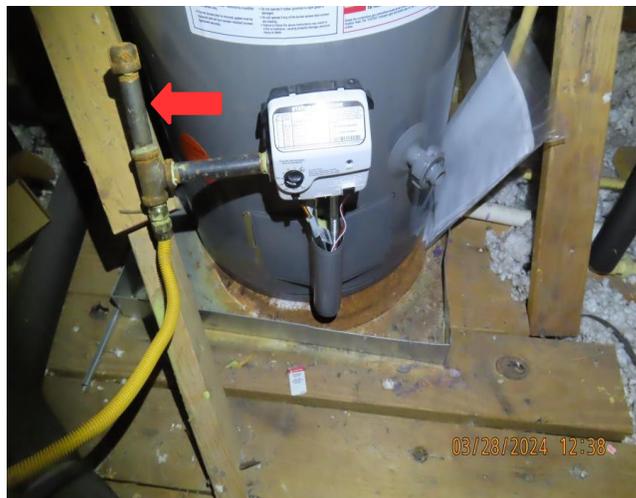
- Noticed rust in the emergency drain pan. No water leaks active at this time. Investigate further as needed
- The sediment trap should be pointing downward for proper trapping of debris

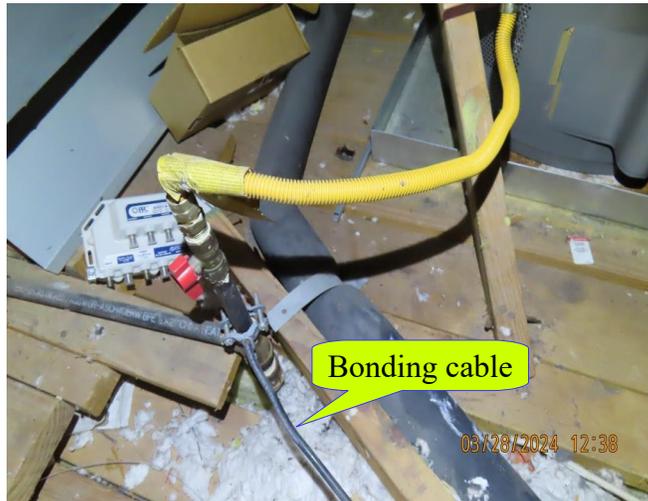
- Information: The electrical bonding on the gas line appeared to be properly attached but could not verify its condition at the inaccessible areas.

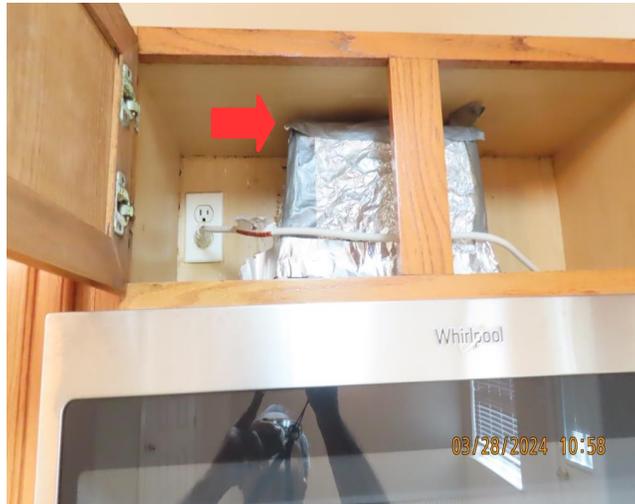
- Replace duct tape (flammable) installed on the exhaust for aluminum tape

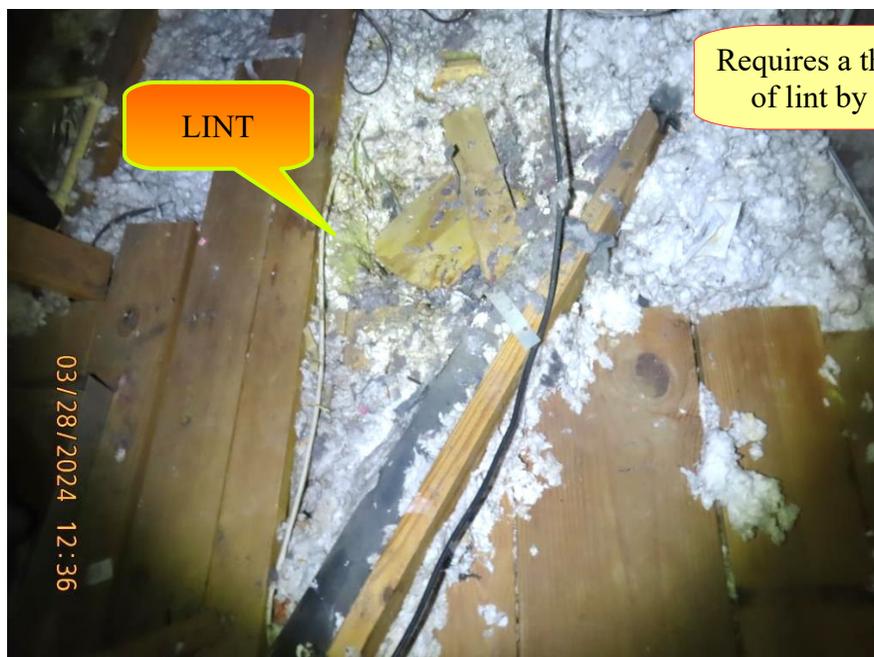
- **Noticed clogged dryer vent/exhaust discharging its contents in the attic space**  
**Note: Clogged dryer vents can contribute to devastating and costly scenarios:**
  - Higher utility bills. Impaired energy performance means more effort is being made from your dryer, driving up your energy bills
  - Decreased lifespan. Because your dryer is working hard to compensate for the blockage, its lifespan declines
  - House fires. Lint is easy to set a flame on and should be disposed of regularly

**Note:** Recommend checking dryer hoses and cleaning ducts approx. every six months. Hoses should be replaced every five years. A dryer can erupt in flames if lint builds up inside the machine or its ducts. Exhaust duct terminations shall be equipped with a back draft damper. Screens shall not be installed at the duct termination
