HOME INSPECTION REPORT

Russell Armstrong	3-10-2022
<i>Name of Client</i>	<i>Date of Inspection</i>
2095 Savannah Trace, Beaumont, TX 77706	
<i>Address of Inspected Property</i>	
Curtis Carr (# 4026) Landon Carr (# 20537)	
<i>Name of Inspector</i>	<i>TREC License #</i>
<i>Name of Sponsor (if applicable)</i>	<i>TREC License #</i>

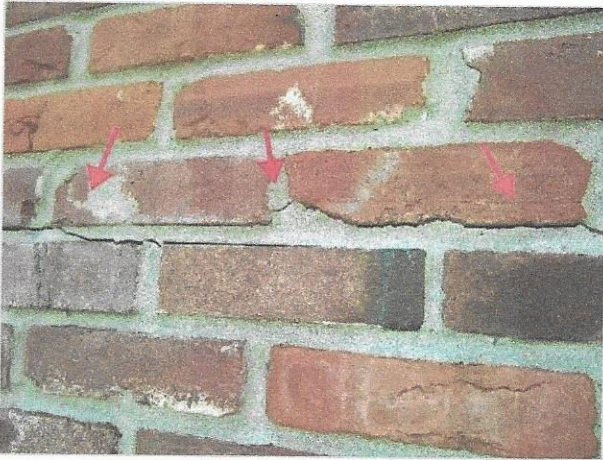
There were cracks in the brick on the left wall of the garage, right wall of the garage and between the overhead doors. It is recommended that a structural engineer perform a further evaluation of the foundation.

brick crack on left wall

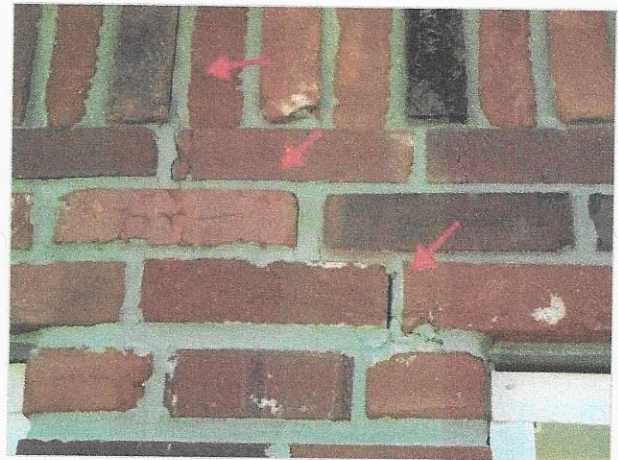
brick crack between doors

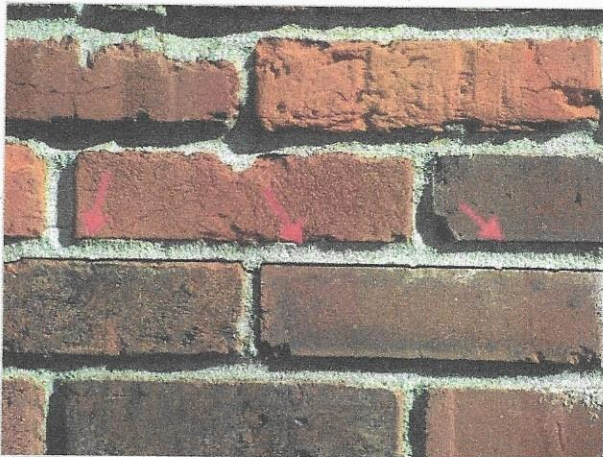
brick crack on right wall

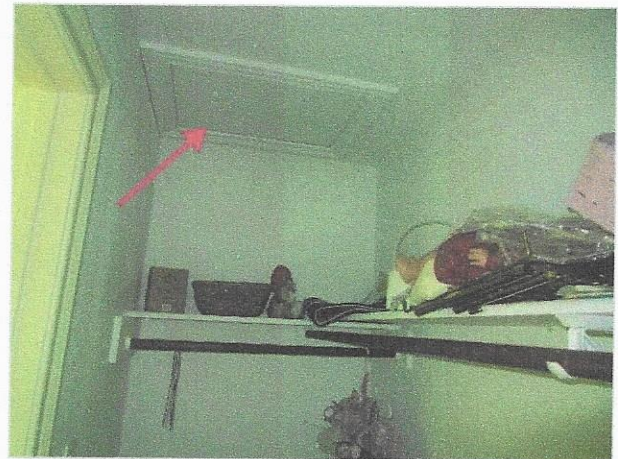
As a note, access was blocked to the upper attic scuttle. The garage drop-down ladder was lacking proper fire blocking. As a note, there was a small "dead-valley" at the right front valley (no visible signs of leaks at the time of the inspection).

access blocked to upper scuttle

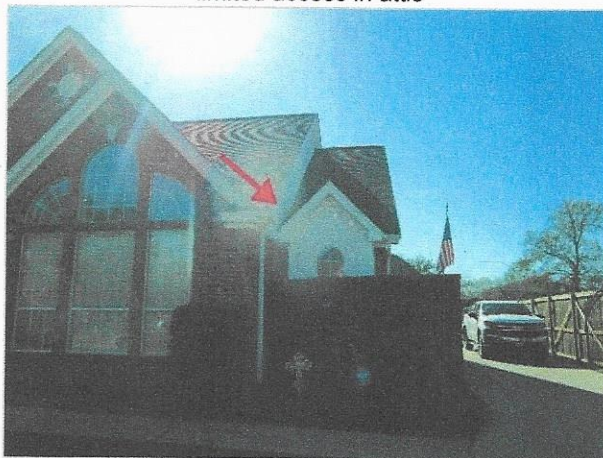
small "dead valley"

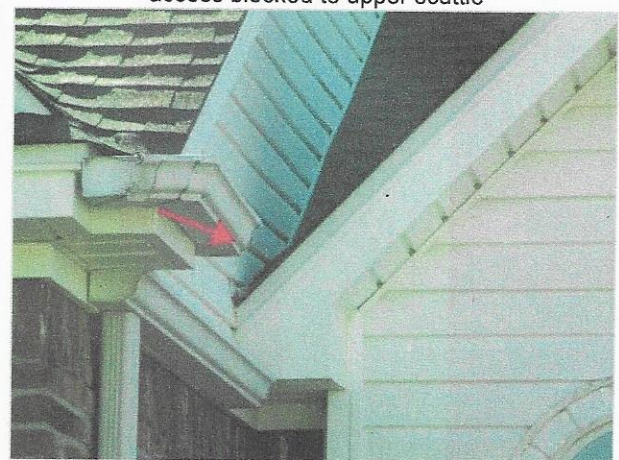
close up of small "dead valley"

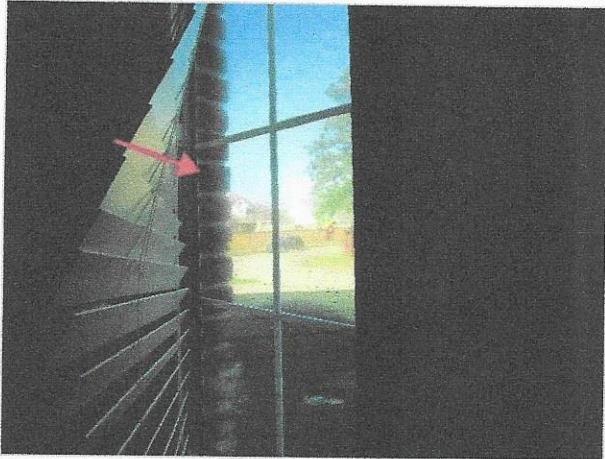
The inner seals were detached at the window to the left of the fireplace. Windows had lost their seals in the study (right window) and in the 2nd floor right bedroom. As a note, lost seals are subject to change with variation in temperature and humidity. The screens had been removed.

lost seal

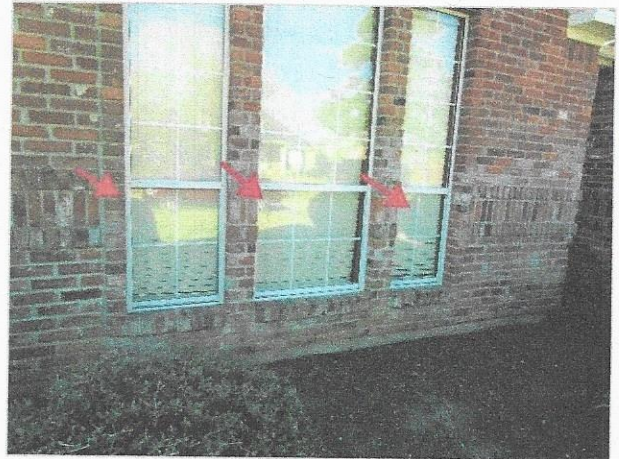
missing screen

- Replaced Screens

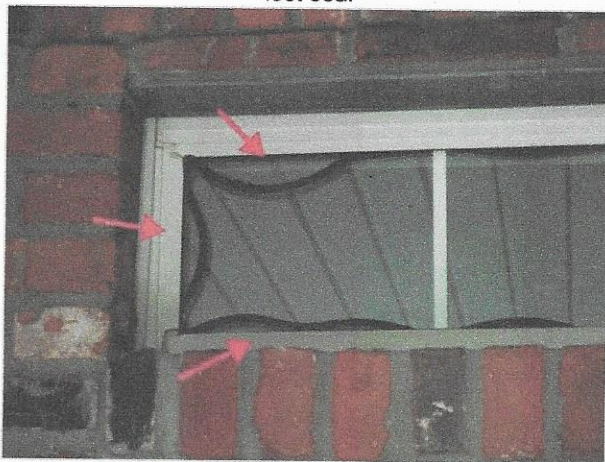
detached inner seals

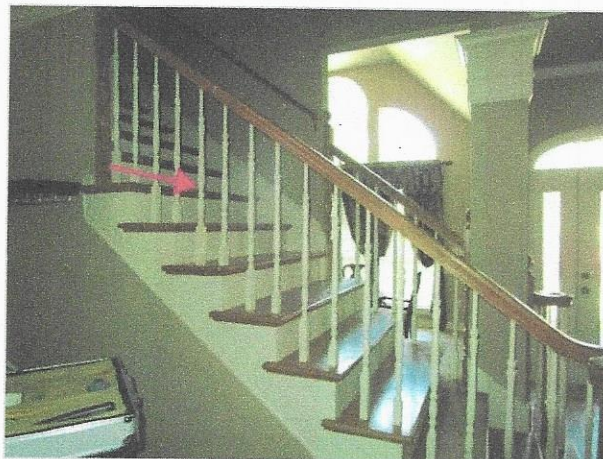
The stairway railing posts were wider than the recommended 4 inch maximum.

posts too wide

- Stairway + balcony balusters replaced with new ones to provide the correct spacing.

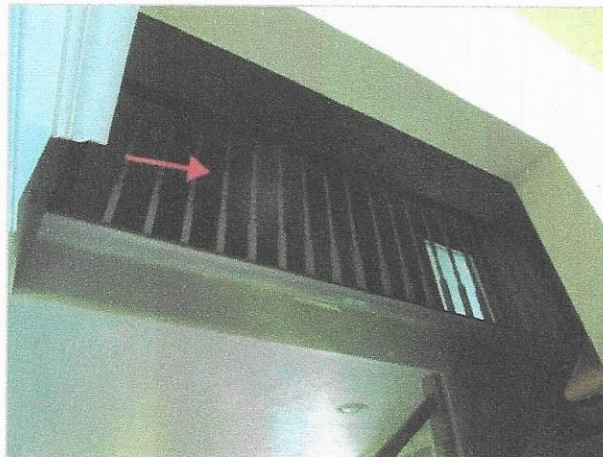
The balcony railing posts were wider than the recommended 4 inch maximum.

posts too wide

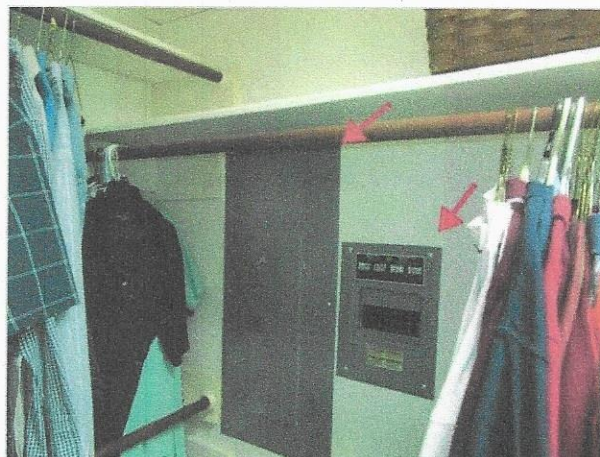
The underground electrical service entered a Square D panel box located in the master bathroom clothes closet with a Square D sub-panel by it and a Square D Sub-panel in the garage. Clothes closets are considered to be a hazardous location. There were no AFCIs present. In the main box, a knockout was missing and we were unable to remove the main box cover (limited clearance). The closet sub-panel did not have a lid.

boxes in clothes closet

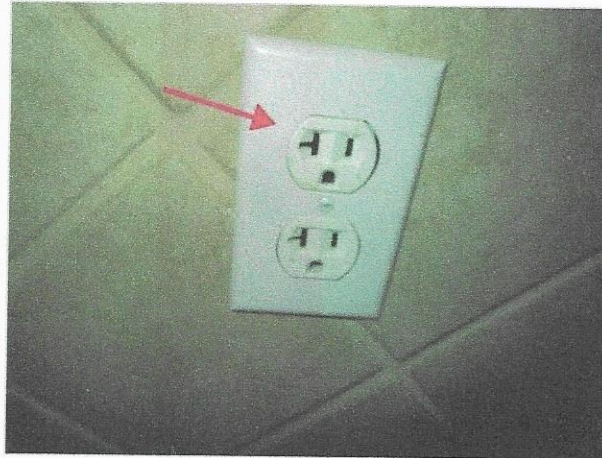
The receptacles were not tamper resistant (TRR). As a note, the receptacles in the garage and exterior were not tested for GFCIs (numerous stored items in garage and there was a concern that an appliance may loose power). Wires under the range were not in conduit. There were no smoke alarms in the bedrooms.

not tamper resistant

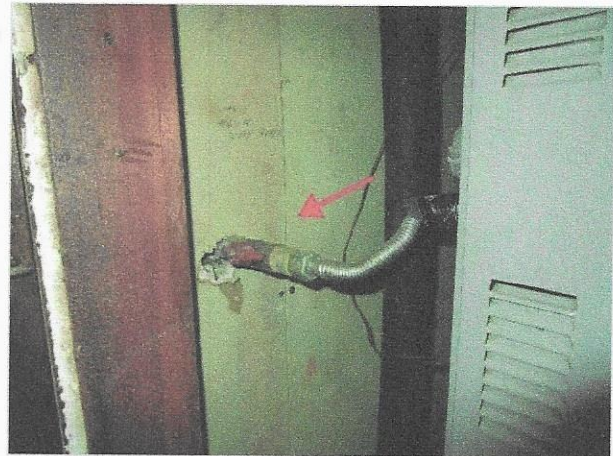
1. (1st floor) The Trane forced air gas heating unit was functioning properly at the time of the inspection (burners not viewed). The gas line had an improper connection at the unit (flex hose through the housing). There was no sediment trap in the furnace gas line.

no sediment trap

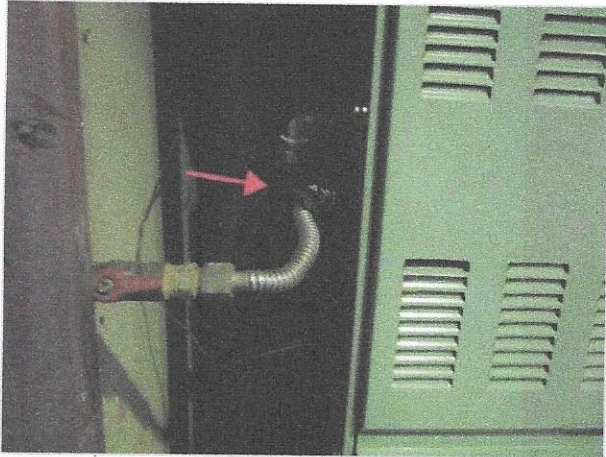
gas line / housing

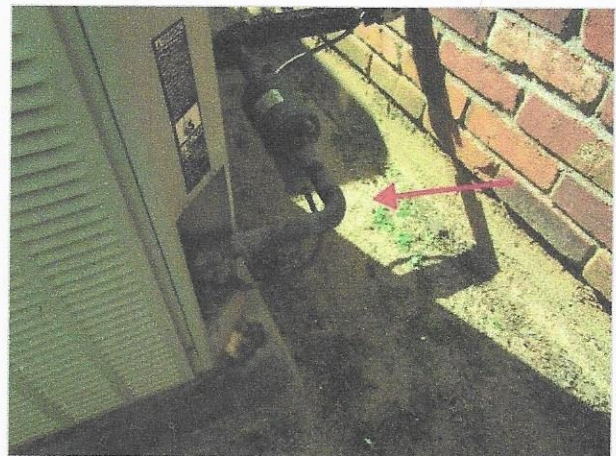
missing insulation

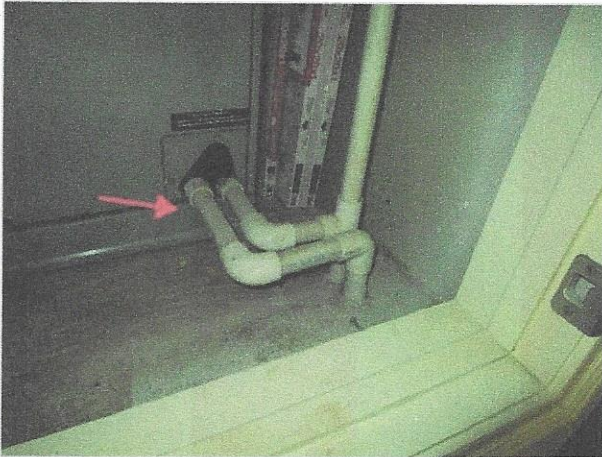
missing insulation

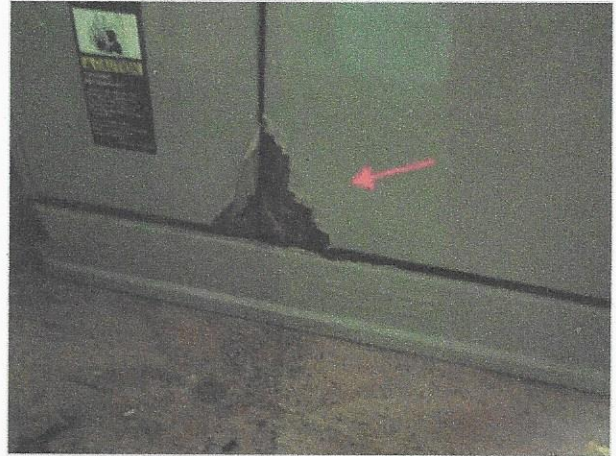
2. (2nd floor) The Trane cooling unit was functioning properly at the time of the inspection with a 20 degree temperature differential. The evaporator coil was viewed and found to be clean. The primary drain line at the evaporator coil was missing insulation. The refrigerant line at the outside unit needed additional insulation. There was rust corrosion to the evaporator coil housing. It is recommended that an HVAC technician perform a service check on the cooling unit.

rust to coil / housing

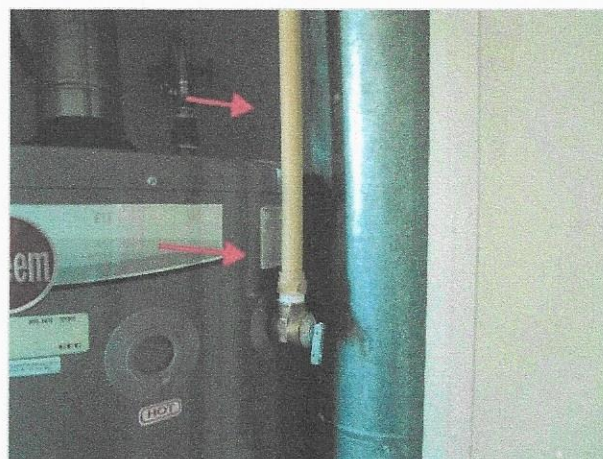
drip leg not gravity fed

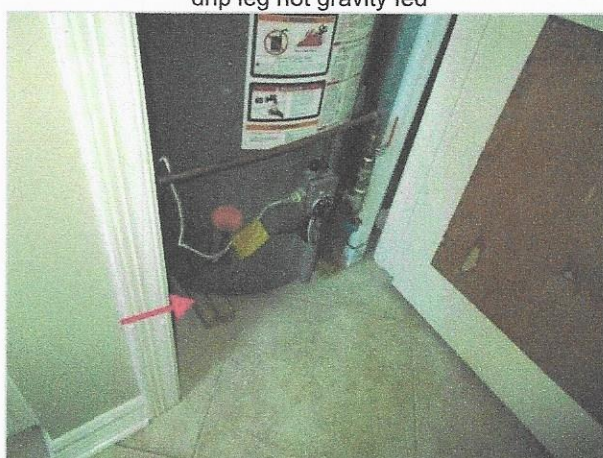
no pan

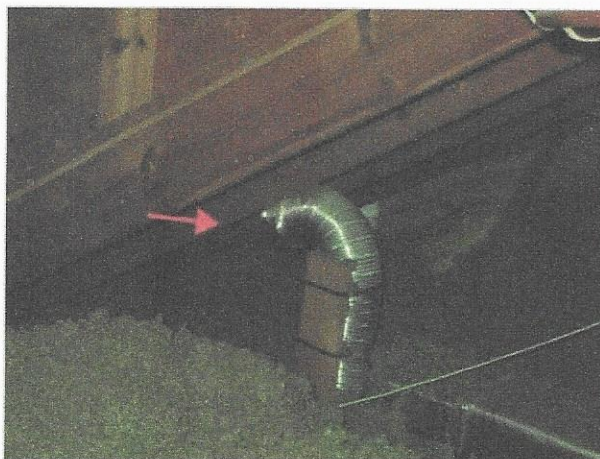
Comments:  
The vent(s) terminated in the attic.

vent to attic

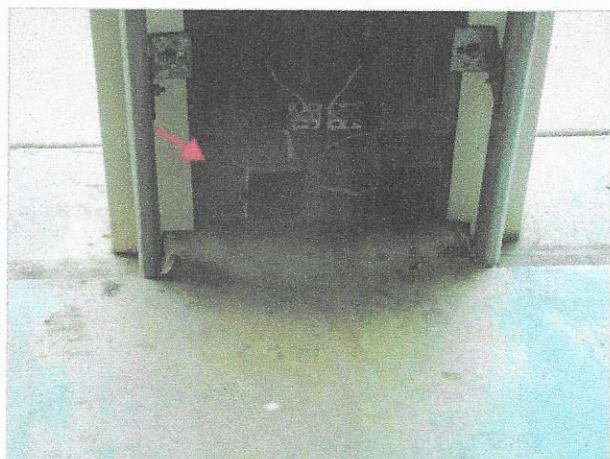
1. The (right) unit was functioning properly at the time of the inspection. The sensors were mounted higher than 6 inches off of the floor.

sensors too high

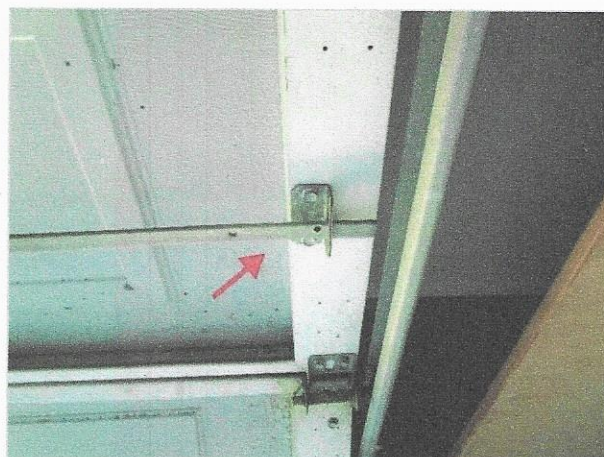
2. The (left) unit was functioning properly at the time of the inspection. However, the manual door lock had not been disabled. The sensors were mounted higher than 6 inches off of the floor.

lock not disabled
