## Home Inspection - TREC

**Inspection Date:** 2/22/2024

**Transferee / Property Information:** Russ Armstrong  
2095 Savannah Trce  
Beaumont, TX 77706

# PROPERTY INSPECTION REPORT FORM

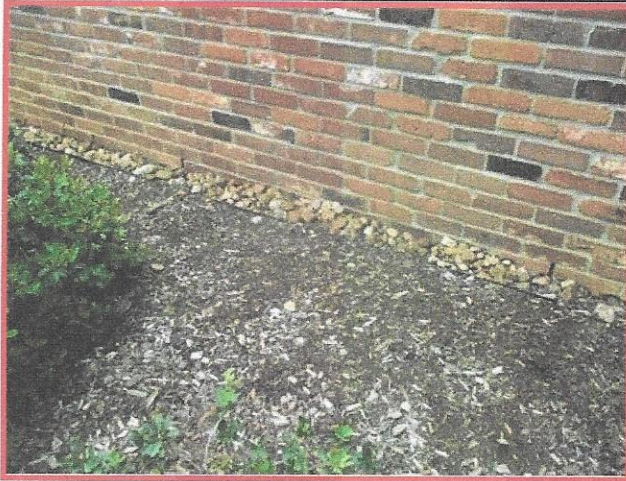
High Grading at Rear

Section	Remarks
<b>Structural Systems</b>	<p>Grading and Drainage  <b>Problem:</b> The grading is too high on the foundation along the rear. There is vegetation against the front exterior walls.  <b>Corrective Action:</b> Contractor to regrade for positive drainage away from the home and cut back the vegetation.</p> <p>Roof Covering Materials #1  <b>Remarks:</b> Recommend obtaining windstorm certification for insurance purposes.</p> <p>Roof Structure and Attic  <b>Remarks:</b> All areas of the attics were not accessible or visible due to insulation, stored items, and low clearances.</p> <p>Walls (Interior and Exterior)  <b>Problem:</b> The sheetrock corner tape is buckled on the top of the front wall of the dining room. Please Note: All the interior walls were not totally visible due to furniture and stored items.  <b>Corrective Action:</b> Contractor to repair / correct the dining room wall.</p> <p>Ceilings and Floors  <b>Problem:</b> The sheetrock tape at the garage ceiling is fractured / cracked.  <b>Corrective Action:</b> Contractor to repair / correct the garage ceiling.</p> <p>Doors (Interior and Exterior)  <b>Problem:</b> The header siding is damaged above the overhead garage doors.  <b>Corrective Action:</b> Contractor to assess all siding and headers around the home and repair / replace all affected siding and headers as needed. Cost to be determined at time of repairs.</p> <p>Windows  <b>Problem:</b> Failed thermal seal window(s) (fogged glass) were observed at the primary bedroom and office.  <b>Corrective Action:</b> Window contractor to inspect all remaining windows to confirm and replace all failed thermal seal windows. Cost to be determined at time of repairs.</p> <p>Exterior Surfaces  <b>Problem:</b> There are horizontal mortar fractures in the brick veneer on each side of the detached garage and on the right side of the house.  <b>Corrective Action:</b> Contractor to repair / correct the brick and mortar.</p>

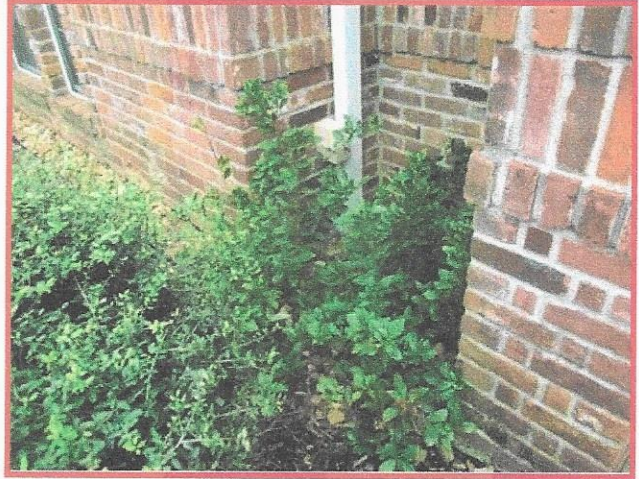
Vegetation in Contact with Structure at Front

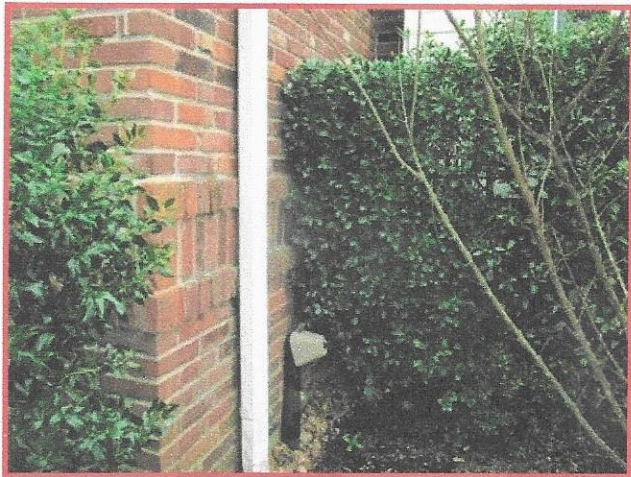
Vegetation in Contact with Structure

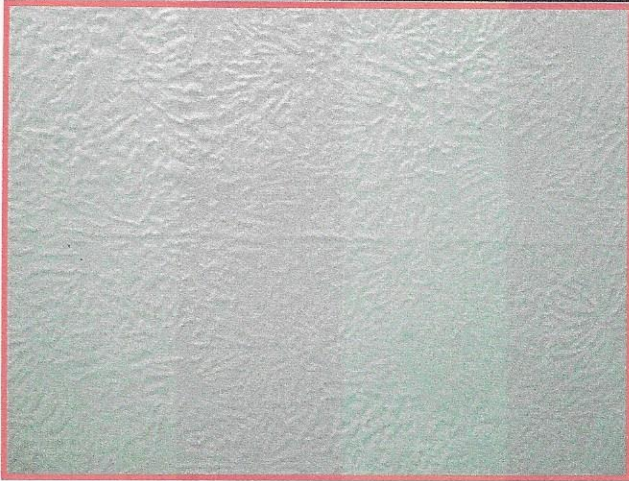
Cracked Garage Ceiling

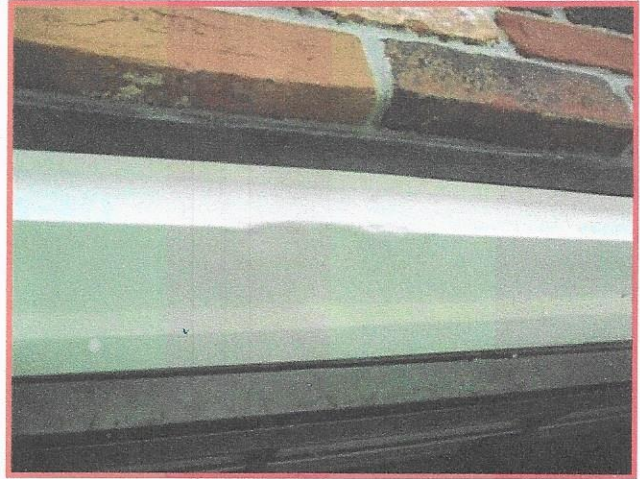
Damaged Header at Garage Door

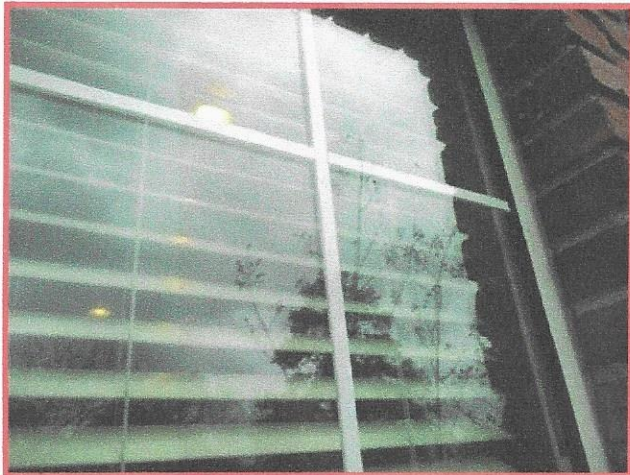
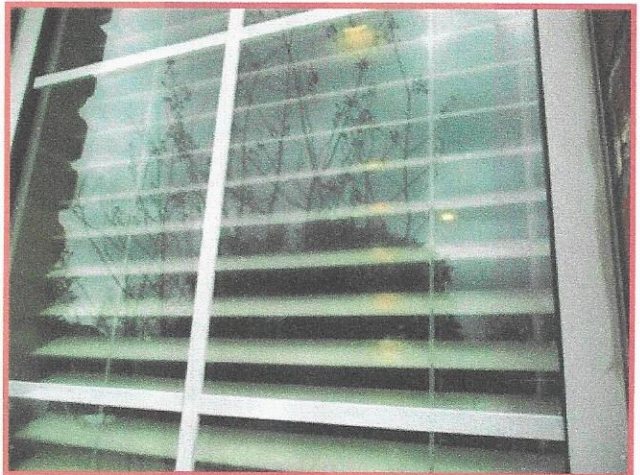
Failed Thermal Seal at Office Window

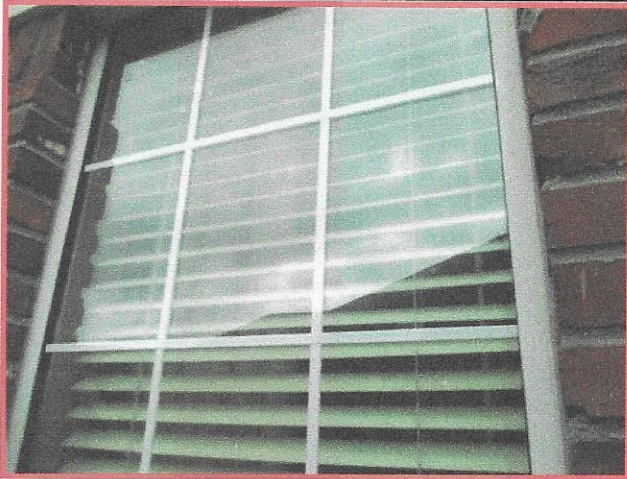
Failed Thermal Seal at Primary Bedroom Window

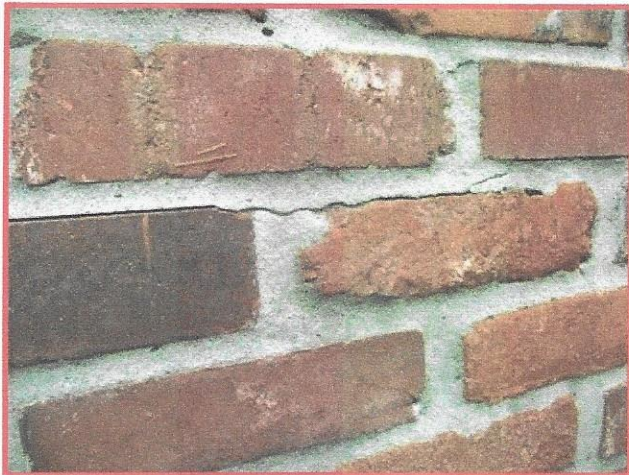
Cracked Mortar at Right Side

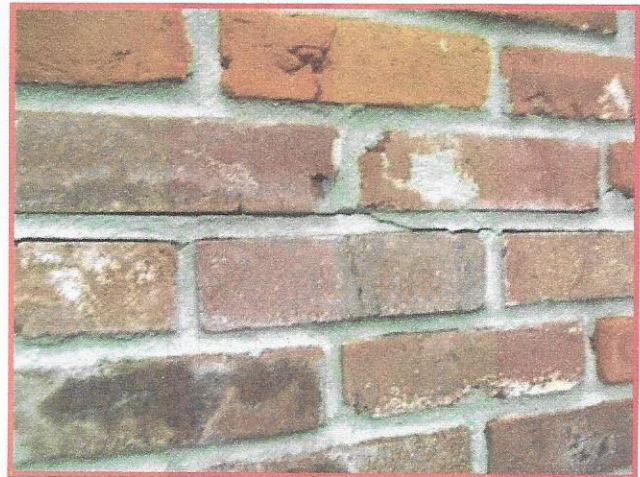
Cracked Mortar Left Side of Garage

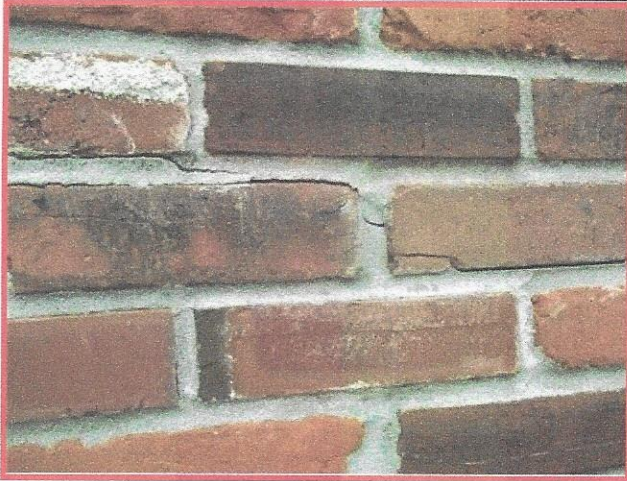
Cracked Mortar at Right Side of Garage

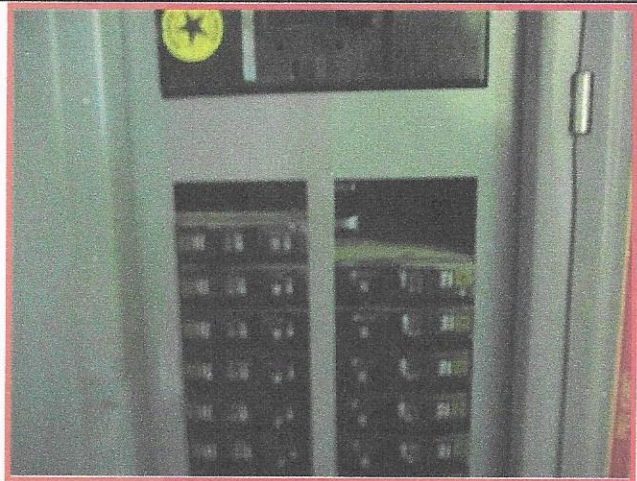
Open Knockouts at Electric Panel

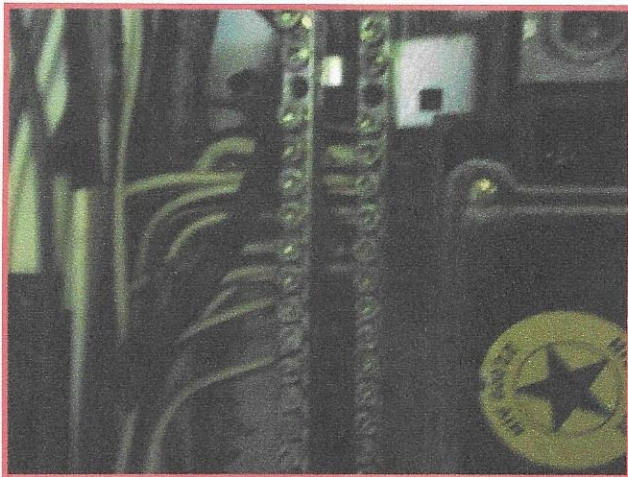
Double Tapped Neutrals on Buss Bar

- Electrician has made all necessary changes to correct the double tapped wires on the neutral bus bar in the primary bathroom closet.
- Double tapped wires on neutral bus in the garage sub panel have been corrected.
- All exterior outlets on the right side of the house and on the front wall of the garage are GFCI protected.
- Electrician has relocated the disconnect from behind the A/C units.
- Smoke detectors installed in all bedrooms.
- Getting estimate on Window repair/replacements.
- Getting estimate to correct water heater TPR Valve extension and install a drain pan.
- Will correct natural gas hose penetrating heater enclosure by adding pipe nipple to move hose connection outside of enclosure.

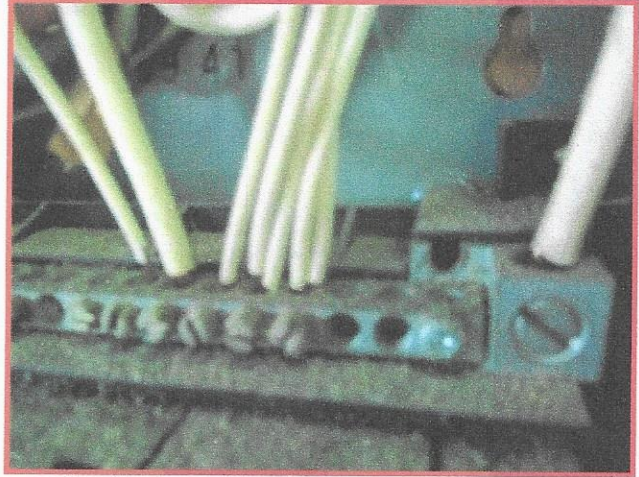
Double Tapped Neutrals on Sub-Panel Buss Bar

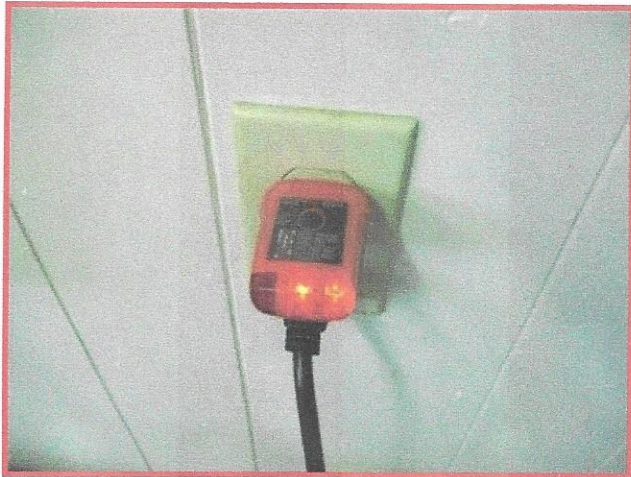
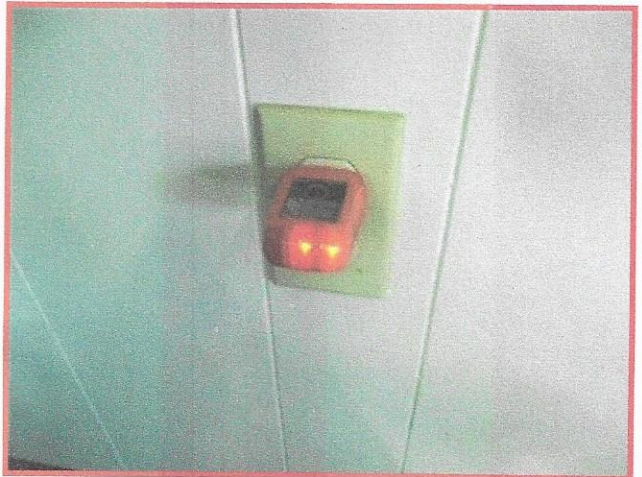
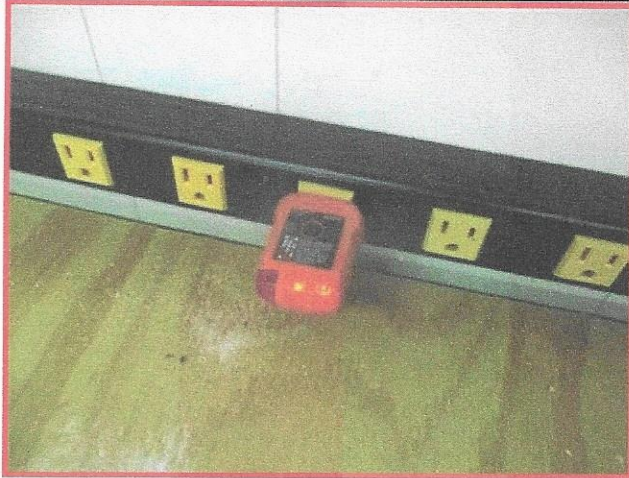
Missing GFI Protection at Garage Outlet

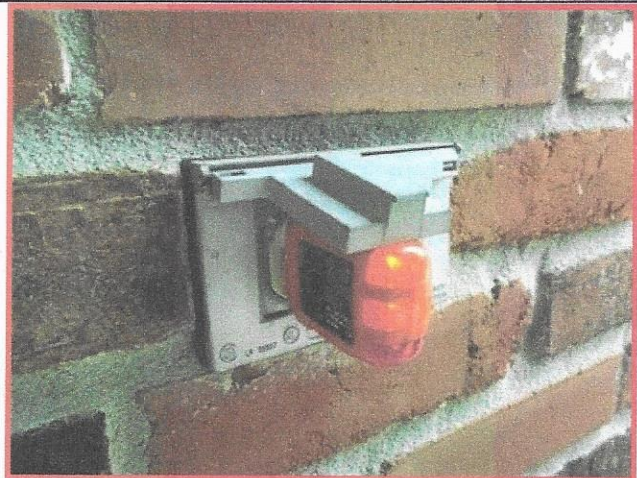
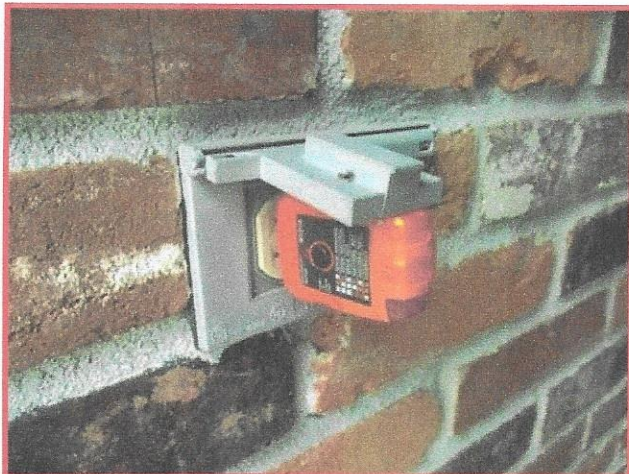
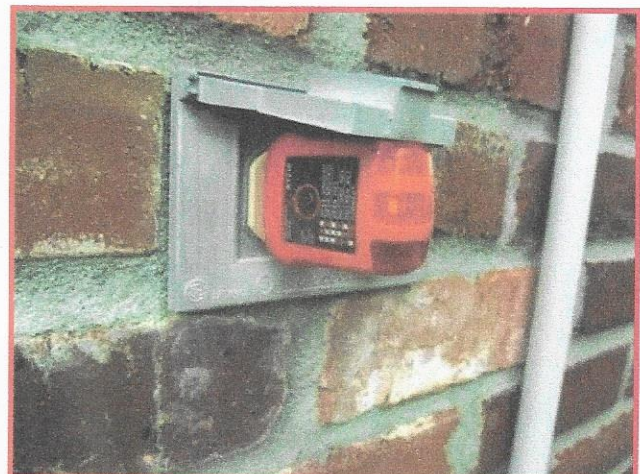
Missing GFI Protection at Exterior Outlet

Missing GFI Protection at Garage Exterior Outlet

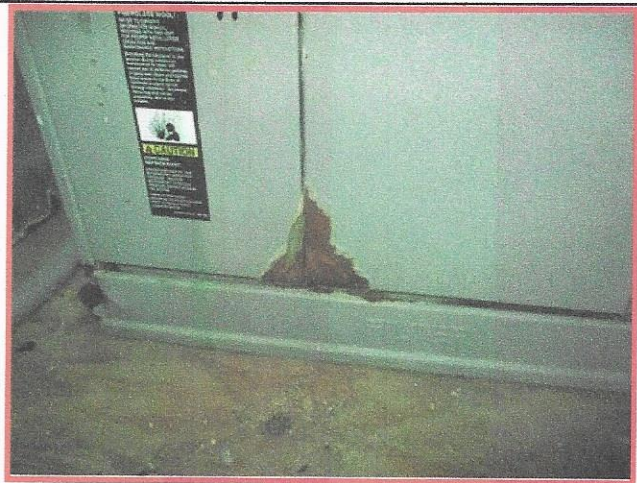
Corroded Upper Level HVAC Cabinet

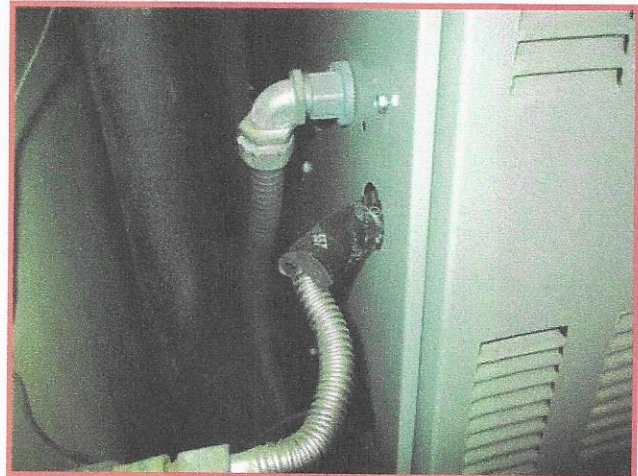
<b>HVAC Systems</b>	<p><b>Type #1 Heating Equipment</b>  <b>Problem:</b> A flexible fuel line improperly penetrates the furnace cabinet. Please Note: The heating equipment was functional at the time of assessment, however; the unit is aged beyond its estimated useful life. No warranties are expressed or implied as to the future performance of the heating equipment.  <b>Corrective Action:</b> Heating technician to replace the flexible fuel line with rigid piping.</p> <p><b>Type #2 Heating Equipment</b>  <b>Remarks:</b> The upper level heating equipment was functional at the time of assessment, however; the unit is aged beyond its estimated useful life. No warranties are expressed or implied as to the future performance of the electric heating equipment.</p> <p><b>Type #1 Cooling Equipment</b>  <b>Problem:</b> The electric disconnect is improperly mounted behind the unit and the insulation is damaged on the exterior refrigerant line. Please Note: The main level A/C unit was functional at the time of assessment, however; the unit is aged beyond its estimated useful life. No warranties are expressed or implied as to the future performance of the main level A/C unit.  <b>Corrective Action:</b> HVAC technician to relocate the electric disconnect and repair / replace the insulation on the refrigerant line.</p> <p><b>Type #2 Cooling Equipment</b>  <b>Problem:</b> The electric disconnect is improperly mounted behind the unit and the insulation is damaged on the exterior refrigerant line. Corrosion was noted on the interior HVAC cabinet.  <b>Corrective Action:</b> HVAC technician relocate the electric disconnect and repair / replace the upper level HVAC equipment and any necessary components. Obtain a cost estimate from a qualified and insured contractor.</p>

Flexible Fuel Line Penetrates Furnace Cabinet

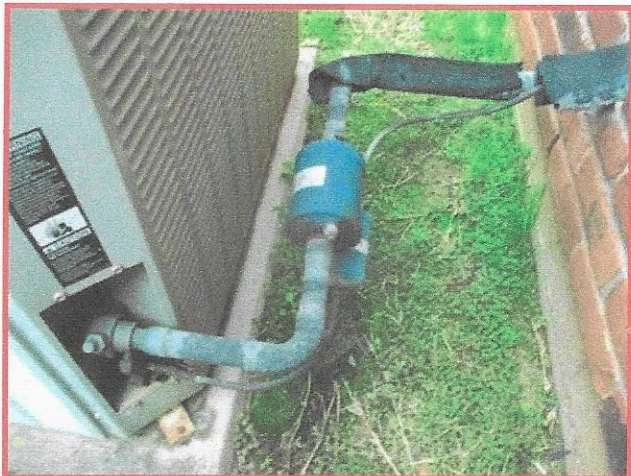
Damaged Insulation on Refrigerant Line

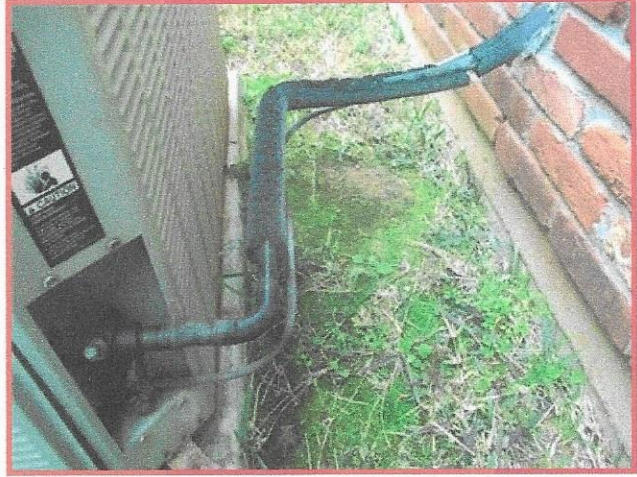
Damaged Insulation on Refrigerant Line

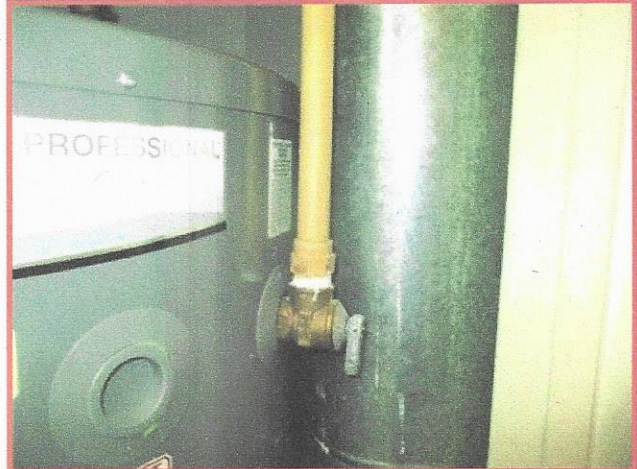
<b>Plumbing Systems</b>	<p><b>Water Heaters</b>  <b>Problem:</b> The water heater TPR valve extension improperly runs up hill and a drain pan is missing below the unit. Please Note: The water heater was functional at the time of assessment, however; the unit is aged well beyond its estimated useful life. No warranties are expressed or implied as to the future performance of the water heater.  <b>Corrective Action:</b> Plumber to repair / correct the water heater TPR valve extension and install a drain pan.</p>

Water Heater TPR Valve Extension Runs Uphill

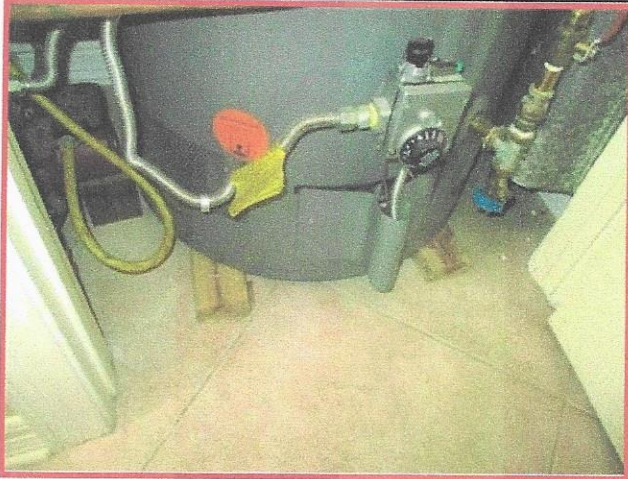
Missing Drain Pan Below Water Heater
