SUMMARY

15335 Poplar Grove Dr,, Houston, TX 77068

Mark Blades
01/11/2024Michael Matthew
TREC License #24801
Elevation Home Inspections
(346) 370-2083
michaelmarkm@gmail.com

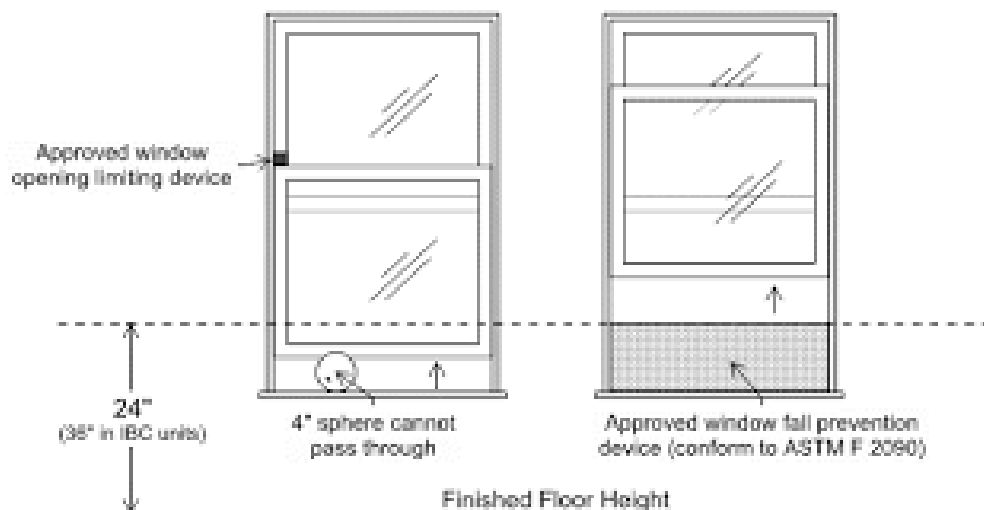
⚠ 2.8.1 I. Structural Systems - H. Windows: Window Opening Control Device

The windows in the following areas do not comply with the requirements of operable windows that are less than 24 inches above the adjacent interior floor when they are more than 6 feet above the grade outside the window.

Note: The IRC requires the bottom of openings created by operable windows to be a minimum height of 24 inches above the adjacent interior floor when they are more than 6 feet above the grade outside the window.

Note: An exception from this requirement is for windows that do not open more than 4 inches or that are equipped with window guards or window opening control devices (WOCDs) that comply with ASTM F2090-17. The WOCD must limit the initial opening of the window to no more than 4 inches.
