## RESIDENTIAL HOME INSPECTION

15335 Poplar Grove Dr,  
Houston, TX 77068

# PROPERTY INSPECTION REPORT FORM

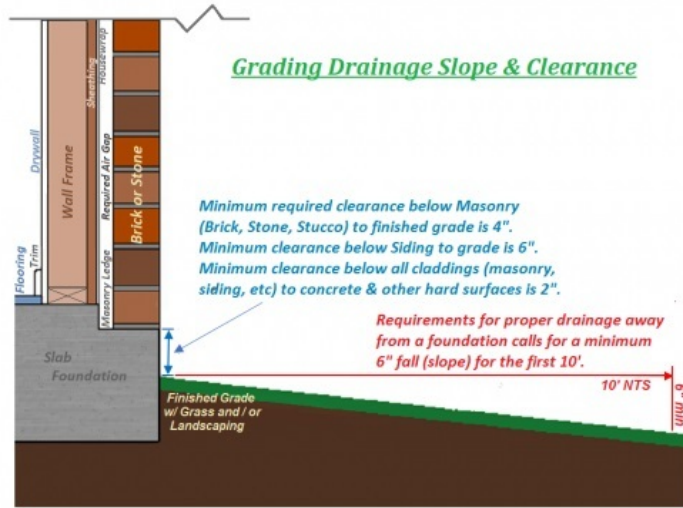
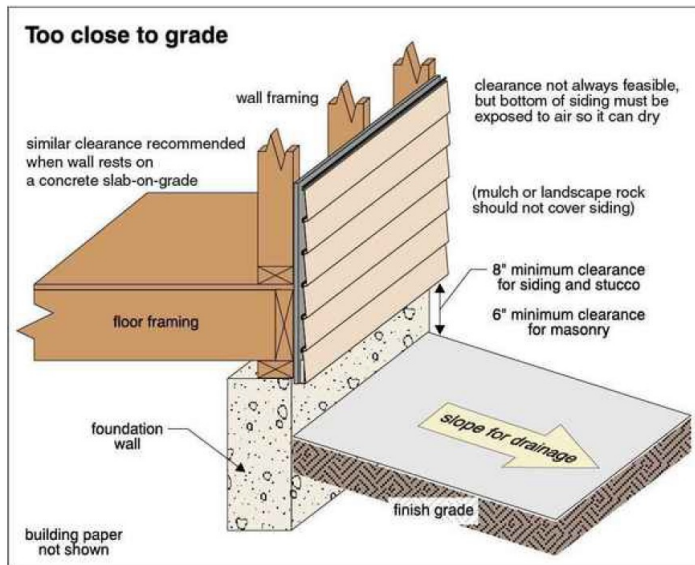
**1: Inadequate Clearance Above Grade**

Proper drainage is defined as grass and landscaping in place to move water away from the foundation and have no low spots to allow pooling next to foundation. The grading should promote the flow of storm water

away from the house and off the lot. The ground should slope away from the house at a rate of one inch per foot for at least the first ten feet. Ideally, at least 4-6 inches of clearance should be maintained between soil level and the top of the foundation walls.

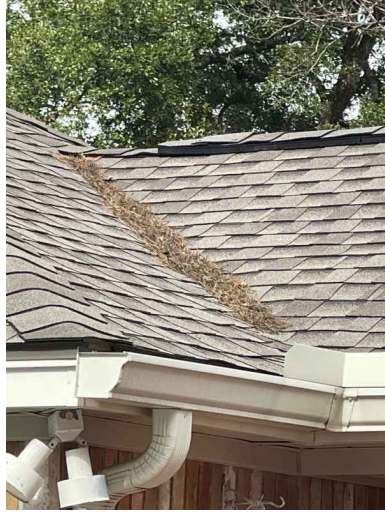
There was debris observed on the roof at the time of the inspection. Debris will hold moisture and negatively impact the roof covering material. I recommend removal of all debris on the roof.

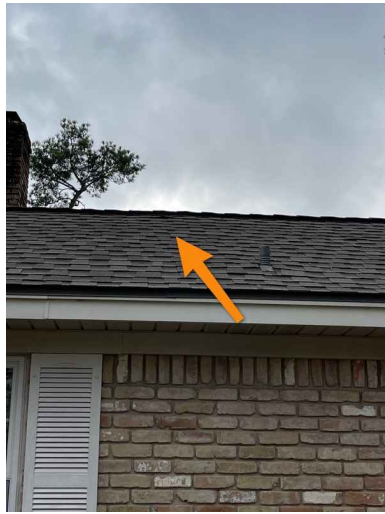
## 2: Raised Shingle

There are a couple raised shingles on the roof. Any raised sections of shingle can be easily blown upwards by strong winds. I recommend evaluation and repair by a qualified roofer.

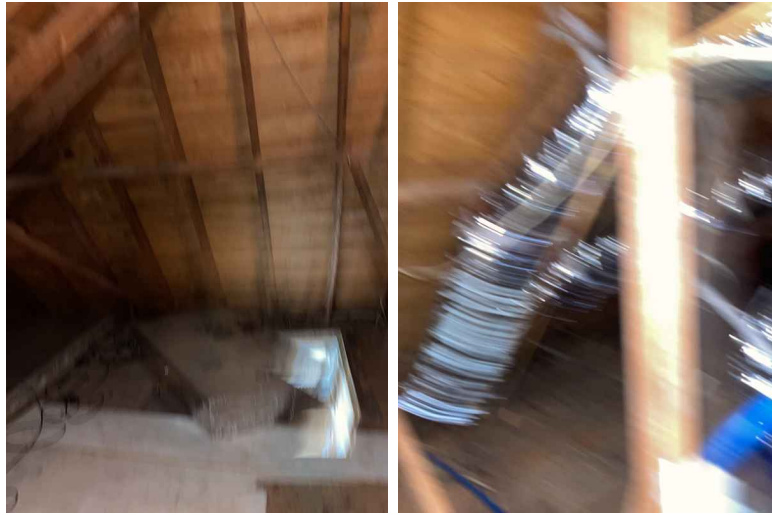
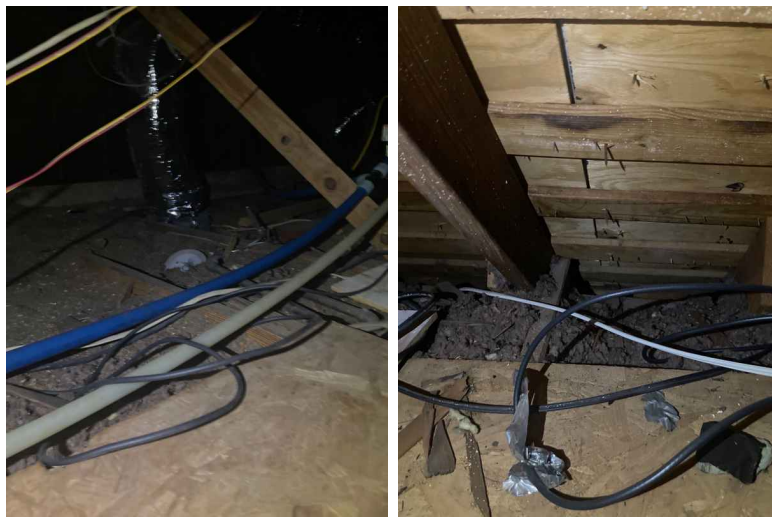
**1: Insufficient/Missing Insulation**

The insulation in the attic was insufficient and missing in some areas. This should be corrected immediately to prevent energy losses. I recommend a qualified attic insulation contractor re-install the appropriate level of insulation.

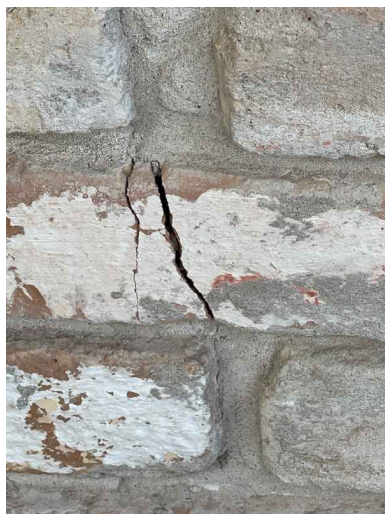
2nd Floor Balcony

**1: Exterior Brick/Stone Veneer Cracks**

There were minor cracks observed in the exterior bricks and brick joints at the time of the inspection. I recommend repair by a qualified contractor and monitor for any future movements.

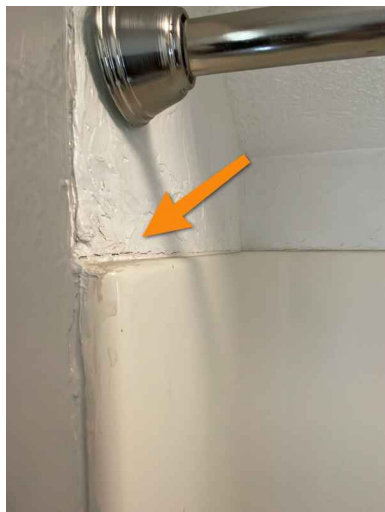
2nd Floor Bathroom

#### 6: Caulk/Grout - Shower/Bath

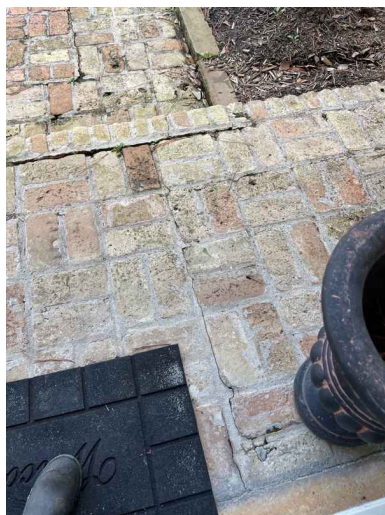
During the inspection of the property, it was observed that there were missing caulking and gaps at several areas around the floor of the home. Proper sealing of these areas is crucial to prevent issues such as moisture intrusion, air leaks, and potential damage to the property. I recommend having a qualified profession to address these deficiencies by properly sealing and caulking the identified areas.

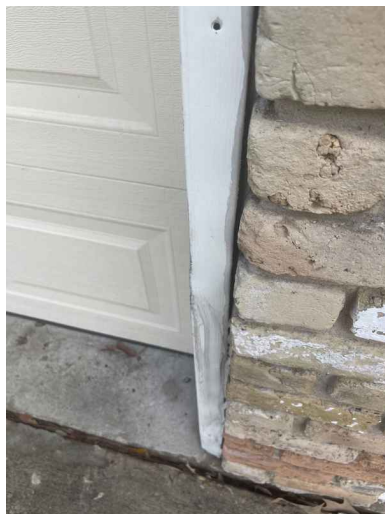
There are several areas of missing or gaps in caulking around the exterior doors. I recommend sealing all these areas with caulking.

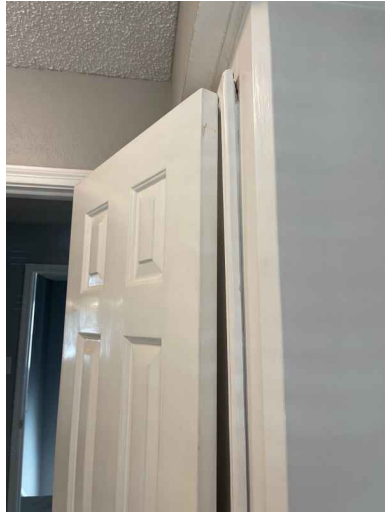
2nd Floor Bathroom

There were missing doorstops on several doors in the home. I recommend installation of door stops to prevent doors from striking the wall therefore damaging the adjacent wall.

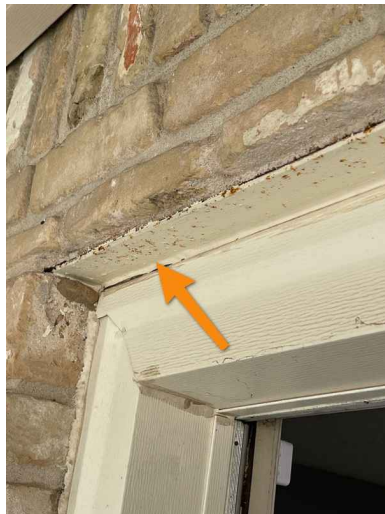
2nd Floor Balcony

### 6: Rusted/Exposed Lintels

Rusted lintels were observed unpainted or exposed in the following locations. Rusting of lintels cause expansion of the steel which may cause further damage to exterior wall cladding. I recommend cleaning, re-painting and sealing all exposed and rusted lintels.

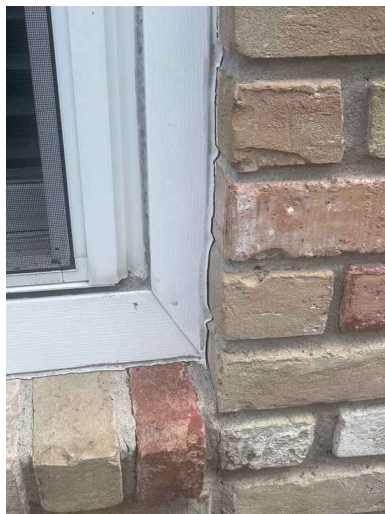
2nd Floor Front Left Corner Bedroom

There were gaps between the window frame and the window openings around several windows at the time of the inspection. I recommend sealing these areas with caulking to prevent moisture and possible pest penetration into the home.

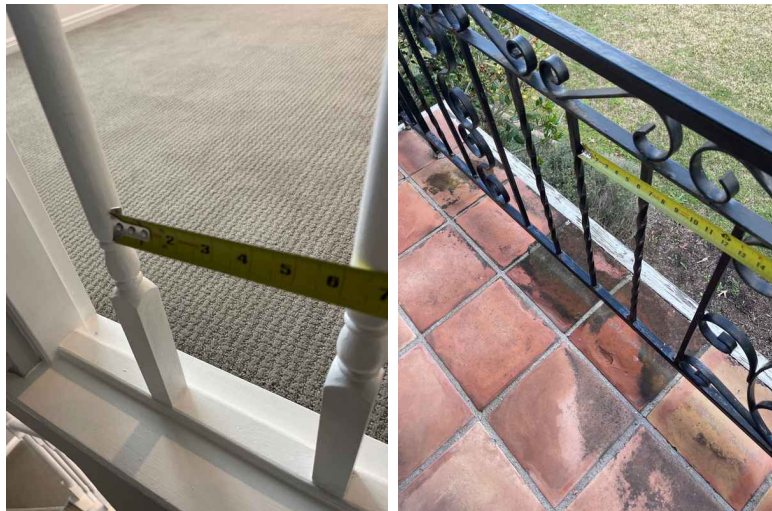
2nd Floor balcony

Vertical stair railing was not present. Vertical stair railing with no more than 4 3/8 inch spacing between the balusters, is recommended for safety.

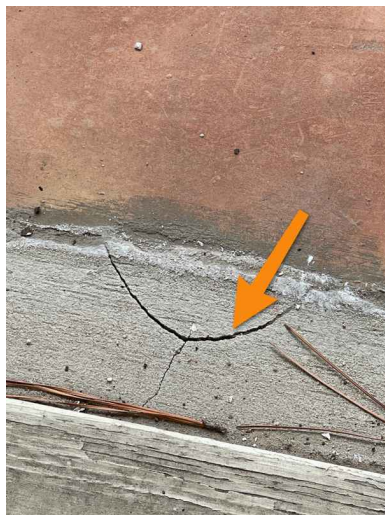
2nd Floor Balcony

## 2: Cracked Exterior Floor

There were minor cracks to the following exterior floor areas. I recommend sealing the cracks to prevent moisture penetration and deterioration over time.

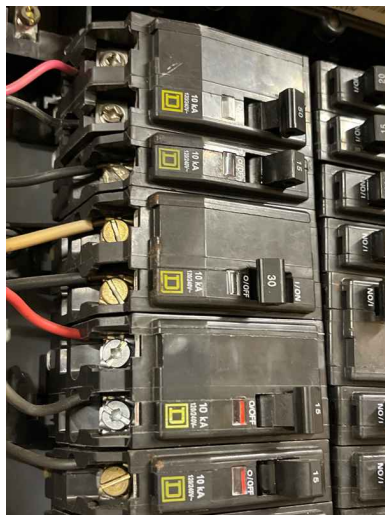
## 2: White Wires on Breakers

There were “white wires” attached to breakers. White wires are deemed neutral and must be identified as hot wires by tape or red or black paint at breaker end.

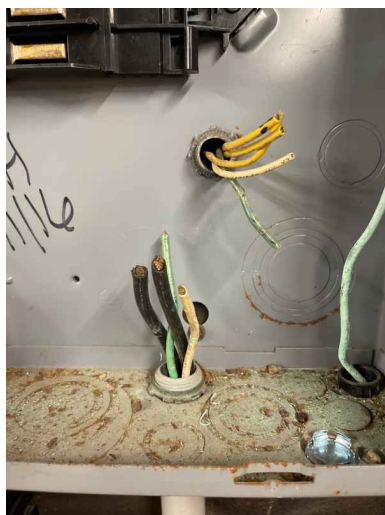
#### 4: Exposed Wires in Panel

There were exposed wires in the electrical panel. Exposed wires can come into contact with live wires in the panel, creating arcs and fires. This presents a hazard that should be immediately rectified.

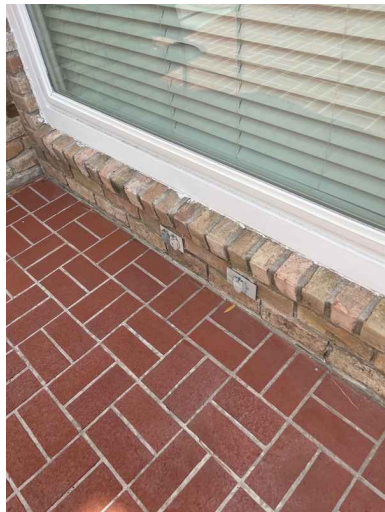
The following exterior electrical outlets do not meet this requirement and should be replaced with the appropriate bubble cover.

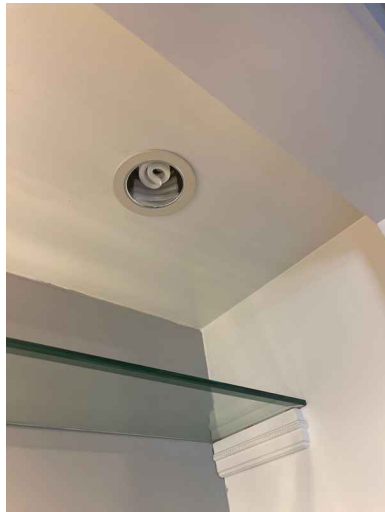
Dining Room

### 3: Missing/Blown Bulb

There are several blown or missing light bulbs in light fixtures around the home. I recommend replacing the blown/missing light bulbs.

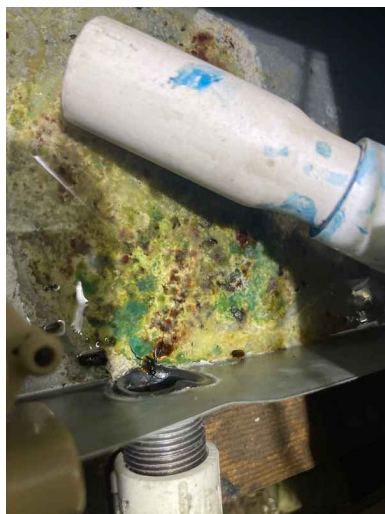
There is evidence of condensation in the attic on or around the unit and in the pan. I recommend that these areas be checked by a qualified HVAC contractor.

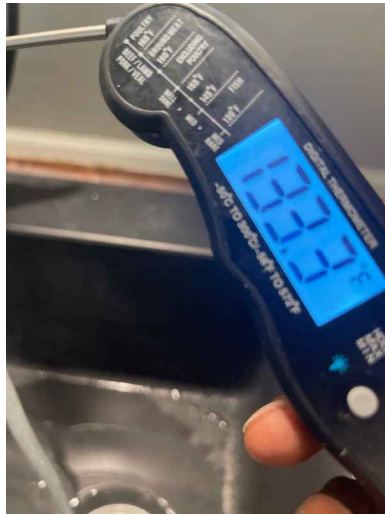
**1: Water temperature too hot**
