DualCheck Inspections LLC
Effective.Efficient.Everytime

03/31/2022

PROPERTY INSPECTION REPORT FORM

Address of Inspected Property: 29002 Dryander Forest Ct. Katy, Texas

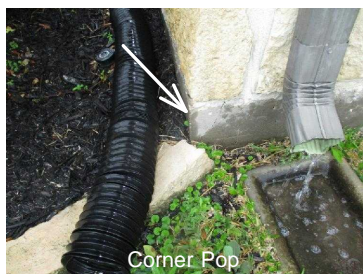
- There were cracks noticed at the corners of the exposed foundation walls. these are referred to as "Corner Pops", they are very common and not a structural issue at this time. However, They should be properly sealed to prevent further deterioration.
- The foundation appears to be performing as intended at the time of the inspection, common settling was noticed.

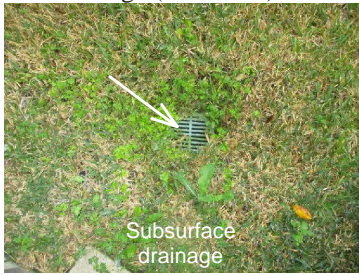
- Sub surface drainage was observed but could not be fully evaluated for performance. Water was draining towards grates/drains at the time of the inspection.

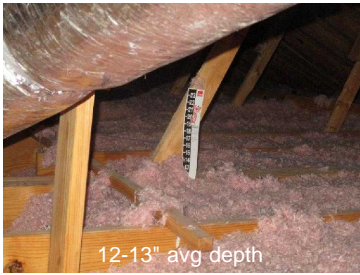
- All wood members appear to be performing as intended at the time of the inspection.
- Insulation appeared to be evenly installed at all required areas and achieving the appropriate R-value.

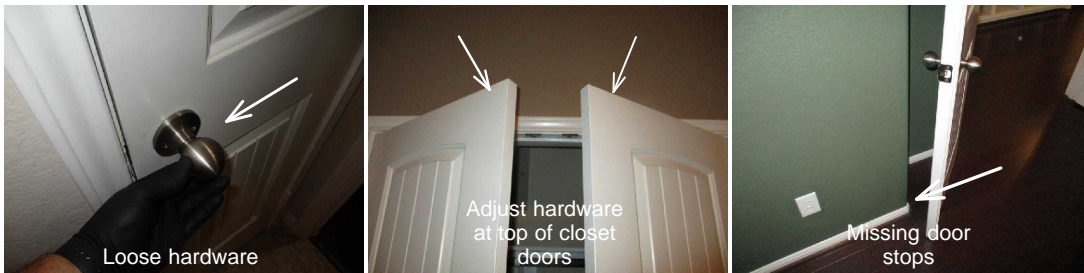
- Several doors are in need of minor adjustments due to loose or worn hardware. Repair/Replace as needed.
- A few door stops were missing throughout the home. Recommend installing door stops to prevent damage to drywall.

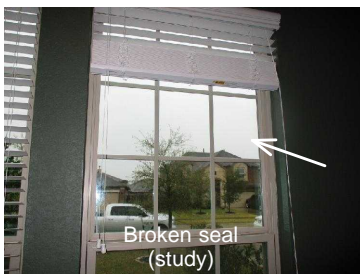
- A window in the study, was observed to have stains on the interior sides of the panes. This is the result of a broken seal. A broken seal does not diminish the integrity of the windows. However, it does lose the majority of its energy efficiency features once the seal is broken. Repair/Replace as needed.

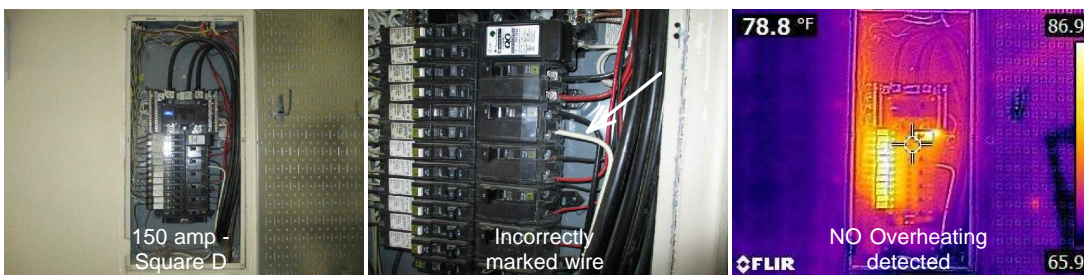
- White wire used for the AC power distribution, was connected to the breaker with no colored tab for identification. This is a safety hazard. Recommend proper labeling of the wire(s).
- The main service wires and electrical panel appear to be performing as intended at the time of the inspection.
- The thermal camera did not detect any areas of overheating breakers or wiring, within the electrical panel.

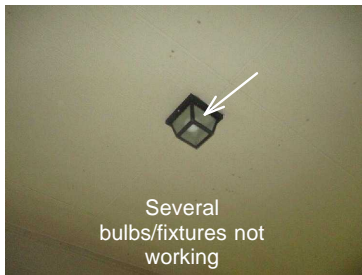
- Several light fixtures throughout the home were not functioning at the time of the inspection. Possibly bulb related. Repair/replace as needed.

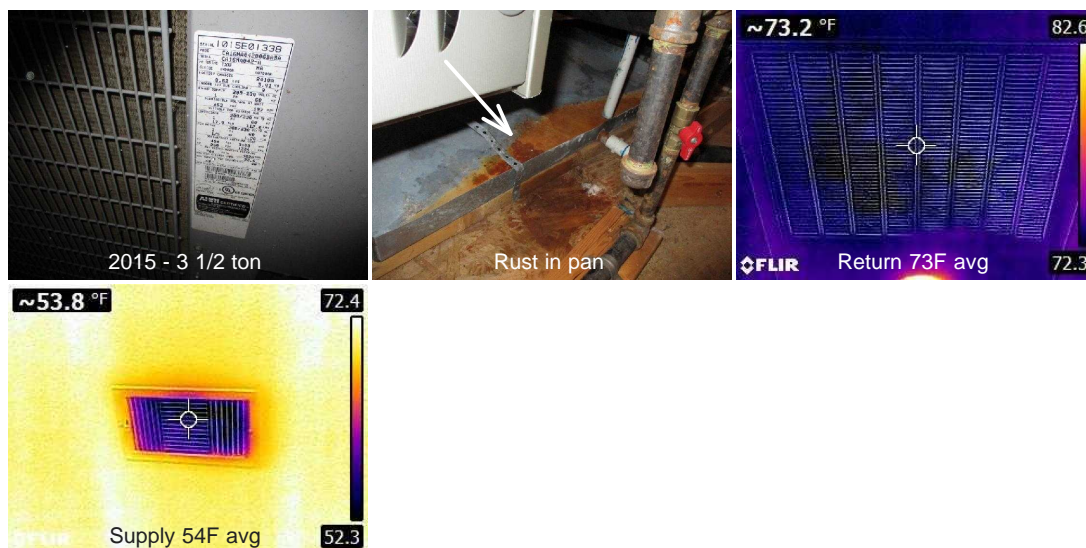
- Rust was observed in the drain pan, this indicates there has been a continuous issue with the primary/secondary drain lines.

- The Cooling equipment was performing as intended at the time of the inspection.
- The thermal camera did not detect any leaks from the condenser or exposed liquid/suction lines at the time of the inspection.

- Rust was observed in the drain pan, this indicates there has been a continuous issue with the primary/secondary drain lines. Recommend A licensed and insured HVAC technician clear drain lines and service equipment if not done so in the past year.

Recommend A licensed and insured HVAC technician clear drain lines and service equipment if not done so in the past year.

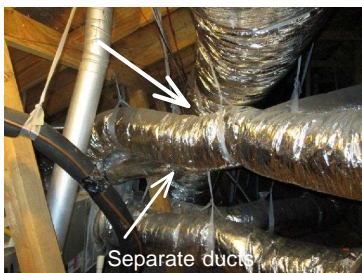
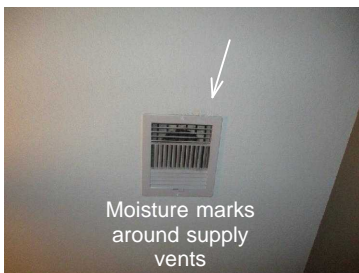
- Duct work touching / overlapping at several locations. These areas should be separated with batt insulation to prevent the buildup of condensation between the ductwork.
- Moisture marks were observed at some vents at the bedrooms, possibly due to built up condensation on the interior of the ductwork. This is a common issue when ductwork is touching at the attic or a system is in need of service. Recommend having an HVAC technician service the equipment if not done so in the past year.

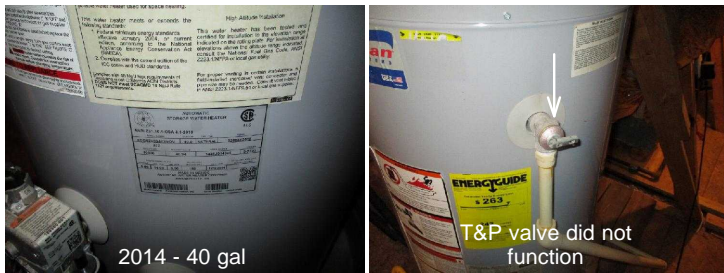
- The temperature and pressure relief valve (T&P) for the water heater would not function properly at the time of the inspection. T&P valves protect the water heater equipment from excess pressure. Repair/Replace as needed.

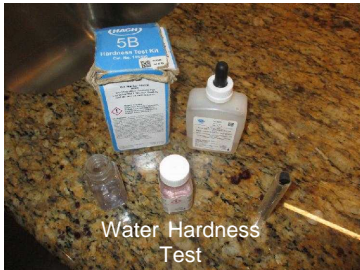
Classification	Mg/L	GPG
Soft	0-17	0-1
Slightly Hard	17-60	1-3.5
Moderately Hard	60-120	3.5-7.0
Hard	120-180	7.0-10.5
Very Hard	>180	>10.5
Current reading :	136.8	8

HARD

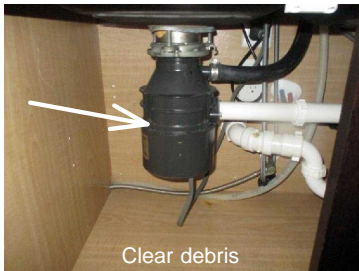
- The Garbage Disposal appeared to have debris trapped inside at the time of the inspection. Recommend cleaning to prevent damage.

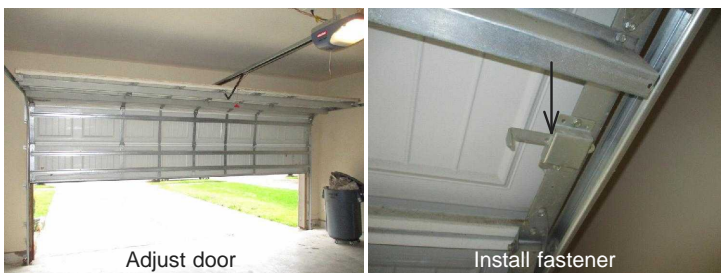
- The overhead garage door operator is in need of maintenance or adjustment. The lift was making excessive noise and in need of lubrication/adjustment. Repair/Replace as needed.

- There should be a fastener installed to disable the locking mechanisms for the overhead garage door, when there is a operator installed. This prevents the door from being locked and damaged. Correct as needed.

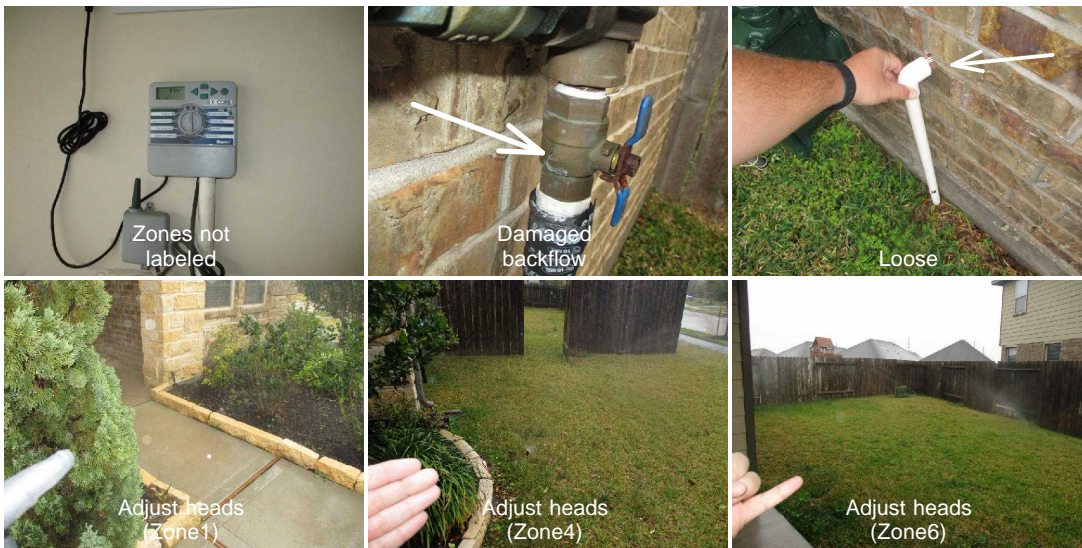
- The backflow for the irrigation system was observed to be cracked at the supply valve, this appears to be from the recent freezing temperatures. The damaged backflow only leaks when turning the valve on or off, not when it is in the on or off position. Correct as needed.

- The conduit that protects the electrical wiring for the irrigation system panel, should be properly secured to the panel and exterior wall. Repair/Replace as needed.

- Several zones have sprinkler heads that are in need of adjustment. heads should not spray structures, flat concrete surfaces, neighboring yards or fences, and should fully cover their zones. This helps to prevent wasting water and deteriorating surrounding features. adjust as needed.
